**2015 ANNUAL REPORT ON
THE CONDITION OF THE MUNICIPAL BEACHES FOR
THE BOROUGH OF STONE HARBOR, CAPE MAY COUNTY, NEW JERSEY**

**PREPARED FOR: THE BOROUGH OF STONE HARBOR
9508 SECOND AVENUE
STONE HARBOR, NJ 08247**

**PREPARED BY: THE STOCKTON UNIVERSITY COASTAL RESEARCH CENTER
30 WILSON AVENUE
PORT REPUBLIC, NEW JERSEY 08241**

February 29, 2016

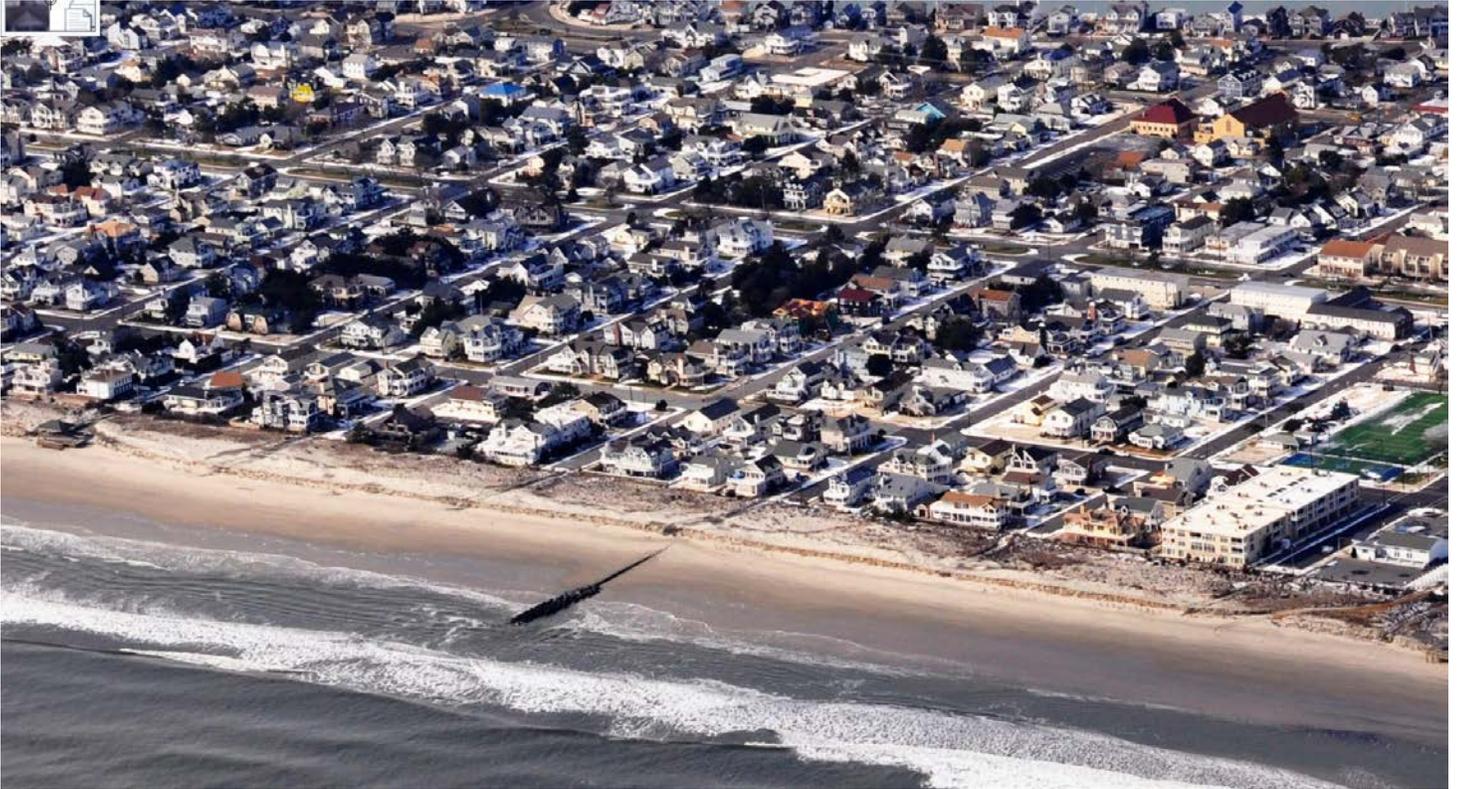
View to the Borough of Stone Harbor on Seven Mile Island. The photo shows the condition of the municipal shoreline two days following northeast storm Jonas on January 24, 2016. The beach and dune were impacted with erosion generating a scarp here between 95th (right) and 101st (left) Streets in the Borough. (Photo by Ted Kingston, January 26, 2016)

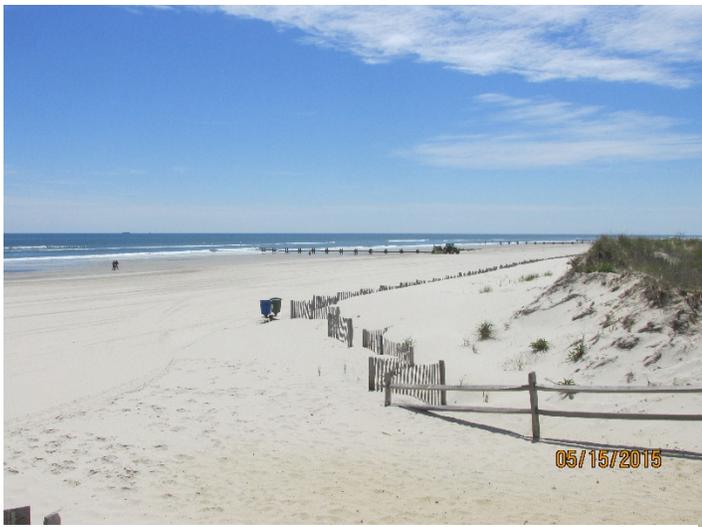
Photoplate 1a - Photo taken May 15, 2015. View to south along the dune toe from 82nd Street. The dune fence installed after the ACOE project to capture aeolian sand had almost filled, but the beach remained relatively narrow.

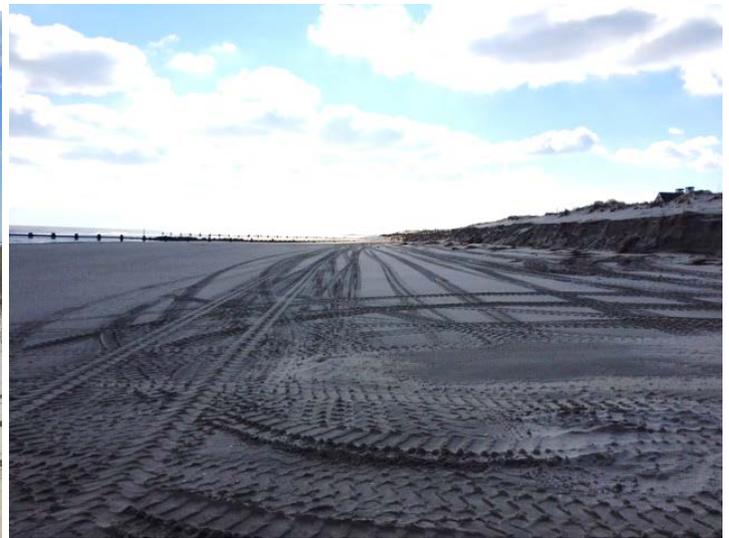
Photoplate 1b - Photo taken February 11, 2016 following both Jonas and a more minor event February 7, 2016. The dune was eroded into the seaward slope removing about half the toe slope. The beach was flat and low enough such that high tide was easily able to reach the dune scarp. All fencing was destroyed.

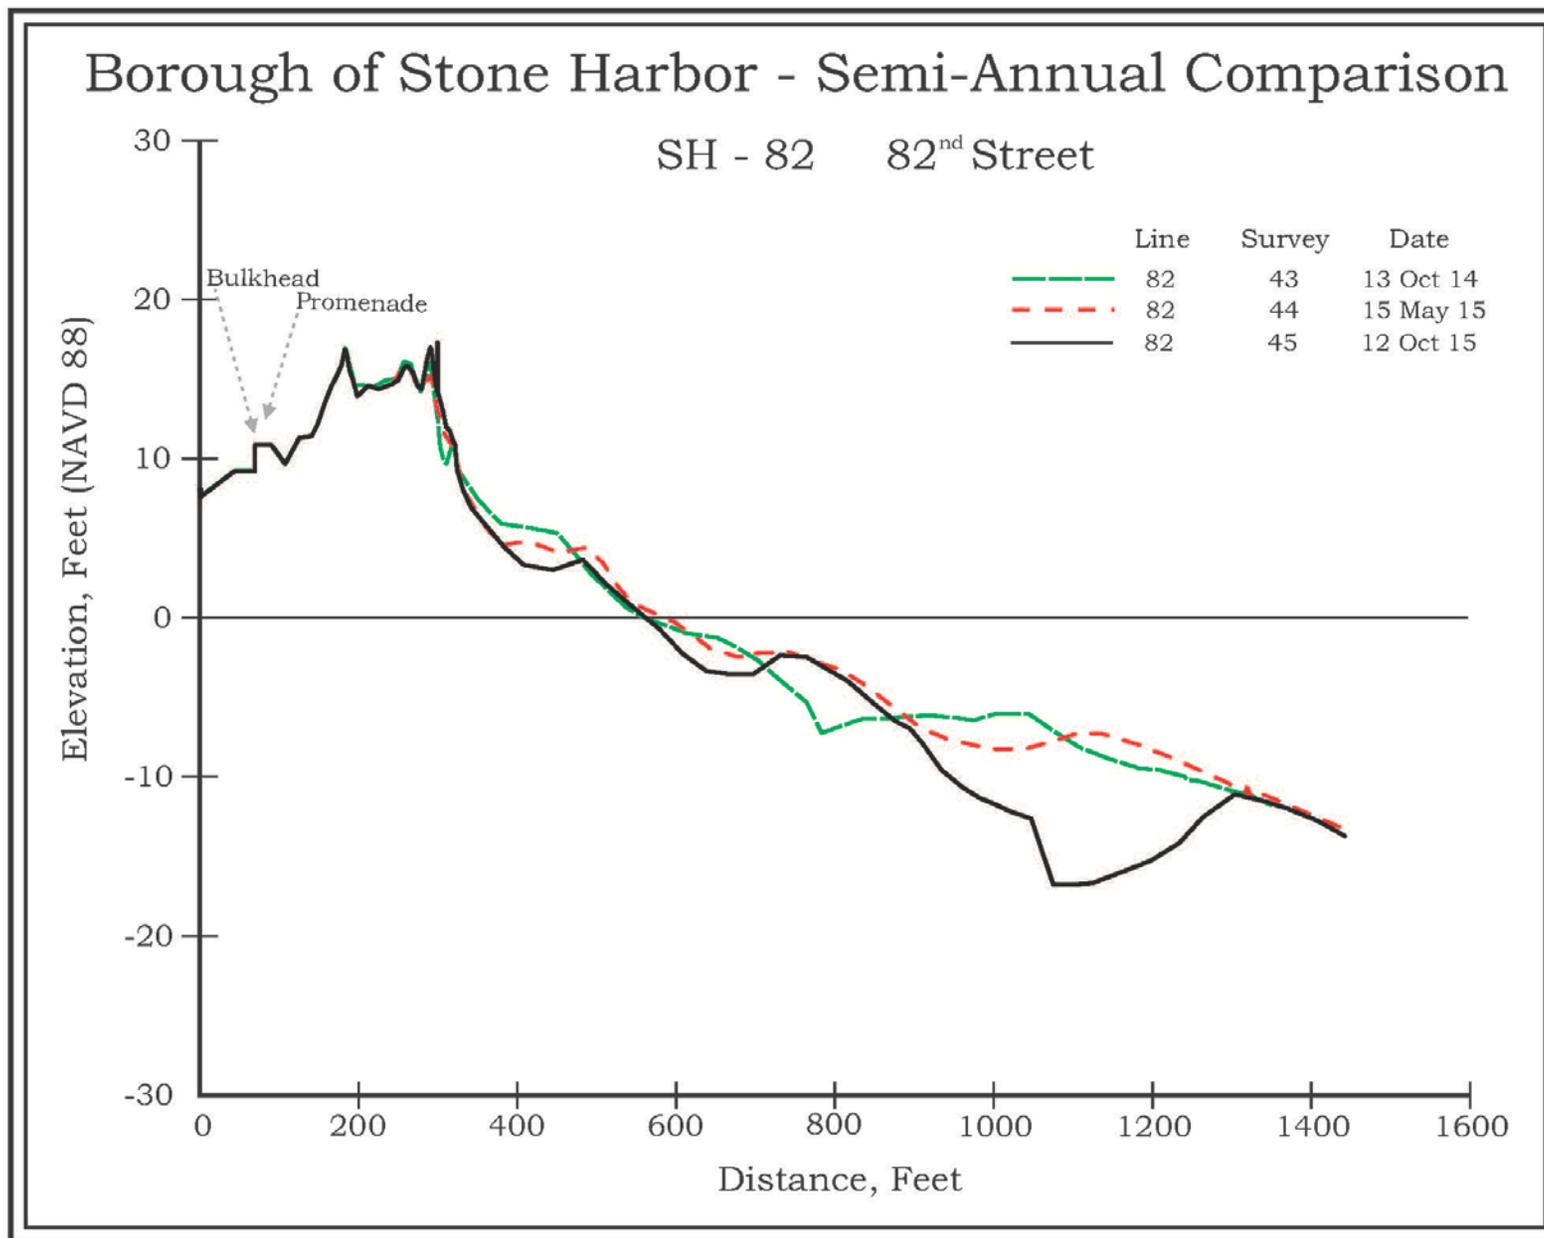
Figure 1a. The post-initial northeast storm of 2015's winter months contributed to the loss in berm elevation shown on the plot for Oct. 12, 2015 above. Waves also generated a deep trough offshore that contributed the lion's share of the seasonal loss recorded (-93.17 yds³/ft.). Stone Harbor has a long history of major offshore troughs that follow storms where the sand is moved over 1,000 feet from the reference position. The dunes remained undamaged until Jonas in late January 2016.

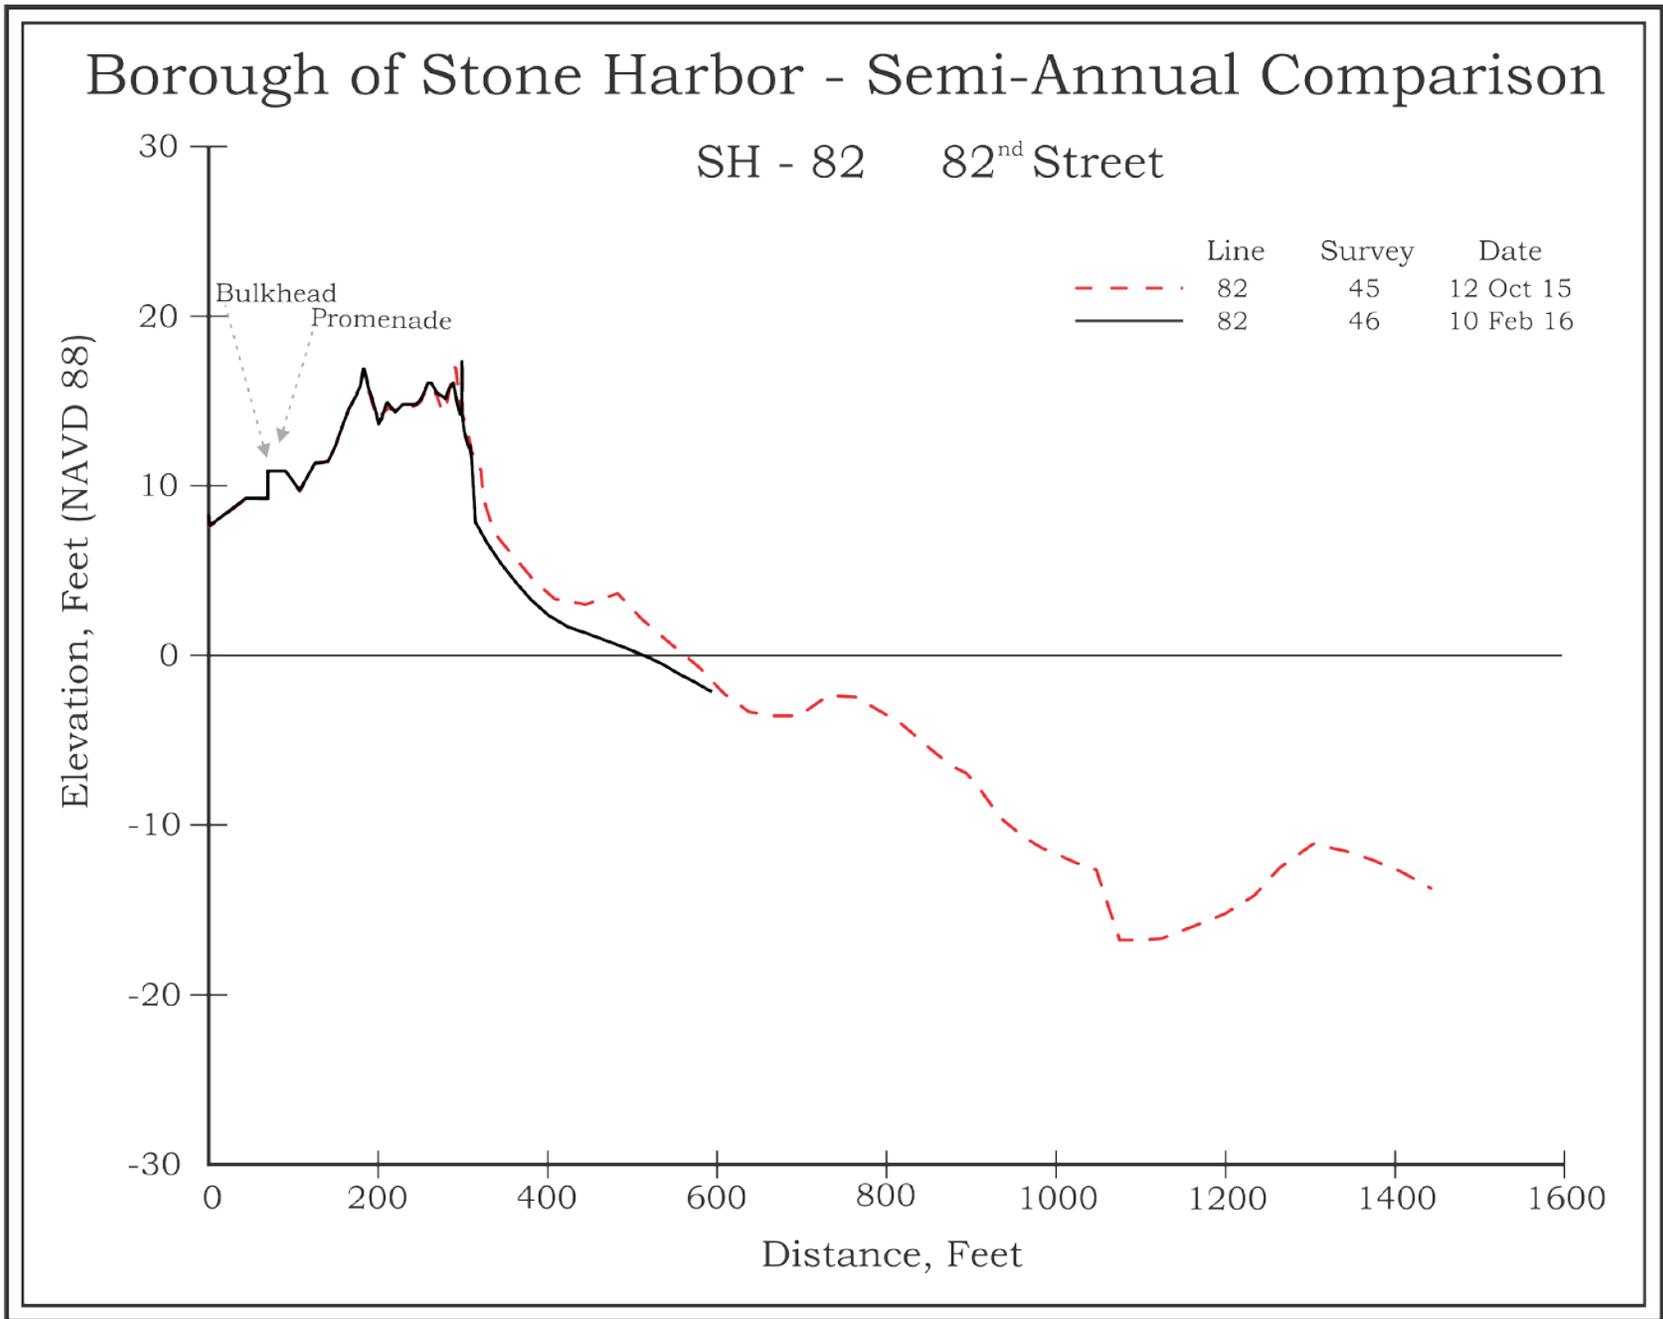
Figure 1b. Post-Jonas erosion at the dune's seaward slope and on the beach compared to conditions from October 12, 2015, which followed 3-4 days of northeast winds. The storm related loss was 15.99 yds³/ft. from the dune to the zero elevation datum (NAVD 1988); followed by a 2.24 yds³/ft. loss below the datum to the end of the survey.

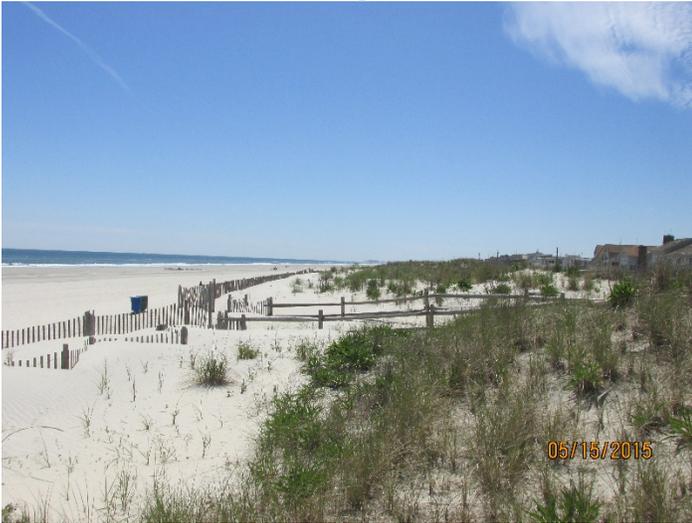
Photoplate 2a - Photo taken May 15, 2015. View to south along the row of dune fence from 90th Street. Aeolian sand had begun to accumulate around the base of the fence, filling in to expand the seaward dune slope.

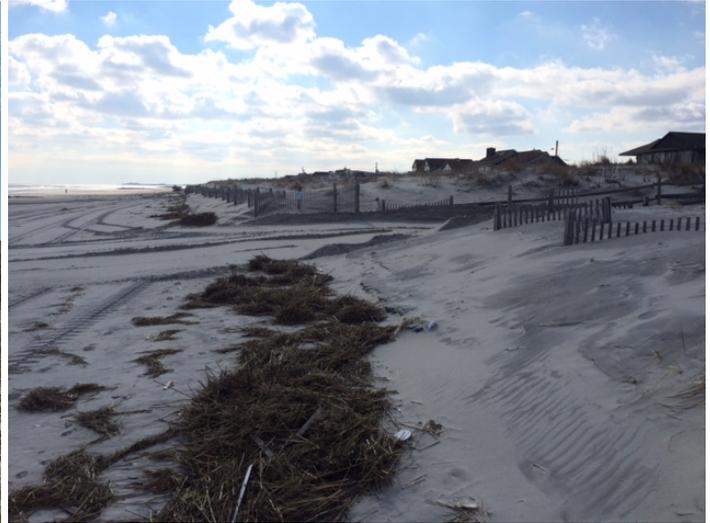
Photoplate 2b - Photo taken February 11, 2016 following Jonas and a second event two weeks later. The wrack line reached the beach entrance at the dune toe making a small scarp in places. The dune fence was still unaffected at this location.

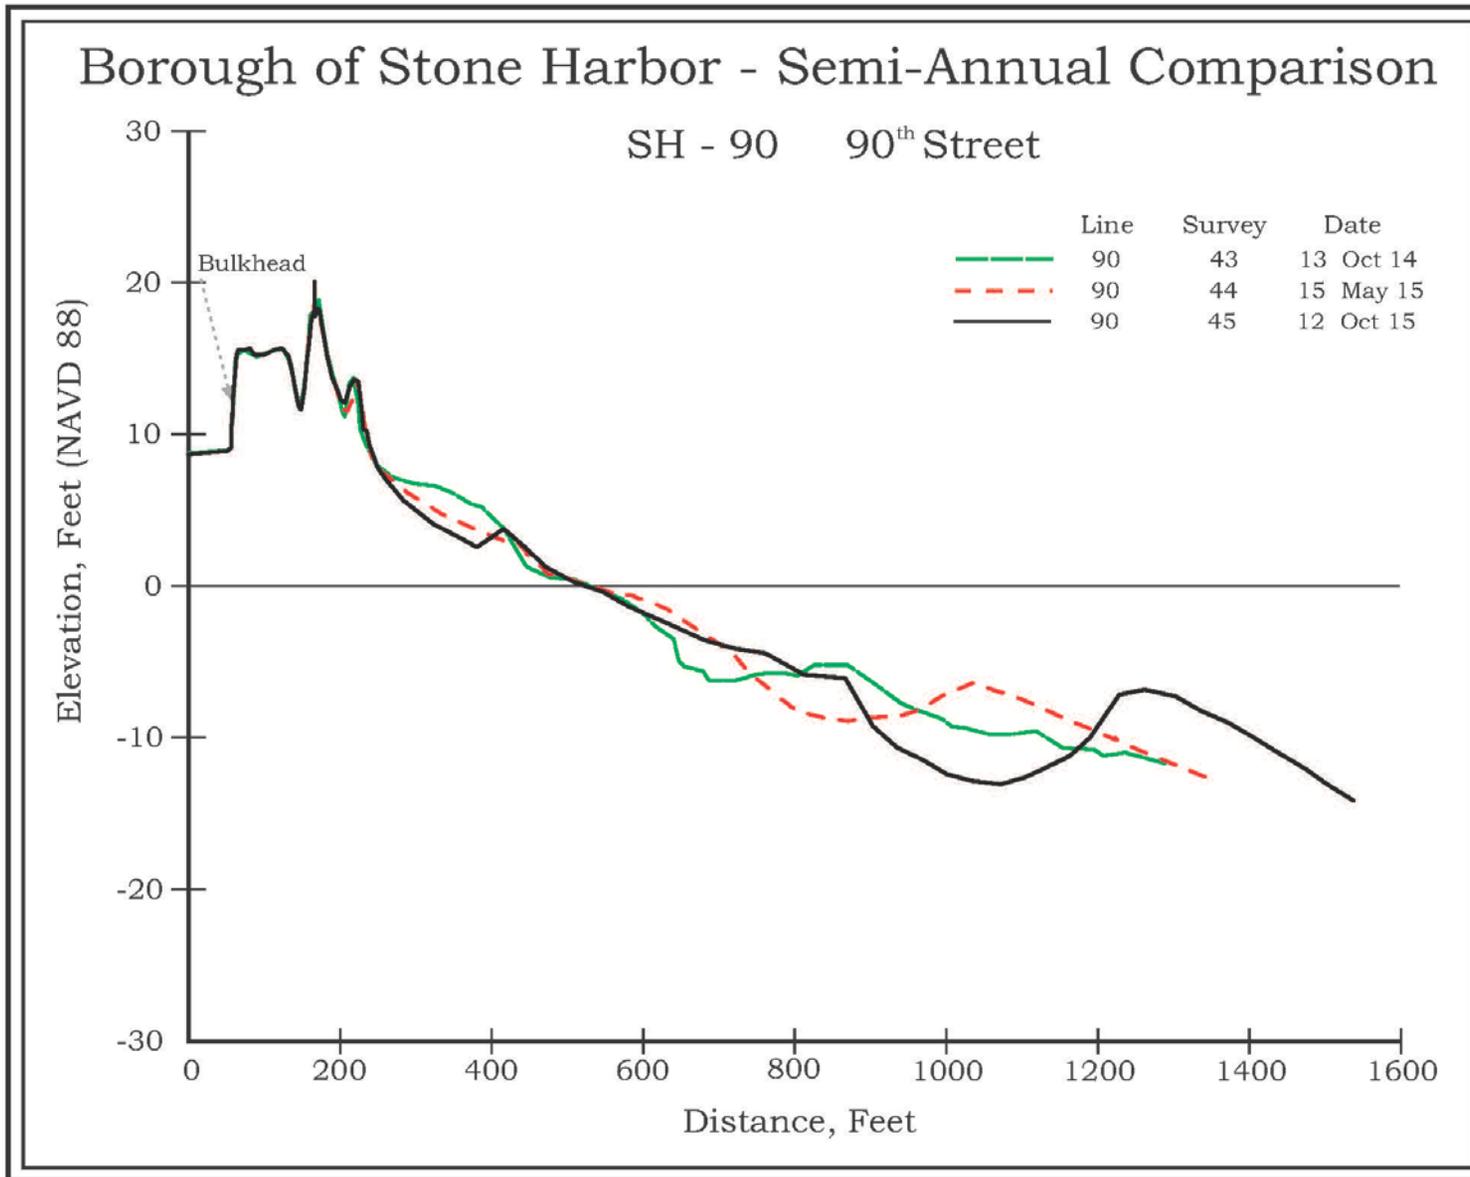
Figure 2a. The beach lost elevation, but remained the same width to the zero elevation datum. The early October 2015 northeast storm flattened the berm, but left the dune untouched until Jonas in January 2016. Note that the bar and trough offshore responded to the October storm by switching between a relatively gentle gradient between zero elevation and the end of the survey to one where there was a deep trough followed by a bar 4 feet higher than previously. The site saw a -12.21 yds³/ft. sand volume change that did not reflect the entire bar deposit due to the length of earlier profiles.

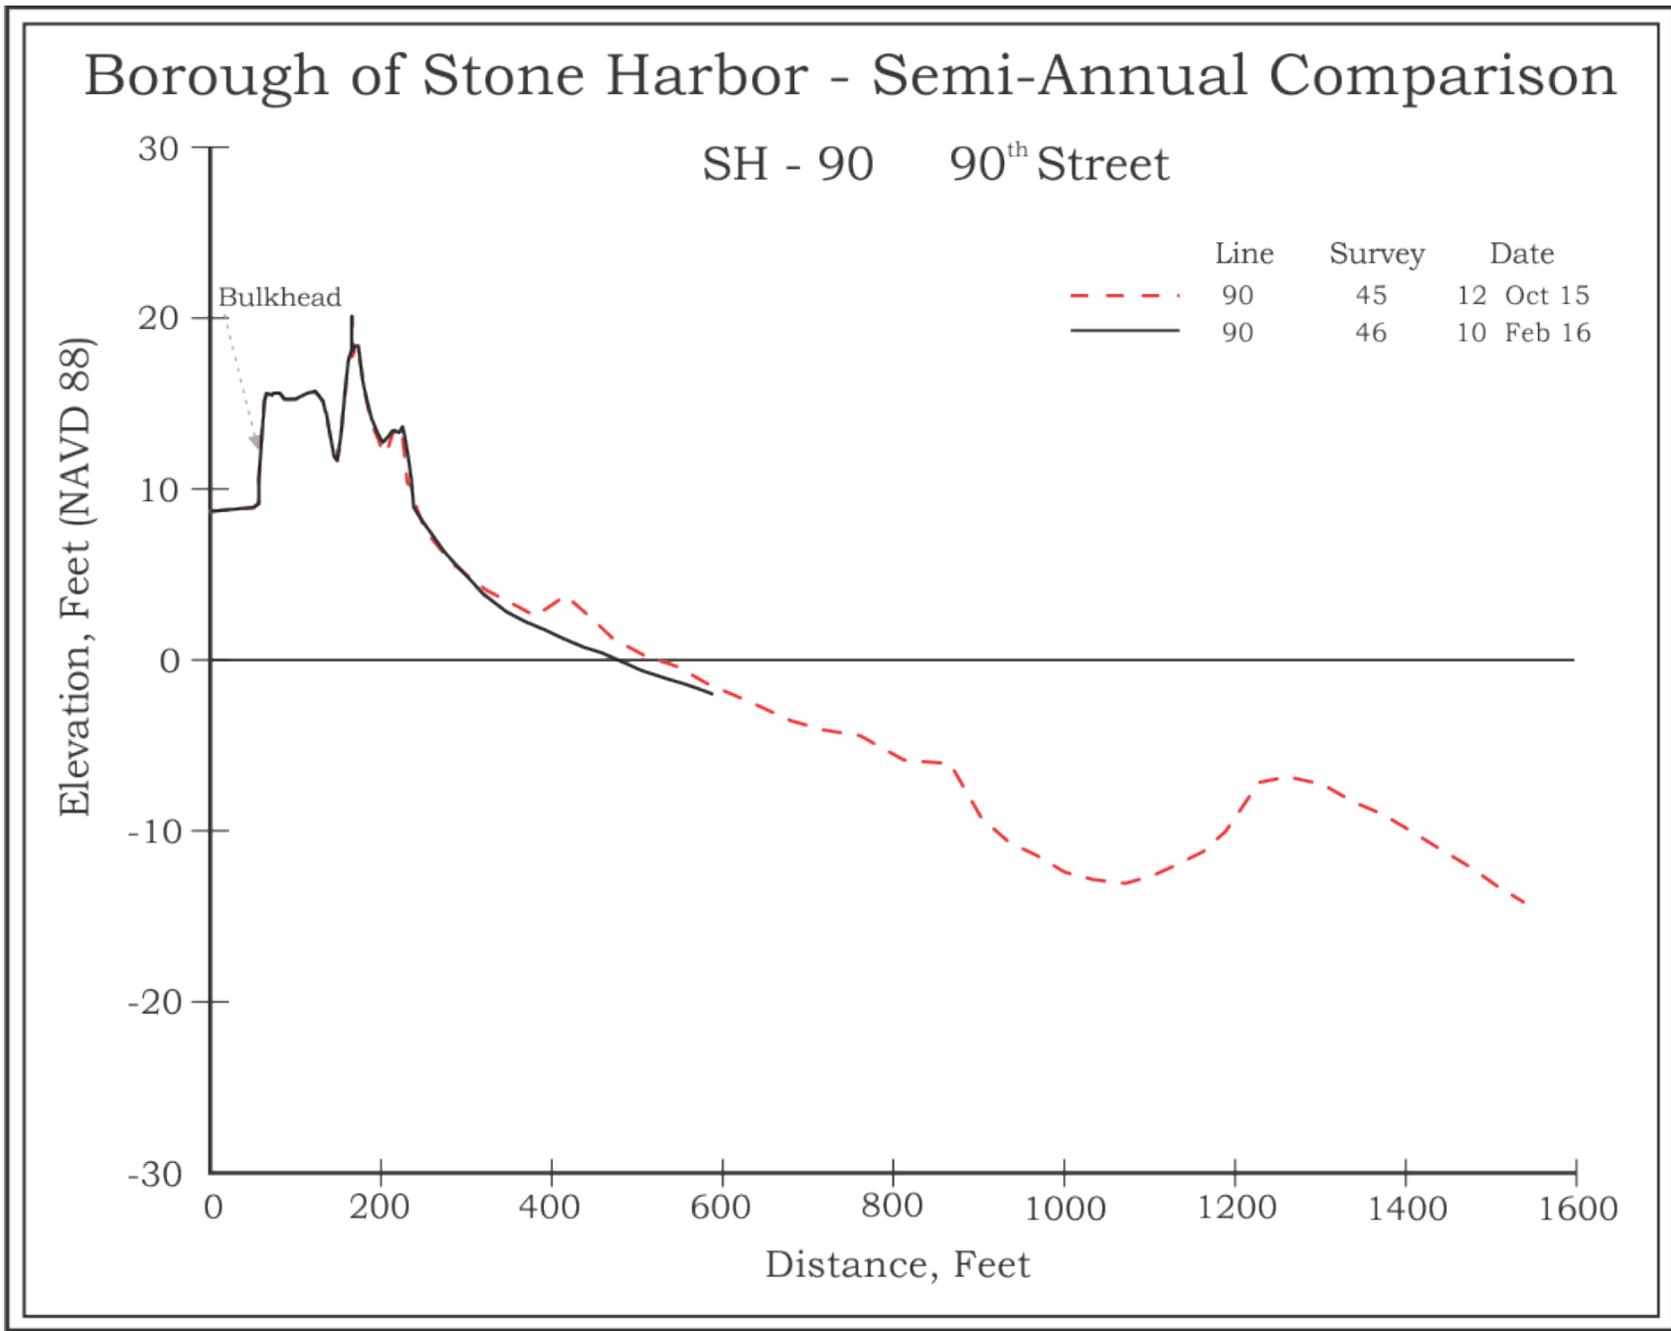
Figure 2b. Post-Jonas erosion on the beach compared to conditions from October 12, 2015, which followed 3-4 days of northeast winds. The storm related loss was 7.20 yds³/ft. above the zero datum and 2.65 yds³/ft. below the datum to the end of the survey line. This site suffered little dune loss.

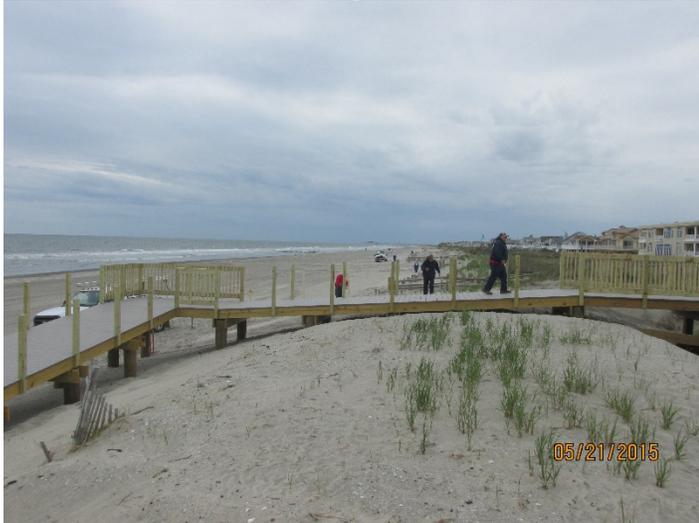
Photoplate 3a - Photo taken May 15, 2015. View to south along the dune toe from 95th Street. A new access ramp featuring ADA access was built and withstood the Jonas storm. The erosion into the dune approximates where the individual standing at the edge of the grass is positioned in the photograph.

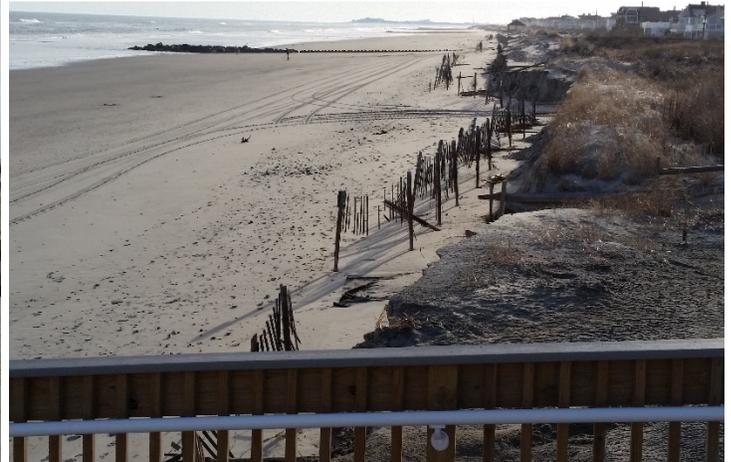
Photoplate 3b - Photo taken January 25, 2016 following Jonas. The access ramp was undercut and exposed. The last segment of the railing was gone, otherwise the structure was fine. The dune fencing was destroyed in both directions with 25 feet of seaward slope erosion beyond the fencing position.

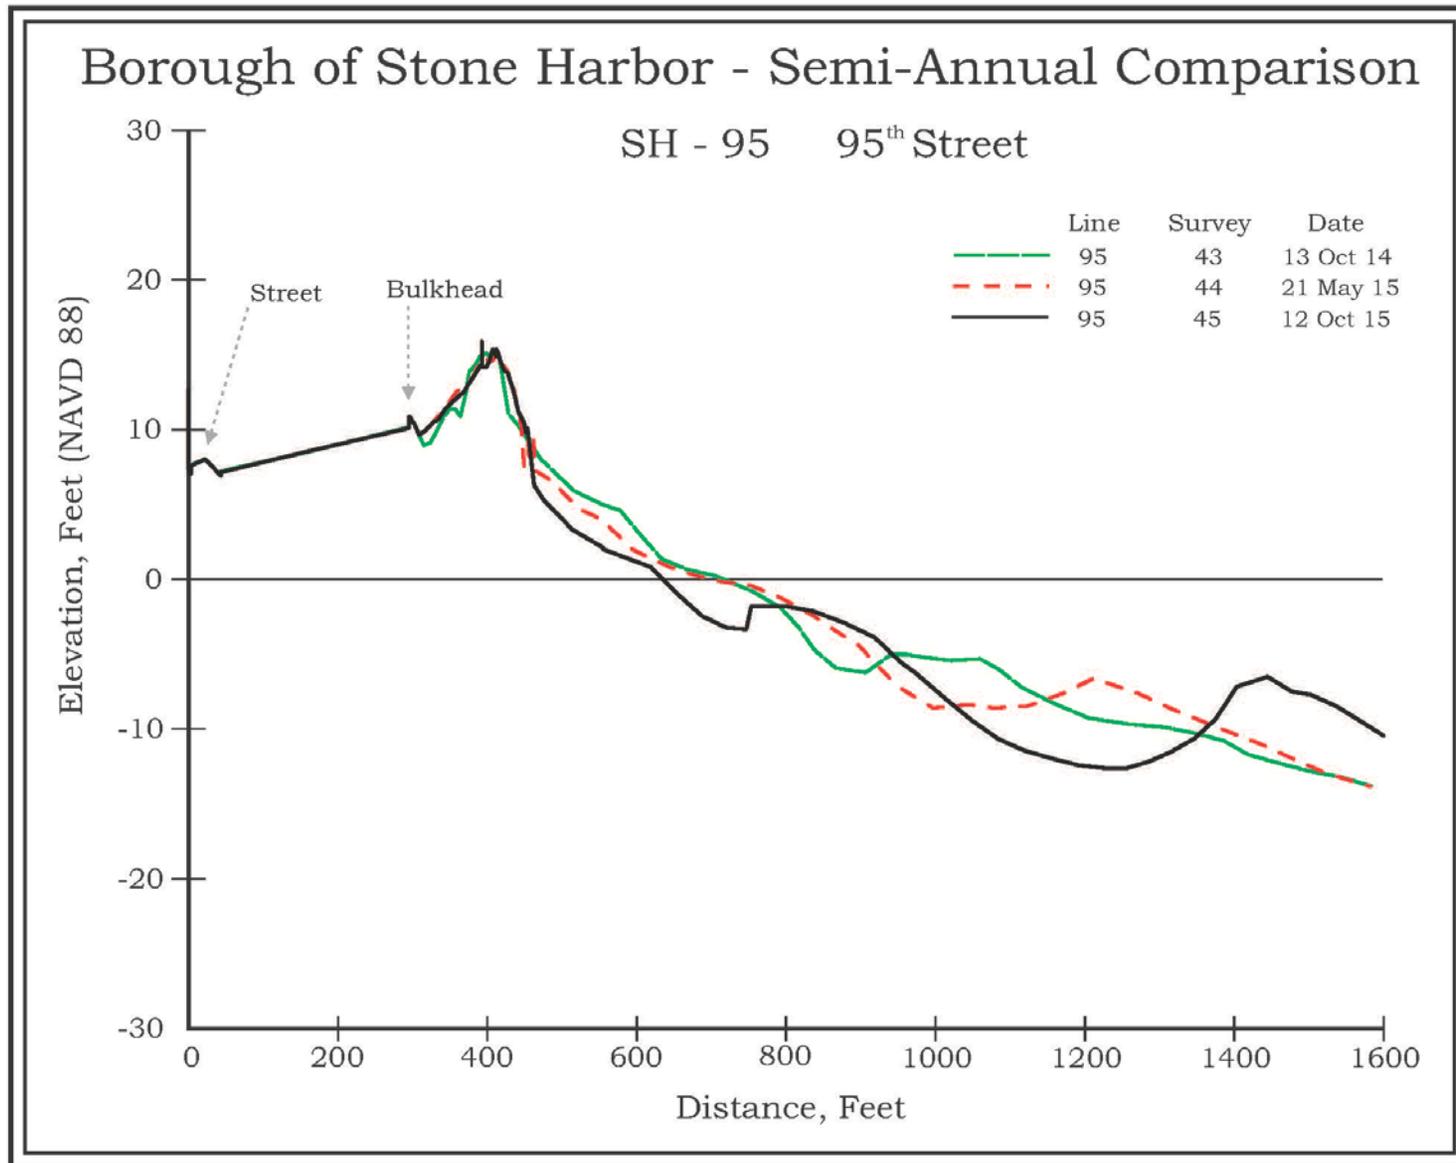
Figure 3a. At 95th Street the storm impact shows as dune erosion into the seaward toe as well as significant berm elevation loss. The shoreline retreated 67 feet (largest value documented) and the profile lost 24.02 yds³/ft. The offshore region also developed a major trough over 400 feet wide with a 4.5-foot higher bar developed further offshore. This bar substantially reduced the net loss to the system, but recovery will require extended periods of calm wave conditions.

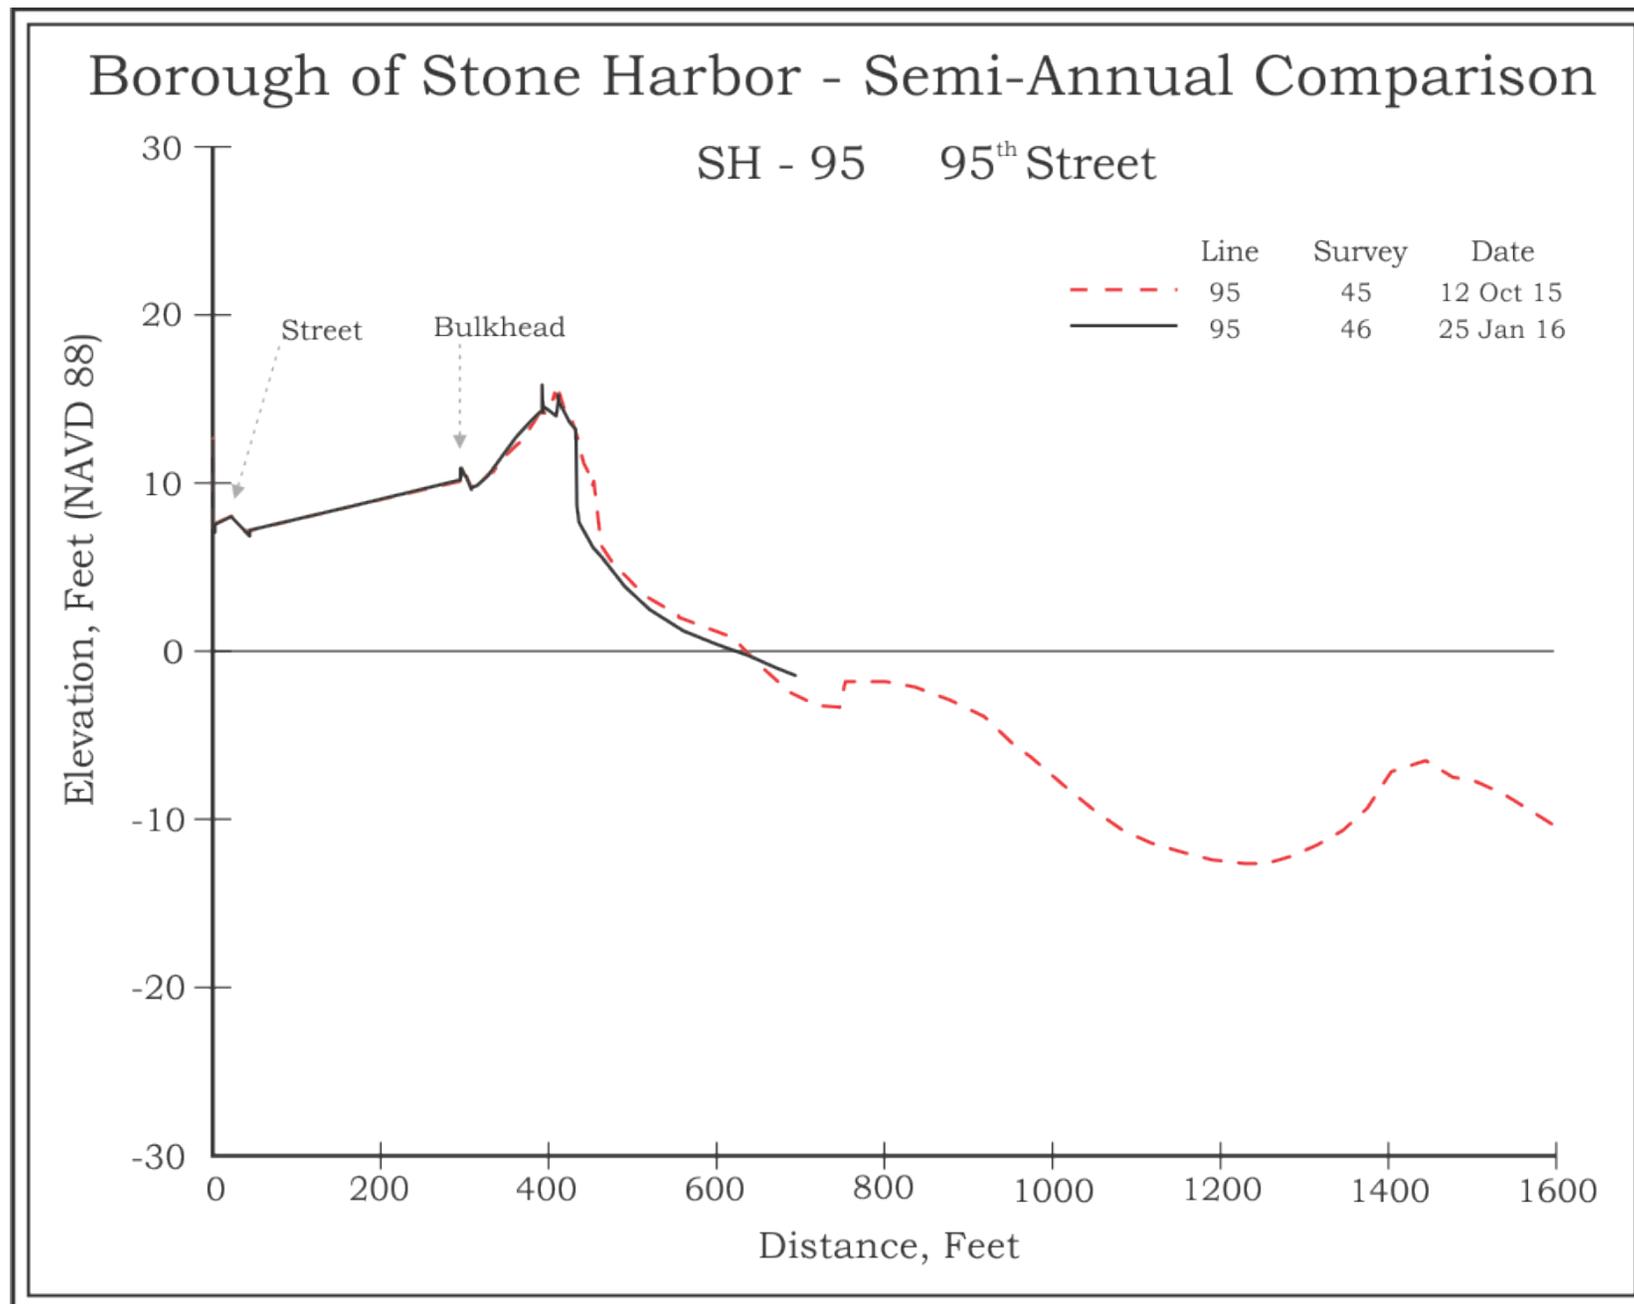
Figure 3b. Post-Jonas erosion at the dune's seaward slope and on the beach compared to conditions from October 12, 2015, which followed 3-4 days of northeast winds. The storm related loss was 7.82 yds³/ft. above the zero elevation datum, and a small gain of 1.27 yds³/ft. below the datum as the nearshore bar trough filled in with sand.

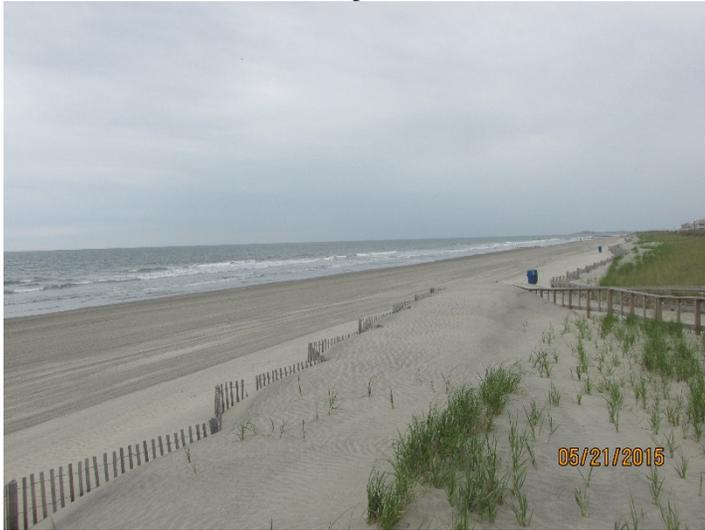
Photoplate 4a - Photo taken May 21, 2015. View to the south along the dune toe from 103rd Street access pathway. The beach remained narrow from the previous fall survey. Wind-blown sand accumulated on the seaward dune slope that reduced the steep scarp and restored a gentler uniform slope.

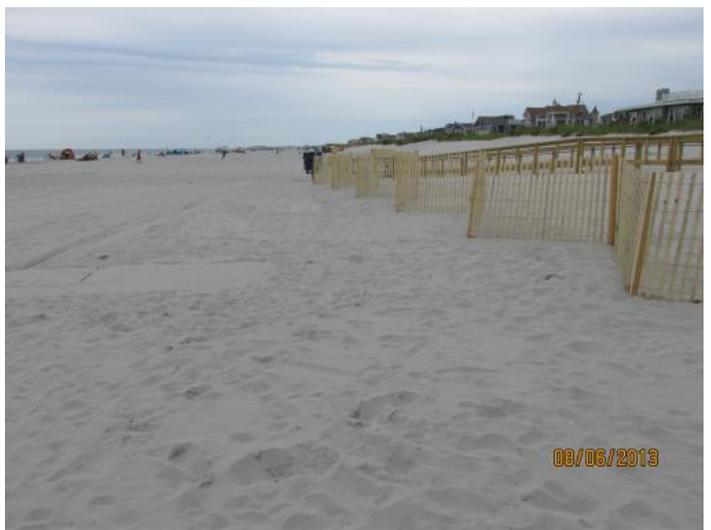
Photoplate 4b - Photo taken August 6, 2013 (spring 2013 survey [40]). View to the south along the dune toe from 103rd Street. The 2013 USACE beach maintenance project restored the beach width and elevation to the original design template. Sand was placed on the seaward dune slope and a row of dune fence was installed to trap windblown sand.

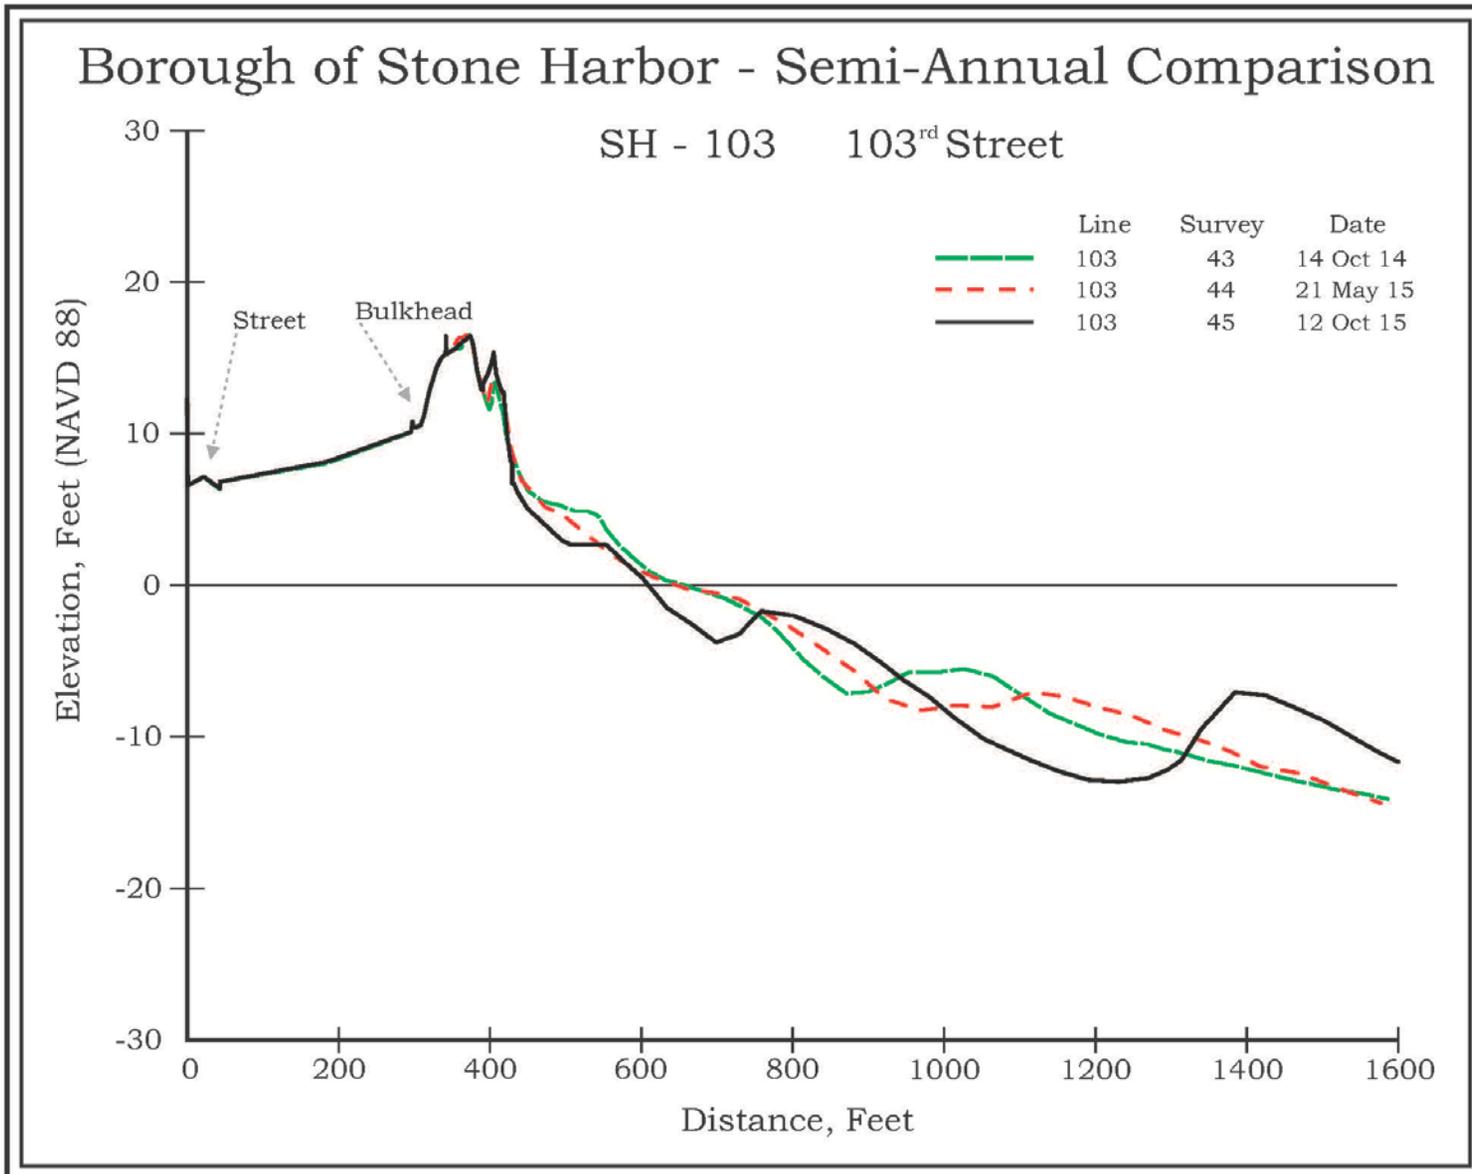
Figure 4a. Dune toe losses continued south into this groin cell as well leaving a minor scarp and a 39-foot shoreline retreat. The berm elevation was reduced similar to elsewhere and the offshore trough developed to a 400-foot wide area between 1,000 and 1,400 feet seaward of the reference location. The sand deposited in the offshore bar balanced the beach and nearshore losses yielding a -12.81 yds³/ft. net loss, a volume easily present in the bar beyond the point 1,600 feet seaward of the street end.

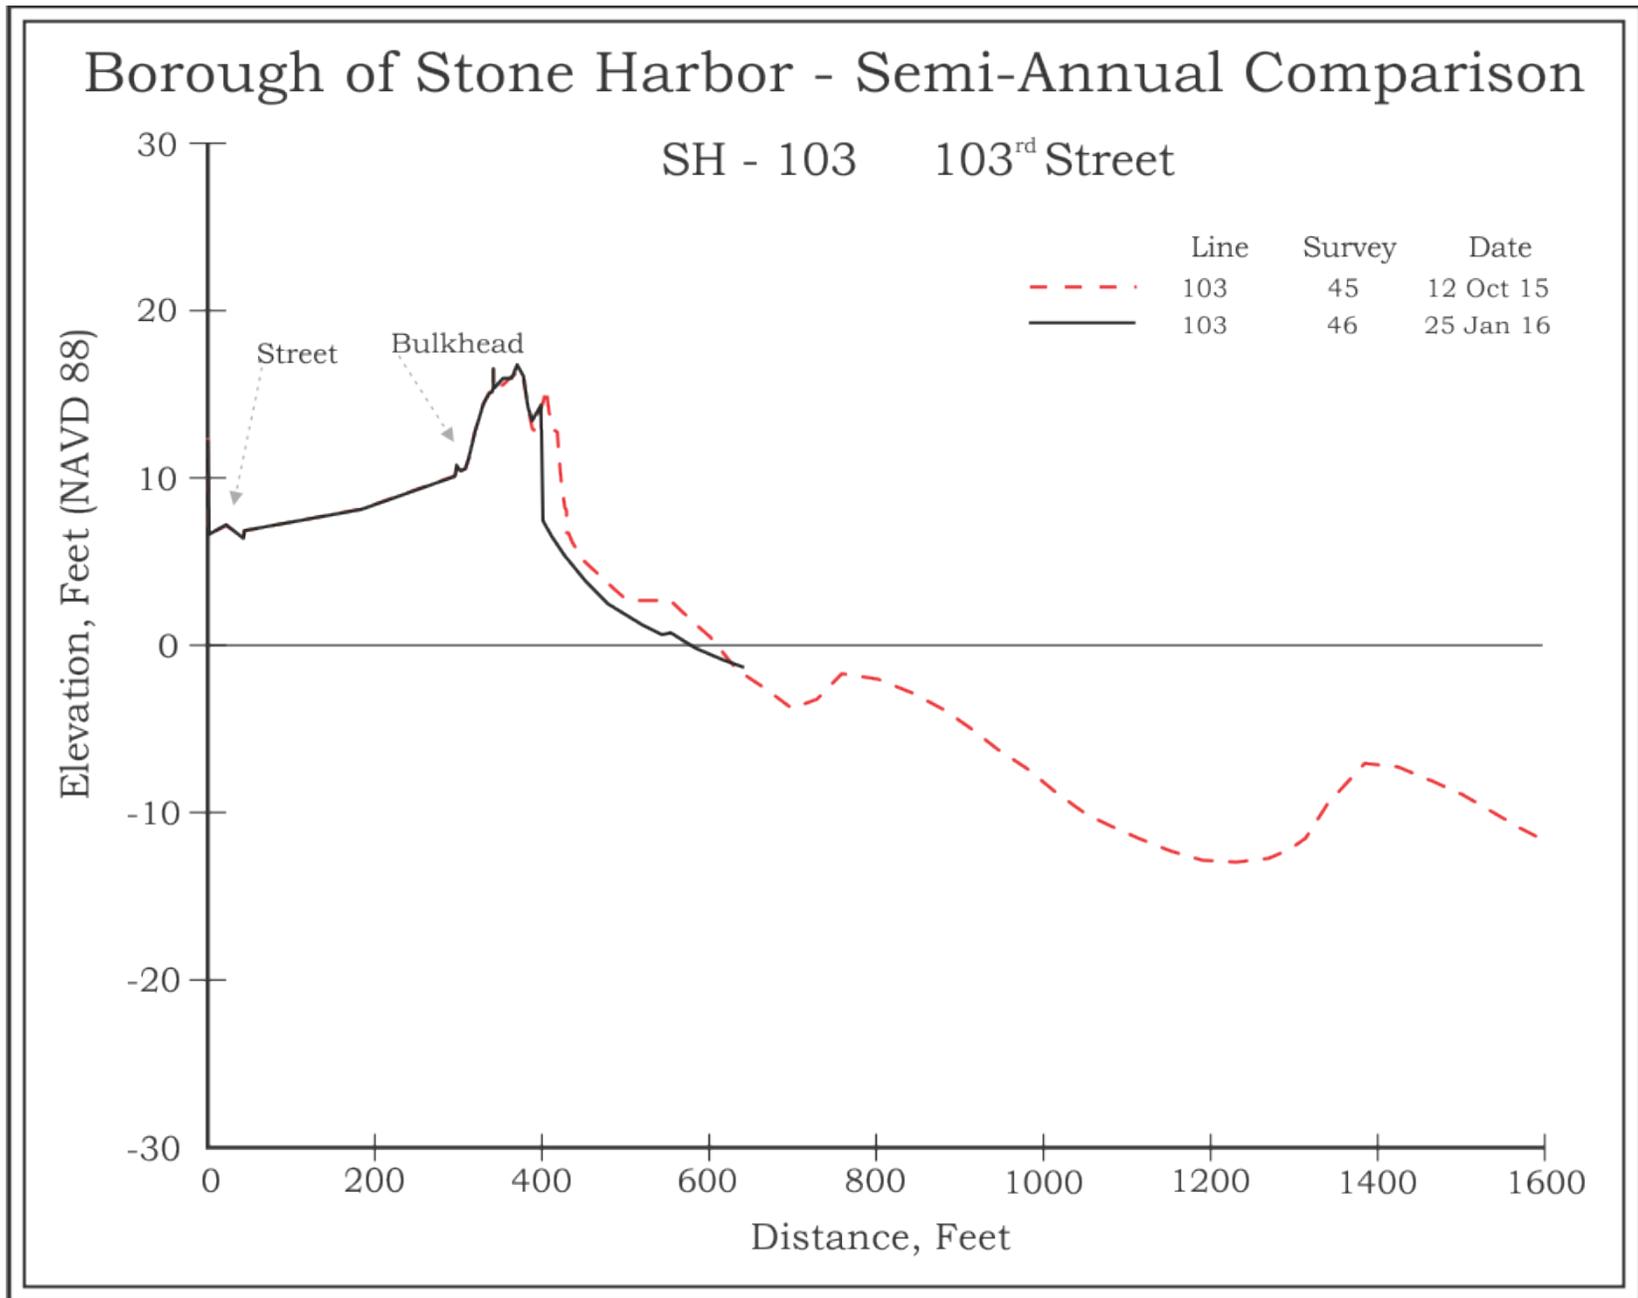
Figure 4b. Post-Jonas erosion at the dune’s seaward slope and on the beach compared to conditions from October 12, 2015, which followed 3-4 days of northeast winds. The storm related loss was 14.83 yds³/ft. above the zero elevation datum, with an additional loss of 0.46 yds³/ft. below the datum to the end of the survey line. This dune was cut back to the landward slope of the foredune added since the ACOE project was completed in 2004.

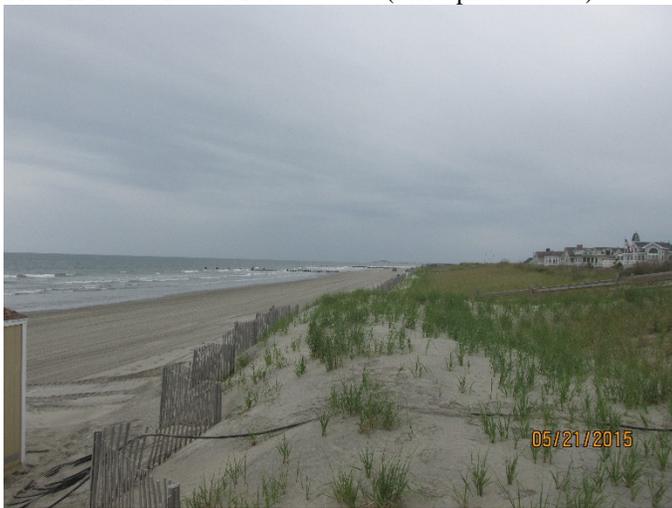
Photoplate 5a - Photo taken May 21, 2015. View to south along the dune toe from 108th Street. Wind-blown sand accumulated on the seaward dune slope.

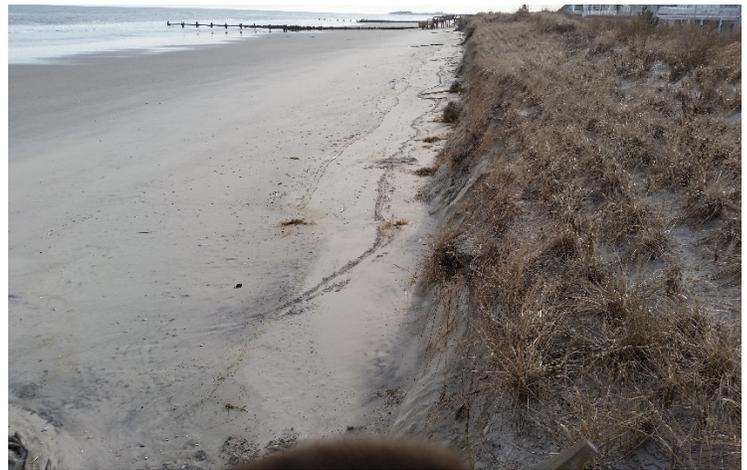
Photoplate 5b - Photo taken January 25, 2016 showing the dune scarp at 108th Street looking south along the cut. The beach was wet to the toe of the scarp from the last high tide. Two weeks later additional erosion took place. All the dune fencing was destroyed with the storm taking all the recent deposition as well.
