**2015 ANNUAL REPORT ON
THE CONDITION OF THE MUNICIPAL BEACHES FOR
THE BOROUGH OF STONE HARBOR, CAPE MAY COUNTY, NEW JERSEY**

**PREPARED FOR: THE BOROUGH OF STONE HARBOR
9508 SECOND AVENUE
STONE HARBOR, NJ 08247**

**PREPARED BY: THE STOCKTON UNIVERSITY COASTAL RESEARCH CENTER
30 WILSON AVENUE
PORT REPUBLIC, NEW JERSEY 08241**

February 29, 2016

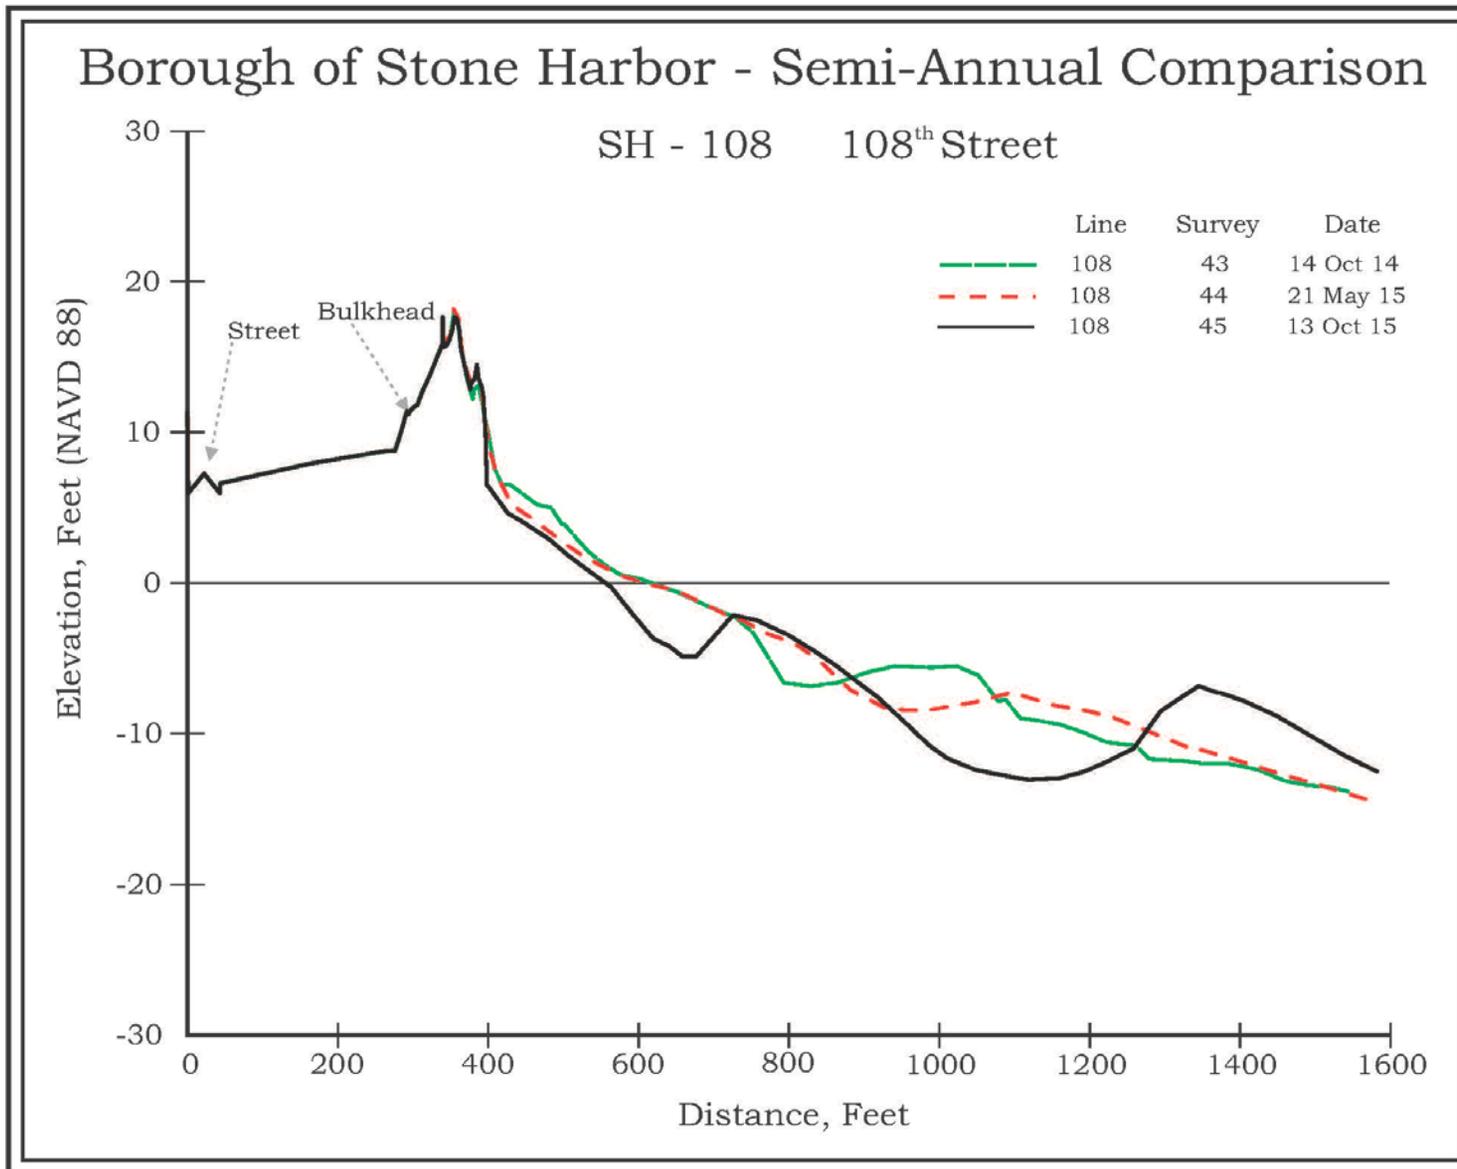
Figure 5a. Beach and shoreline retreat was 52 feet at this site. Berm elevation loss was substantial as was the scarp cut into the dunes. Jones made the situation worse, creating over a 6-foot scarp and causing additional retreat. Offshore the bar and trough situation was identical to northern sites where the sand lost from the beach was deposited offshore 800 feet seaward. The bar compensated for much of the loss leaving the net change as $-27.81 \text{ yds}^3/\text{ft}$.

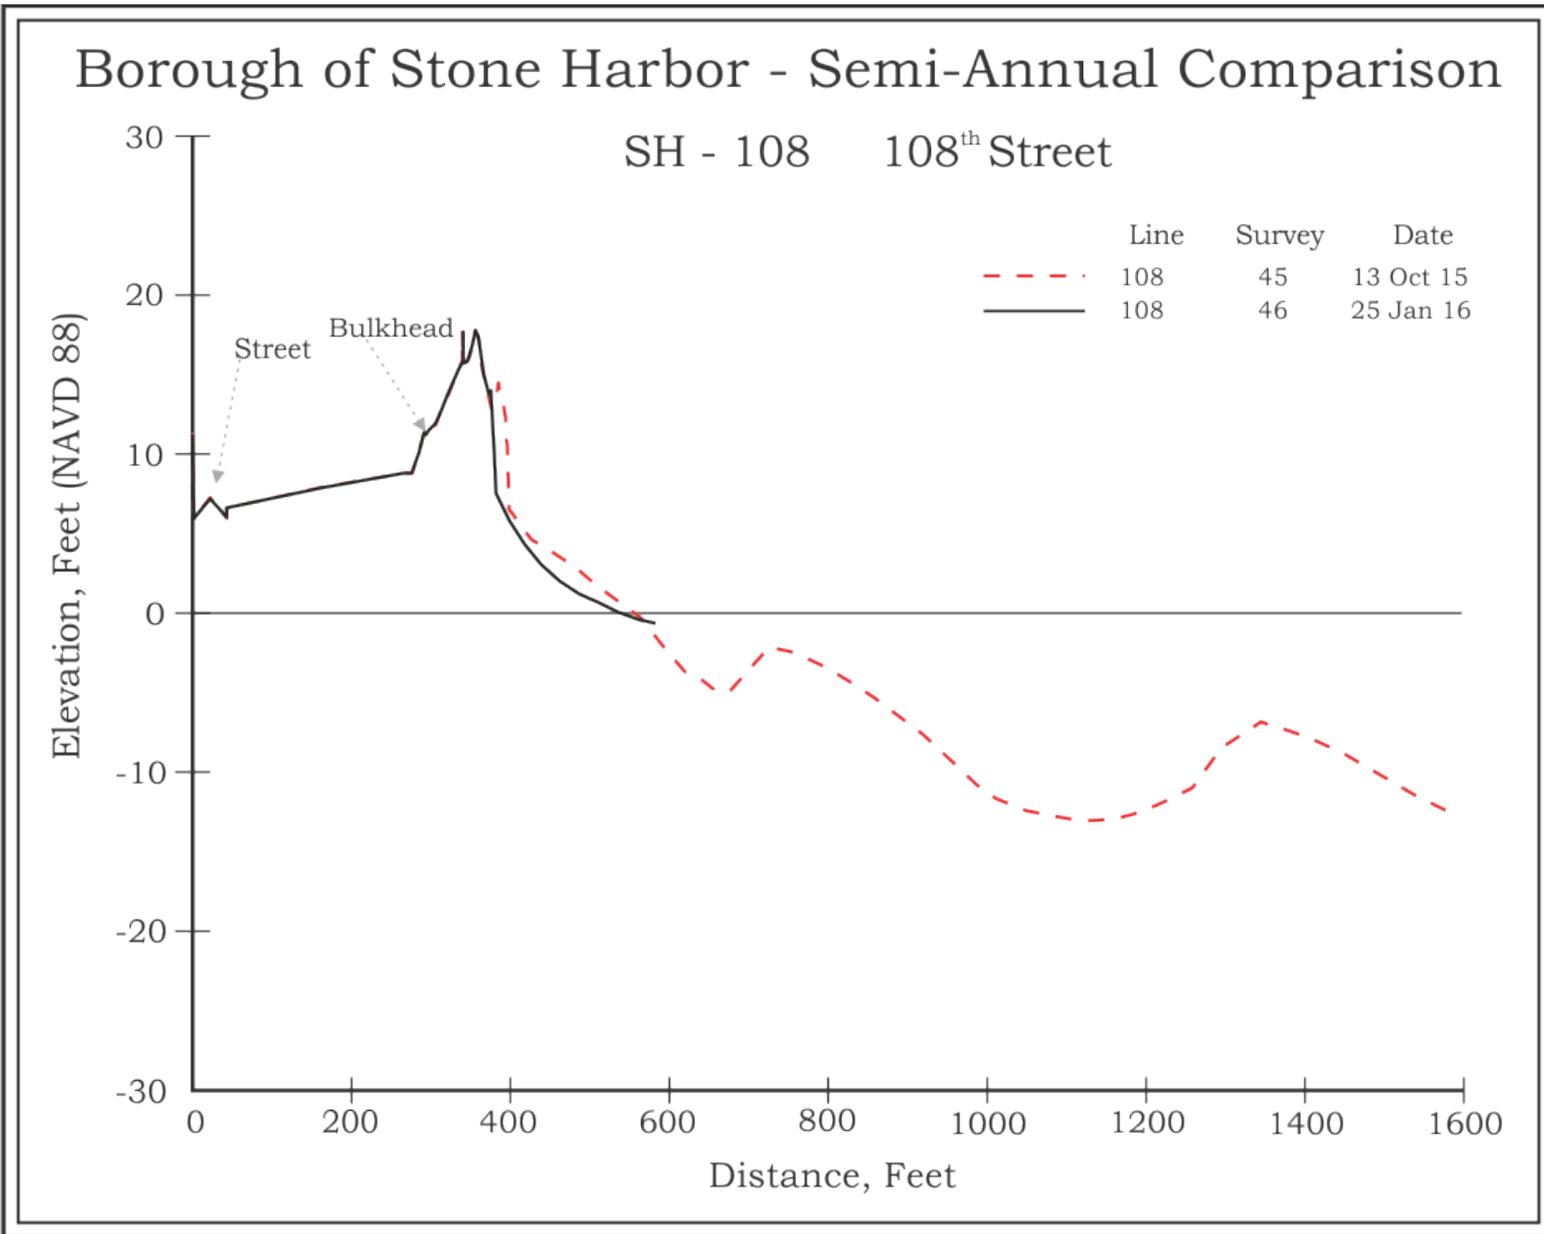
Figure 5b. Post-Jonas erosion at the dune’s seaward slope and on the beach compared to conditions from October 12, 2015, which followed 3-4 days of northeast winds. The storm related loss was 9.93 yds³/ft. from the dune’s seaward slope and beach with minimal data determined below the datum (0.072 yds³/ft.).

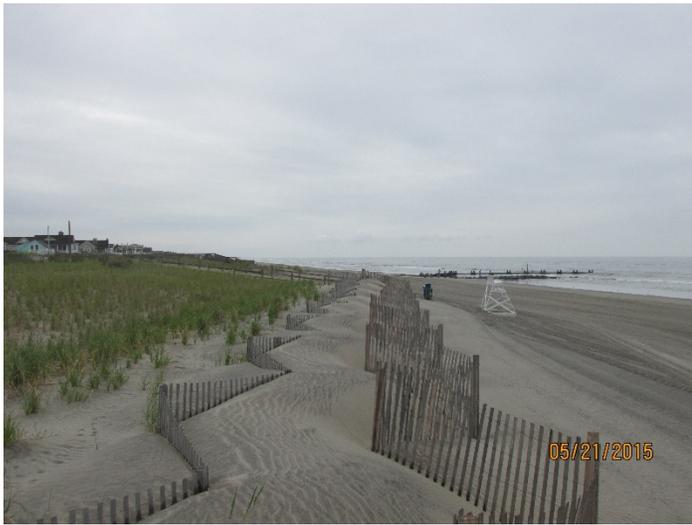
Photoplate 6a - Photo taken May 21, 2015. View to north along the dune toe from 112th Street. The beach was narrow but wind-blown sand accumulated on the seaward dune slope.

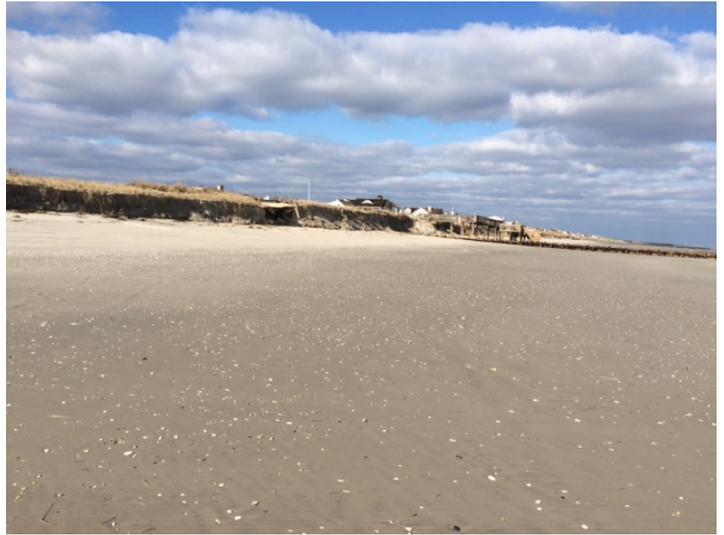
Photoplate 6b - Photo taken February 11, 2016 following Jonas and a second storm February 7, 2016. Note the 3 to 4-foot scarp cut into the seaward dune toe slope and the flat beach showing high tide wave activity nearly to the scarp days later. The newly accumulated foredune was removed back into the established grasses.

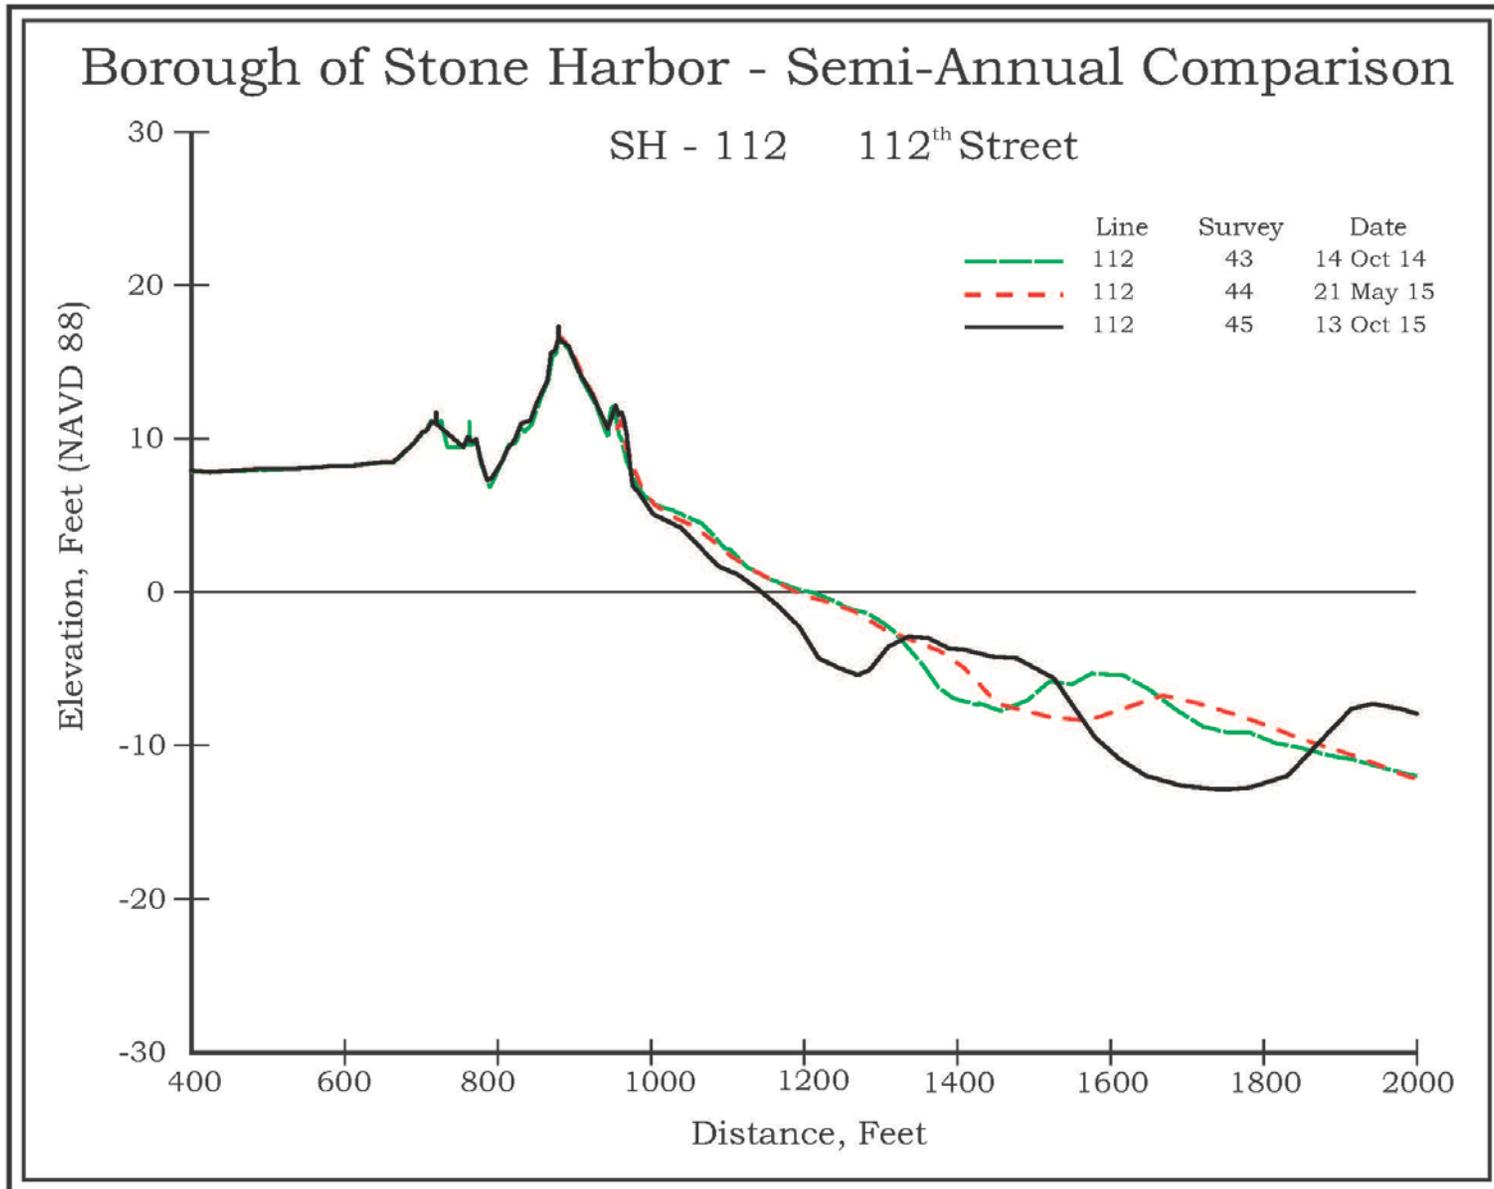
Figure 6a. The pattern of storm damage changed slightly at 112th Street where the dune remained untouched, while the berm was lowered in its gradient and the shoreline retreated 47 feet as the consequence of the early October storm. Two offshore troughs developed, the inner one at the base of the beachface with a 200-foot wide bar seaward of that trough. The deepest trough was positioned further seaward with a large bar extending beyond the 2,000-foot mark from the reference location. The site lost 15.03 yds³/ft., but most of that sand lies further seaward than the 2000-foot marker.

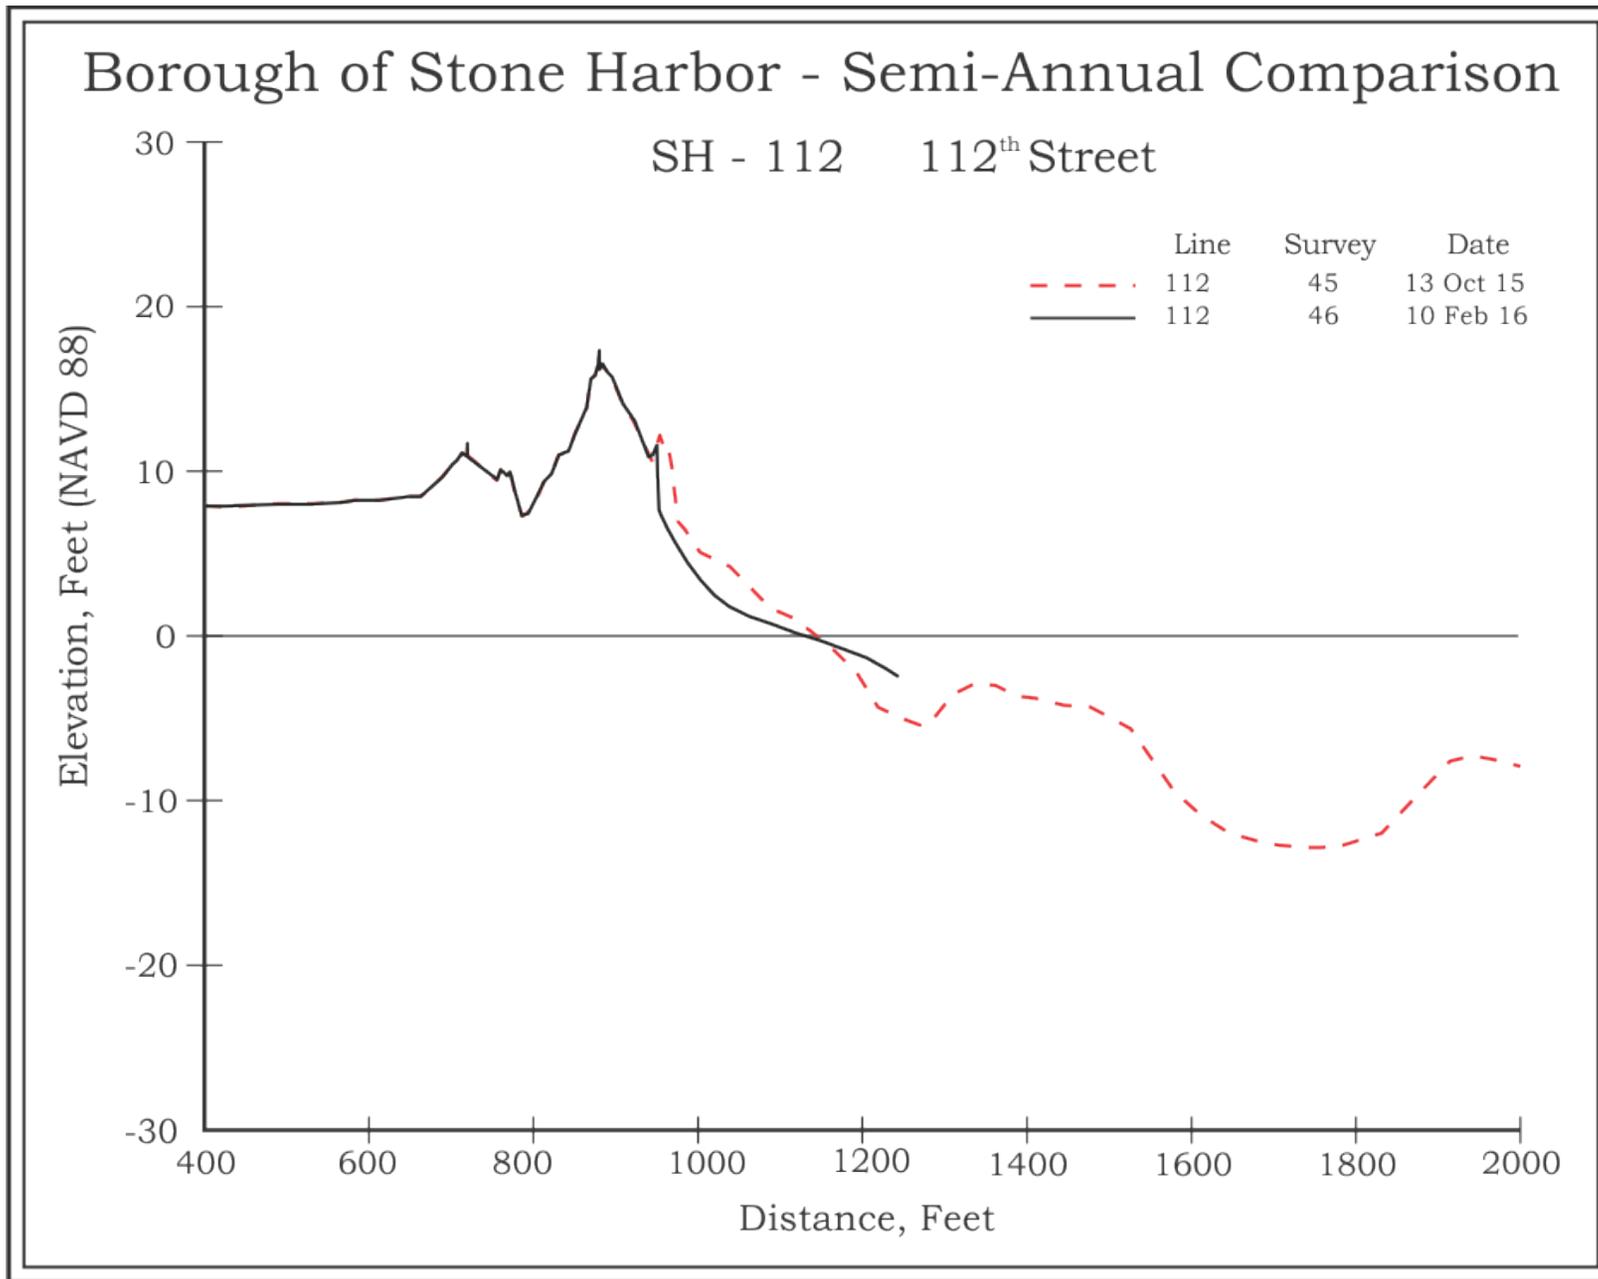
Figure 6b. Post-Jonas erosion at the dune's seaward slope and on the beach compared to conditions from October 12, 2015, which followed 3-4 days of northeast winds. The storm related loss was 12.83 yds³/ft. from the foredune area and the beach with a 4.88 yds³/ft. sand volume gain in the nearshore trough below the datum.

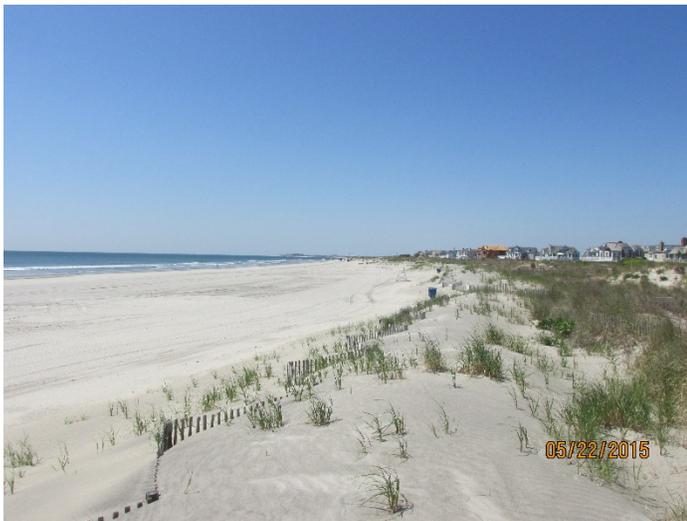
Photoplate 7a - Photo taken May 22, 2015. View to south along the dune toe from 116th Street. Wind-blown sand accumulated on the seaward dune slope and plants began to colonize the new slope. The beach is significantly wider, a fact that benefitted the location thus far this winter.

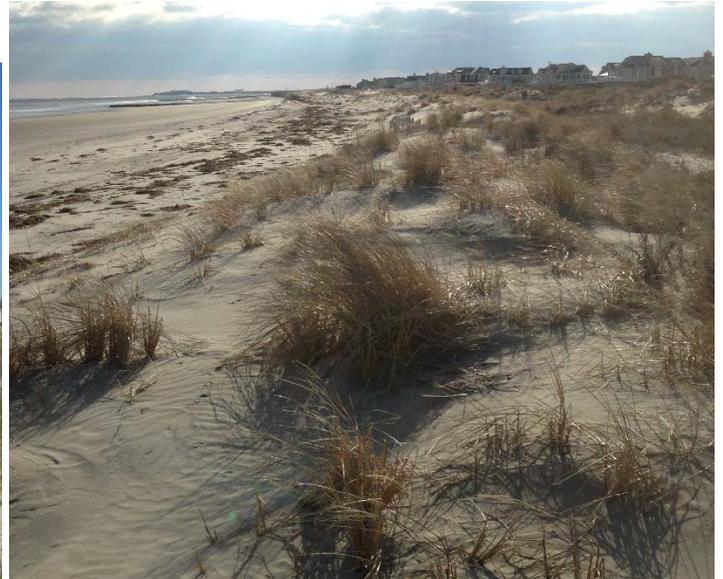
Photoplate 7b - Photo taken February 1, 2016 following Jonas and a second, smaller northeast storm two weeks later. Note the wrack line at the toe of the dunes making the beach wet to the toe following the storms. The dune damage was relatively minor at this site

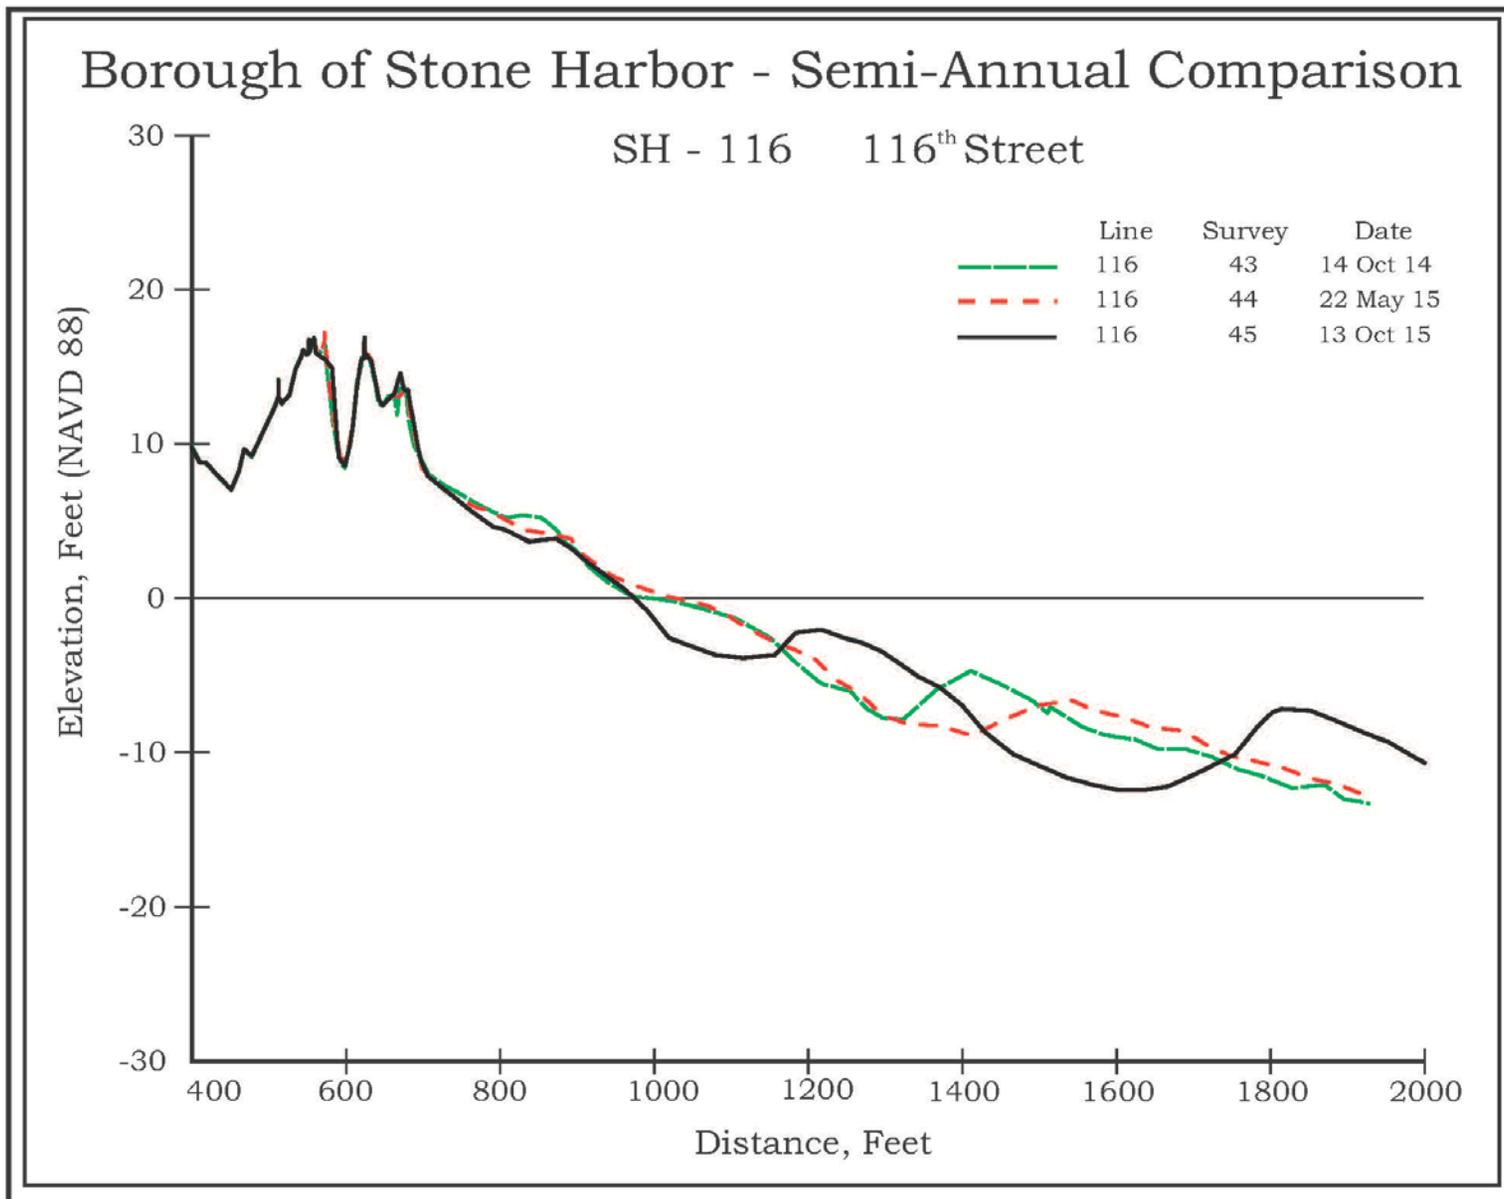
Figure 7a. 116th Street was one of three sites with low net berm losses combined with a double offshore bar system. The berm was a little lower, but the beach retreated 56 feet from the May 2015 location. The distant offshore bar reflected the sand redistribution seaward as a minor net loss (-12.28 yds³/ft.) because the bar was still 3 feet higher than the seafloor was previously at the 2,000-foot distance.

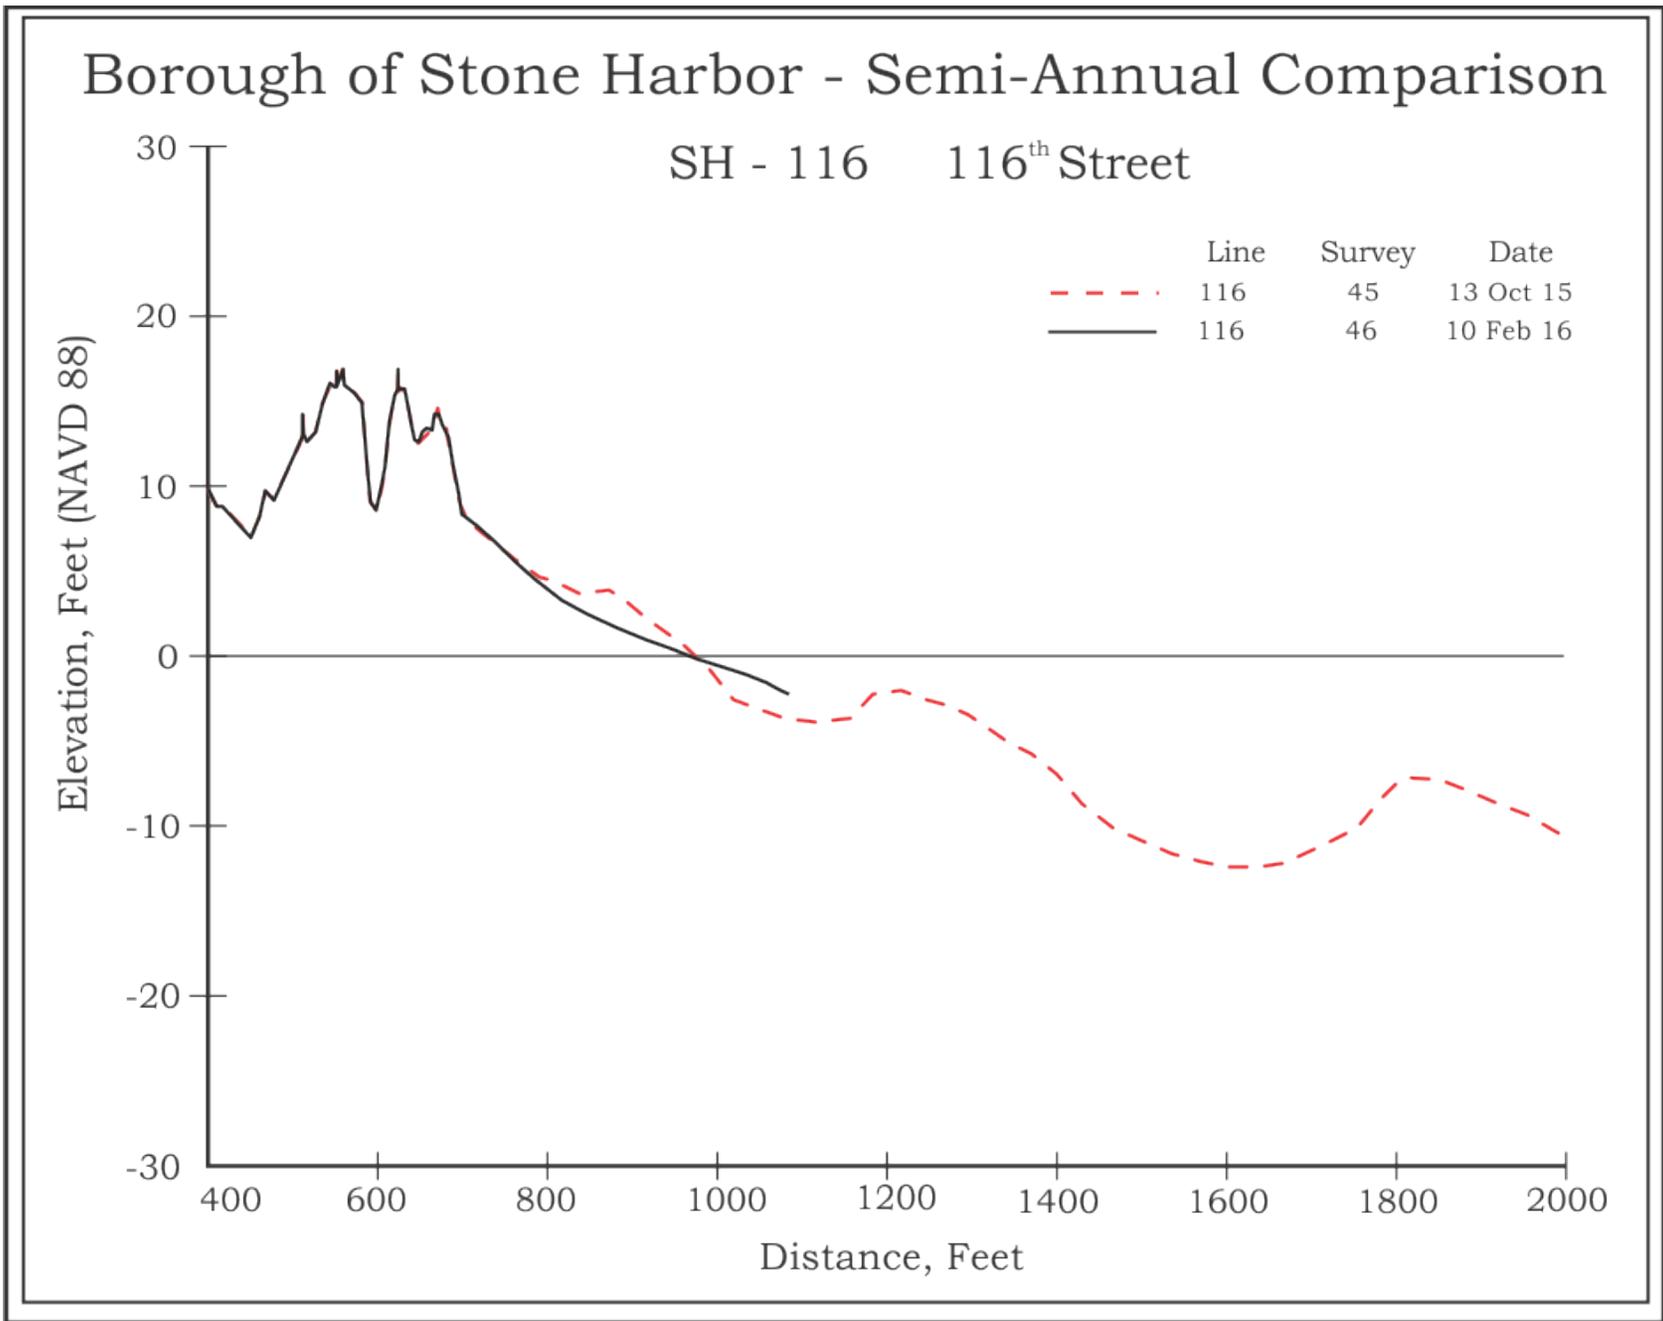
Figure 7b. Post-Jonas erosion on the beach compared to conditions from October 12, 2015, which followed 3-4 days of northeast winds. The storm related loss was 7.28 yds³/ft. eroded from the beach above the zero datum elevation. The deposit offshore filled a nearshore trough yielding a 5.27 yds³/ft. sand volume gain to the end of the survey line.

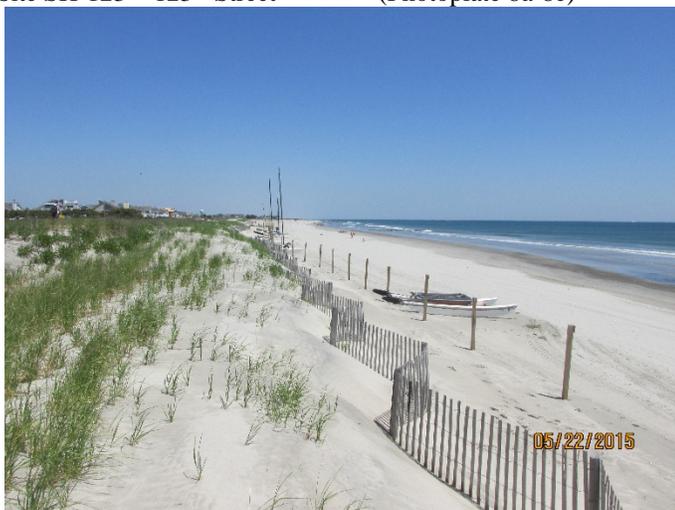
Photoplate 8a - Photo taken May 22, 2015. View to northeast across the dune crest from 123rd Street. Note the catamaran poles and the newer dune fencing on the foredune slope. The bench to the crest elevation is to the left in the picture.

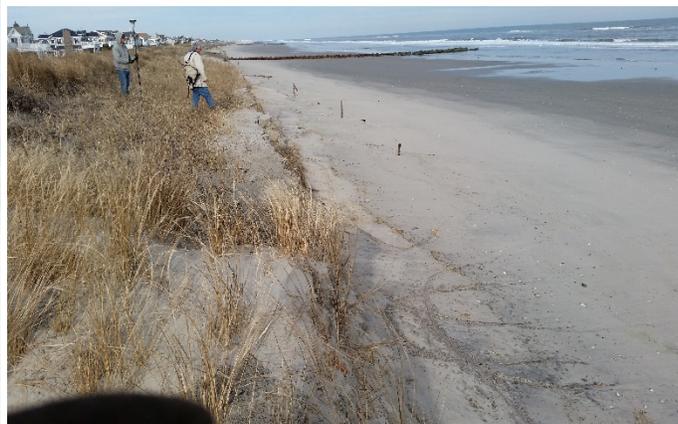
Photoplate 8b – Photo taken January 25, 2016 following Jonas. The scarp was 8 to 10 feet high and the seaward dune toe was cut back to within 20 feet of the bench up to the crest. The beach was flat and wet to the toe on the last high tide.

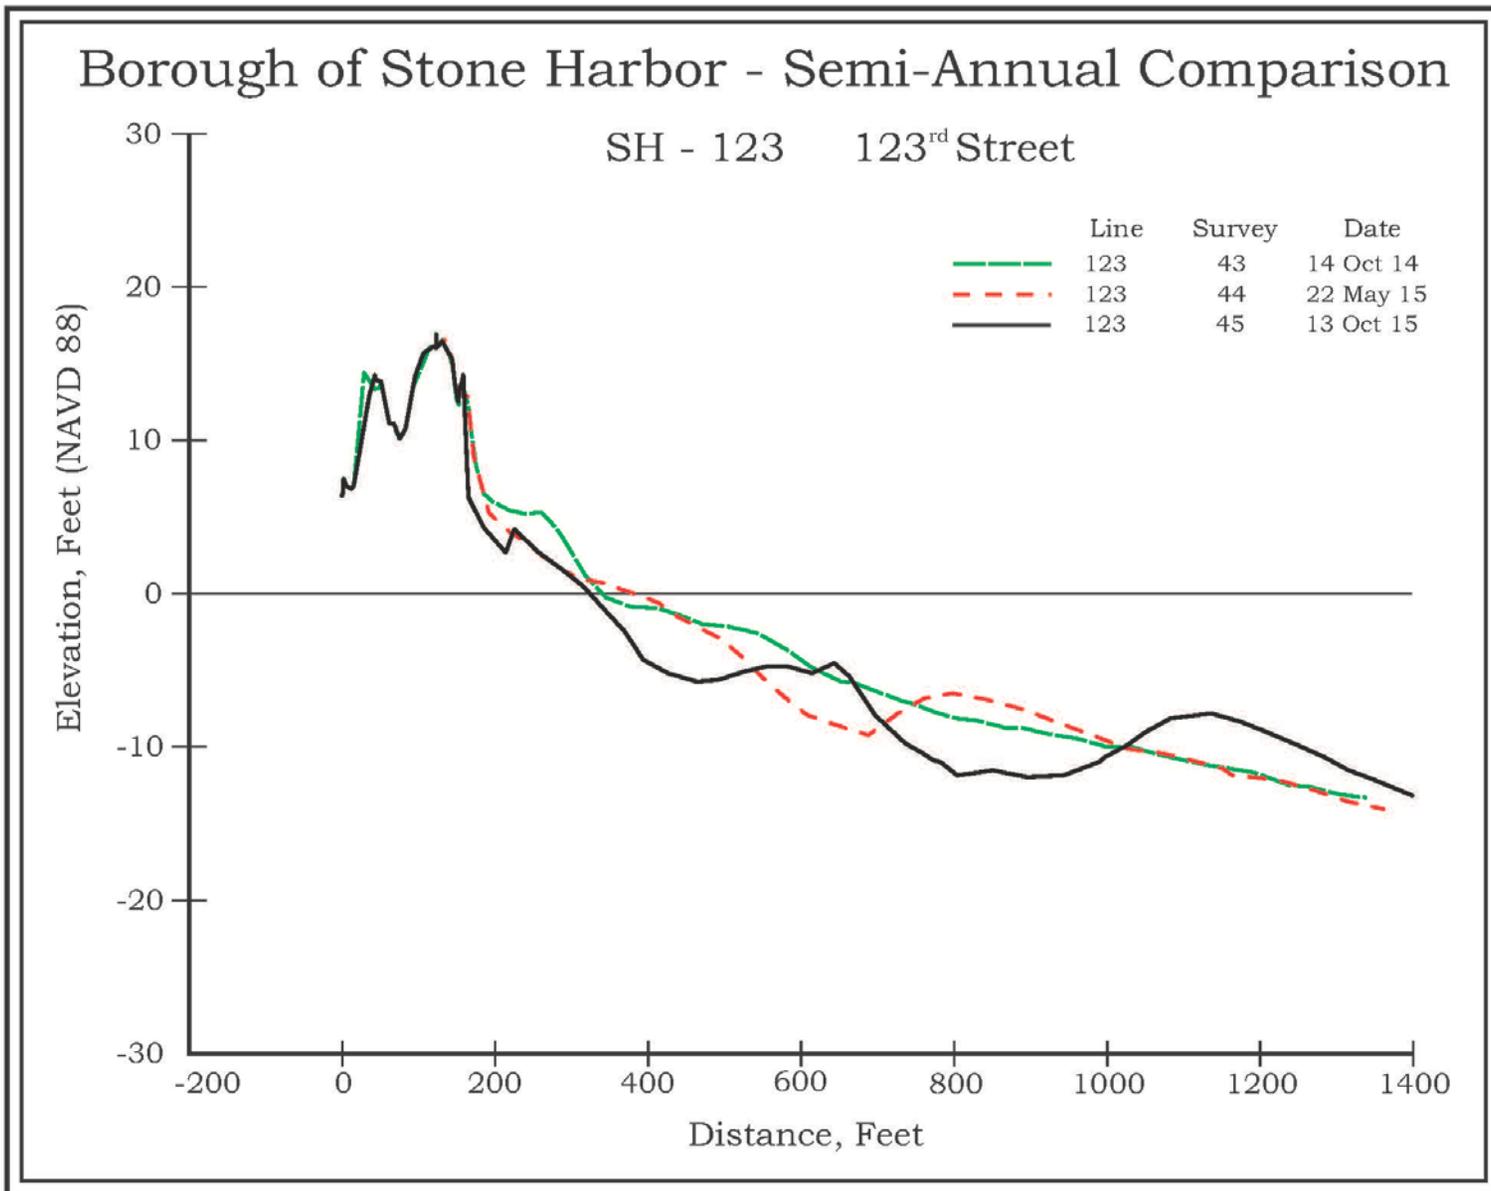
Figure 8a. 123rd Street suffered dune toe erosion and the loss of the summer berm during the early October 2015 northeast storm. Sand was moved offshore forming two bars, one at 600 feet seaward and the second at 1,200 feet seaward of the reference position. In late January the dune scarp became worse with elevations approaching 15 vertical feet and retreat into the upper seaward slope. The beach was flat and wet to the dune toe following Jonas.

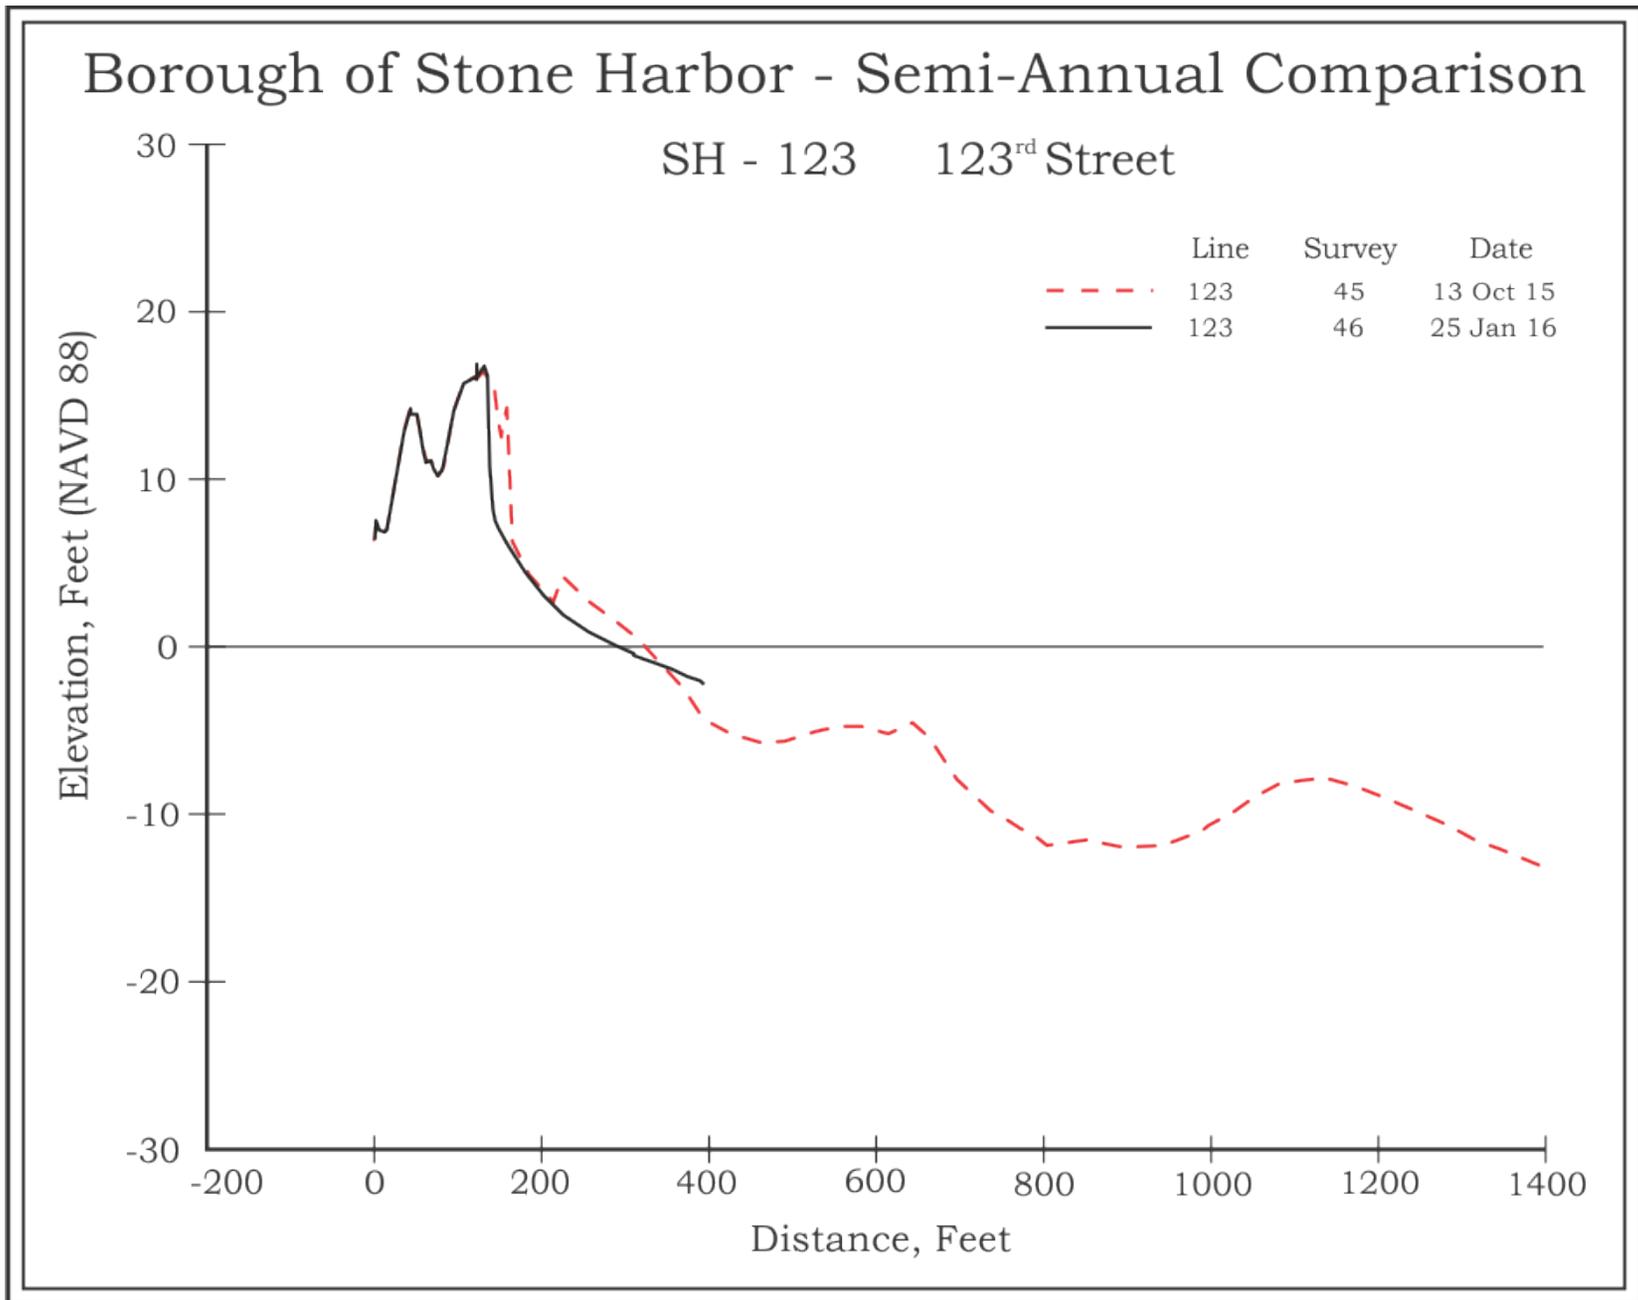
Figure 8b. Post-Jonas erosion at the dune's seaward slope and on the beach compared to conditions from October 12, 2015, which followed 3-4 days of northeast winds. The storm related loss was 12.37 yds³/ft. from the dune's seaward slope and the beach with a 1.11 yds³/ft. sand volume gain below the datum to the limit of the survey line. This location suffered the most dune erosion with the highest scarps in the Borough, but the sand volume taken was not the most extensive.
