**FINAL REPORT FOR 2017
ON THE CONDITION OF THE MUNICIPAL BEACHES
IN
THE TOWNSHIP OF UPPER, CAPE MAY COUNTY, NEW JERSEY**

**PREPARED BY: THE STOCKTON UNIVERSITY COASTAL RESEARCH CENTER
30 WILSON AVENUE
PORT REPUBLIC, NJ 08241
March 31, 2018**

**Annual Report for 2017
To
The Township of Upper On the
Condition of the Municipal Beaches**

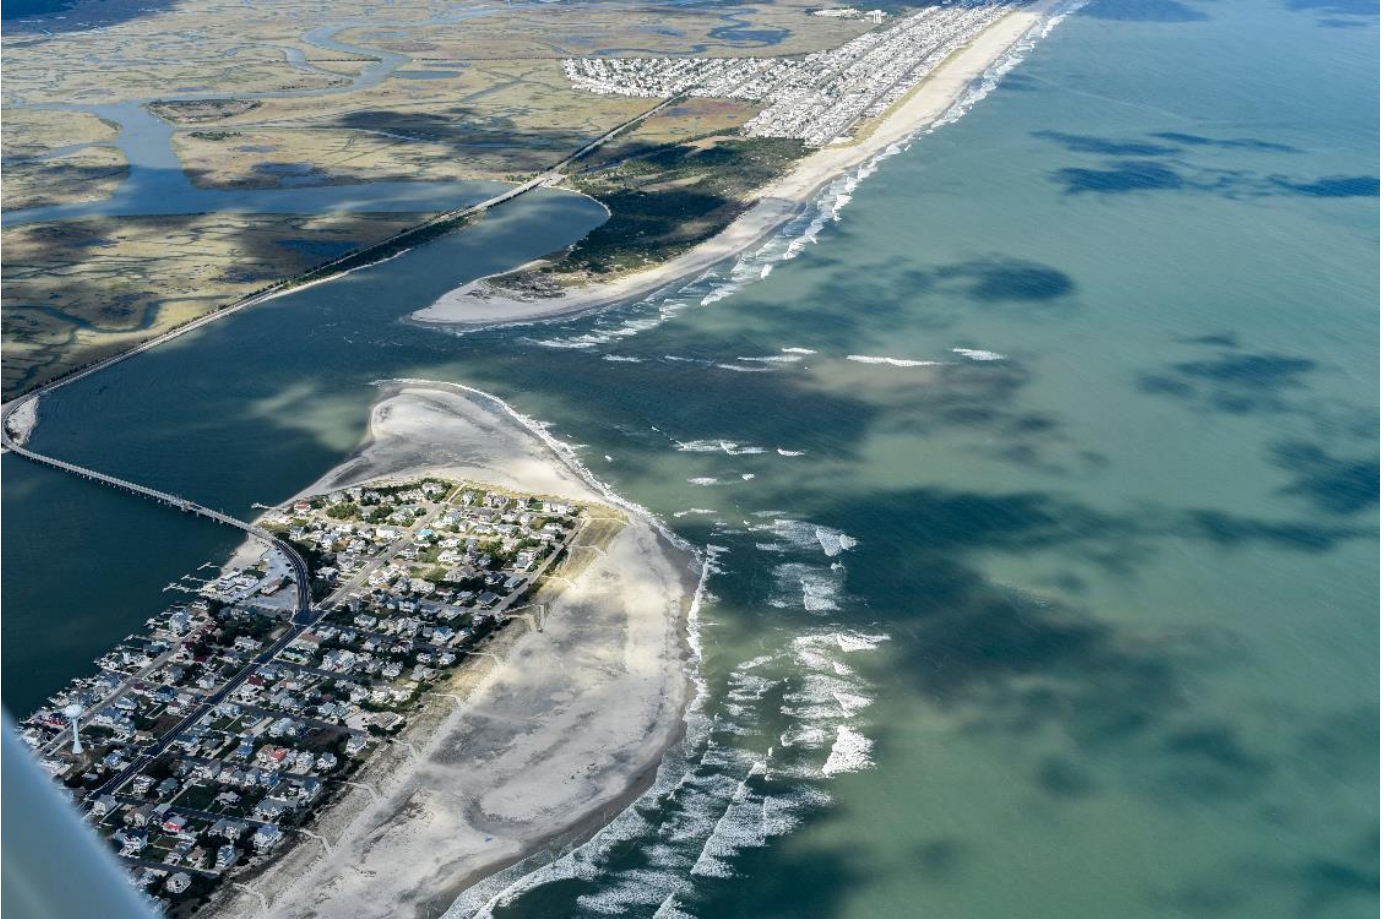
Above is an aerial view of Strathmere, taken September 29, 2017, showing the close proximity of the shoreline to the extreme northeast corner of the dune system at the northeast of the end of Seaview Avenue. There is evidence of the offshore deposits given by the waves breaking seaward of the entire northern segment of the Strathmere beach. (Photo by Ted Kingston).

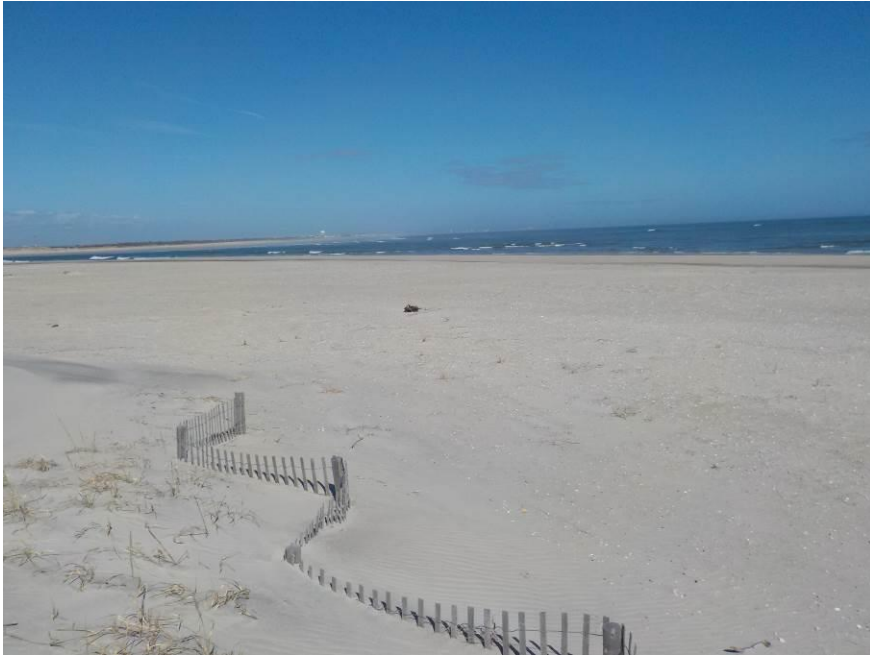
2a. February 24, 2017

Photograph 2a shows the extent of the wider beach at the toe of the dunes.

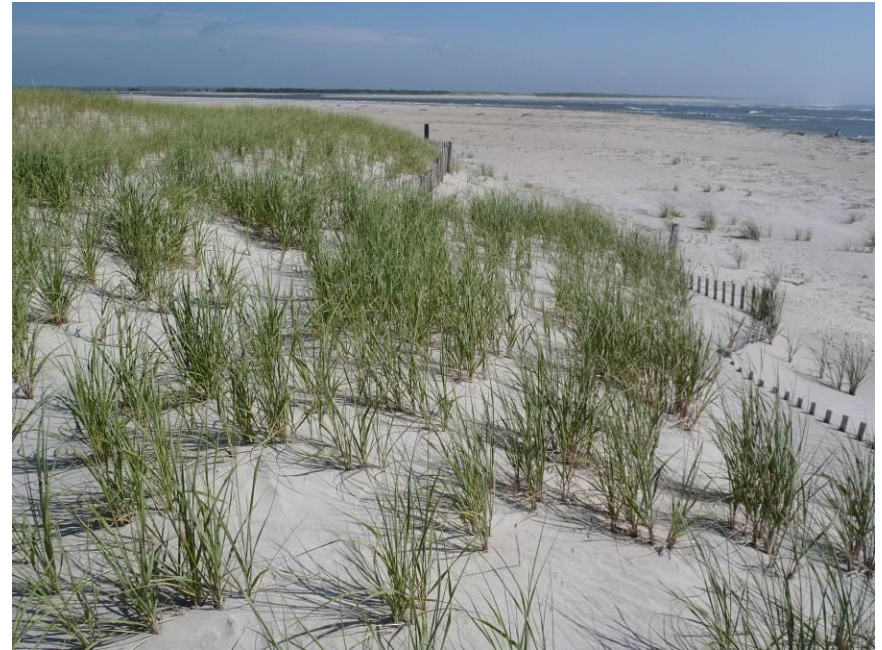
2b. June 19, 2017

Photograph 2b shows the same perspective in June with a healthy crop of dune grass present.

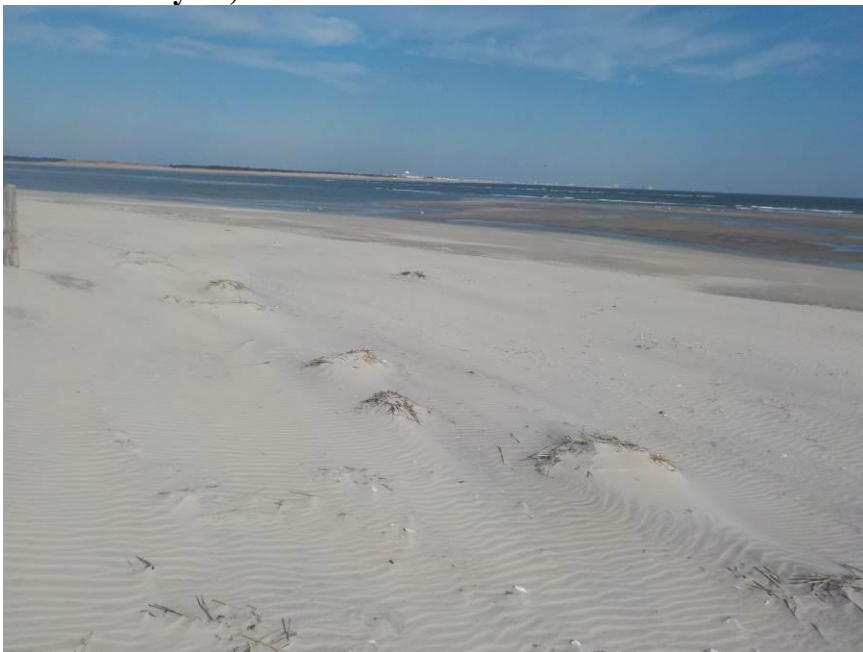
2c. December 1, 2017

Photograph 2c was taken on December 1, 2017 and closest to Corson's Inlet of the three pictures. Here the below datum sand flats are exposed at low tide.

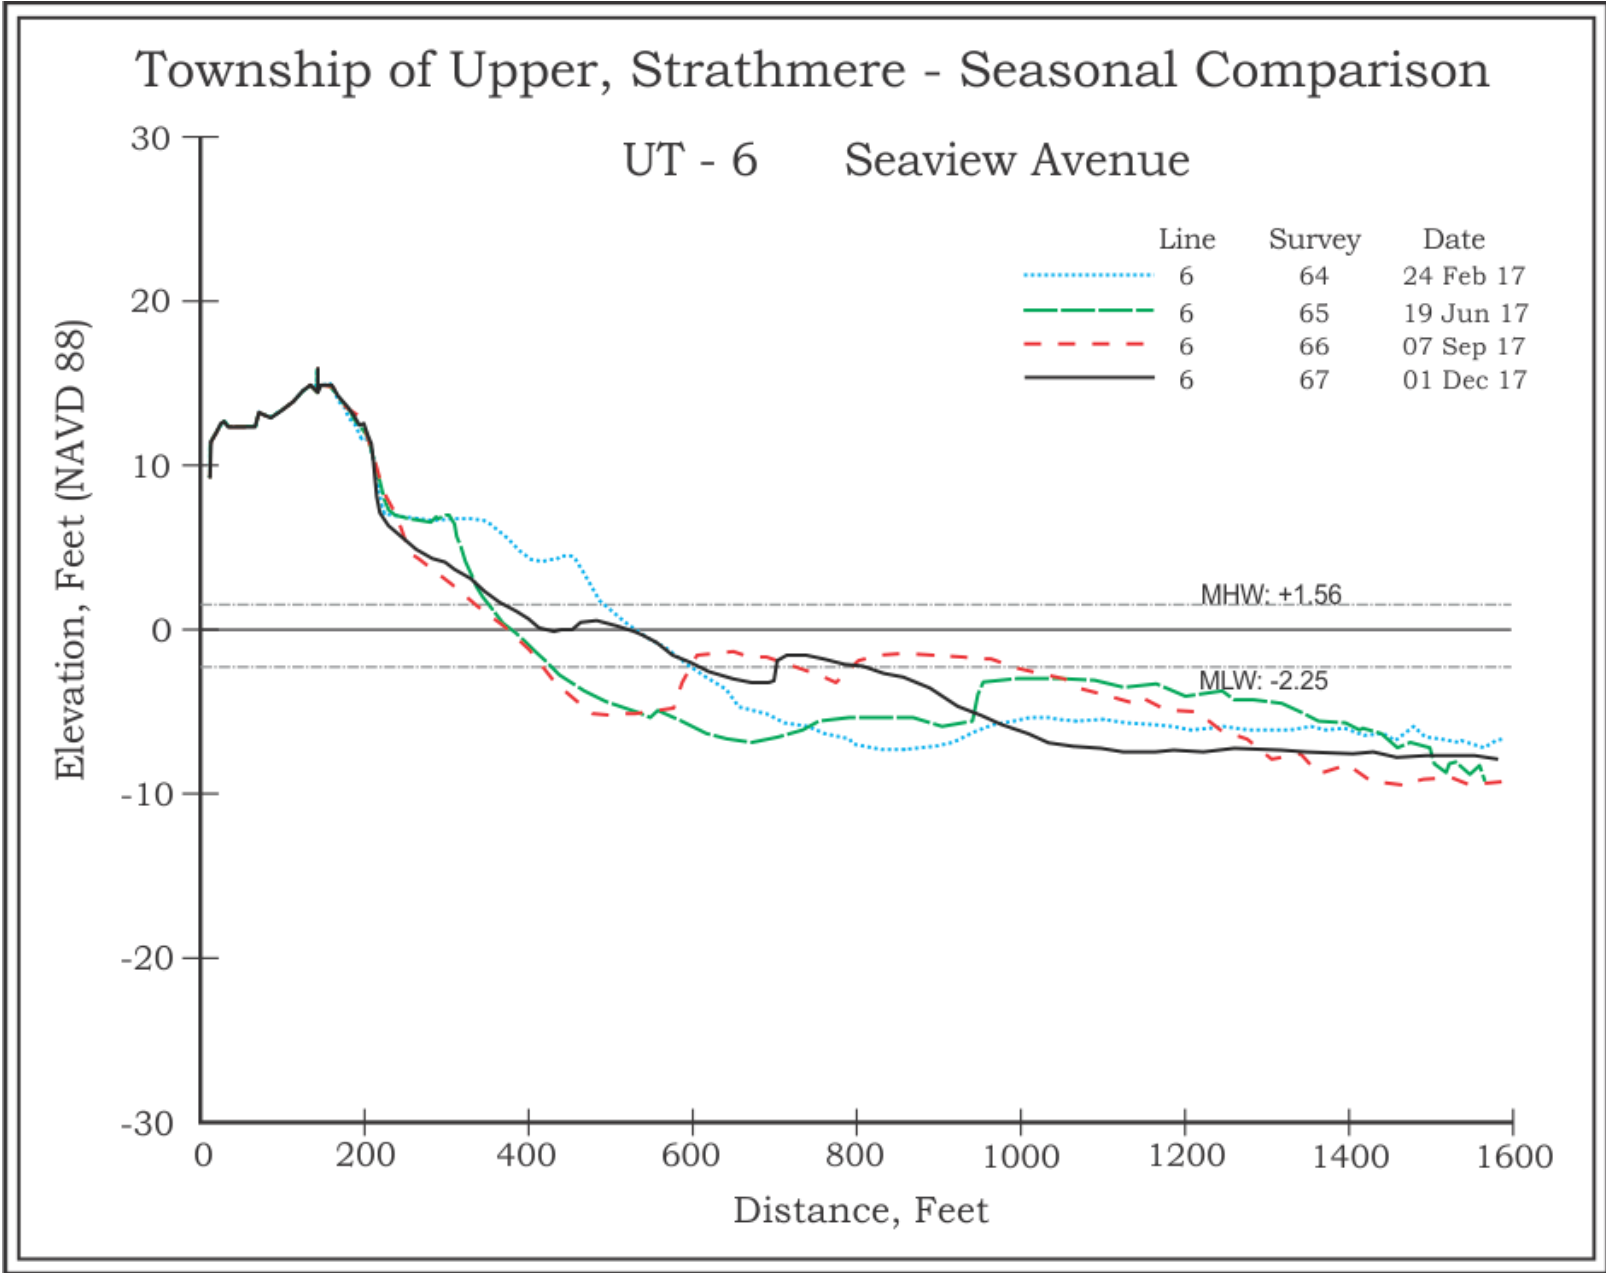
Figure 3. The first half of 2017 saw major losses in the recreational beach, beachface, and nearshore trough. This trend reversed itself by the second half of the survey year as the offshore bar continued to migrate landward, eventually welding onto the beachface by the December survey. However, from December 2016 to December 2017 the annual change was a -60.70 yds³/ft. loss in sand volume combined with a 34-foot shoreline retreat. However, during the past year, a tremendous sand volume was added offshore due to inlet current and wave refraction interactions bringing the sand to this site from the south.

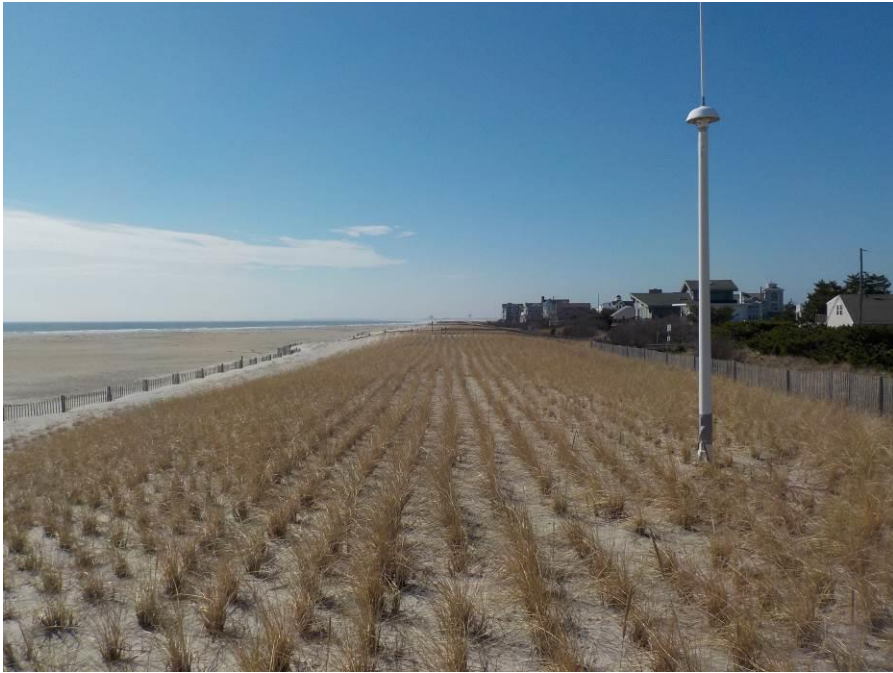
4a. February 23, 2017

Figure 4a shows the winter beach from the seaward dune crest perspective.

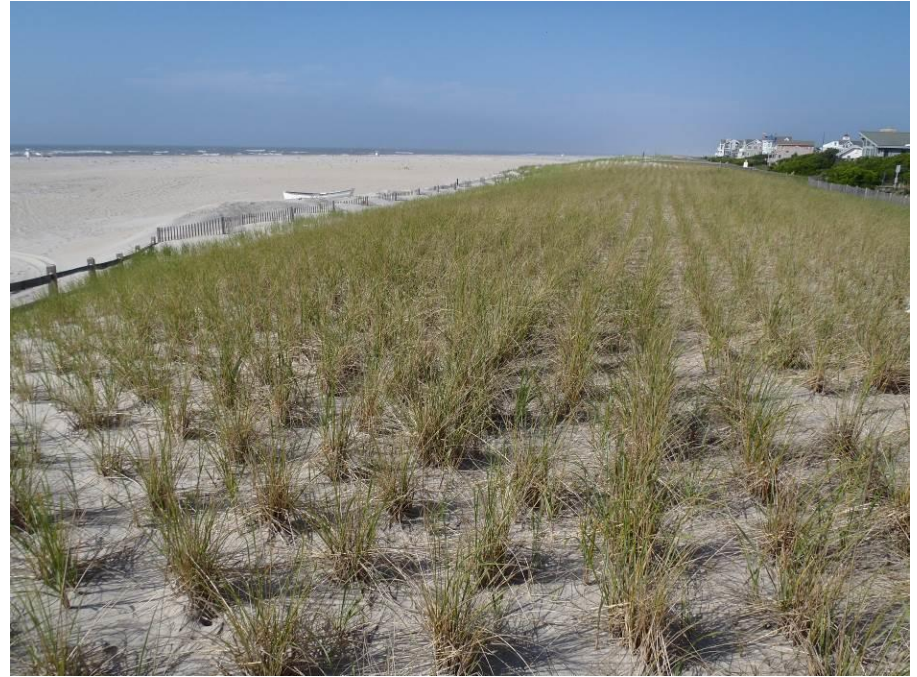
4b. June 19, 2017

Figure 4b was taken in June looking south from the dune.

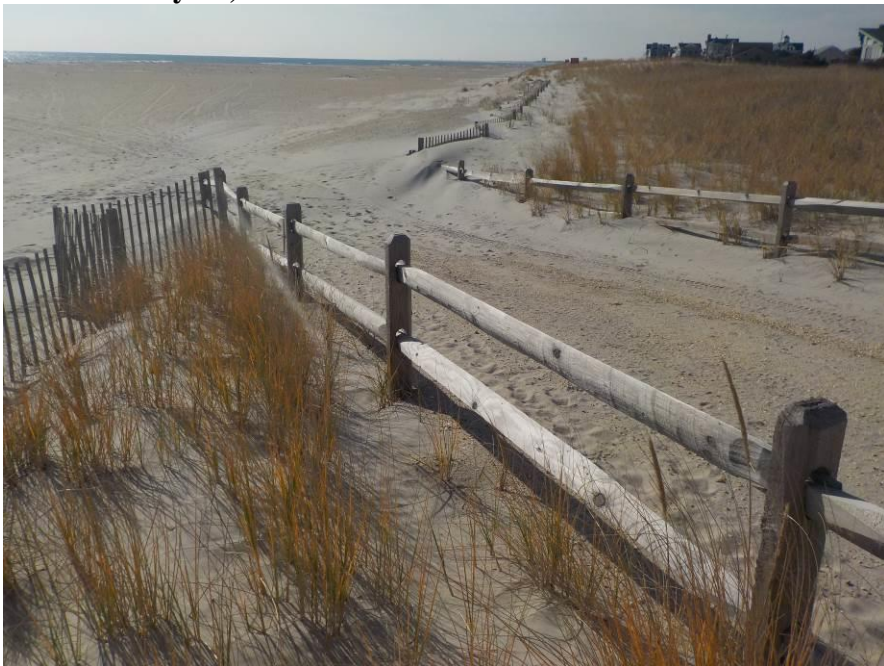
4c. December 1, 2017

Figure 4c shows the recreational beach at the accretional dune toe position looking south.

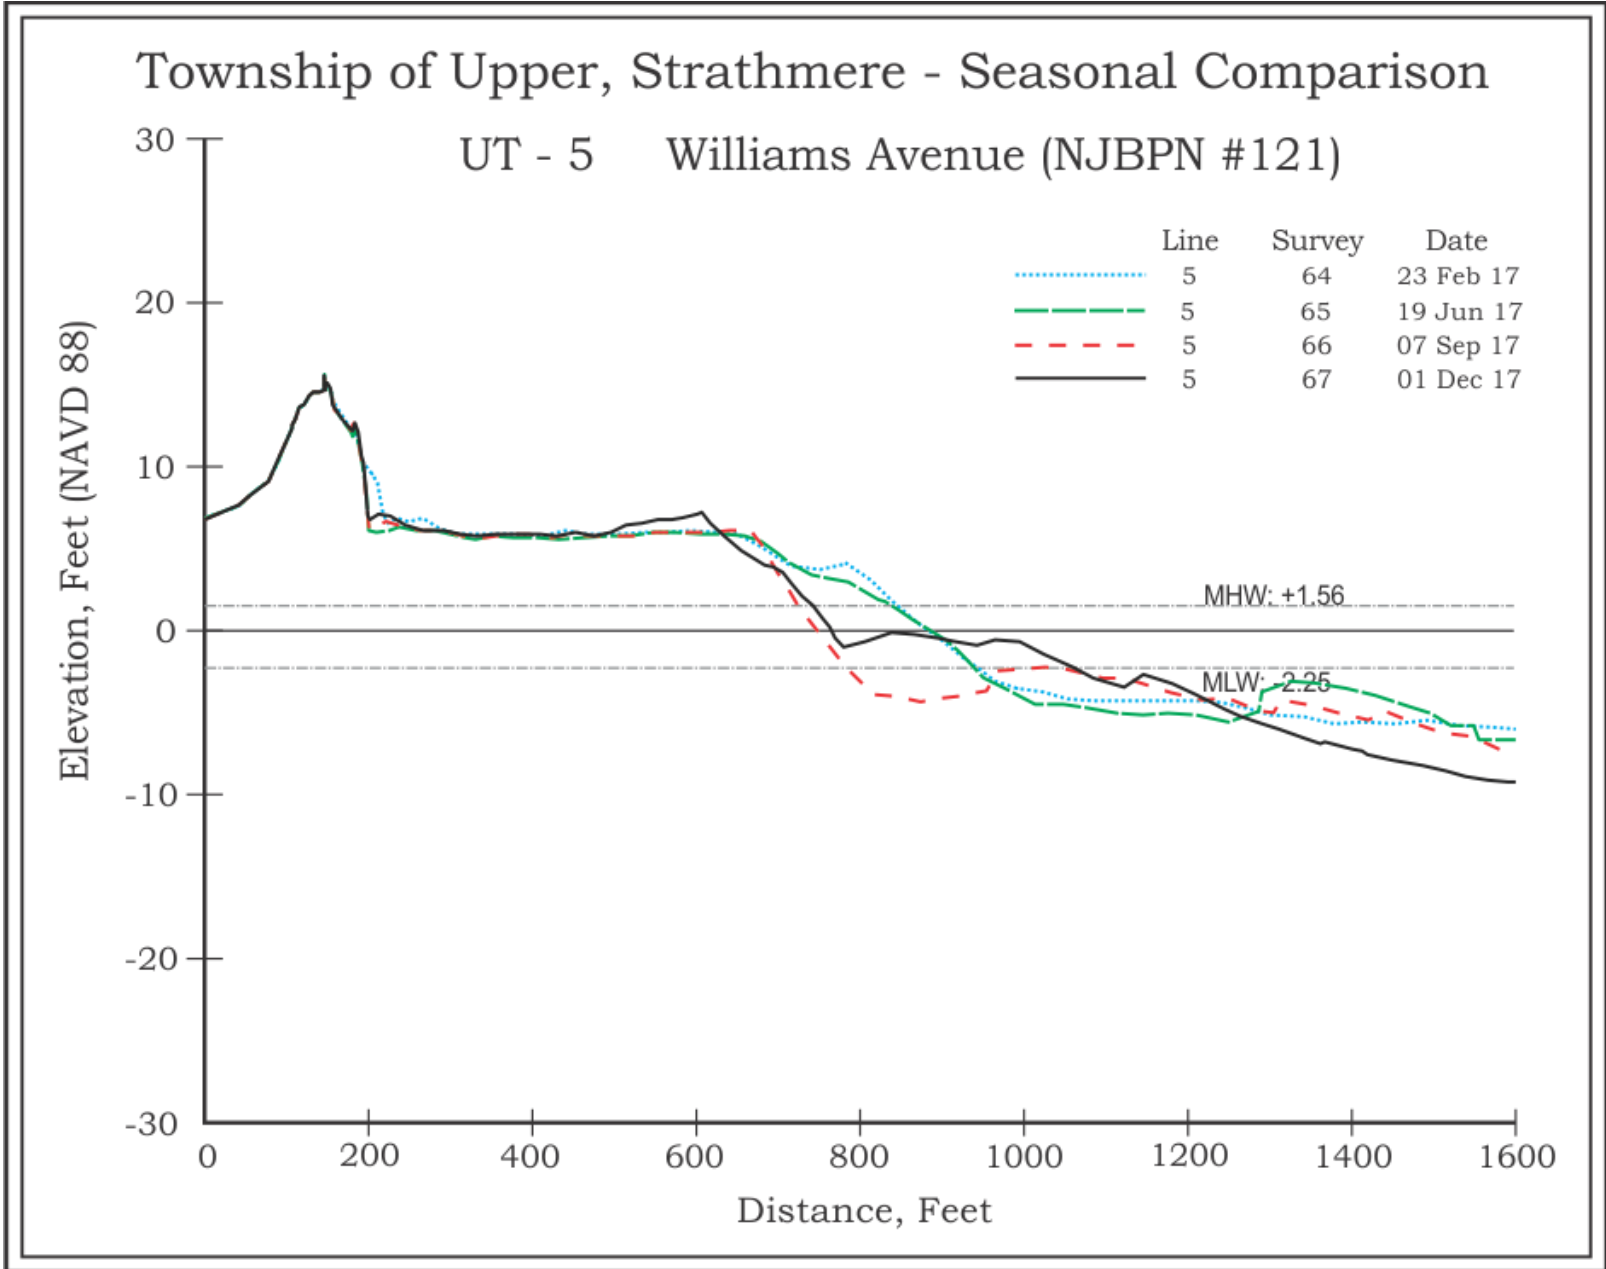
Figure 5. This site lies just south of the influence of the ebb-tidal delta for Corson’s Inlet, but not beyond the accretion generated by sand moving landward. Considerable losses in the beachface and nearshore regions were recorded between June and September 2017. However, the landward migration of materials had all but filled in the scour trough by December. Unfortunately, this was not enough as the annual comparison yielded a loss of 65.97 yds³/ft. while the shoreline retreated 166 feet.

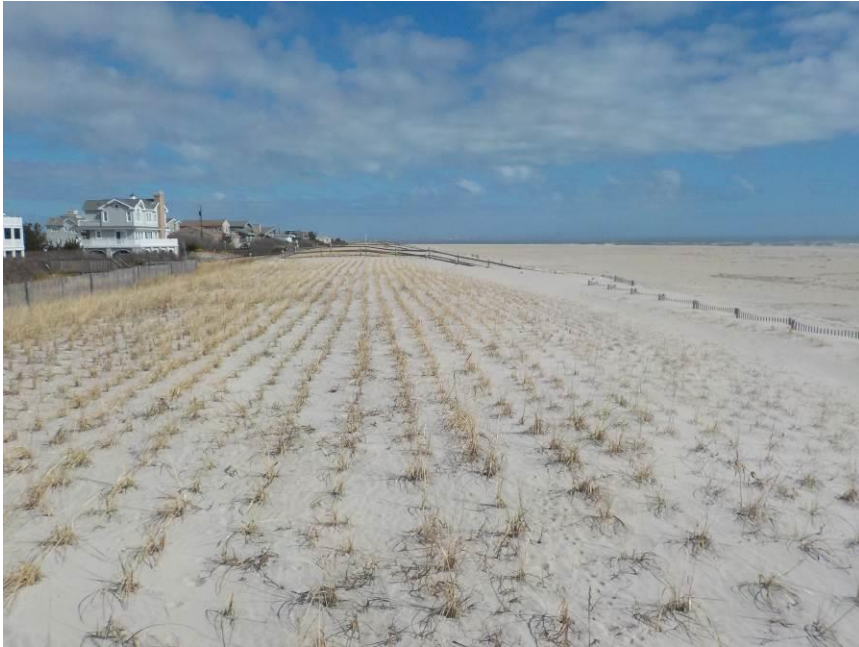
Figure 6a. February 24, 2017

Figure 6a is a view to the north along the dune crest during the winter.

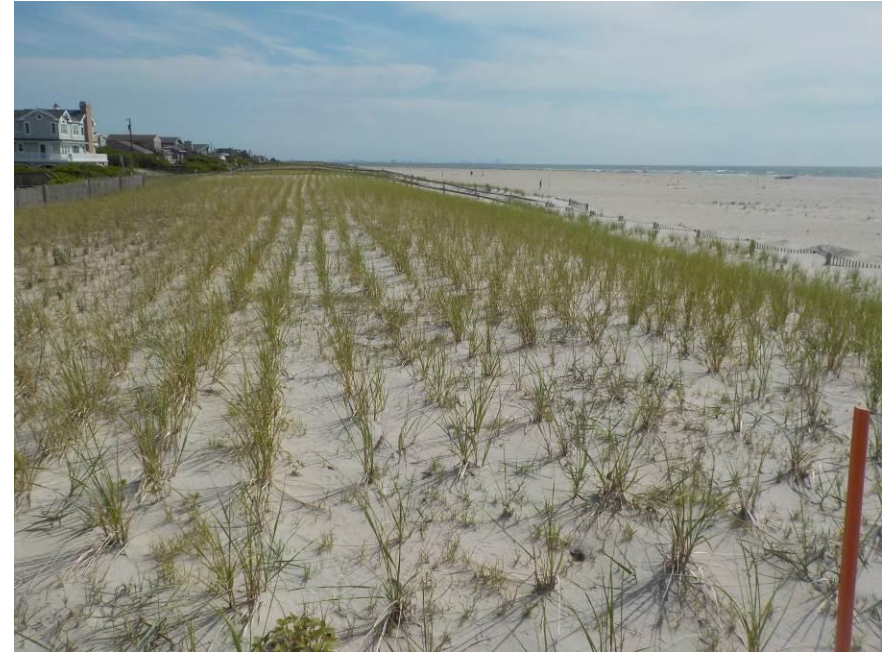
Figure 6b. June 15, 2017

Figure 6b shows the planted dune grass and stable recreational beach during the summer.

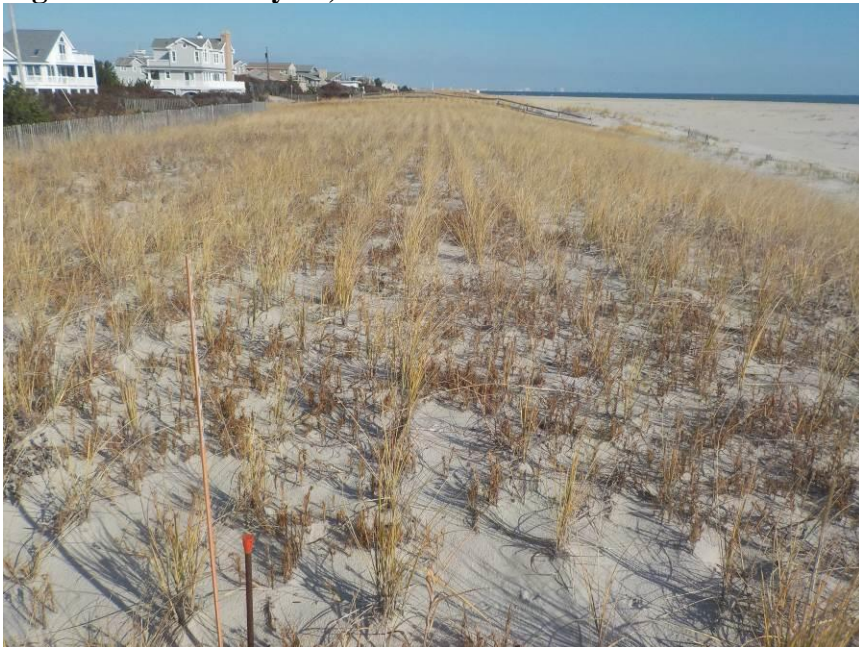
Figure 6c. December 1, 2017

Figure 6c shows the same perspective by December 2017 fencing along the dunetoe virtually completely buried by accretional sands.

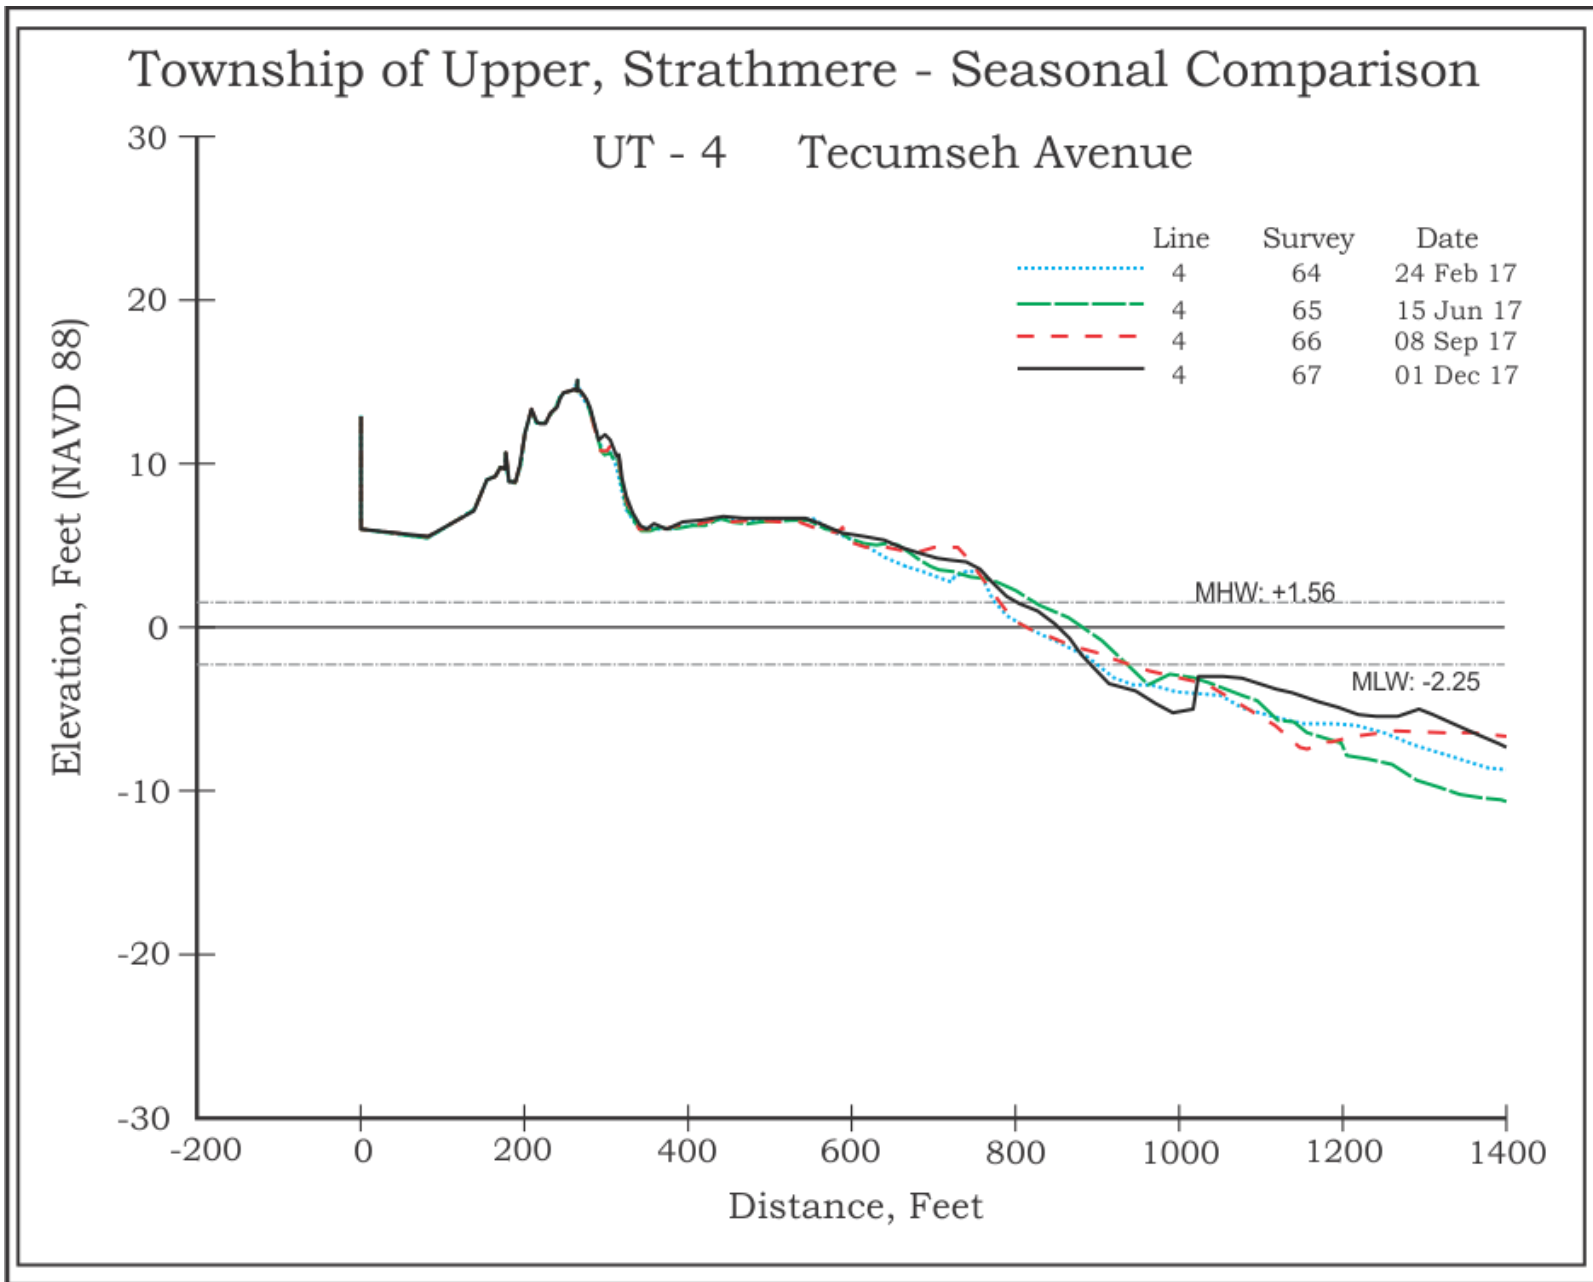
Figure 7. The dune and recreational beaches displayed no major changes in 2017, adding only minor sand to the foredune. The berm region fluctuated seasonally with its highest elevation recorded in September. The offshore bar showed a series of landward migrations to the nearshore and beachface. The annual comparison yielded a 49.65 yds³/ft. gain and a shoreline advance of 24 feet.

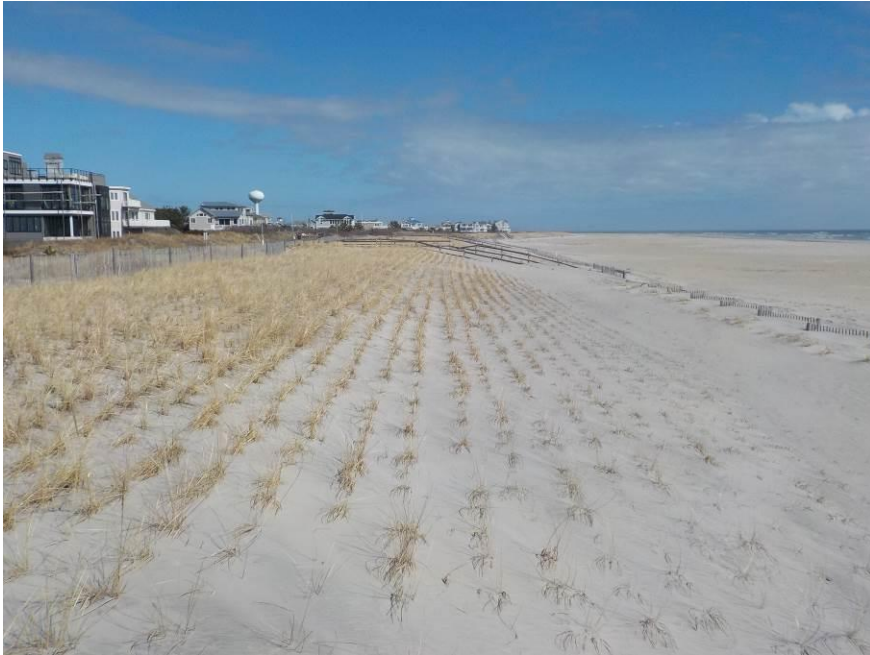
8a. February 24, 2017

Photo 8a is a view to the north along the dune crest during the winter. The tops of the foredune fence are exposed at this time.

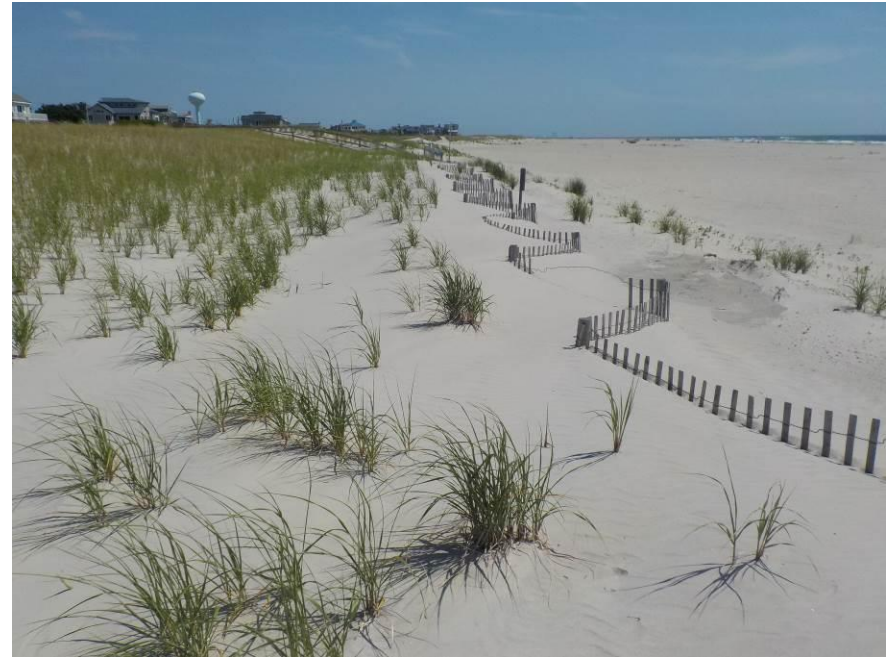
8b. June 15, 2017

Photograph 8b shows the view to the north taken from the foredune perspective.

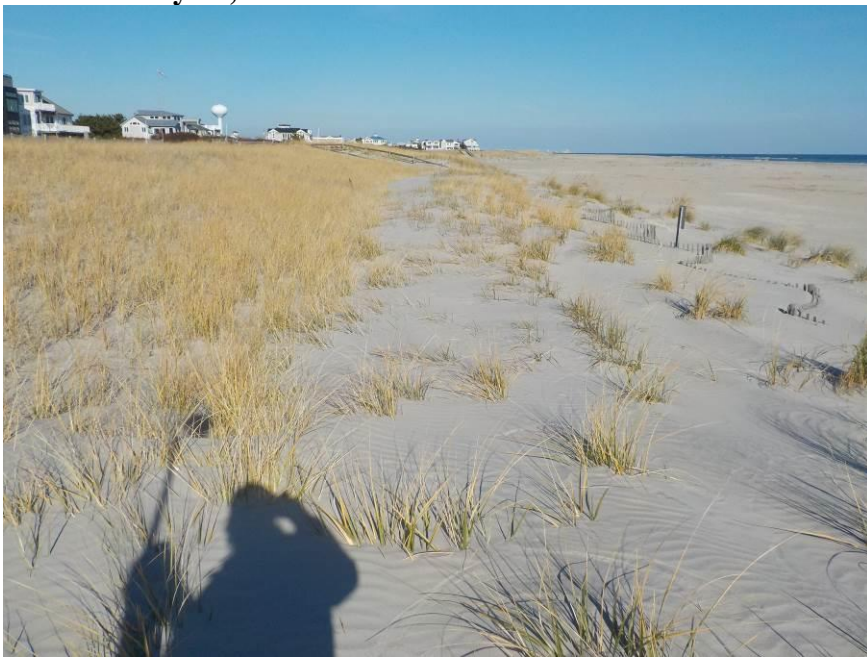
8c. December 1, 2017

Photograph 8c shows the deposit at the foredune fence in one year. The foredune has built up to the point where it shows below on the cross section.

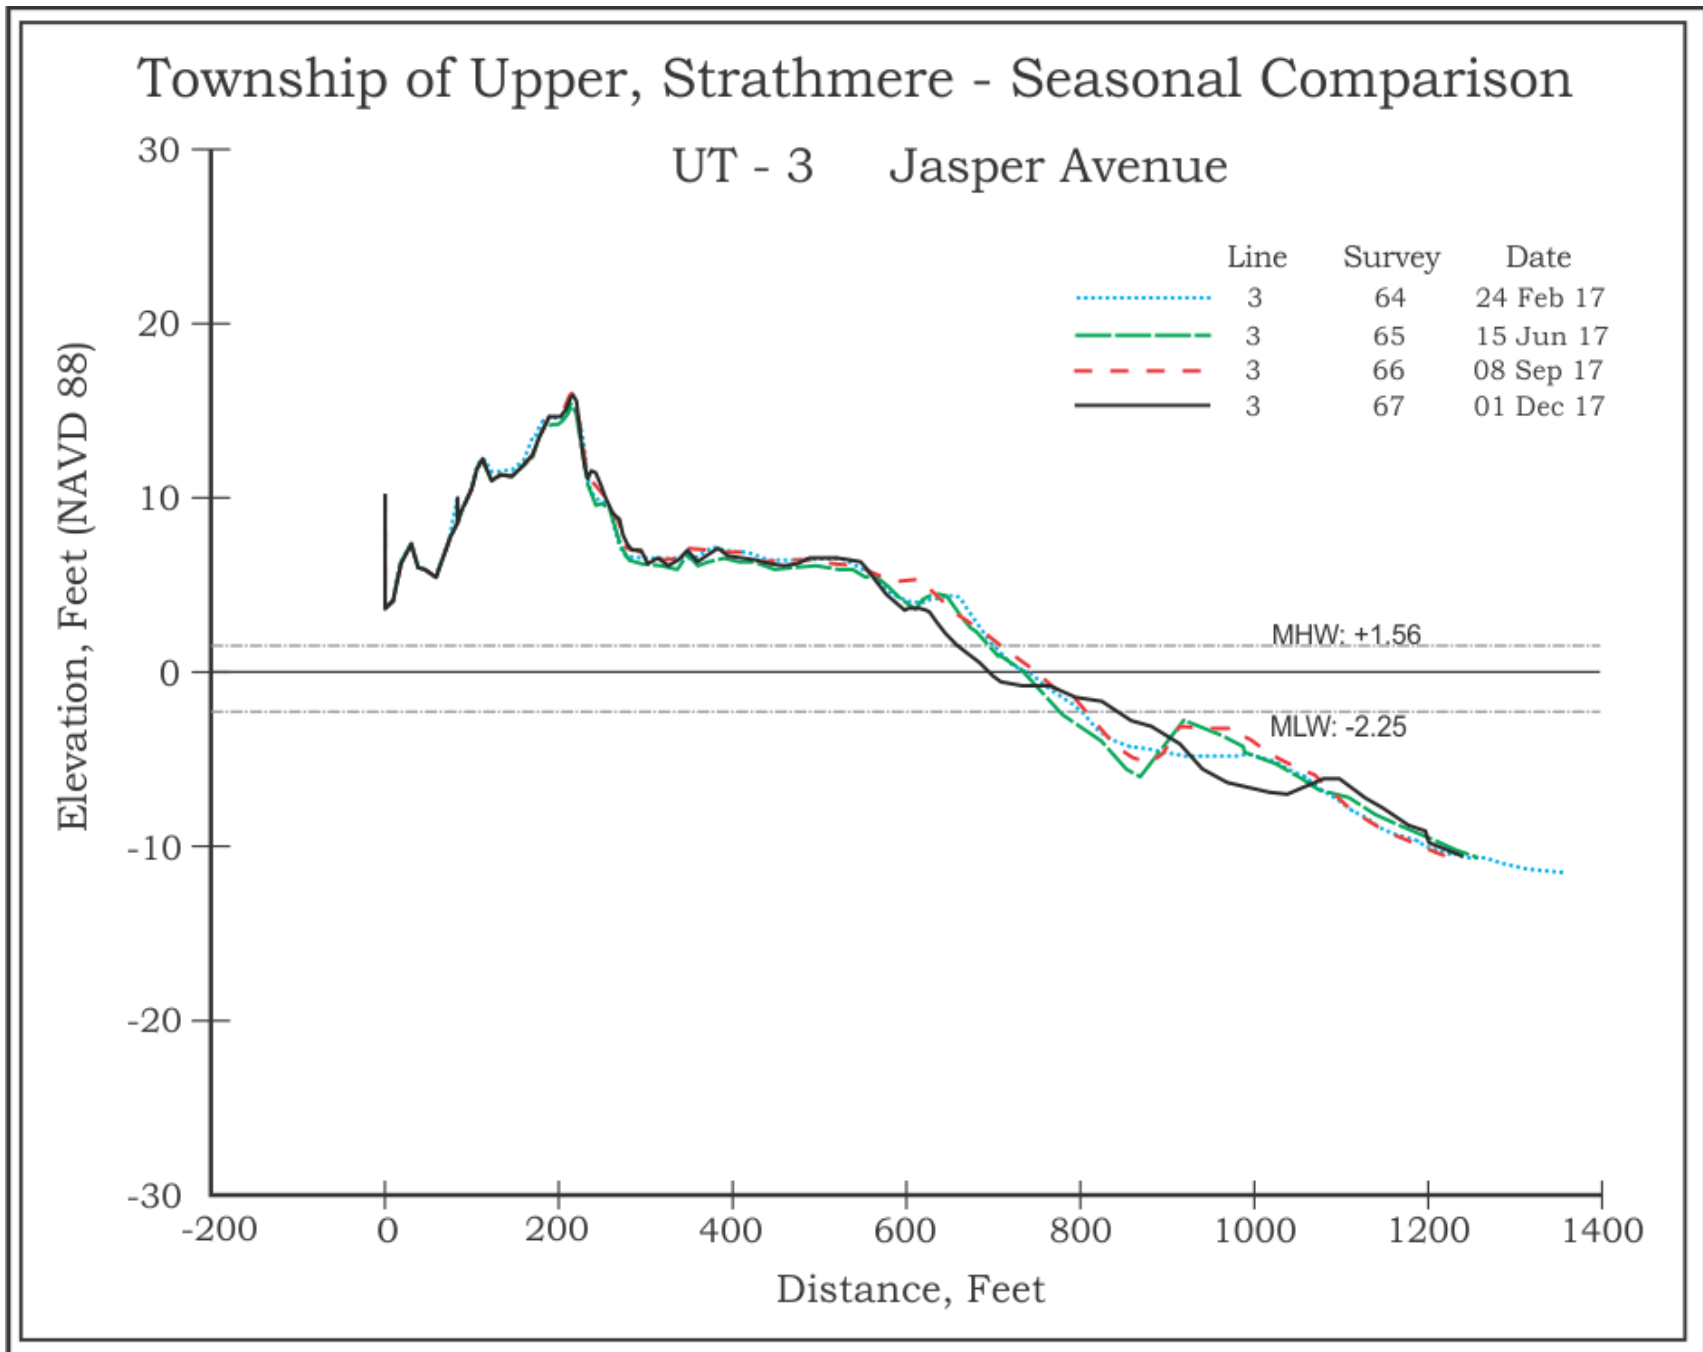
Figure 9. At Jasper Avenue the berm crest developed at the seaward edge of the dry beach with an offshore bar in September similar to that measured in June. The shoreline retreated 25 feet for the year and negligible volume gains of 0.39 yds³/ft. were recorded.

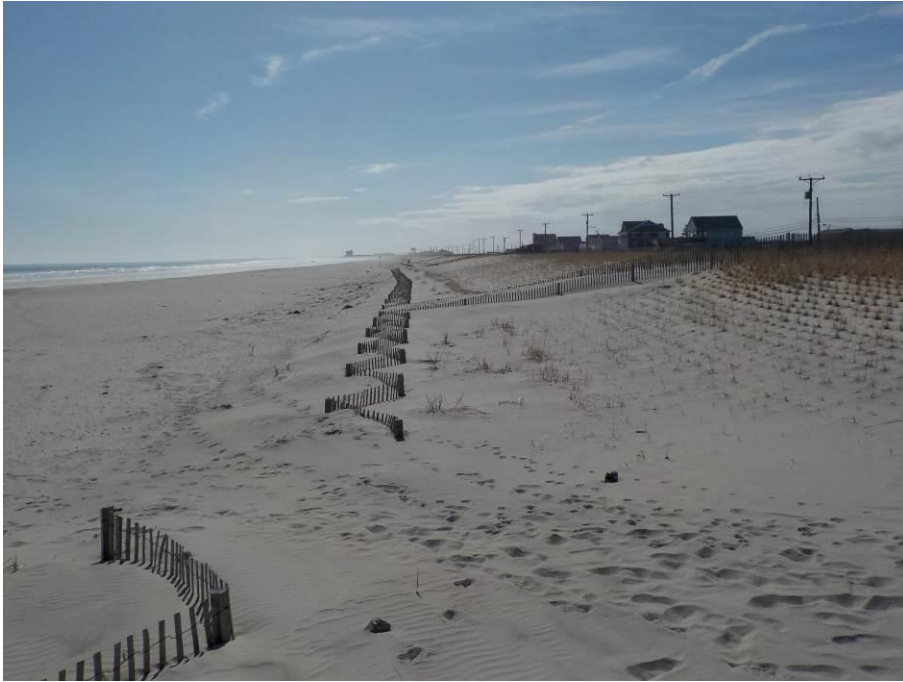
10a. February 24, 2017

Figure 10a is a view to the south along the dune toe displaying the growth of sand around the beach fencing and the recently installed dune vegetation.

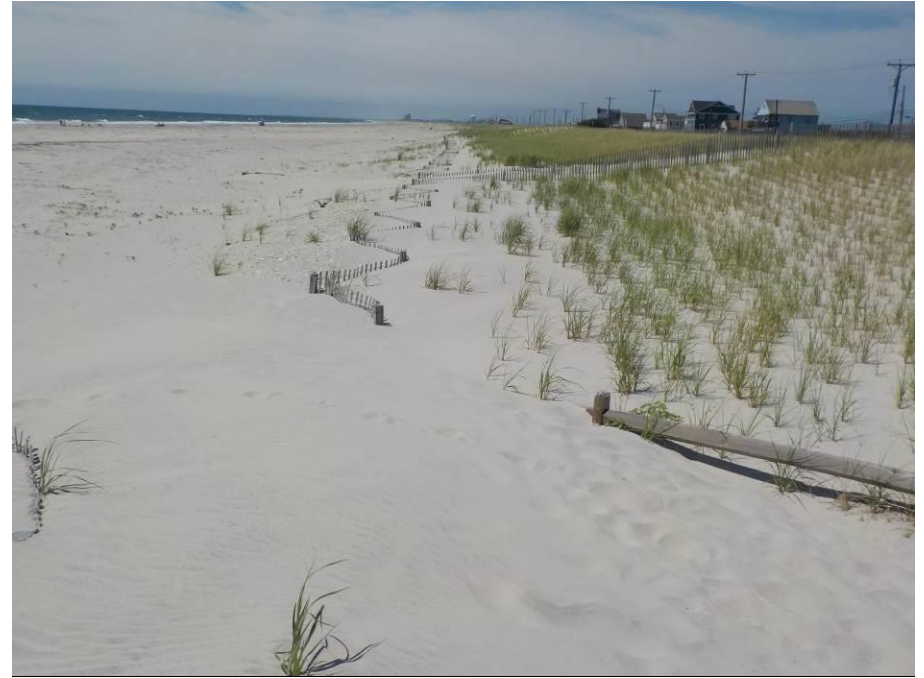
Figure 10b. June 15, 2017

Photograph 10b shows the dune toe in June with a substantial deposit of wind transported sand added at the fence. The plants are doing well with root extensions migrating seaward.

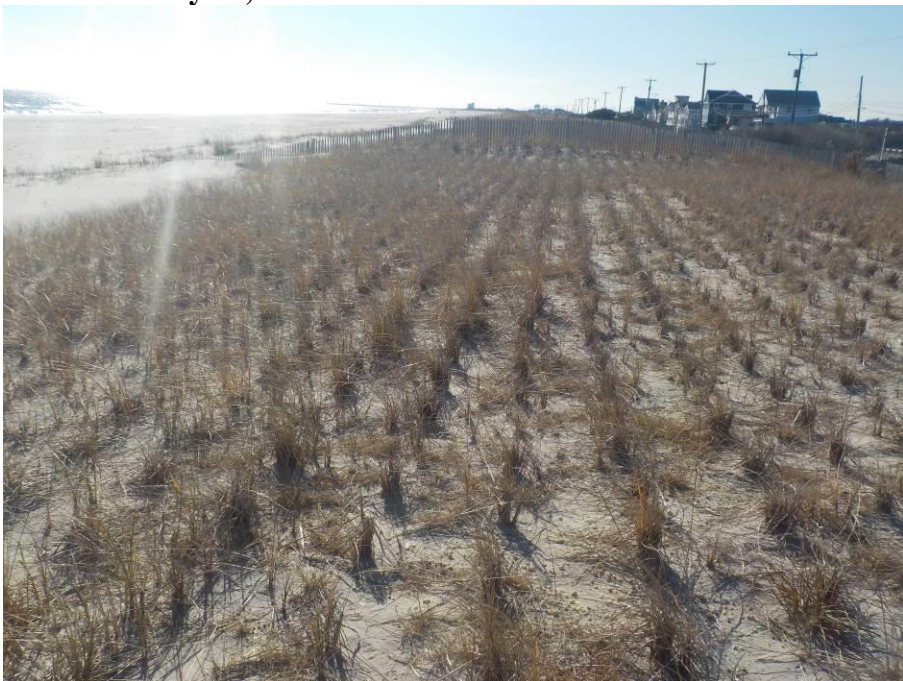
10c. December 1, 2017

Photograph 10c is a view to the south along the seaward dune crest displaying the overall width of the heathy dune system. The foredune fence has enhanced this system by continuing to add wind transported sand.

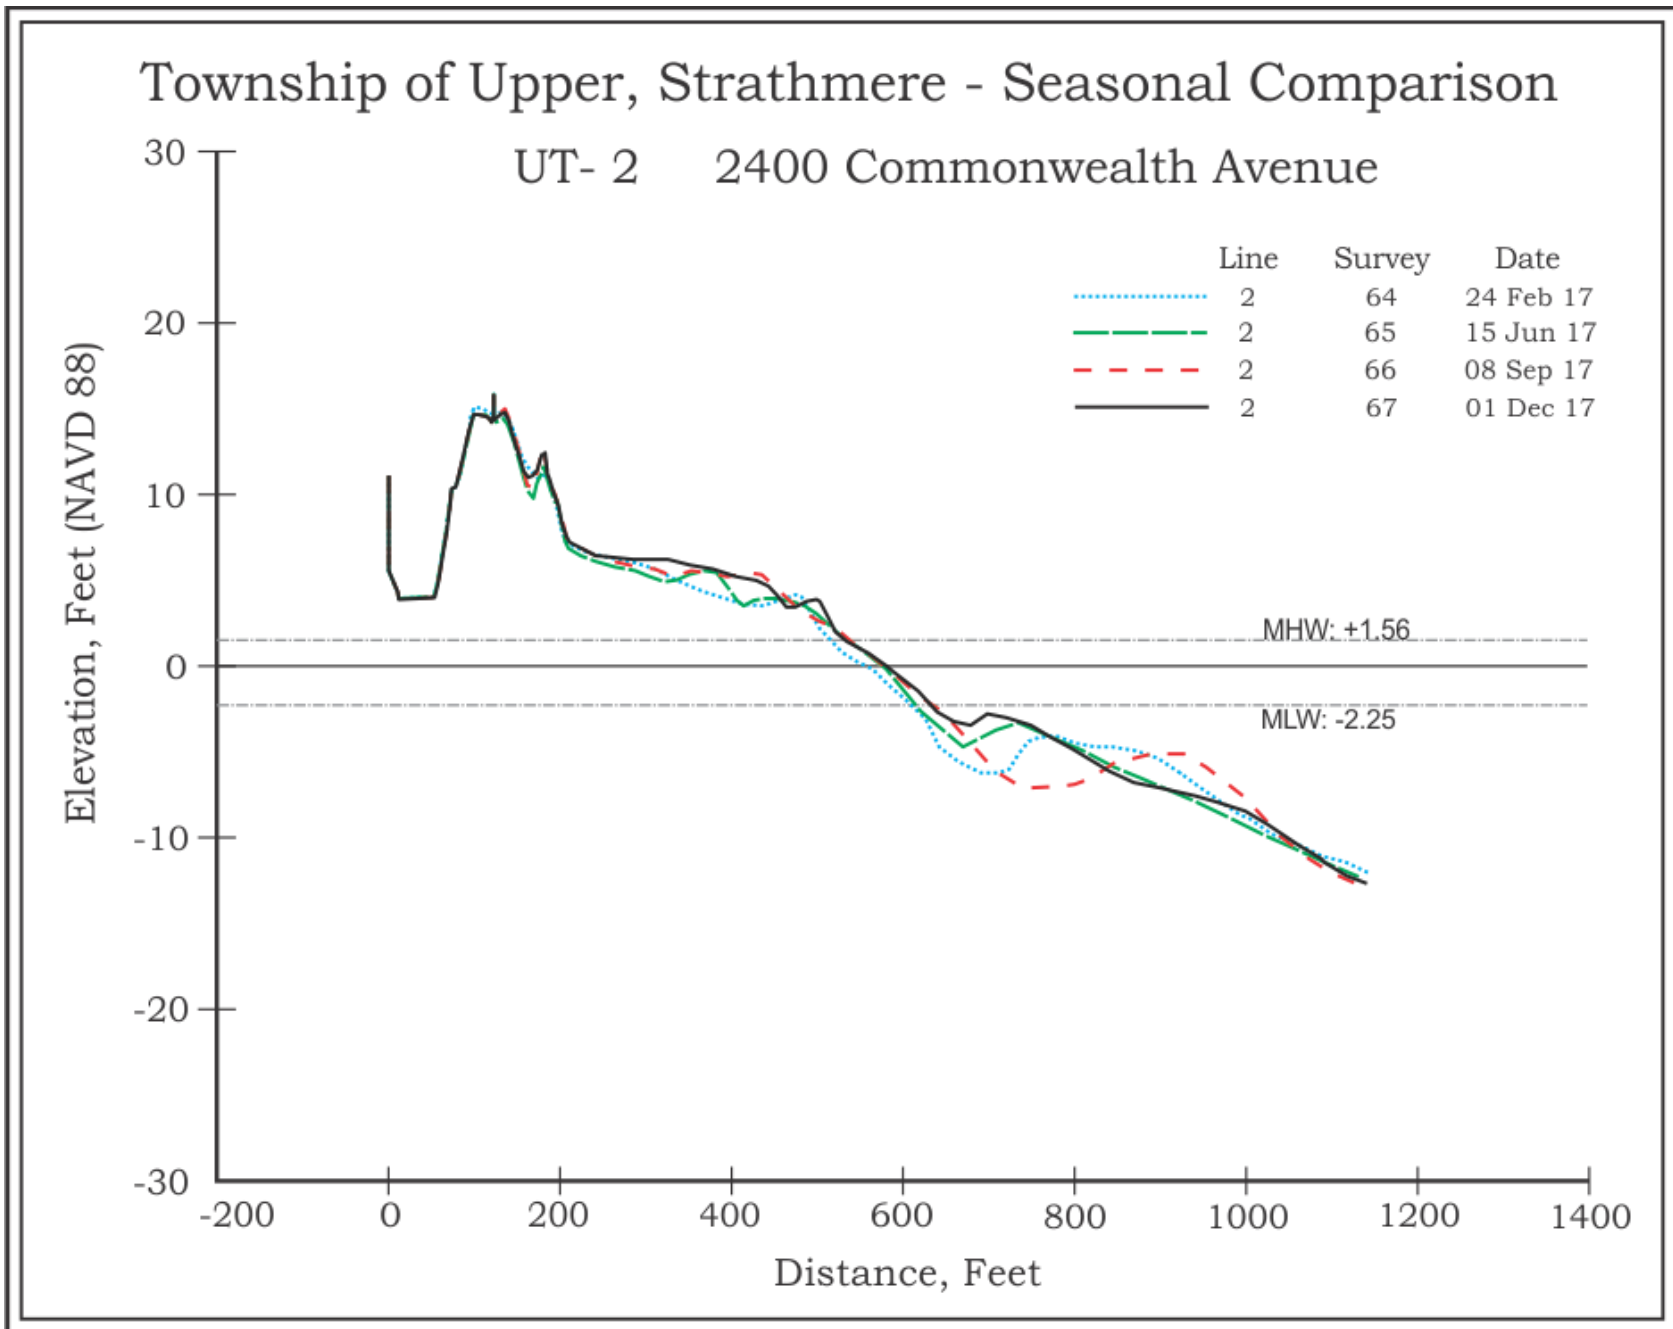
Figure 11. These cross sections display the growth of the foredune through wind transported material. The recreational beach and beachface have also shown growth over the year. The final survey in December documents the landward migration of the offshore bar. For the year this site gained 8.58 yds³/ft. of sand and the shoreline advanced 38 feet.

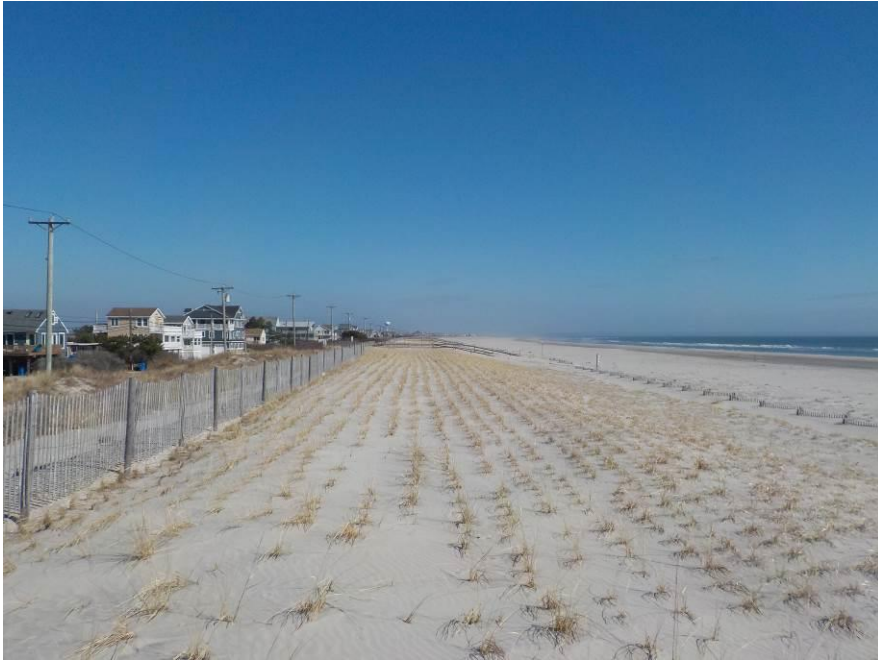
12a. February 23, 2017

Photograph 12a shows the dune fencing at the landward crest and seaward base of the USACE dune.

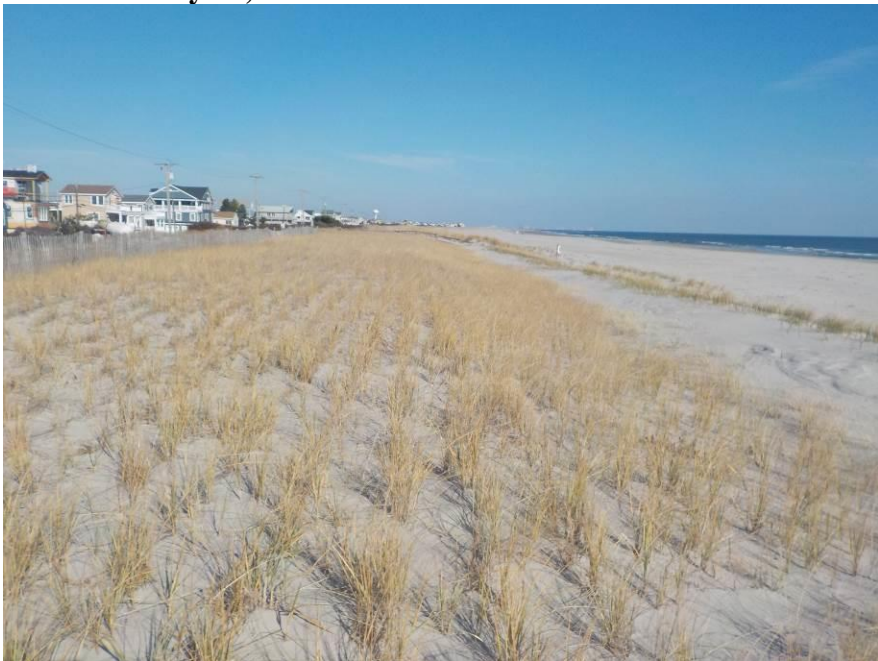
12c. December 1, 2017

Photograph 12c provides the winter view to the north across the dune and onto the beach. The fence continues to be increasingly buried in new sand added to the dune toe.
