**FINAL REPORT FOR 2017
ON THE CONDITION OF THE MUNICIPAL BEACHES
IN
THE TOWNSHIP OF UPPER, CAPE MAY COUNTY, NEW JERSEY**

**PREPARED BY: THE STOCKTON UNIVERSITY COASTAL RESEARCH CENTER
30 WILSON AVENUE
PORT REPUBLIC, NJ 08241
March 31, 2018**

**Annual Report for 2017
To
The Township of Upper On the
Condition of the Municipal Beaches**

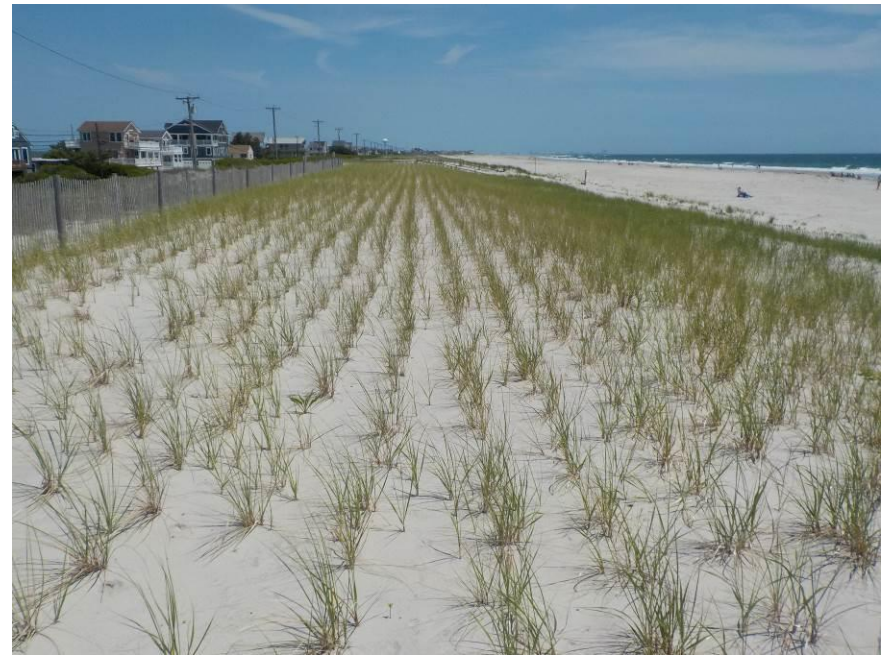
12b. June 15, 2017

Photograph 12b shows the dune with grass plants and the deposition of wind transported sand covering the top of the 4-foot fence.

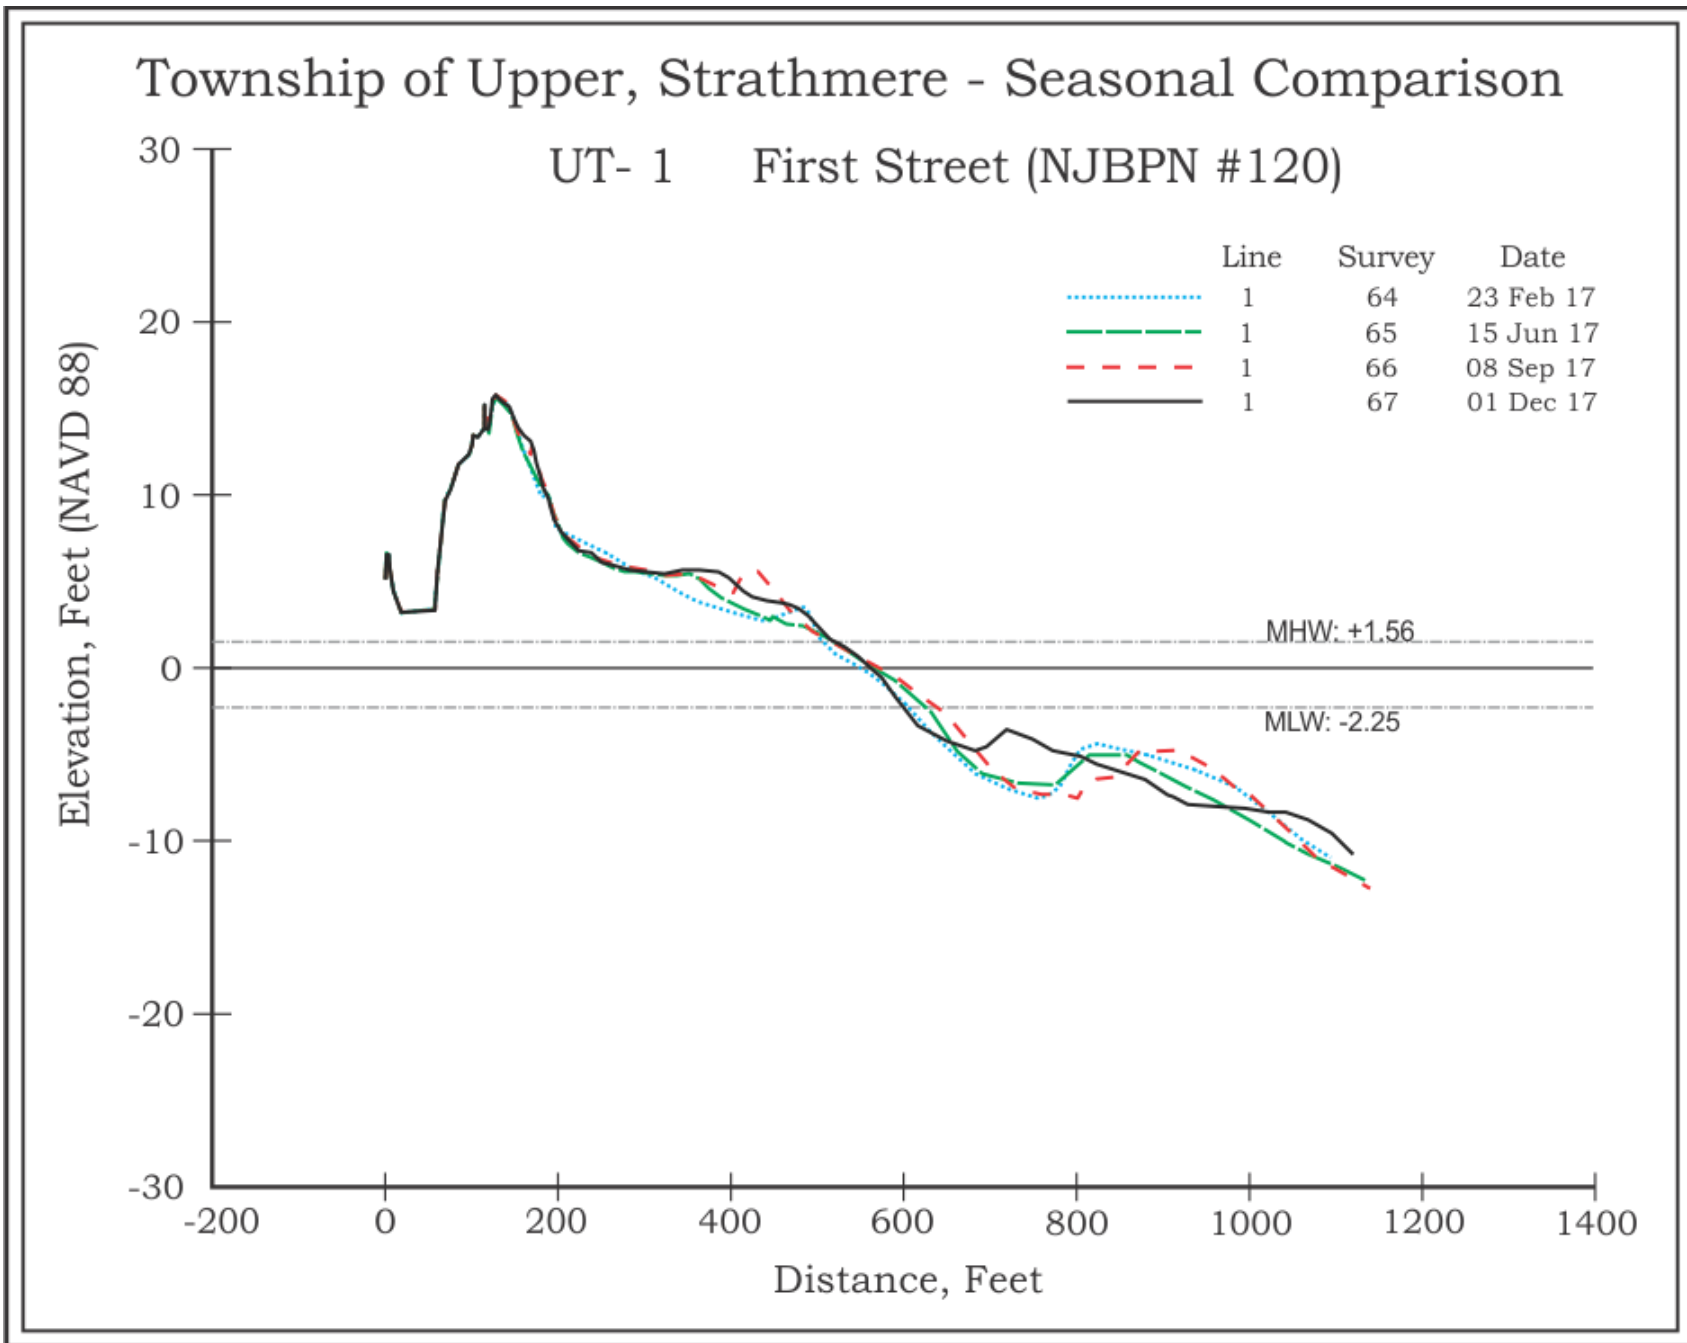
Figure 13. Overall, this site remained relatively stable throughout the 2017 survey year. The annual changes recorded were a shoreline advance of 11 feet with cumulative volume losses of -3.72 yds³/ft. The recreational beach and berm both widened during this timeframe and additional sand was added to the seaward dune crest.

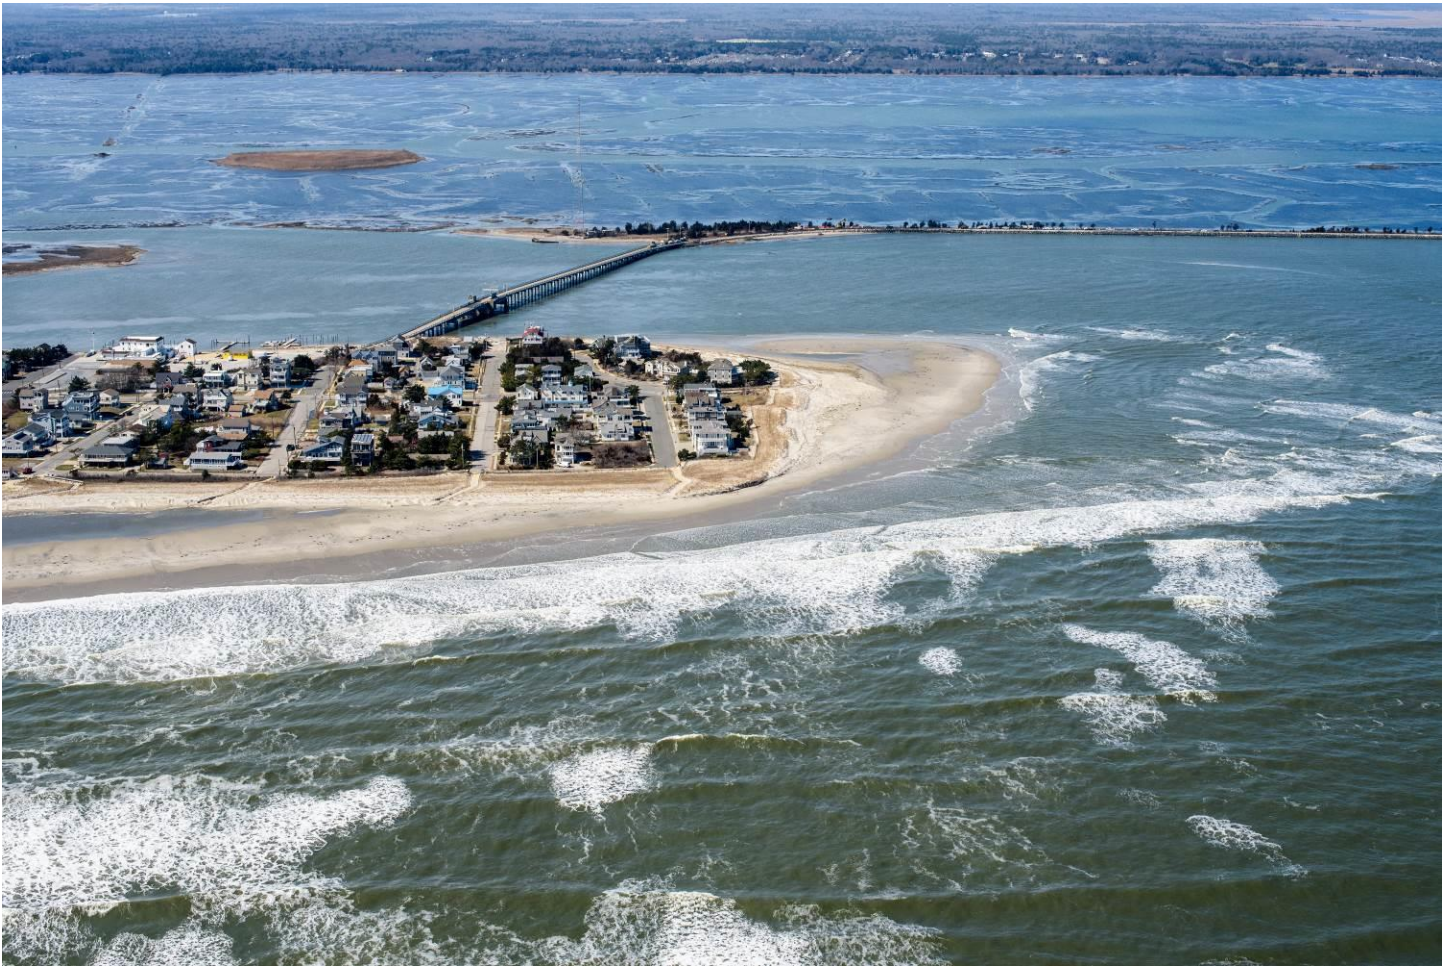
Figure 14. View March 6, 2018 as the second of four northeast storms to impact the NJ coast was getting underway during a spring tide. Note the flooded salt marshes in the bay. The very northeastern corner of the dunes at Seaview Avenue have been scaped, but offshore bar sand added to the beach in December is still present (photo by Ted Kingston).
