**Beach-Dune Performance Assessment of
New Jersey Beach Profile Network (NJBPN) Sites at
Between Manasquan Inlet and Allenhurst, New Jersey
Related to FEMA DR-JI 4086 Declared for Hurricane Sandy**

December 5, 2012

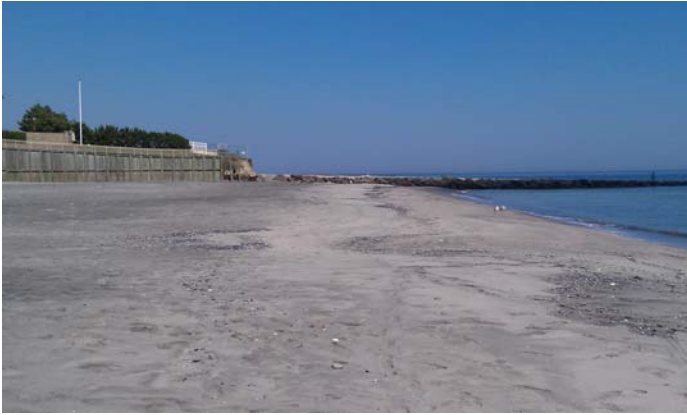
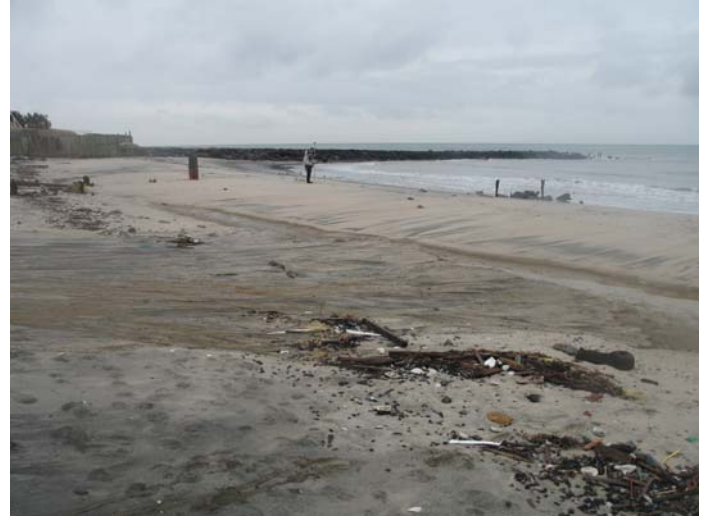
NJBPN 169 – Darlington Avenue, Deal

The photographs above were taken on October 5, 2012 (left) and November 13, 2012 (right).

Figure 2. The following figure shows the unexpected retreat in the uplands bluff in Monmouth County. Darlington Ave. was picked because a small sand beach was contained between two larger groins and a view of the bluff sediments had been historically visible. During the storm the beach was submerged and waves obviously broke directly on the various types and quality of “bluff armor”. Very little man-made work survived along this shoreline segment. This was the most extensive view of the natural bluff sand, gravel and silt ever seen in the past 50 years. The retreat in the bluff location was partly the removal of waste concrete debris dumped over the edge at the street end and erosion into the uplands sediments. To the north of the profile line about 25 feet of bluff retreat occurred after the timber bulkhead had been destroyed.

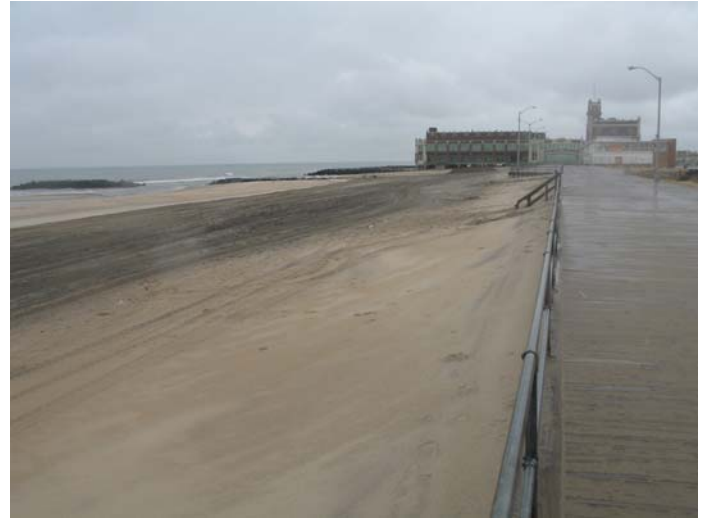
NJBPN 267 – 7th Avenue, Asbury Park

The photographs above were taken on October 5, 2012 (left) and November 13, 2012 (right).

Figure 4. Hurricane Sandy stripped sand from the beach, pushed the berm landward with sand washed up to the boardwalk as a ramp allowing the waves to pass over the structure inland. The smaller structures showing on the left photograph are missing after sandy, but the boardwalk had minor damage as waves forced sand under and upward raising decking in an irregular pattern. The City was sorting sand from debris at 7th Ave. and placing sand to fill voids scoured into the surface landward of the boardwalk. Sand was being carted back to the beach as well.

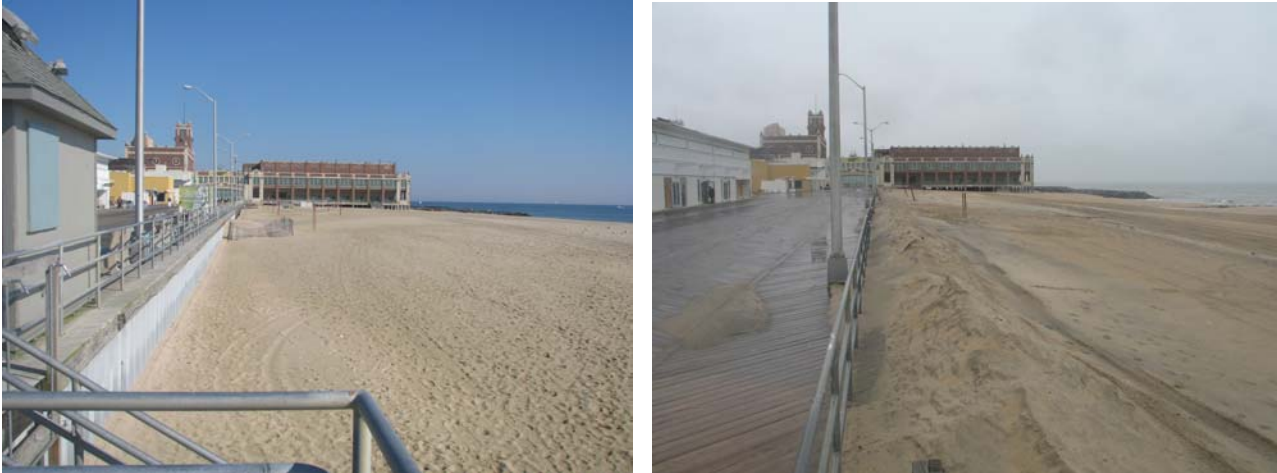
NJBPN 167 – 3rd Avenue, Asbury Park

The photographs above were taken on October 5, 2012 (left) and November 13, 2012 (right).

Figure 5. A similar impact occurred at 3rd Avenue where sand, stripped from the beach was ramped up to the boardwalk allowing the waves to pass over the structure without destroying it. The small building to the left side of the left photograph was gone, but boardwalk damage was limited to raised sections of decking. Wave flooding had clearly impacted boardwalk businesses however. The miniature golf course between the boardwalk and Ocean Avenue had an abundance of new sand trap hazards for potential players after Sandy.

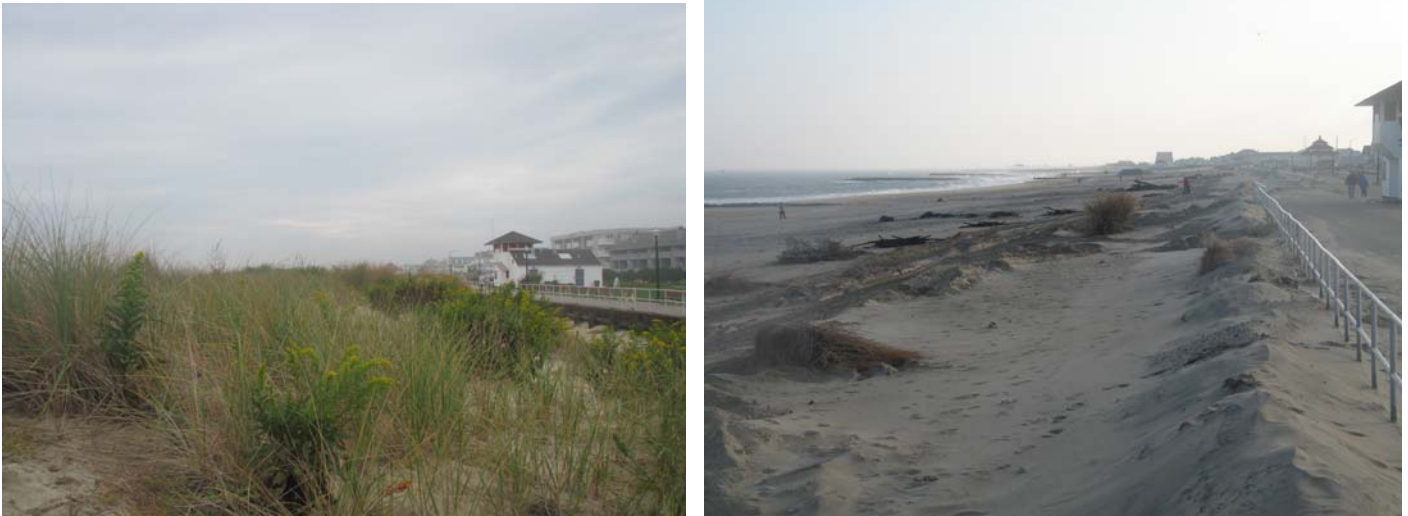
NJBPN 165 – McCabe Avenue, Bradley Beach

The photographs above were taken on October 4, 2012 (left) and November 12, 2012 (right).

Figure 7. Dune damage was extensive, but the result produced a reduction in the damages landward. The promenade was impacted, but not destroyed and abundant sand was still present in Ocean Avenue. The swale between the dune system and the promenade was filled with sand and the volume lost was significant from the beach. Berm recovery was underway at all these Monmouth County Sites.

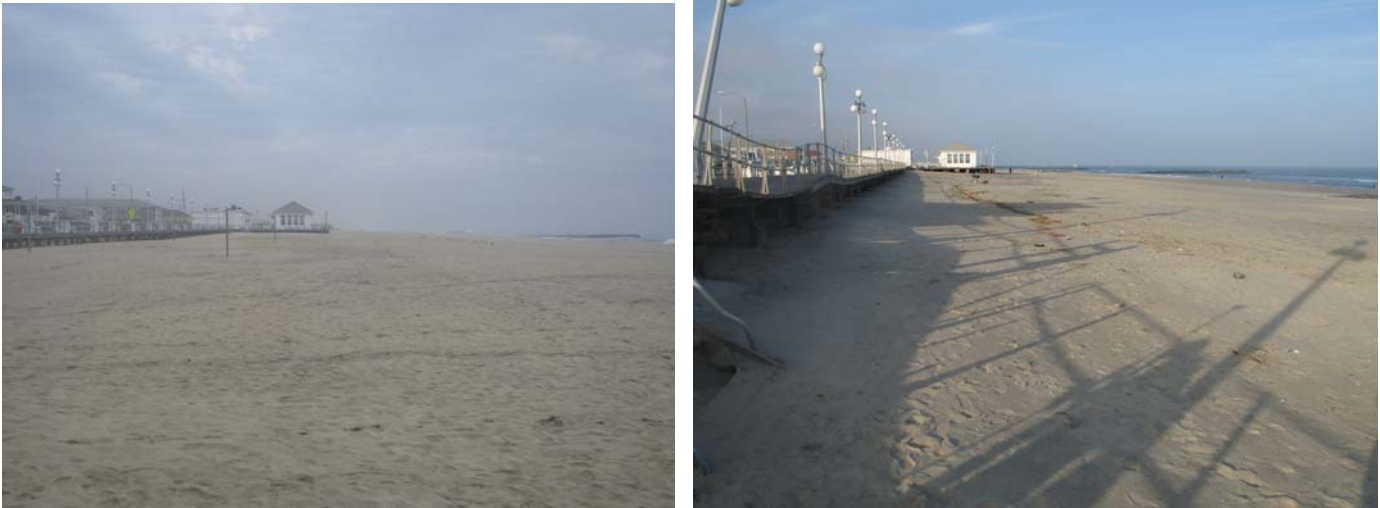
NJBPN 164 – Sylvania Avenue, Avon-by-the Sea

The photographs above were taken on October 4, 2012 (left) and November 12, 2012 (right).

Figure 8. The beach had been totally submerged and sand was washed inland well beyond Ocean Avenue. The swale between Ocean Avenue and the boardwalk was filled in. Damage to the building just north of the profile line was extensive. The small lakes were also impacted with sand burying the drainage system as well as raising lake level with salt water. Efforts were underway to excavate the drainage and lower lake level.

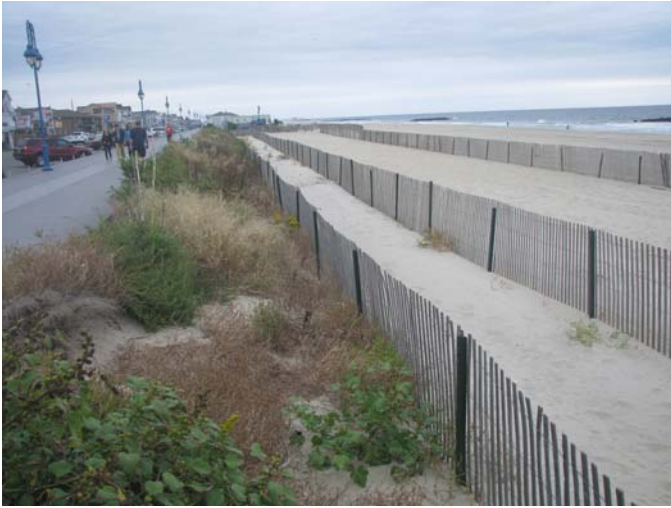
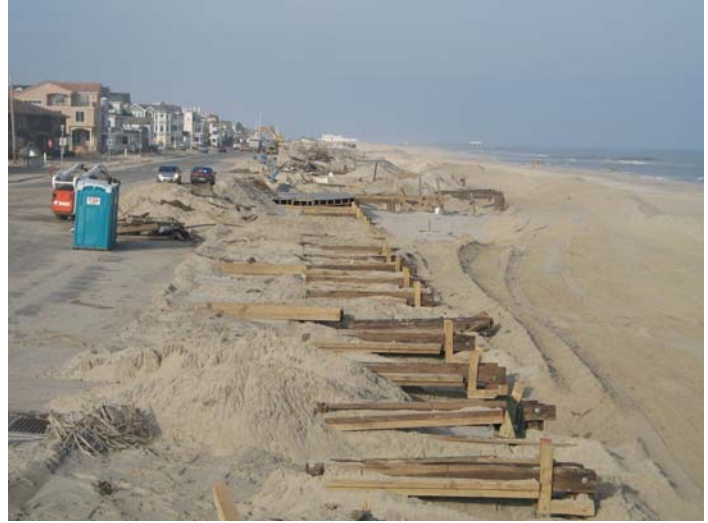
NJBPN 162 – 18th Avenue, Belmar

The photographs above were taken on October 2, 2012 (left) and November 12, 2012 (right).

Figure 10. The southern Belmar shoreline was completely overrun by the force of Hurricane Sandy. Lake Como segment was closed to traffic because multiple pumping pipelines were in place moving lake water back to the sea. Excavators were digging to clear the normal drainage system as well. Nothing but the supports remained from the boardwalk, with the small dune and all the fencing swept away. Even the lamp standards were taken away. Mounds of sand had been carted back to the beach.

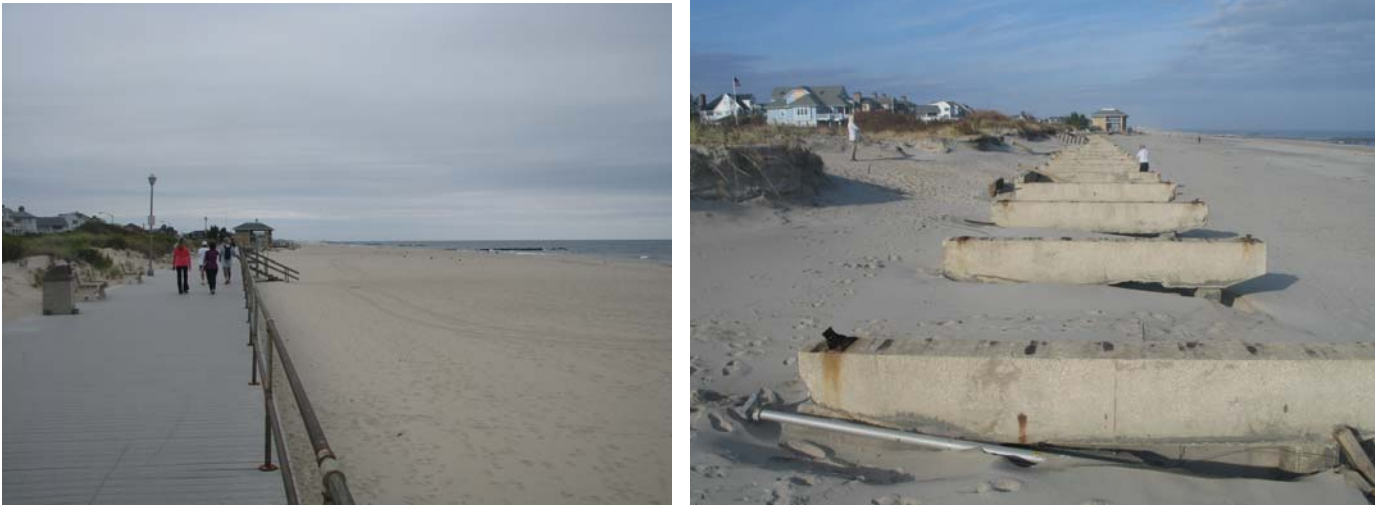
NJBPN 161 – Brighton Avenue, Spring Lake

The photographs above were taken on October 2, 2012 (left) and November 12, 2012 (right).

Figure 11. Spring Lake lost the entire boardwalk deck. Extensive damage occurred at the ocean-side bathing buildings with most of the dunes breached frequently and some segments removed entirely. Since the boardwalk had been seaward of the dunes for over 60 years, the waves impacting the dunes acted to lift the boardwalk deck sections from the concrete supports. The fact that the steel deck retainers (extreme left and right on the top of the concrete supports) were rusted away by decades of neglect did not help matters in terms of boardwalk survival.

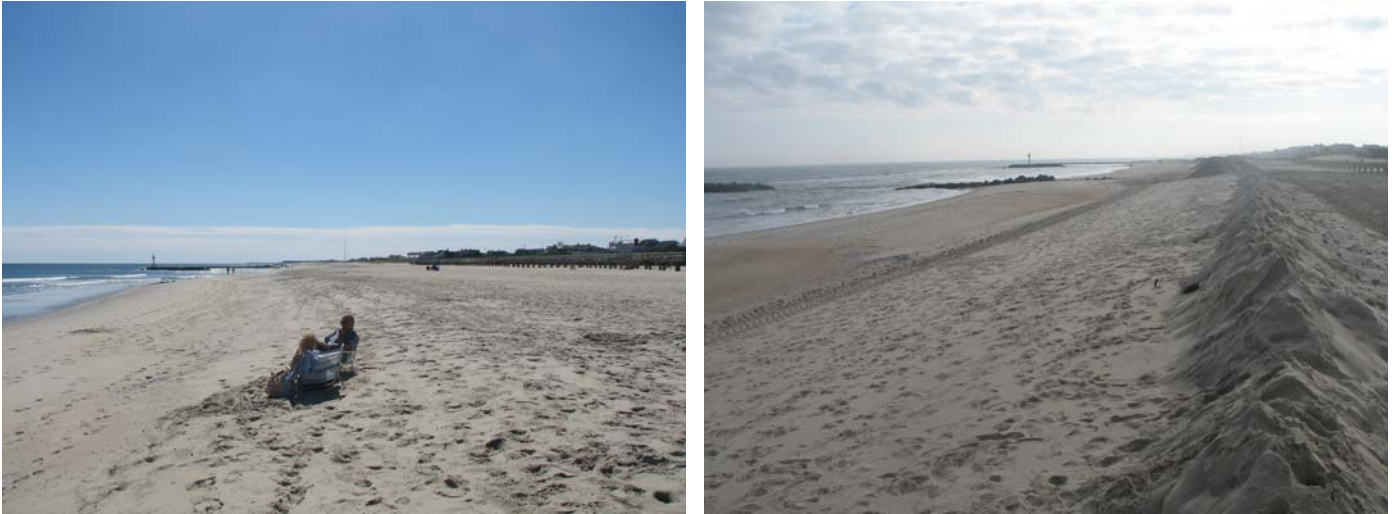
NJBPN 160 – Salem Avenue, Spring Lake

The photographs above were taken on October 1, 2012 (left) and November 12, 2012 (right).

Figure 12. Serious dune erosion allowed waves to move sand into Ocean Avenue and strip the boardwalk deck from the supports. A ridge of sand had been carted back to the beach as the feature showing on the beach on the November 12th survey line. Sand loss was extensive on the berm.

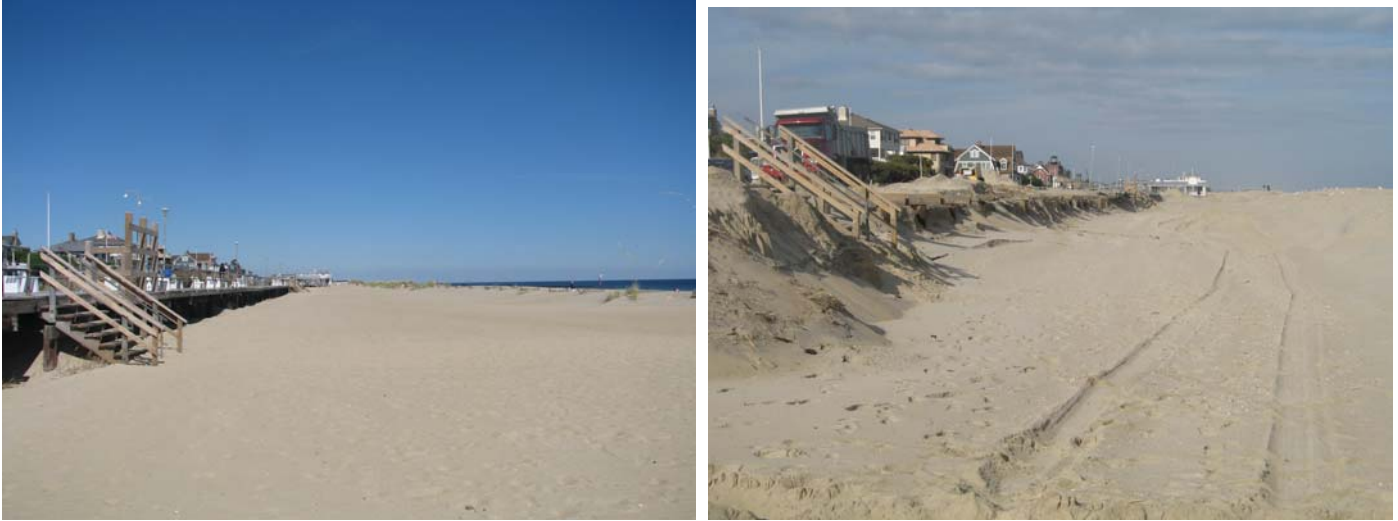
NJBPN 159 – New York Avenue, Sea Girt

The photographs above were taken on October 1, 2012 (left) and November 12, 2012 (right).

Figure 13. The damage along the northern Sea Girt shoreline impacted the infrastructure more intensely than further south. The boardwalk was damaged and washed over completely. Sand was being carted back the beach as a sizable ridge. The berm was reduced in both width and elevation in dramatic fashion. The sand was still present along New York Avenue west of Ocean Avenue. Wreck Pond was an active site with excavators attempting to clear sand from around the normal drainage weir system and pump the salt water inflow out to sea. Wreck Pond has been the most active “estuary lake” in terms of the sea opening it to tidal flow during storms.

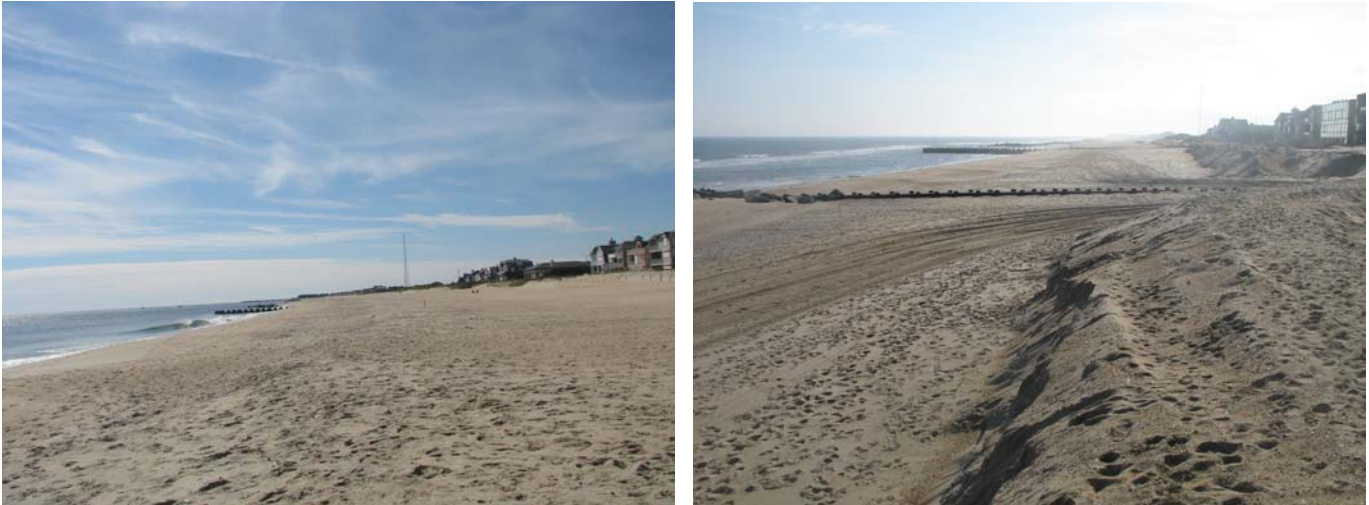
NJBPN 158 – Trenton Avenue, Sea Girt

The photographs above were taken on October 1, 2012 (left) and November 12, 2012 (right).

Figure 14. At Trenton Avenue the beach was reduced in elevation and width, with sand from the street end carted back to the beach as the ridge showing in the right-hand photograph. Since Ocean Avenue does not continue south to this location, the beach to the north suffered dune loss, but no waves reached the homes because both the dune was extensive following the 2000 Federal Project (developing naturally over the past 12 years) and the homes sit on top of the Monmouth County bluff.

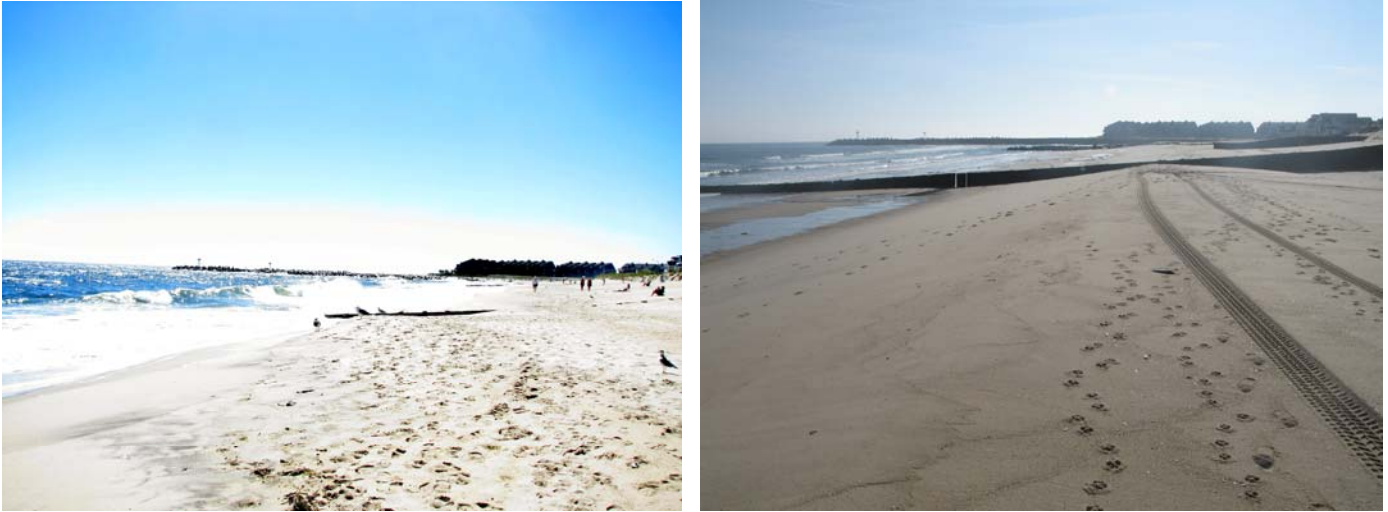
NJBPN 256 – Pompano Avenue, Manasquan

The photographs above were taken on September 21, 2012 (left) and November 12, 2012 (right).

Figure 16. Damage was worse further south at Pompano Avenue a few hundred feet from the Manasquan Inlet jetty. The promenade was removed, as were the dunes and all the material missing below the black line below had been transported through the homes into First Avenue in the Borough. Sand was dragged offshore as well since the post-Sandy cross section extends seaward at shallow depths beyond that surveyed September 21, 2012. Multiple homes had been “red-stickered” with “unfit for habitation” tags with some clearly off their foundations.
