Beach-Dune Performance Assessment of

New Jersey Beach Profile Network (NJBPN) Sites

Between Deal and Sea Bright, New Jersey

Related to FEMA DR-NJ 4086 Declared for Hurricane Sandy

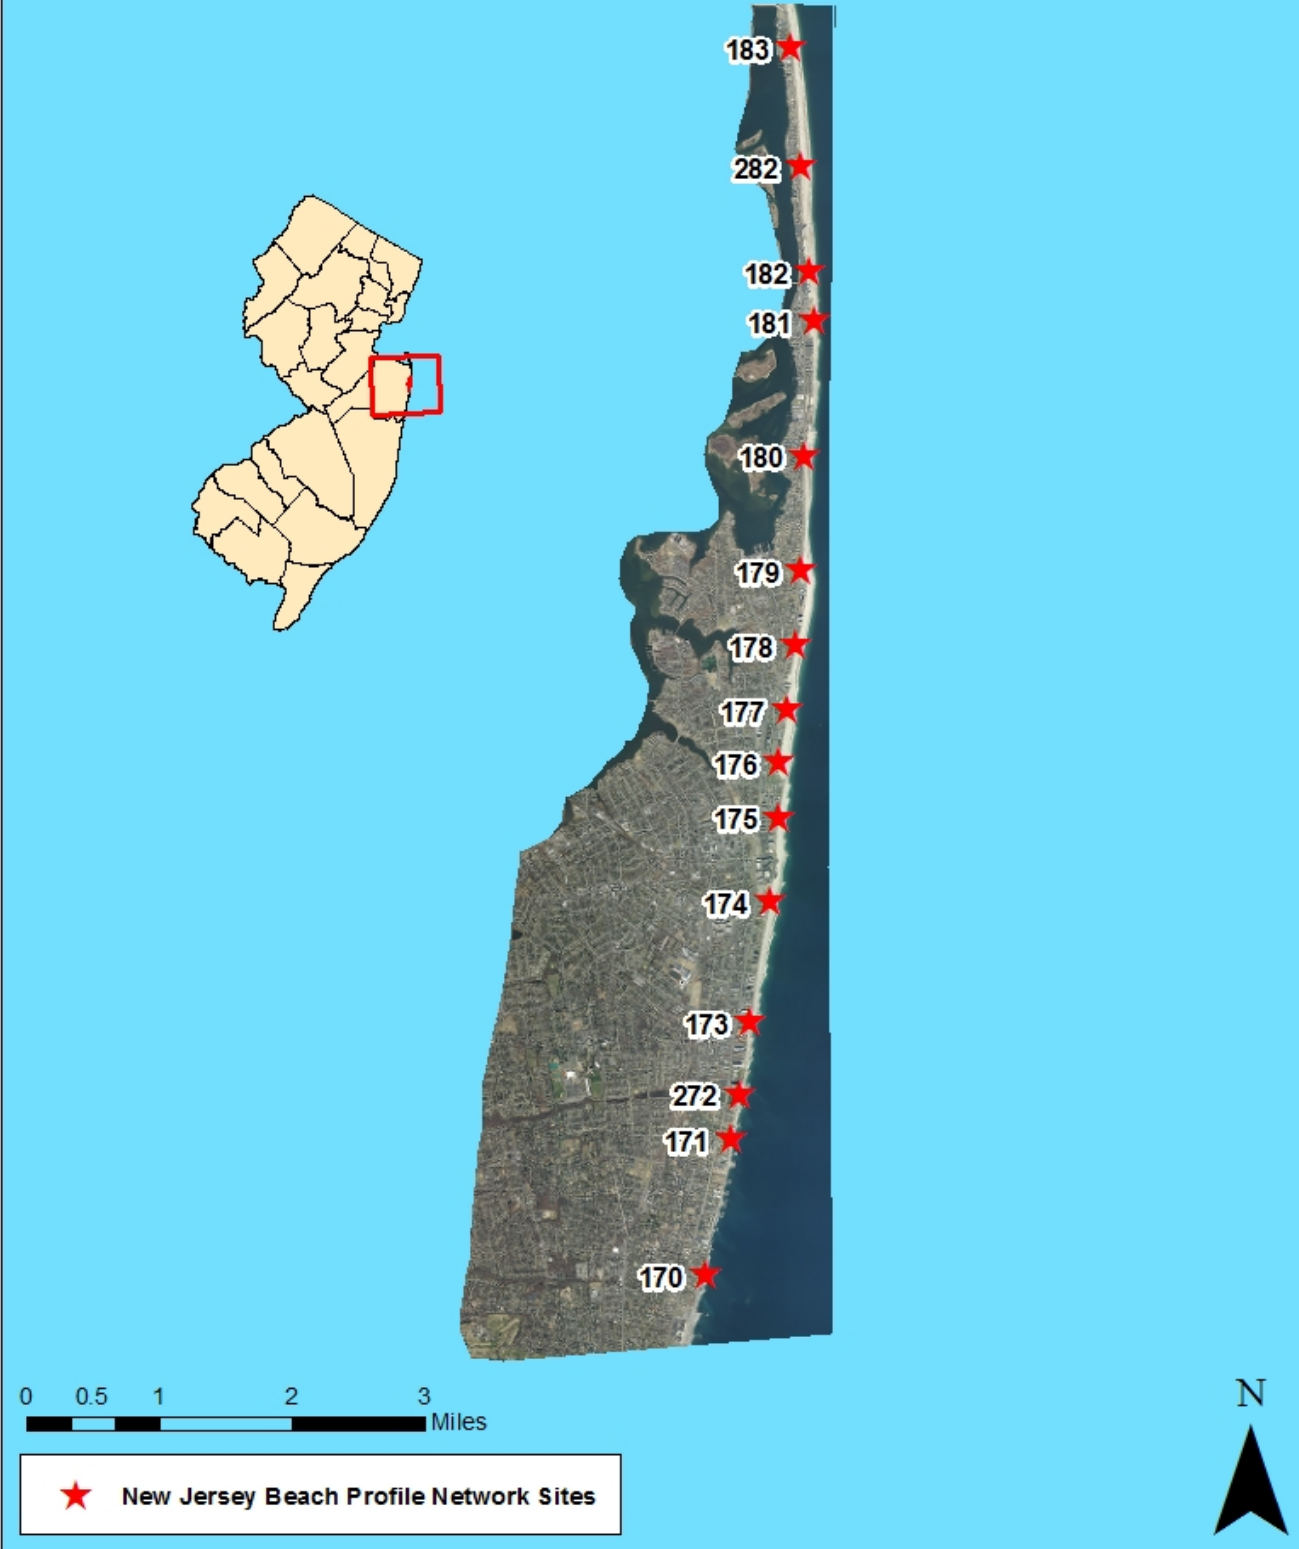
**New Jersey Beach Profile Network Locations,
Northern Monmouth County**

Figure 1. NJBPN Profile Locations, between Roosevelt Avenue, Deal and Sandy Hook National Seashore, Monmouth County, New Jersey

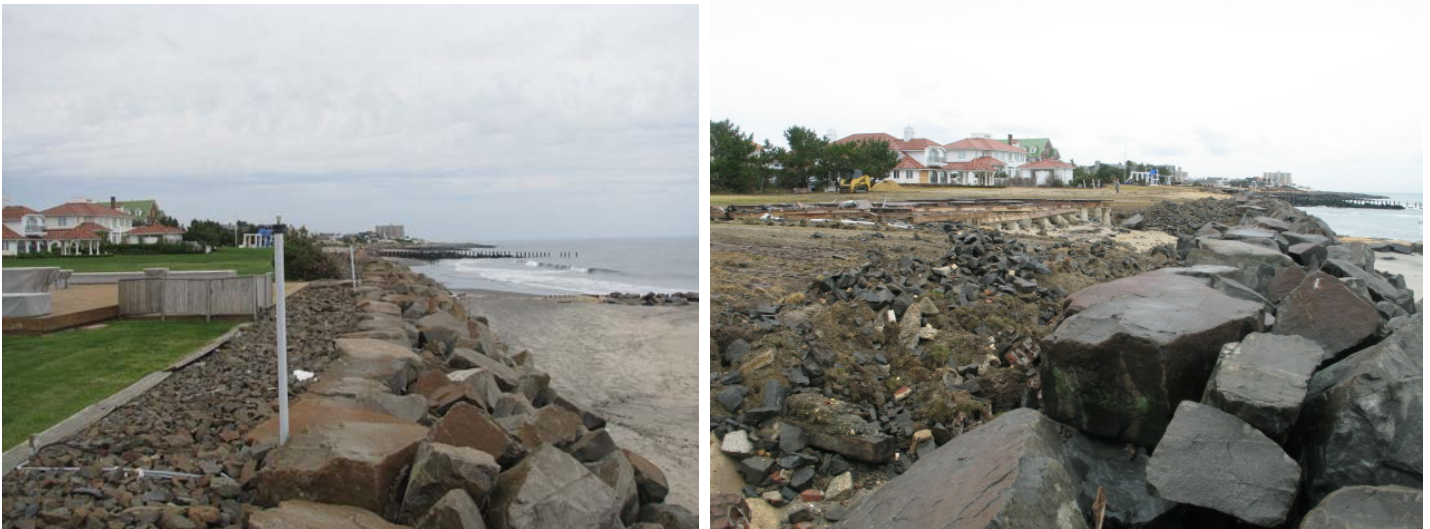
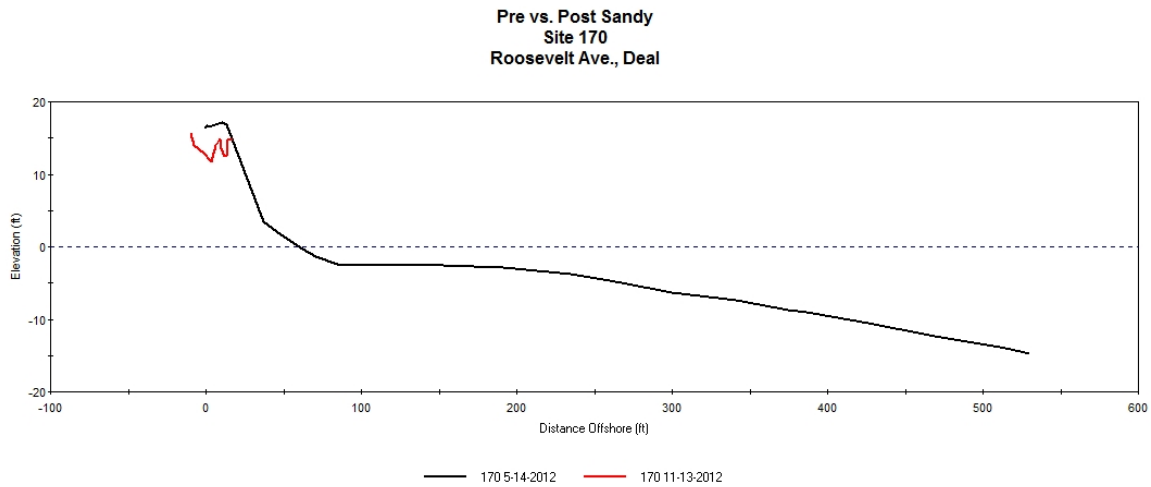
NJBPN 170 – Roosevelt Avenue, Deal

The photographs above were taken on May 13, 2012 (left) and November 13, 2012 (right).

Figure 2. This profile is located between two rock groins that limit sediment movement. This area has never received sand during beach nourishment and has never benefited from the addition of sand from the littoral system derived from the Federal beach fills. Here the bluff is 20 feet higher than the beach, armored with rocks, yet waves crashed over the rocks and dug deeply into the area just landward of the rock revetment. Water poured across the private property and flooded Ocean Avenue at least 3 feet deep. The seaside private patio was destroyed as was the Deal sewage pumping station at the seaward end of Roosevelt Avenue.

The Roosevelt Avenue site is located north of the Deal sewage pumping station built in 1906 at the base of the sedimentary bluff. It is essentially a three-story building with just the top story presented at the end of Roosevelt Avenue. South of this street is a series of private homes built on the bluff with a decent sand beach seaward of the dune-mantled bluff edge. Phillips Avenue is the location of a public bathing complex that was totally destroyed by the loss of the Phillips Avenue fishing pier built decades ago over the rock groin at the end of Phillips Avenue. North of Roosevelt Avenue there is essentially no dry beach between closely-spaced groins. Site #170 has a 26-year history of a wet beach against the rocks. Occasional offshore bars have migrated to the shoreline yielding a temporary dry beach less than 25 feet in width. Sandy's waves over-topped the rock wall and scoured deeply into the soil, fill debris (bricks etc.) and bluff sediments. Water poured landward flooding both Roosevelt and Ocean Avenues to 3-foot depths as seen in debris lines on nearby properties. The tile roof was torn off the seaward side of the sewer plant pumping station and all three floors of the facility were filled with seawater. Deal's \$650,000 investment in rehabilitation of the facility last year was in ruins.

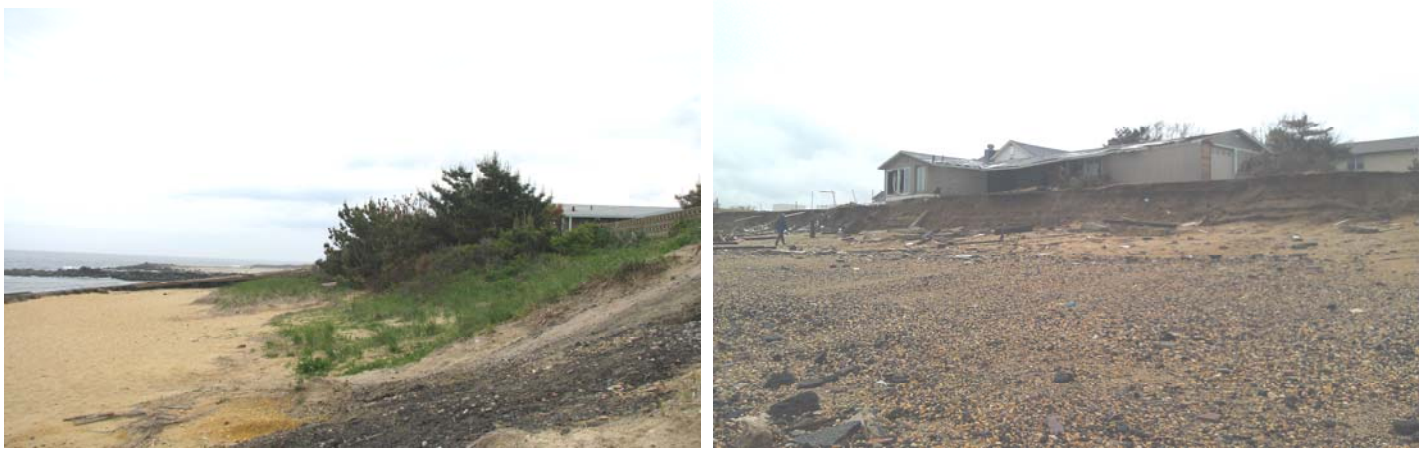
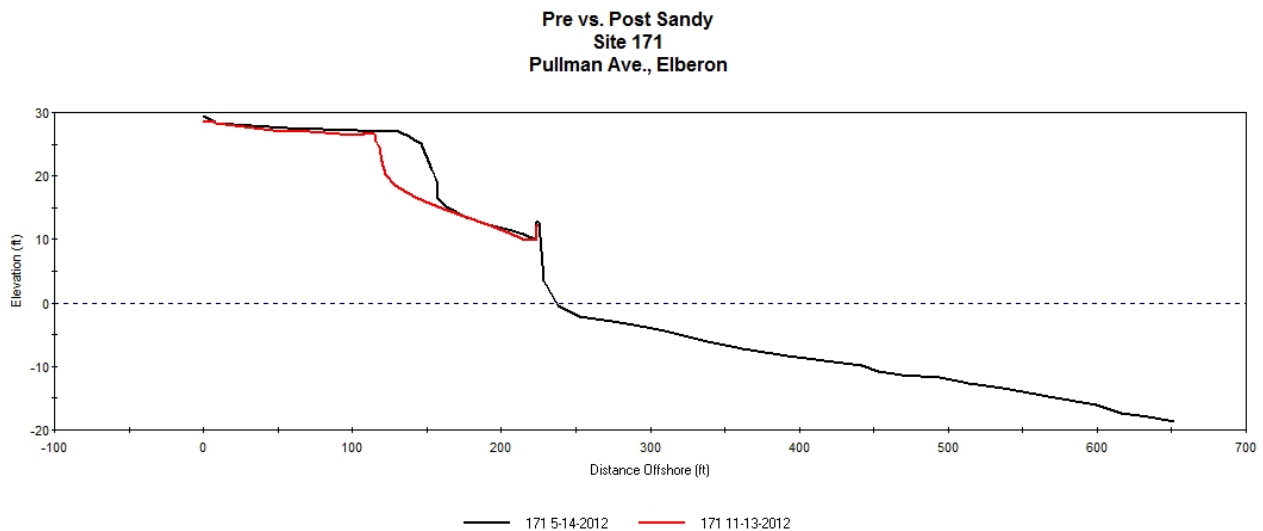
NJBPN 171 – Pullman Avenue, Elberon

The photographs above were taken on May 13, 2012 (left) and November 13, 2012 (right).

Figure 3. This site is located on the highest point along the bluff shoreline and in the past, has had very little sub-aerial beach as this community was not included in the Federal beach nourishment projects. Prior to Hurricane Sandy, the private properties were separated from the shoreline by a bulkhead and rock revetment which rises 12 feet in elevation and was un-damaged. However, waves apparently broke over the rock revetment, attacked upper un-armored bluff sediments and pushed the edge back 40 feet. The waves reached both homes either side of the street destroying both and removing a third of the building lot in the process. A small wedge of sand was observed in the corner created between the revetment and the south groin in this cell. The beach in front of the profile was virtually unchanged.

The single cross section located in Elberon at Pullman Avenue demonstrated the susceptibility of even the high bluff located here (28 feet NAVD88) to major erosion from the storm surge and waves generated by Hurricane Sandy. Homes built at the bluff edge were destroyed by waves with about a third of each lot's width inland gone. The rock revetment and timber wall account for about 40% of the bluff height and were unaffected. Apparently waves broke on the revetment with crests at least 35 feet high because both homes were smashed in on the seaward side. This was not from wave spray on impact with the fortifications. The end of Pullman Avenue was eroded landward by about 50 feet.

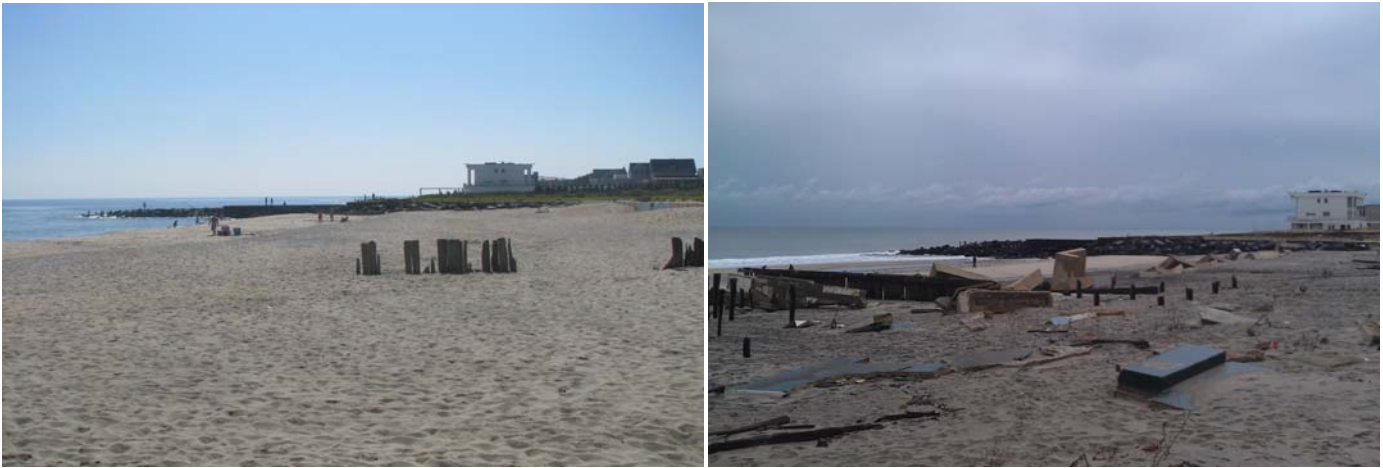
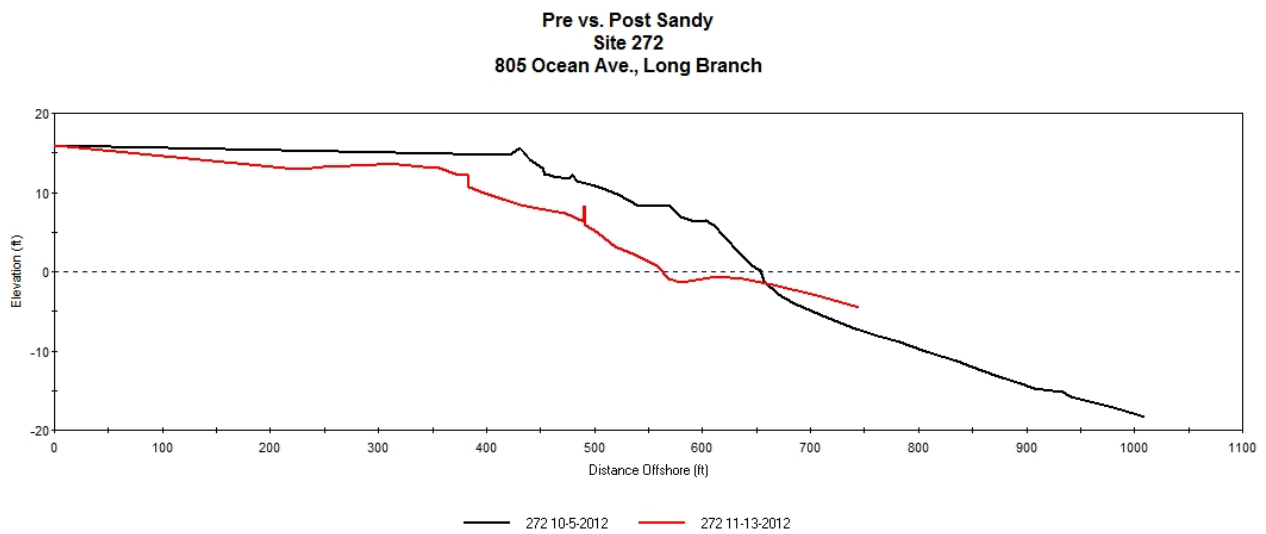
NJBPN 272 – 805 Ocean Ave, Long Branch

The photographs above were taken on October 5, 2012 (left) and November 13, 2012 (right).

Figure 4. This site was established in 2010 and has gained in sand volume over the past two years. Unfortunately, Hurricane Sandy stripped sand from the beach and pushed the berm landward. All structures landward of the original dune crest were erased and reduced to rubble. Sand was pushed landward or washed back out to sea.

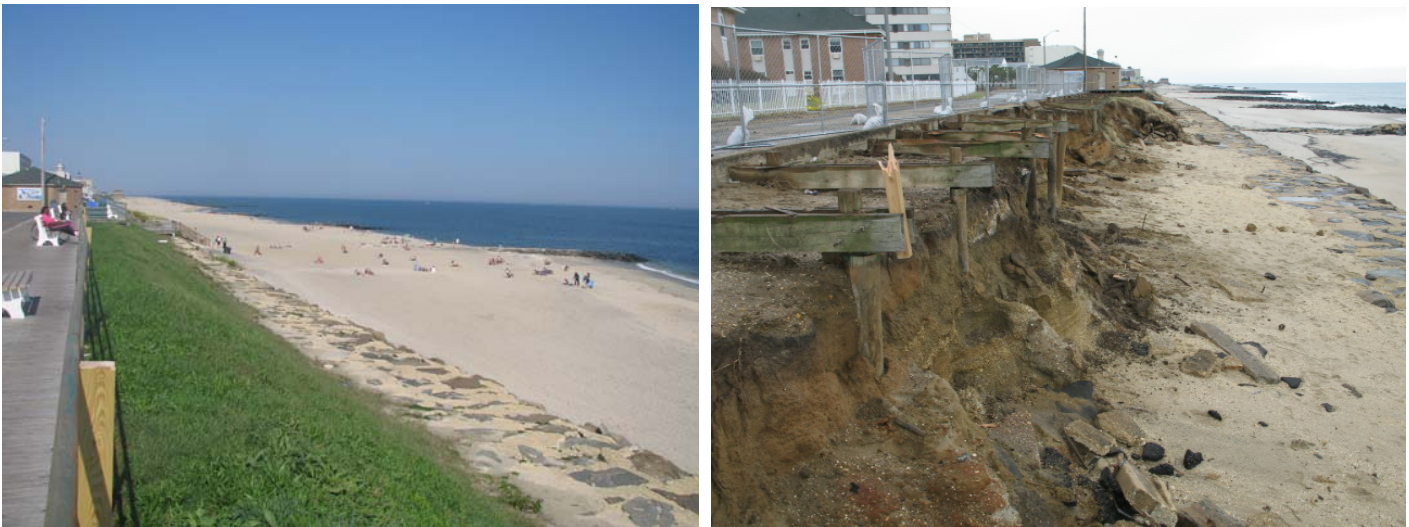
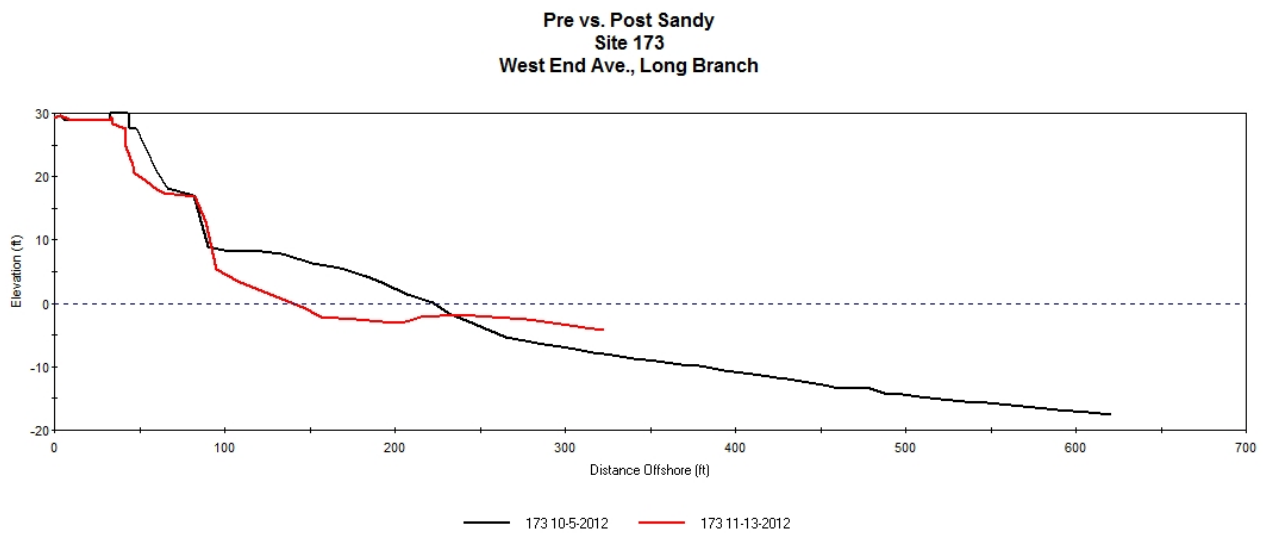
NJBPN 173 – West End Avenue, Long Branch

The photographs above were taken on October 5, 2012 (left) and November 13, 2012 (right).

Figure 5. This site is located near the southern limit of the Federal beach nourishment project. Long Branch did not include the construction of a protective dune. It was decided at the time of planning the project that the bluff elevation and the presence of the rock revetment was enough protection for landward properties and the sand was put into the berm. While the revetment held in place during Hurricane Sandy, the boardwalk built on the upper bluff sediments was destroyed with bluff retreat to the edge of the old southbound Ocean Avenue roadway. Much of the berm sand was moved to the nearshore bar. This was the site of the 2010 experimental “bump-out” replenishment designed in part to answer surfing related issues with the beach restoration work.

Located near the southern end of Phase I within the NY District Corps of Engineers Monmouth County beach restoration project, this site has a rock revetment protecting the base of the bluff, with the boardwalk positioned at the edge of the bluff some 15 feet above the revetment. The former Ocean Avenue was a four-lane highway with a grass median and a grass strip between the roads and the bluff edge before the boardwalk that was located on the beach perched on concrete supports. During the 1950's hurricanes and northeasters carved away at the bluff, destroyed the old boardwalk and reduced Ocean Avenue to the southbound two lane roadway with a tiny grass plot seaward of it. Long Branch abandoned the old Ocean Avenue in the 1970's; locating a modern highway a block inland and parallel with Ocean Avenue extending south into Elberon. The rock revetment was built and the boardwalk was placed on the narrow

remnant of grass east of the southbound roadway. In 1999 the initial beach replenishment was completed giving this location a 250-foot wide beach, but no dune was included. Sandy rolled over the beach and struck the revetment with massive force tearing out the bluff under and the boardwalk over the grass strip. The erosion extended to the concrete curbing bordering the old roadway. Water damage existed on properties landward of the roadway as evidenced by debris and sand deposits. The City was in the process of hauling sand to Morris Avenue where it was being sieved to remove debris and returned to the beach. The beach was reduced in elevation, width and ramped up against the revetment somewhat. There was a significant offshore bar moving landward that almost reached the low tide position and was included in the wading survey.

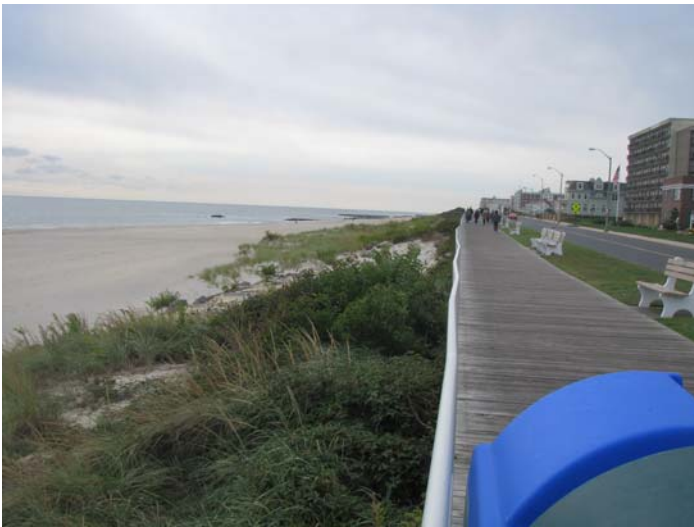
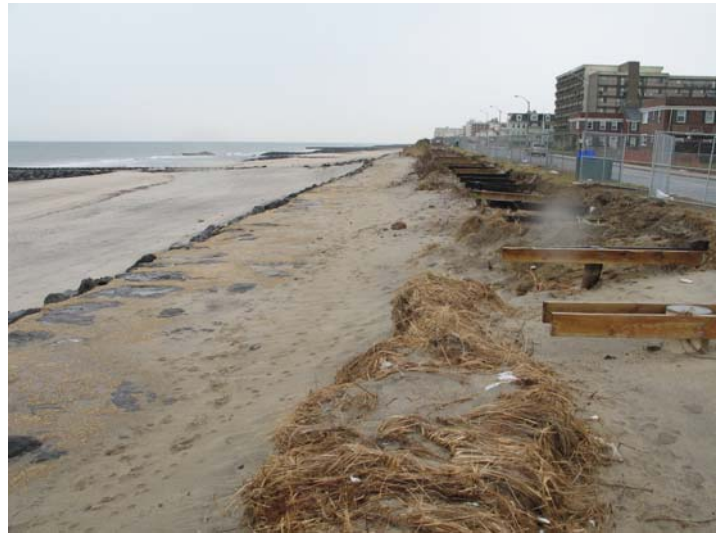
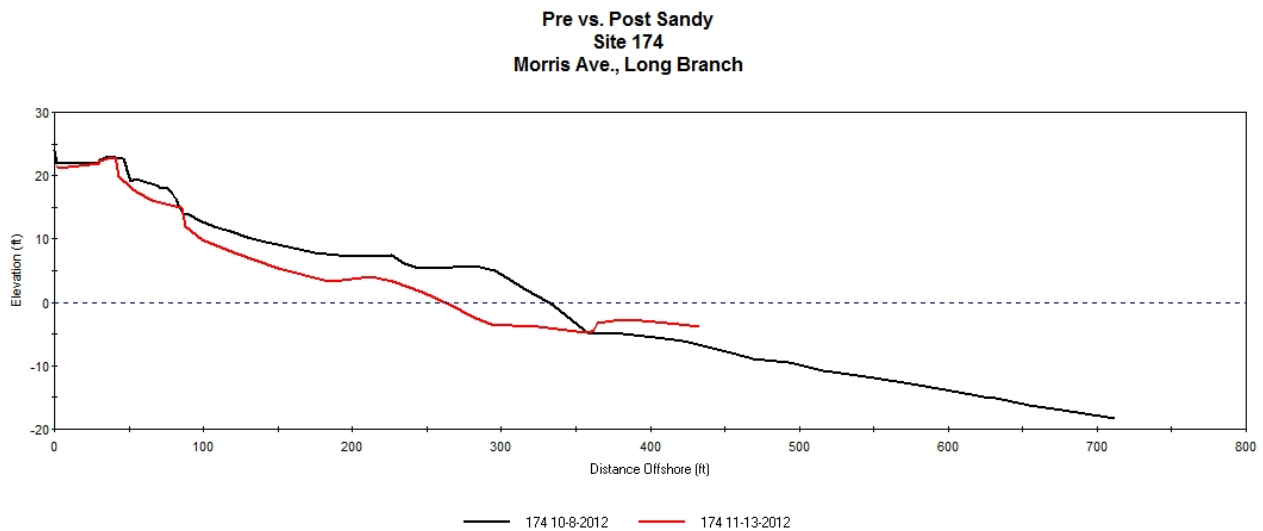
NJBPN 174 – Morris Avenue, Long Branch

The photographs above were taken on October 8, 2012 (left) and November 13, 2012 (right).

Figure 6. This site also was the recipient of the Federal beach nourishment project and was a direct beneficiary from the 2010 maintenance fill completed to the south. Strong northerly littoral sand transport moved abundant sand from that project into this segment. Hurricane Sandy removed the sand from on top of the seawall, eroded into the upper bluff sediments and destroyed the boardwalk. The beach was reduced in elevation and width with sand deposited offshore. The recovery berm and a small offshore bar are indicated on the survey from 11/13/2012.

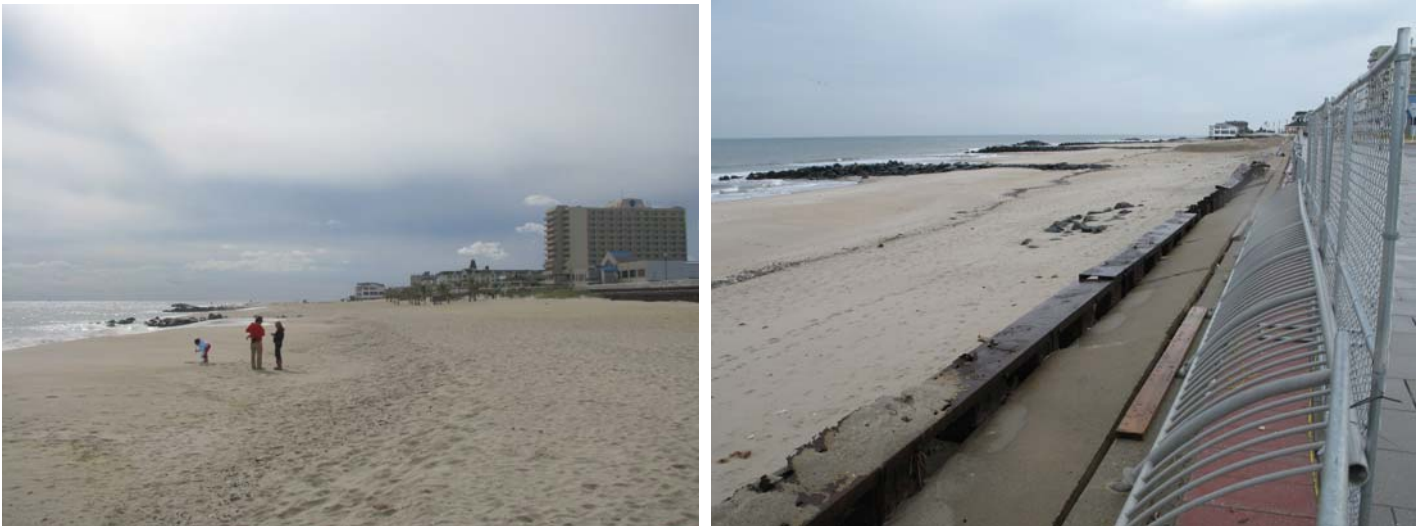
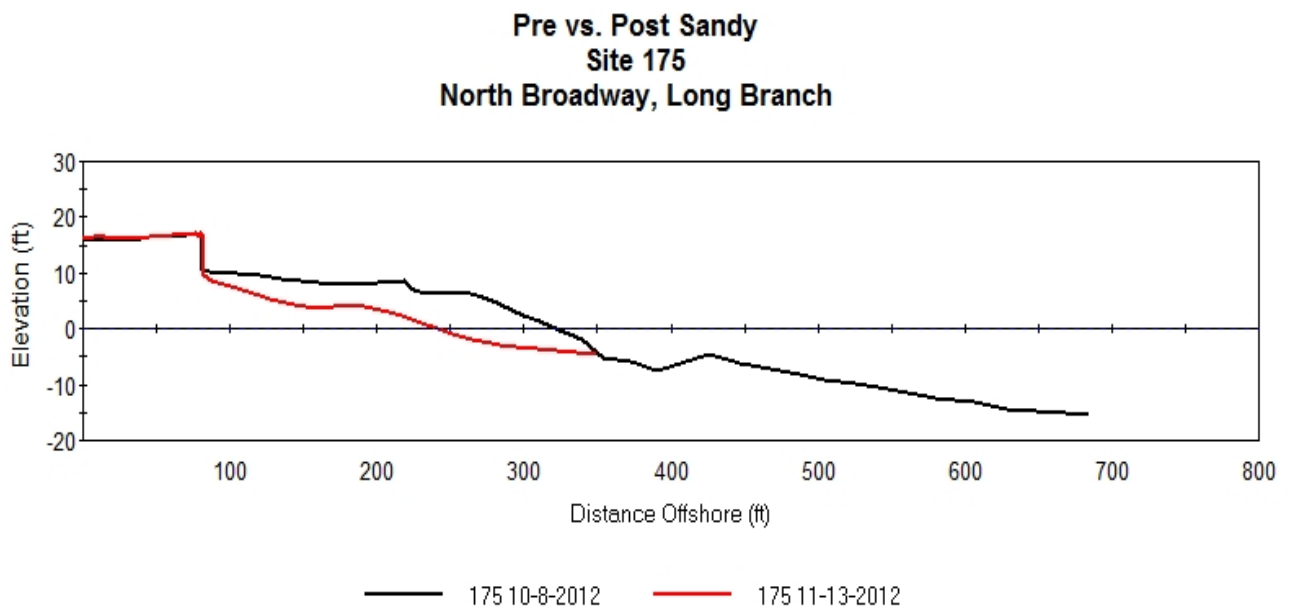
NJBPN 175 – Broadway Avenue, Long Branch

The photographs above were taken on October 8, 2012 (left) and November 13, 2012 (right).

Figure 7. This site lost a huge amount of sand from the berm with some moved over the vertical steel wall, but the vast majority deposited offshore beyond the reach of the wading profile survey. The railing on the right photograph was bent landward by wave action 17 feet above the zero datum elevation.

Here the Corps project beach was at 79% of the as-built sand volume in the fall of 2011. Sandy's waves rolled across this beach as well and impacted the steel wall protecting the bluff. Water crashed down on the paved promenade without incident and cascaded into the new development causing minor flooding and damage. The high-grade railing along the edge of the promenade was bent landward and would need replacing along much of the distance. The beach was lower and narrower, but still in place with a sizable offshore bar just offshore.

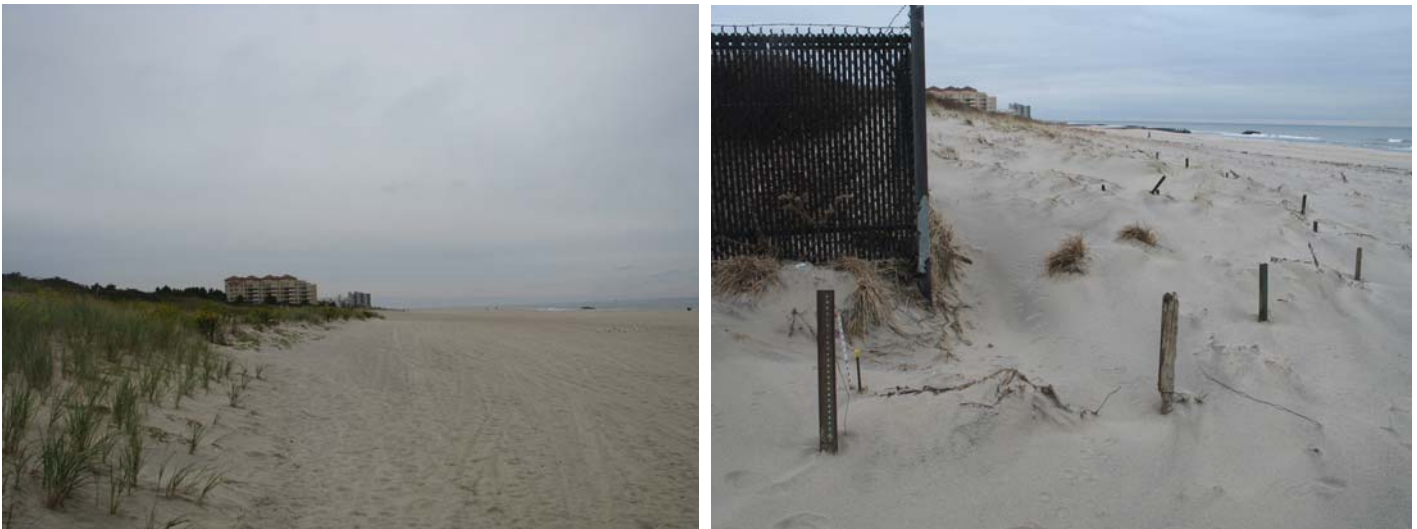
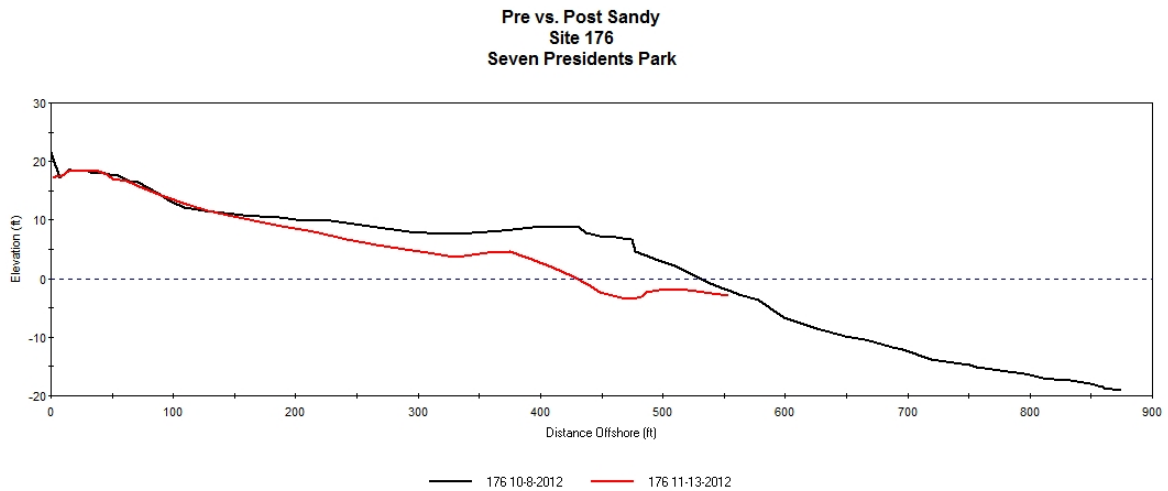
NJBPN 176 – Seven President’s Park, Long Branch

The photographs above were taken on October 8, 2012 (left) and November 13, 2012 (right).

Figure 8. This site is a popular recreational park with a partial ridge of 25-foot elevation dunes and an expansive berm that has undergone variable volume changes through the years. During Hurricane Sandy, the grade-level public access points created channeled flow from the storm waves and washed sand landward into the parking lots. Measurements of wave run-up on the dune’s seaward slope north of the profile line found debris at 24.6 feet NAVD88 indicating a massive surge of wave power during the storm.

This site was converted into open parkland space 20 years ago with the purchase of all commercial and private buildings near the waterfront. The area has 25 foot dunes with several prominent gaps to allow public easy access to the beach. The Federal project was completed here in 1999 and 74% of the initial sand placed was still present in October 2011. The cross section is located at the southern gap in the dunes, so storm damage in the form of abundant sand washed landward into the parking lot was evident. Park employees were busy scraping up the sand and returning it to the beach to clean up. The park public use buildings were inundated, but built to take impacts, so remained standing, if wet. The remarkable event was the discovery that wave run-up on the immediately adjacent dunes went to their crest. The GPS elevation of the dune crest was 24.6 feet NAVD88, so Sandy's waves registered over 10 vertical feet more run-up elevation than measured in Avalon or Atlantic City south of the hurricane eye. This is strong evidence of the massive difference in storm damage seen in Ocean, Monmouth Counties in NJ (plus NY) as compared to Cape May and Atlantic Counties south of the landfall point for the center of storm rotation.

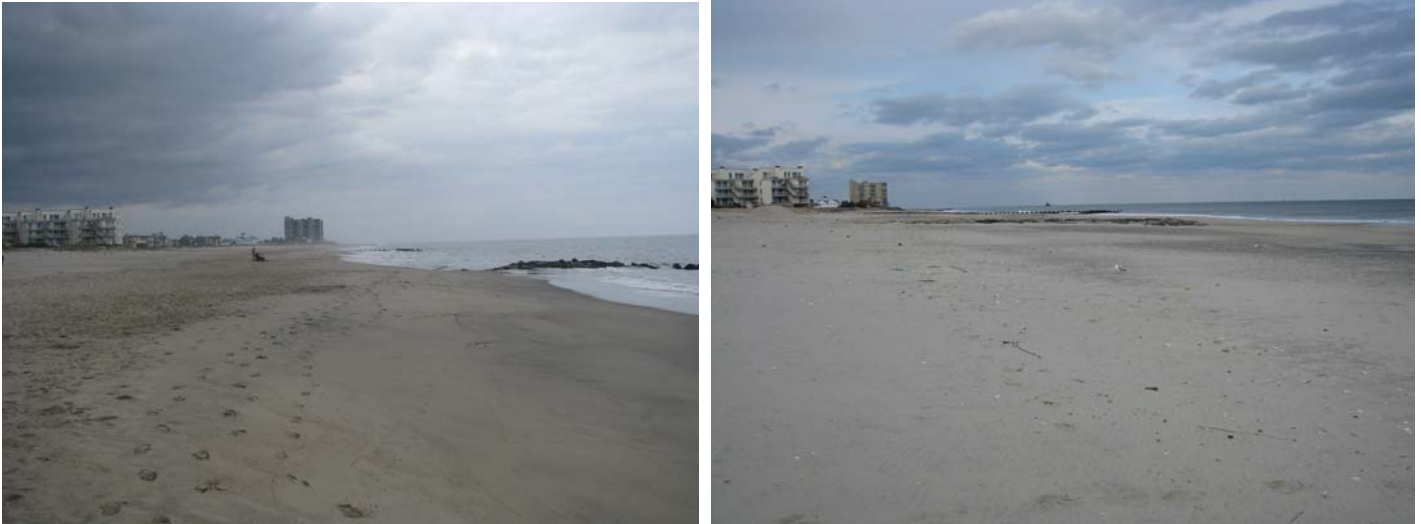
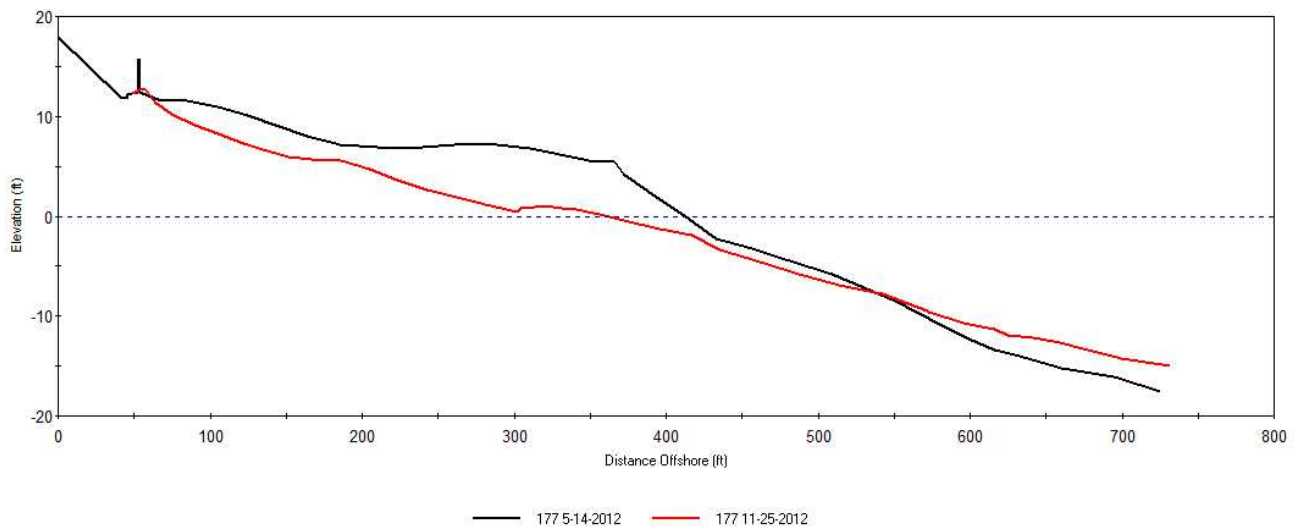
NJBPN 177 – 404 Ocean Avenue, Long Branch

The photographs above were taken on May 14, 2012 (left) and November 25, 2012 (right).

Figure 9. This site was the recipient of sand from the initial Federal beach nourishment project. The beach here has remained relatively constant in width and volume due to the presence of the large rock groin which slows the littoral flow and allows for sand deposition. Waves washed sand into Ocean Avenue and associated businesses. The berm was reduced in elevation and pushed landward, with sand deposited offshore as well. This cross section was the southernmost one NOT surveyed prior to Sandy, so the pre-storm profile is from the spring of 2012 and shows that sand was carried seaward beyond the normal 16-foot ending depth for NJBPN surveys. The normal survey procedure was used from this point north and serves to additionally document offshore transport of sand volumes that indicate either a major transport further landward into the community or a reflection seaward where the deposit offshore approximates the loss to the beach above the zero elevation. At this site, the offshore sand movement was to a greater distance than the 16-foot depths the CRC normally surveys using swimmers.

**Pre vs. Post Sandy
Site 177
404 Ocean Ave, Long Branch**

This site was once a USO non-commissioned officer's beach recreation area for Fort Monmouth personnel. Presently part of the Seven-Presidents Park system belonging to Monmouth County, this site was part of the Federal Project and retained 72% of the initial fill sand volume. However, Sandy rolled across the beach to Ocean Avenue and transported abundant sand into the roadway. Clearing was nearly complete so traffic was moving slowly by, but more work needed to be completed. Nearby businesses were flooded by the combination of storm surge and wave overwash.

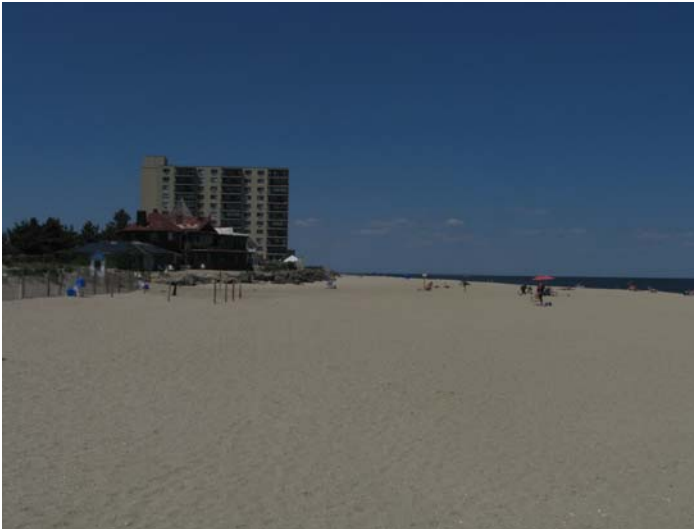
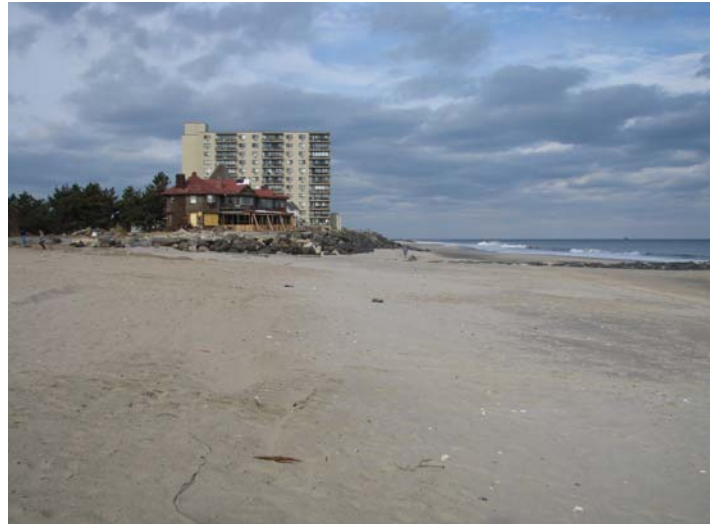
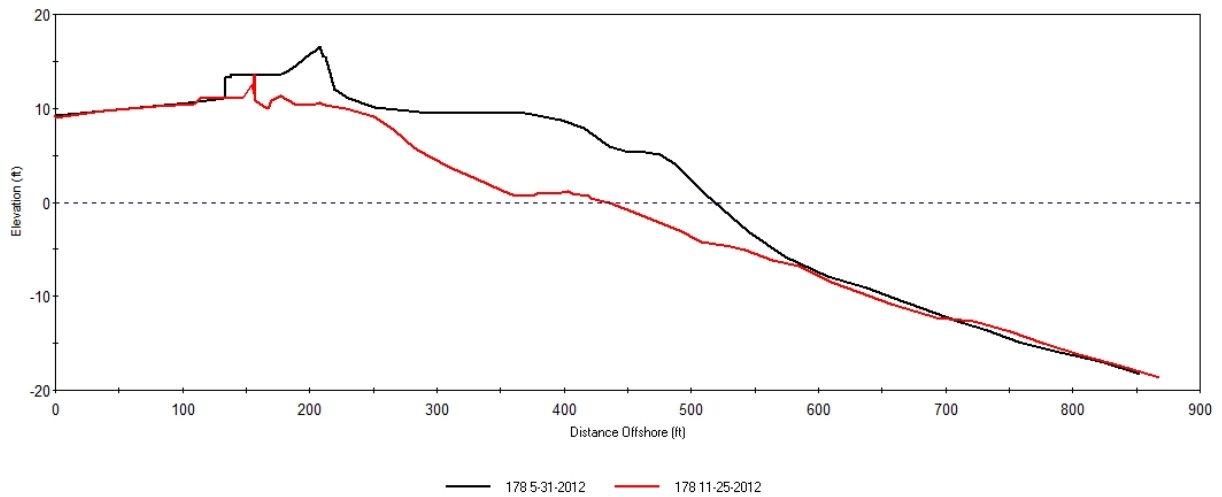
NJBPN 178 – Monmouth Beach Club, Monmouth Beach

The photographs above were taken on May 31, 2012 (left) and November 25, 2012 (right).

Figure 10. This profile was the recipient of the initial Federal beach nourishment project and since that time, shoreline and volume changes have been relatively stable. Hurricane Sandy removed significant amounts of sand from the berm, destroyed a moderate-sized dune and utterly destroyed the buildings associated with the facility. Sand was not carried offshore because much of the loss was moved either landward or to the immediate south of this profile.

**Pre vs. Post Sandy
Site 178
Beach Club, Monmouth Beach**

The Valentine Street site is located on the premises of the venerable Monmouth Beach Club with the survey starting point in the landward segment of the timber deck overlooking the seawall. On the day of the post-Sandy visit, three excavators were picking apart the ruins of the entire facility and transferring the debris into huge dumpster vehicles for

transport to the staging area. The beach was much lower and narrower because only 53% of the initial sand volume was still present from the Federal project. In addition, no dune had been designed into the project, but irregular sand dunes had appeared over time by natural growth processes. These dunes failed to stop the wave attack.

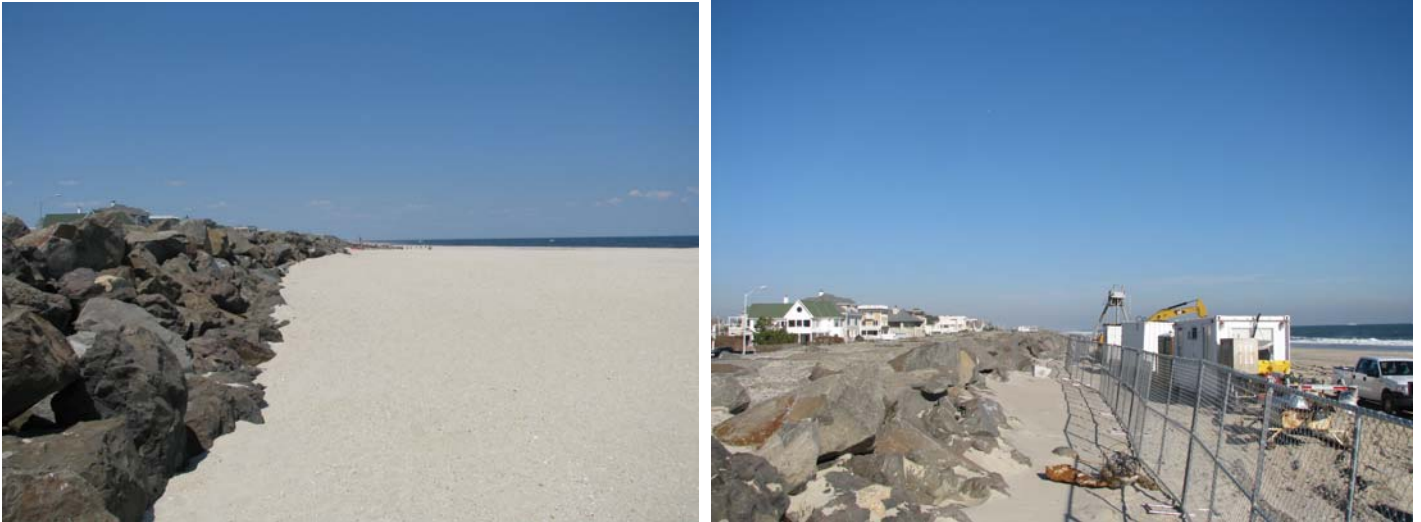
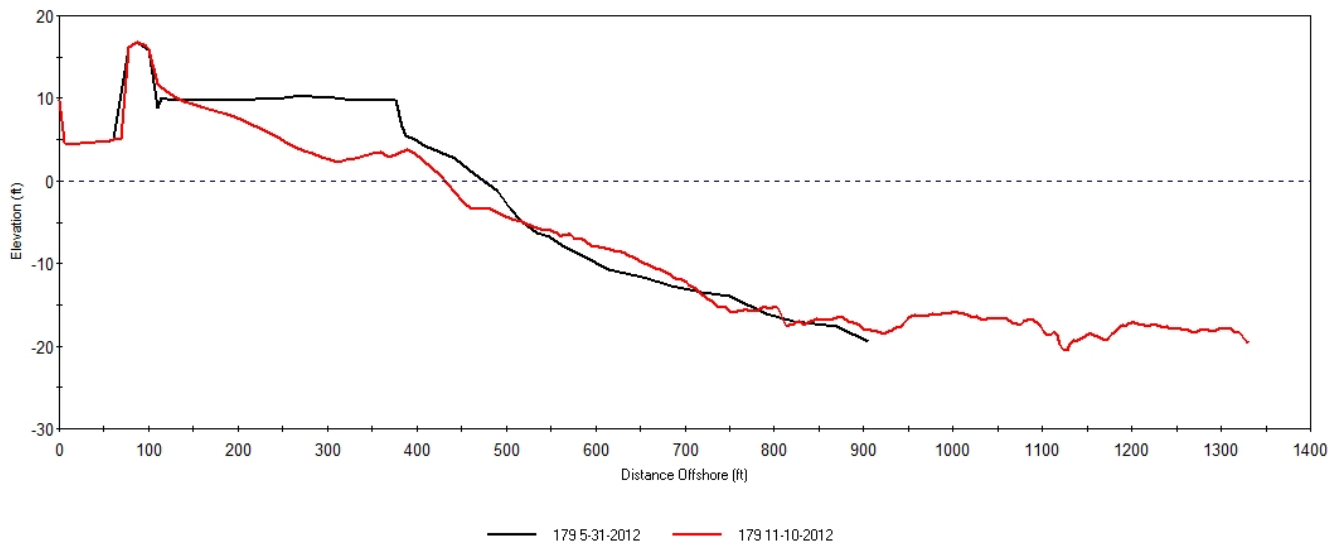
NJBPN 179 – Cottage Road, Monmouth Beach

The photographs above were taken on May 31, 2012 (left) and November 21, 2012 (right).

Figure 11. This site has the worst erosion history of any site in Monmouth County. It was the recipient of sand from the initial Federal beach nourishment project, though no dunes were constructed due to the presence of the seawall and rock revetment. Chronic volume losses have been recorded over the years because the rock groins adjacent to the site block sand transport from the south. The spring 2012 survey recorded a high 300-ft wide berm and most of that sand was moved to the nearshore or over the seawall during Hurricane Sandy's waves. There is a current maintenance project underway with the post-Sandy data supplied by the contractor who had closed the beach segment as construction was underway.

**Pre vs. Post Sandy
Site 179
Cottage Rd, Monmouth Beach**

The Cottage Road location has been the poster for “Hot Spot” erosion in an otherwise very successful Federal beach restoration project. Here a massive stone groin was privately built decades ago to restrict sand movement north from the beach fronting an equally venerable coastal recreational edifice from the 19th Century. The groin obviously serves its intended purpose, but to the detriment of the Federal beach project’s durability just north of the groin. The Cottage Road site commenced losing sand as soon as it was completed. Losses were replaced in 1997, 1999, 2001, and modest sand volume was added in 2010 from Shrewsbury River dredging. Currently a contractor has the site closed to anyone not involved in the construction project as a 2012 restoration starting here and moving northward is underway. There is only a narrow, dry beach that gets wet to the rocks under normal wave action at high tide. Sandy barreled over the seawall, dumping many thousands of tons of seawater into the highway making storm surge flooding worse. The beach is in the process of being replaced by sand dredged from the approved borrow sites as this is being written.

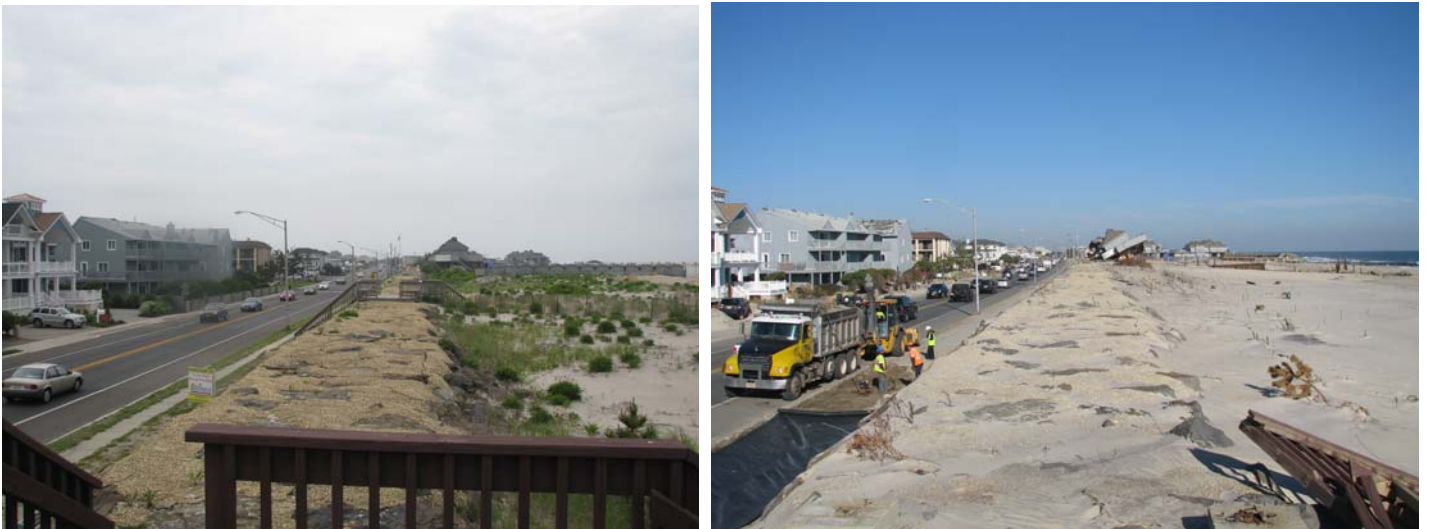
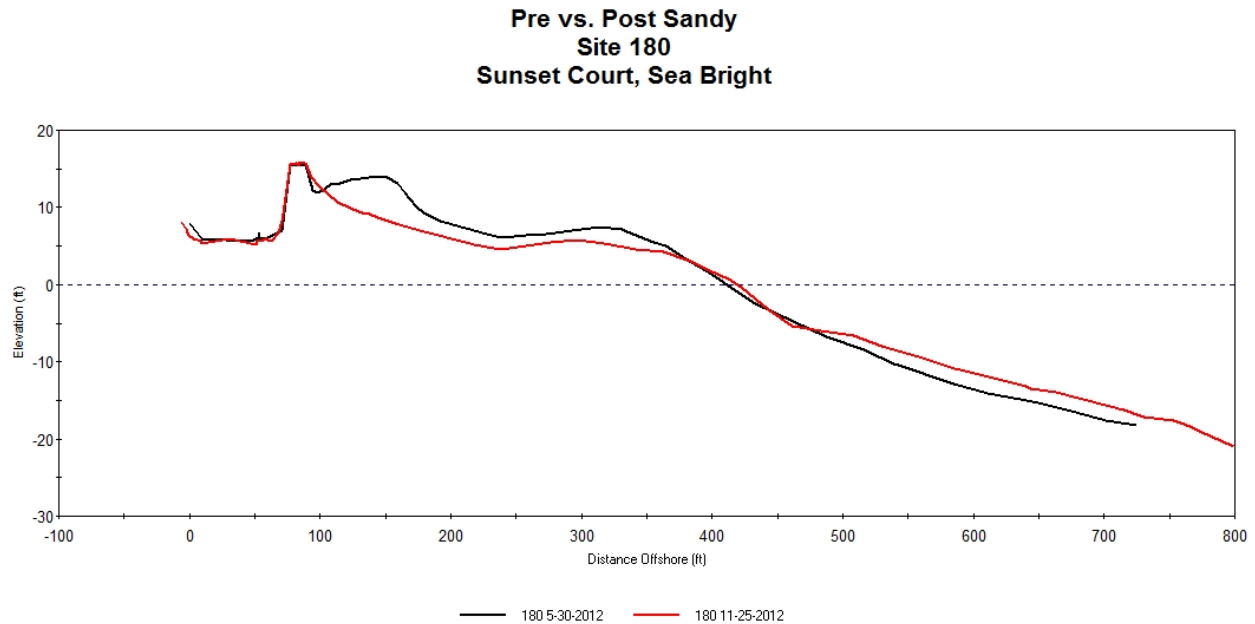
NJBPN 180 – Sunset Court, Sea Bright

The photographs above were taken on May 30, 2012 (left) and November 21, 2012 (right).

Figure 12. This site was the recipient of sand from the initial Federal beach nourishment project. The left photograph shows the variety in height, width and vegetation density associated with the naturally developed dunes seaward of the seawall along the Sea Bright shoreline. Sandy's waves pushed sand into a gentle ramp up the seaward rock slope and allowed the wave bores to pour over the wall into Ocean Avenue and associated properties with a vengeance. Sand was also transported well seaward as the post-storm survey shows.

The next location north of Cottage Road maintained 45% of the initial sand volume placed in 1999. The repeated deposition of maintenance material at Cottage Road moved north through this location. There was no dune, other than grass here and there among the rocks of the seawall. Storm waves over-topped the wall in quantity and caused flooding and debris damage that kept the highway closed for weeks to general traffic. A lower, narrower beach remains, but the restoration process is underway just to the south.
