Beach-Dune Performance Assessment of

New Jersey Beach Profile Network (NJBPN) Sites

Between Deal and Sea Bright, New Jersey

Related to FEMA DR-NJ 4086 Declared for Hurricane Sandy

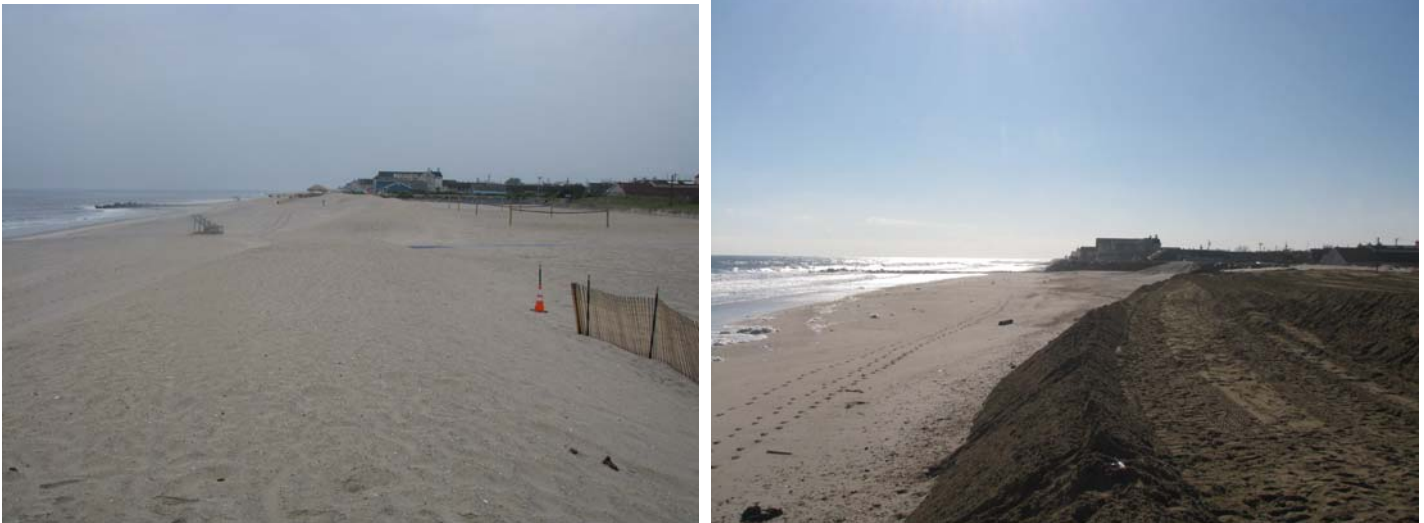
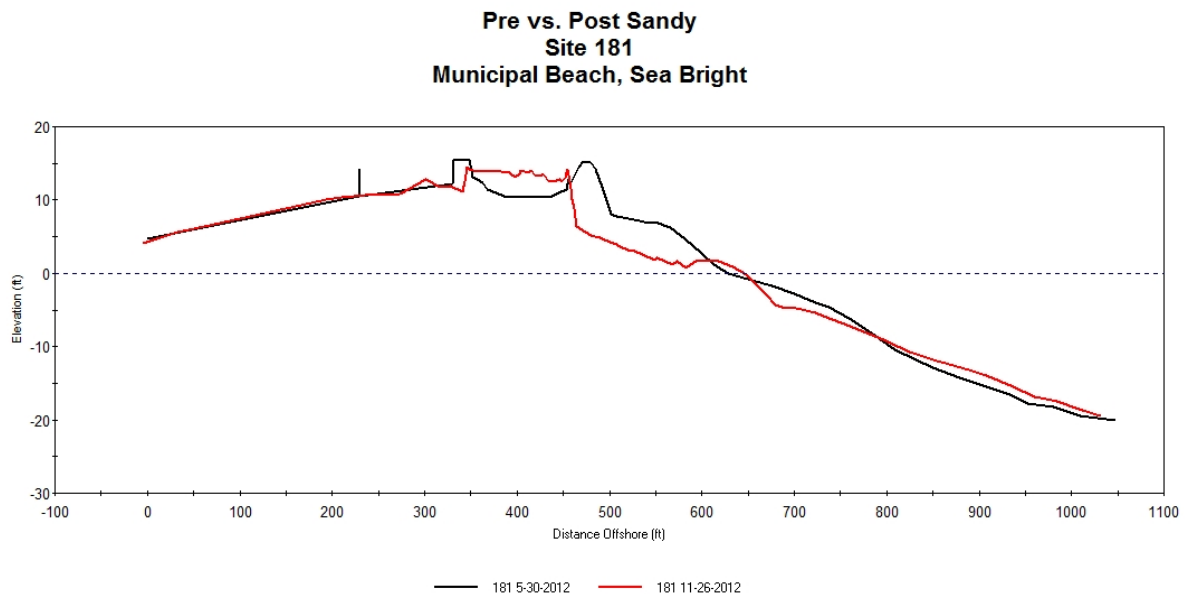
NJBPN 181 – Municipal Beach, Sea Bright

The photographs above were taken on May 30, 2012 (left) and November 21, 2012 (right).

Figure 13. This site was the most heavily damaged along the northern Monmouth County shoreline because there was a gap in the rock seawall at the municipal beach protected by dunes (but with large grade-level pedestrian gaps) and an aging, low bulkhead separating the beach from the municipal services landward. Sandy blasted through these defenses and wrecked the fire and police departments plus extensively damaged the businesses on both sides of Ocean Avenue. The wave surge added to the tidal flooding coming in from Raritan Bay up the Navesink and Shrewsbury Rivers, so Sea Bright was battered from both directions, especially right here. The irregular high zone landward of the dune and seaward of the timber boardwalk is sand gathered from the streets and hauled back to the beach to act as a temporary barrier. The cross section appears to show the transfer of sand landward into Sea Bright because this location does not have a significant volume deposited offshore as compared to the others where longer profiles were taken.

The peninsula widens here to include commercial businesses on both sides of Ocean Avenue plus parking for the beach. However, no rock seawall extended across a several hundred foot gap at the municipal beach. An ancient timber bulkhead was the back shot position for the survey and it had gaps cut in it to allow easy public access to the beach. The resulting storm wave damage and tidal flooding was intense and destruction was wide spread and devastating. The situation was made worse because both the fire company and the police station were located between the municipal beach and Ocean Avenue. Both were gutted by waves. Debris impacted businesses on the west side of Ocean Avenue while the storm surge flooding into Raritan Bay flowed up the Shrewsbury and Navesink River Estuaries compounding the disaster. While the beach is still present, it is narrower and lower in elevation with a massive amount of sand moved landward into Sea Bright Borough.

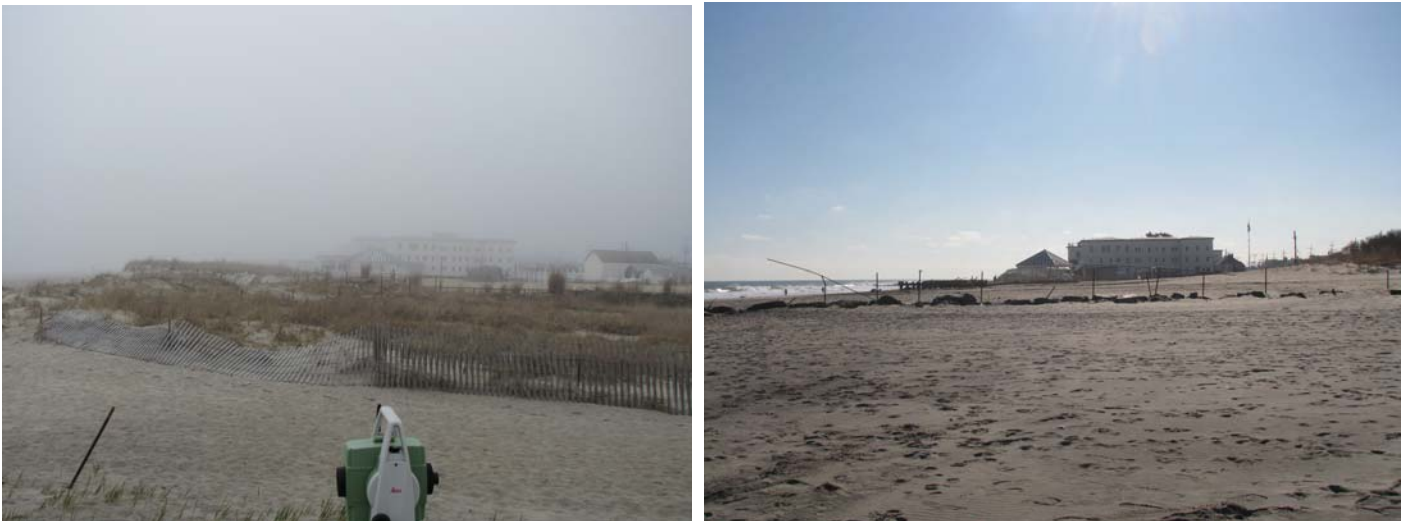
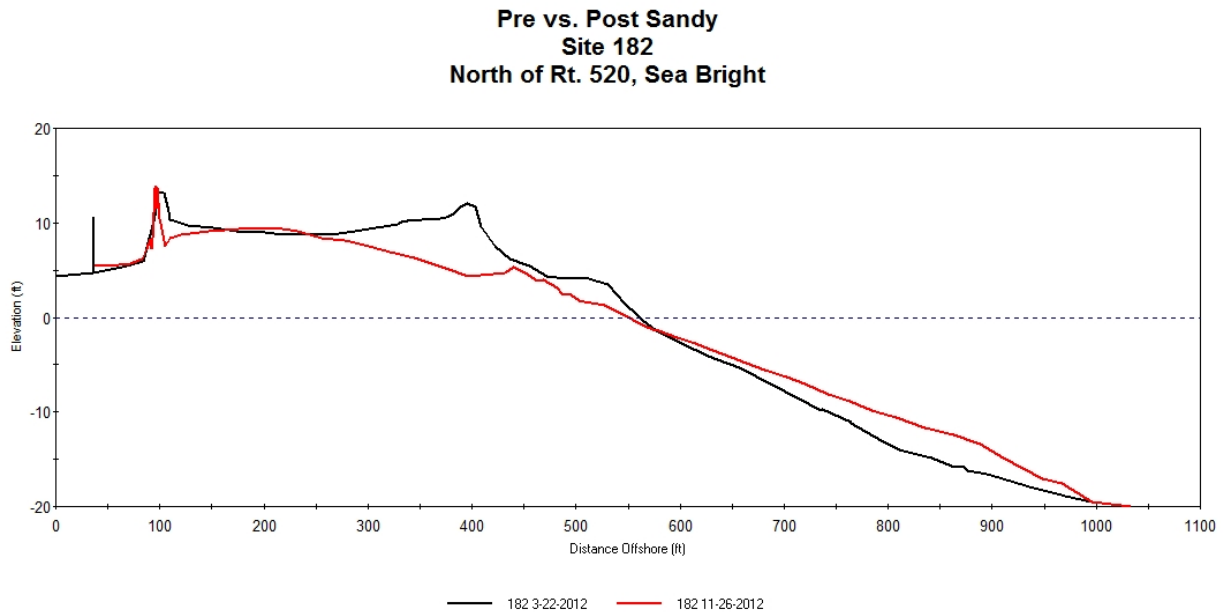
NJBPN 182 – Public Beach, Sea Bright

The photographs above were taken on March 22, 2012 (left) and November 21, 2012 (right).

Figure 14. At this location, low, wide dunes established naturally following the initial Federal beach nourishment project did not stop the wave damage. Sand volumes have been relatively stable since that time. Hurricane Sandy's storm surge and waves relocated sand from the dune and berm both landward to the rocks, over the rocks and to the nearshore. A second gap was a 20-foot wide break in the rock seawall that had a timber barrier. This failed allowing torrents of sea water into the Sea Bright business area at the north end. The deposition of sand offshore was less than the quantity removed from the beach/dune system, but it appears as if closure was achieved including sand lost except for the quantity transported landward into the community.

The next location north was obtained by NJ State purchase 25 years ago and converted into a public bathing area with some off-street parking. There was a modest dune at the toe of the rocks, but the waves ramped up and over the rocks using that sand as a deposit forming the ramp. In addition there was a timber bulkhead protecting a 20-foot wide gap in the rock seawall at this location. Sandy blew through the timber section and poured into Ocean Avenue with sand, debris and lots of salt water. This compounded the water coming in from Raritan Bay making flooding the worst ever recorded. This beach contained 98% if the initial Federal project’s fill material as of fall 2011. No dune existed other than grass growing at the toe of the rock seawall. The post-Sandy survey showed a narrower and lower elevation beach with an as yet unknown ratio of sand lost offshore versus sand transported through the gap or over the seawall.

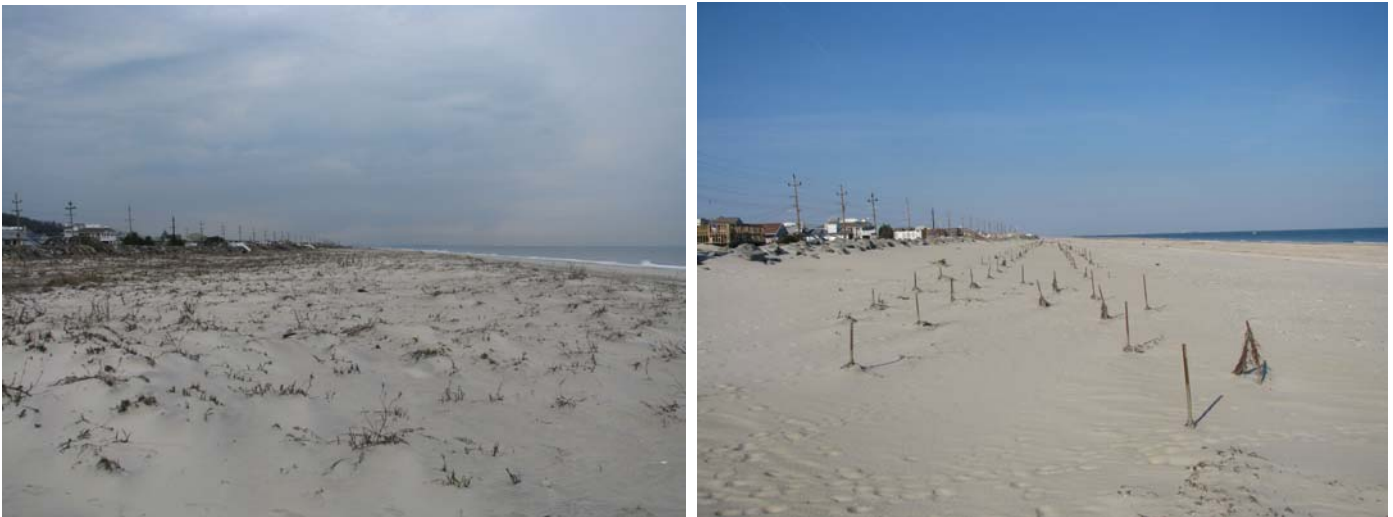
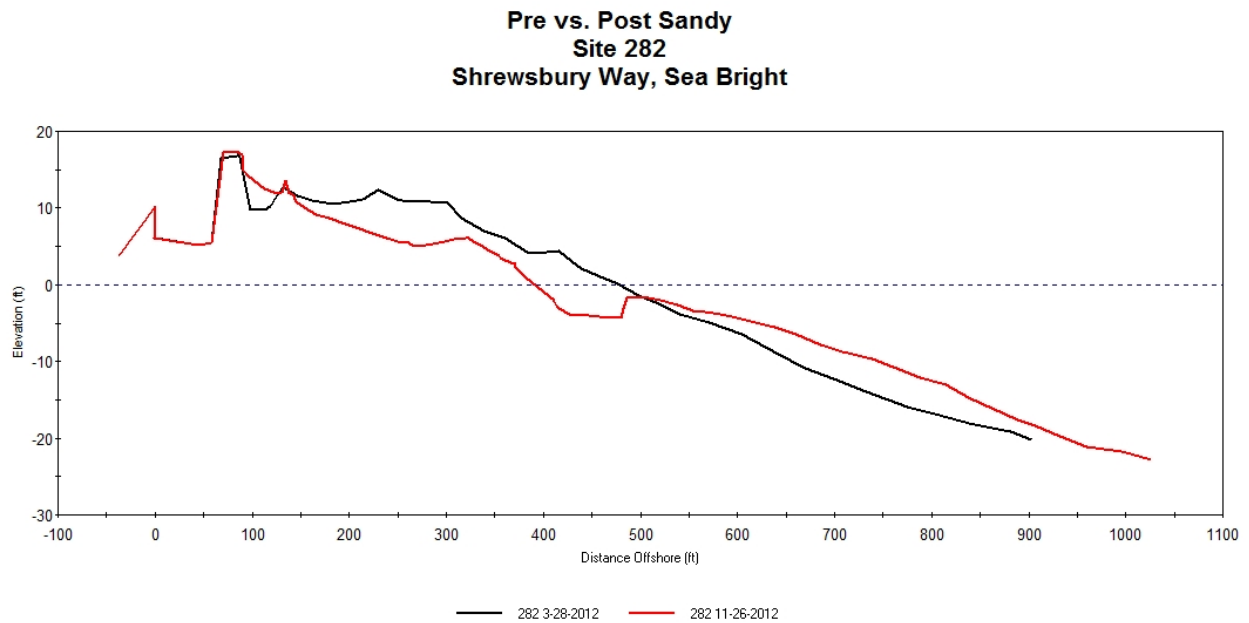
NJBPN 282 – Shrewsbury Way, Sea Bright

The photographs above were taken on March 28, 2012 (left) and November 26, 2012 (right).

Figure 15. This site was included in the initial Federal beach nourishment project but did not include an engineered dune. A low, wide dune field was established surrounding a pair of fence rows built immediately following beach restoration and planted with grass between them. The left photograph shows the natural development of the dune system over the past 12 years. The site has gained in sand volume since the project (116% of the initial sand volume placed by 2011). Hurricane Sandy's storm surge and waves created a ramp of sand adjacent to the seawall and transported sand both further landward with back-rush carried to the nearshore bar. Substantial sand volume was deposited offshore below the zero elevation datum. The normal length surveys here documented this process.

This site was the only northern Monmouth County site along Phase I Federal project that had exceeded the initial sand volume placed on the beach (116%). Even so, the storm waves broke over the Sea Bright seawall as they ramped up the sand against the rocks allowing wave run-up to crest the 28-foot wall. The beach profile was reduced in elevation and width.

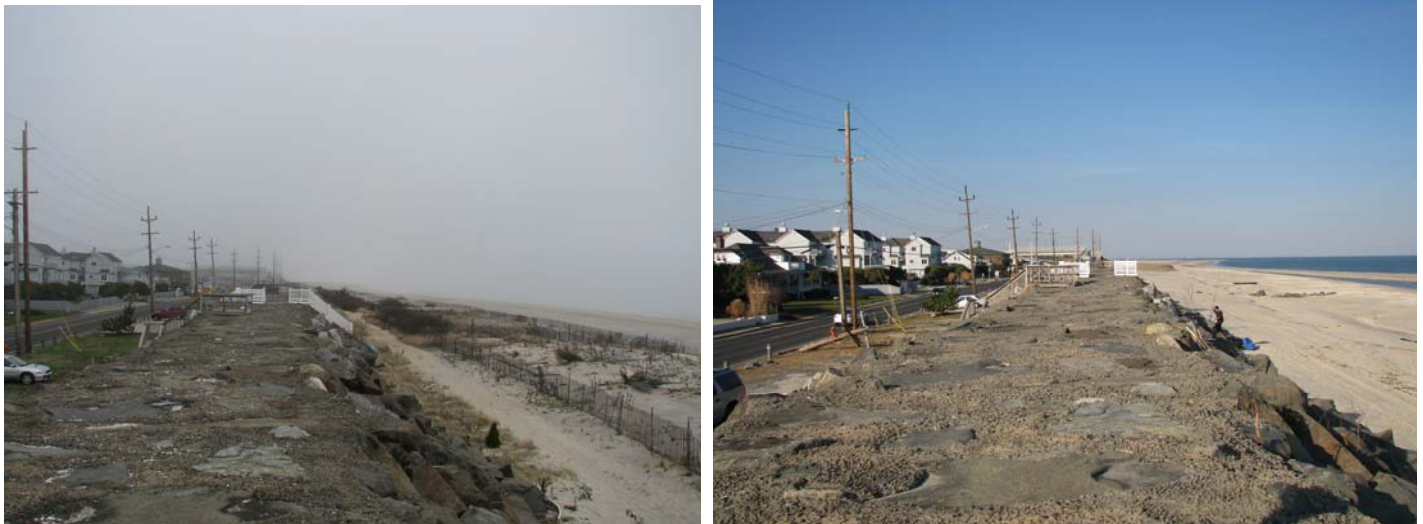
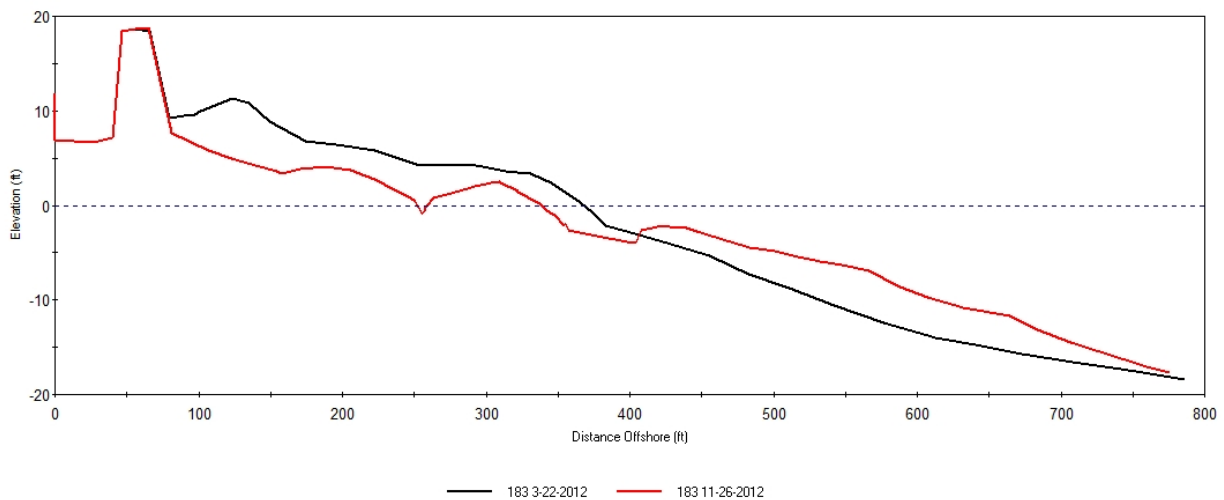
NJBPN 183 – Via Ripa Street, Sea Bright

The photographs above were taken on March 21, 2012 (left) and November 26, 2012 (right).

Figure 16. This site was near the northern limit of the initial Federal beach nourishment project and has experienced only moderate sand losses since that time. An engineered dune was not constructed due to the presence of the seawall with the sand placed in the berm. A low dune established naturally between two parallel rows of sand fence. Hurricane Sandy’s storm surge and waves moved sand to the nearshore bar, most of which is post-storm recovery as seen in the right photograph’s right edge. This location was surveyed to the normal distance offshore following Sandy and as can be seen, the sand deposited offshore approximates the volume lost above the crossing point on the two surveys. Above Datum: the loss amounted to -34.101 cu. yd/ft, while below the datum; the gain was 35.500 cu. yd/ft. Since this site did not see extensive over-topping of the seawall, the net change to a depth of -18.11 feet NAVD88 actually was a gain of 1.40 yds³/ft. Therefore, in spite of huge waves, a massive storm surge, and a strong southerly littoral drift current during Hurricane Sandy, the beach at this site has been shown to have had nearly a zero change in net sand volume.

**Pre vs. Post Sandy
Site 183
Via Ripa St, Sea Bright**

This northern location lies just south of the bridge to Atlantic Highlands across the entrance into the Shrewsbury and Navesink Estuaries. The beach was at 74% of the initial Federal project placement sand volume and waves ran up and over the wall, but in a lower magnitude based on the sand found landward of the wall. Also, there was a much smaller ramp leading to the top of the wall on the sea side. Located closer to the fetch limit produced by Long Island, perhaps the waves were simply smaller.

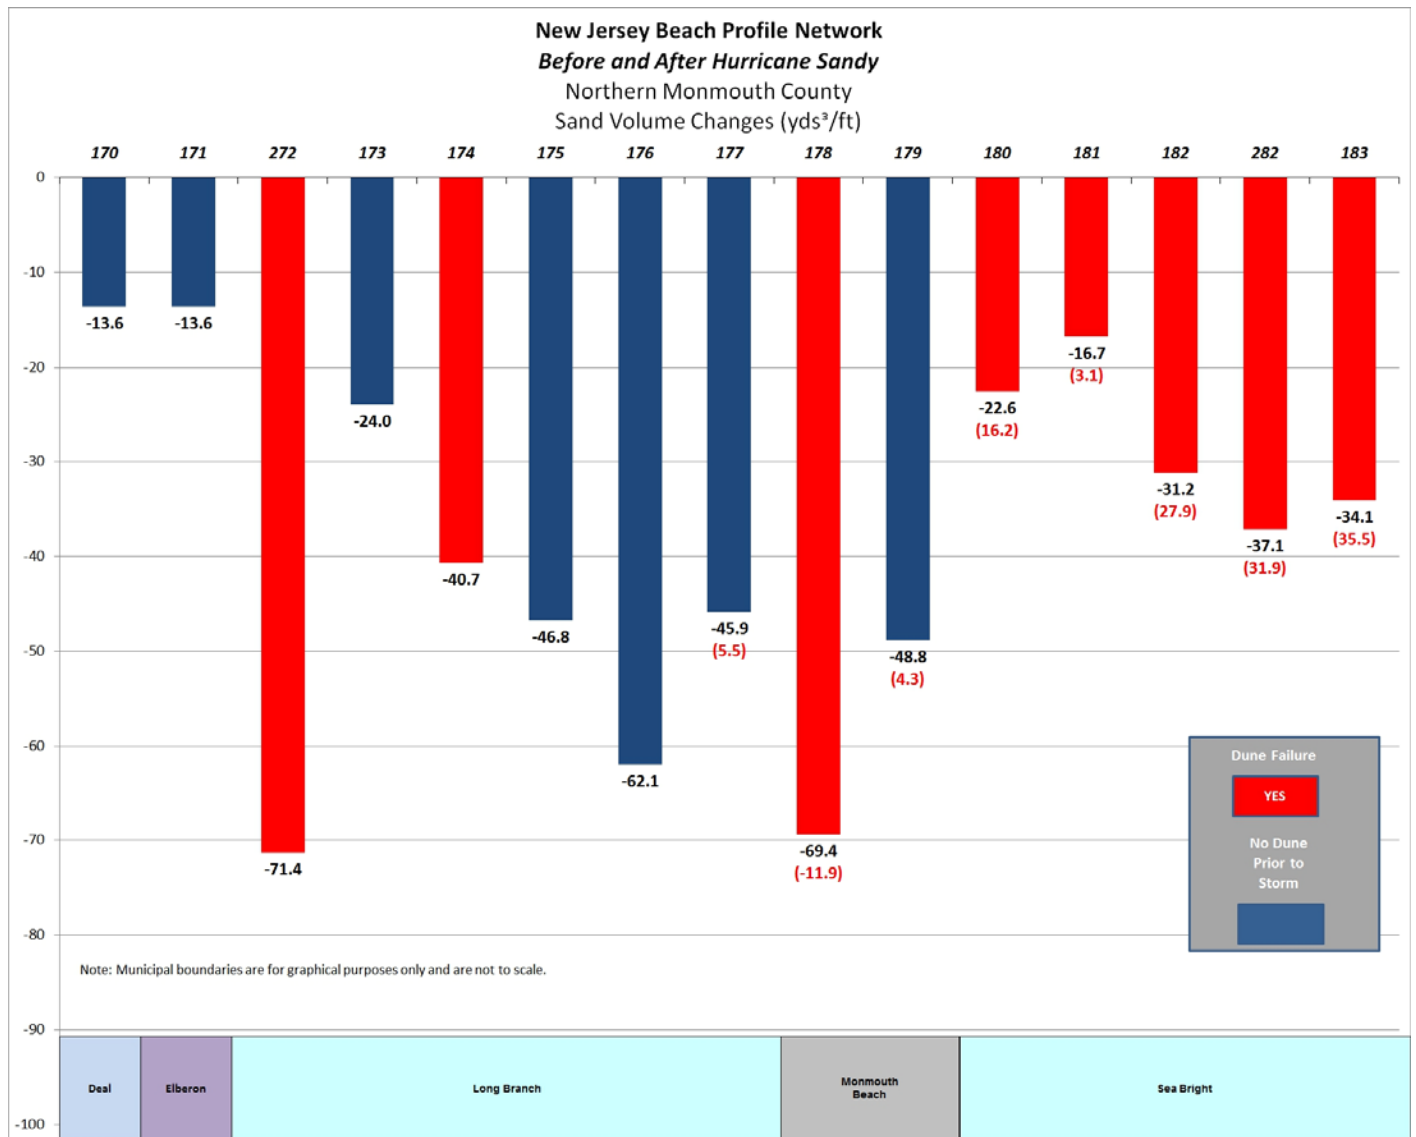
Figure 18. This is a graphical display of the sand volume lost at each site combined with an indication of the presence, absence or failure of the dune system along the Northern Monmouth County shoreline. The natural area north of Sea Bright (Sandy Hook National Seashore) has three cross sections that will be surveyed before December 21, 2012. The sand volume losses are expressed in cubic yards of sand per foot of shoreline. For comparison, the Federal placement volumes were between 225 and 300 cubic yards of sand per foot of shoreline.

Figure 17 shows a table of sand loss volumes per foot of shoreline at each of the Northern Monmouth County sites. No beach nourishment was done at the three southern sites because Allenhurst/Loch Arbor, Deal and Elberon declined to participate in the project. The hightide ownership issues were the major stumbling block. Because there was a high sediment bluff in Long Branch fronted with a rock revetment and a very high bathing use demand on the beach space, no dune was designed into this project. Sea Bright's shoreline was defended solely by a 28-foot rock wall that had served as the only form of shore protection during the decades prior to the NY District Corps Project, and this zone was not designated as needing dunes. Fencing was installed along the Sea Bright section and planted between the rows of fence. Natural processes served to allow dunes to develop over 12 years, but with no general design specifications, the process was pretty random. A significant recommendation would be to re-assess the view on creating a wide, double ridge of sand to provide a higher level of storm protection to serve as a blocker for wave run-up that went over the seawall. More importantly, efforts must be made to close the two gaps in the rock wall in the central section of Sea Bright with huge dunes or extend the wall with a serious barrier to seal these two entry points from future waves.
