**FINAL REPORT FOR 2015
ON THE CONDITION OF THE MUNICIPAL OCEANFRONT BEACHES
THE BOROUGH OF AVALON, CAPE MAY COUNTY, NEW JERSEY**

**PREPARED BY: THE STOCKTON UNIVERSITY COASTAL RESEARCH CENTER
30 WILSON AVENUE
PORT REPUBLIC, NEW JERSEY 08241**

MARCH 2016

**ANNUAL REPORT FOR 2015 - TO THE BOROUGH OF AVALON
ON THE
CONDITION OF THE MUNICIPAL BEACHES**

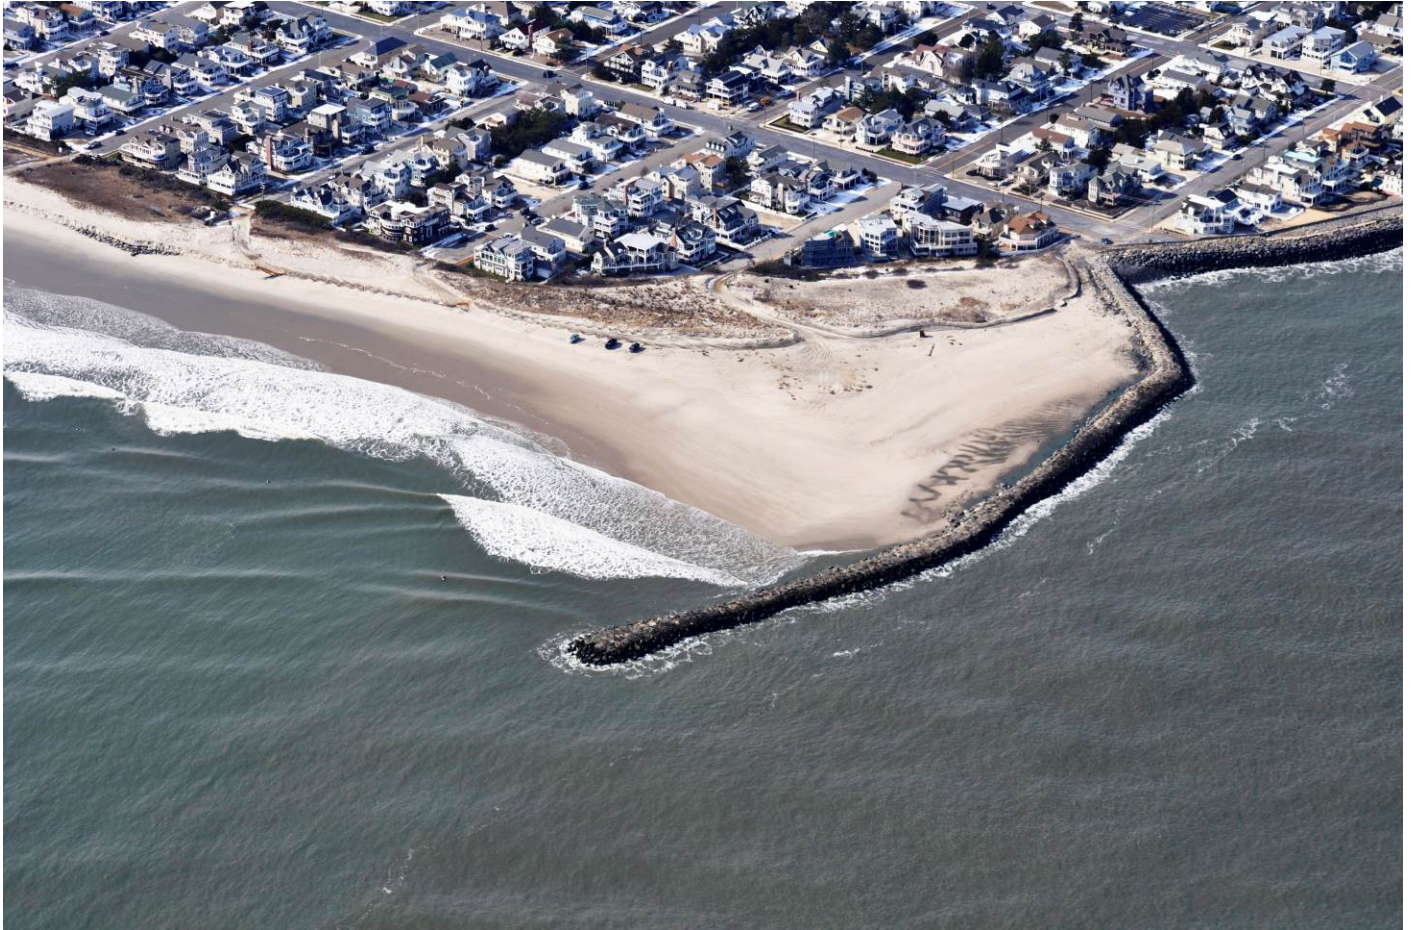
Photo above was taken two days after a January 2016 northeast storm named Jonas. Its impact on the north end of the Avalon shoreline is visible with exposed rocks at 11th Street. Waves overtopped the jetty scouring the beach along the south margin. The water reached the dune toe other places, but fortunately did little serious damage. (photo by Ted Kingston for the CRC).

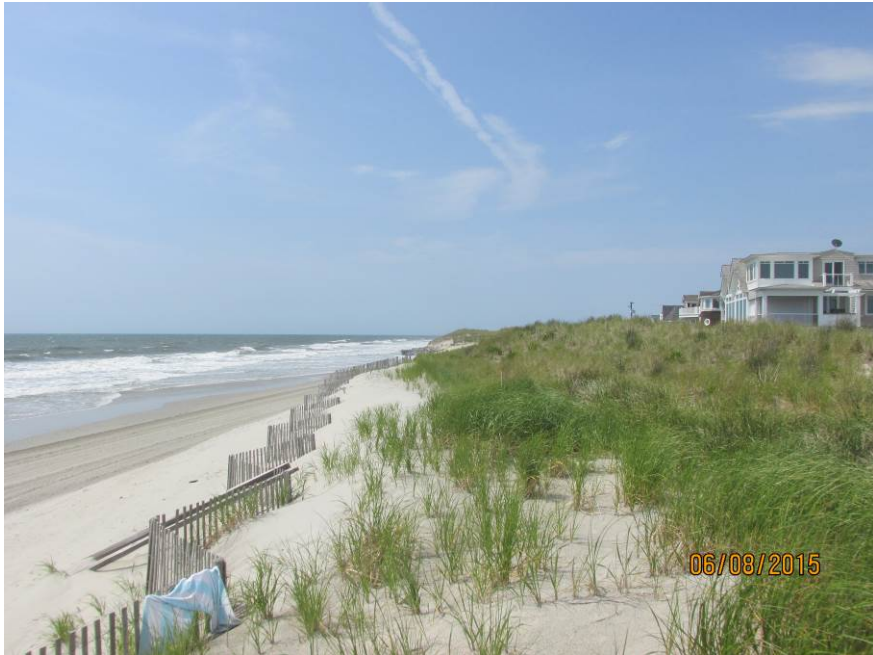
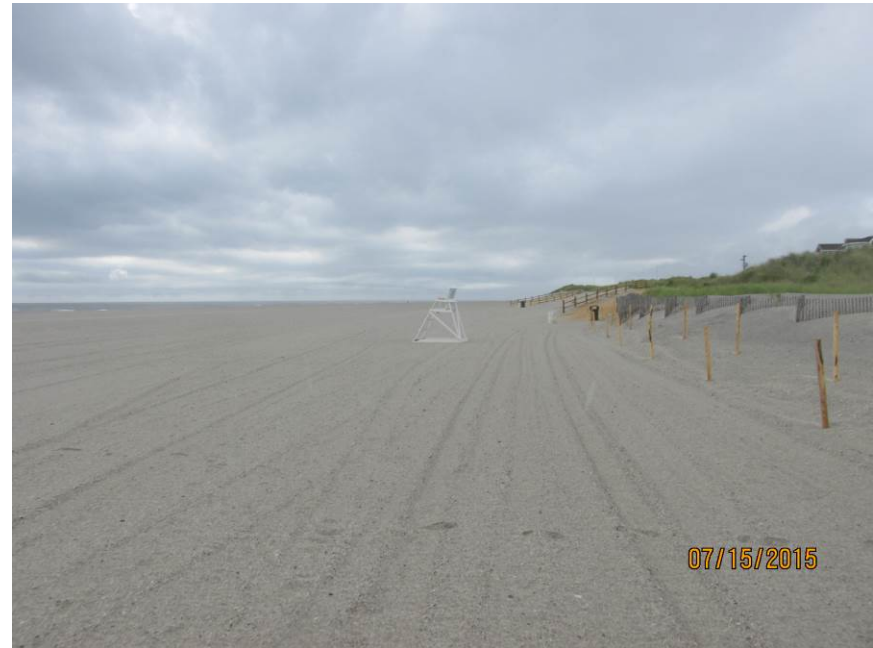
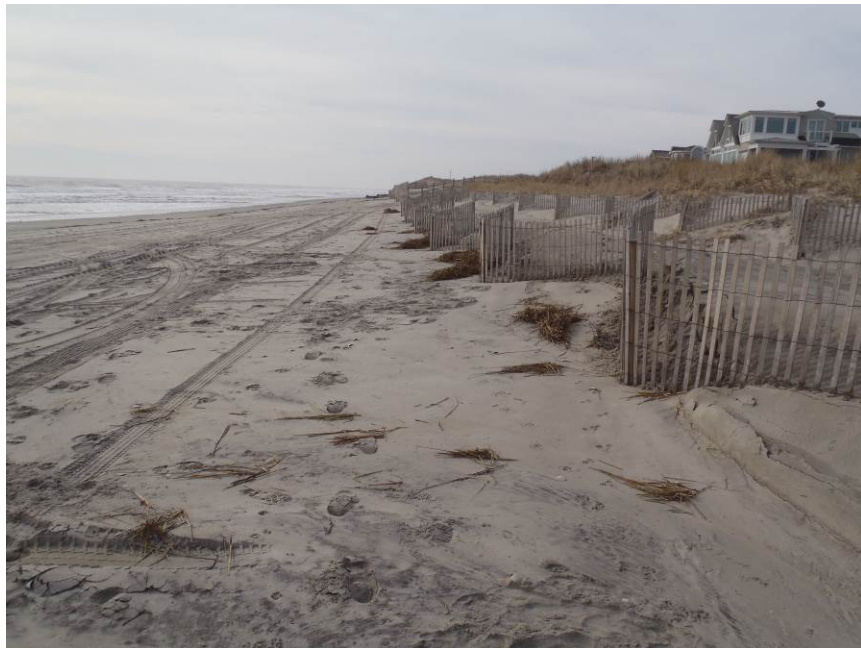
Photographs 1a to 1c. 9th Street view to the south.

View 1b immediately follows the 740,000 cy sand fill and demonstrates the visual effect of the material showing in the cross section below for July 15, 2015.

View 1c after the worst northeast storm since Sandy (Jonas on January 24th) the storm waves reached to the dune fencing and the loss to the berm width shown on the cross sections becomes apparent.

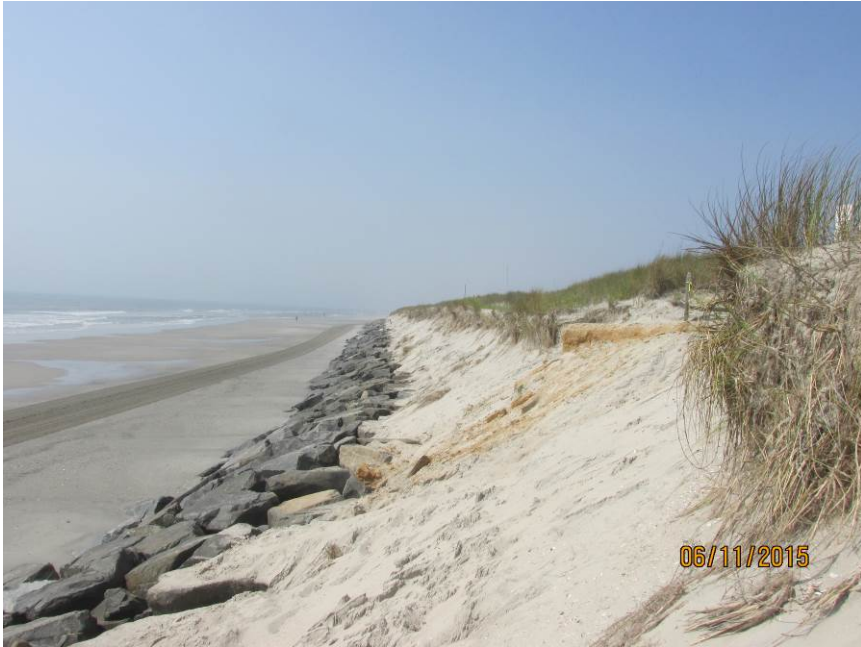
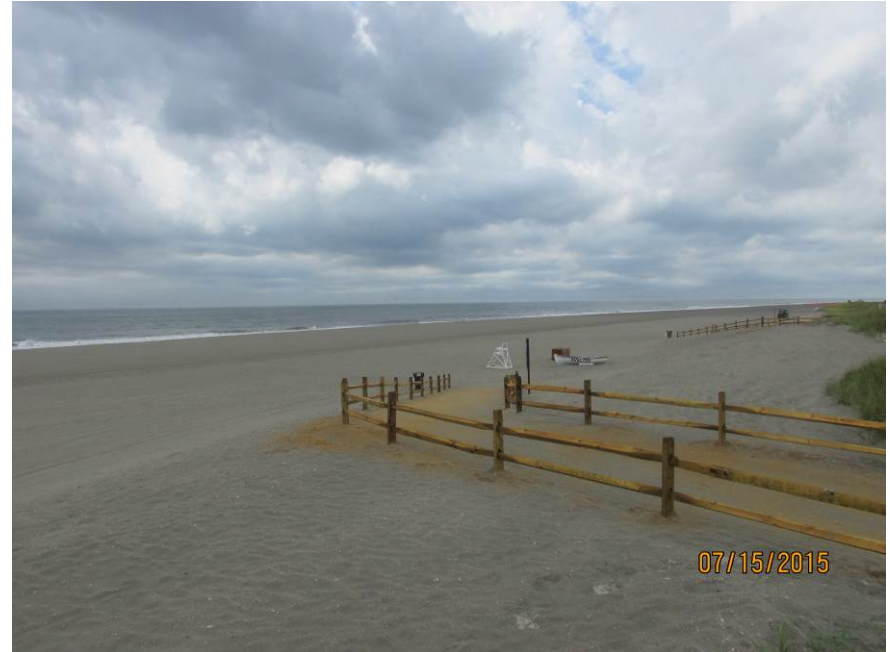
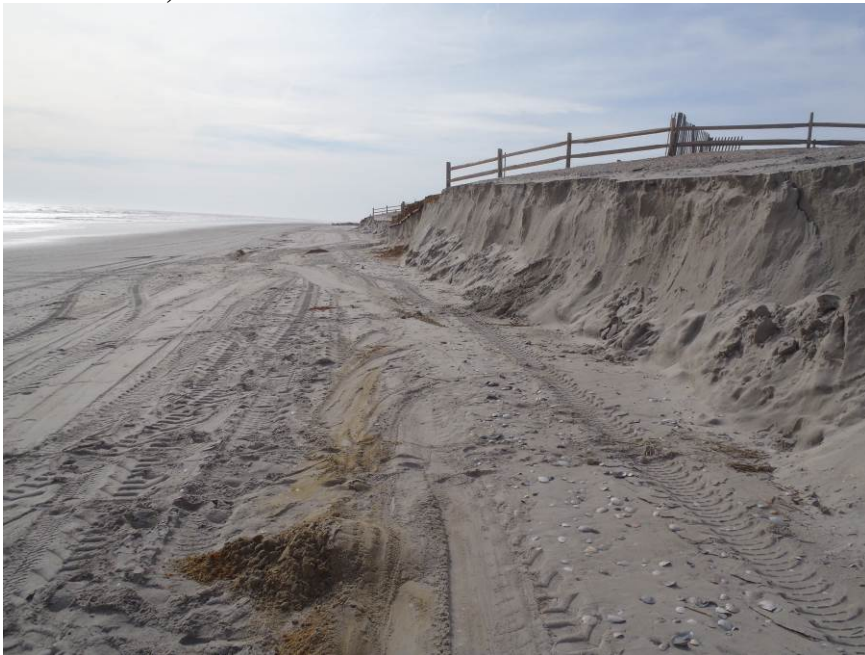
Photographs 2a to 2c. 12th Street Views to the south.

Photograph 2a shows the 12th Street entrance just prior to the Avalon beach restoration where the rocks were exposed, the sand wet to the rocks, a condition that had existed since the previous winter.

View 2b taken just after the July project was complete looking southeast from the dune crest across the new beach entrance ramp onto the wide berm present following the fill.

View 2c was taken January 26th following the NE storm Jonas. The access pathway was cut into a scarp near the location of the revetment rocks, but the beach was still high and wide enough to not have them exposed to wave action. The dune scarp diminished rapidly in both directions from 12th Street.

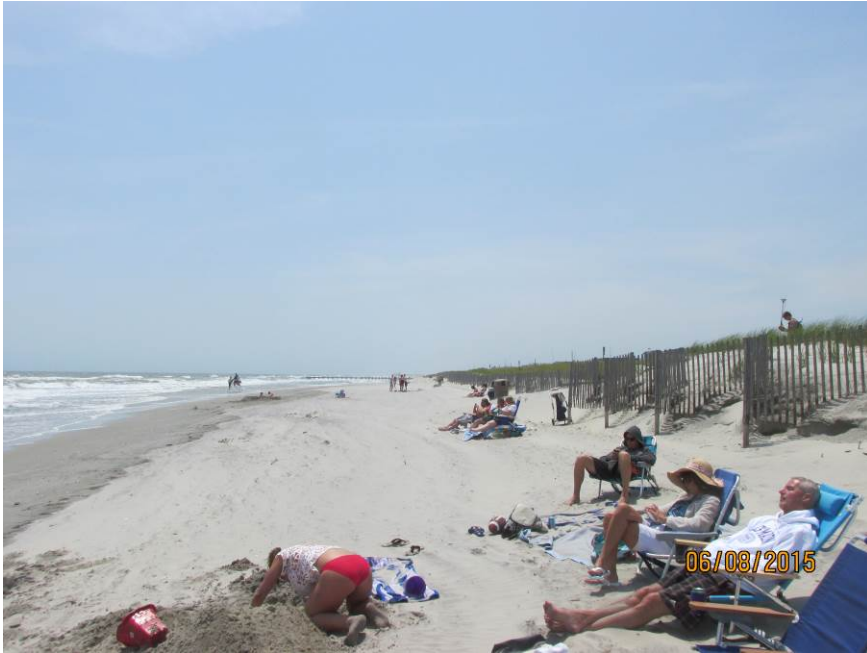
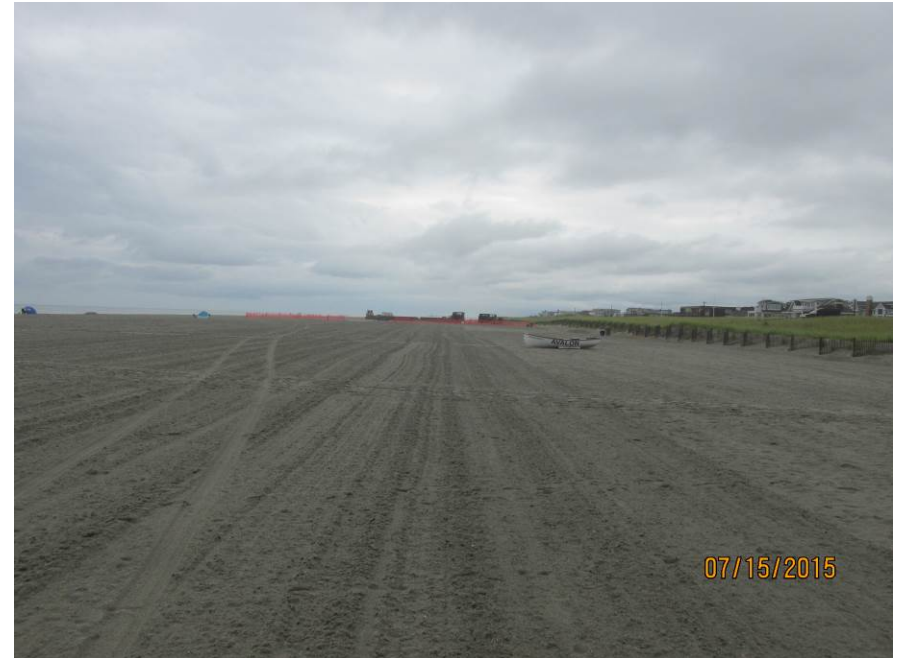
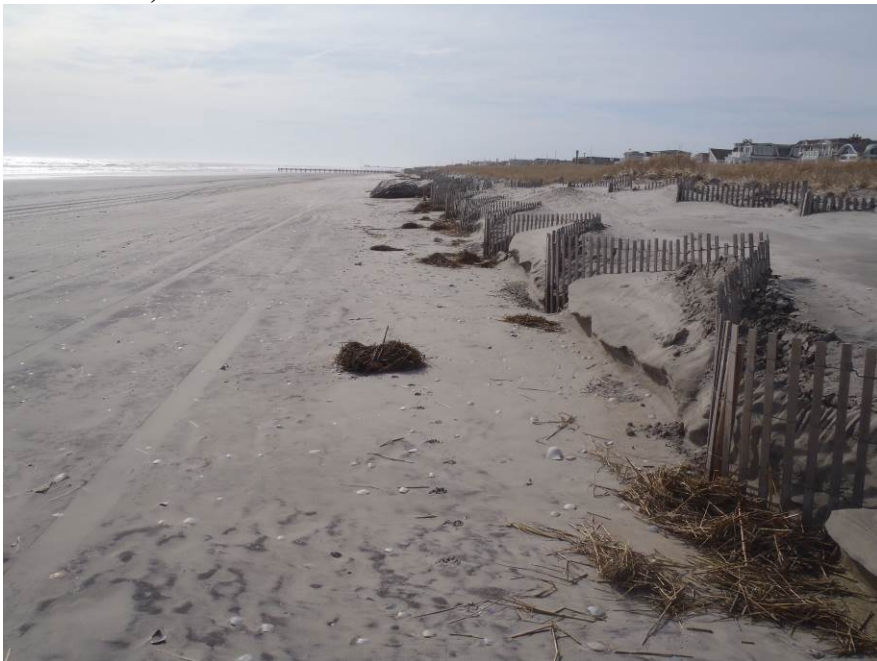
Photographs 3a to 3c. 17th Street, view to the south.

View 3b following the beach fill in July, the width of the berm and the scale of the deposit is apparent in this view. The cross section below shows the vertical plane as the flat berm surface.

View 3c shows the impact of NE storm Jonas where the storm waves reached the dune toe and cut a small scarp into the accumulated wind deposit there. The berm is much narrower with a flatter beachface, but still provides a considerable buffer at this moment.

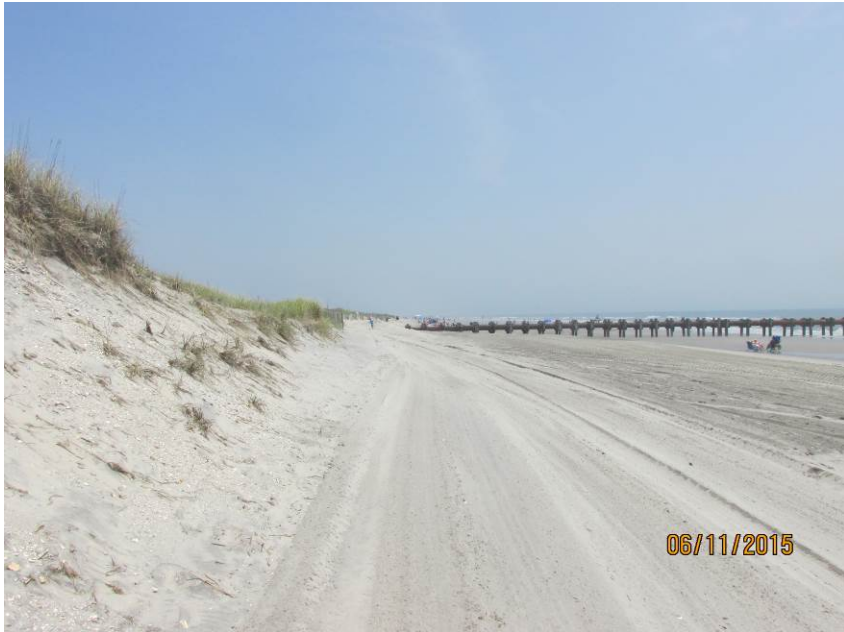
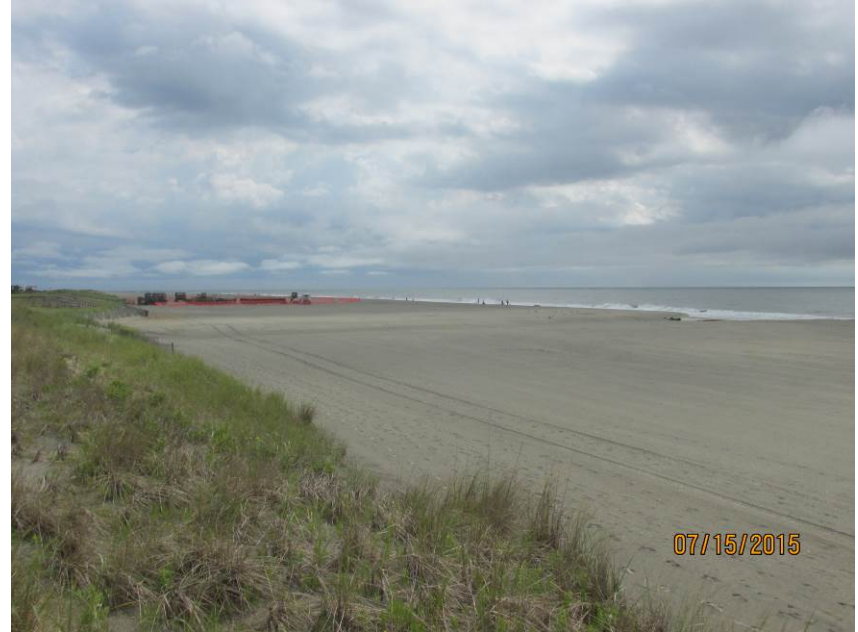
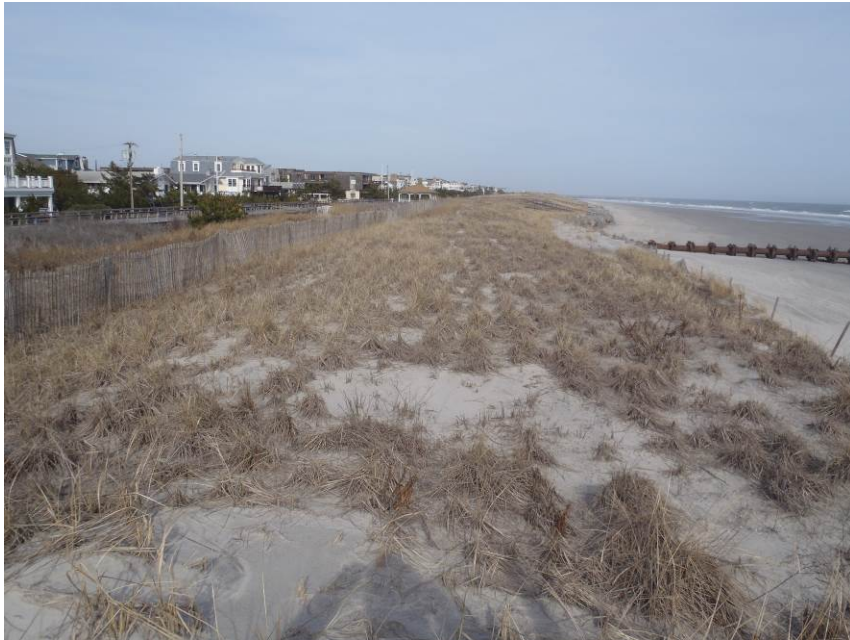
Photographs 4a to 4c. 23rd Street, views to the north.

View 4b was taken immediately following sand placement. The equipment area is still fenced off up the beach. The storm pipeline is buried to the outfall in new sand.

View 4c as of NE storm Jonas the beach width and elevation was severely reduced. Even the December 18th survey before Jonas shows nearly total loss of the berm width and the photograph clearly shows the storm pipeline exposed to the dune toe once again. The erosion focus at 23rd Street is relatively new and perhaps a consequence of the specific wave directions in the two northeasters that occurred between July and this photo.

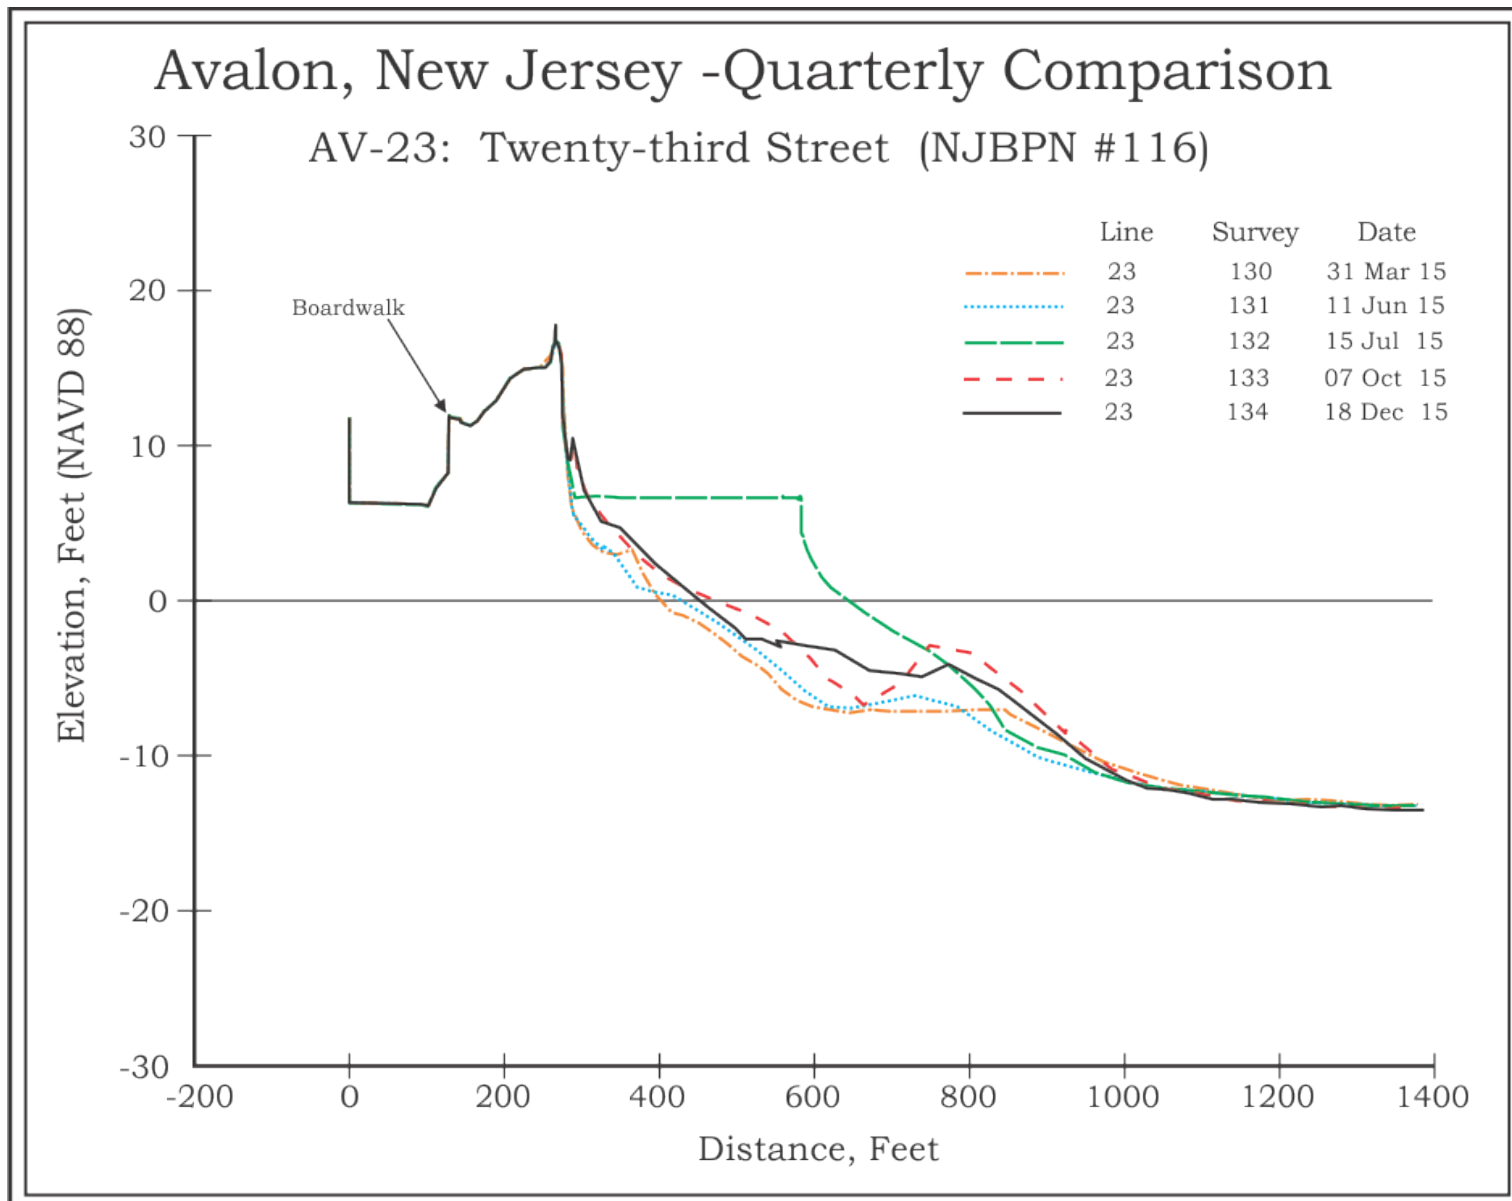
Since then retreat was extremely rapid, achieving near total removal by October 7, 2015. The additional change by December was positive on the beach and neutral offshore as bar crests and troughs filled in or leveled off. The July to December change was a loss of 75.65 yds³/ft. and a 192-foot shoreline retreat. Most of the remaining sand is to be found below the elevation of low tide. The beach width is but 24 feet wider than it was prior to the July beach fill.

The five profiles merge to one elevation 1,000 feet seaward of the reference line which strongly implies that there is little seaward transport taking place into water over 15 feet deep. This sand loss is most likely moving south toward the 35th Street region.

Figure 4. The five surveys really show the speed at which sand moves away from the locality where beach maintenance places it. The berm built in July 2015 had eroded within 24 feet of the June location by October 7th. Of the sand placed 75.65 yds³/ft. moved south or remained in the immediate offshore region as a bar.

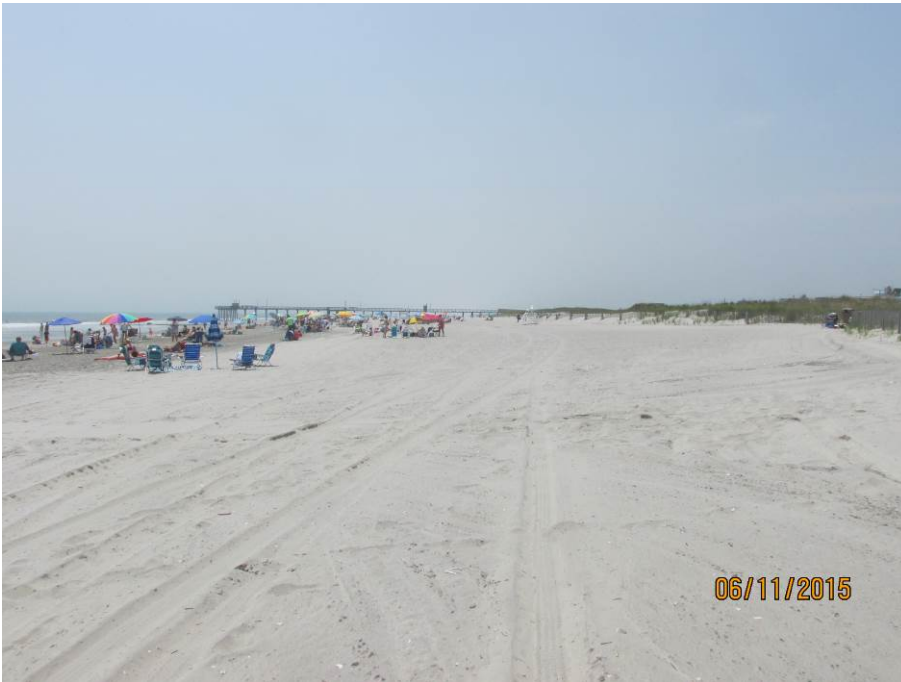
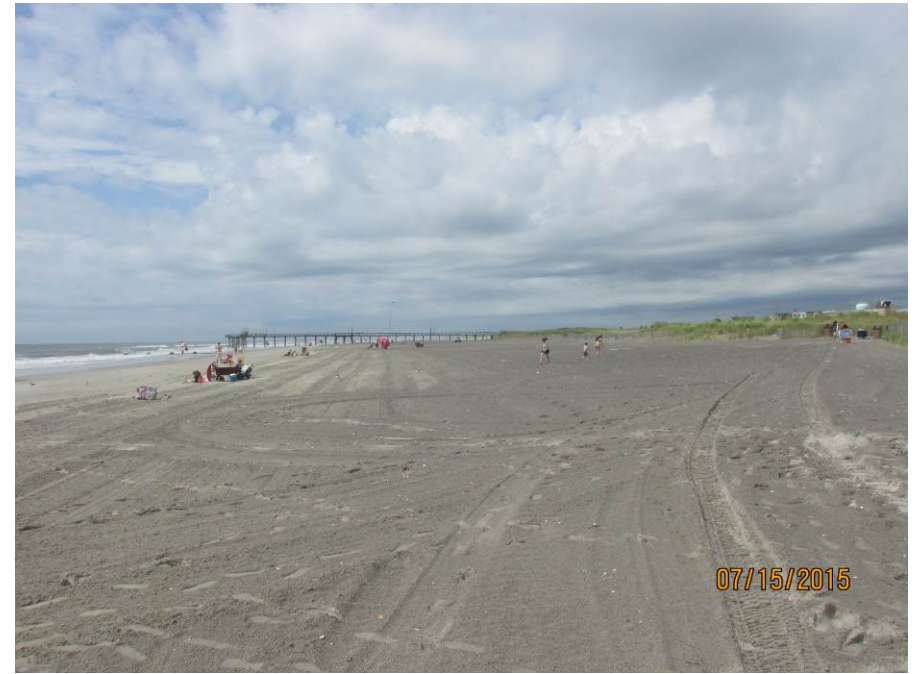
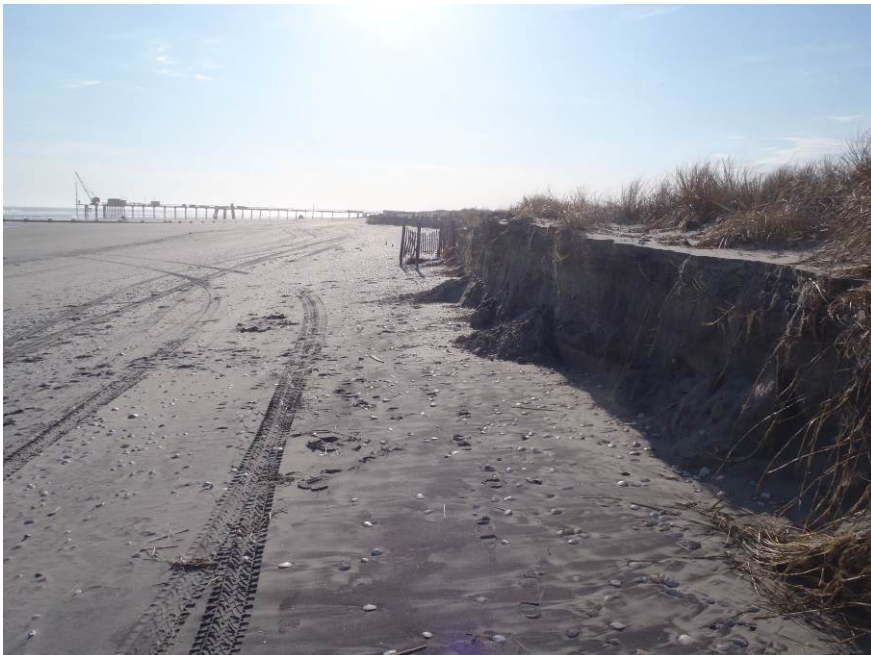
Photographs 5a to 5c. 28th Street, views to the south.

View 5b show the 28th Street beach following the July beach fill project. No sand was added this far south, but subsequently, evidence points to sand migrating here largely in the offshore portion of the profile.

View 5c is a view 2 days after NE storm Jonas that took a bite out of the dune toe slope and flattened the berm beyond that shown in the December 18, 2015 profile below. Material lost was transported south and offshore.

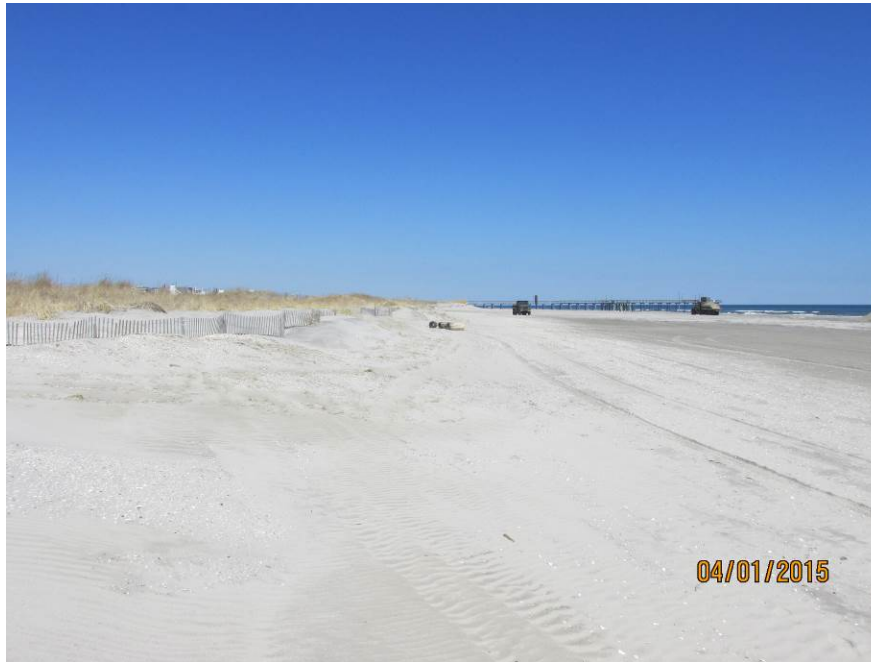
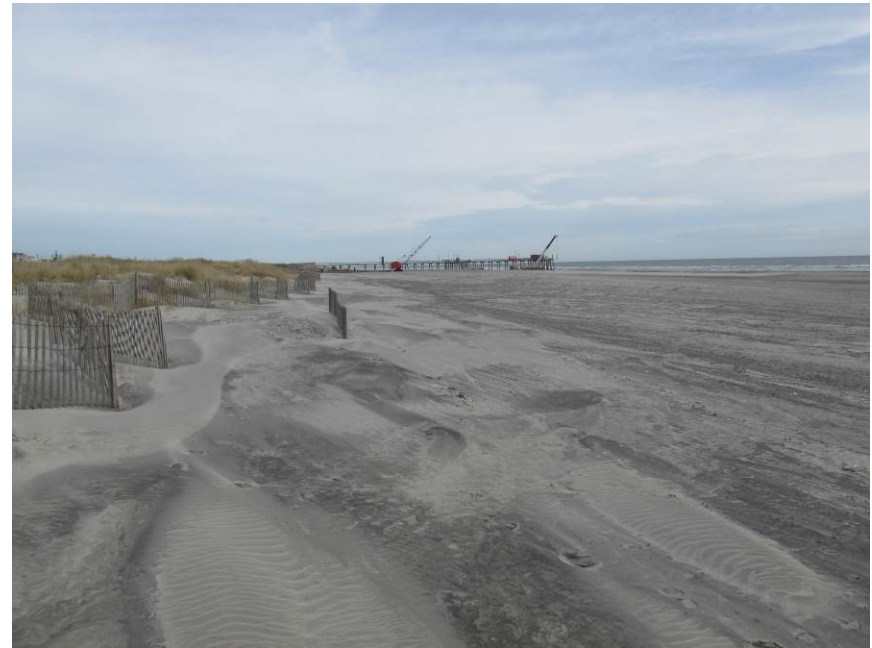
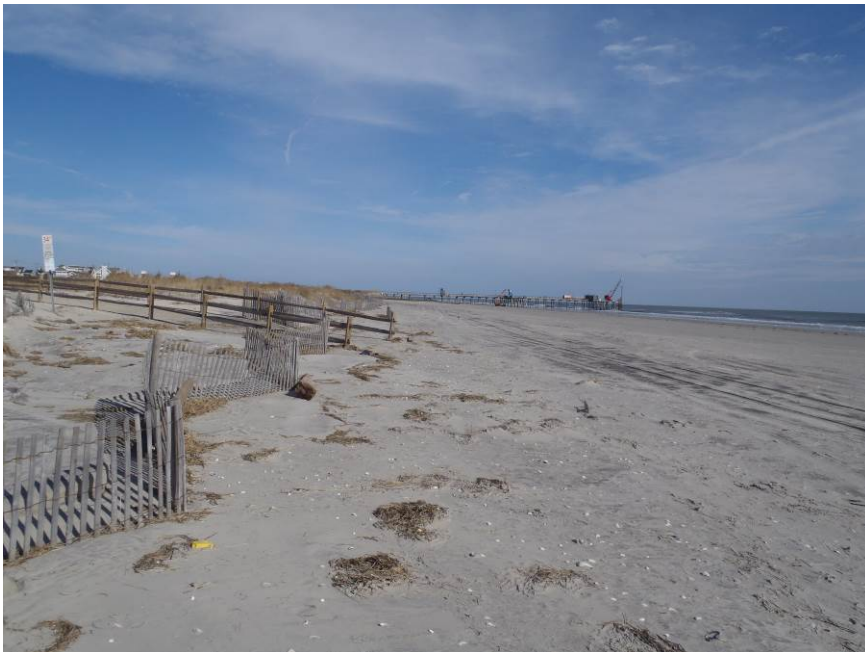
Photographs 6a to 6c. 35th Street, views to the north.

Photograph 6a shows the conditions at the end of the first quarter of 2015. The dune toe has accumulated sand nearly to the top of another row of fencing.

View 6b photo taken in December 2015 shows deposition around a new row of fence as the process of dune growth continues. Work is in progress on the fishing pier.

View 6c was taken as a survey was done on the northern borrow area reserved for sand backpass operations. This view was taken 3 days after NE storm Jonas and is the southernmost post-storm picture in the set of surveys. The wave run-up reached the proximity of the dune toe, but did no harm. The beach berm is flat and a large bar system had developed offshore.

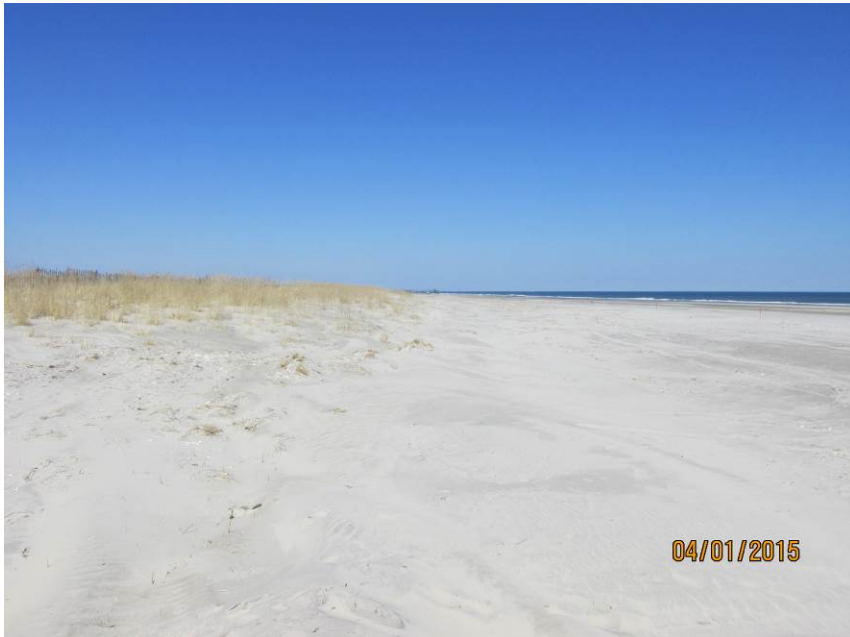
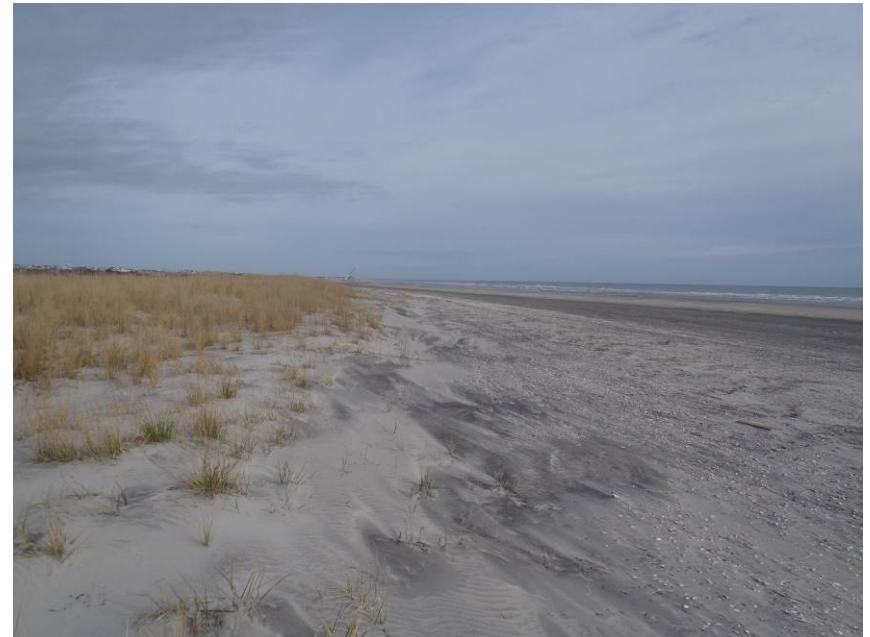
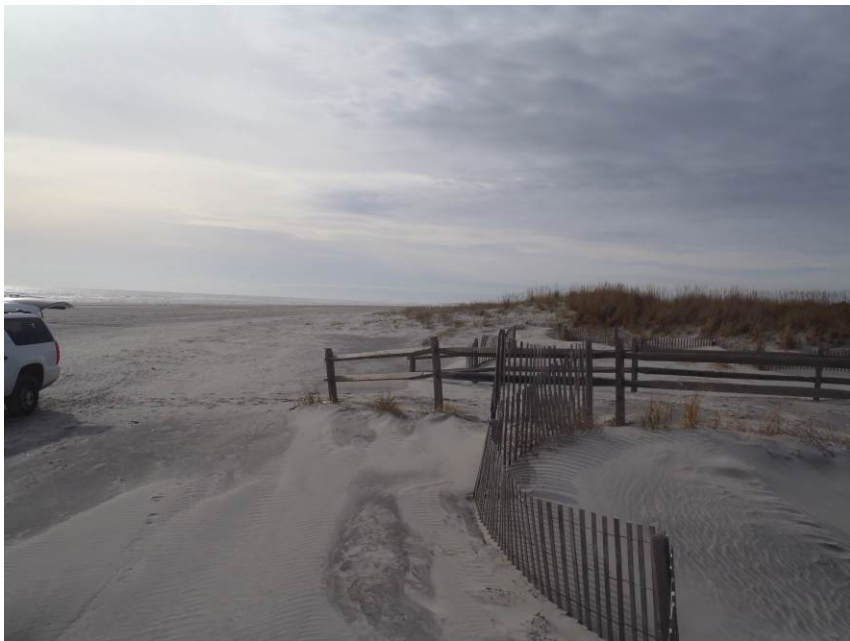
Photographs 7a to 7c. 44th Street, views to the north & south.

View 7c is a view to the south in December 2015 showing the access pathway leading back to Dune Drive.

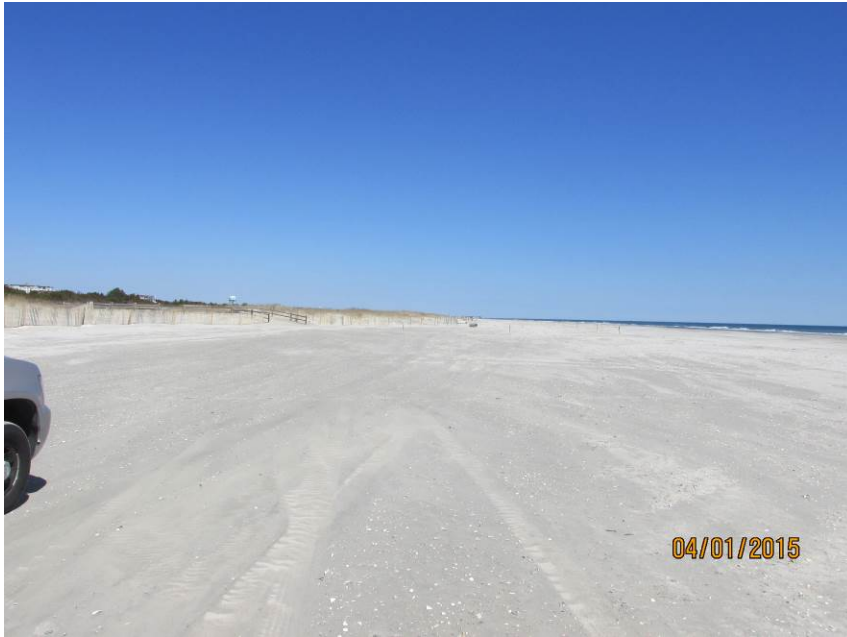
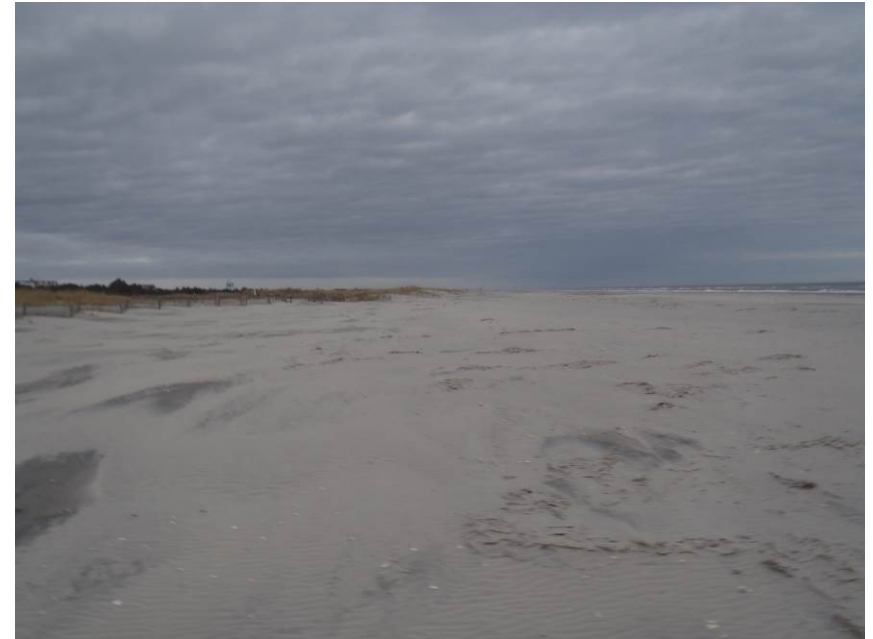
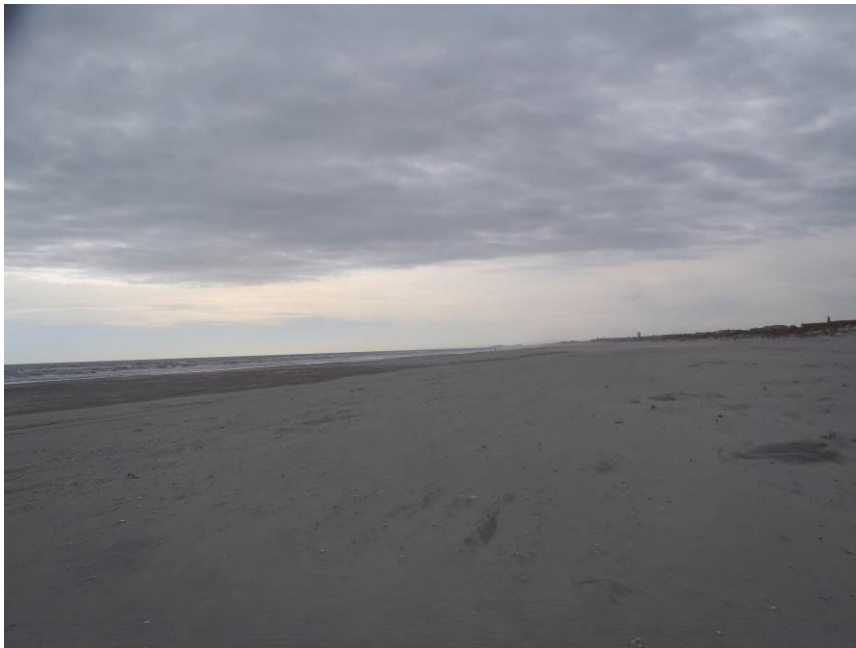
Photographs 8a to 8c. 58th Street, views to the north along the seaward dune toe and mid-beach.

View 8c shows the December 2015 beach mid-way between the dunes and the high tide line at 58th Street.

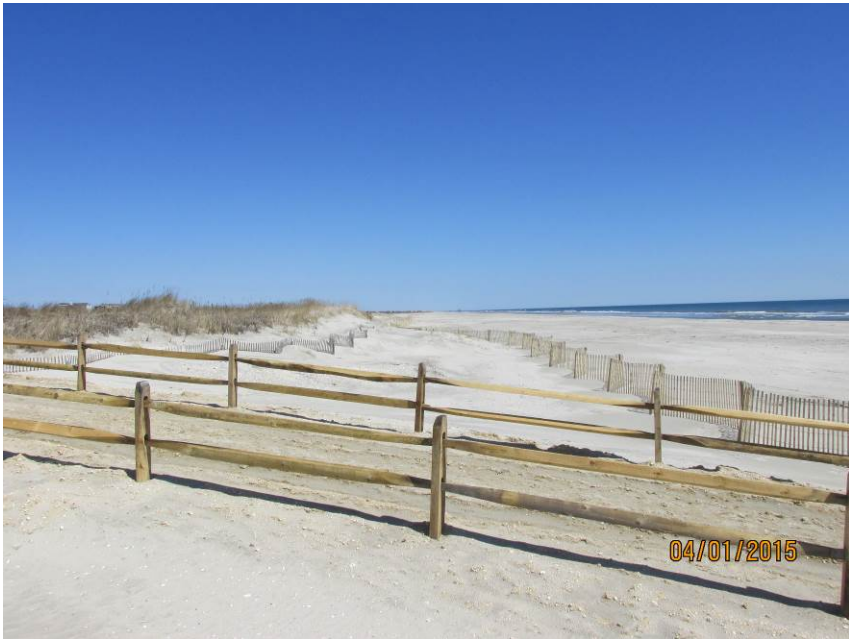
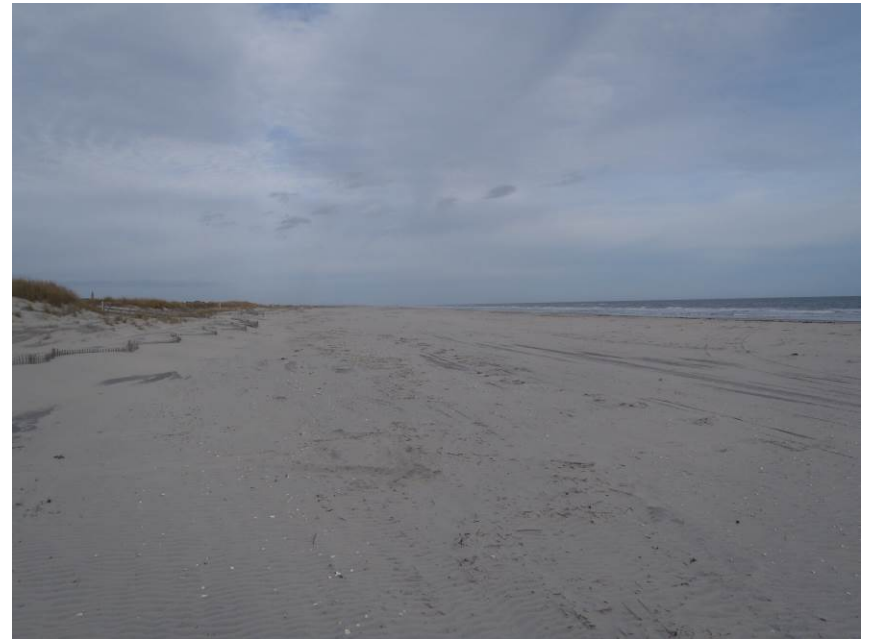
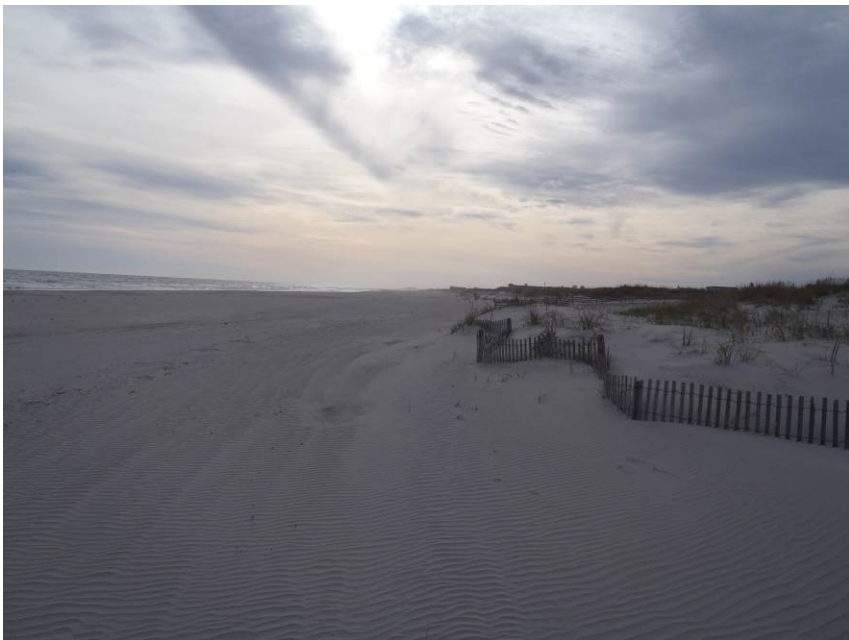
Photographs 9a to 9c. 70th Street, views to the north & south.

Photograph 9a shows the dune toe and beach conditions at the beginning of April 2015. The new fence has already started to accumulate sand

View 9c shows the view to the south along the same fencing placed earlier in the year.

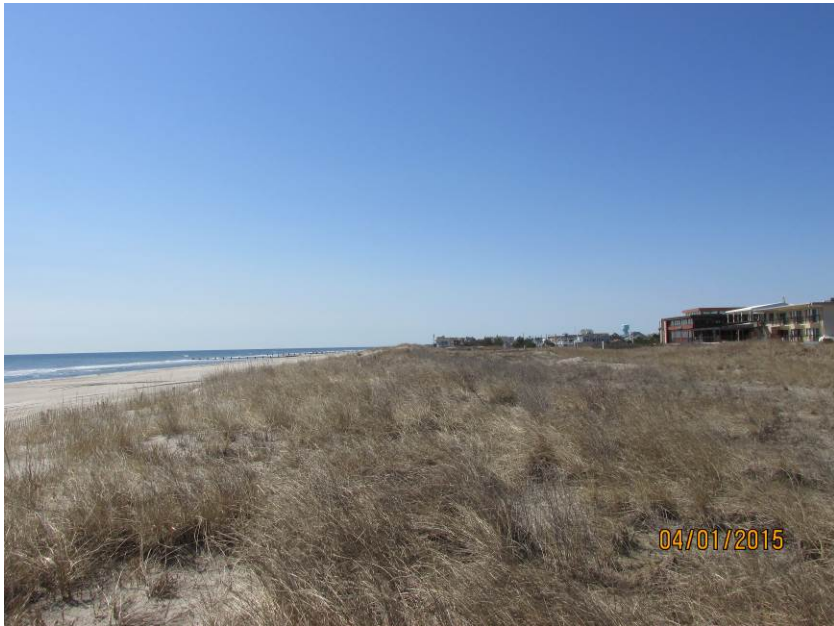
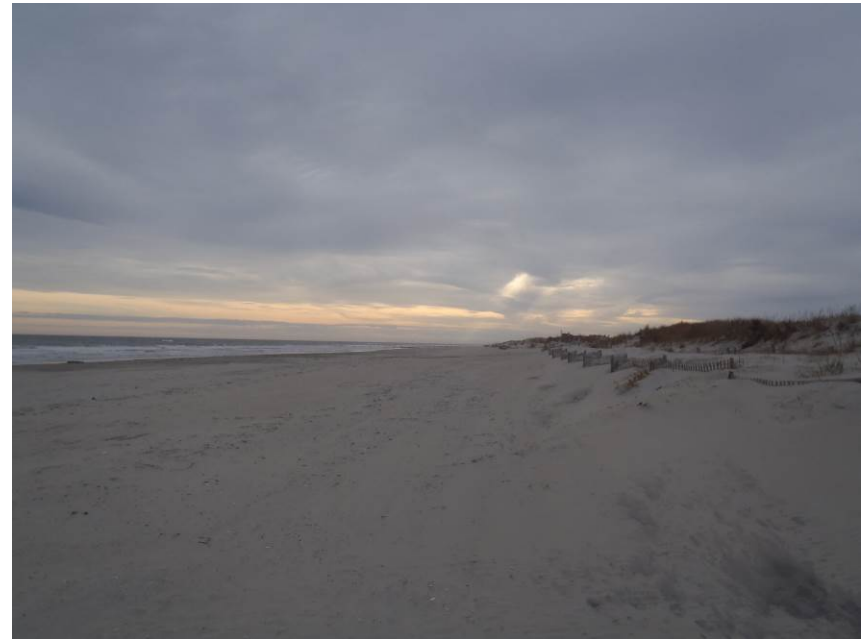
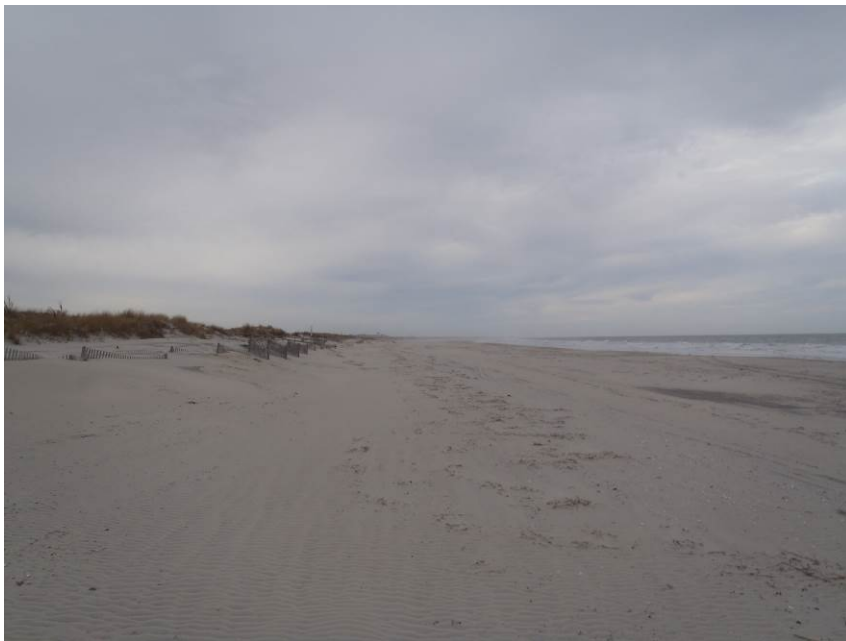
Photographs 10a to 10c. 78th Street, views to the south & north.

View 10c was taken on the same day looking north along the dune toe showing the view back into Avalon.
