**FINAL REPORT FOR 2015
ON THE CONDITION OF THE MUNICIPAL OCEANFRONT BEACHES
THE BOROUGH OF AVALON, CAPE MAY COUNTY, NEW JERSEY**

**PREPARED BY: THE STOCKTON UNIVERSITY COASTAL RESEARCH CENTER
30 WILSON AVENUE
PORT REPUBLIC, NEW JERSEY 08241**

MARCH 2016

**ANNUAL REPORT FOR 2015 - TO THE BOROUGH OF AVALON
ON THE
CONDITION OF THE MUNICIPAL BEACHES**

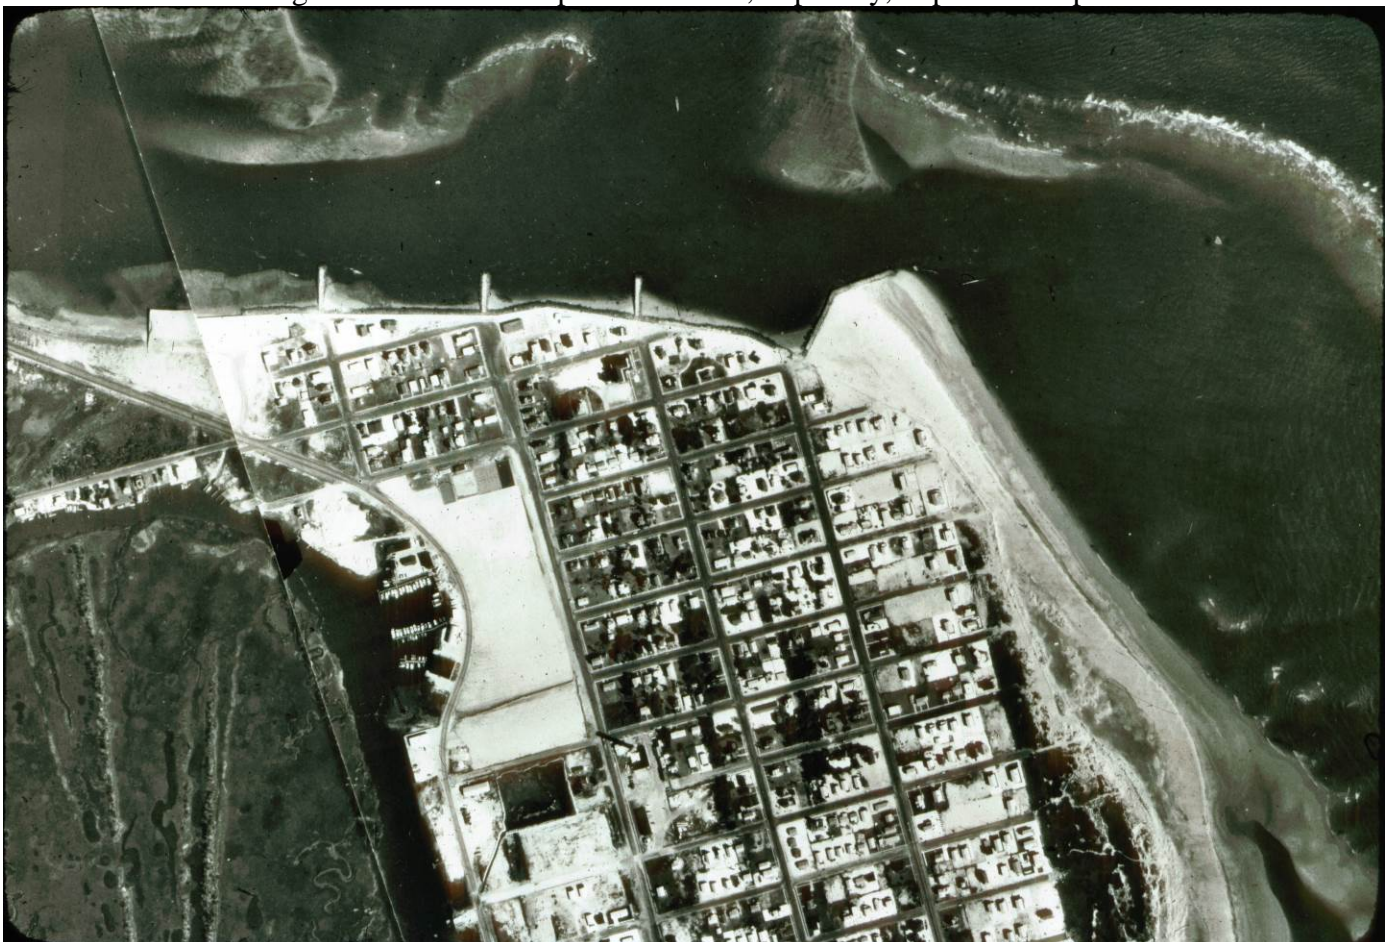
Sand shows as exposed over wide areas in the ebb-tidal zone in these older photographs. These deposits have slowly disappeared due to excavation for beach restoration in both municipalities since 1978. With the introduction of the new Ludlam Island-wide offshore sand supply in 2015, the long shore transport of this sand should restore large ebb-tidal shoal deposits that will, hopefully, duplicate the pre-1978 situation.

Figure 11. 1971 aerial photograph of Townsend's Inlet after construction of the 8th Ave. jetty, the rock revetment and 3 short finger groins in the inlet. The main channel lies next to the revetment with vast shoals exposed at low tide immediately northeast of the channel. Note that the seaward parts of the shoal wrap around the inlet mouth and contributed large slugs of sand to the beach lying between the jetty and 17th Street in Avalon. At this time there was a 465-foot wide vegetated dune system seaward of the end of 17th Street before reaching the dry, high tide beach. Flood tidal currents and storm wave action moved sand over the jetty into the inlet where the ebb-tidal currents carried it back out to the shoals for eventual return to the north end beach. A stable cycle of sediment was in place.
