**FINAL REPORT FOR 2016
ON THE CONDITION OF THE MUNICIPAL OCEANFRONT BEACHES
THE BOROUGH OF AVALON, CAPE MAY COUNTY, NEW JERSEY**

**PREPARED FOR: THE BOROUGH OF AVALON
3100 DUNE DRIVE
AVALON, NJ 08202**

**PREPARED BY: THE STOCKTON UNIVERSITY COASTAL RESEARCH CENTER
30 WILSON AVENUE
PORT REPUBLIC, NEW JERSEY 08241**

**ANNUAL REPORT FOR 2016 - TO THE BOROUGH OF AVALON
ON THE
CONDITION OF THE MUNICIPAL BEACHES**

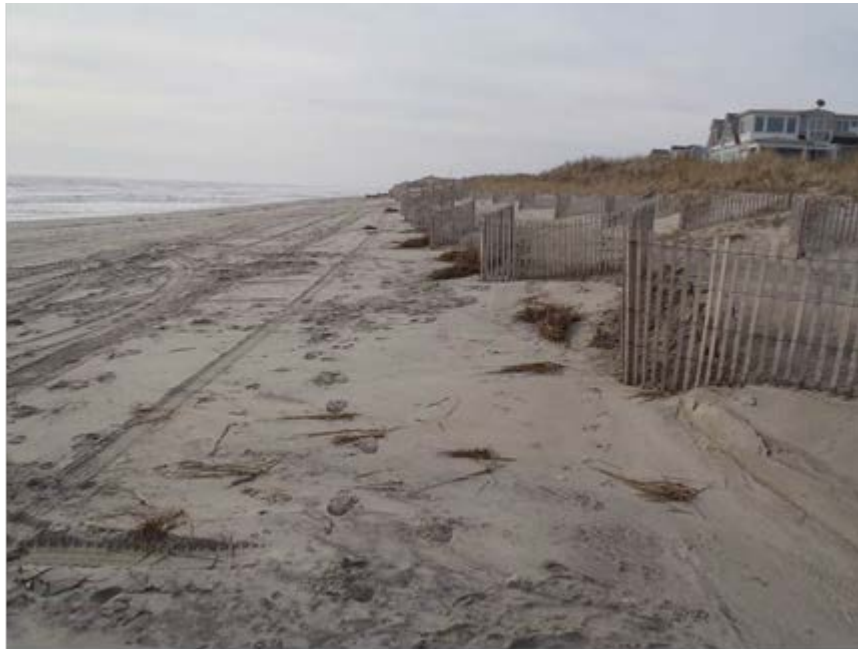
1a. January 26, 2016

Photograph 1a shows the beach and seaward dune slope immediately following winter storm Jonas. The dry beach is very narrow with wrack material deposited at the dune toe indicating storm wave run-up reached the fence line. The fence remained intact and little damage was suffered.

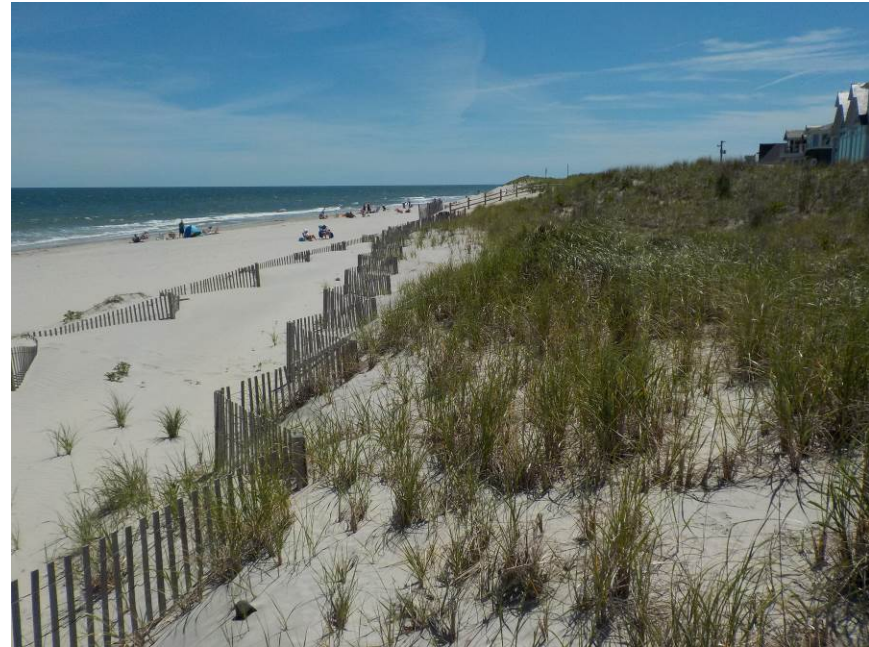
1b. June 13, 2016

Photographs 1a to 1c. 9th Street view to the south.

View 1b taken on June 13 follows the 2016 Sand Backpass project. Although no sand was directly placed here aeolian accumulation along the seaward dune toe has nearly buried the fence line.

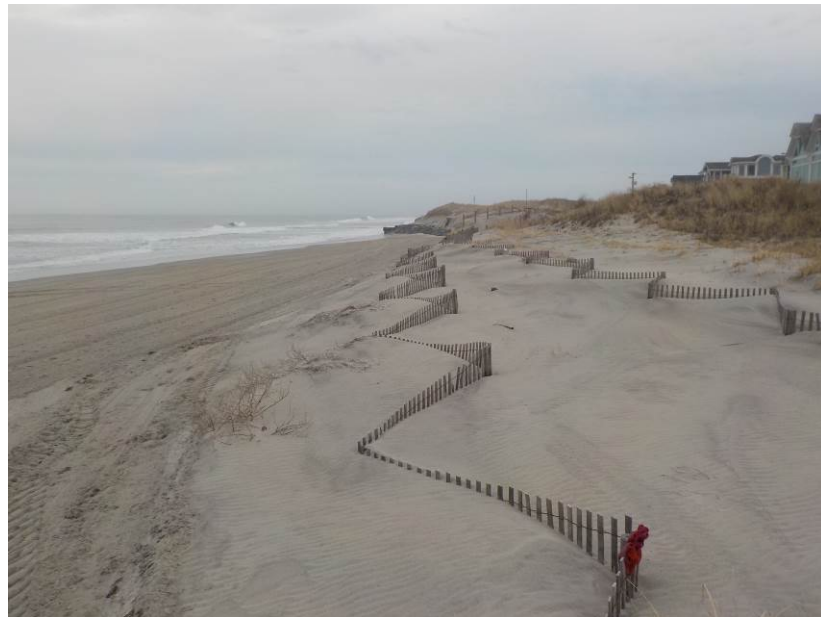
1c. January 20, 2017

View 1c Northeast storms continued to slowly erode and flatten the beach berm but the foredune continued to accumulate aeolian sand throughout 2016. Storm wave sheltering from the 8th Street jetty helps this minimal beach width at 9th Street protect the foredune while south at 10th Street erosion has exposed the rock revetment.

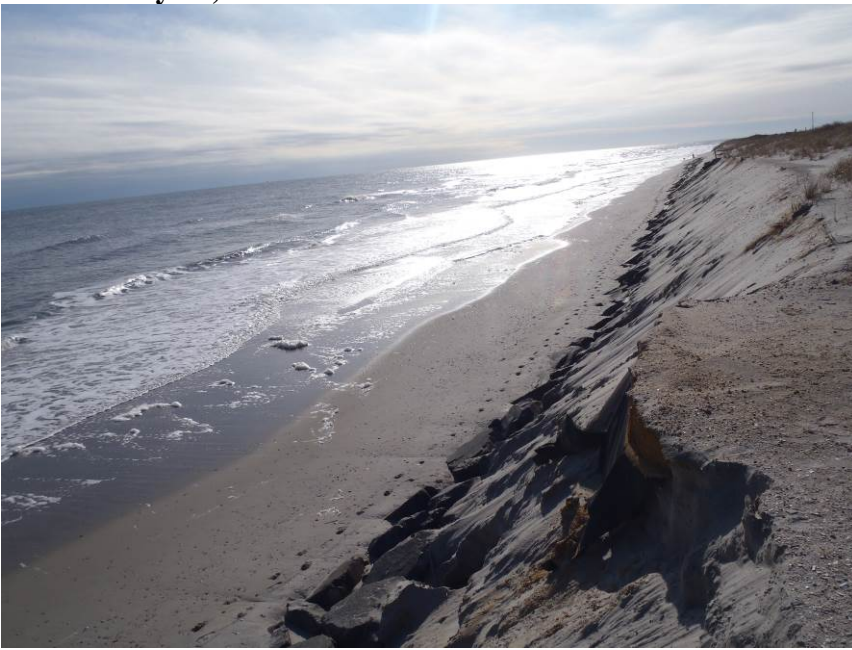
2c. December 18, 2016

View 2c was taken December 18th following a series of storm events that started in September with tropical storm Hermine. During the fall waves cut away at the beach and dune. The access pathway was destroyed leaving a scarp in the seaward dune slope, exposing the revetment rocks buried below, with essentially no dry beach remaining.

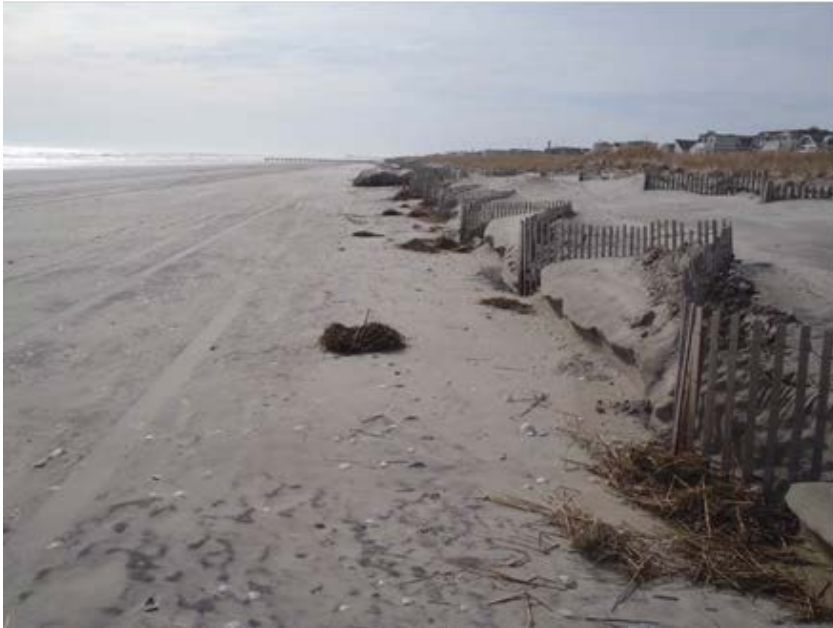
3a. January 26, 2016

Photograph 3a shows the low narrow dry beach at 17th Street following winter storm Jonas. Storm wave run-up reached the foredune toe and fence line scouring a small scarp along the toe and deposited wrack material. Wave energy in this region was not sufficient to cause damage to the fence.

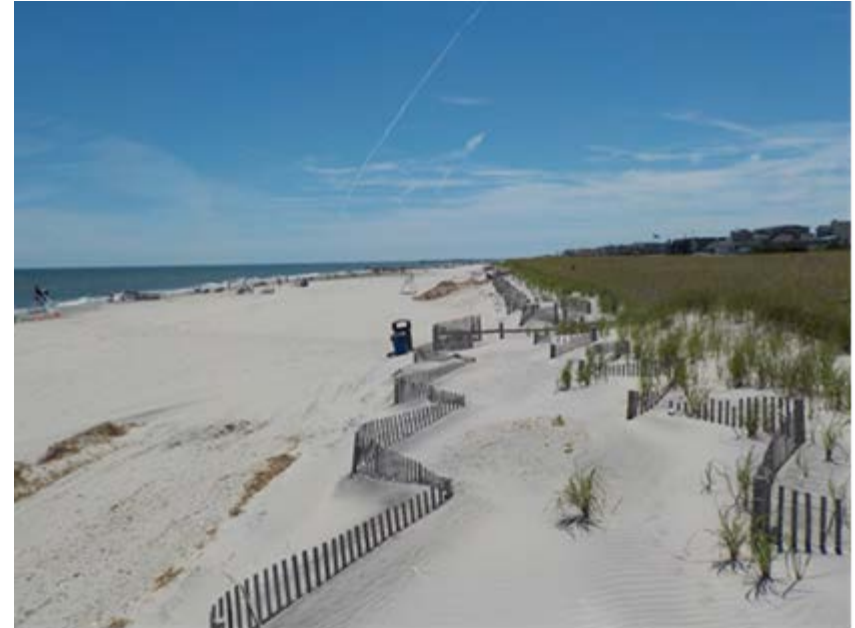
3b. June 13, 2016

Photographs 3a to 3c. 17th Street, view to the south.

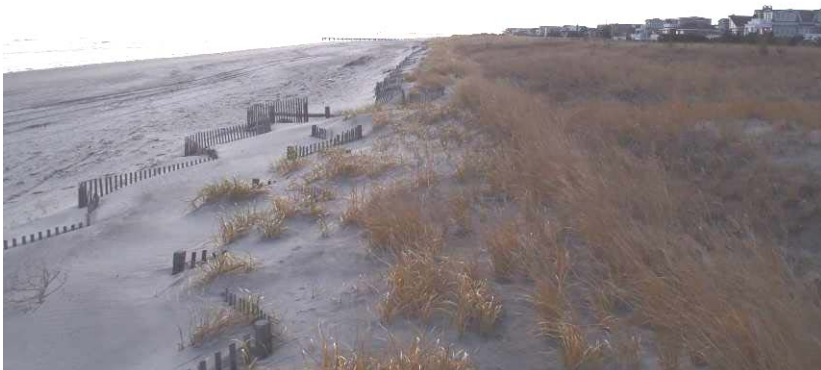
3c. December 18, 2016

View 3c shows the impact of storms in fall 2016 that reduced the beach berm width and elevation. The dune system here was spared erosion with aeolian sand accumulation continuing on the foredune.

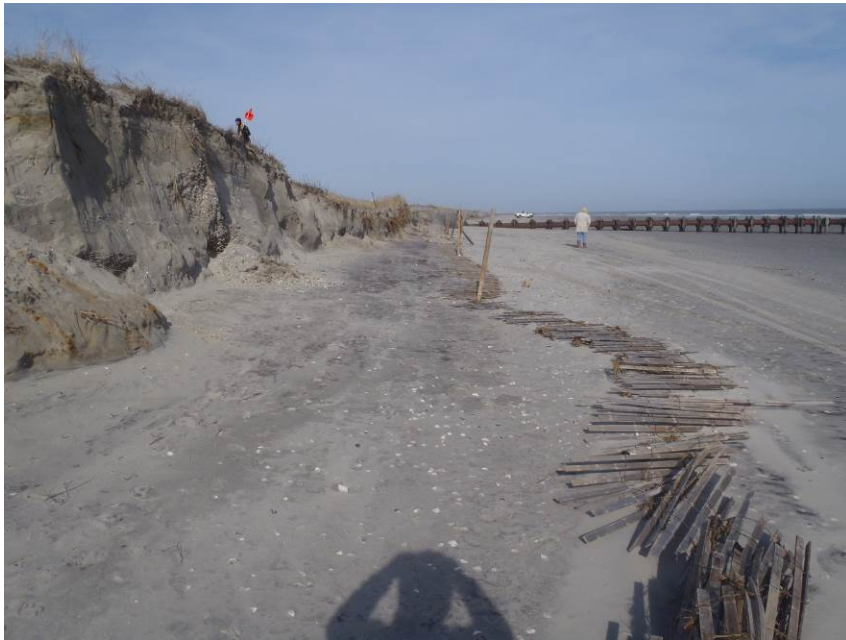
4a. January 26, 2016

Photograph 4a shows the dune erosion at this site caused by winter storm Jonas. The storm outfall pipeline (distance) is exposed to the dune and the beach is flattened and narrow.

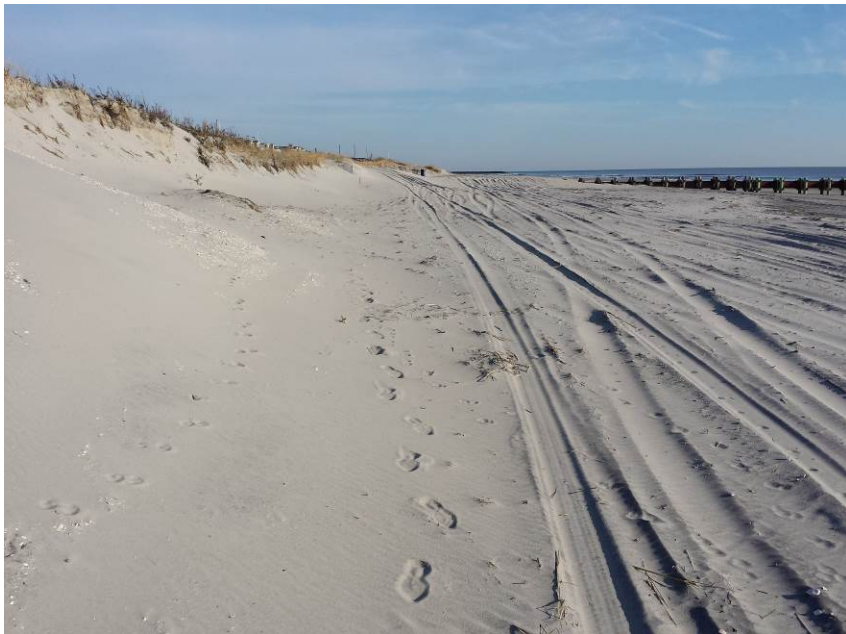
4c. December 18, 2016

View 4c was taken in late fall, this site continued to accumulate sand following completion of sand backpassing. The dune slope has been partially restored through natural aeolian processes and the beach berm elevation was raised. The beachface slope eroded over the fall exposing more of the pipeline.

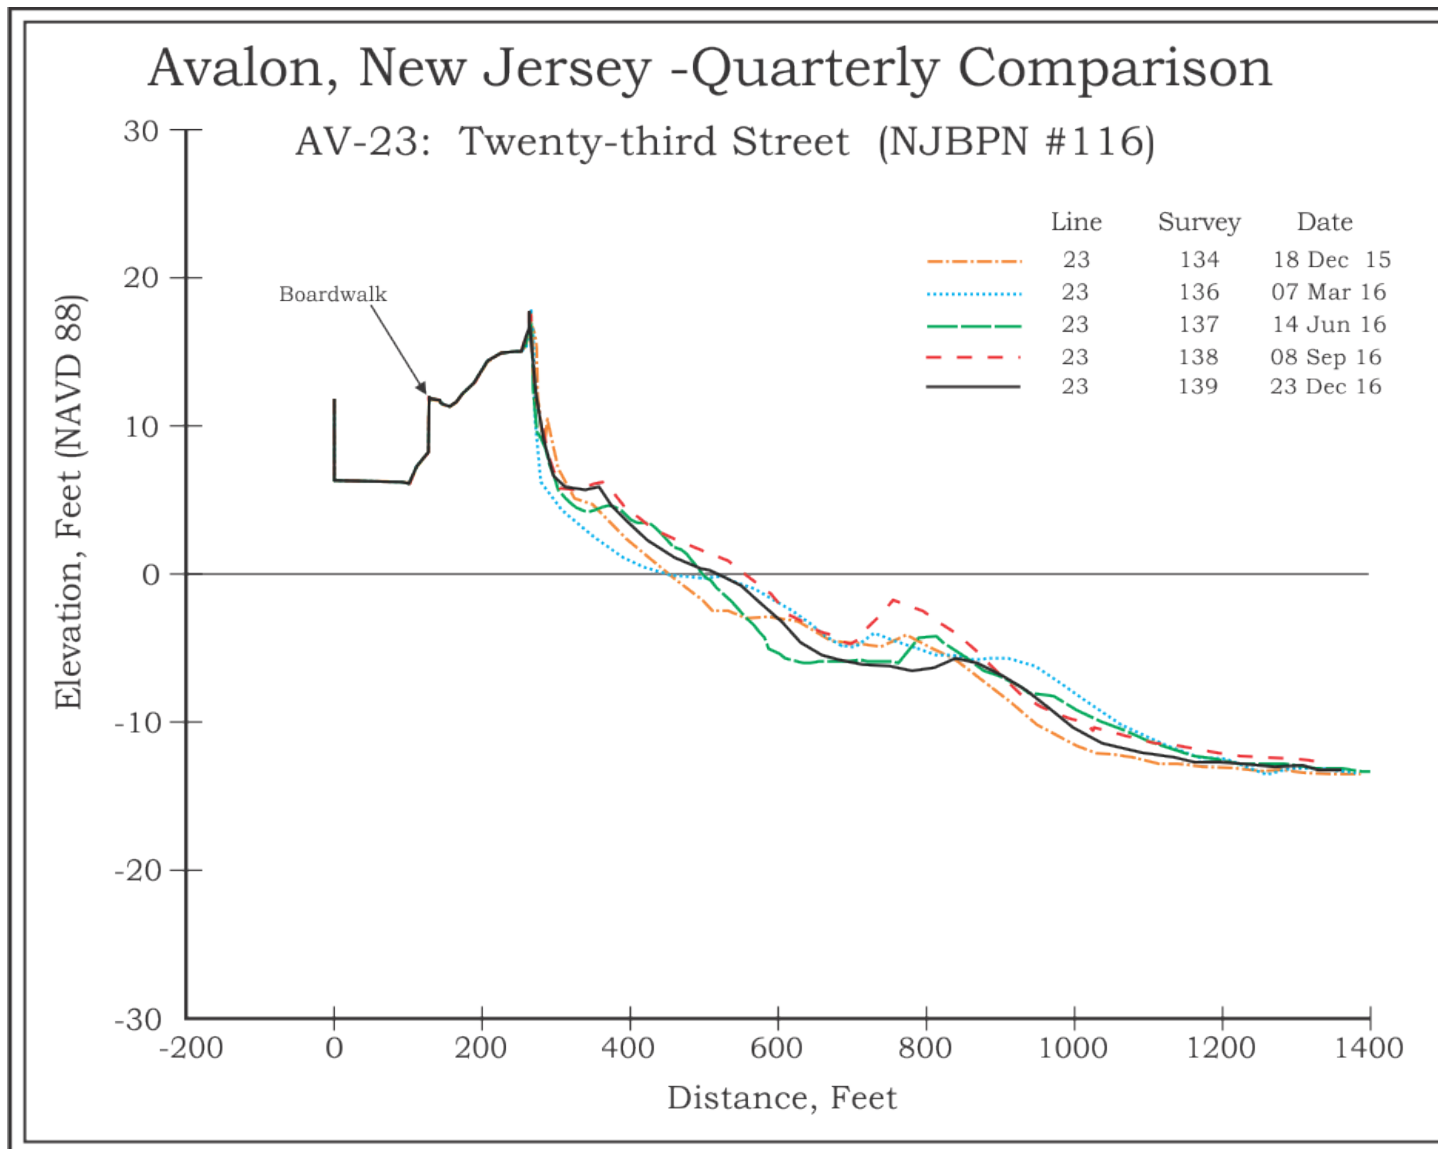
Figure 6. The five profiles show the significant variation in beach configurations in 2016. Winter storms combined to initially erode the beach and seaward dune slope leaving a vertical scarp 10 feet high and removing the dry recreational beach berm. During the spring, the 2016 backpass project restored a 100 foot-wide beach berm and partially restored the seaward dune slope, allowing for safe access to the beach. Natural sand recovery continued here through the summer, elevating the beach berm nearly two feet as sand accumulated nearshore and on the beachface slope then pushed onshore during the favorable summer wave climate. During the fall, the dry beach provided a source for aeolian sand that accumulated on the seaward dune slope. Early fall storm events began to erode the beachface slope and scour the nearshore seafloor, flattening a significant shore parallel sand bar that had developed over the summer. The net result for the year was a significant shoreline position advance of 65 feet with the addition of 14.14 yds³/ft. of sand.

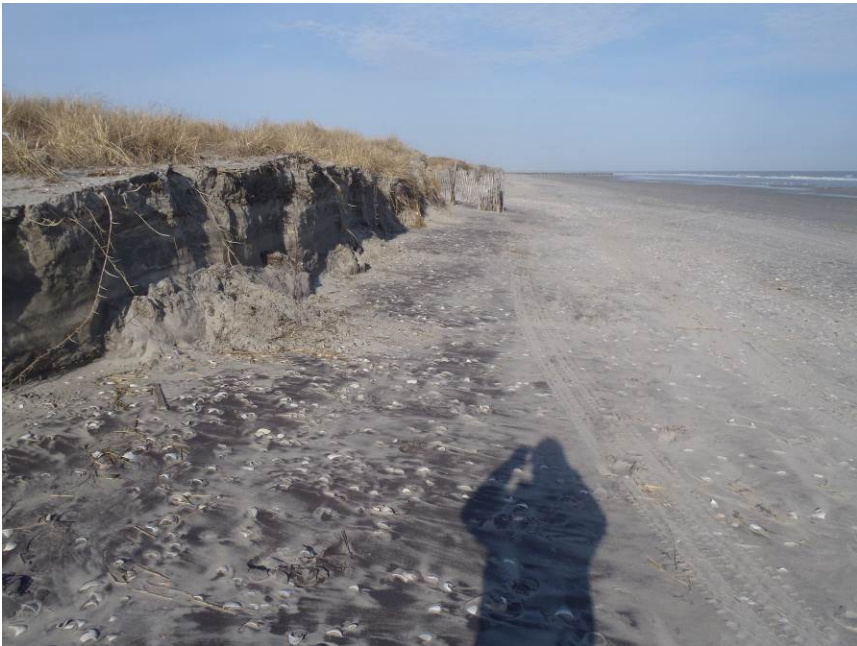
5a. January 26, 2016

Winter storm Jonas cut into the beach and seaward dune slope leaving a 4-6 high vertical scarp from the foredune crest to the beach with nearshore scouring, the shoreline retreated 31 feet and the beach lost -12.65 yds³/ft. of sand. Modest offshore gains reduced the net winter loss to -9.27 yds³/ft. of sand from December 2015 to March 2016. During the spring, the erosional trend continued for a net loss of -15.02 yds³/ft. of sand. Sand accumulated on the beachface slope restoring a low berm ridge but the nearshore seafloor was scoured offsetting the gains onshore.

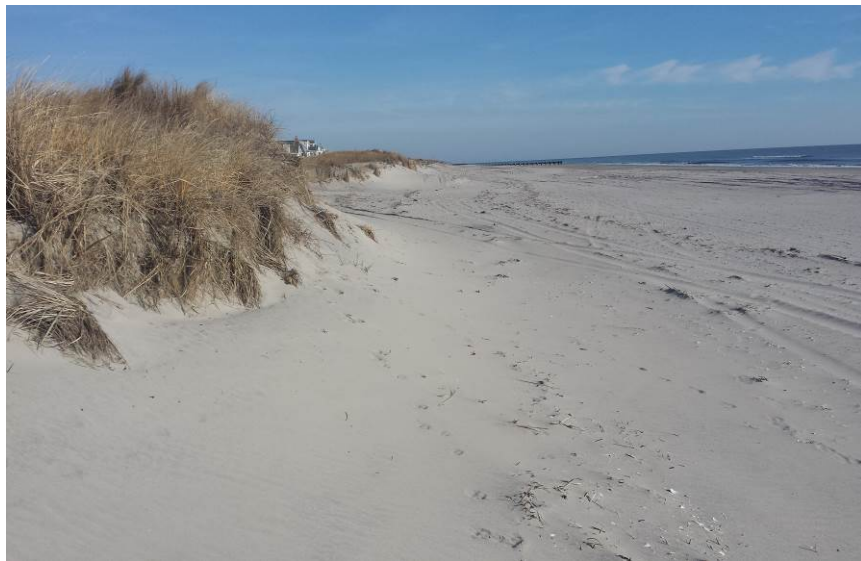
5c. December 23, 2016

View 5c is a view December 23, 2016. Sand has accumulated naturally on the beach berm and along the seaward dune toe nearly restoring the damage from Jonas.

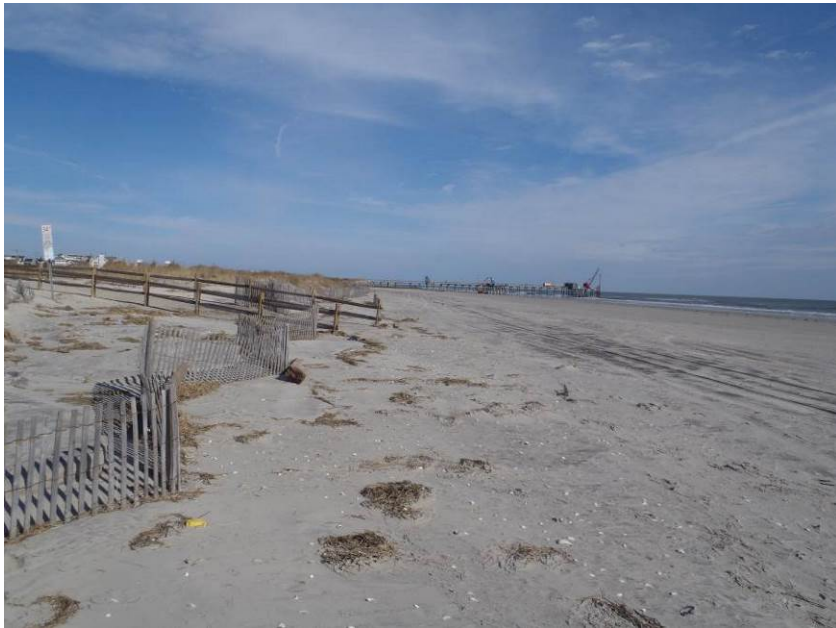
6a. January 27, 2016

Photograph 6a shows the conditions following winter storm Jonas and before sand backpassing commenced. The beach was flattened by the storm, wrack debris provides evidence that storm waves reached the toe but did no damage.

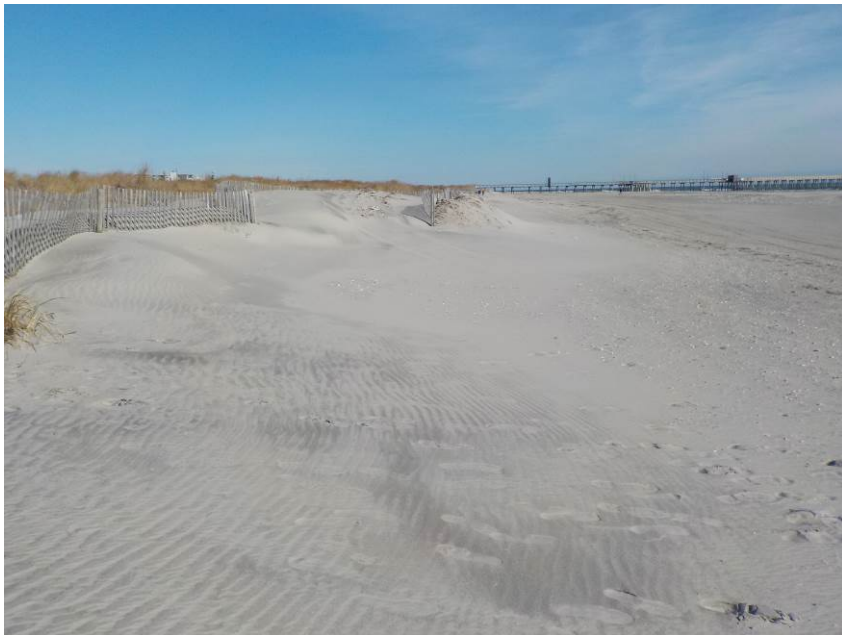
6c. December 23, 2016

View 6c was taken approximately 6-months following sand harvesting. The beach elevation and width have fully recovered and the dune fence continued to trap aeolian sand from the wide beach.

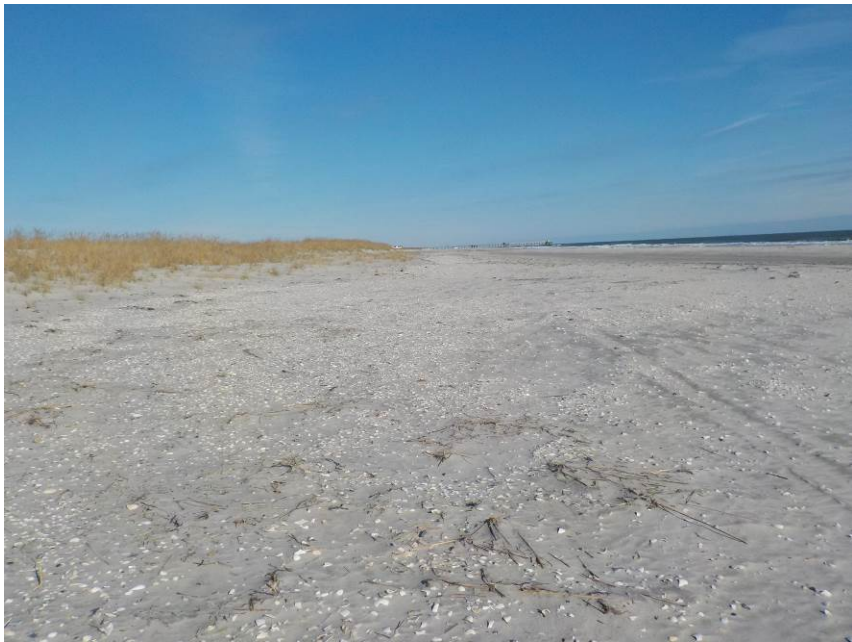
7c. December 19, 2016

View 7c is a view to the south in December 2016 showing the wide dry beach continues to accumulate sand supporting foredune development and expansion of the system seaward onto the upper beach.

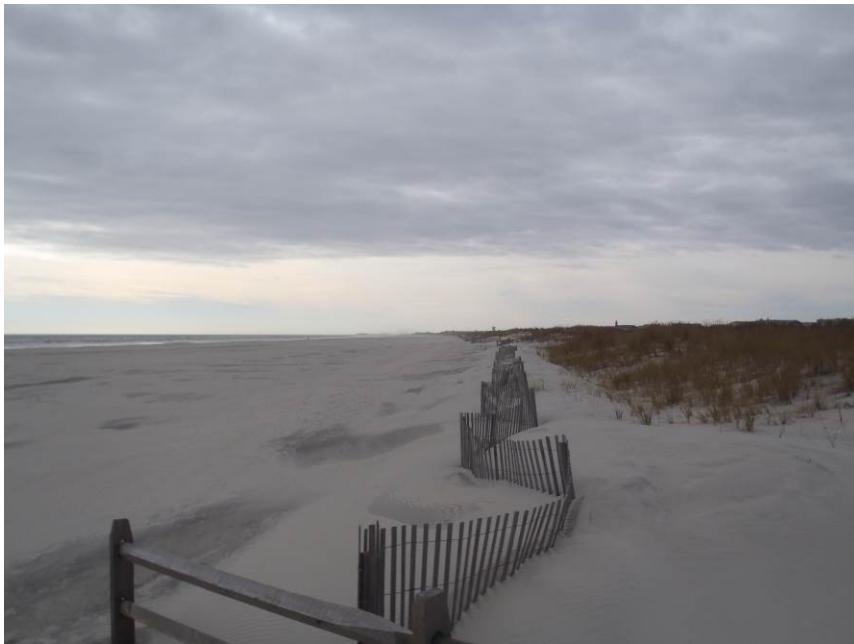
8a. December 21, 2015

Photographs 8a to 8c. 58th Street, views to the south along the seaward dune toe.

Photograph 8a illustrates the broad expanse of the dry beach that extends seaward from the edge of the dune grass. The wide beach supports continued dune growth as evident by the new foredune accumulation of sand along the zig zag fence row.

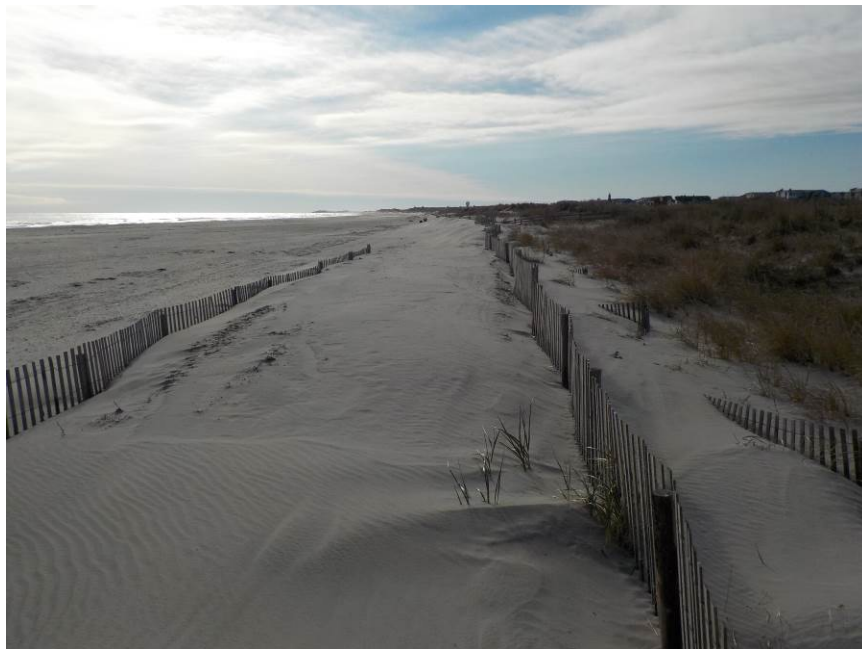
8c. December 19, 2016

View 8c shows the December 2016 dry beach and dunes. Despite a several fall storm events that caused erosion on the north end, this section of shoreline with its wide beach continued to support dune growth.

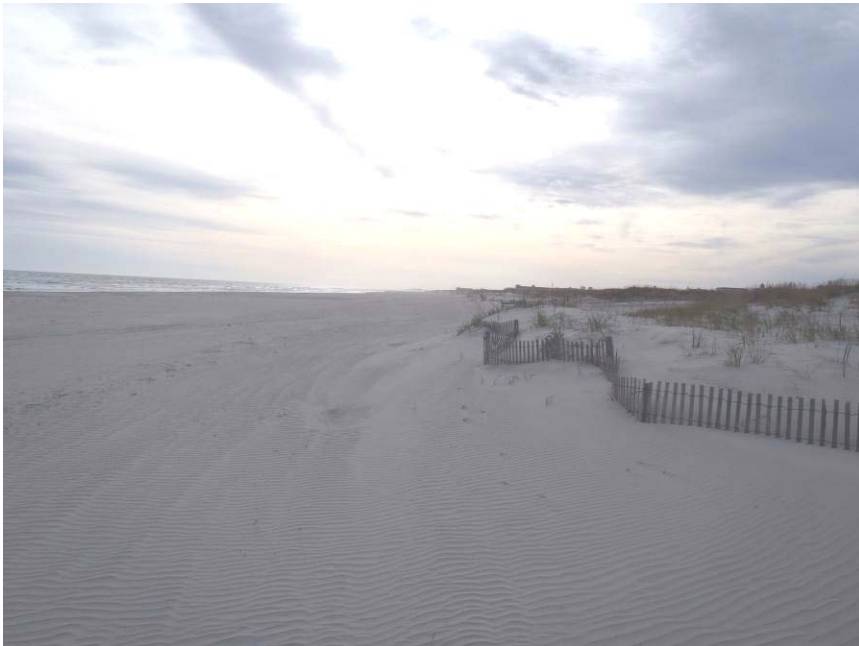
9a. December 21, 2015

Photograph 9a shows the dune toe and beach conditions at the end of December 2015. The fence has accumulated sand and is nearly buried. The wide dry beach supports continued dune growth both as a source of sand and as a wave buffer.

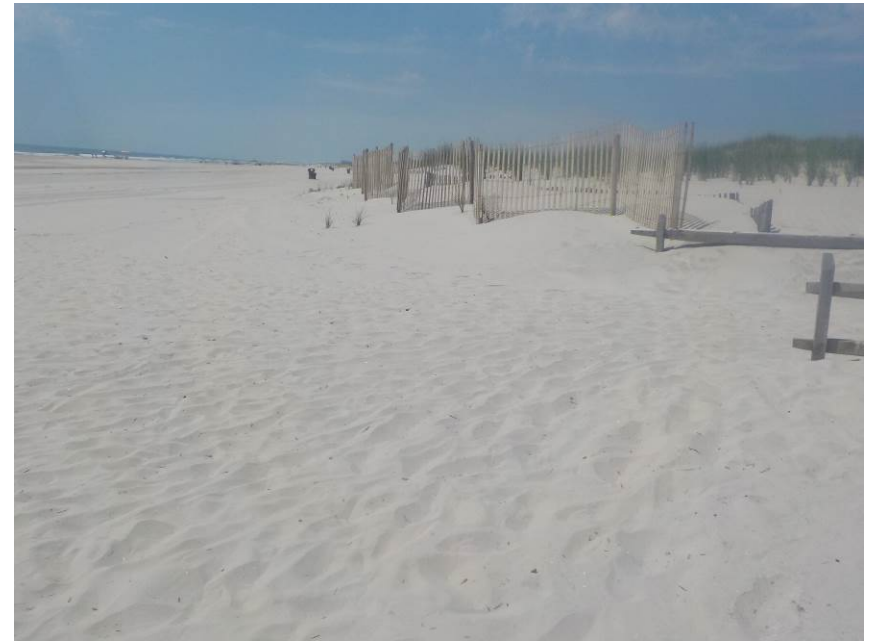
9b. June 19, 2016

Photographs 9a to 9c. 70th Street, views to the south along the dune toe.

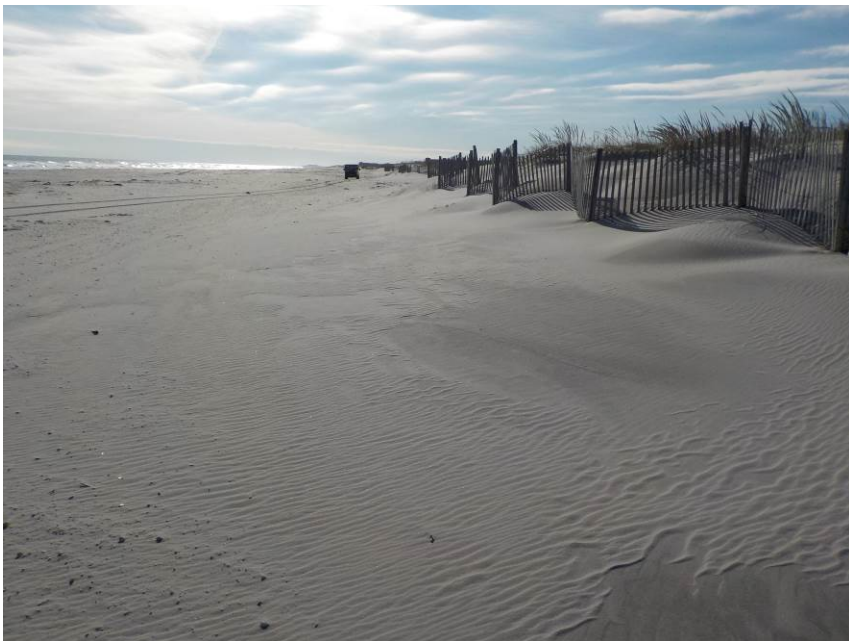
9c. December 19, 2016

View 9c shows the view to the south along the same fencing placed earlier in the year. By December 2016 it is half buried as dune growth continued.

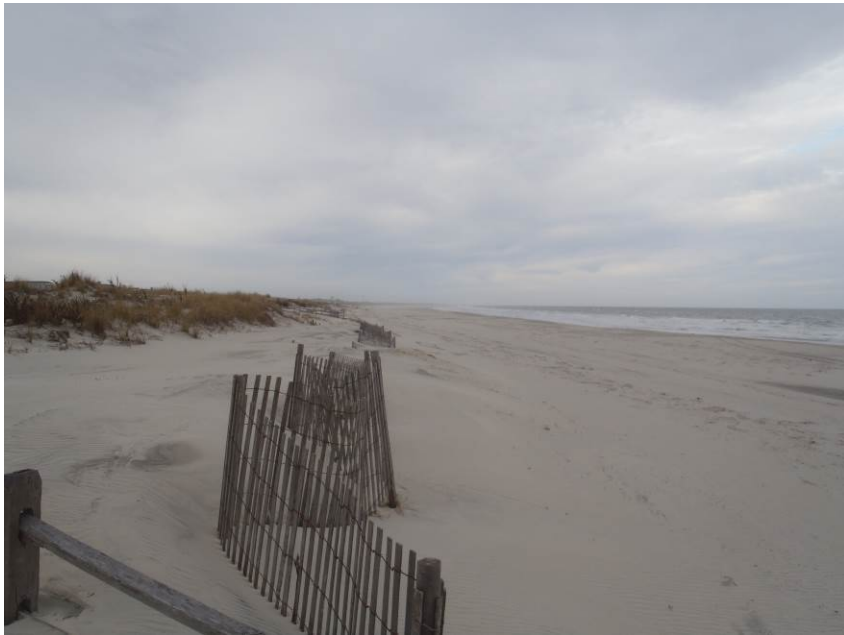
10a. December 21, 2015

Photographs 10a to 10c. 78th Street, views to the north.

Photograph 10a shows the dune and beach from near the beach access path. Sand has accumulated along the seaward fence line and the beach elevation and width are more typical of late summer/early fall.

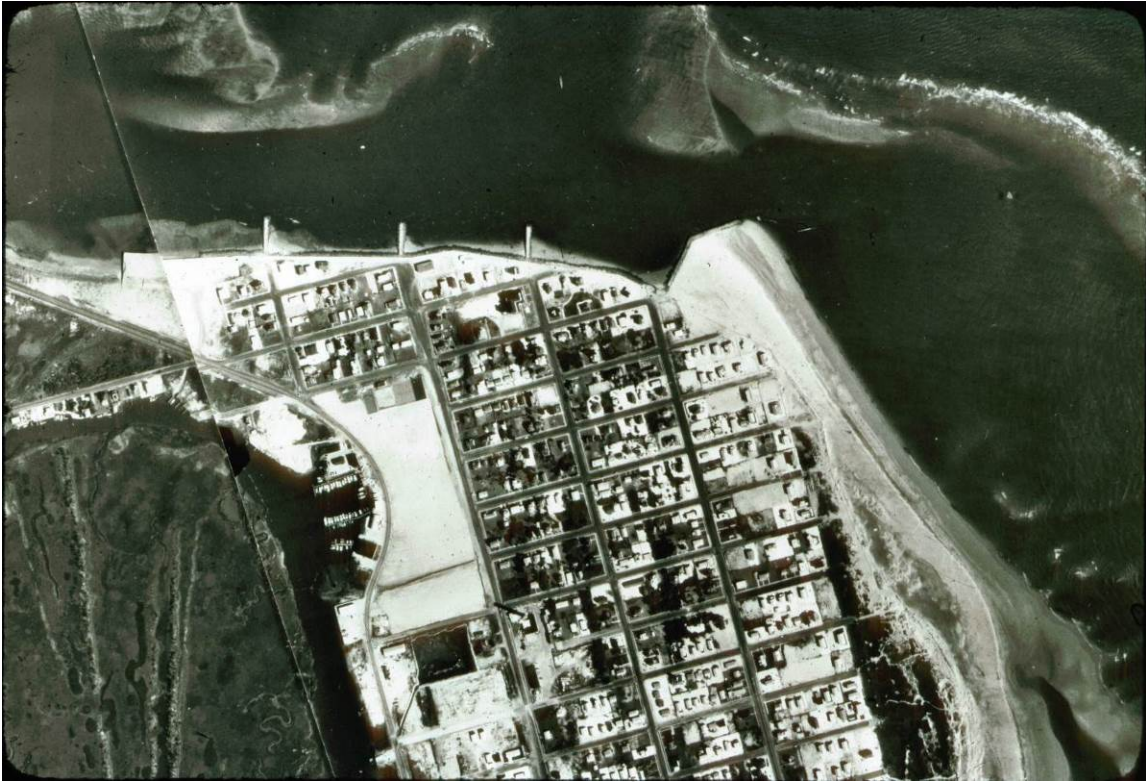
Figure 13. 1971 aerial photograph of Townsend's Inlet after construction of the 8th Ave. jetty, the rock revetment and 3 short finger groins in the inlet. The main channel lies next to the revetment with vast shoals exposed at low tide immediately northeast of the channel. Note that the seaward parts of the shoal wrap around the inlet mouth and contributed large slugs of sand to the beach lying between the jetty and 17th Street in Avalon. At this time there was a 465-foot wide vegetated dune system seaward of the end of 17th Street before reaching the dry, high tide beach. Flood tidal currents and storm wave action moved sand over the jetty into the inlet where the ebb-tidal currents carried it back out to the shoals for eventual return to the north end beach. A stable cycle of sediment was in place. The jetty was also lower in elevation and shorter so that sand did move back into the inlet from Avalon generating a feed-back loop process. Deposits of sand washed over the jetty or around it were rapidly re-positioned by the ebb-tidal currents to the offshore bar and eventually back onto the Avalon ocean beach.

Figure 13 on the previous page is an aerial photograph taken in 1971 that shows shoaling conditions and configurations ideal for sand bypassing and wave sheltering to the Avalon shoreline. This was included again in 2016 to demonstrate shoal conditions beneficial to Avalon. Sand shoals are emergent over a wide area in the ebb-tidal zone and form a crescent shape towards Avalon in this photograph. These shoal deposits have slowly disappeared due to excavation for beach restoration in both municipalities since 1978 and a diminished sand supply entering the system as the Ludlam Island beaches deteriorated. With the introduction of sand to Ludlam Island from offshore in 2015 and 2016, long shore transport from project beaches should restore larger ebb-tidal shoal deposits that may, hopefully, duplicate these pre-1978 situation.
