**FINAL REPORT FOR 2017
ON THE CONDITION OF THE MUNICIPAL OCEANFRONT BEACHES
THE BOROUGH OF AVALON, CAPE MAY COUNTY, NEW JERSEY**

**PREPARED FOR: THE BOROUGH OF AVALON
3100 DUNE DRIVE
AVALON, NJ 08202**

**PREPARED BY: THE STOCKTON UNIVERSITY COASTAL RESEARCH CENTER
30 WILSON AVENUE
PORT REPUBLIC, NEW JERSEY 08241**

**ANNUAL REPORT FOR 2017 - TO THE BOROUGH OF AVALON
ON THE
CONDITION OF THE MUNICIPAL BEACHES**

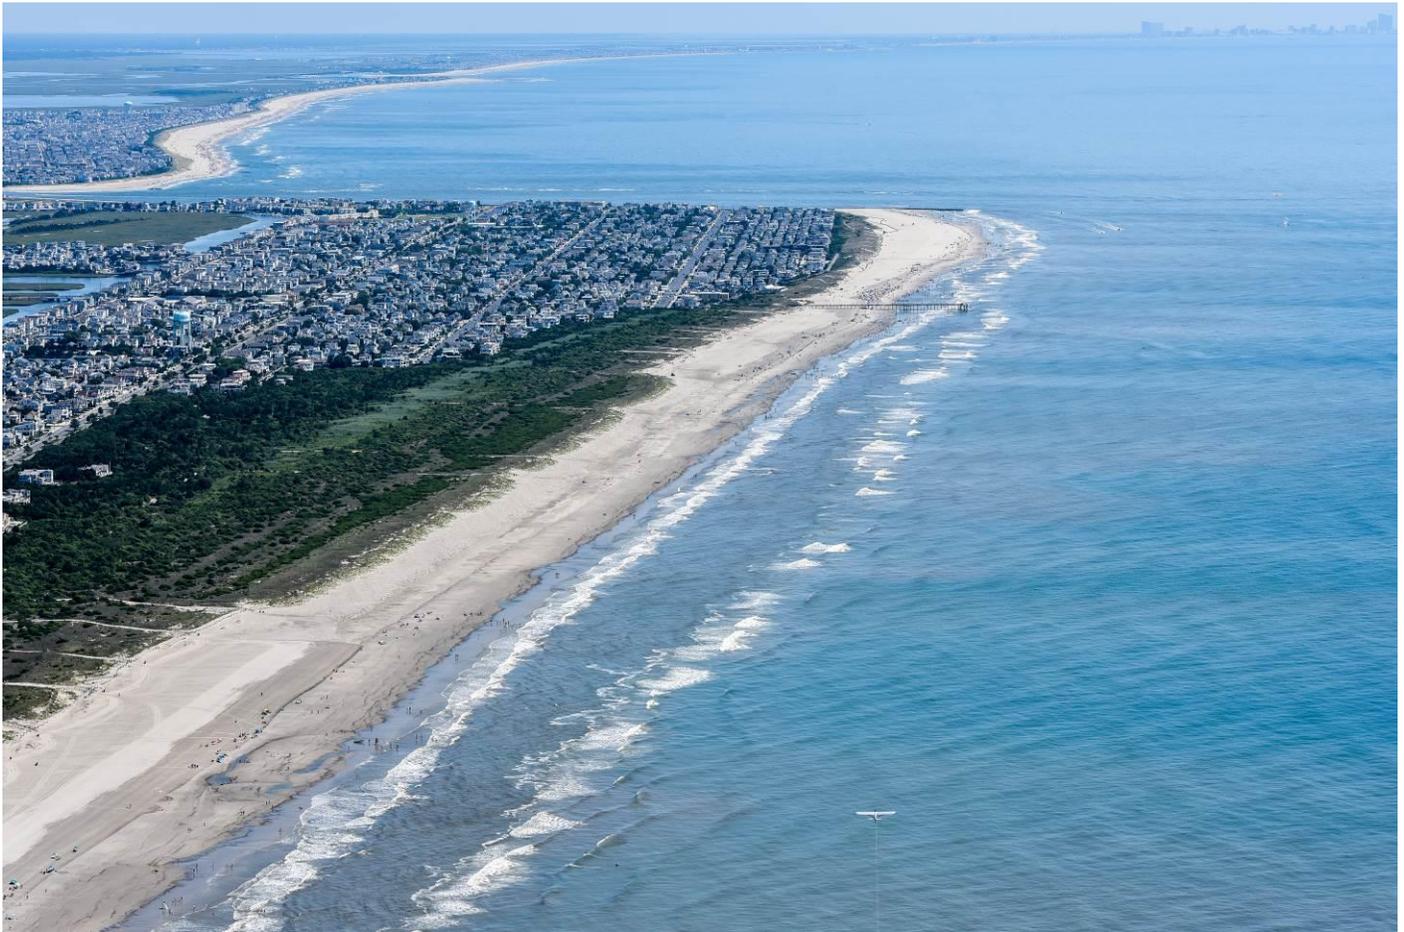
View of the Avalon oceanfront July 2, 2017 following the US Army Corps of Engineers maintenance beach nourishment put between 9th and 26th Streets restoring the project to the initial design specifications. The view also illustrates the 100-acre dune park that is unparalleled as a municipally-owned open space on the mid-Atlantic coastline (photo by Ted Kingston for the CRC). The origin of the offshore bar system just north of the fishing pier is a possible answer to where the beach nourishment sand migrates to as the wave climate chronically redistributes it away from 9th to 26th Street beaches.

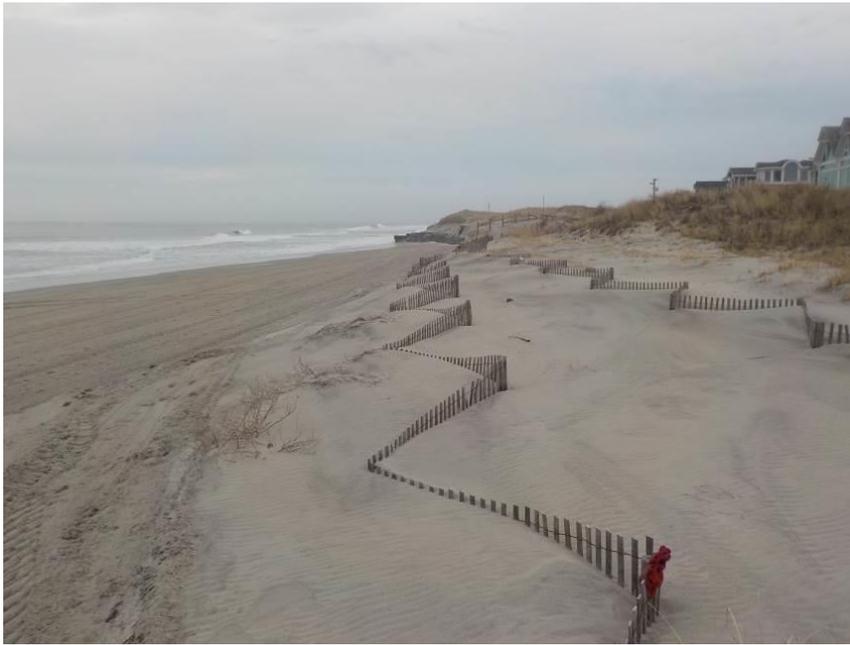
1a. January 20, 2017

View 1a shows the beach and seaward dune slope prior to sand placement in 2017. The dry beach is very narrow with wrack material deposited at the dune toe indicating storm wave run-up reached the fence line. However, from 10th Street south the revetment was exposed.

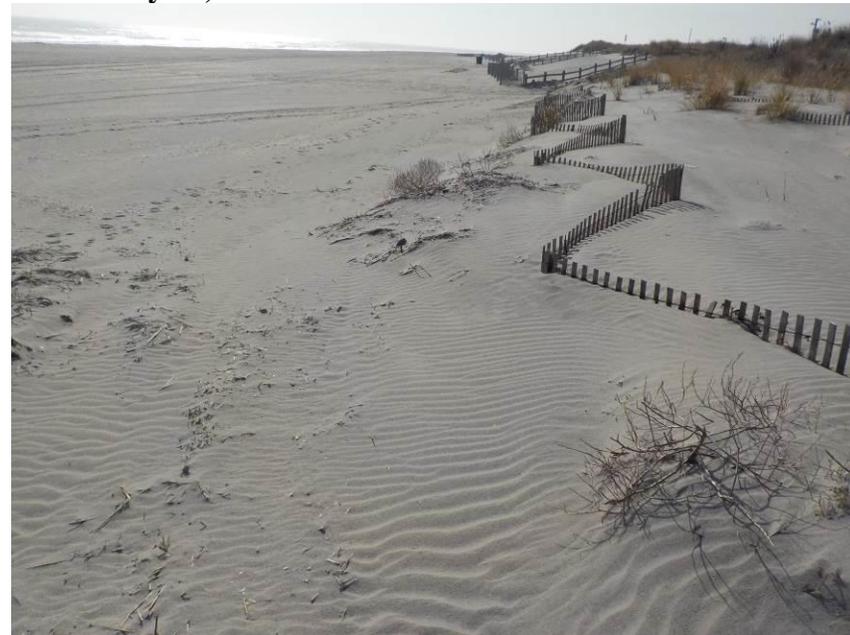
1c. December 4, 2017

View 1c This view from early December shows that the majority of the sand was still present, but loss commenced between the September and December surveys (-47.99 yds³/ft.). The shoreline retreated 73 feet.

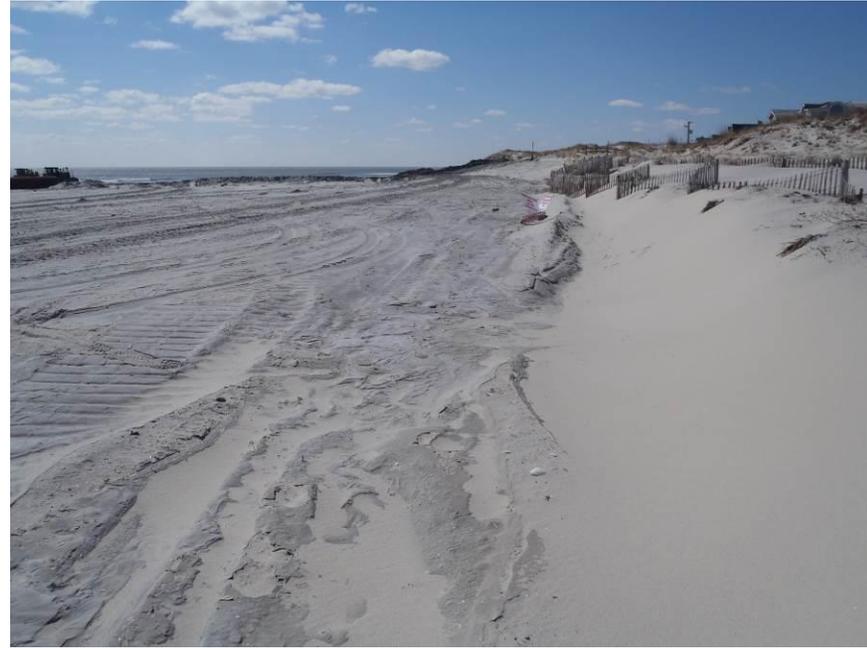
1b. March 16, 2017

View 1b was taken in March as the beachfill was underway. The width of the dry beach is now several hundred feet wider. The project proceeded south, finishing in May.

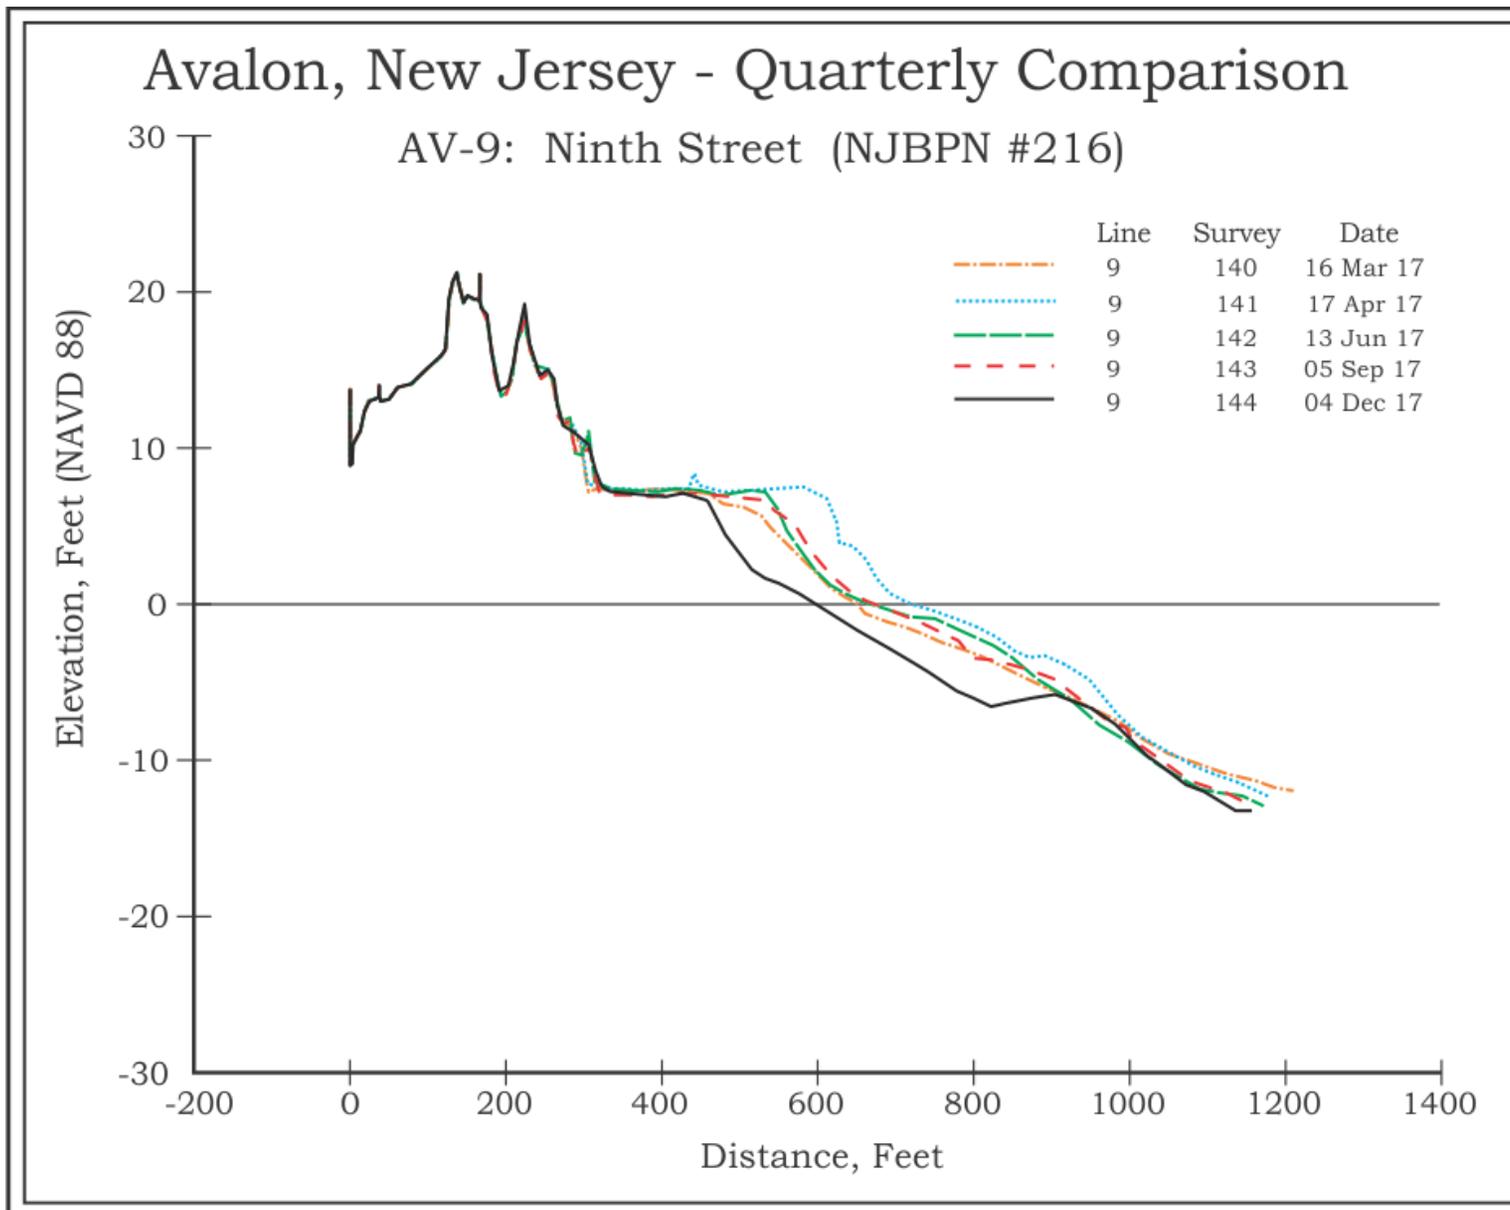
Figure 1. At 9th Street the CRC has provided five cross sections to reflect the conditions as the beach restoration had taken place as of March 16, 2017, followed by a final profile from April. There was adjustment by June with the next six months showing little change up until September 2017. By the December survey, sand had moved seaward forming a bar approximating the offshore slope present earlier, but with an erosional trough between the berm and a point 400 feet further seaward.

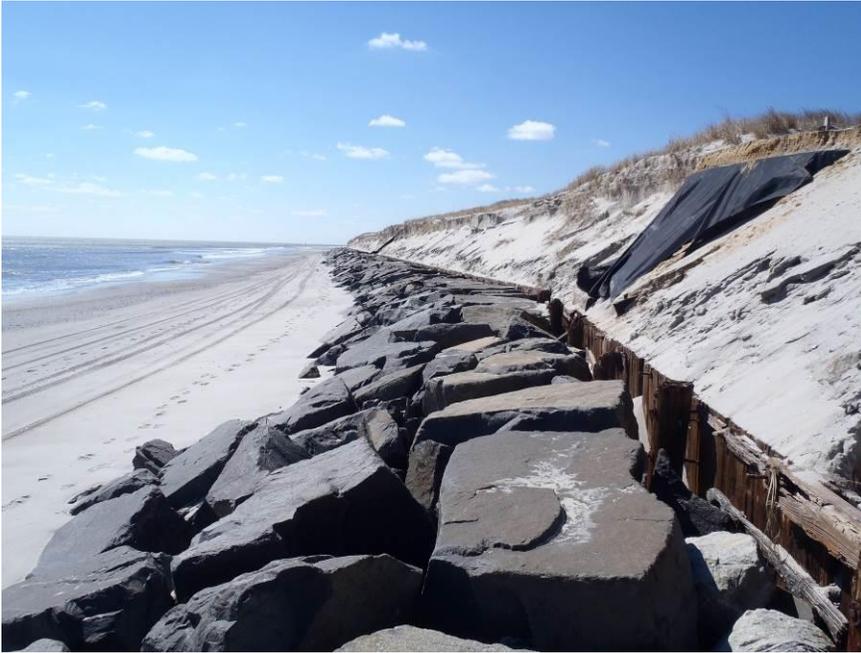
2a. March 16, 2017

View 2a shows 12th Street following the winter just prior to the onset of the federal beach project. Some dune loss occurred above the timber bulkhead and the beach was passable at low tide.

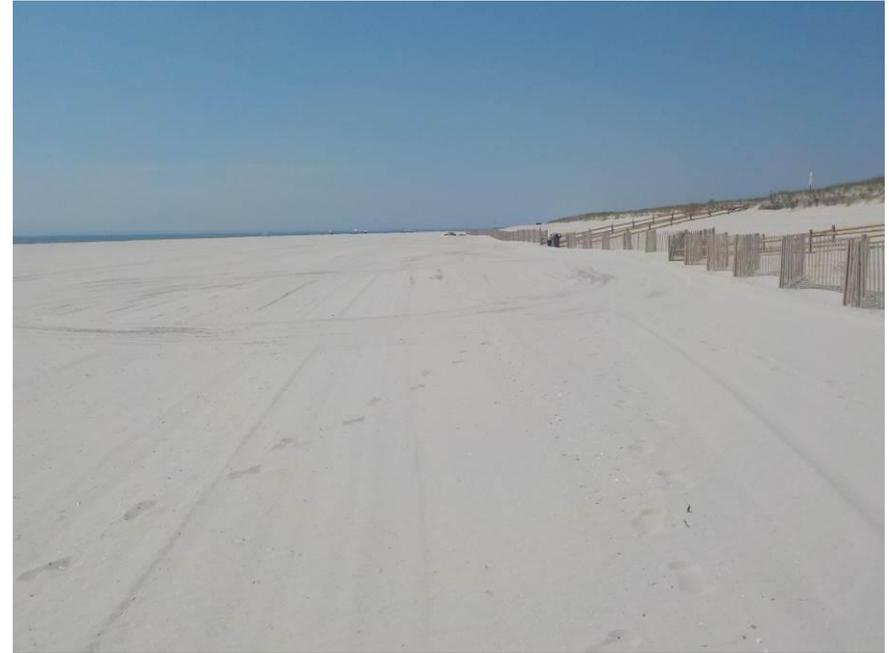
2b. June 13, 2017

View 2b was taken following completion of the federal project showing the 385-foot wide beach to the zero elevation position.

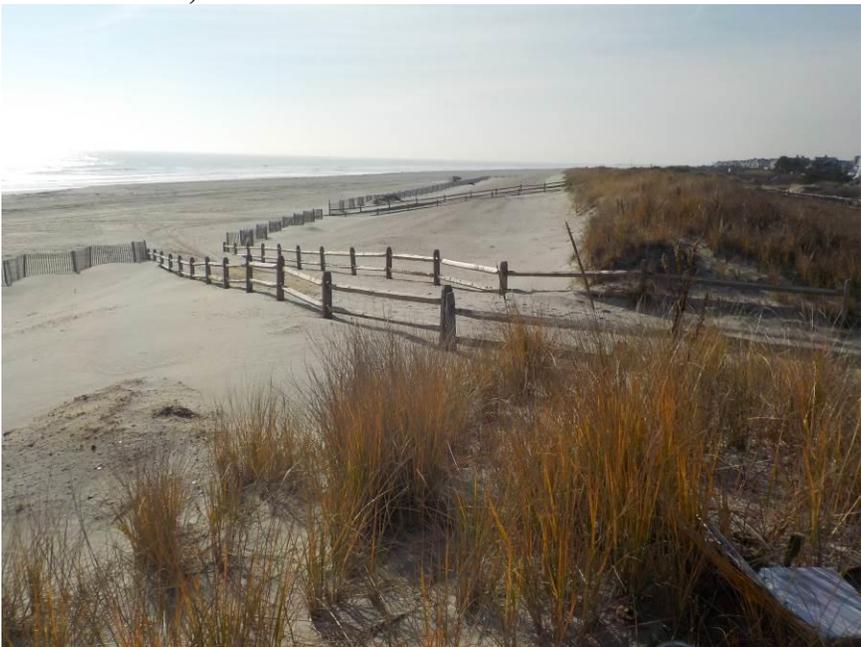
2c. December 4, 2017

View 2c was taken after some minor northeast events with a total shoreline retreat of 120 feet and sand losses totaling 100.91 yds³/ft. from June to December.

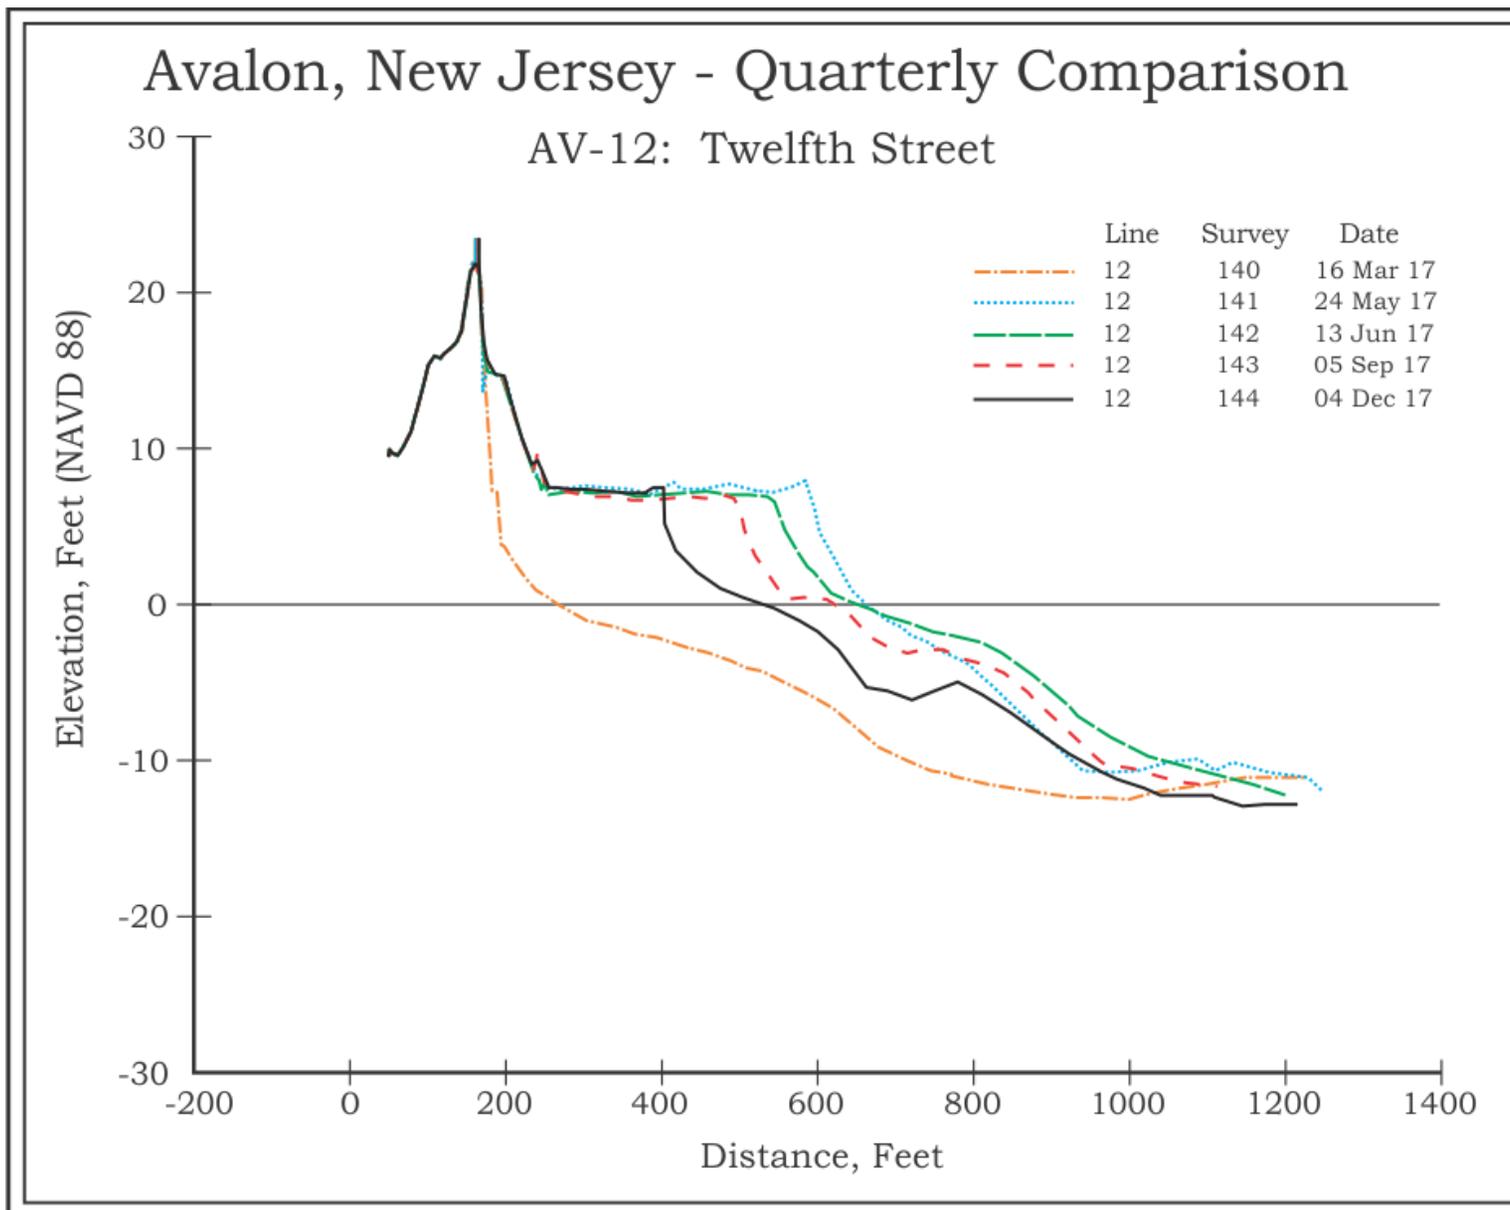
Figure 2. The initial survey of 2017 started at the revetment rocks and showed that the beach was wet at low tide to the rocks. The May survey defined the widest berm. The net change in beach sand volume during the May to June period was relatively small in spite of a berm becoming less steep. Sand moved seaward adjusting the profile slope. Between June and September loss did occur (-39.20 yds³/ft.), a problem that accelerated by December 4, 2017 (-57.64 yds³/ft.). These losses were not substantially storm driven due to low storm frequencies and low intensity of individual events.

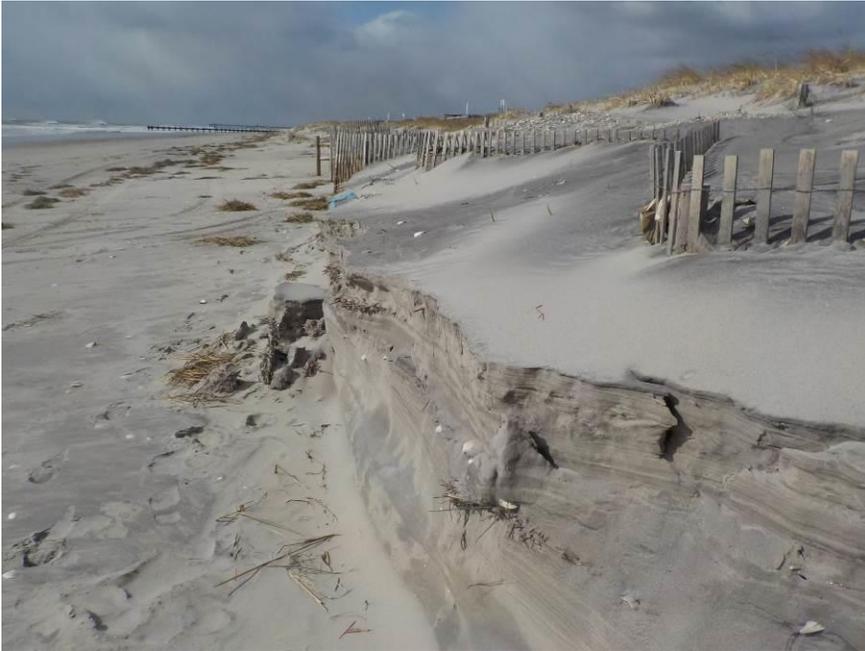
3a. March 15, 2017

View 3a shows that storm damage has impacted the seaward dune toe leaving a 3-foot scarp. While the rocks remained buried, exposure was seen two city blocks to the north.

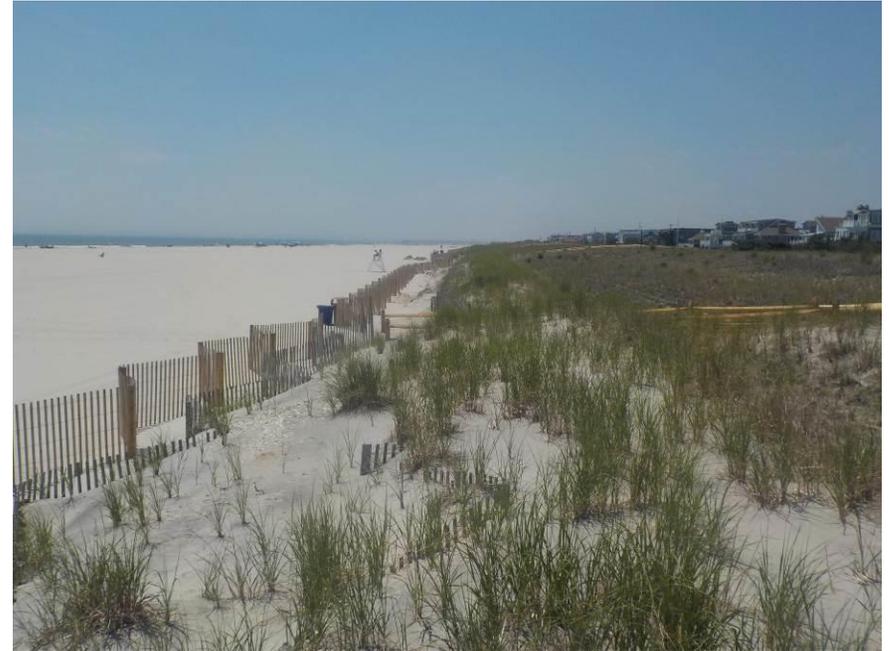
3b. June 13, 2017

View 3b Following the beach restoration, this view to the south shows the wide beach and new sand in place as of June.

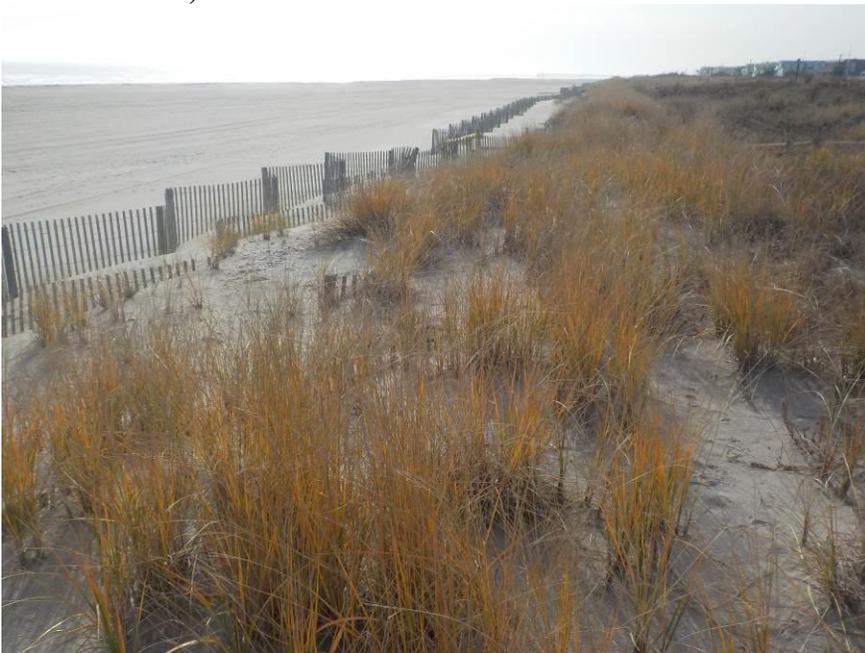
3c. December 4, 2017

View 3c The December view does not illustrate the berm retreat since the width remains substantial.

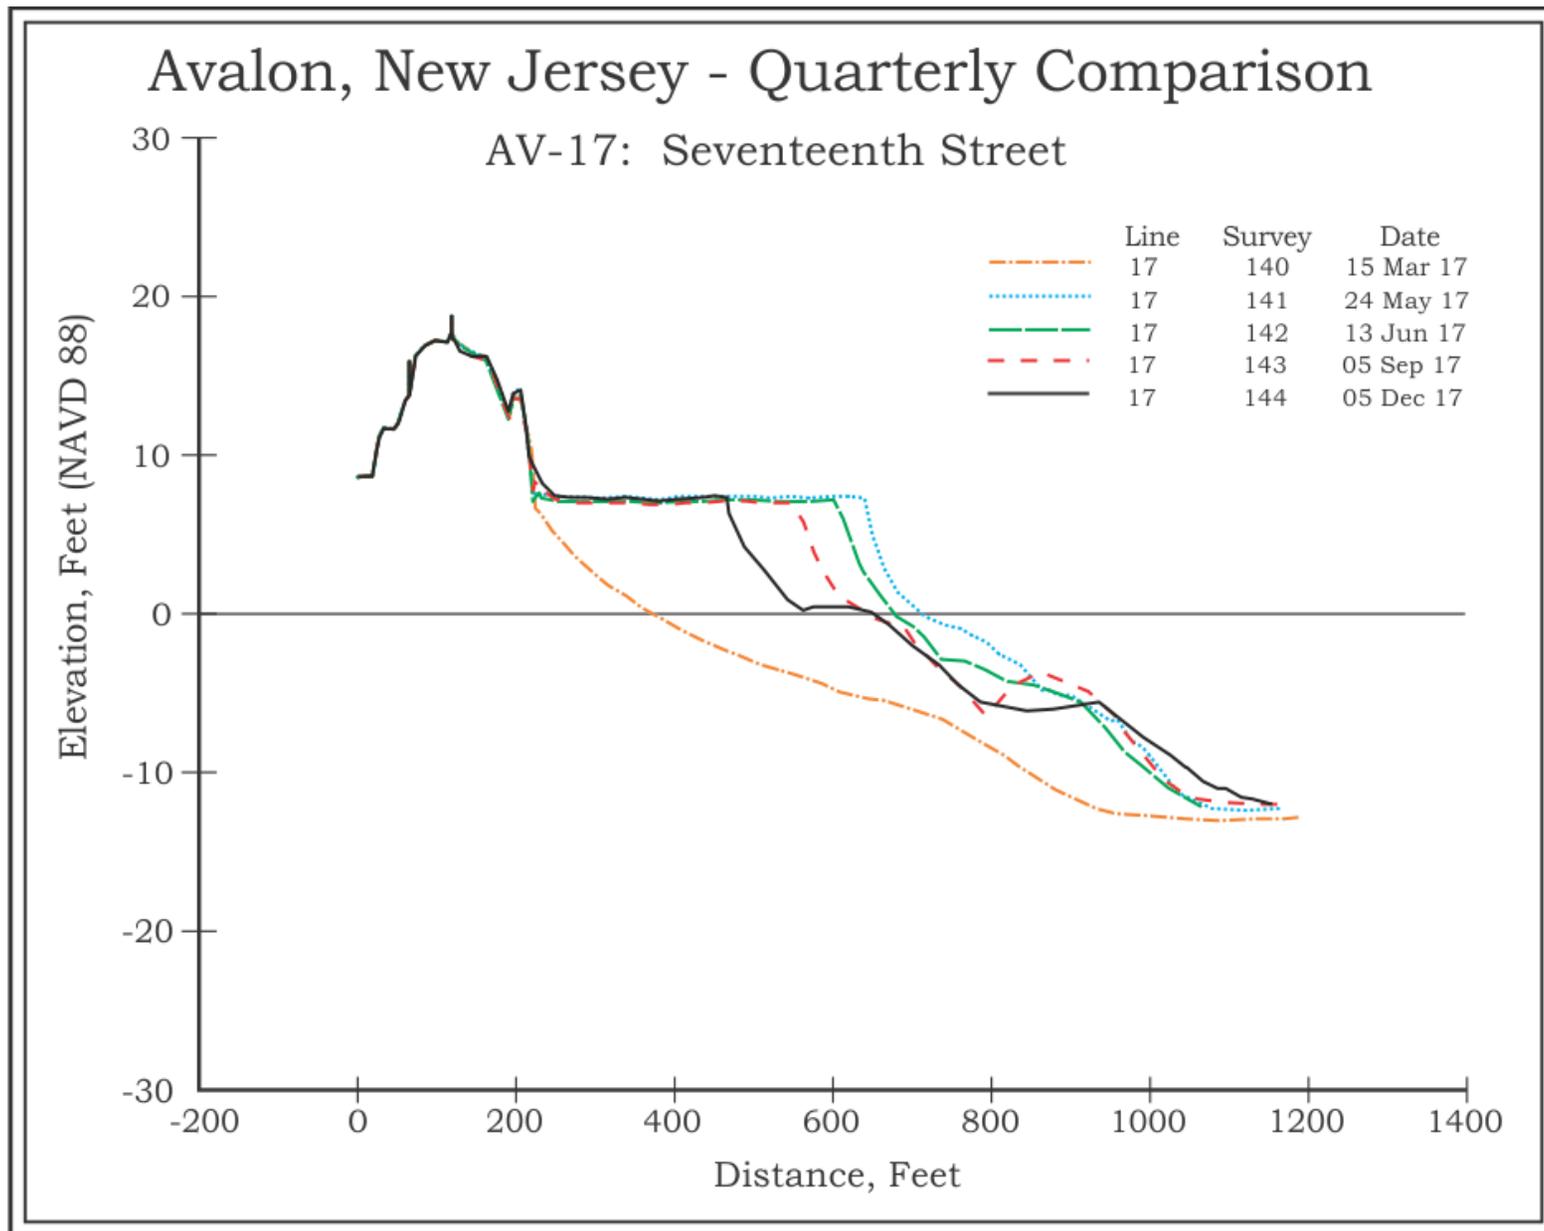
Figure 3. The five surveys show the dramatic process of adding a large volume of sand to the Avalon shoreline. The May cross section represents the maximum deposit that adjusted slowly to a more gentle slope during the summer. Between September and December erosion cut into the berm, but sand moved offshore leaving the zero elevation position practically the same as it was in May (-52 feet) Very little sand was moved seaward of the initial profile (May 2017). Lost sand volume moves south rather than offshore.

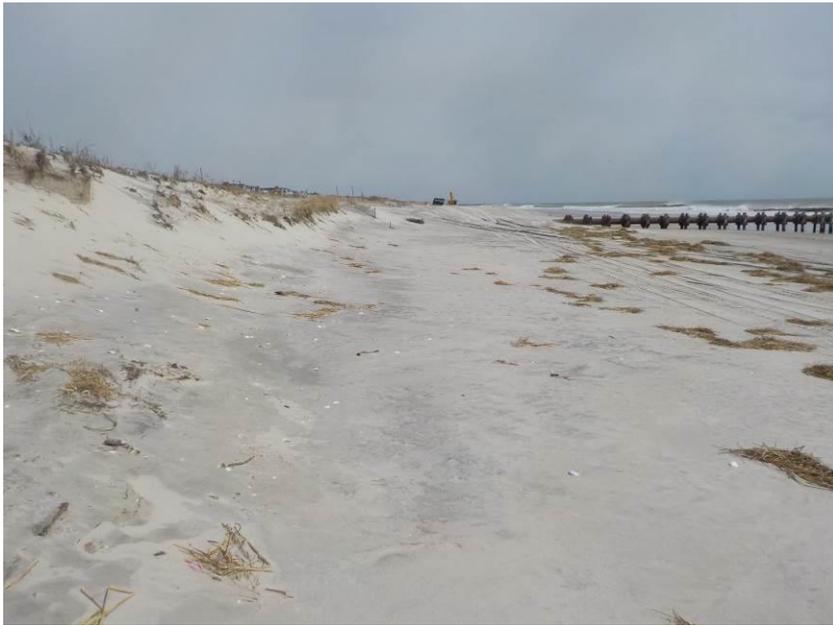
4a. March 15, 2017

View 4a shows the dune erosion at this site caused by winter storms. The stormwater outfall pipeline (distance) is exposed nearly to the dune and the beach is flattened and narrow.

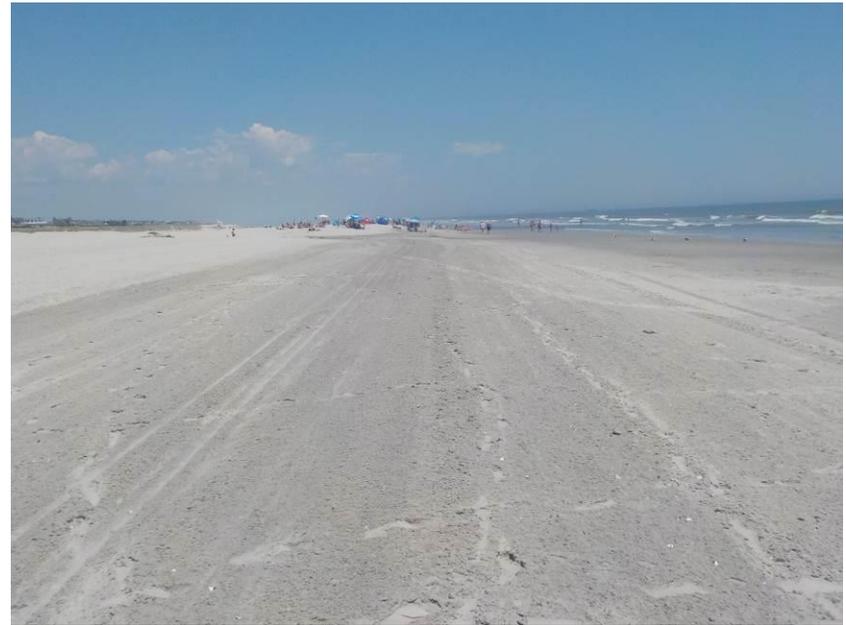
4b. June 13, 2017

View 4b was taken immediately following sand placement during the recent federal maintenance project. The storm pipeline is now buried again as the restored beach extends to the outfall end. Sand also accumulated along the toe of the dune scarp.

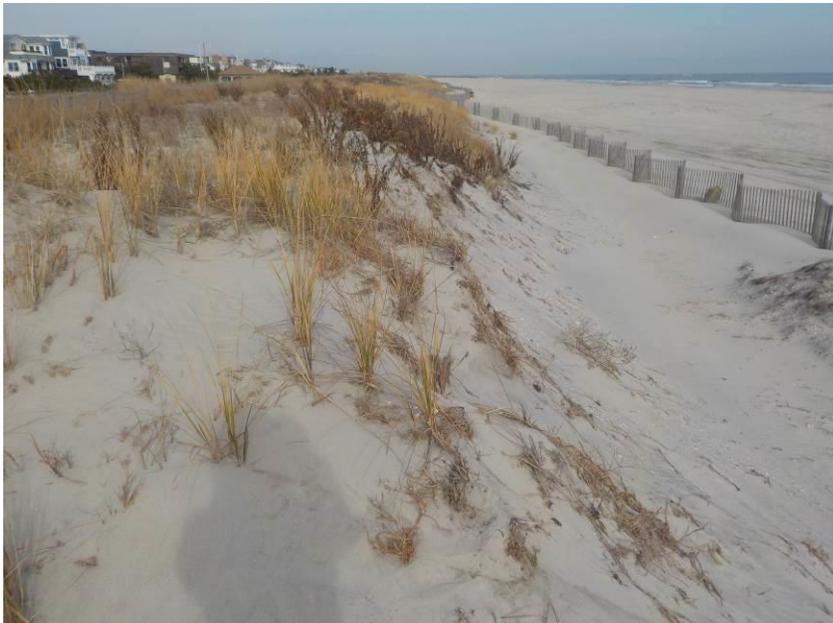
4c. December 4, 2017

View 4c was taken in late fall, showing the new fencing with minor accumulated sand. The stormwater pipeline remains buried.

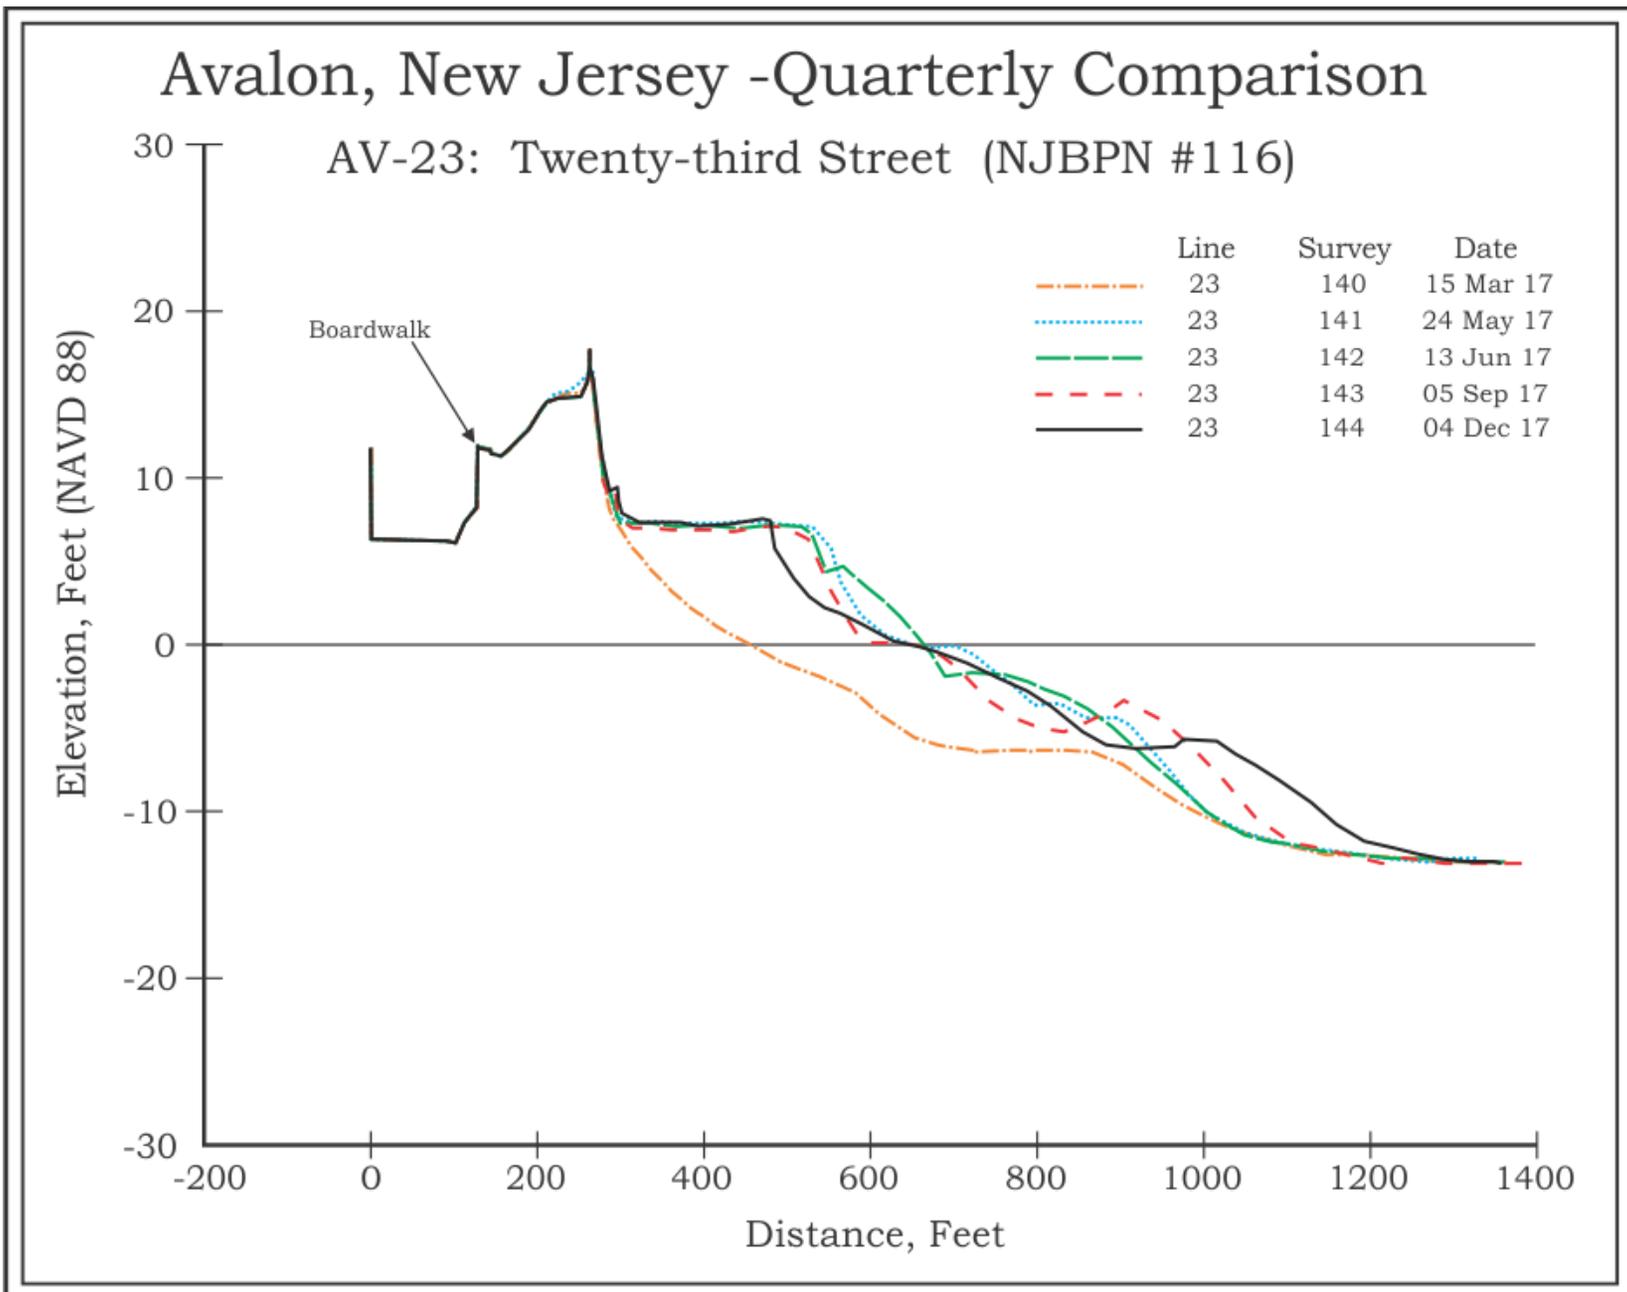
Figure 4. The impact of the 2017 federal maintenance work shows dramatically between March and May of 2017. Adjustments since have resulted in sand deposited offshore creating a bar system while minor retreat occurred in the berm. This site is presently the nodal area between erosion to the north and deposition to the south along the Avalon coast.

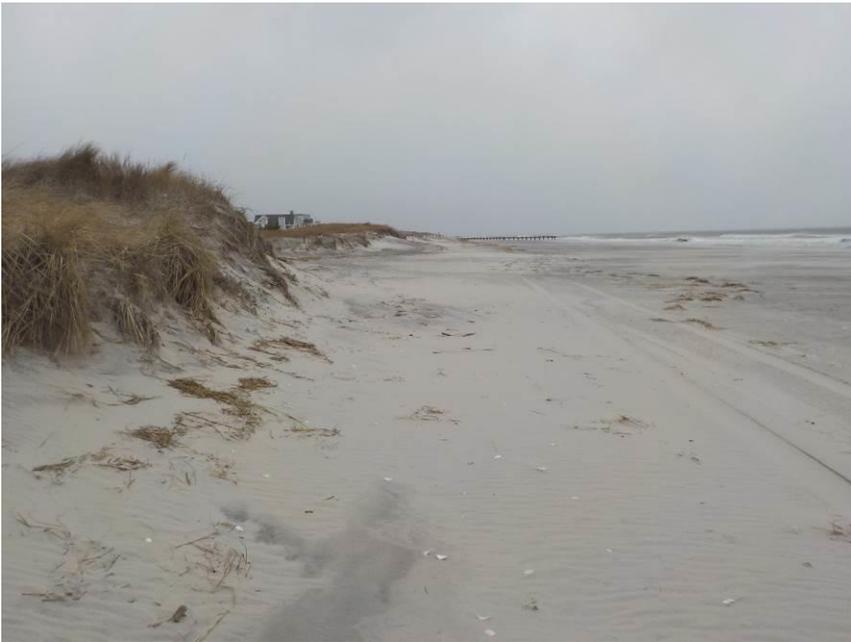
5a. March 15, 2017

View 5a was taken prior to federal beach work reaching the area as can be seen in the far distance where the 21st Street stormwater pipeline can be seen.

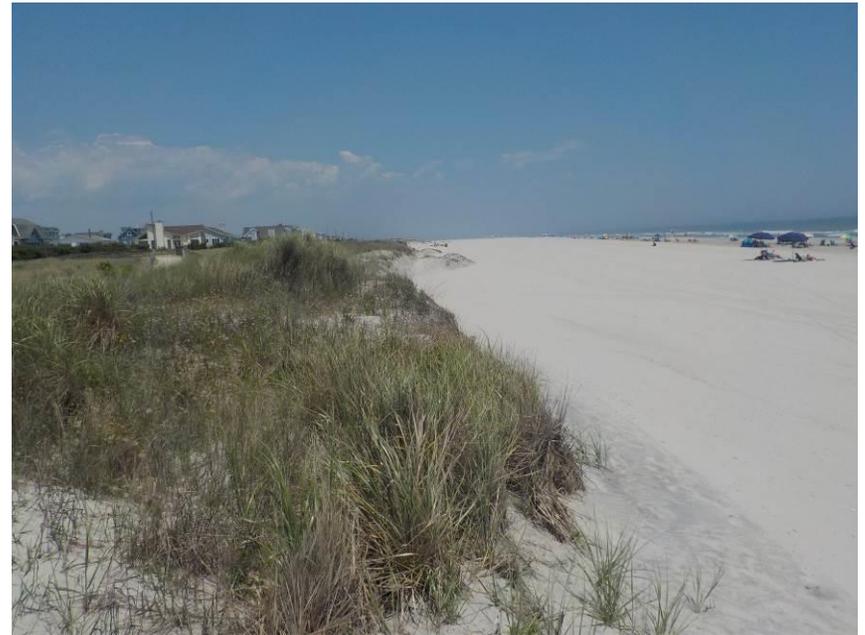
5b. June 13, 2017

View 5b shows the 28th Street beach following sand being added as far south as 23rd Street, but not directly on this beach.

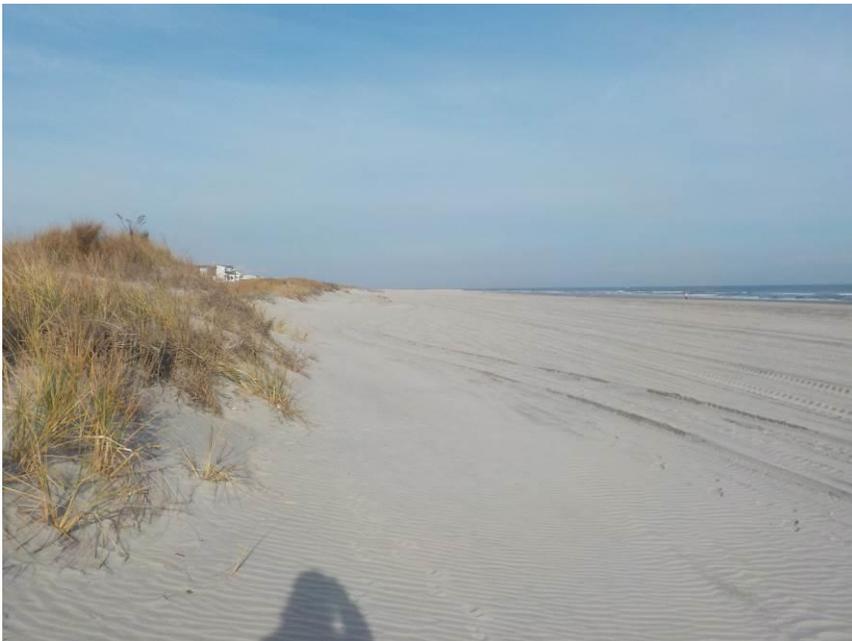
5c. December 4, 2017

View 5c is a view December 4, 2017. No sand fencing has been installed as yet, but the dune toe shows evidence of wind transport into the immediate vicinity of the dune grass.

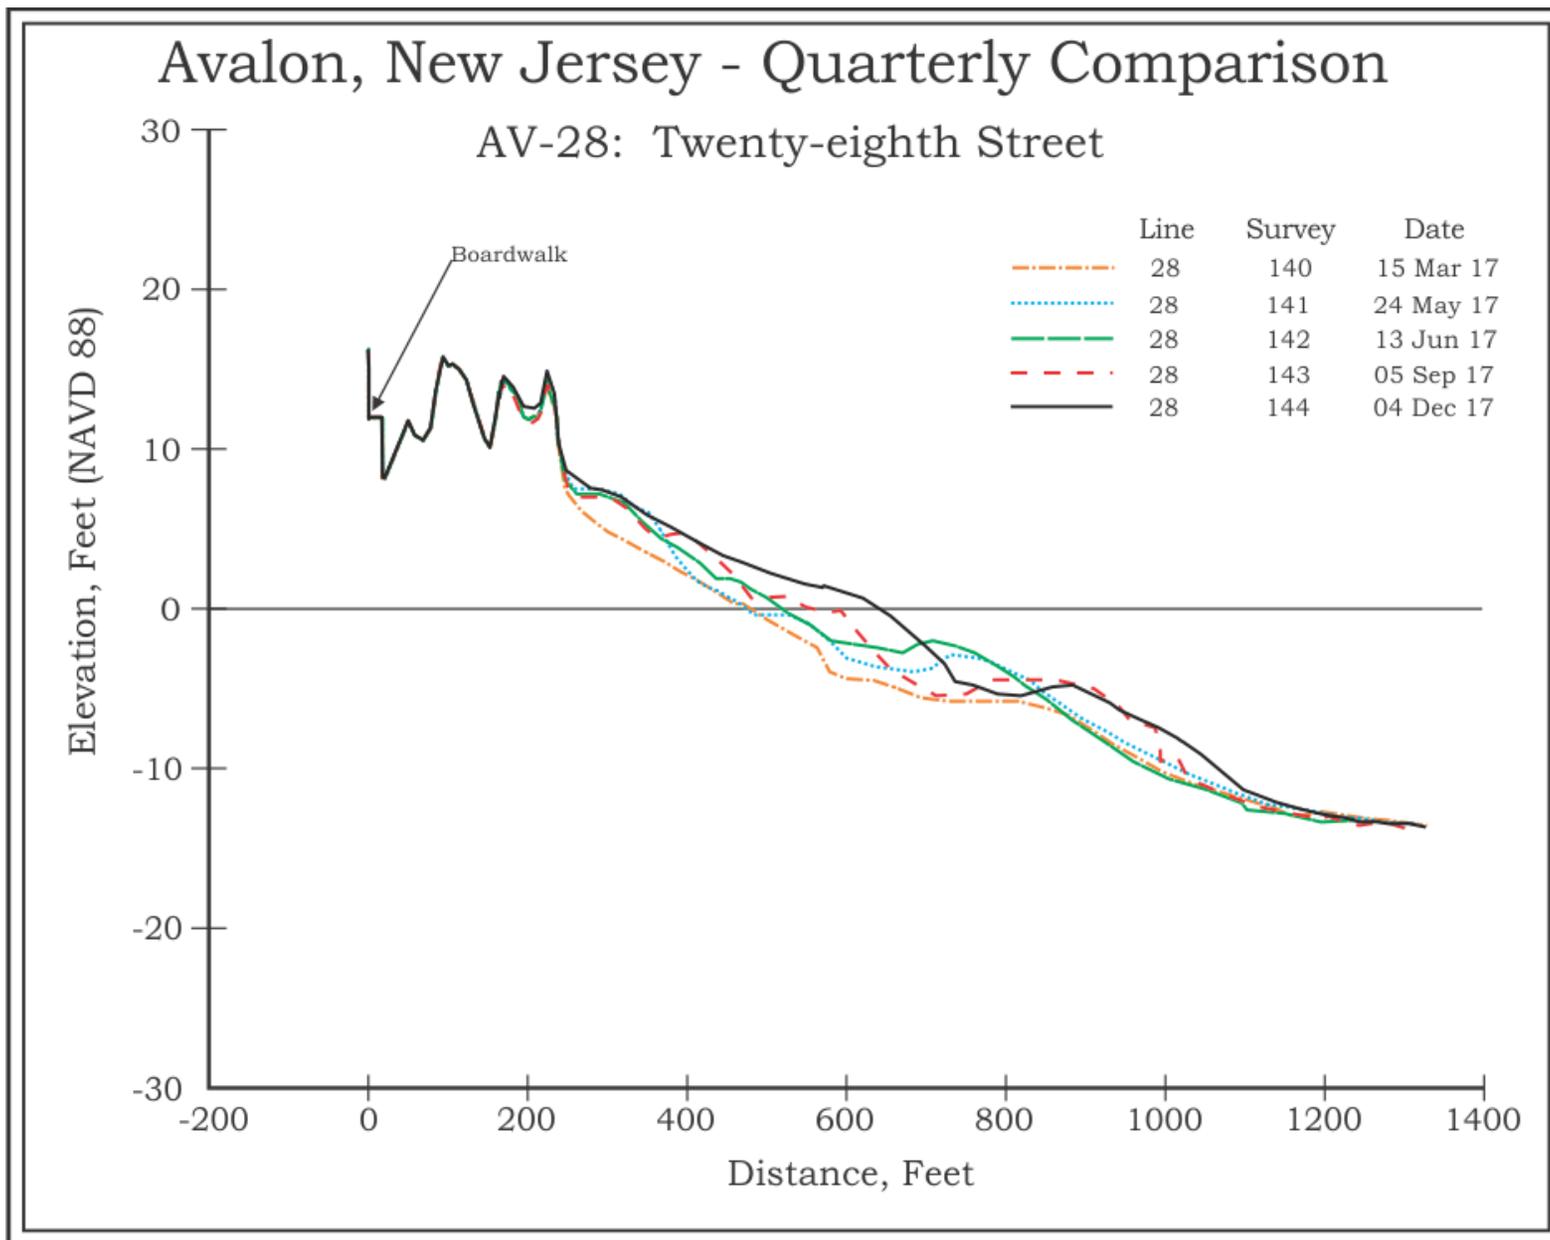
Figure 5. The 28th Street site was deficient in sand as of March 2017, and material was not directly added to the site, but moved in rapidly as the federal project approached from the north. By May, a mound of sand had appeared at the toe of the dunes and was added offshore as a bar system. This bar grew larger and seaward by September. Sand also added to the beach raising its elevation over that seen in March. By December the site had gained 81.32yds³/ft. as the shoreline advanced 162 feet seaward. This represents a significant addition to the area's sand supply.

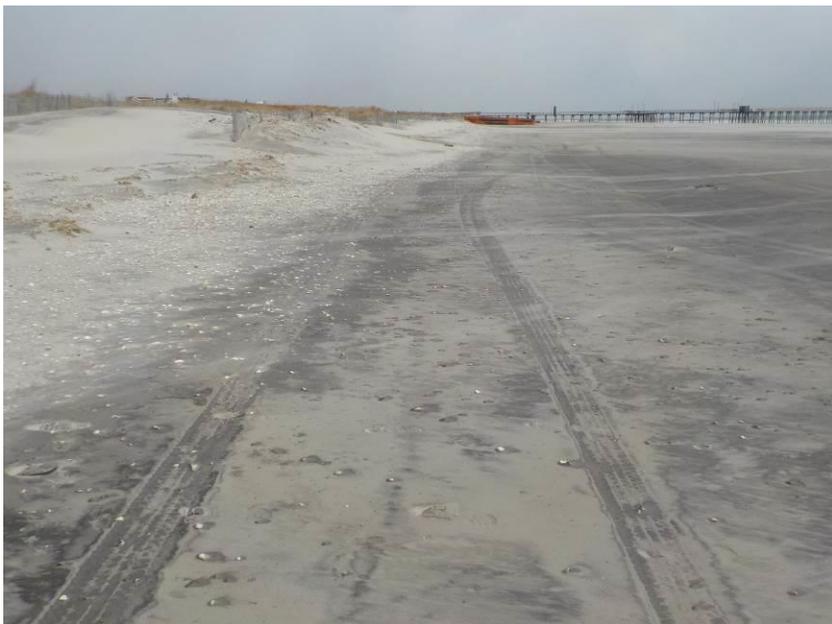
6a. March 15, 2017

View 6a shows the conditions following the winter of 2016-2017 where some wave action reached the dune toe but without damage.

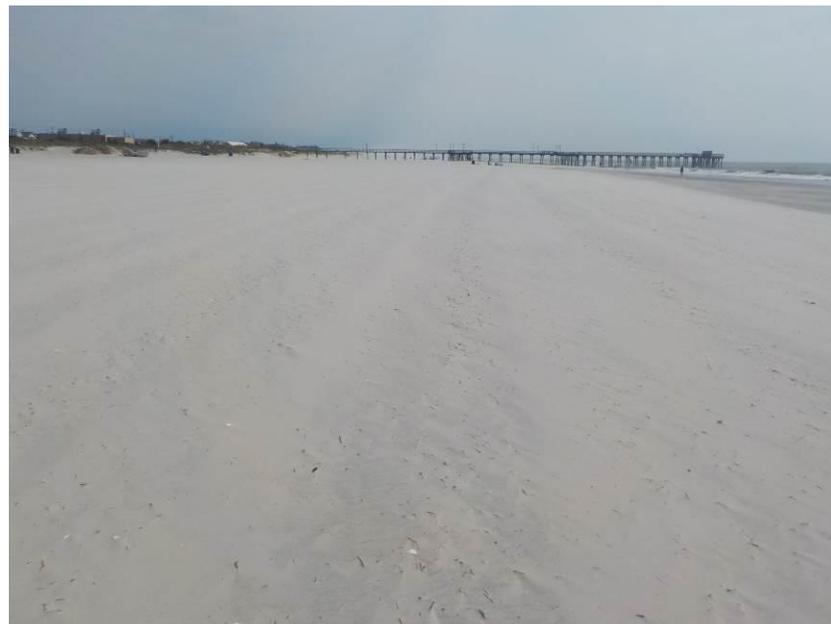
6b. June 14, 2017

View 6b photo taken in June 2017 shows deposition of a higher berm on the dry beach as summer got underway.

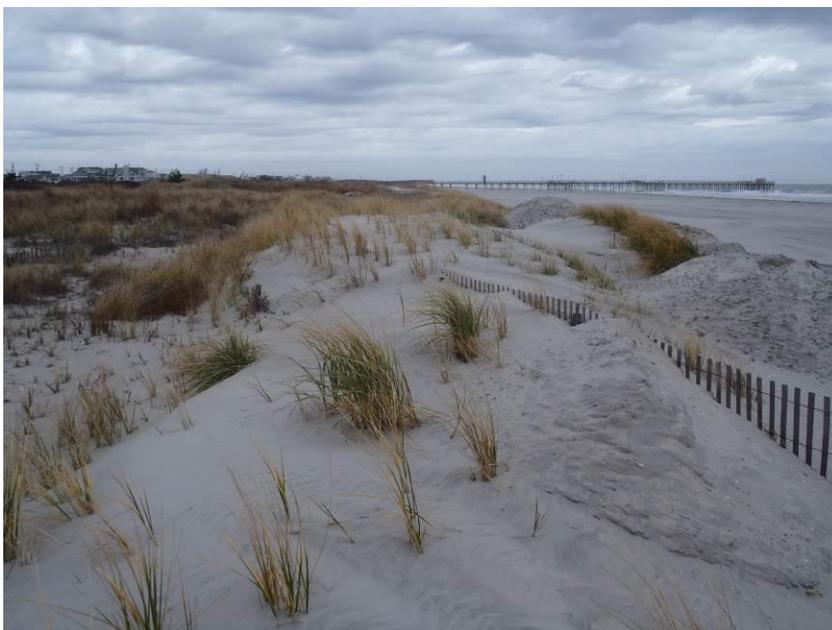
6c. December 5, 2017

View 6c was taken from the seaward dune crest across the outer dune field toward the newly extended Avalon fishing pier. The beach width is evident as sand moves in from the recent federal maintenance fill.
