**FINAL REPORT FOR 2017
ON THE CONDITION OF THE MUNICIPAL OCEANFRONT BEACHES
THE BOROUGH OF AVALON, CAPE MAY COUNTY, NEW JERSEY**

**PREPARED FOR: THE BOROUGH OF AVALON
3100 DUNE DRIVE
AVALON, NJ 08202**

**PREPARED BY: THE STOCKTON UNIVERSITY COASTAL RESEARCH CENTER
30 WILSON AVENUE
PORT REPUBLIC, NEW JERSEY 08241**

**ANNUAL REPORT FOR 2017 - TO THE BOROUGH OF AVALON
ON THE
CONDITION OF THE MUNICIPAL BEACHES**

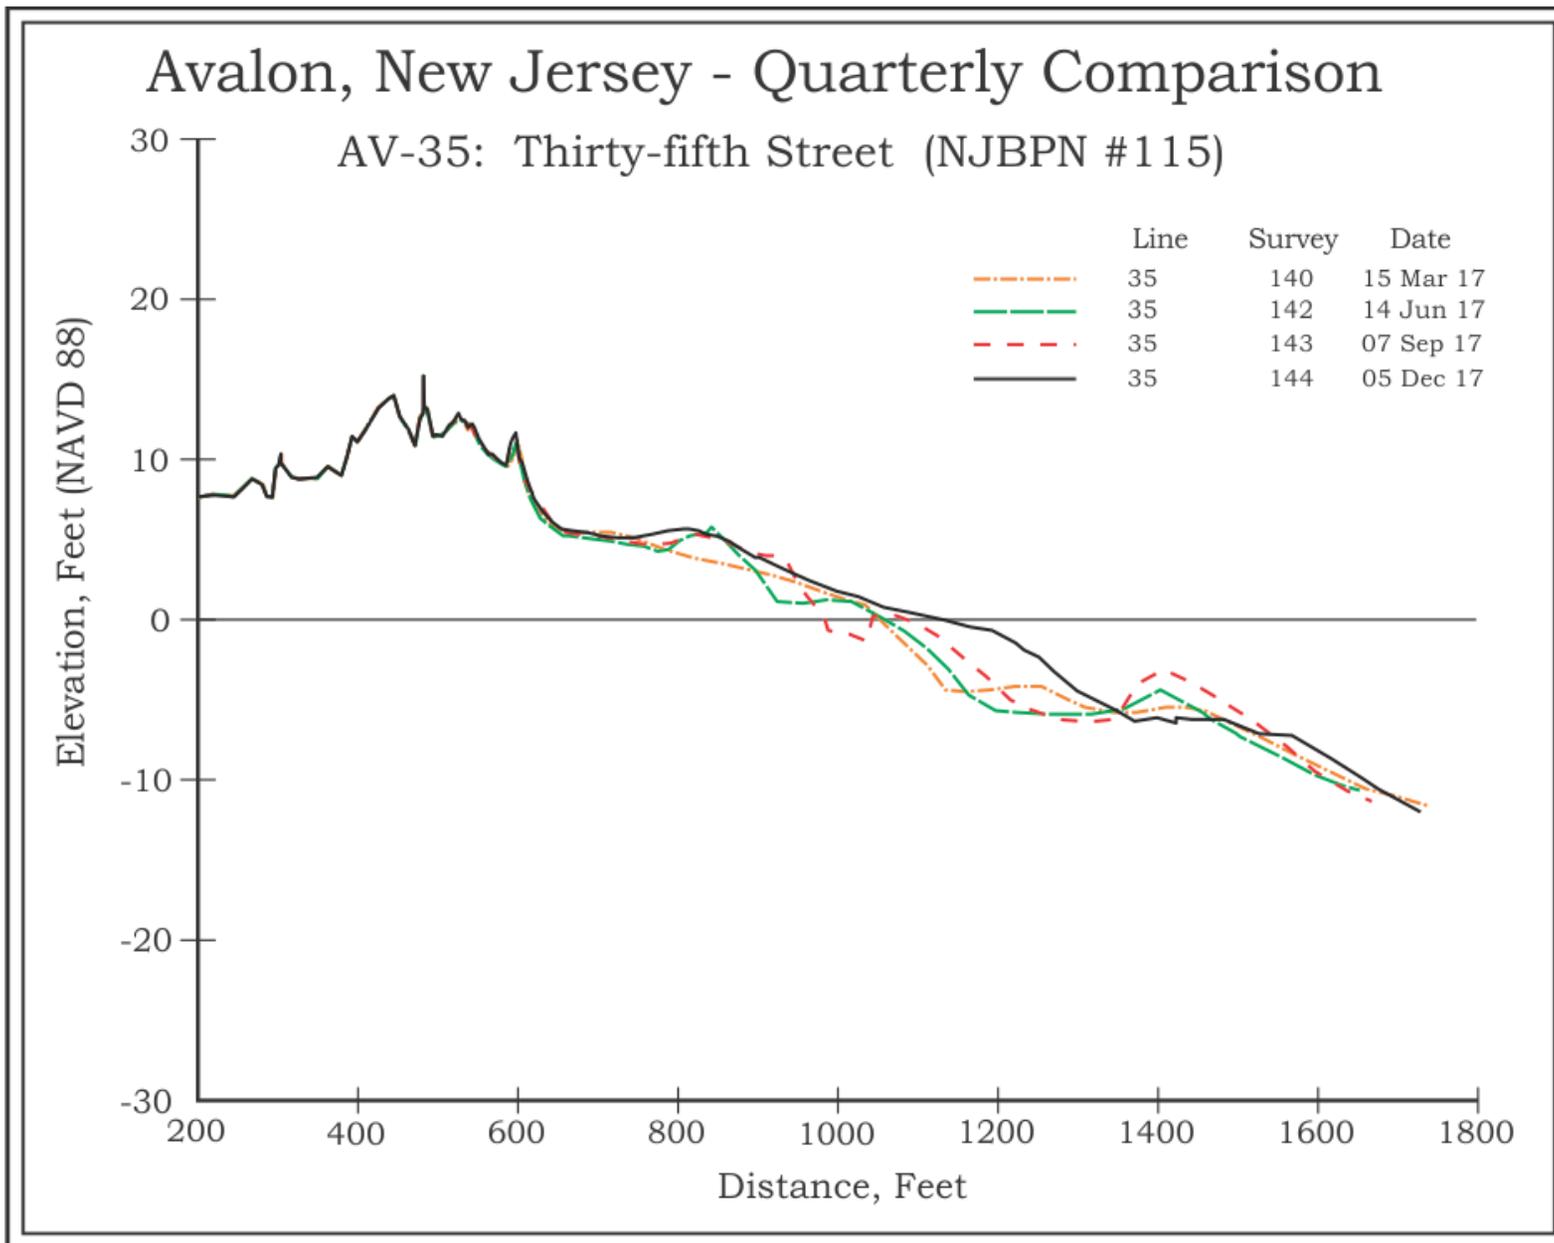
Figure 6. 35th Street is located centrally within an area accepted for sand harvesting for back pass operations. The beach since March 2017 has developed a significant berm and high beach where dune growth is favored. Offshore, the bar system added to the submerged part of the beachface slope creating a very wide berm at the close of 2017.

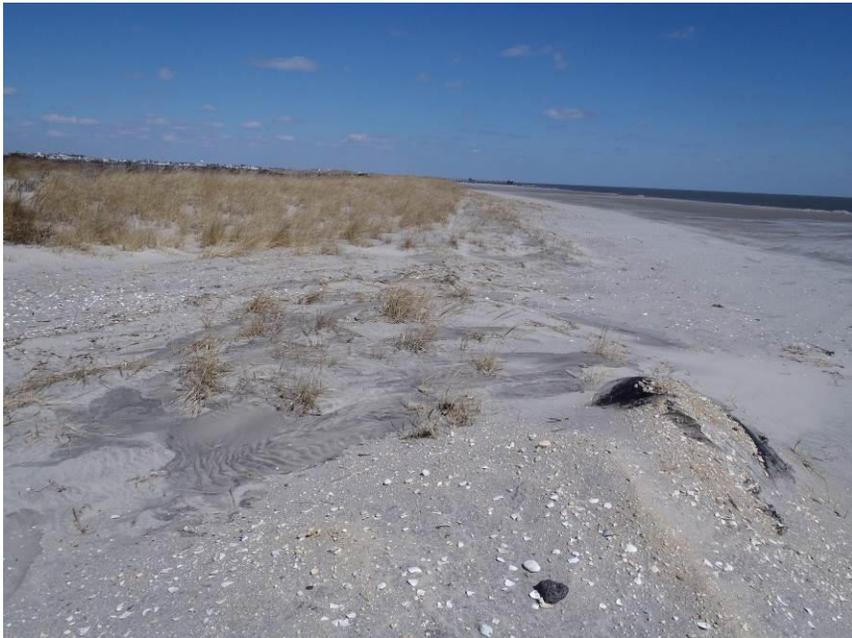
7a. March 16, 2017

View 7a is a view northeast across the foredune area and beach. Located within the exclusion zone rapid dune growth still occurs without dune fencing as the region continues to accumulate sand and the dune expands seaward through natural aeolian processes.

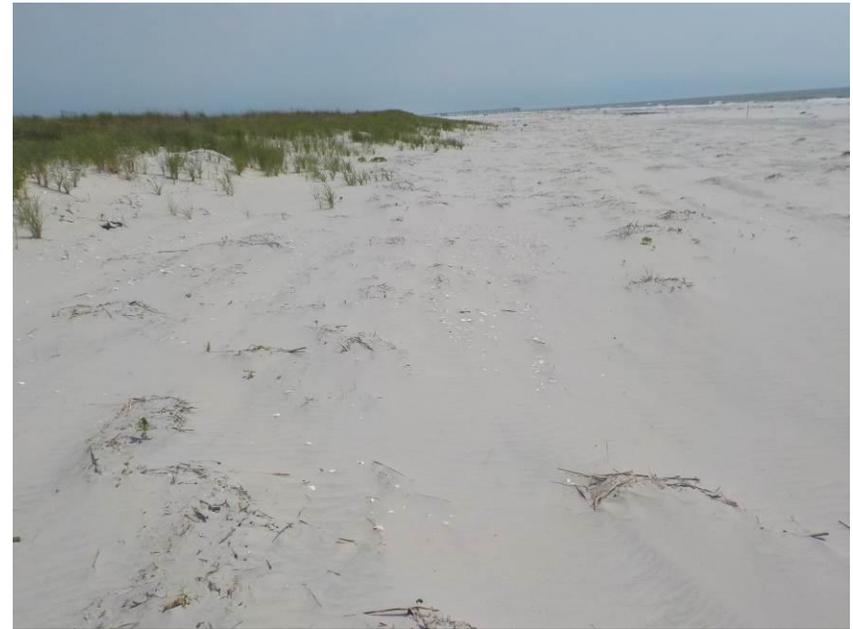
7b. June 14, 2017

View 7b is the same view in June, the dry beach is favored by piping plovers as are the sparser regions among the dune grass plants.

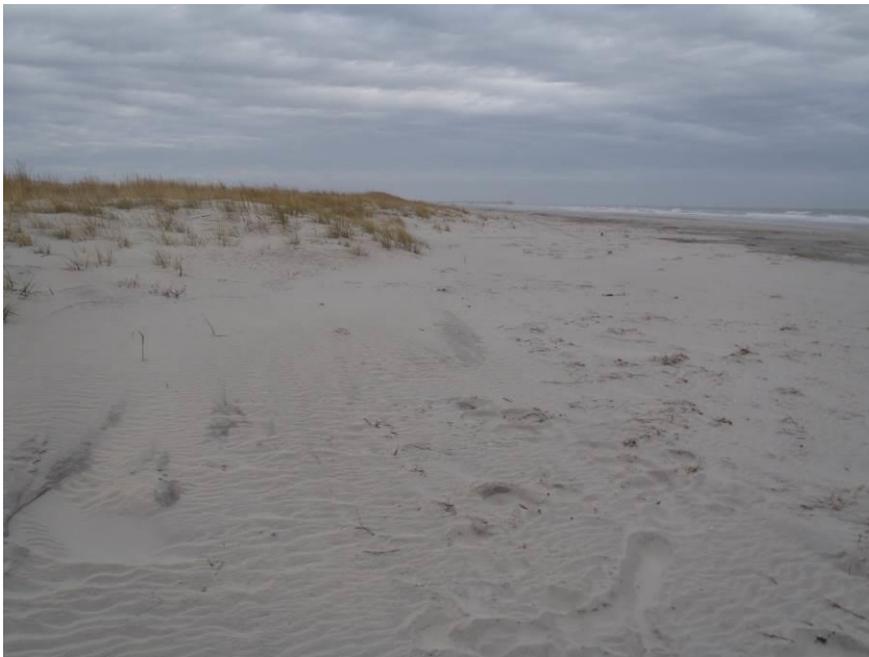
7c. December 5, 2017

View 7c shows the winter beach at the end of 2017 where the ocean waves have reached within 100 feet of the dune toe, but the width of the shore area prevents dune erosion.

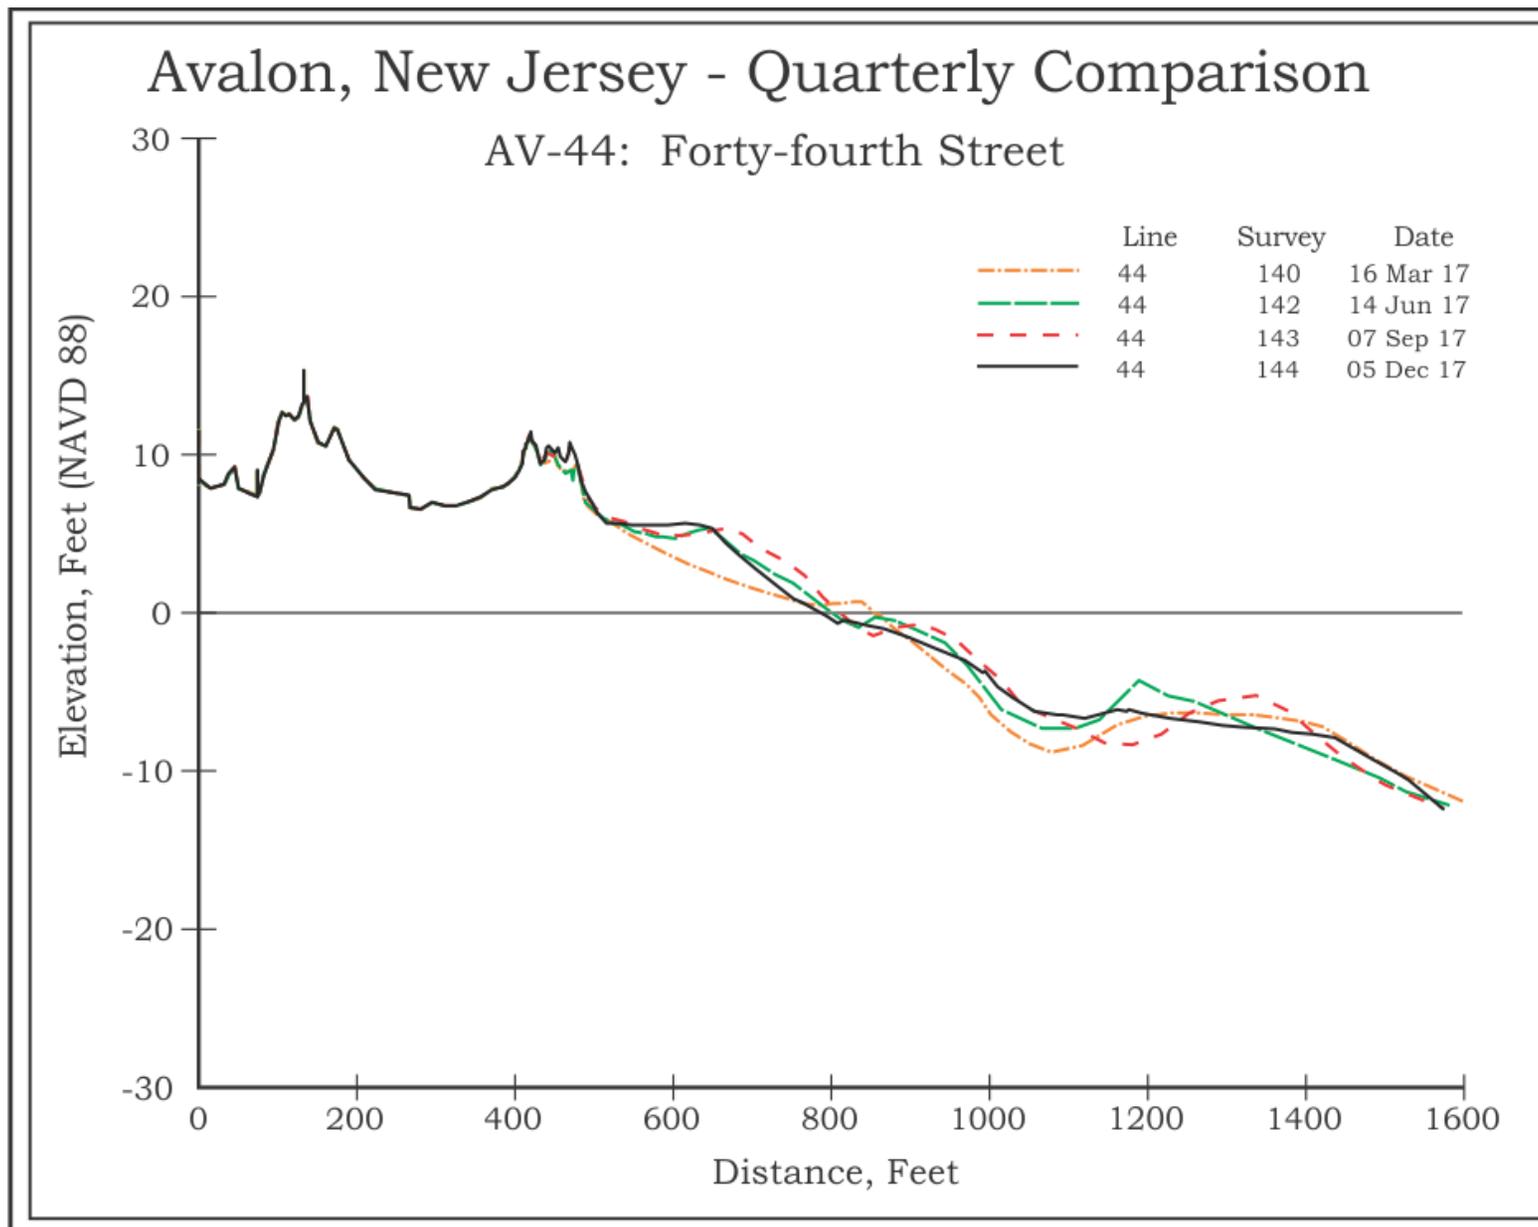
Figure 7. Dune growth is a nearly continuous process along this section of the Avalon shoreline. Beach sand moves inland driven by the on-shore winds and develop on the seaward edge of the existing dune field. The beach developed a seasonal berm early in 2017 and maintained the configuration throughout the year. Offshore the bar system remained relatively consistent with sand shifting in elevation and position. The trough landward of the bar was the deepest in March of 2017.

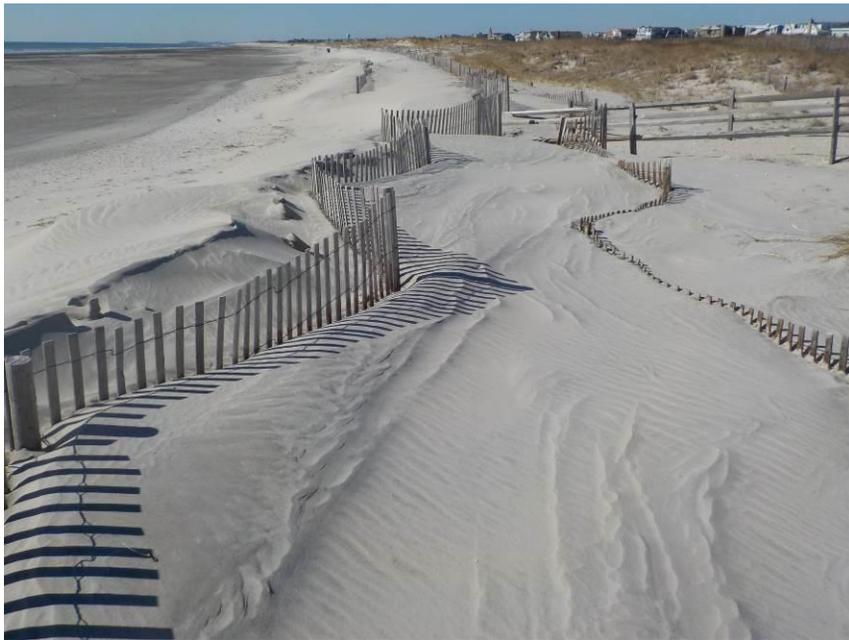
8a. March 17, 2017

The 58th Street site has shown a long term accretional trend over the monitoring history. This site lies at the southern margin of the Avalon high dune area and natural area exclusion zone. Currently, 350 feet of dune width protects oceanfront properties in this region. With an additional 300 feet of beach width to support dune growth shore protection continues to be enhanced.

The impact of sand placement either on the northern beaches of Avalon or south of the site in Stone Harbor during 2017 did not have direct influence on the beach at this location. However, minor shoreline position shifts were accompanied by dune growth and sand accumulation on the beach and in the offshore trough landward of the bar system. A minor foredune present over several years grew wider and higher right at the seaward limit of the dunes and if it continues will easily become the next significant addition to the dunes.

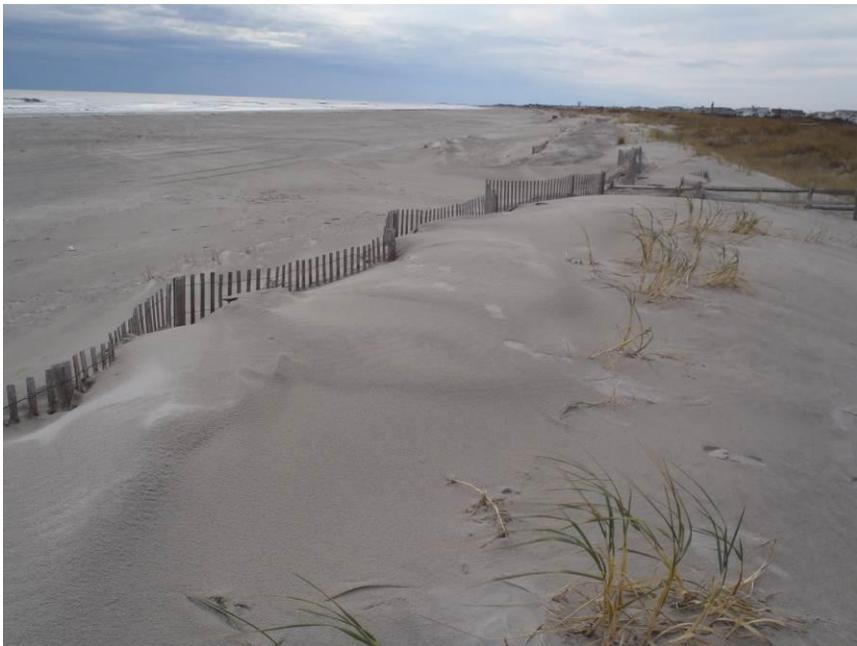
8c. December 6, 2017

View 8c The December view of the dune toe looking south indicates vertical growth on the fence as sand was added this year. The older fence line in 8a, above, is buried completely.

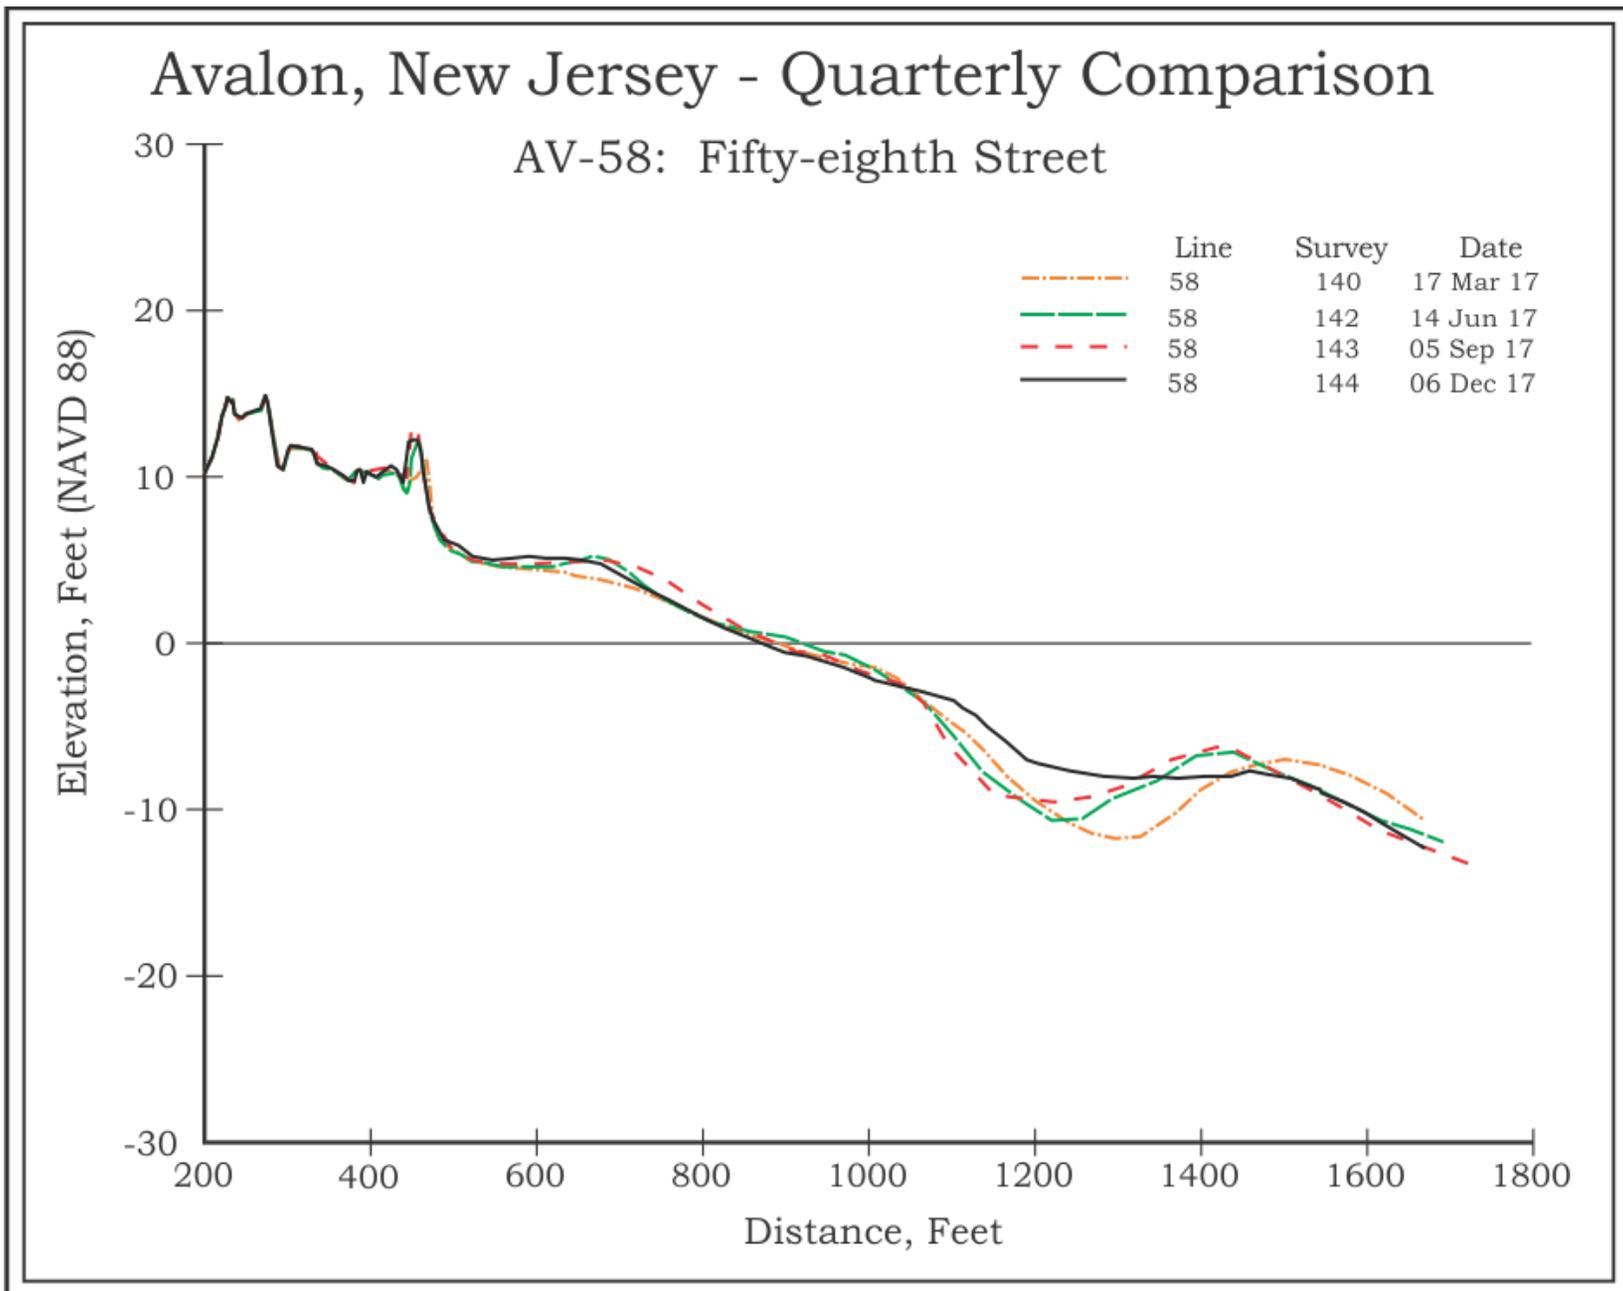
Figure 8. Sand was added to the dunes, the beach and filled in the offshore bar trough over the course of 2017. The annual change was the addition of 9.27 yds³/ft. in sand volume all below the zero datum, and a 1-foot shoreline retreat.

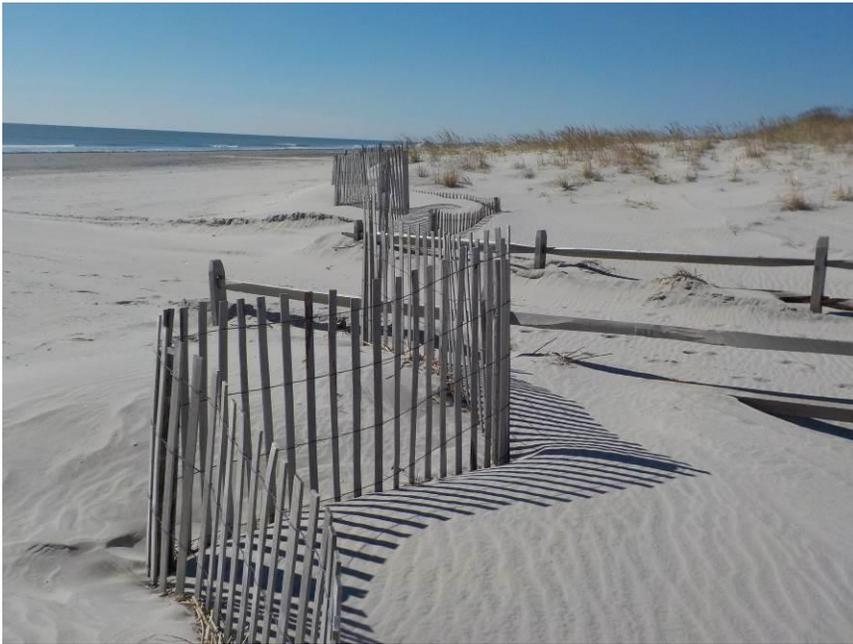
9a. March 17, 2017

View 9a shows the dune toe and beach conditions near the end of the winter of 2017.

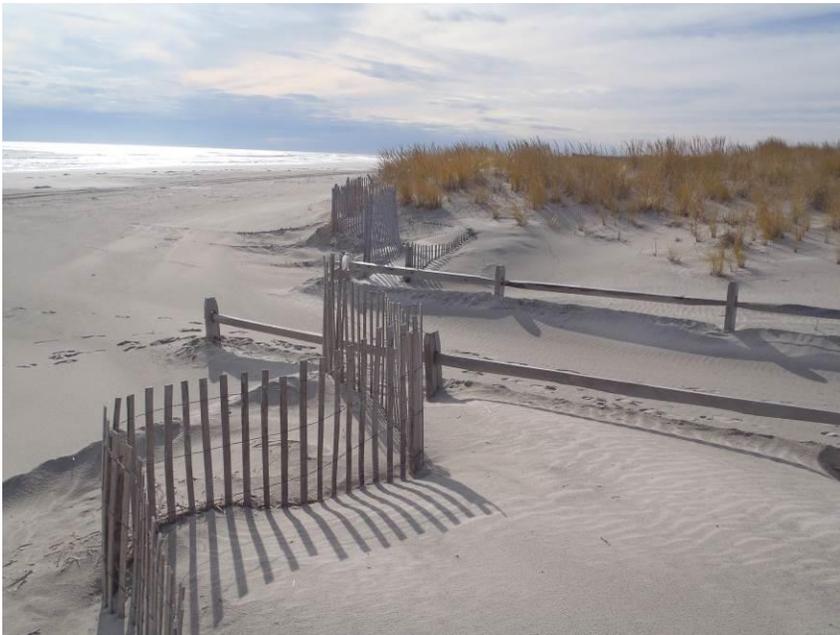
9c. December 6, 2017

View 9c shows the view to the south at the same location, but now there are just two wires showing as sand accumulation has buried more of the fence placed in 2015.

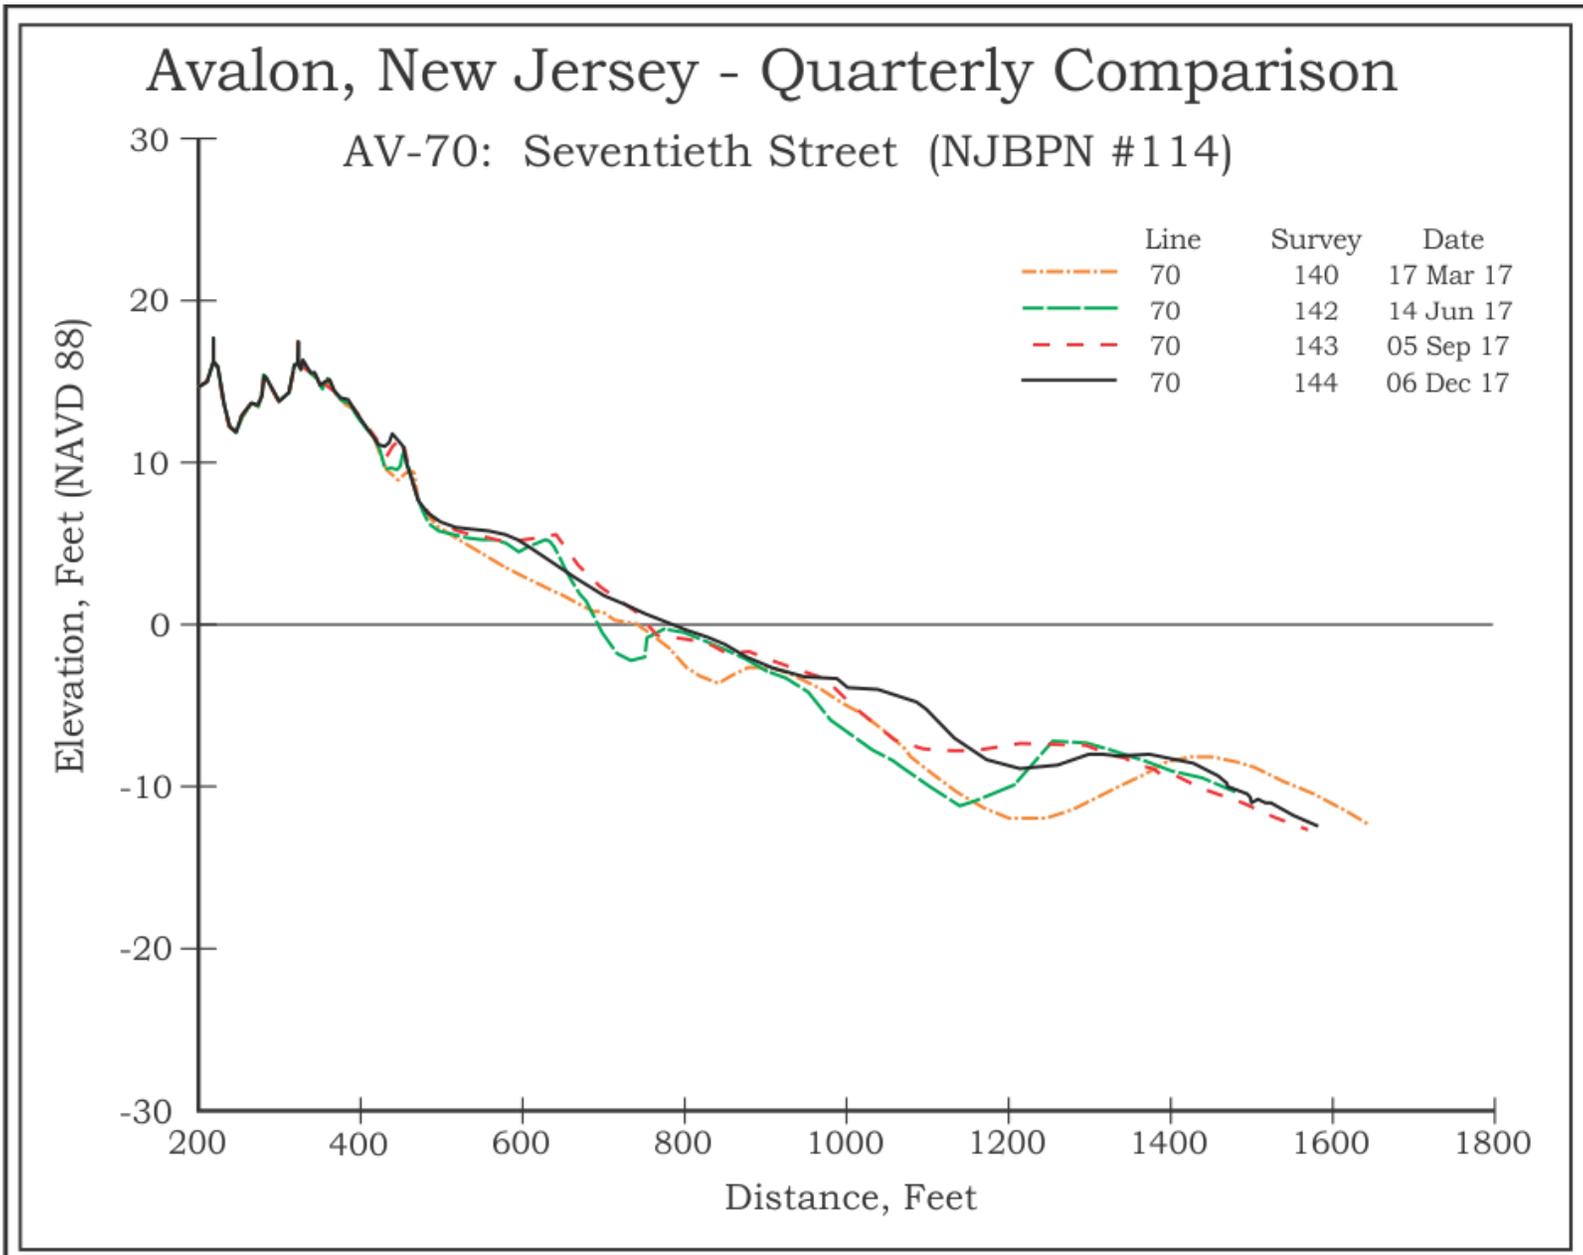
Figure 9. This site did change configuration substantially on the beach and especially offshore. The annual sand volume grew by 50.49 yds³/ft. with all but 9.6 yds³/ft. being added offshore. The shoreline position advanced 41 feet seaward as the beach added sand as well.

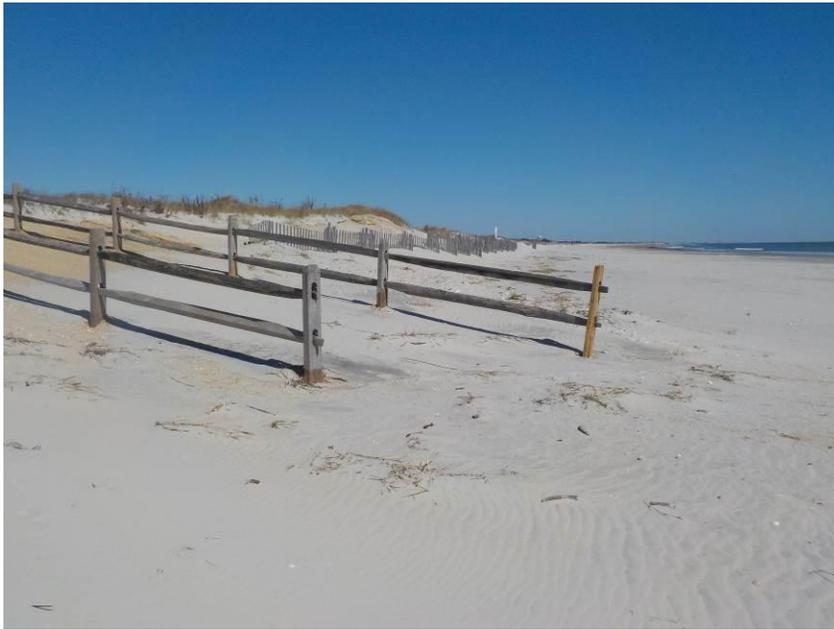
10a. March 17, 2017

This site is located near the boundary with Stone Harbor and is within the placement taper for the Stone Harbor federal nourishment project. The site did receive direct sand placement during 2017, probably between the March and June surveys. The sand volume added was 35.91 yds³/ft. and the shoreline moved 38 feet seaward. Material continued to accumulate in the offshore and berm during the summer, but material moved from the berm to the offshore by December. The annual change was the addition of 34.25 yds³/ft. with a 33-foot shoreline advance seaward.

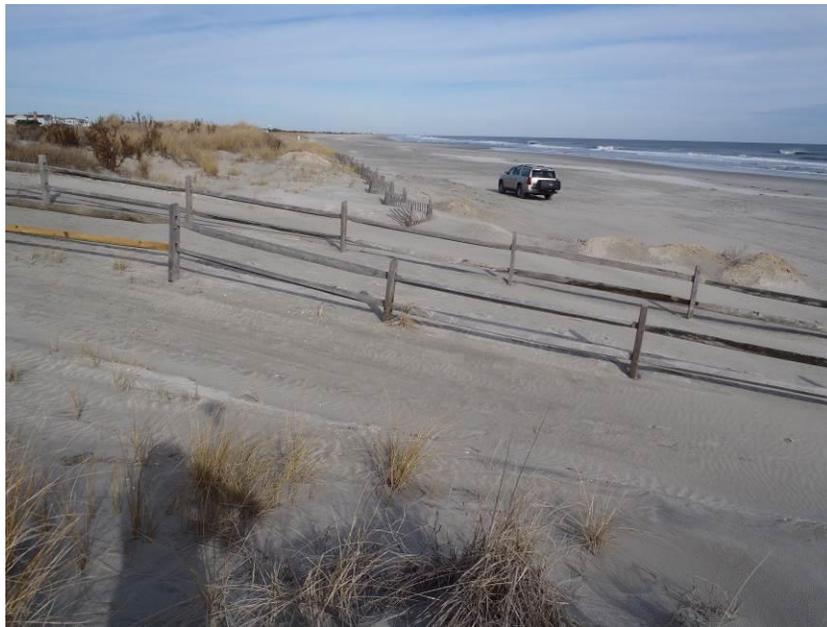
10c. December 6, 2017

View 10c shows continued dune growth, but a wetter beach as the berm had flattened out somewhat as shown in the figure below.

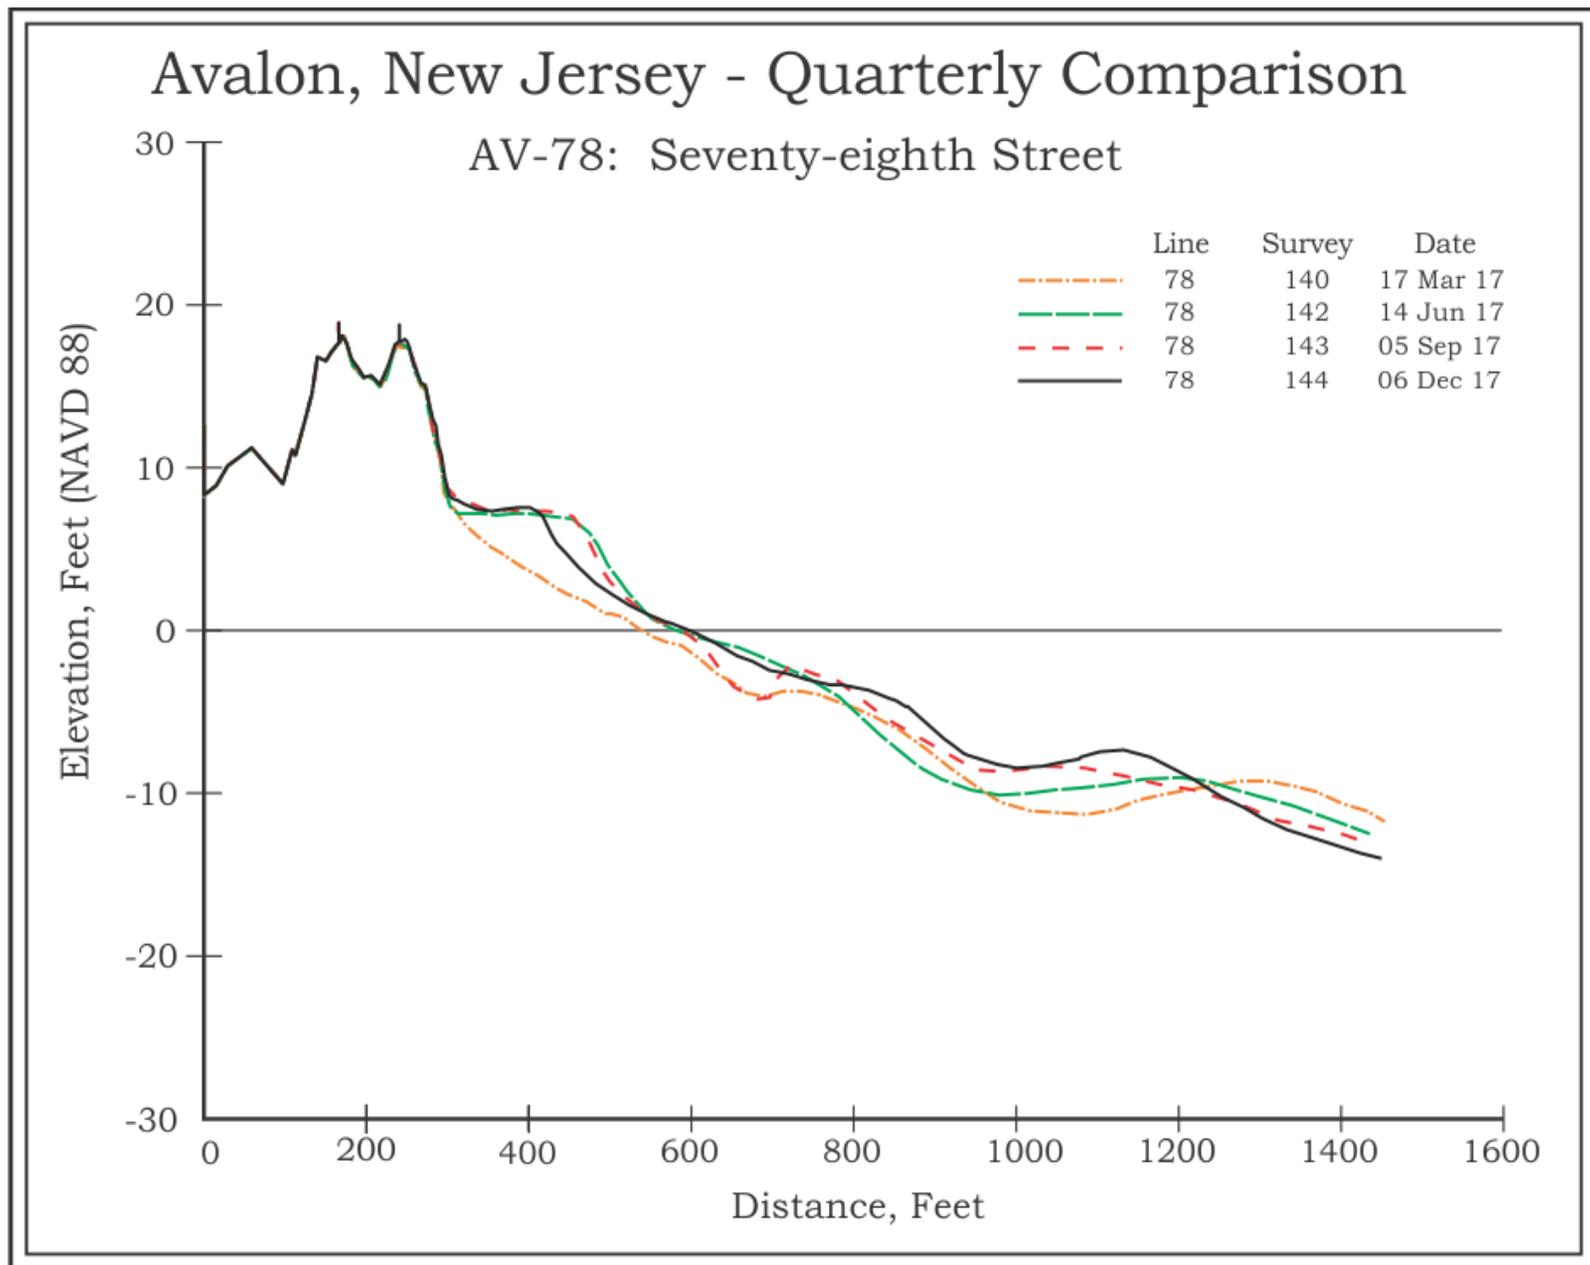
Figure 10. While sand did not add substantially to the dune beyond the seaward toe, the beach did gain sand and material accumulated offshore. The net sand volume change was more evenly balanced between the beach and the bar system at 78th Street likely due to direct sand placement by the USACE in the spring.

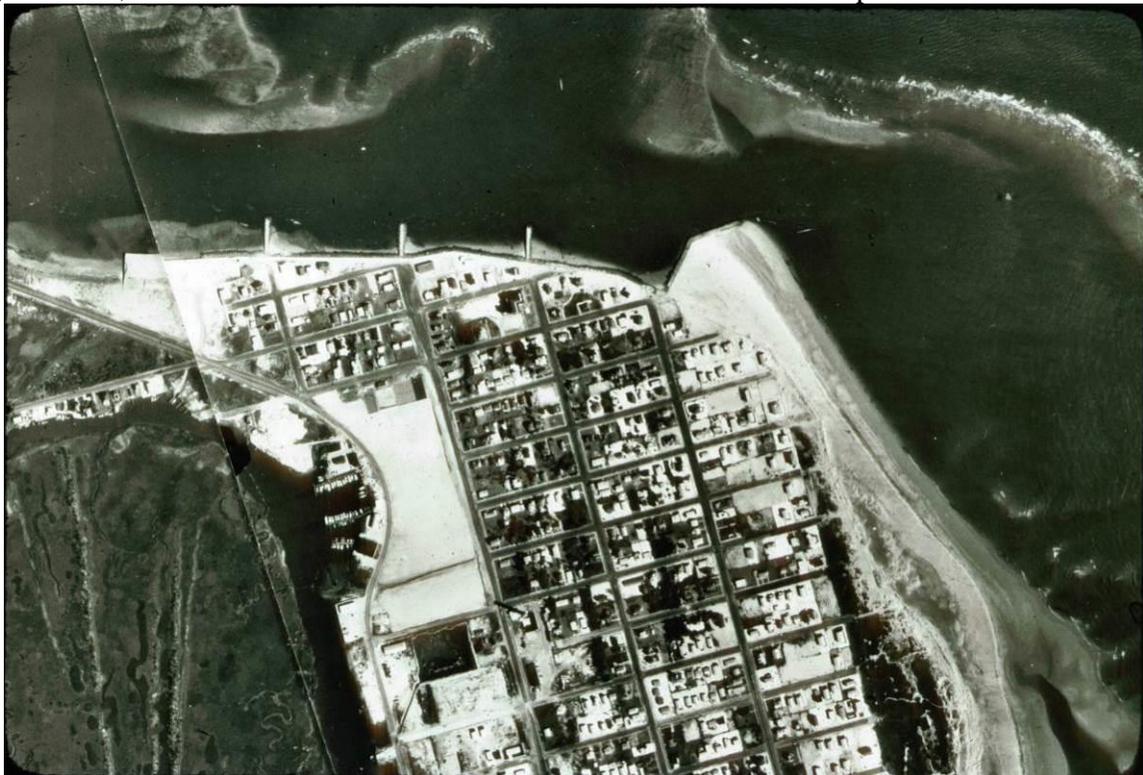
Figure 11. 1971 aerial photograph of Townsend's Inlet after construction of the 8th Ave. jetty, the rock revetment and 3 short finger groins in the inlet. The main channel lies next to the revetment with vast shoals exposed at low tide immediately northeast of the channel. Note that the seaward parts of the shoal wrap around the inlet mouth and contributed large slugs of sand to the beach lying between the jetty and 17th Street in Avalon. At this time there was a 465-foot wide vegetated dune system seaward of the end of 17th Street before reaching the dry, high tide beach. Flood tidal currents and storm wave action moved sand over the jetty into the inlet where the ebb-tidal currents carried it back out to the shoals for eventual return to the north end beach. A stable cycle of sediment was in place. The jetty was also lower in elevation and shorter so that sand did move back into the inlet from Avalon generating a feed-back loop process. Deposits of sand washed over the jetty or around it were rapidly re-positioned by the ebb-tidal currents to the offshore bar and eventually back onto the Avalon ocean beach. The bar at the extreme lower right in the photograph is the point of attachment for sand moving landward from the offshore ebb-delta deposit.

Figure 11 above is an aerial photograph taken in 1971 that shows shoaling conditions and configurations ideal for sand bypassing and wave sheltering to the Avalon shoreline. This discussion is included again in 2017 to demonstrate shoal conditions beneficial to Avalon. Sand shoals are emergent over a wide area in the ebb-tidal zone and form a crescent shape towards Avalon in this photograph. These shoal deposits have slowly disappeared due to their excavation for beach restoration in both municipalities since 1978 and a diminished sand supply entering the system as the Ludlam Island beaches deteriorated. The introduction of sand onto Ludlam Island from offshore deposits in 2015 and 2016, longshore transport from project beaches should restore larger ebb-tidal shoal deposits that may, hopefully, duplicate these pre-1978 situation.

Since over a million cubic yards of sand was removed, the prospect for its replacement plus a need for increases sufficient to promote large scale sand by-passing of the inlet to Avalon remain at best a wish for future development. The prospect of inlet processes establishing an ebb-tidal shoal system at Townsend's Inlet depend on developing an annual average sand extraction limit that is substantially less than the sediment volume arriving from the Ludlam Island beaches. Right now, that volume coming to the inlet is as high as it will ever get given that the USACE introduced over 3.5 million cubic yards of sand from offshore onto the island's oceanfront beaches and the transfer process will simply diminish over time, returning to pre-project levels. The evaluation of a more Avalon-beneficial borrow zone placement is important as this zone of repetitive extraction of sand has implications for sand supplies and their distribution throughout the inlet ebb-dominated region. The pre-inlet dredging location of the main ebb-tidal channel was historically closely associated with the Avalon side of the inlet to the point of causing the loss of the Avalon cross streets numbered 1st through 6th since 1900. The inlet channel proximity to Avalon determined where the main ebb-tidal delta shoal seaward of the inlet would be positioned, and that position was once, more beneficial in allowing sand to reach the Avalon beachfront in a by-passing of the inlet opening from Ludlam Island (Figure 11, 1971, seaward ebb shoal).

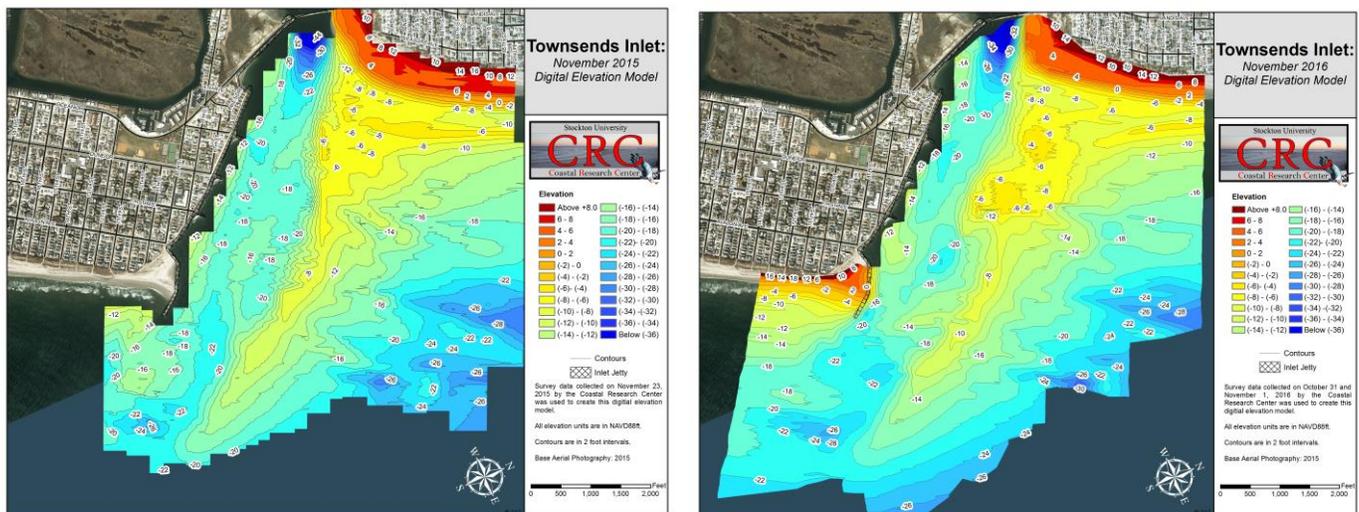
Figure 12. The DEM on the left shows elevation conditions in November 2015, red and orange colors represent the beach and dunes while blues are the lowest elevations, contour intervals are shown at two foot intervals. The light blue to green area shows the extent of the ebb shoal before sand placement was completed on Ludlam Island. The DEM on the right shows elevation conditions on November 1, 2016, about one year after the initial survey. Again, light blue to green colors represent higher elevations while dark blues are the lowest elevations, contour intervals are at two foot intervals. These two images provide the historical perspective leading to this year's survey after the most recent USACE maintenance beach restoration effort.

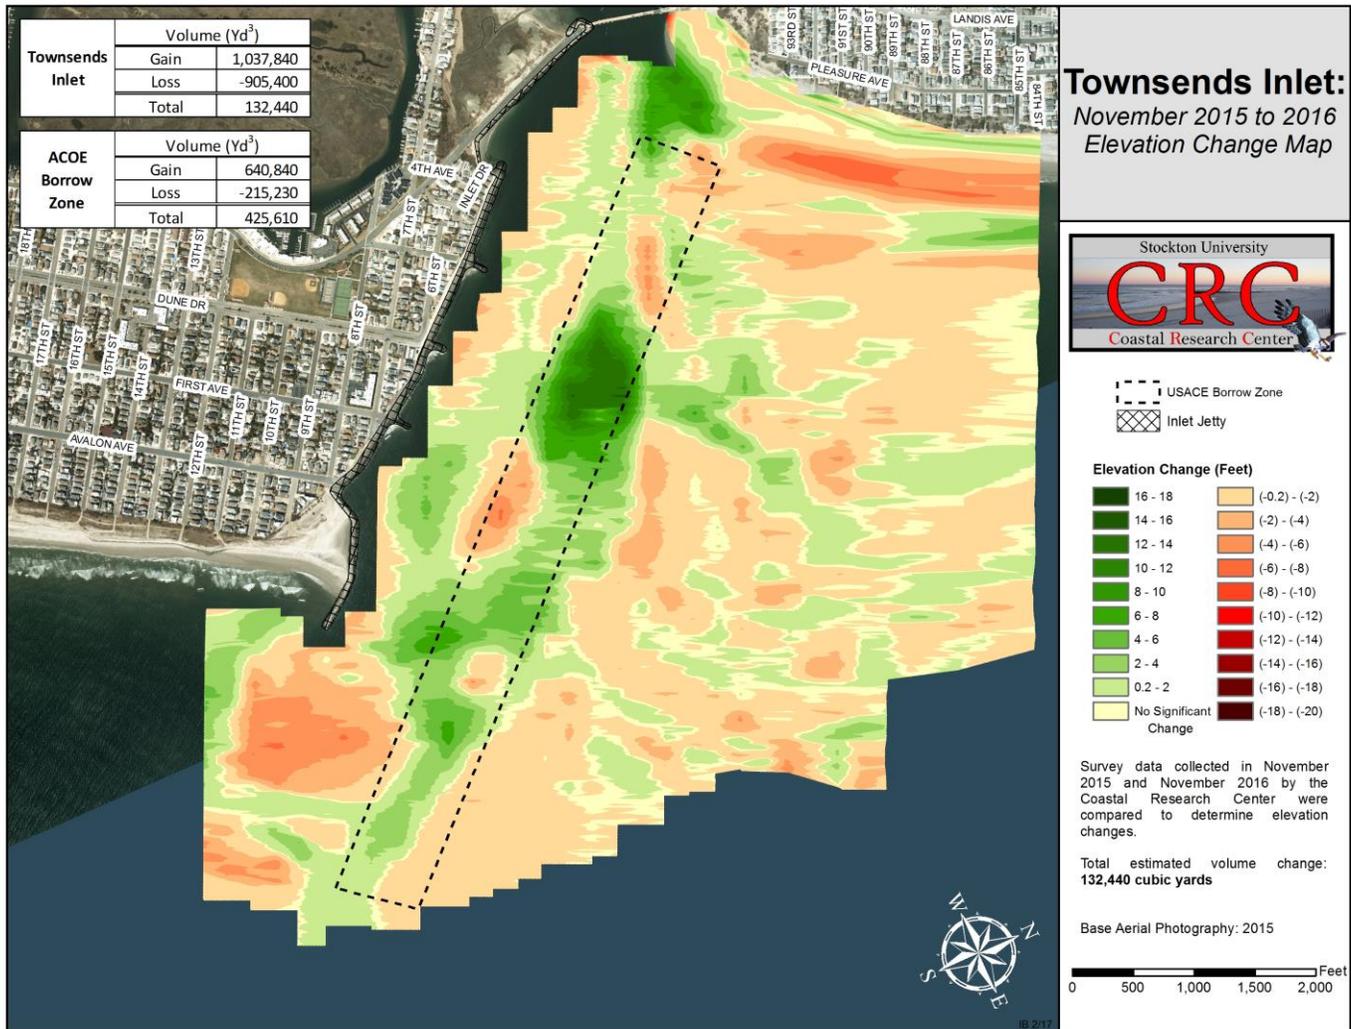
Figure 13. The map above is an elevation change map between surveys conducting November 2015 and November 2016. Green colored regions are areas of elevation gains while orange and red are regions where the elevation decreased. Yellow shaded areas are regions of no significant elevation change. The black dashed rectangle demarks the approved borrow zone used for each cycle of the federal nourishment maintenance efforts on Avalon's north end. The most depositional zone in the inlet appears to have been centrally located within the designated sand borrow zone.

Figure 13 above is an elevation change map between the November 2015 and the November 2016 survey of the inlet. The map clearly shows regions of sand accumulation on the shoal and an area of loss from an extensive linear area along Sea Isle City's shoreline into the nearshore region, extending north from 93rd Street to the northern limits of the survey. A second area of loss occurred in the inlet channel mouth off Avalon seaward of the 8th Street jetty. The changes in elevations are associated with a change in sand volume. Within the borrow zone the areas of gains accumulated 640,840 cy of sand within a year. There were pockets of sand loss within the borrow zone area focused along the channel margin where -215,230 cy of sand moved away between 2015 to 2016. The net volume change within the borrow zone was a gain of 425,610 cy of sand. This exceeds the annual anticipated recharge rate of just over 300,000 cy of sand. The volume change analysis indicates that within the first year 1,037,840 cy of sand accumulated in regions throughout the inlet system. Areas of loss were significant with -905,440 cy moved mostly from the two regions of loss described above, Sea Isle City beaches and the mouth of the inlet. The net inlet change was a modest gain of 132,440 cy of sand.

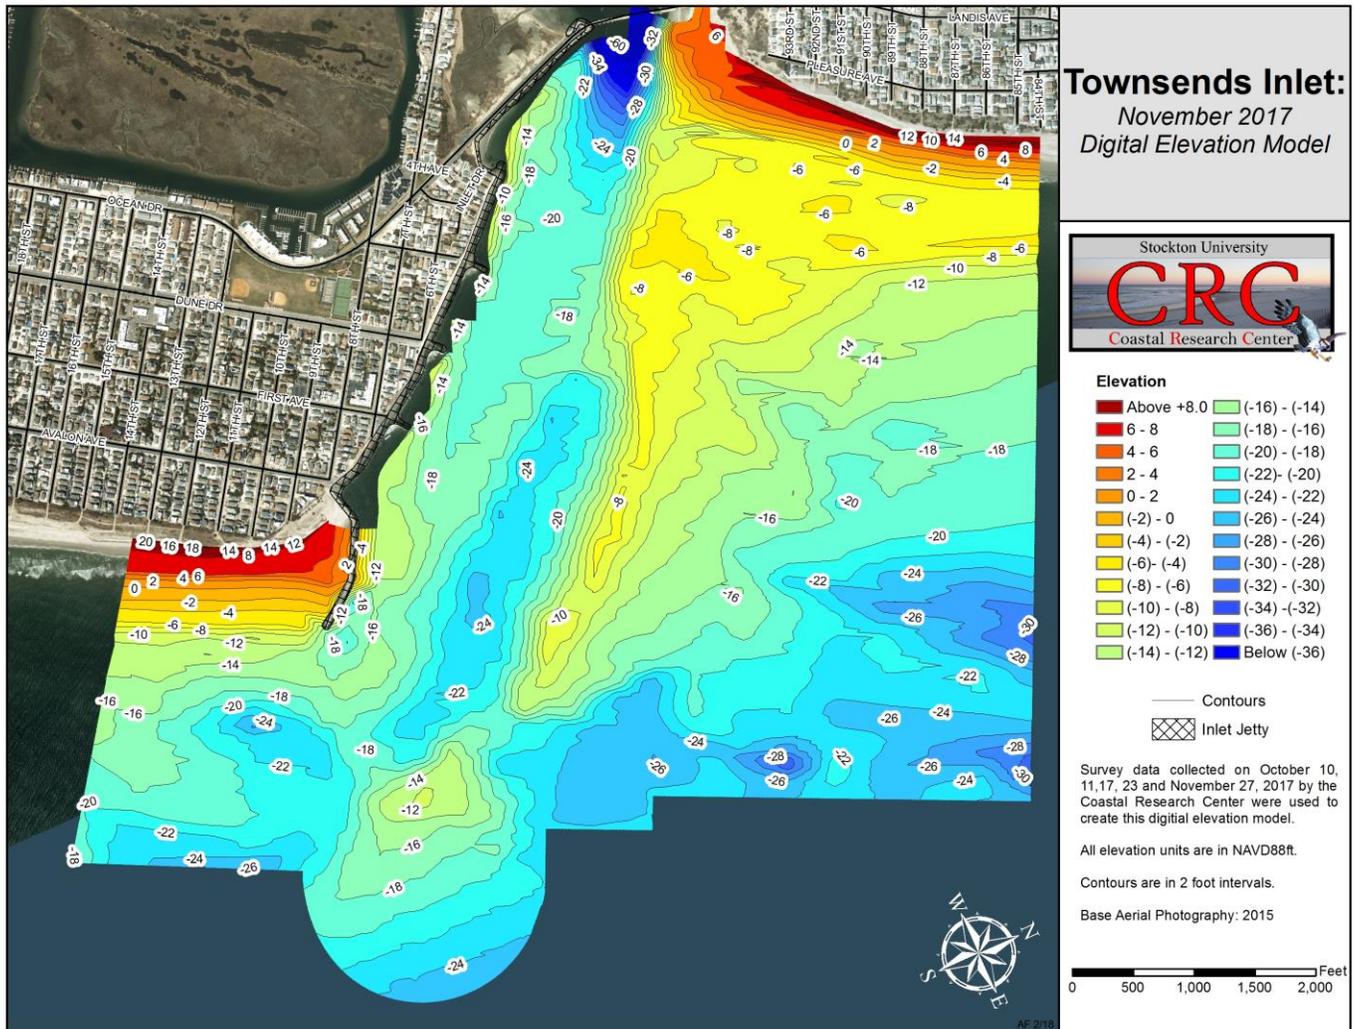
Figure 14. Digital elevation map of Townsends Inlet representing conditions existing in November 2017 using the same color and contour patterns. The USACE excavation in the borrow zone area can be clearly seen as 22 to 24-foot depths where the depth was 14 feet in 2016. The beach in Avalon received the majority of this sand, but 320,000 cubic yards were sent south into Stone Harbor to complete that part of the project.
