**FINAL REPORT FOR 2017
ON THE CONDITION OF THE MUNICIPAL OCEANFRONT BEACHES
THE BOROUGH OF AVALON, CAPE MAY COUNTY, NEW JERSEY**

**PREPARED FOR: THE BOROUGH OF AVALON
3100 DUNE DRIVE
AVALON, NJ 08202**

**PREPARED BY: THE STOCKTON UNIVERSITY COASTAL RESEARCH CENTER
30 WILSON AVENUE
PORT REPUBLIC, NEW JERSEY 08241**

**ANNUAL REPORT FOR 2017 - TO THE BOROUGH OF AVALON
ON THE
CONDITION OF THE MUNICIPAL BEACHES**

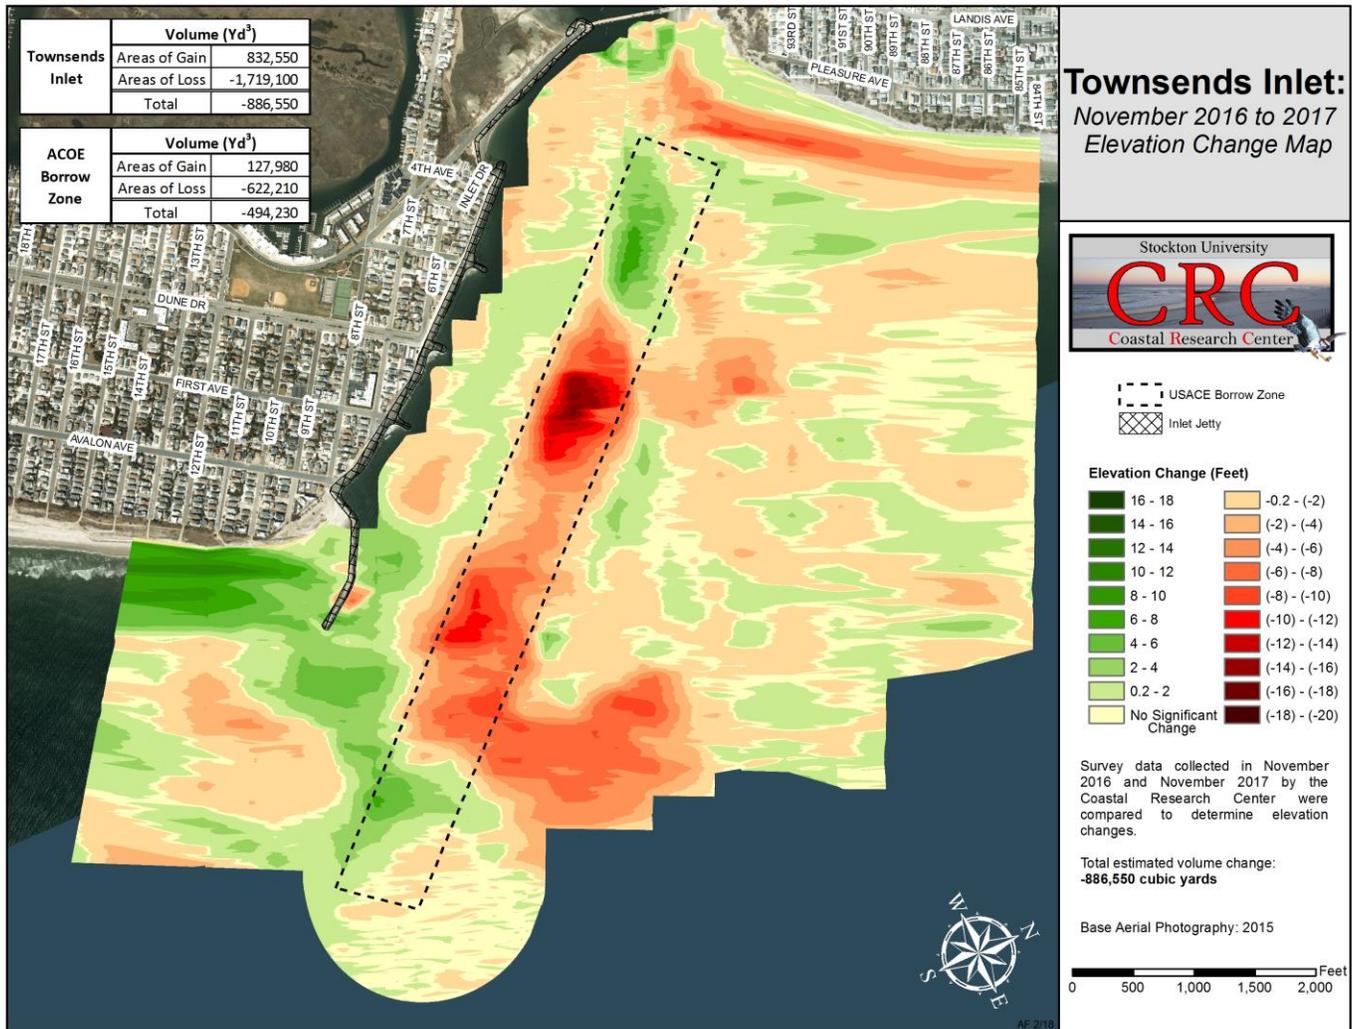
The second elevation change map compares the data from 2016 with the 2017 information and shows that across the entire area surveyed, the inlet shoal system lost 886,550 cubic yards of sand. The areas of loss amounted to 1.7 million cubic yards, while within the defined borrow zone the net loss was 494,230 cubic yards because sand was added on the inner quarter while excavation for the beach projects concentrated on the central half. Sand also was deposited in the seaward quarter of the zone. The deposition on the Avalon beach clearly shows up as accumulation. Additional material was obtained outside the rectangular outline of the traditional borrow zone to the south and east of the seaward segment to obtain extra FCCE sand for Stone Harbor to complete the 2017 maintenance effort. That area in red color on Figure 15 below contributed 375,630 cubic yards in the digital comparison with the survey from fall 2016. Combined the 832,550 cy plus the 375,630 cy totals 1,208,180 cubic yards of material derived from Townsend's Inlet ebb-tidal delta for both Avalon and part of the Stone Harbor work. The balance of the Stone Harbor material came from Hereford Inlet funded by state and local money.

Figure 15. Elevation change map for 2016 to 2017 at Townsends Inlet ebb-tidal shoals. The red zone of loss represents the sand excavation undertaken during the spring of 2017 to serve the needs of the Avalon and part of the Stone Harbor USACE shore protection maintenance project. Sand did accumulate naturally by 4 to 6-foot elevation rise of the sea floor immediately east of the 8th Street jetty, extending into the outermost borrow zone region where a 10-foot elevation rise was recorded. This represents sand that might migrate to the Avalon side of the inlet. The USACE sand placement on the Avalon beach near the jetty also shows as a wide green zone to 13th Street. The 24-foot deep excavation will need to fill in before large scale cross inlet sand transfer can occur, with that sand derived from Ludlam Island’s USACE project.
