**FINAL REPORT FOR 2016  
ON THE CONDITION OF THE MUNICIPAL BEACHES  
IN  
THE CITY OF BRIGANTINE BEACH, ATLANTIC COUNTY, NEW JERSEY**

**PREPARED BY: THE STOCKTON UNIVERSITY COASTAL RESEARCH CENTER  
30 WILSON AVENUE  
PORT REPUBLIC, NEW JERSEY 08241**

**December 12, 2016**

# **Annual Report for 2016 to the City of Brigantine Beach on the Condition of Municipal Ocean Beaches**

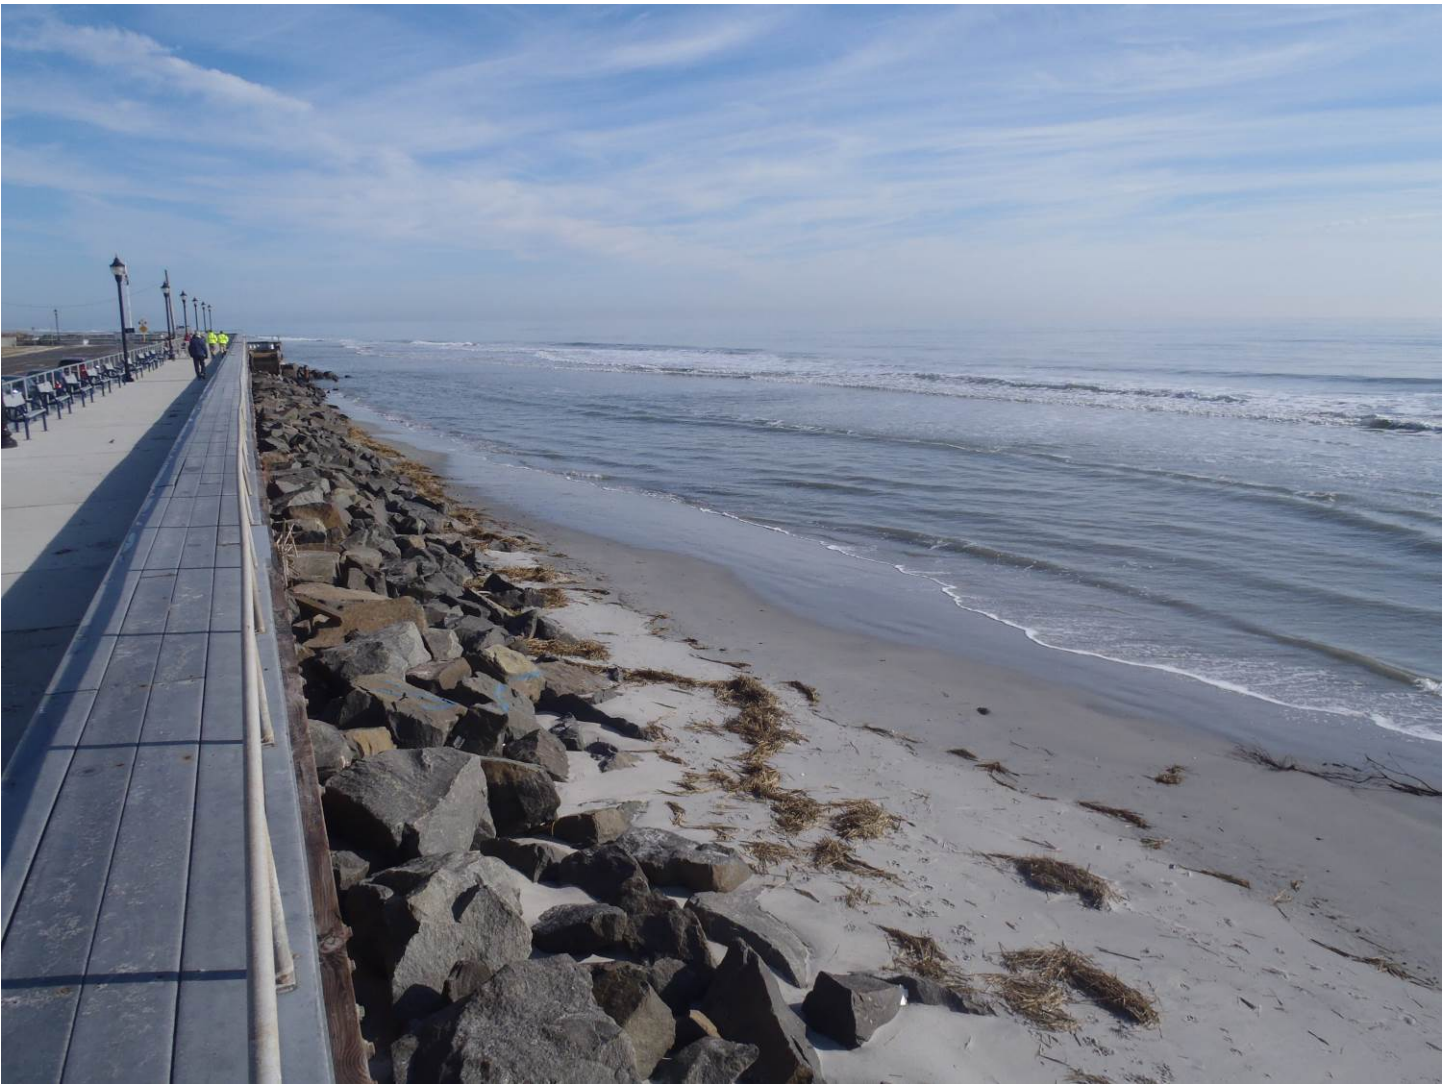
View to the north from 12<sup>th</sup> Street showing the promenade, bulkhead and revetment just after Northeast Storm Jonas. The beach was eroded 4 feet vertically and the shoreline moved to the rocks at high tide. The white water offshore represents the bar created by this storm that slowly migrated landward improving the situation by summer's end.(Photo taken January 29, 2016). This oceanfront reach is the potential destination for the vast surplus of sand accumulating along the southern two miles of the Brigantine City oceanfront.

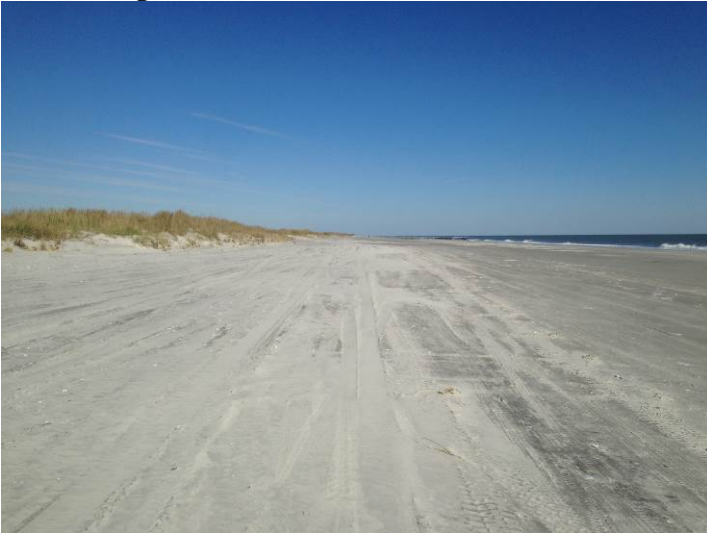
**Figure 1a taken on October 16, 2015 and shows a flat beach affected by storm waves from the early October 2015 northeaster. The existing beach width protected the dune toe from storm waves and further erosion.**

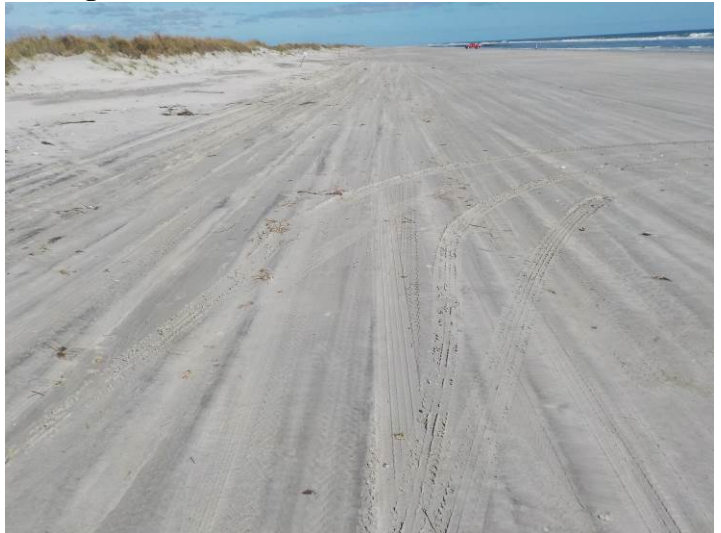
**Figure 1b taken on October 12, 2016 also followed a three day northeast event with low wind velocities, but long duration action. Again, waves did no damage to the dunes, but flattened out the beach. Waves are breaking on the large bar offshore.**

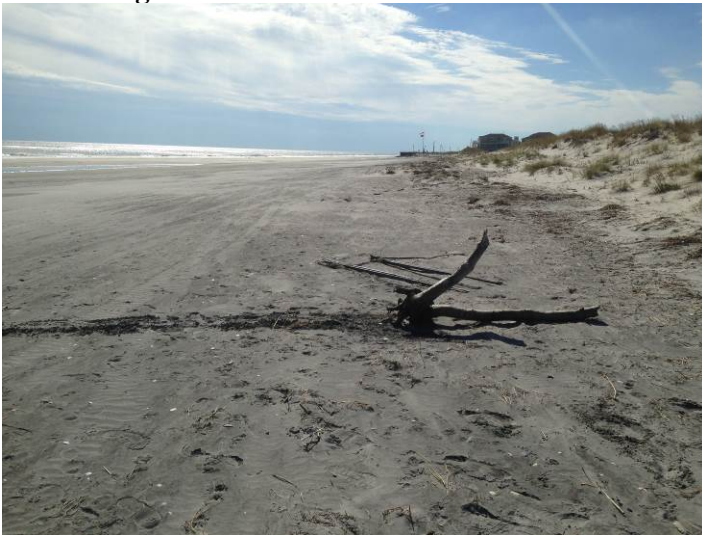
**Figure 2a** was taken October 16, 2015 shows storm waves from the early October northeaster reached the seaward dune toe. The beach was flattened but the dune remained intact.

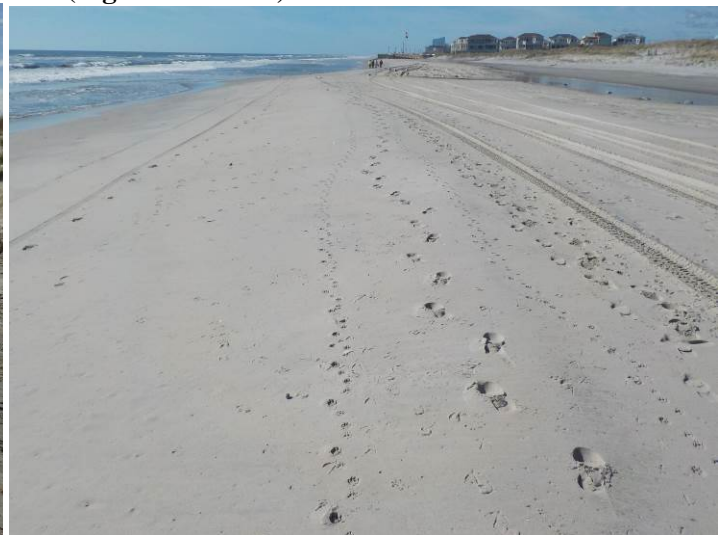
**Figure 2b** taken October 12, 2016 from the crest of the new berm developed over the summer. This berm is very recent indicated by the water standing between it and the dune toe. There are waves breaking on the offshore bar extending south into developed Brigantine.

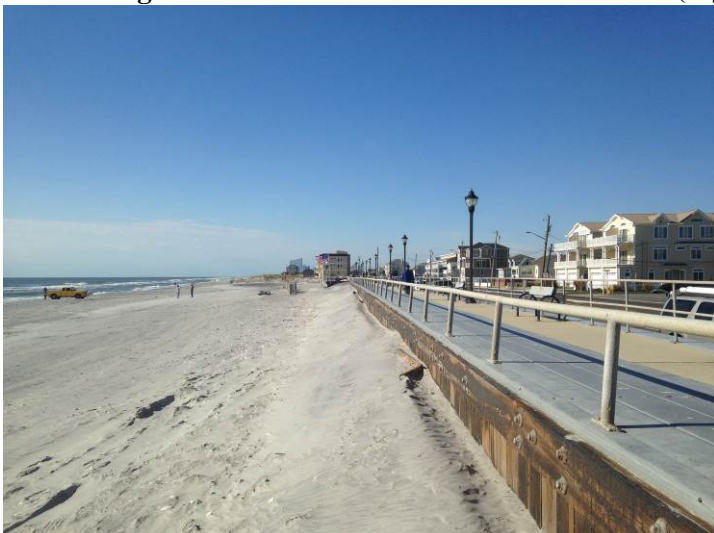
Figure 3a taken October 16, 2015 from the top of the sand against the revetment wall. The wide beach berm still present in spring 2015 has been flattened by storm wave run-up that nearly reached the revetment two weeks prior during the early October northeaster.

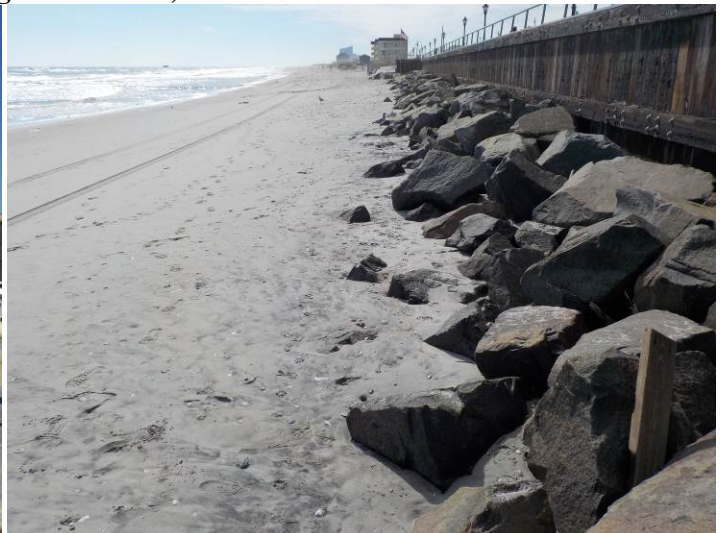
Figure 3b photo above was taken October 12, 2016 showing the significant loss over the past year. Rocks exposed and a hundred-foot narrower beach is present with a generous deposit seen offshore where waves are breaking.

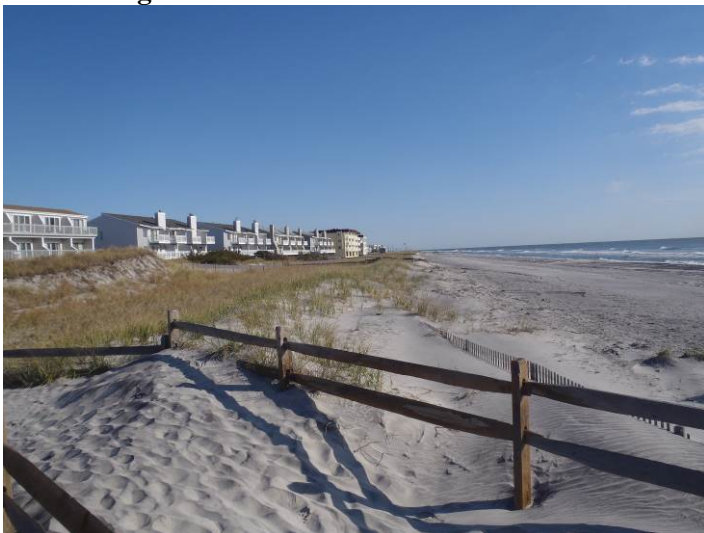
Figure 4a photo was taken looking north on October 15, 2015 following the early October storm. The beach width and elevation were reduced by the storm waves but the developing foredune remained intact.

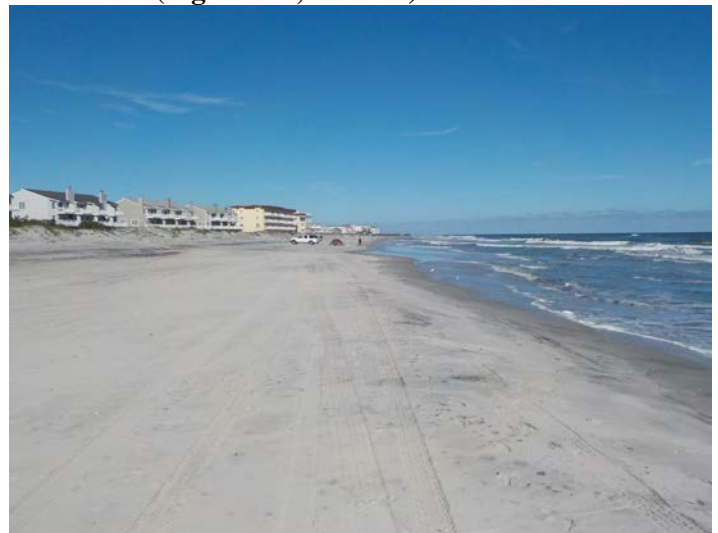
Figure 4b photo was taken looking north on October 12, 2016 following Hurricane Hermine and a late September 3-day northeast event. The resulting bar deposit and flat beach are evident.

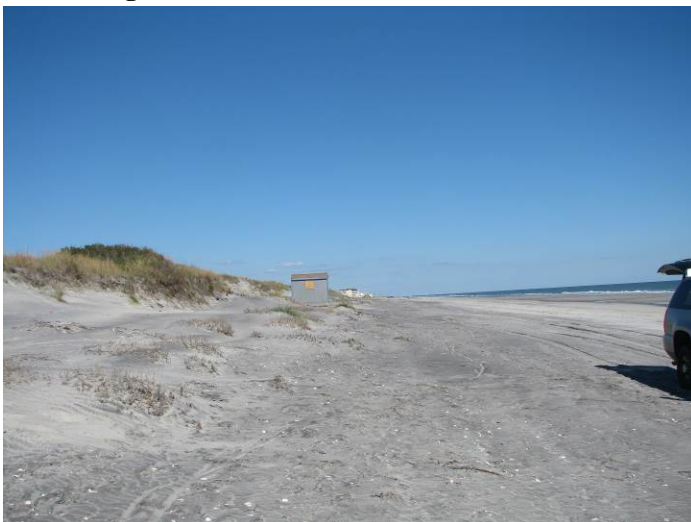
**Figure 5a** photo was taken looking north October 15, 2015. Sand moved slightly landward into the dune toe with evidence of early colonizing plants propagation during the summer season.

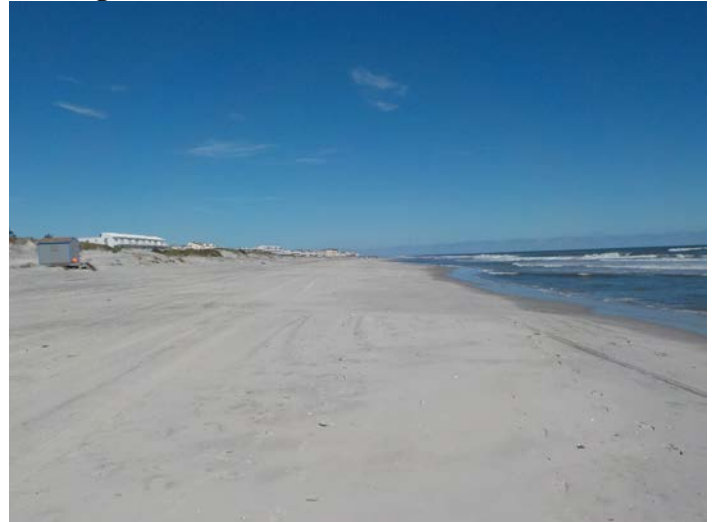
**Figure 5b** photo was taken looking north on the beach near the swash on October 11, 2016. The beach was flat due to the late September northeast storm.

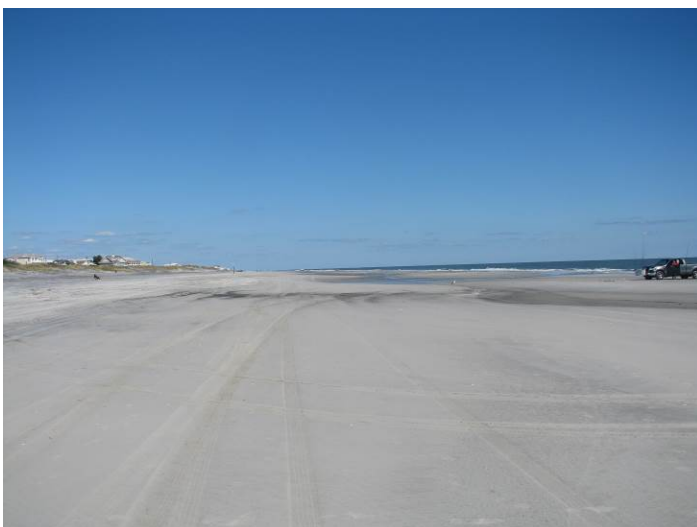
Figure 6a photo was taken on October 15, 2015 after the October northeaster. The berm has been lowered and pushed seaward with a shallow runnel and ridge pictured here at low tide.

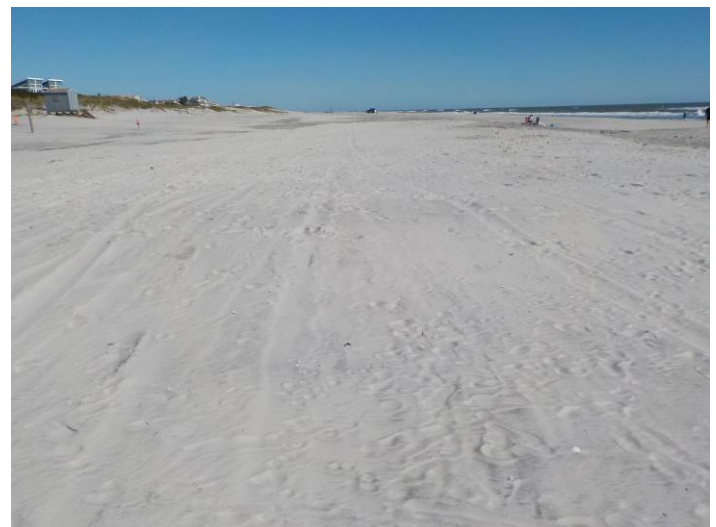
Figure 6b taken October 11, 2016 also following a late September 3-day northeaster event. Waves did not reach the dune toe and the beach remains wide and well developed.

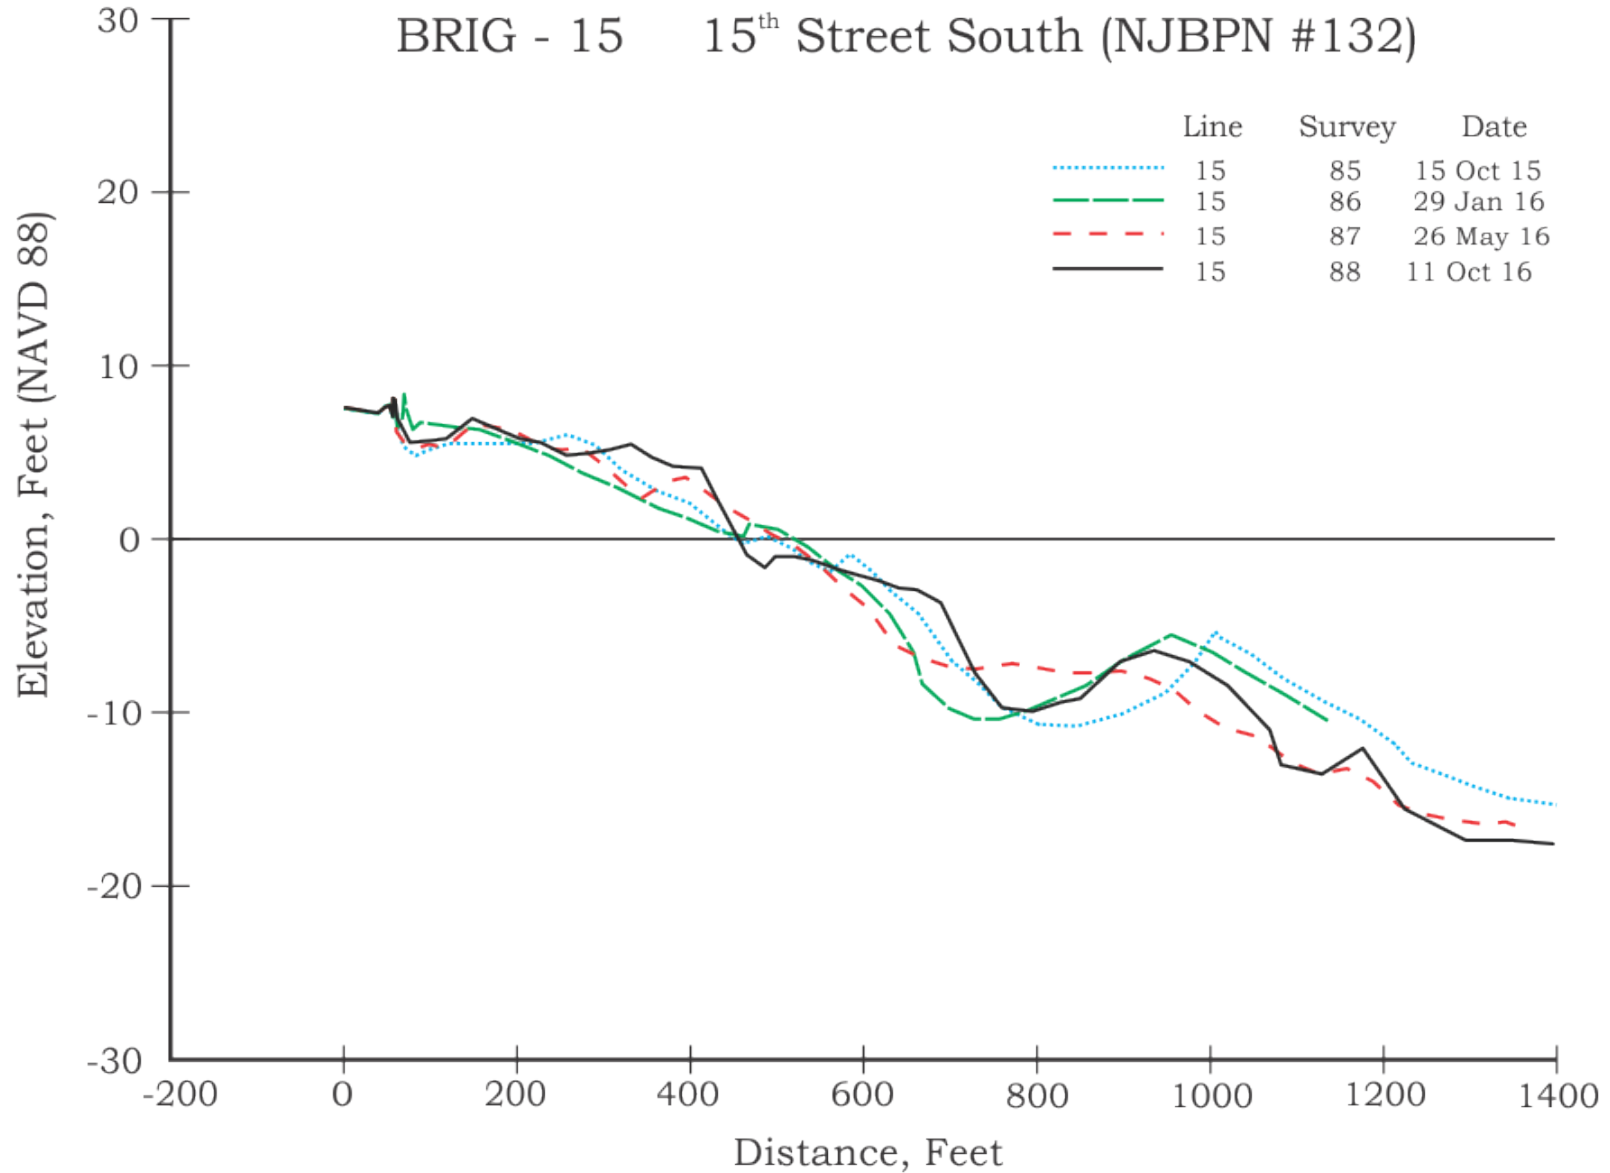
BRIG - 15 15<sup>th</sup> Street South (NJBPN #132)

Figure 6c - At 15<sup>th</sup> Street South sand was added to the beach as a wide berm with proximal bars just offshore nearly attached to the beach by October 11, 2016. Two additional bars existed offshore, but at lower elevations than present in 2015, generating the sand volume loss documented.

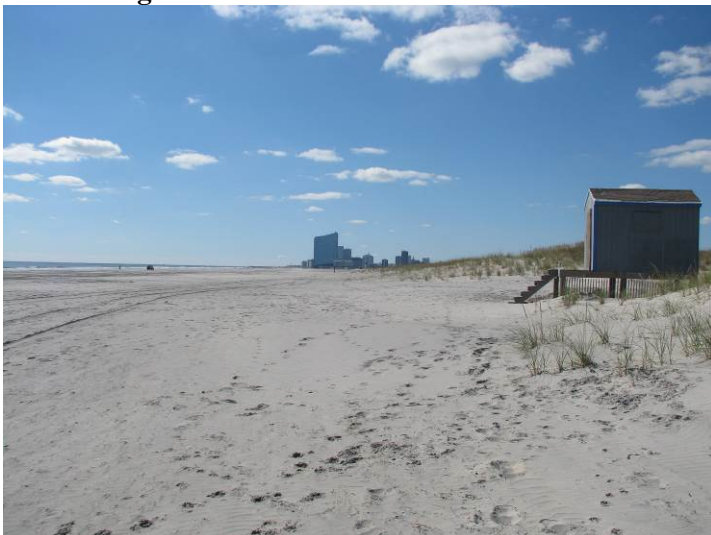
**Figure 7a photo was taken looking south on October 15, 2015. The wide beach berm absorbed the full impact of the early October 2015 northeast storm event, first of a series in this El Nino season. There's no wrack line or indication wave run up reached anywhere near the dune.**

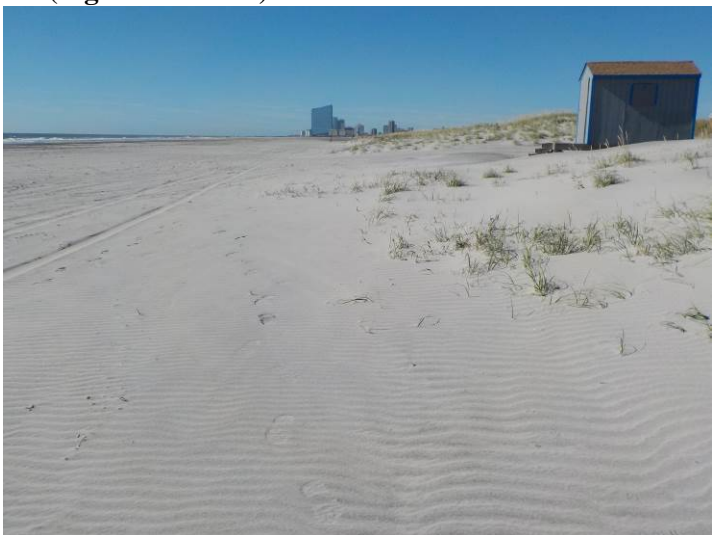
**Figure 7b. October 11, 2016 shows that the dune continued to accumulate sand filling in around the lifeguard shack at 27<sup>th</sup> Street. The wide beach and great dune system protect all built infrastructure behind it.**

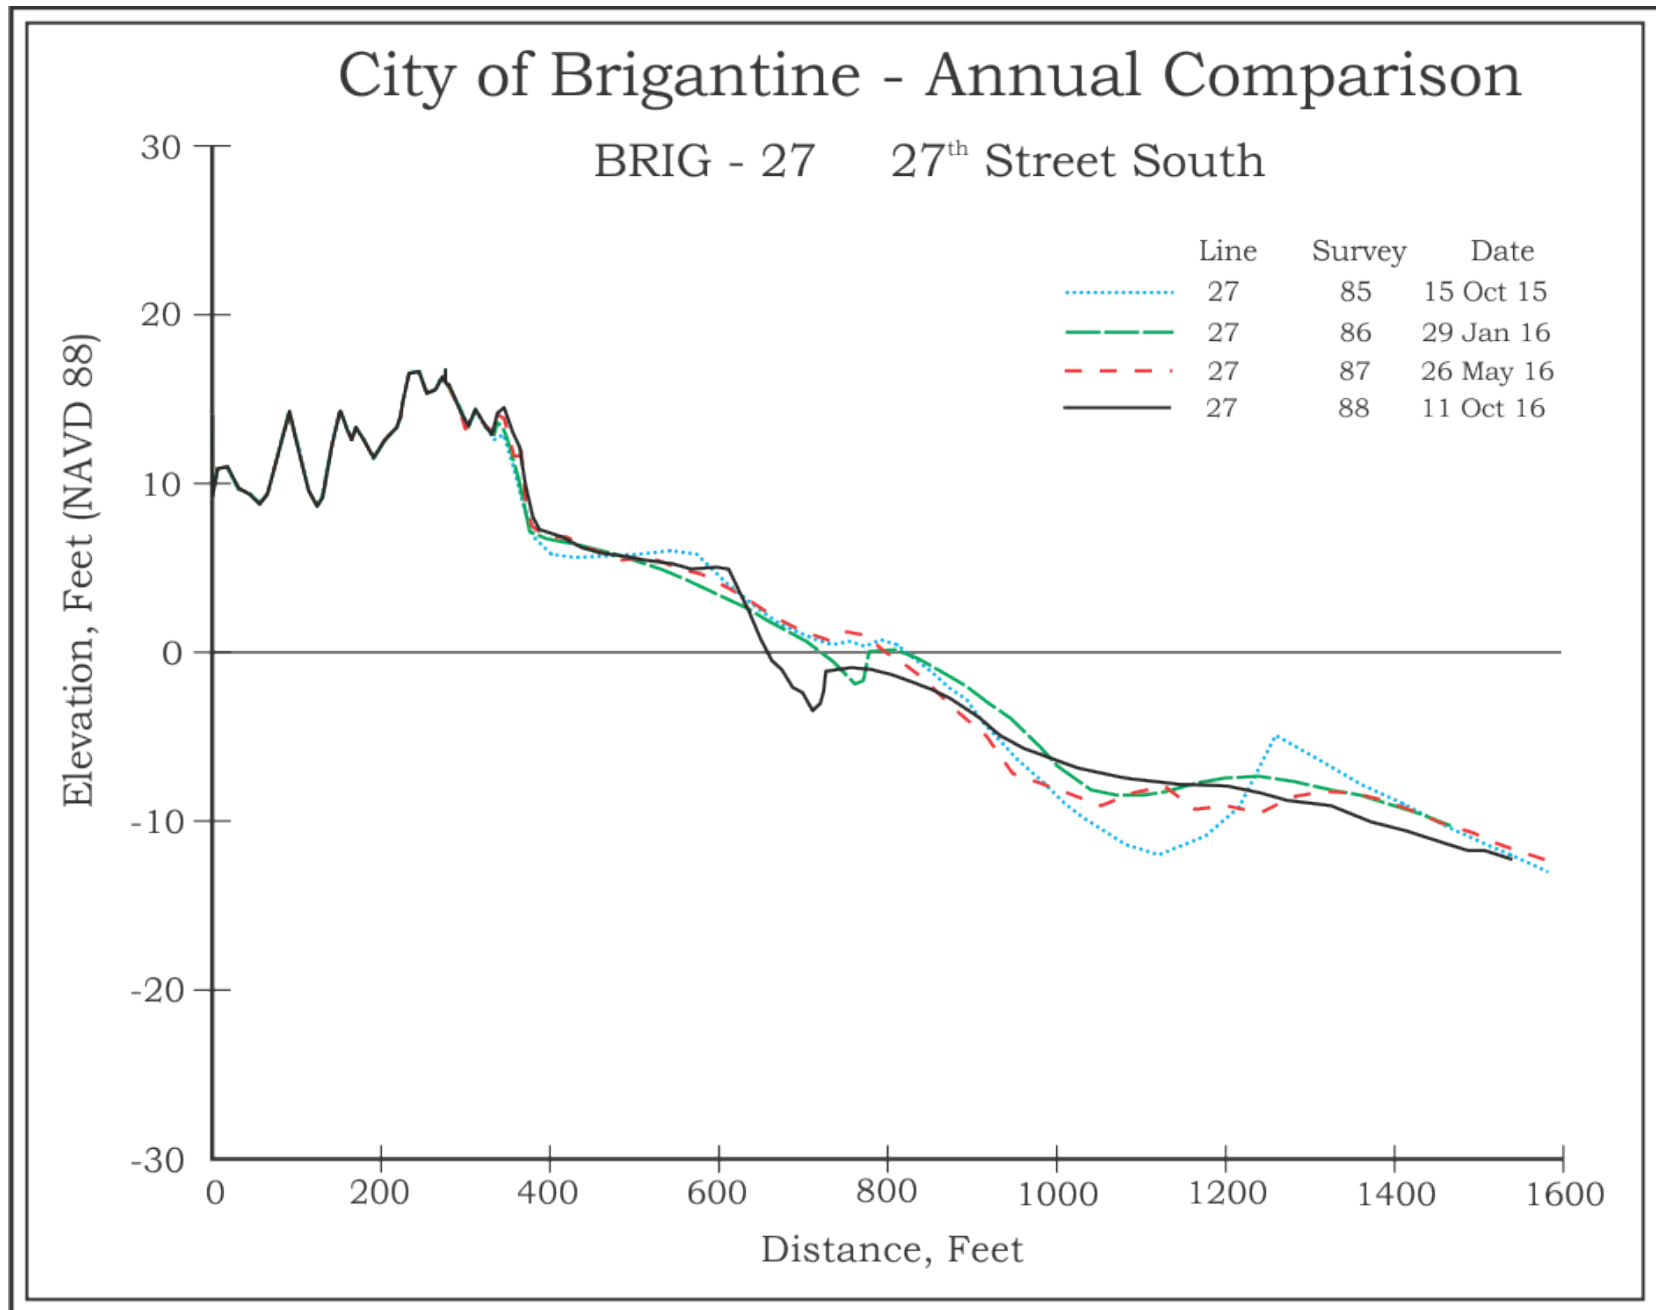
**Figure 7c - The shore did change at the zero elevation position with a steep beachface leading to a nearshore bar about to weld onto the beach in October 2016. The beach width was affected by the contrast between the gentler slope and bar a year earlier. The distal offshore bar was quite flat by the end of 2016.**

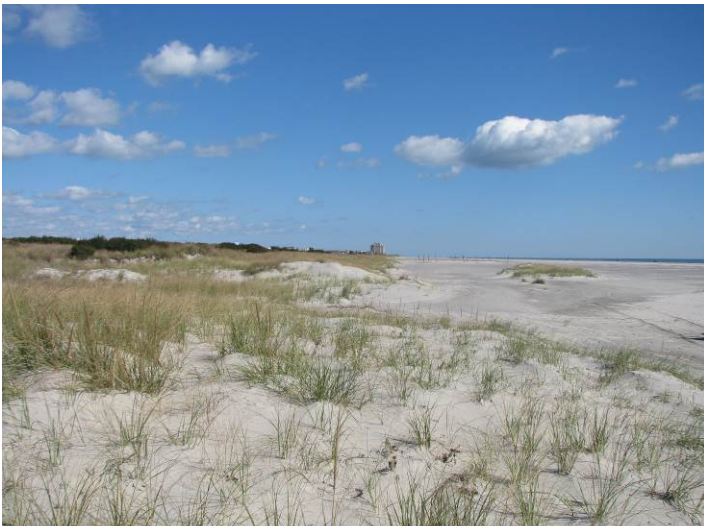
**Figure 8a photo was taken looking north on October 15, 2016. The new foredune ridge was colonized by grasses and there is evidence of development of a new foredune seaward of the current toe position but no storm damage.**

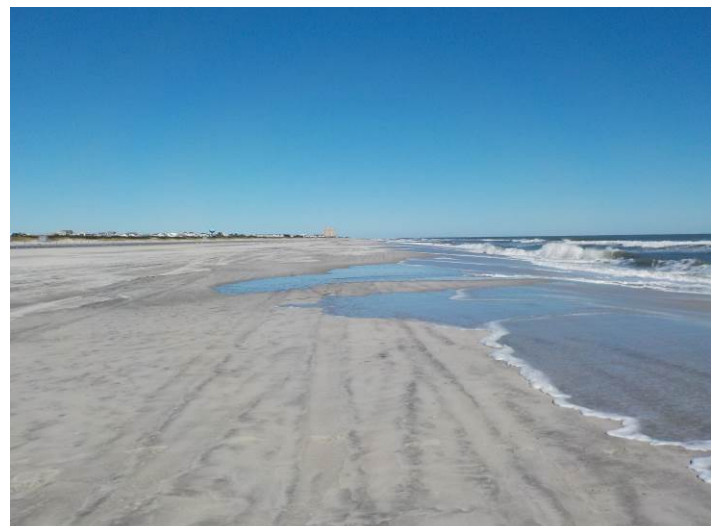
**Figure 8b photo was taken looking north on October 10, 2016 10 days after a 3-day northeast storm. Water flooded about half the beach width, but did no real damage.**

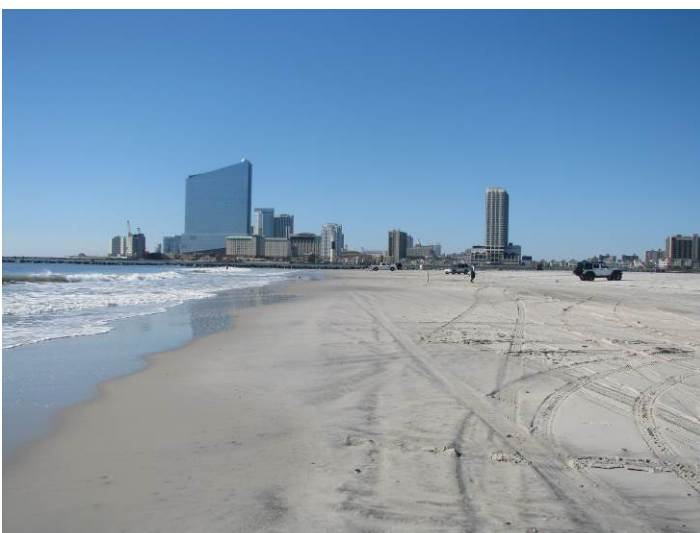
**Figure 9a** photo was taken looking south from October 15, 2015 after the first in a series of El Nino year northeast storm events. The wide beach protected the dune system from erosion with little net impact to the beach.

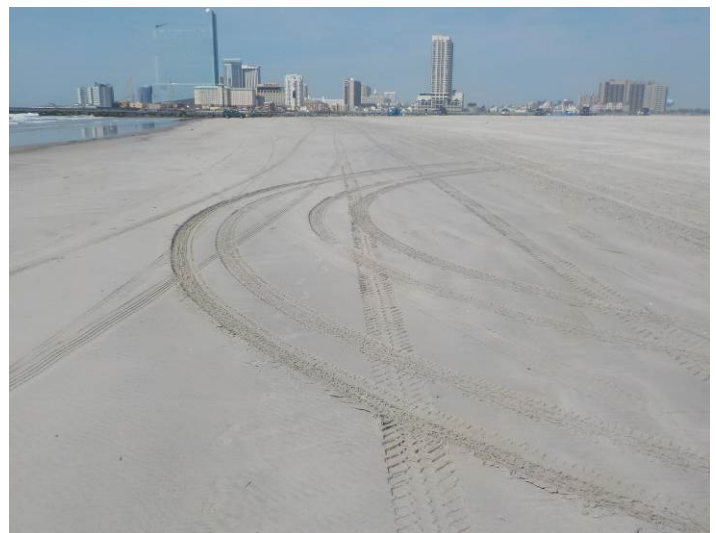
**Figure 9b** photo taken May 25, 2016 near the water's edge shows the beach width adjacent to the Absecon Inlet jetty.
