THE RICHARD STOCKTON COLLEGE OF NEW JERSEY

The Richard Stockton College of New Jersey Coastal Research Center conducted its annual survey of the nine cross section stations along the municipal beach on April 16 and 17, 2012. These were compared to previous studies that were completed in April 2010 and April 2011. This work completes the annual review of the municipal beaches prior to the tourist season.

Review of Each of the Beach Cells in Cape May Point:

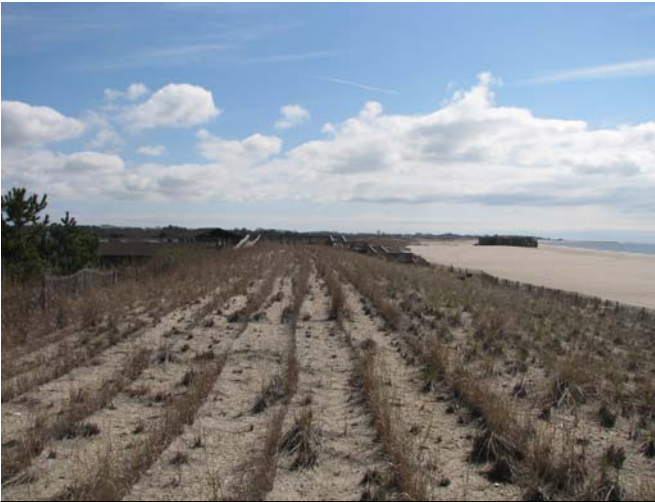
Figure 1. In April 2011 the dune remained stable and the berm and beachface extended noticeably seaward of the old bunker on the beach to the right in this photo. This is due to the beach sand pumping activity.

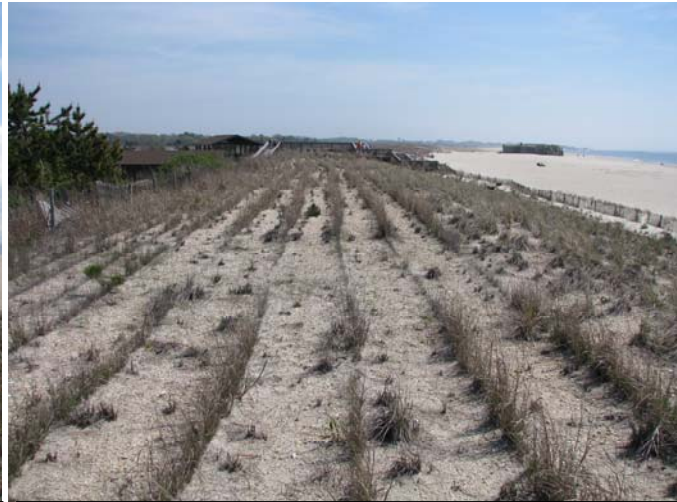
In April 2012, there was very little change to the dune and subaerial beach; though the shoreline moved landward and sand losses occurred.

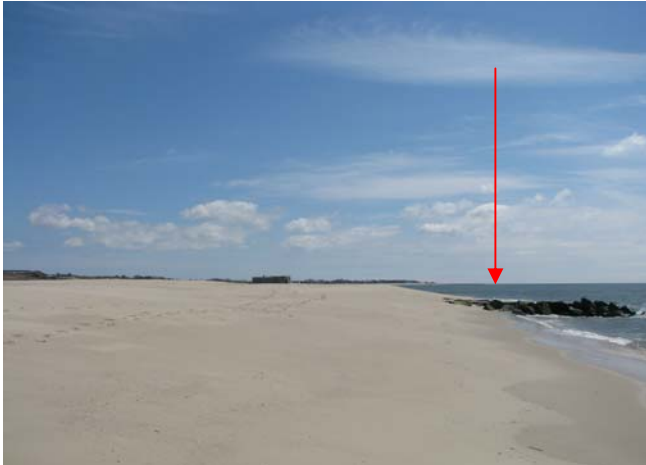
Figure 3. April 2011 shows a wide beach from the bunker to the first groin. Note that with the exception of the seaward end, the groin is buried by sand.

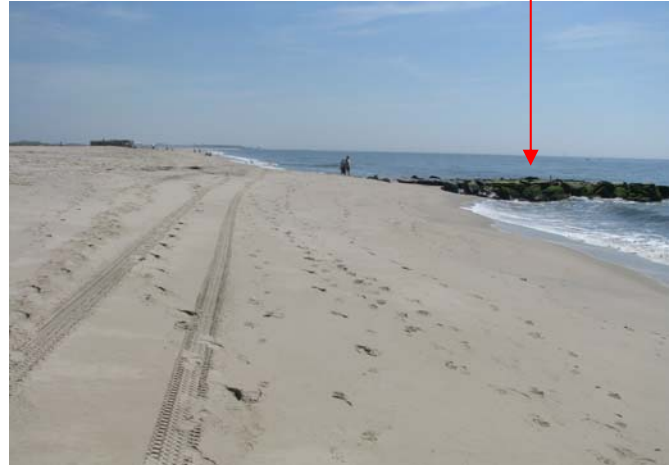
April 2012 More of the rock groin is exposed from the previous year.

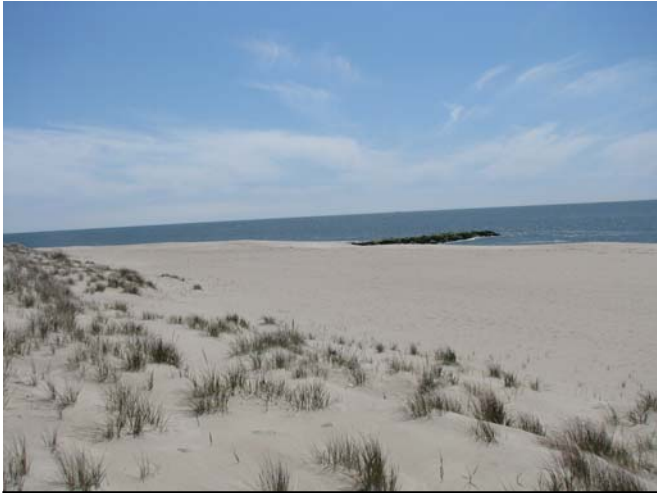
Figure 5. In April 2011 no additional fencing had been installed but plants were now spreading seaward onto the upper beach.

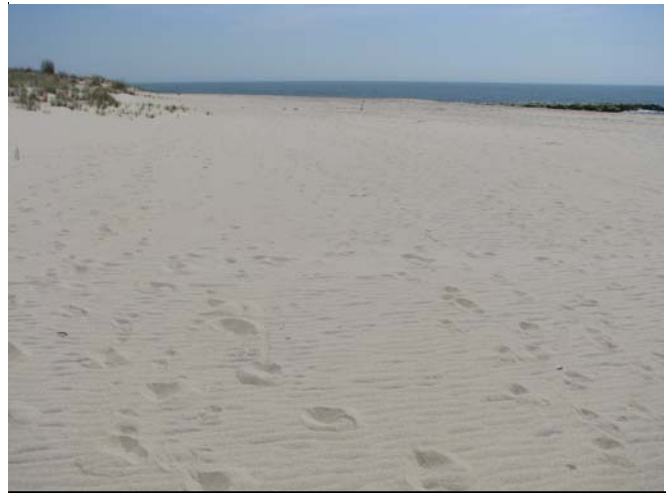
By April 2012, the dry beach changed very little, though there was some gain in elevation.

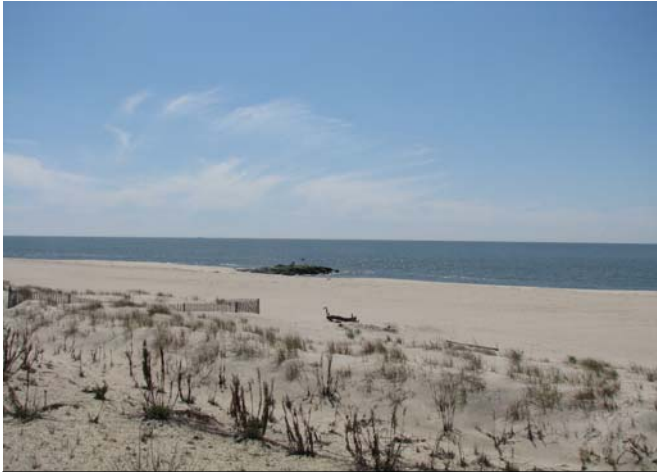
Figure 7. April 2011 the foredune had spread seaward and nearly engulfed the vehicle access path. No additional fencing was installed but plants had spread onto the upper beach, trapped sand and expanded the dune toe.

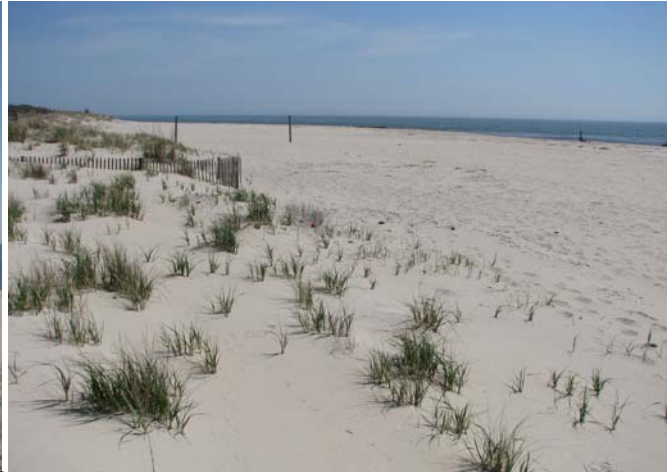
In April 2012, the foredune continued its seaward expansion.

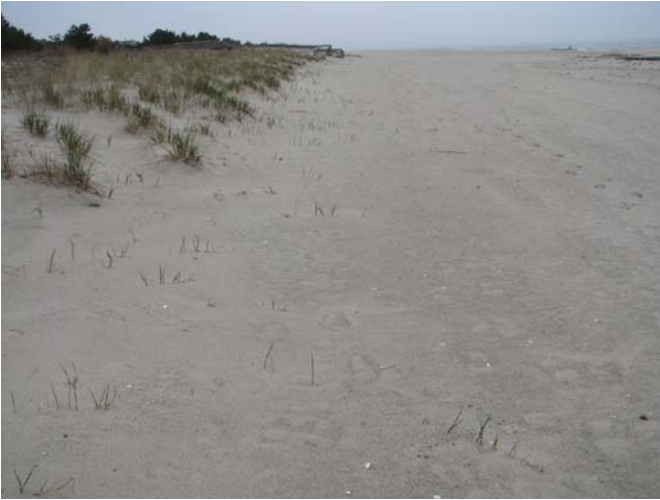
Figure 9. April 2011 the ACOE maintenance fill was complete leaving a wider beach. No effort has been made to install additional dune fence at this site.

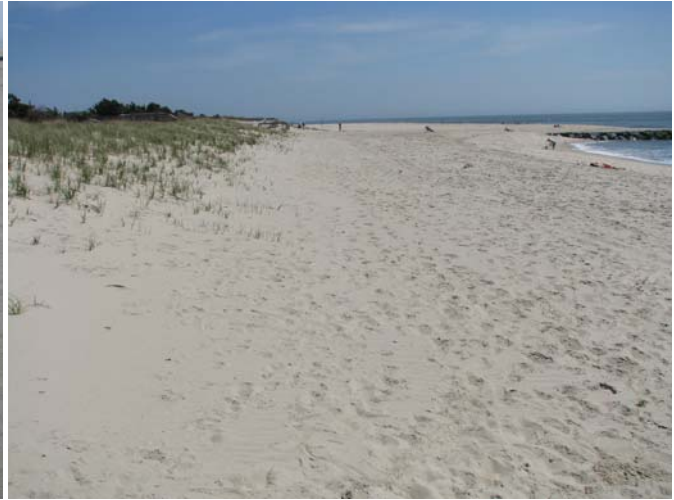
The April 2012 photo shows the accumulation of sand on the northeast (updrift) side of the groin at Coral Avenue.

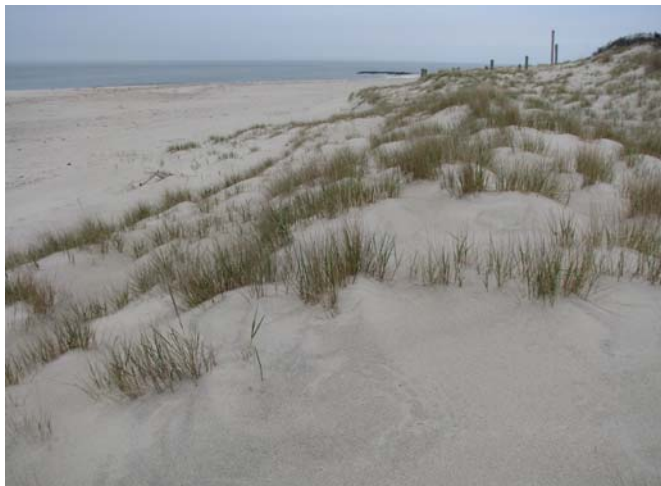
Figure 11. April 2011 the foredune had grown into a significant feature. Wind-blown sand accumulated around dune grass that has spread across the dune onto the beach.

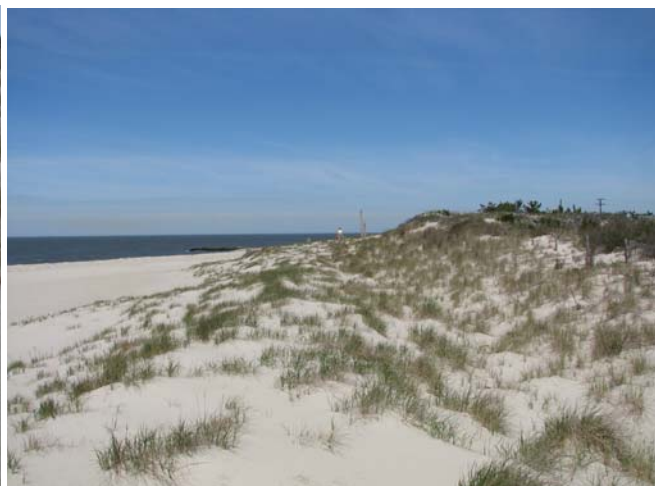
By April 2012 the foredune continued to grow in elevation from the previous year.

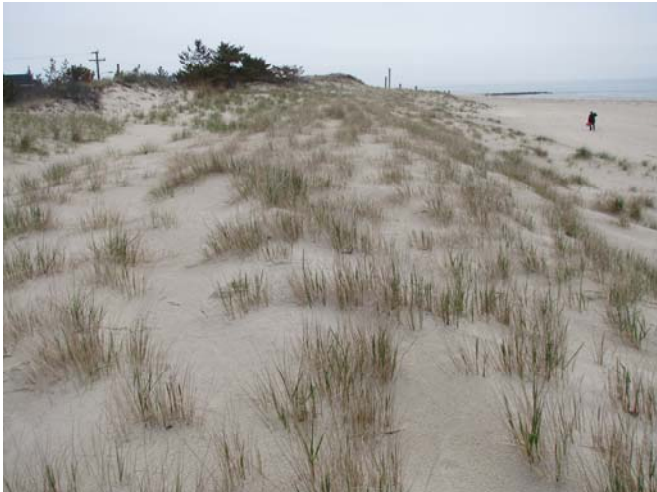
Figure 13. April 2011, This dune continues to accumulate sand with extensive plant coverage spreading seaward onto the beach. The wider beach allows for natural dune advances without the

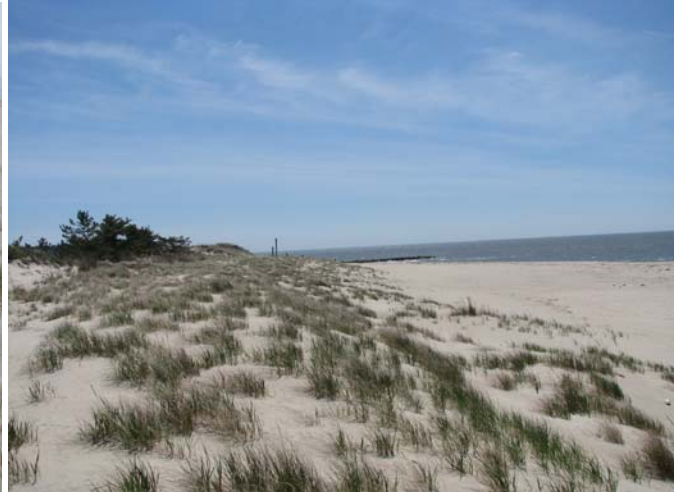
By April 2012, the foredune increased in elevation and expanded seaward from its 2011 location.

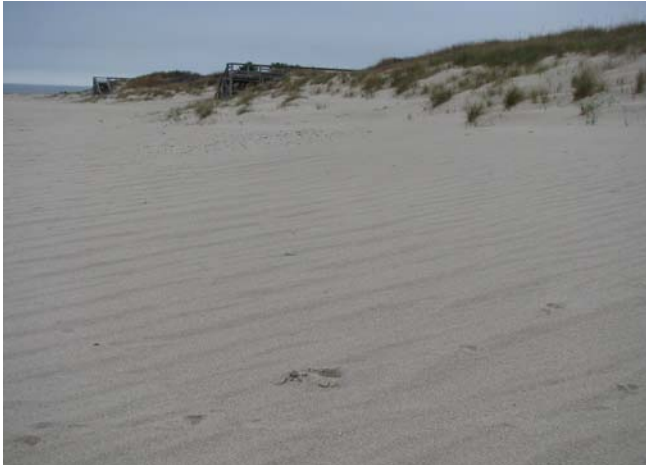
Figure 15. April 2011 The wider beaches continue to support seaward dune growth. Note the dune crossovers are now engulfed by the foredune expansion.

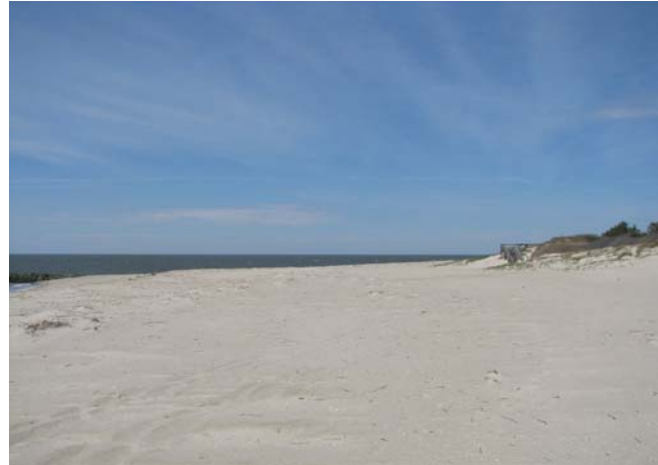
By April 2012, the foredune continued its upward and seaward growth from wind-blown sand.

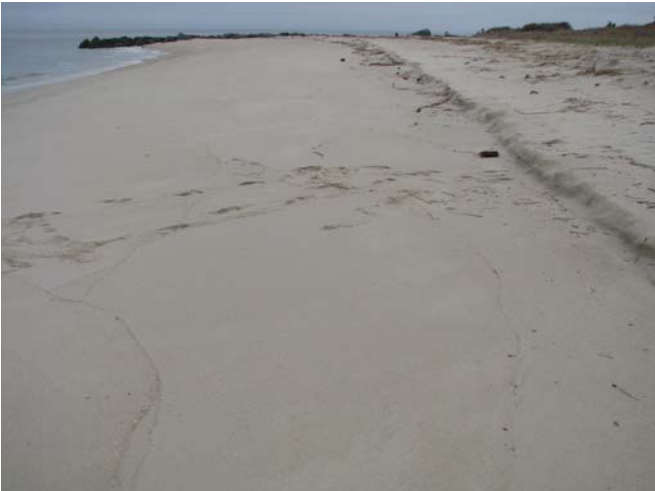
Figure 17. April 2011 the beach has extended seaward to near the tip of the Alexander groin. The beach is now wide enough to support both dune growth and recreational users.

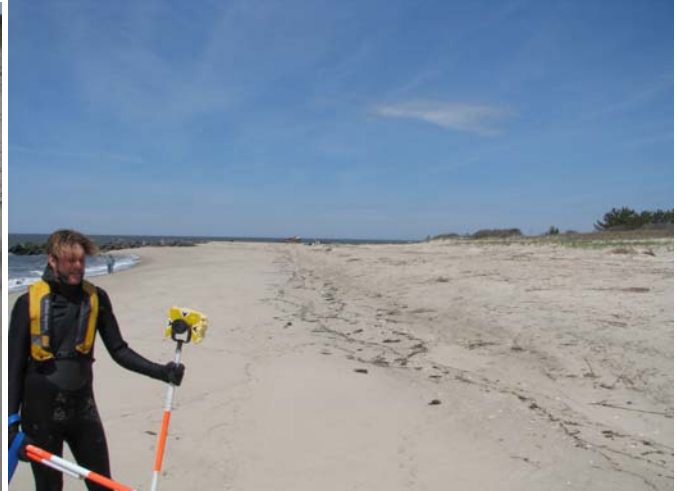
By April 2012, wind-blown sand continued to deposit in the foredune increasing its height and seaward growth.

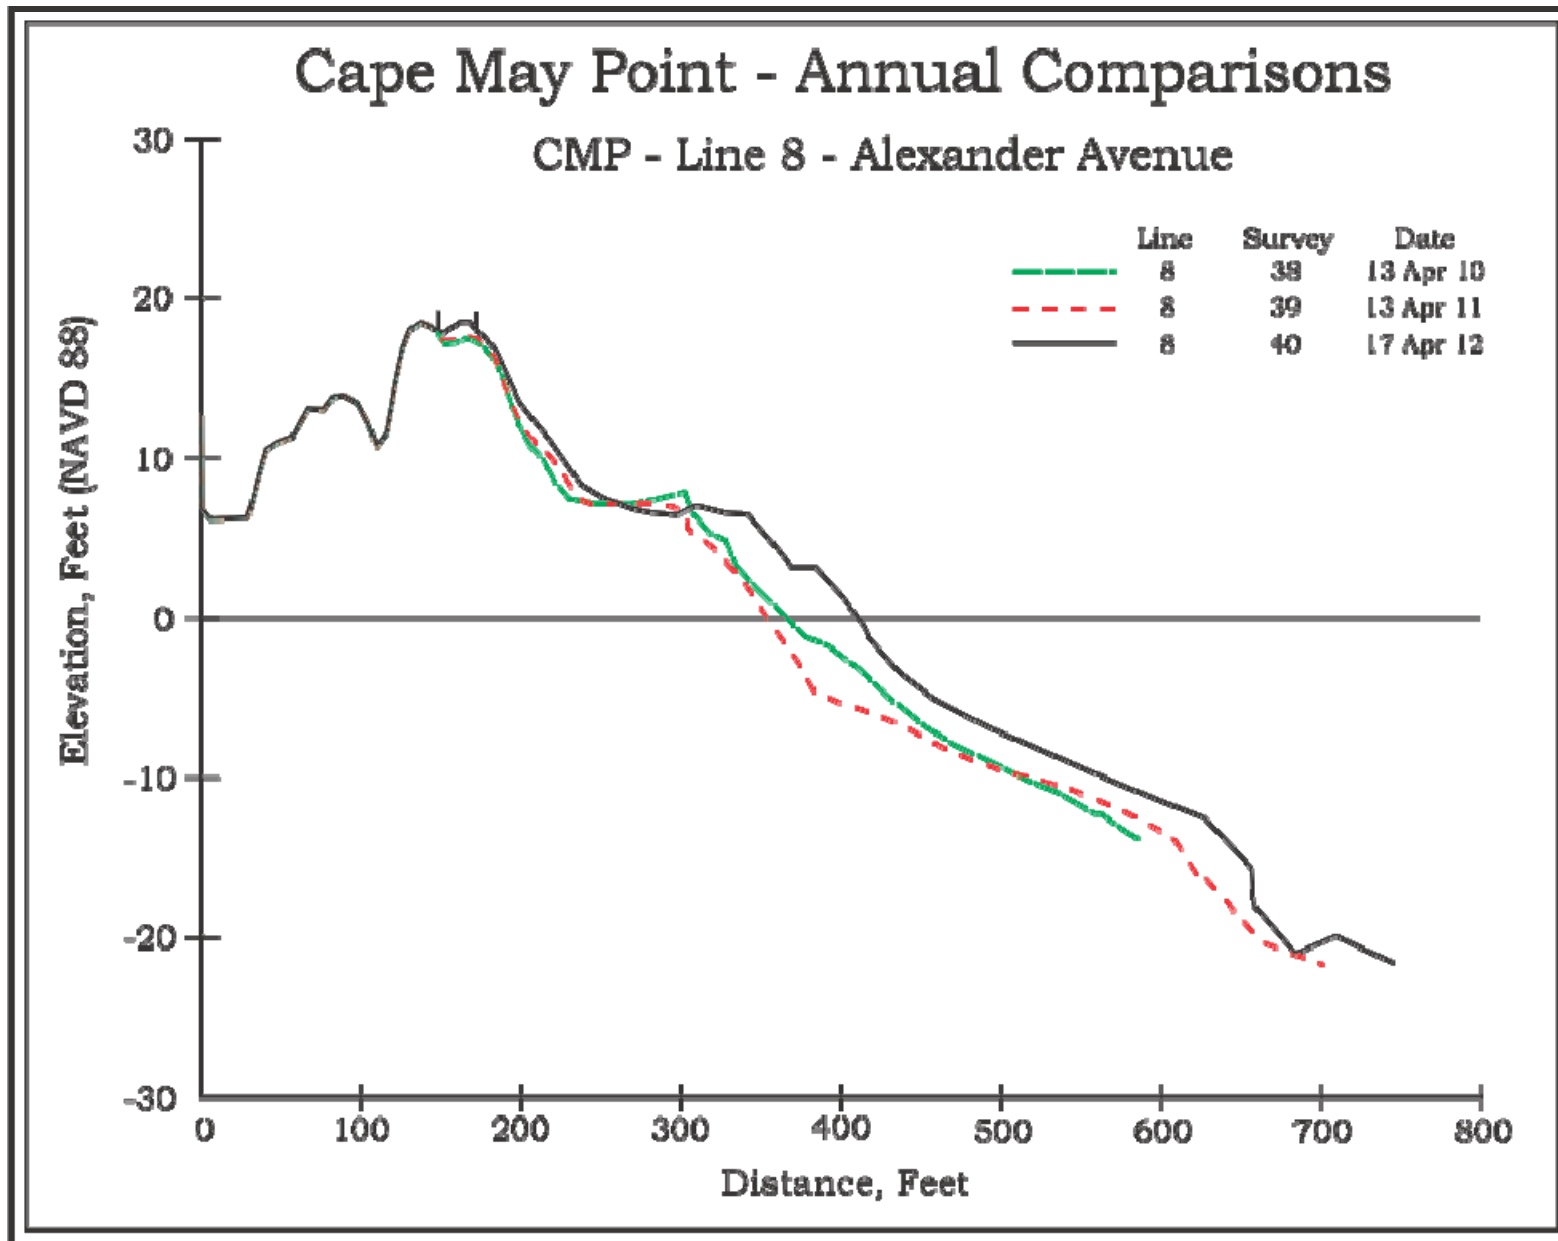
The Alexander Avenue location, CMP-8 and the westernmost cell (Cell 8), is positioned between the last two groins in Cape May Point. Sand has never been placed on the shoreline here either during the USACE projects or earlier, yet sand continues to move into this cell due to the high volume of material added to the east. This cell gained the most in sand volume with the largest shoreline advance of any of the Borough's beaches from sand that moved from the beaches to the east indicating that the western-most "terminal" groin at this site still has the capability to retain sand. It is evident that sand escapes the Alexander Avenue groin to move further into Delaware Bay toward the Sunset Beach area, but there is a strong shoreline offset at the Alexander Avenue groin with abundant gravel at the surface on the western side of the structure. Swimming is currently not allowed here because this is both a popular fishing beach, and has very strong tidal currents sweeping past on either flood- or ebb tides.

Figure 18. The Alexander Avenue location continued to accumulate sand across the profile (48.11 cy/ft) and the shoreline moved 56.66 feet seaward of the 2011 location.
