**ANNUAL REVIEW FOR 2015
OF THE CAPE MAY POINT, NJ MUNICIPAL BEACHES**

PREPARED FOR: THE BOROUGH OF CAPE MAY POINT
215 LIGHTHOUSE AVENUE
CAPE MAY POINT, NJ 08212

PREPARED BY: STOCKTON UNIVERSITY COASTAL RESEARCH CENTER
30 WILSON AVENUE
PORT REPUBLIC, NJ 08241

MAY 29, 2015

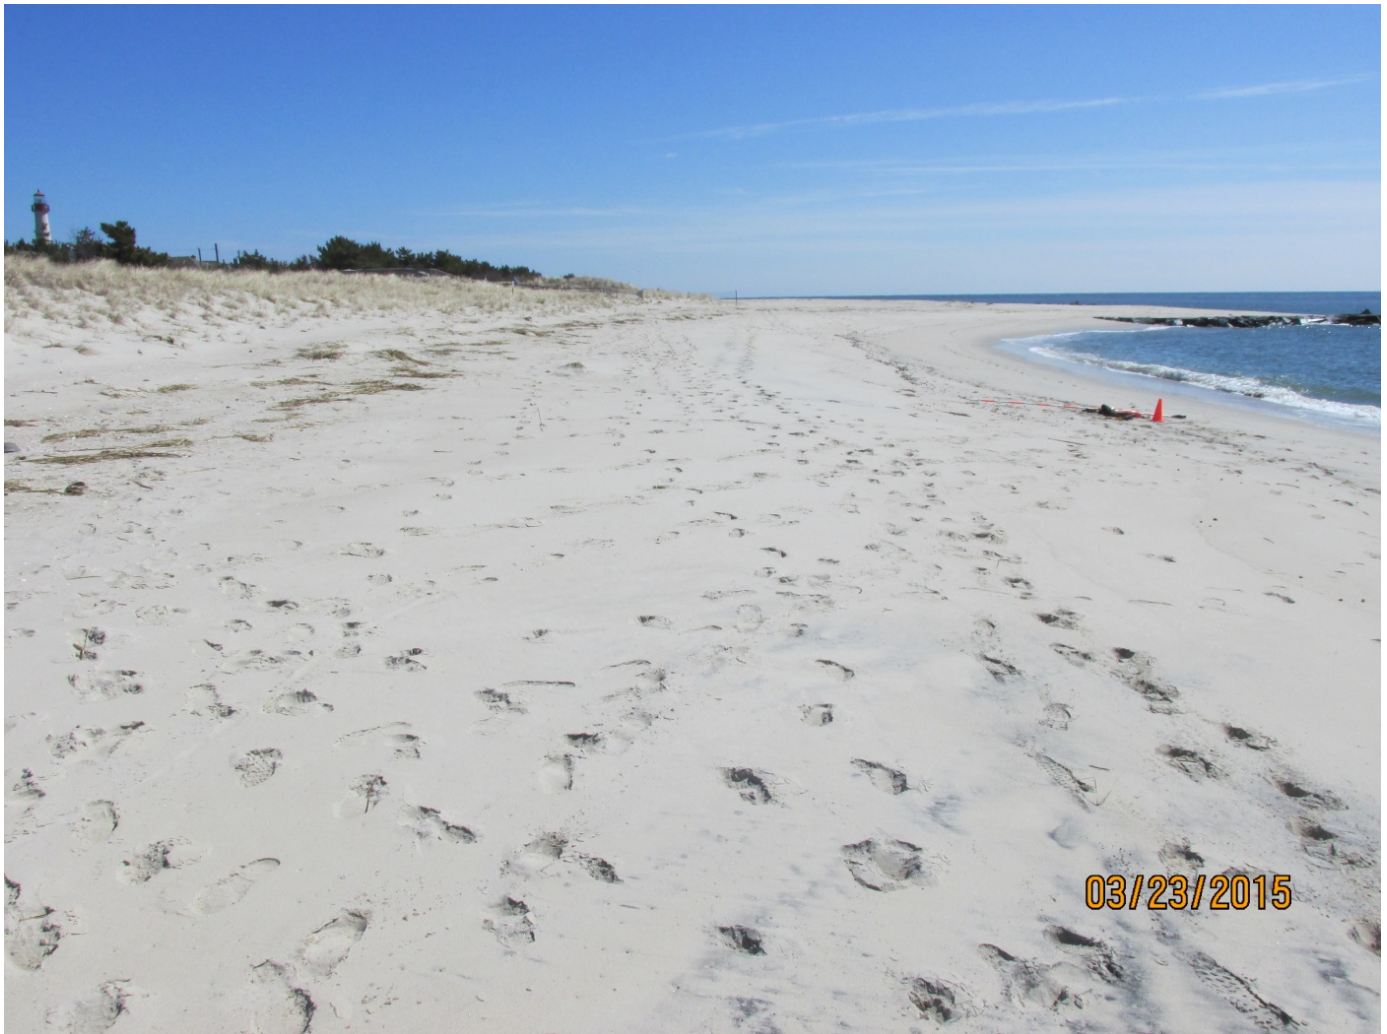
The Photo above taken on March 23, 2015 shows the existing offset conditions between the beaches at Lake Avenue in the foreground and Coral Avene on the updrift side of the rock groin. In 2009 the USACE transferred sand from the Coral Avenue beach cell to the Lake Drive beach to improve conditions in both cells temporarily alleviating the disruption in natural sand flow by the groin that results in the beach offset.

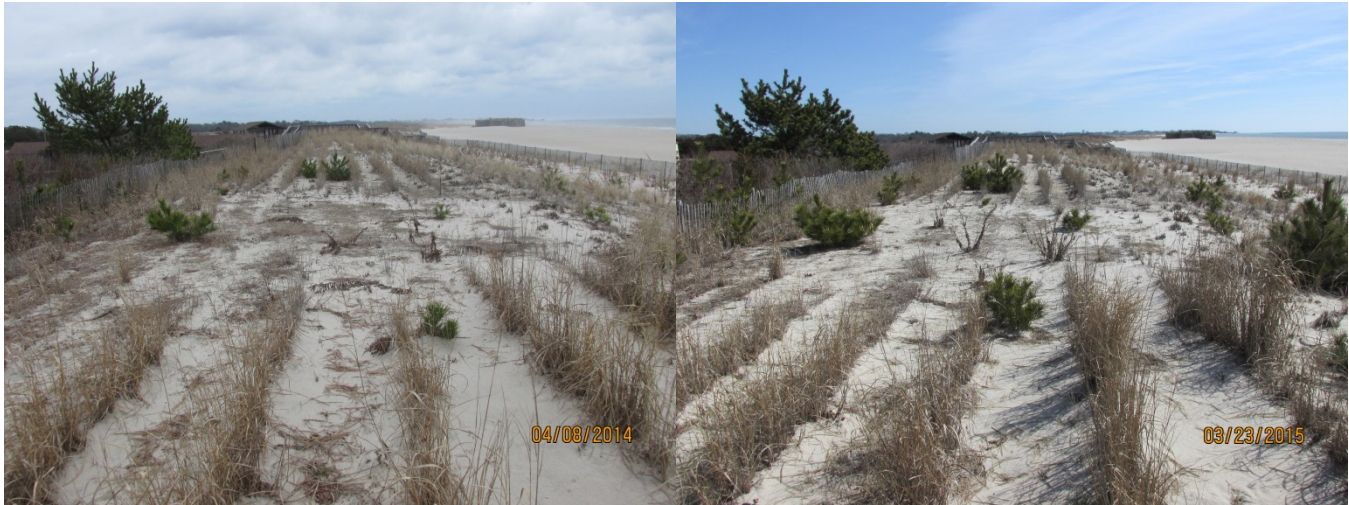
Lighthouse Avenue

This shot taken in April 2014 shows the view looking northeast from the dune crest. The bunker in the distance offers a good visual reference point for qualifying changes to the beach.

The photo taken on March 2015 shows the dune and beach remained remarkably stable this year. There were no visible changes to the beach or dune system other than plant growth.

The beach and dune system remained stable through March 2015. Modest beach erosion along the beachface slope removed some sand from the system. The shoreline retreated a modest 8 feet while -9.84yds³/ft. of sand eroded from the site. Almost all of the eroded sand (-13.35yds³/ft.) was from the berm and beachface. This beach still provides ample storm protection to prevent significant storm damage to the dune system and oceanfront properties while aeolian sand from the beach continues to feed sand to the seaward dune slope and foredune around installed dune fences. The beach configuration on March 23, 2015 closely mimicked the April 2014 profile. The beachface slope remains relatively steep at a rate of approximately 10 to 1 so that within 200 feet the seafloor goes from 0 to -20 feet NAVD 88. Proximity to the nearshore tidal channel cause stronger longshore currents along this shoreline moving sand in the down drift direction.

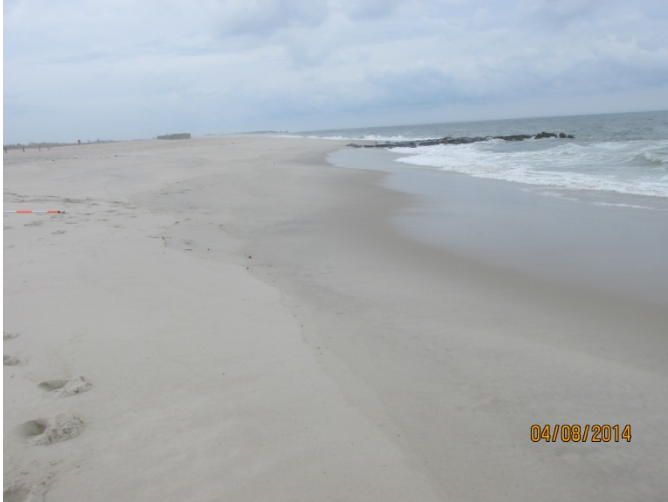
04/06/2014

This photo taken on April 2014 shows beachface erosion has exposed more of the rock groin along the down drift shoreline.

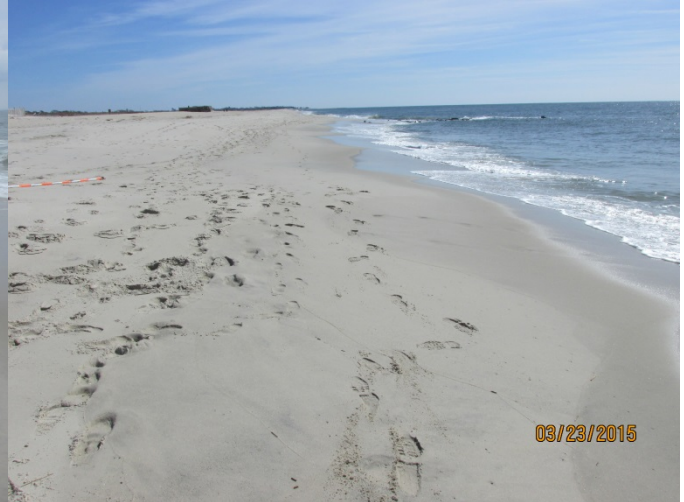
03/23/2015

Taken on March 23, 2015, this photo shows that the beachface recovered some of the sand lost by the April 2014 survey. The berm is noticeably wider and higher.

The project beach rapidly eroded through April 2014, however, by March 2015 the erosional trend had reversed and this site gained 13 feet of shoreline with a net increase of 19.36 yds³/ft. of sand. This beach still provides ample storm protection to prevent significant storm damage to the dune system and oceanfront properties while aeolian sand from the beach continues to feed sand to the seaward dune slope and foredune around installed dune fences. The beachface slope remains relatively steep within the initial 125 feet the slope then steepens to an angle of repose slope into the adjacent tidal channel. The proximity of this beach to the nearshore tidal channel with strong longshore currents near the end of the groins creates the potential for rapid retreat of the beachface slope as the channel cuts landward into the nearshore slope.

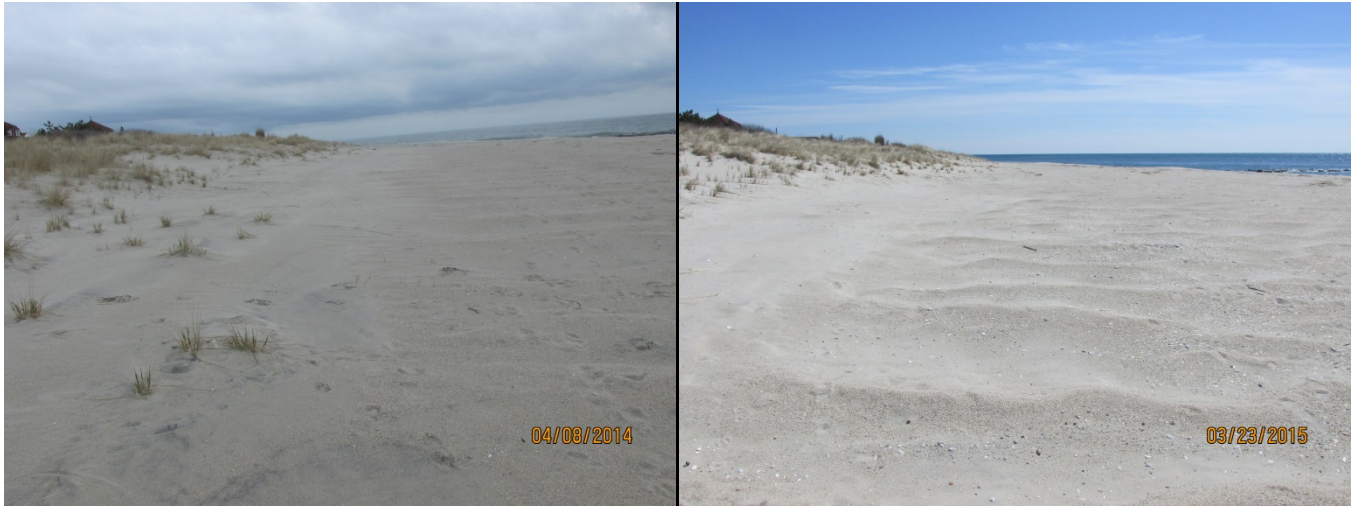
Lehigh to Whilldin Avenues

The photo was taken on April 8, 2014 from the toe of the dune. Plants are colonizing the seaward dune slope where aeolian deposition has expanded the feature seaward.

The photo taken on March 23, 2015 shows continued aeolian accumulation and colonization of plants seaward onto the open beach. The overall beach width has decreased while the elevation has remained stable.

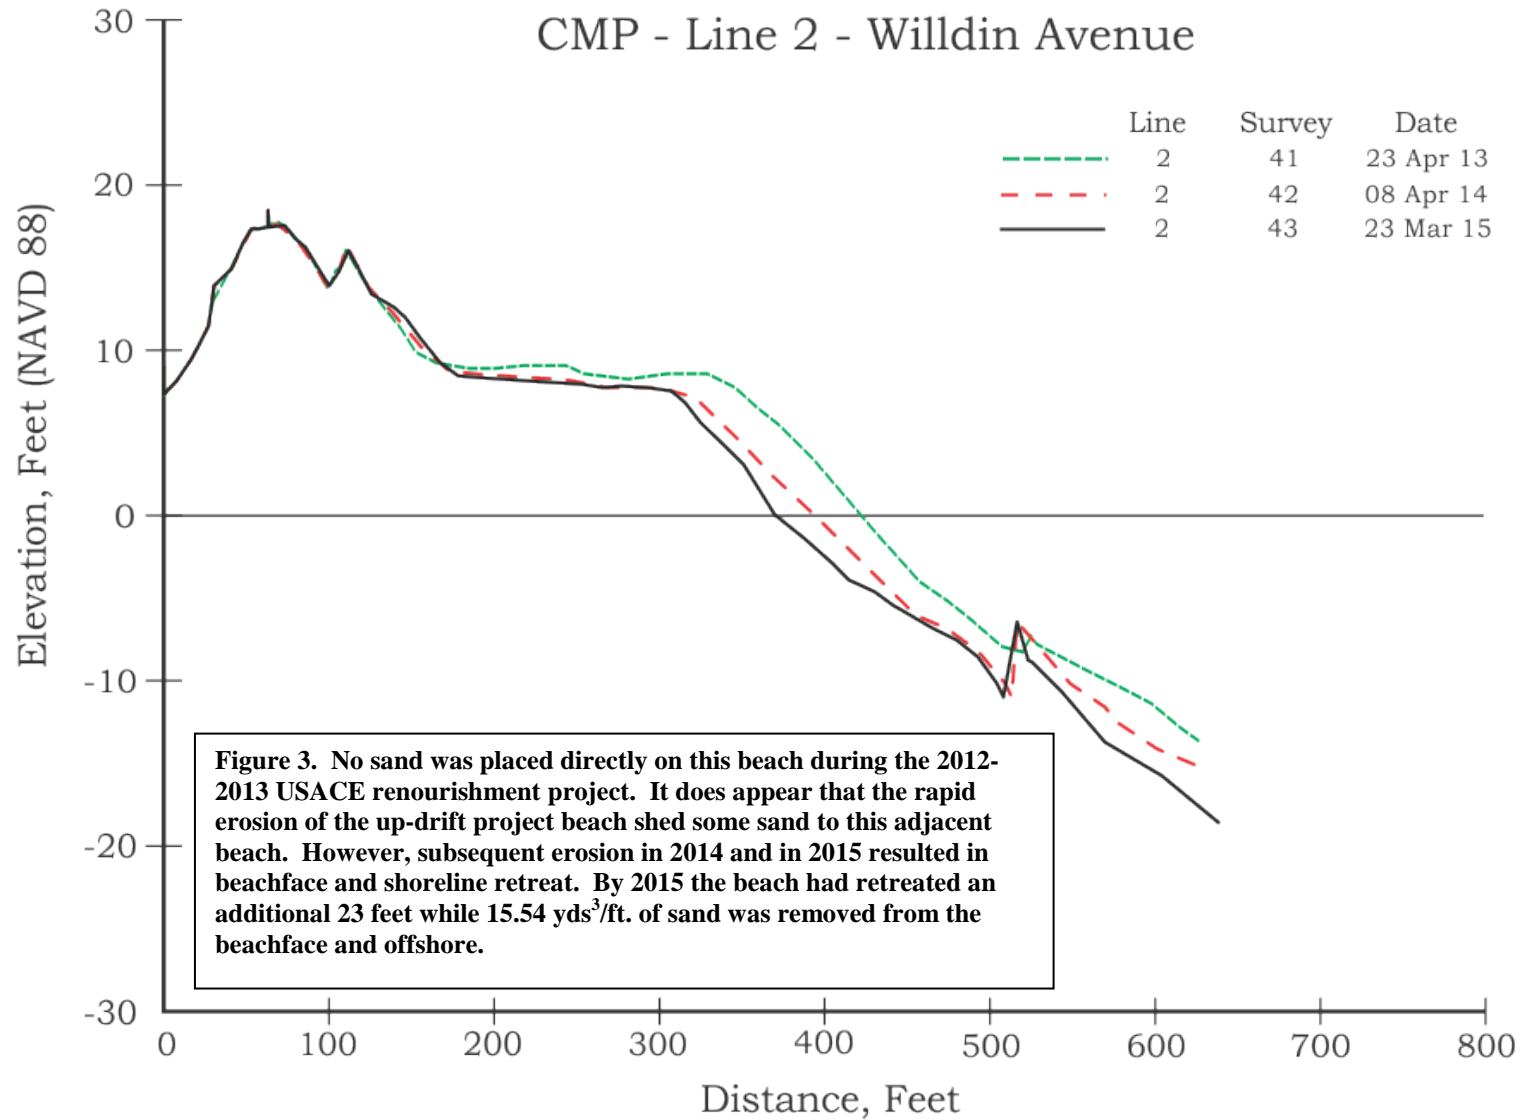
CMP - Line 2 - Willdin Avenue

Sand shed from the recent project beaches accumulated rapidly in this cell during 2013. The site gained 32.58 yds³/ft. of sand and the shoreline advanced seaward 32 feet. Accumulation of sand continued from the foredune seaward to the profile limits. However, by April 2014 over half of this gain eroded primarily shed from the beachface and berm. The shoreline position retreated 28 feet with a loss of 26.64 yds³/ft. of sand eroded from the beachface. By March 2015 the erosional trend has continued with an additional 15.540 yds³/ft. of sand lost with a shoreline retreat of 23 feet. The deeper trough (-11 feet NAVD88) that was scoured in 2014 landward of the “Beachsaver” units has remained, while beyond the units offshore sand has also been lost for 2 consecutive years.

The “Beachsaver” unit crest protrudes about two feet above the nearshore slope. Landward of the units a deep trough was scoured that exposed 5 feet of the vertical landward face of the unit. The crest is 125 feet seaward of the zero elevation shoreline position (about mid-tide position) with the concrete units residing in -11 feet (landward) and -8.0 feet (seaward) of water below the NAVD88 zero elevation. The crest protrudes up to elevation – 6 feet NAVD88. In this instance the units are unlikely to be encountered by swimmers this season within the middle of the groin cell. As always caution and restrictions should be in placed closer to the groins where the shoreline sand extends outward toward the concrete reef along each groin.

2. The zero elevation position (NAVD 88 zero, which equals about 1.5 feet above the average low tide) in Cell 2 at Whilldin Avenues is now about 150-foot distance from the breakwater structure. In 2013 the shoreline position was less than 100 feet from the submerged units. A deeper trough has developed between the water's edge and the breakwater units nearly -11 feet immediately landward of the units. While about 50 feet landward of the units the depth is approximately -7 feet. The swimming area is limited, but may again be manageable this year. The CRC again recommends installing a line of floats indicating the maximum distance for swimming that should be about 30 feet from the breakwater reef. Swimming near the groins has been avoided in all

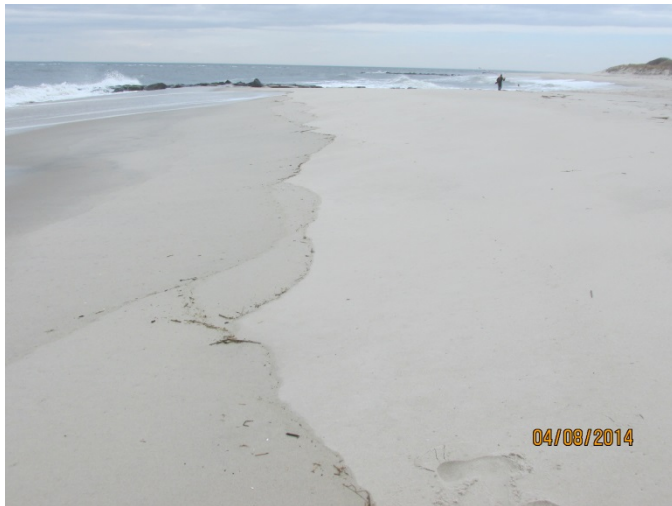
The 2014 photo taken on April 8 shows the dune and beach have remained relatively stable. The adjacent groin represents a good visual reference point for qualitative comparison.

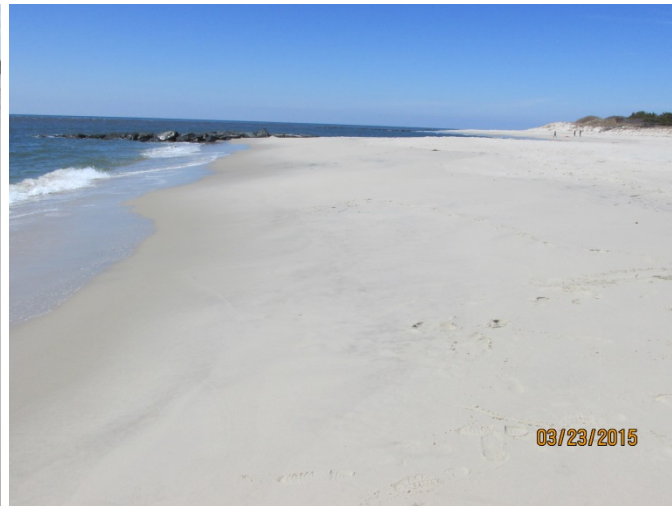
The 2015 photo taken on March 23 shows that the berm appears to have lost a modest amount of width and height. The adjacent groin appears to have less beach around it in 2015.

By March 2015 the beach had modestly eroded along with the beachface slope. The shoreline position retreated landward 9 feet with a loss of 21.663 yds³/ft. of sand. This modest loss of beach width kept the units in relative close proximity to the shoreline approximately 90 feet. The concrete crest lies in 5.0 feet of water at mid-tide (NAVD88 zero datum). This location remains the most problematic in terms of swimmers encountering the structure while using the beach. There is no deep trough at the landward side of the reef structure. The swimming space has increased by 30 feet and if the guards are diligent in keeping swimmers close to shore in shallow water less than 3-4 feet deep regardless of the tide level, water access could be allowed here. Water access near the groins where the units are closer to shore should be prohibited.

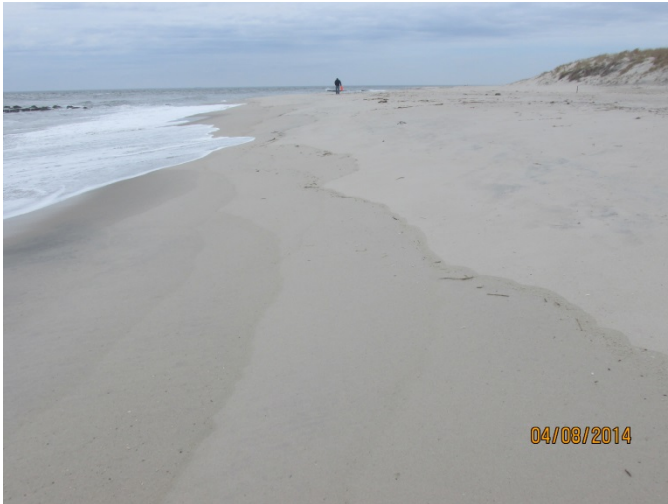
By April 2014 the beachface had eroded nearly 40 feet, while the dune system remained stable.

By April 2014 approximately half the beach width added during the recent project was eroded. The shoreline retreated 29 feet with a loss of 24.79 yds³/ft. of sand scoured from the beachface slope and swept by longshore currents from the beach cell. The dune and offshore seafloor were relatively stable.

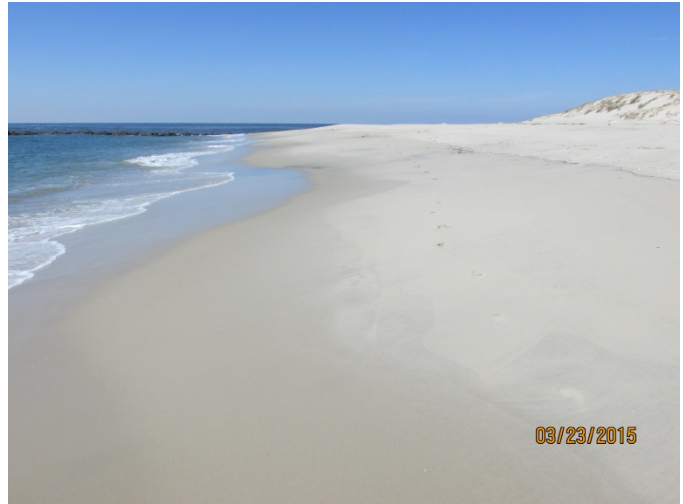
Photo above was taken from the swash on March 23, 2015. The erosion of the beachface has continued in 2015 as an additional 13 feet of shoreline was lost.

By March 2015 the erosional pattern continued, and the shoreline retreated an additional 13 feet while 16.764 yds³/ft. of sand volume was lost. Since 2013 this site has lost 41.956 yds³/ft. of sand and the shoreline has retreated 42 feet. Despite the recent losses this beach should still support recreational activity this summer. This location remains one of the more desirable bathing beaches in the Borough with approximately 70 feet of dry recreational beach, a gradual descent into deeper water and a relatively large, shallow offshore platform area for recreational swimming.

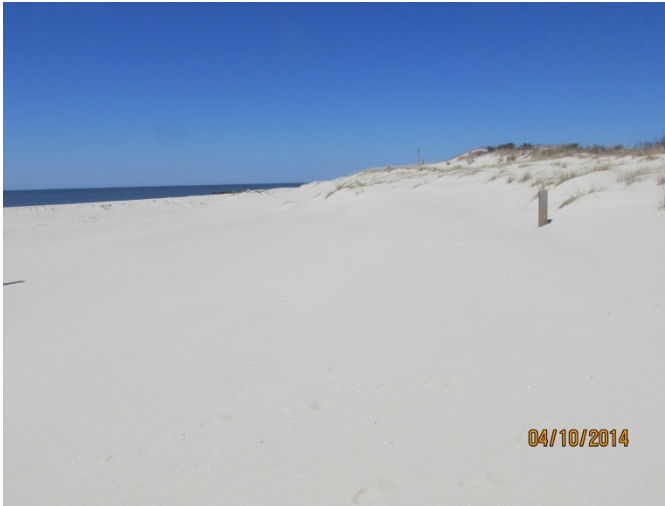
The photo taken on April 10, 2014 shows a significant accumulation of aeolian sand on the seaward slope. Sand deposition buried the dune grass on the seaward slope. The beach berm remained stable this year.

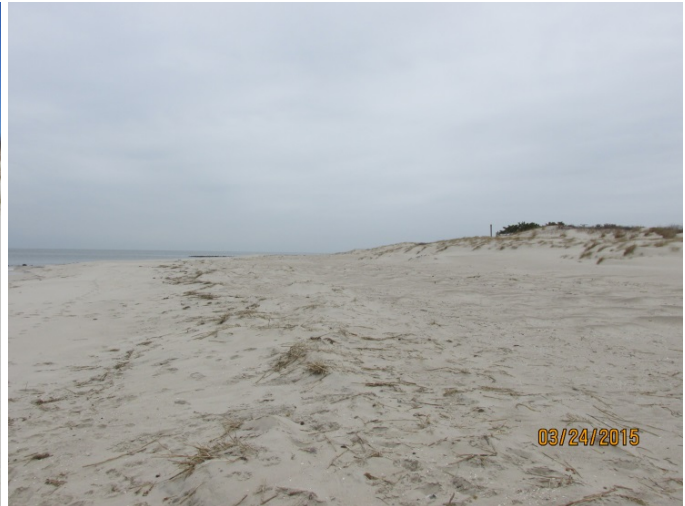
The photo taken on March 24, 2015 shows berm and dune conditions similar to the April 2014 survey. Modest volume gains occurred above the 0.0 ft NAVD88 datum.

Dune and berm conditions remained between the April 2014 and March 2015 surveys. Most of the volume losses occurred below the 0.0 ft NAVD88 datum (-6.6 yds³/ft) where the profile was lowered in elevation about 2 feet. The shoreline moved seaward a modest 4.5 ft.

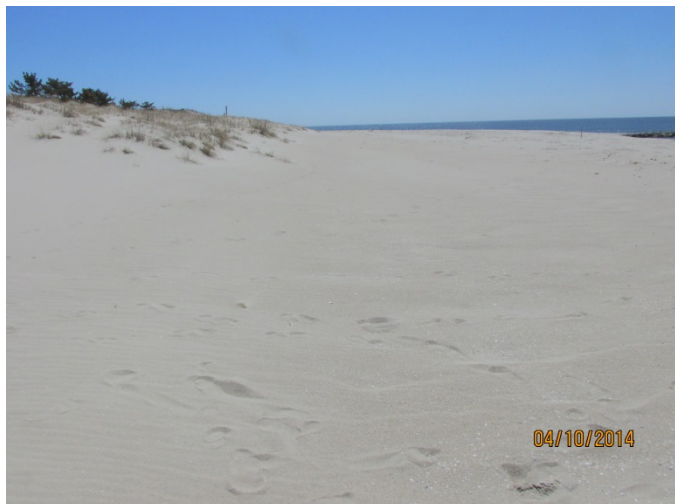
Aeolian sand continued to accumulate and has buried the dune grass on the seaward slope by April 10, 2014. The recreational beach berm remained stable and provides ample recreational space for beach patrons.

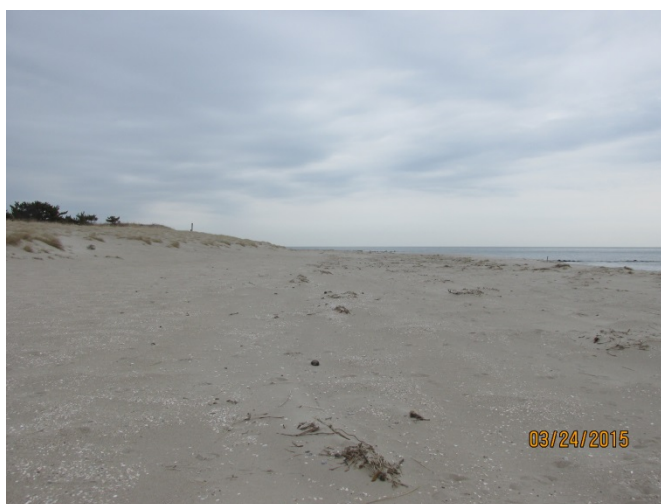
This photo taken on March 24, 2015 shows some of the seaward growth of the dune and vegetation that occurred during 2014-2015. (View to the east).

The dunes continued their seaward migration into 2015, and the entire profile gained 12.1 yds³/ft (similar to the amount that was found in 2014) and the dry beach moved seaward by 12.2 ft. These beach and nearshore changes make this beach an excellent option for most recreational activities. The relatively long public access pathway from Pearl Avenue to the beach has become further elevated by the deposition of at least four feet of new sand at the crest of the pathway to the beach. Since this change will likely bring pedestrian complaints about the difficulty of the “trek” to the beach this summer, we suggest the installation of “rolled boardwalk” sections to assist in the journey over the dune.

This could be accomplished by public works by obtaining retired fire company hose, make up 3.0 foot long decking, and buy neoprene capped roofing paper nails. Lay out the deck boards with the spacing in the sand, put the firehose along each edge about 6 inches in, nail to each deck board leaving about 8 inches of hose left over at one end of the section created. Then nail the sections together when finished and flip the walk over to use it. This particular ascent would require about 100 feet of walkway. Alternatively, Mr.Boardwalk.com will supply the material in sections at a much higher price. Perhaps contact the public works director in Avalon Borough because I know they use it and in far longer sections than Mr. Boardwalk supplies.

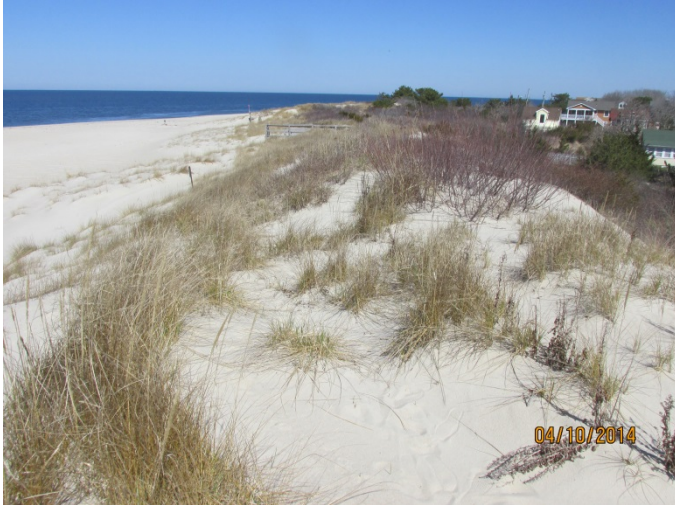
The April 10, 2014 photo shows continued sand accumulation on the seaward dune slope. The recreational beach berm width has expanded seaward approximately 20 feet during the year.

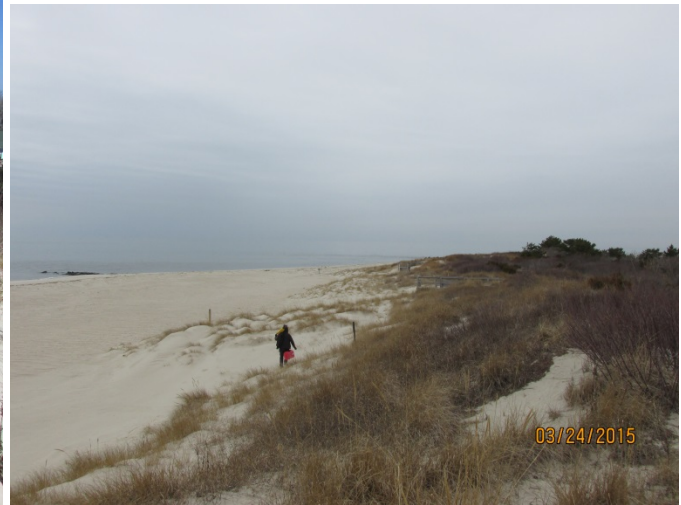
This photo taken on March 24, 2015 shows the stable dune that occurs from natural aeolian conditions. The berm and nearshore remained at nearly the same elevation as the 2014 survey (View to the west).

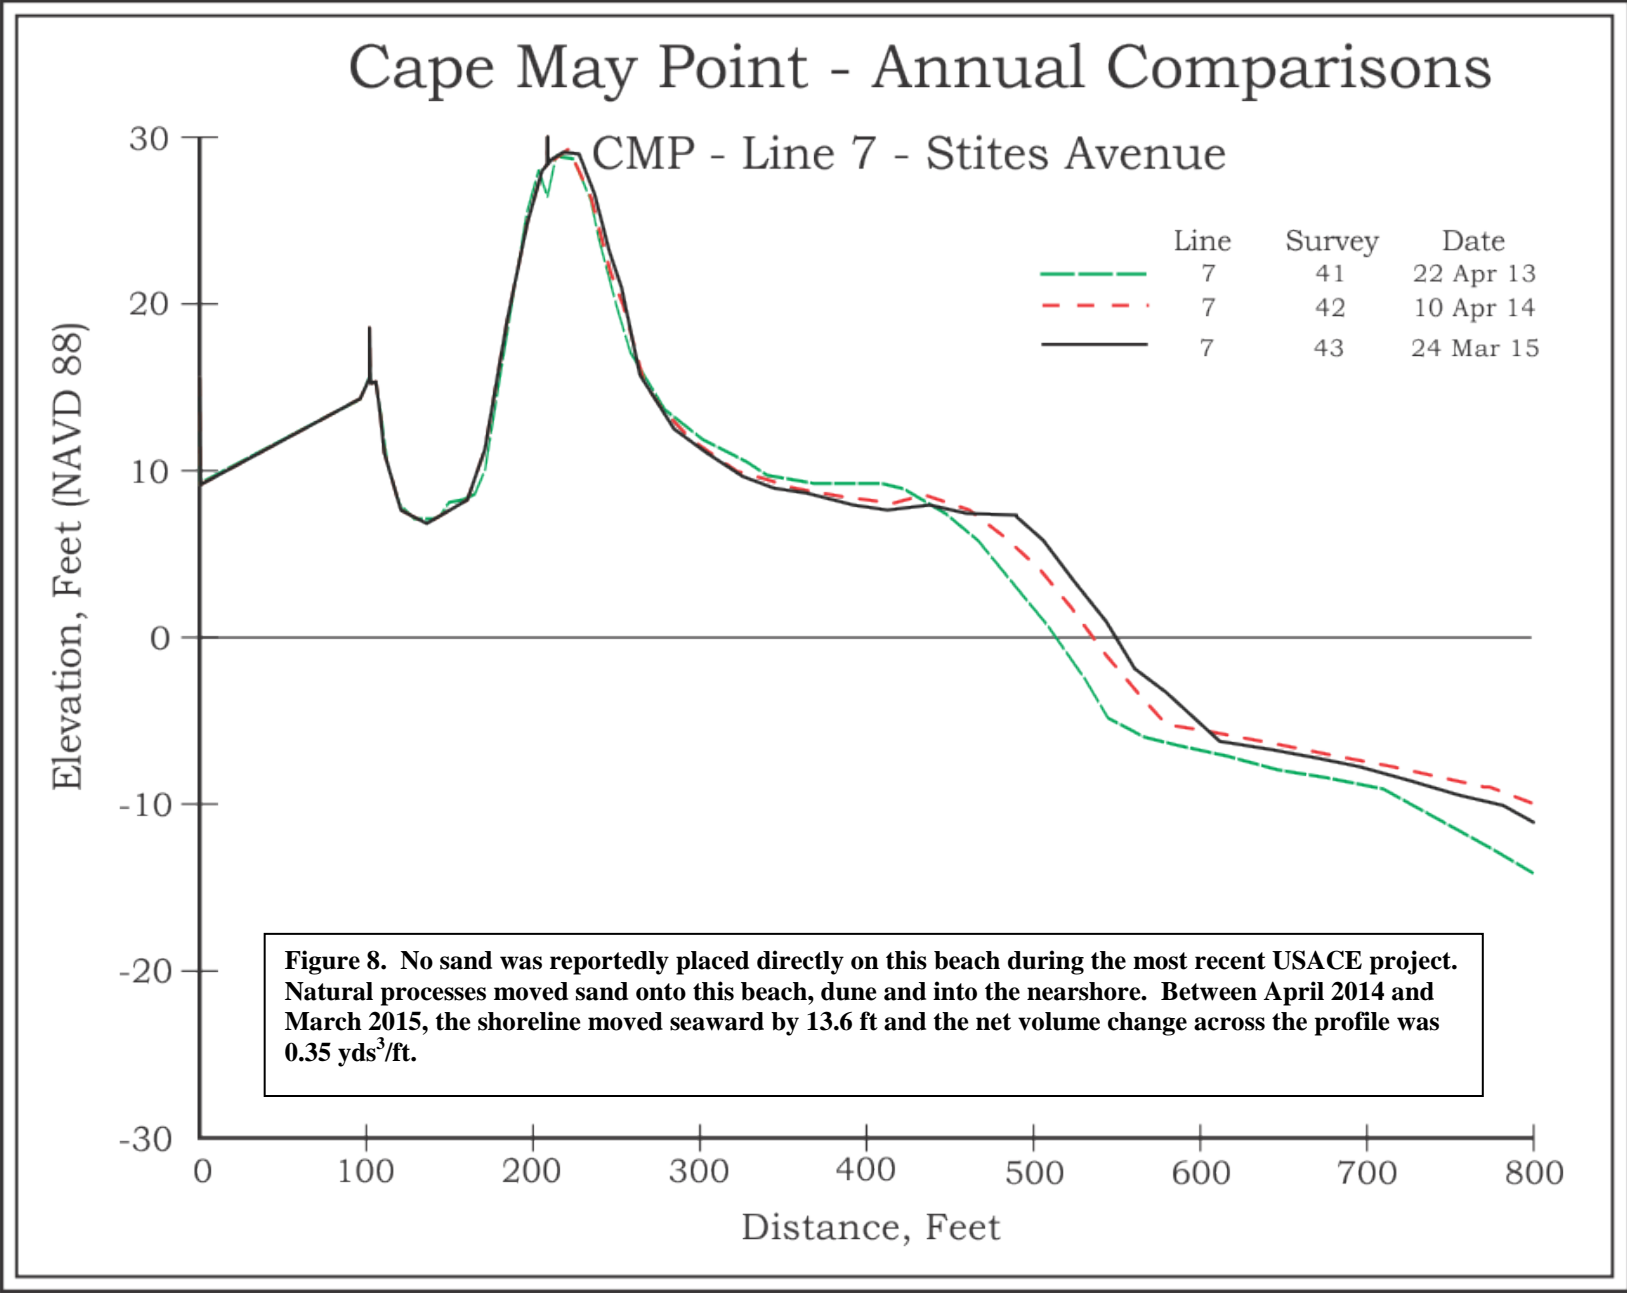
By April 2014 another lobe of sand had moved landward from offshore onto the nearshore and beachface slope up to the berm crest and the net annual gain was 33.51 yds³/ft of sand. The accreting trend continued into 2015 moving the shoreline seaward (13.6 ft) from the 2014 position. Though there was a negligible amount of volume gain across the profile (0.35 yds³/ft) during that time period.

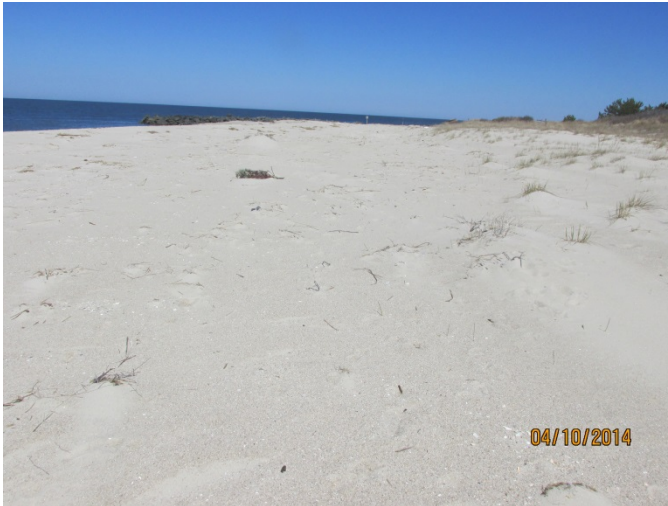
Sand continued to accumulate both on the beachface and across the recreational beach berm. By April 10, 2014 aeolian sand had buried much of the dune grass that had colonized the lower slope and dune toe in 2013.

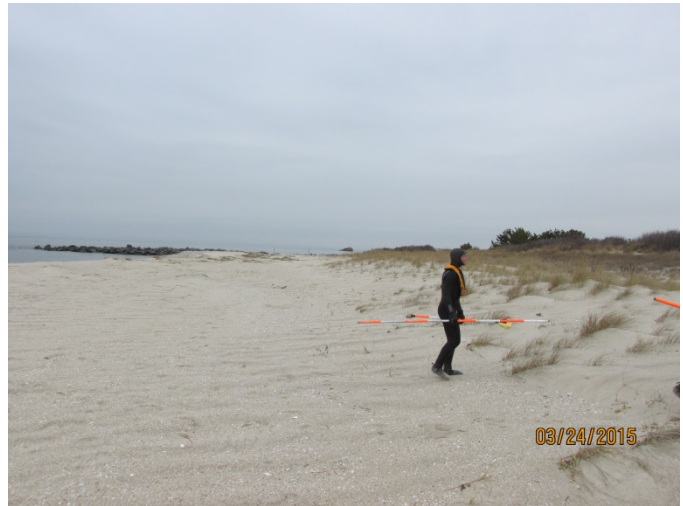
This photo taken on March 24, 2015 shows the dune and berm conditions similar to the 2014 survey. This site experienced negligible changes between 2014 and 2015.

Between 2014 and 2015, the profile experienced negligible volume losses (-0.86 yds³/ft) though the shoreline moved landward (-9.6 ft.). During this time, sand was added to the top of the berm from the 2014 position. The dry beach remains wide enough to support summer recreational activity onshore while the nearshore slope is steeper in this cell with water depths of -10 feet NAVD88 within 100 feet of the shoreline. The steeper slope and drop off near the end of the groins along with strong tidal currents in this region should probably limit swimming activity by most to the shallow nearshore region.

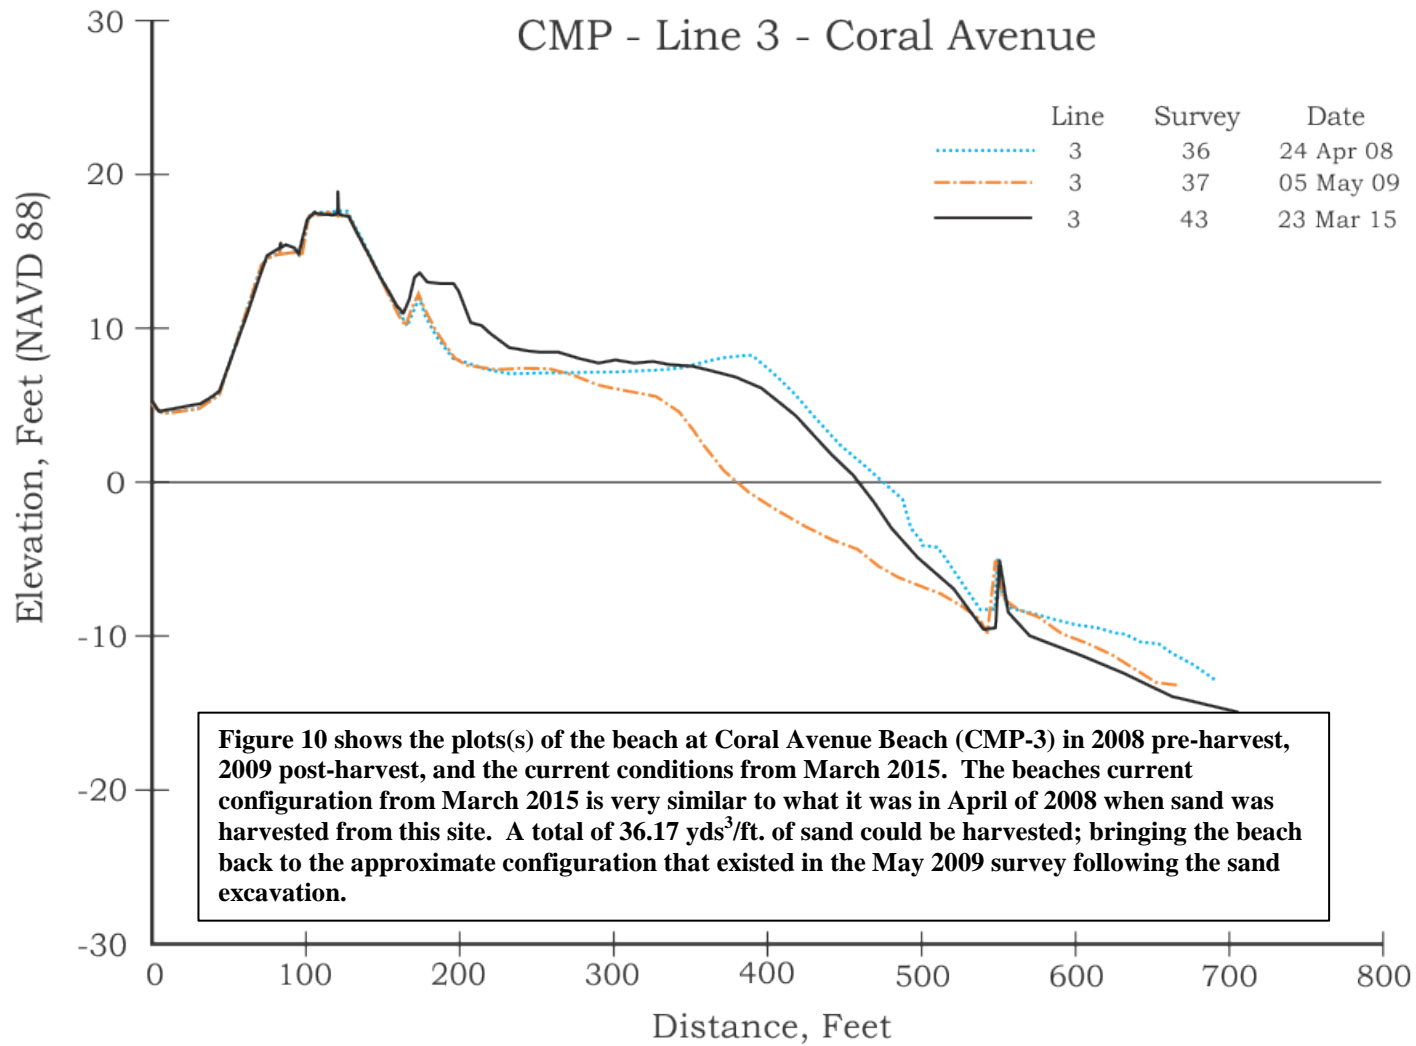
CMP - Line 3 - Coral Avenue

The 2015 configuration of both beaches in Cell 3 and 4 are again very similar to the conditions that prompted these USACE modifications to improve beach conditions in the winter of 2008/2009. For CMP-3 at Coral Avenue a volume comparison was done to determine how much sand is currently available for harvest. The calculation compared the 2009 post-USACE project condition to the current 2015 conditions. That analyst showed 36.14 yds³/ft. of sand could be harvested from the beach, restoring the 2009 USACE post-harvest beach conditions at Coral Avenue. In addition to supplying sand this would also again reduce concerns of swimmers in close proximity to the submerged concrete breakwater reef.

The plots below showing the pre & post project conditions compared with current beach conditions demonstrate the feasibility and benefits of conducting another sand transfer project for cells CMP 3 & CMP 4.

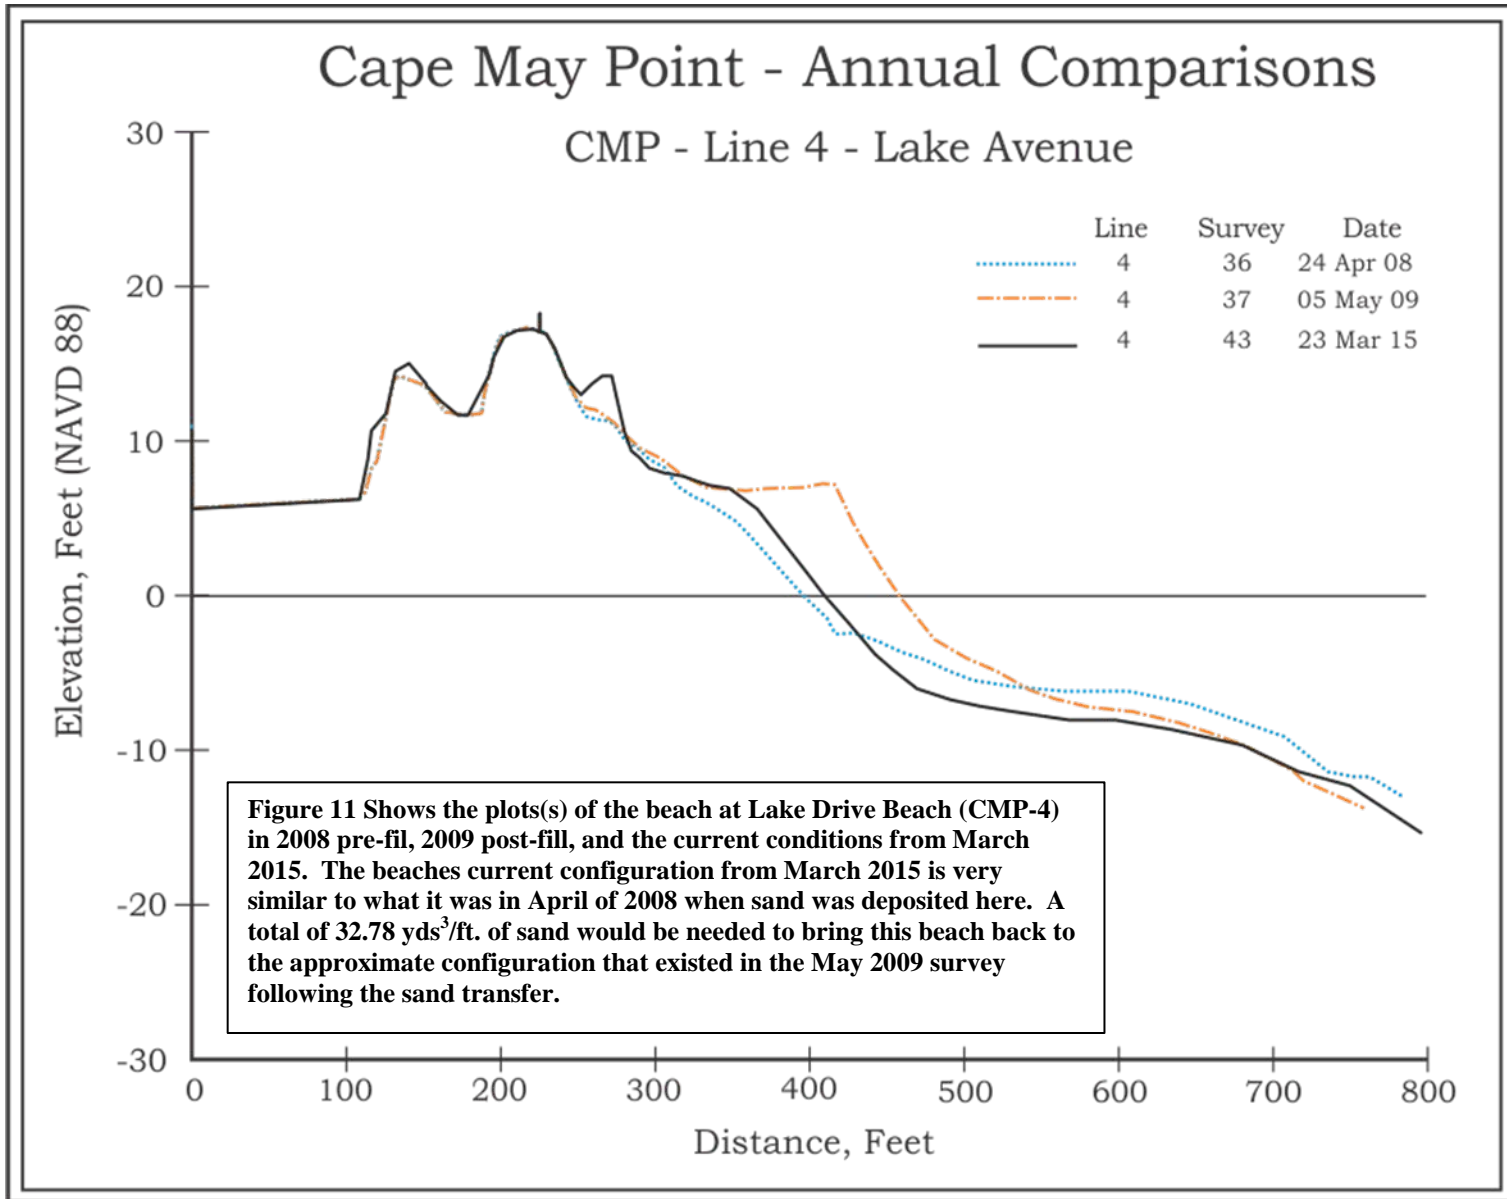
A separate volume comparison was done at CMP-4, Lake Drive to determine how much sand it would take to reach the USACE 2009 post-sand transfer beach configuration. The calculation compared the 2009 post-fill condition to the current 2015 conditions. It was determined that 32.78 yds³/ft. of sand is required to meet the USACE 2009 post-construction beach conditions and restore a wider recreational beach width to enhance both shoreline stabilization and storm protection.
