**FINAL REPORT FOR 2015
ON THE CHANGES MEASURED ON THE OCEANFRONT BEACHES
IN
THE BOROUGH OF MANTOLOKING, OCEAN COUNTY, NEW JERSEY**

**PREPARED FOR: THE BOROUGH OF MANTOLOKING
202 DOWNER AVENUE
MANTOLOKING, NJ 08738**

**PREPARED BY: STOCKTON UNIVERSITY COASTAL RESEARCH CENTER
30 WILSON AVENUE
PORT REPUBLIC, NEW JERSEY 08241
March 25, 2016**

Annual Report for 2015
To
The Borough of Mantoloking
On the
Oceanfront Municipal Shoreline

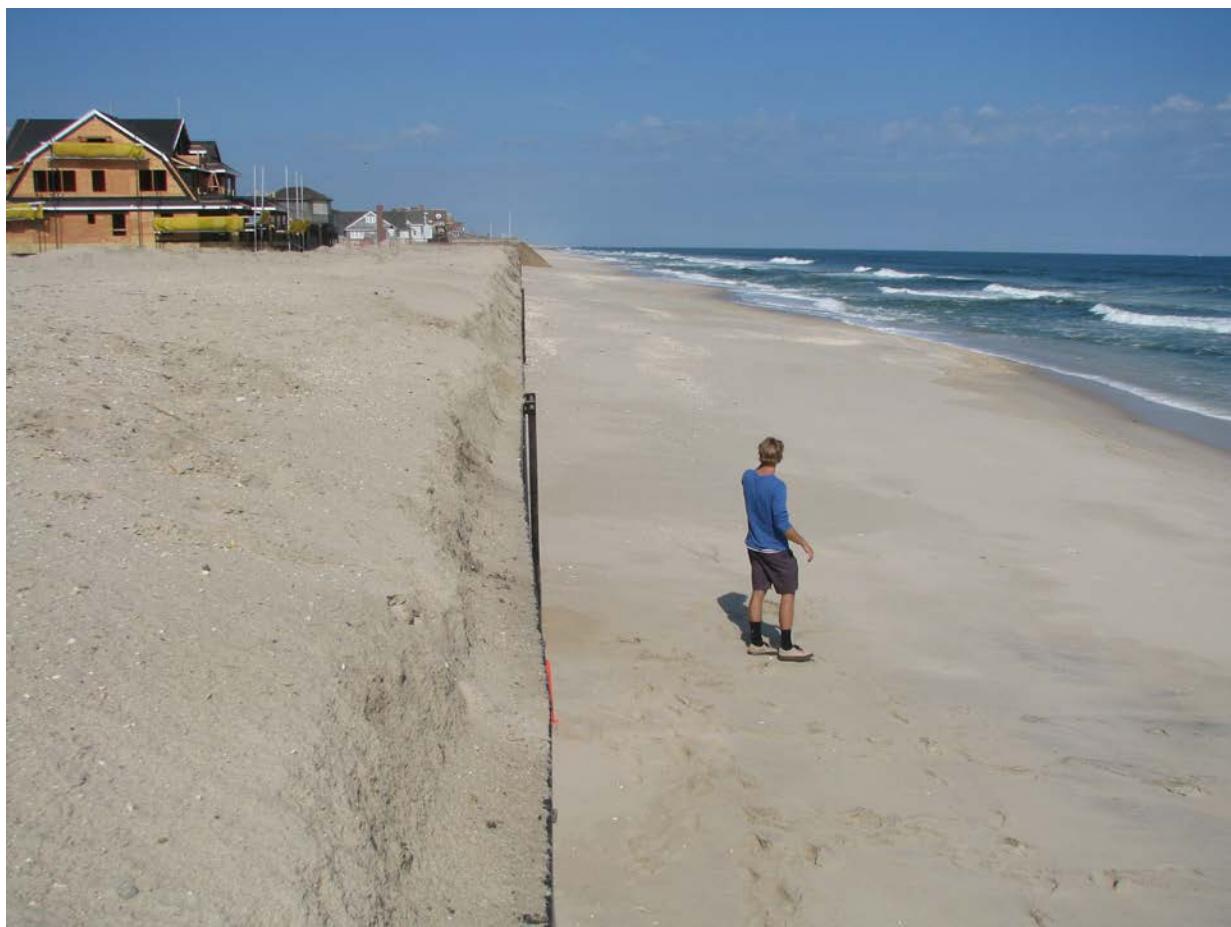
View to the north at 1041 Ocean Ave (Mant-2) from the top of the NJDOT steel bulkhead (wall) on October 8, 2015 following a moderate (winds not exceeding 25 mph) three-day northeast storm. That event eroded the berm and exposed the wall to storm waves. This photo shows new home construction adjacent to the low-elevation and narrow beach as well as the lack of a significant dune system. This places Mantoloking in a vulnerable state with respect to future coastal storms.

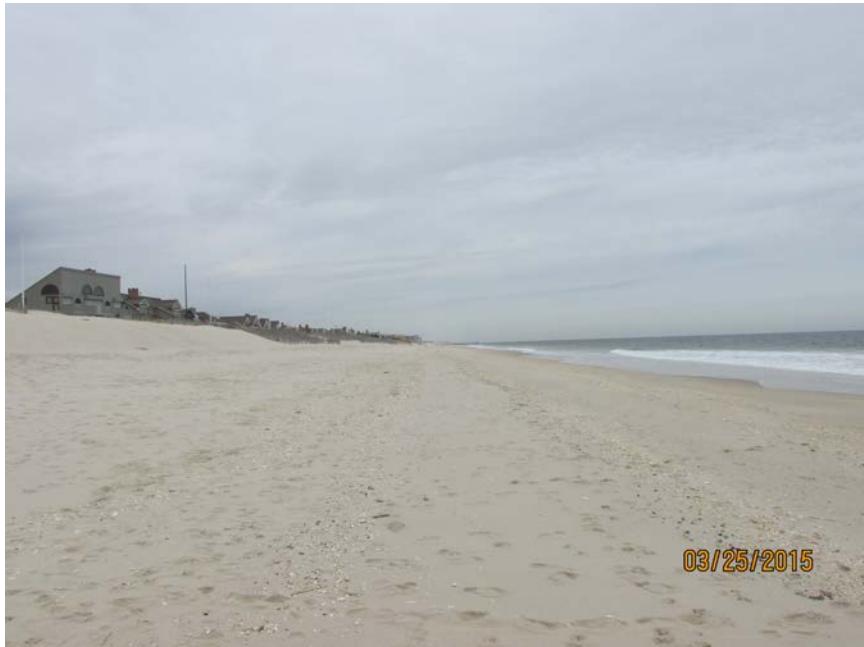
1a. March 25, 2015

Photograph 1a shows the view from the beach berm following a landward movement of the shoreline (-24 feet) from its December 2014 position.

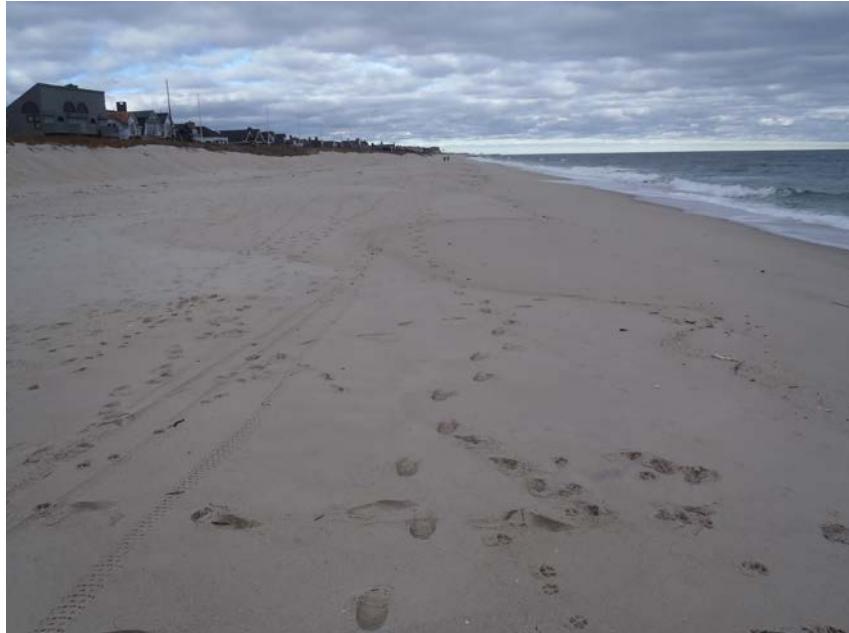
1c. December 16, 2015

Photograph 1c shows the high water marks on the berm. The shoreline moved considerably landward since the September survey (-33 feet) in part due to the October 2-5, 2015 northeast storm.

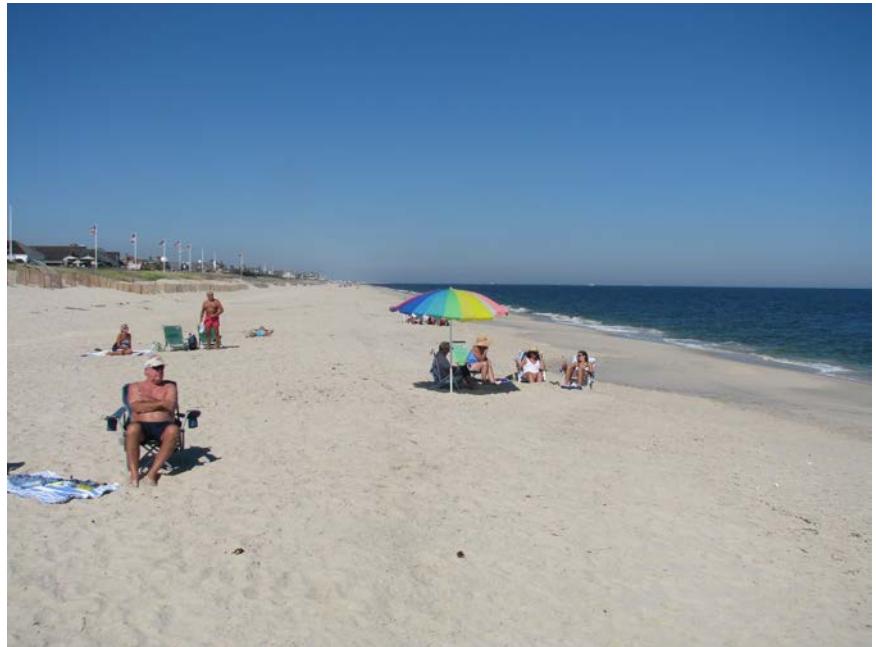
1b. September 18, 2015

Photograph 1b shows the berm and shoreline in relatively the same position as measured in March 2015. Minimal sand volume losses occurred between Survey 91 and Survey 93 (less than -1.0 yds³/ft).

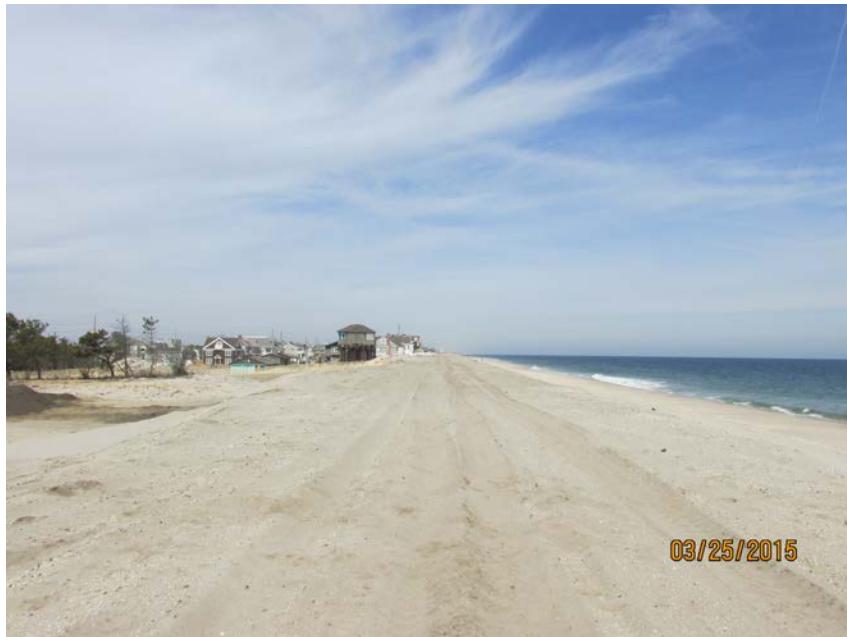
2a. March 25, 2015

Photograph 2a. shows the manmade dune that covers the steel wall. The dune crest remained at nearly the same 18.5 ft (NAVD88) elevation during 2015.

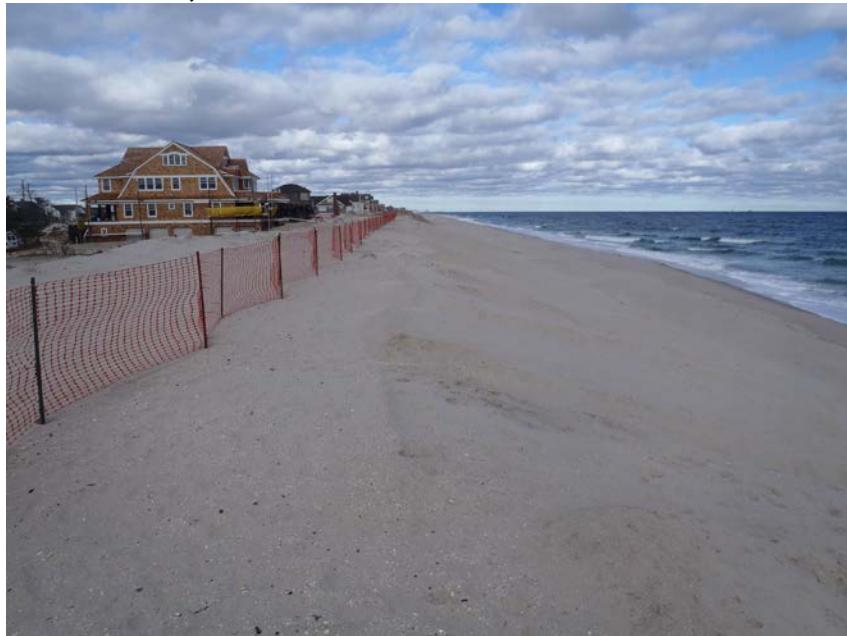
2c. December 16, 2015

Photograph 2c. shows a steep, narrow beach and fencing on top of the steel wall in an effort to trap windblown sand. The dune at this site also benefitted from the Borough's bulldozing efforts.

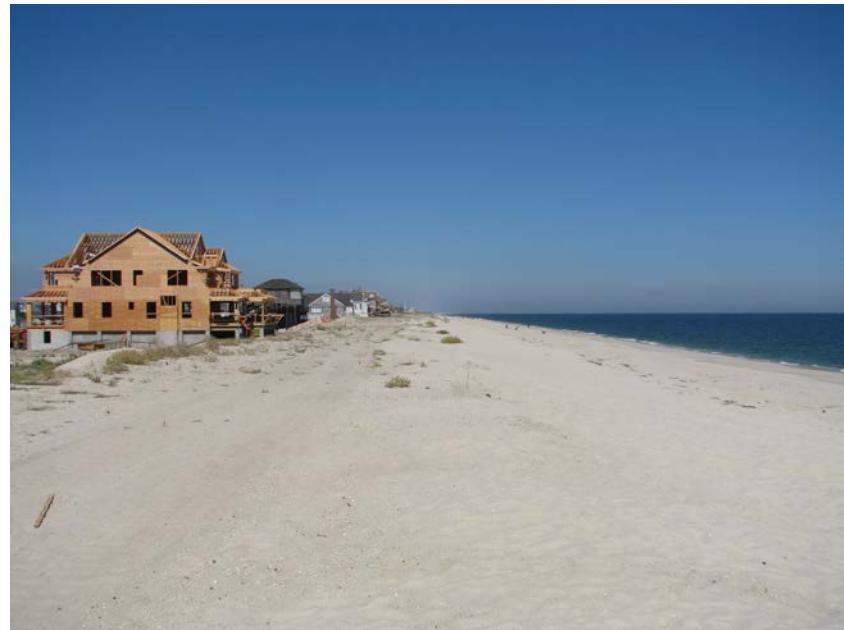
2b. September 18, 2015

Photograph 2b. shows the inflated summer beach as a result of bulldozing sand from the lower berm to the dune. Note the lower elevation of the nearshore and summertime volume losses recorded for this site (see Table 3).

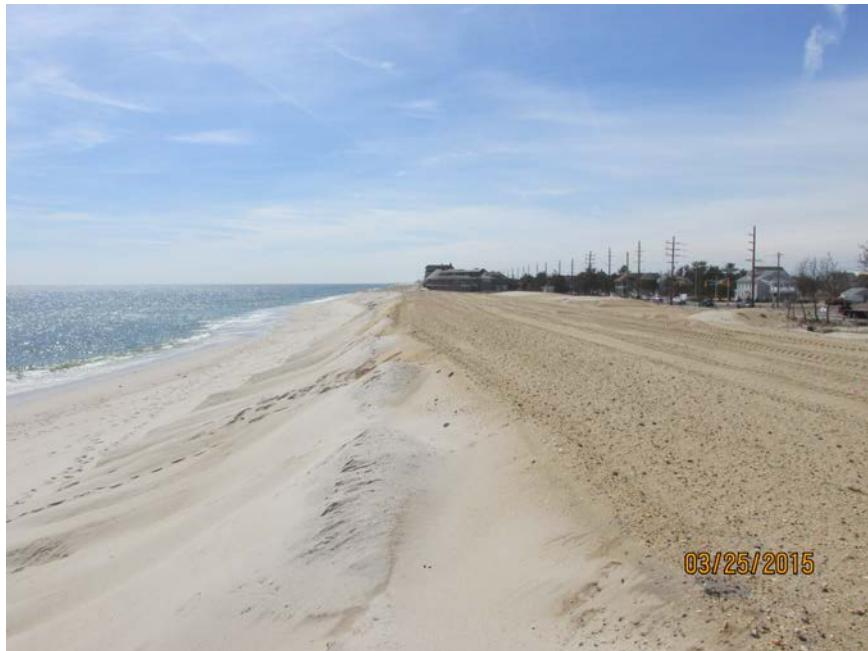
3a. March 25, 2015

Photograph 3a shows the steep, narrow beach. Over the winter, there was a net loss of sand (-16.02 yds³/ft) below the 0.0 ft NAVD88 datum as the nearshore bar became less pronounced and was located in deeper water than its December 2014 position. Quarry sand was brought in to add elevation to the dune crest.

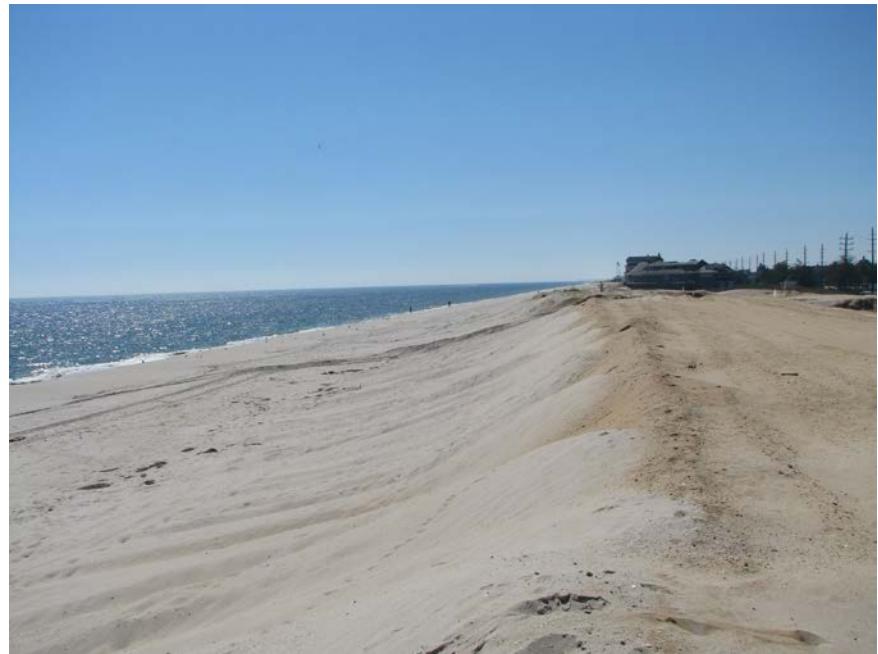
3b. September 18, 2015

Photograph 3b shows remnant bulldozer tracks on the seaward dune slope. The September 2015 profile displays a typical summertime wide dry beach (100 ft) though no nearshore bar was recorded.

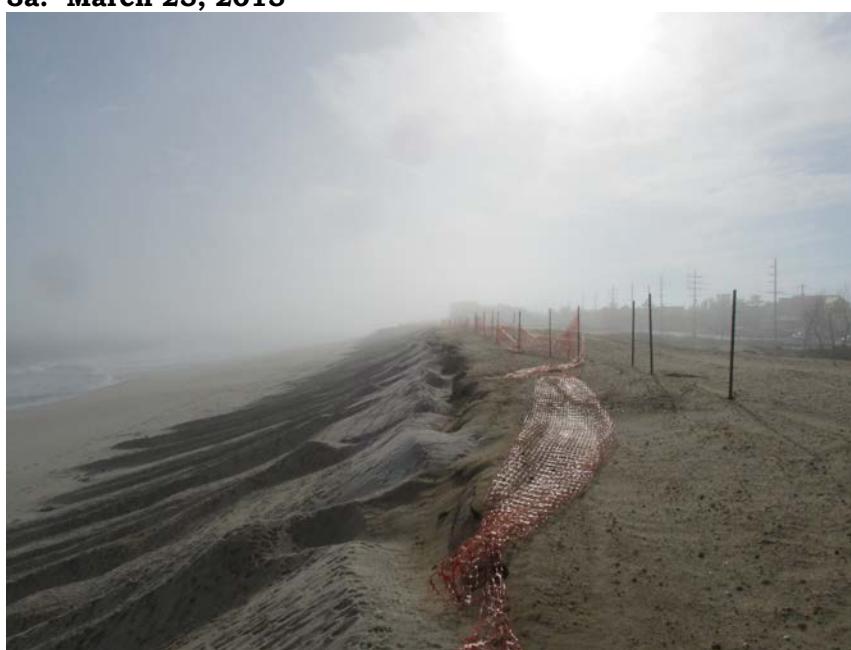
3c. December 16, 2015

Photograph 3c. The October 2-5, 2015 northeast storm waves eroded the berm and dune sands and exposed over 10 vertical feet of the wall. This hindered public access as beach goers had to climb up & down the wall to reach the water. Photo shows recent bulldozed sand up the dune slope.

The October 2-5, 2015 northeast storm event eroded the beach and dune slope that removed sand and exposed over 10 vertical feet of the wall impacting public access to the beach. Over 31.1 yds³/ft of sand was eroded from the dry beach and dune and 15.45 yds³/ft was deposited in the nearshore bar, indicating that the remaining sands were transported to the south by the littoral current or farther offshore.

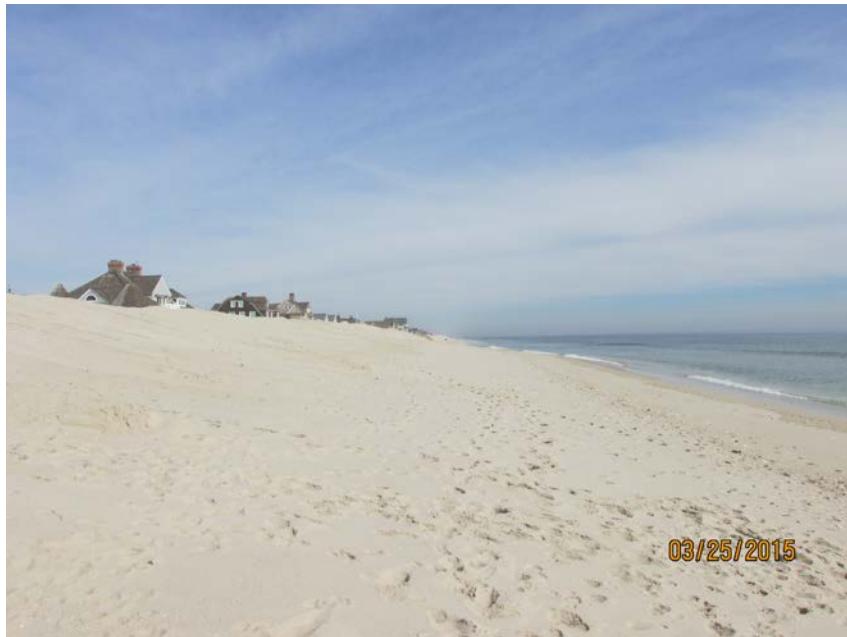
4a. March 25, 2015

Photograph 4a shows a narrow beach and bulldozed sand on the dune slope.

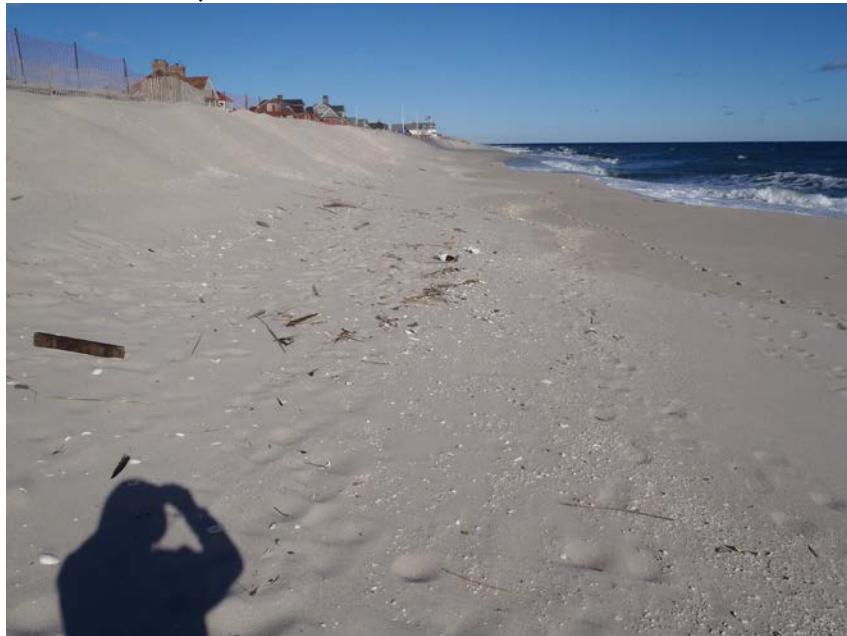
4c. December 16, 2015

Photograph 4c from December 16, 2015 shows the narrow beach and bulldozed sand to recover from the impacts of the October 2-5, 2015 northeast storm. The loss of sand from above the 0.0 ft datum was deposited in a bar that was 500 ft seaward from the top of the dune.

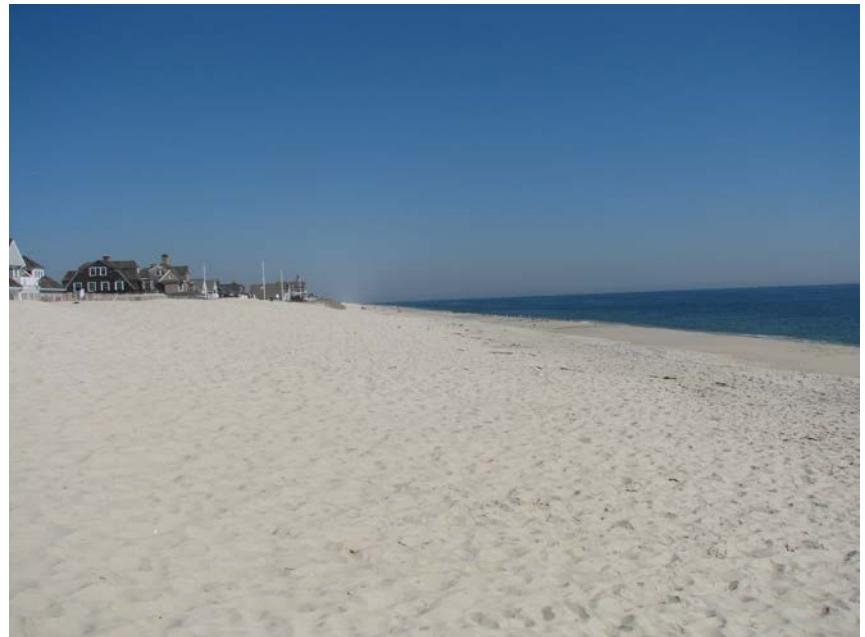
4b. September 18, 2015

Photograph 4b from September 18, 2015 shows a more natural inflated summer beach as traces of bulldozing was not evident. The berm crest was at its lowest elevation for 2015.

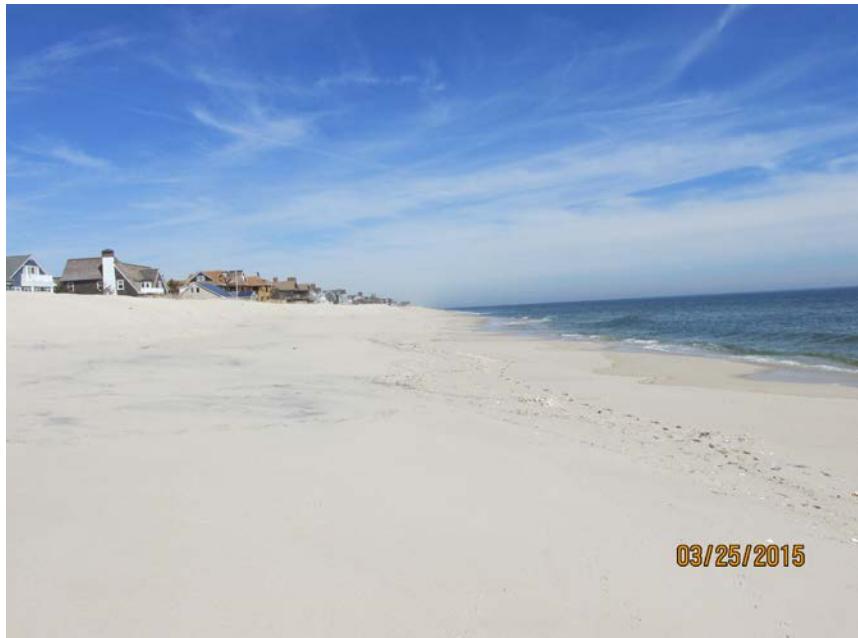
5a. March 25, 2015

Photograph 5a shows the narrow winter beach and the location of the high water line. The profile of the seaward dune slope was a result of the Borough's bulldozing efforts.

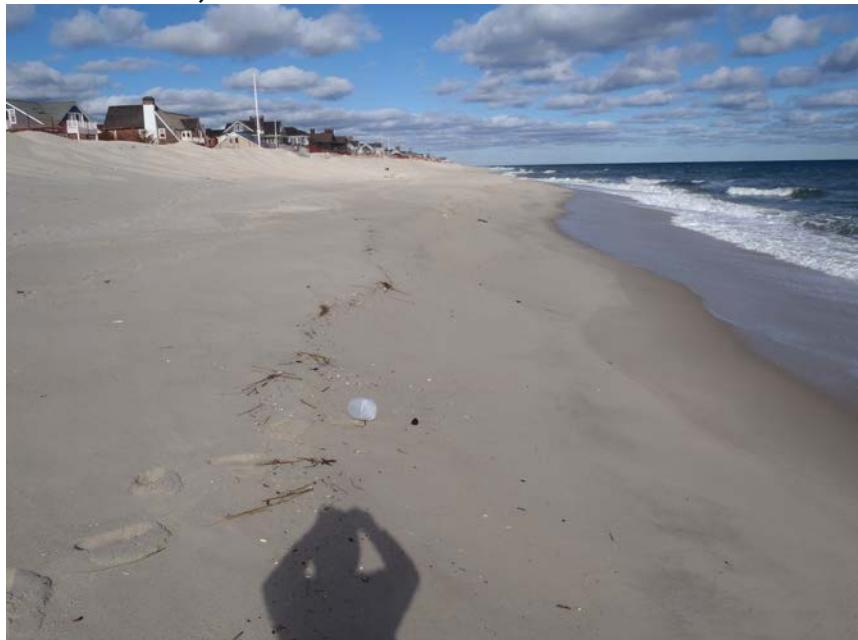
5c. December 16, 2015

View 5c from December 2015 shows the steep dune-beach profile that was initiated by the October 2-5, 2015 northeast storm which generated above datum volume losses (-19.66 yds³/ft) and shoreline retreat (-62.4 ft).

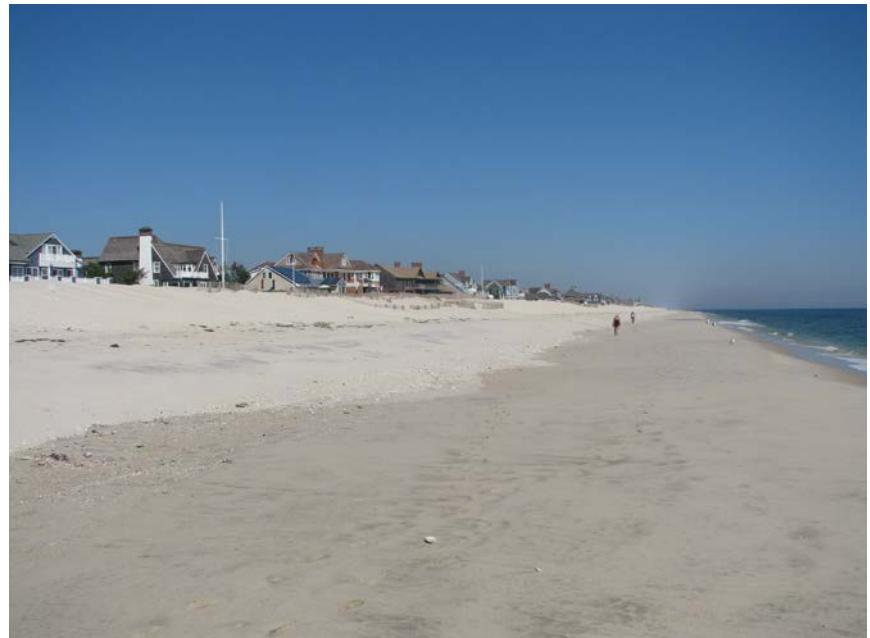
5b. September 18, 2015

View 5b shows the summertime accretion between the June and September surveys that resulted in an above datum volume gain of 8.92 yds³/ft and the shoreline moved 39 feet seaward.
