FINAL REPORT FOR 2016
FOR
THE BOROUGH OF MANTOLOKING, OCEAN COUNTY, NEW JERSEY
REVIEWING CHANGES TO THE MUNICIPAL BEACHES SINCE HURRICANE SANDY

PREPARED FOR: THE BOROUGH OF MANTOLOKING
202 DOWNER AVENUE
MANTOLOKING, NJ 08738

PREPARED BY: STOCKTON UNIVERSITY COASTAL RESEARCH CENTER
30 WILSON AVENUE
PORT REPUBLIC, NEW JERSEY 08241
December 25, 2016

Annual Report for 2016 On the Mantoloking Oceanfront Municipal Shoreline

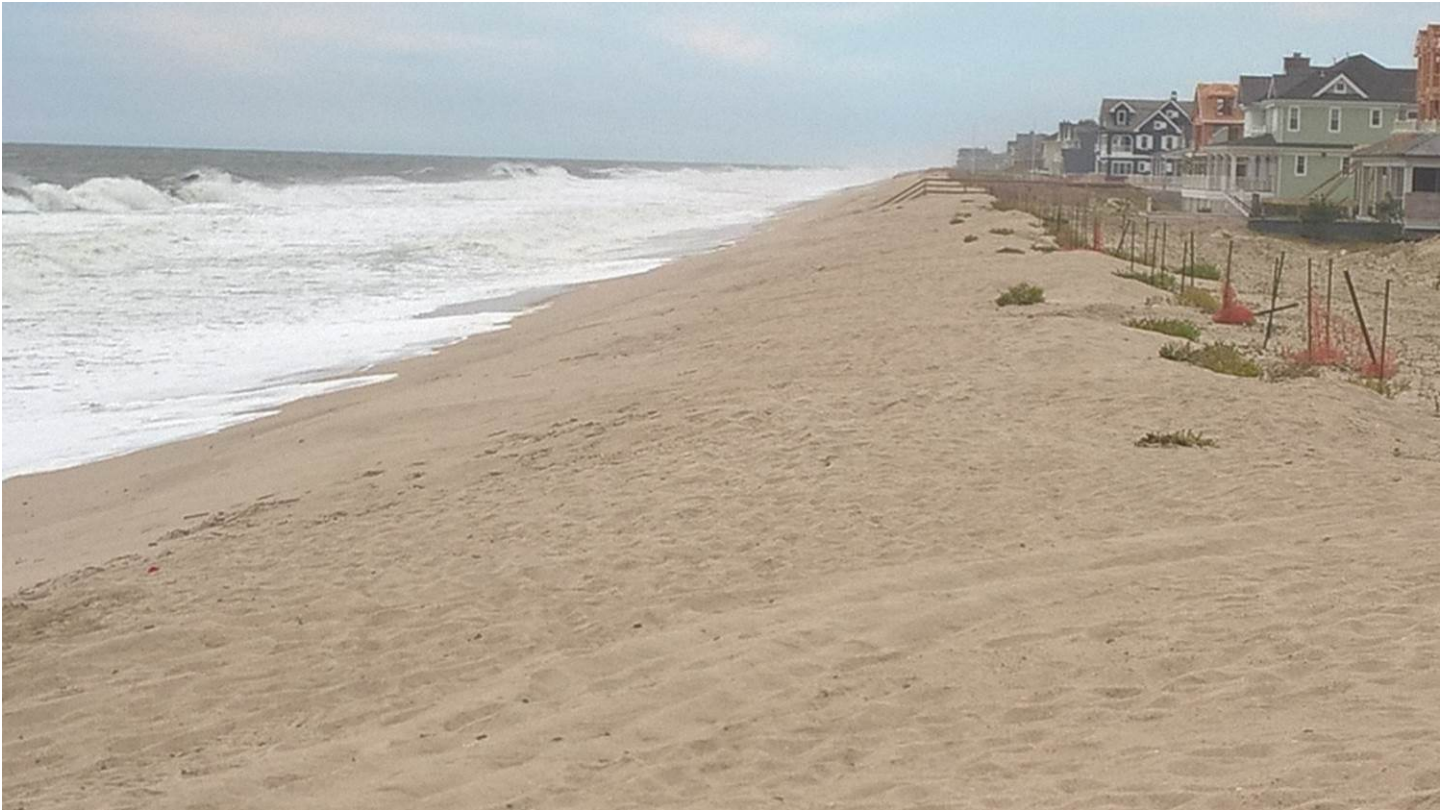
View to the south during Hurricane Hermine's coastal transit of New Jersey in early September 2016. Far from the worst event during 2016, this storm essentially ended the summer's sand accretion phase for the year. Since Hermine, Hurricane Mathew and a September 2016 three-day mild event kept the beach in a state of flux between erosion and accumulation seaward of the steel wall.

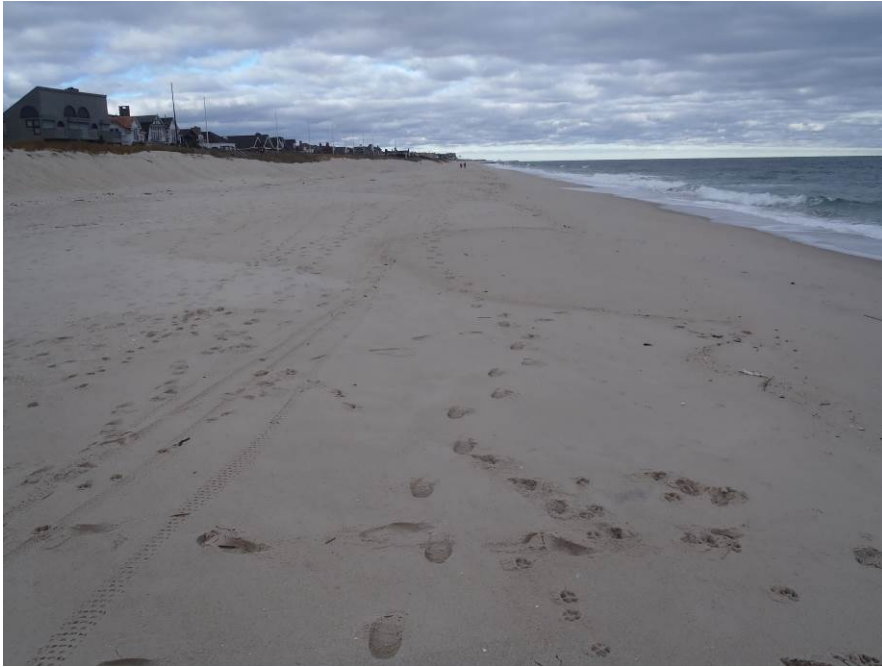
1a. December 16, 2015

Photograph 1a shows the view from the beach berm during the final survey for 2015 with a relatively robust berm and beach.

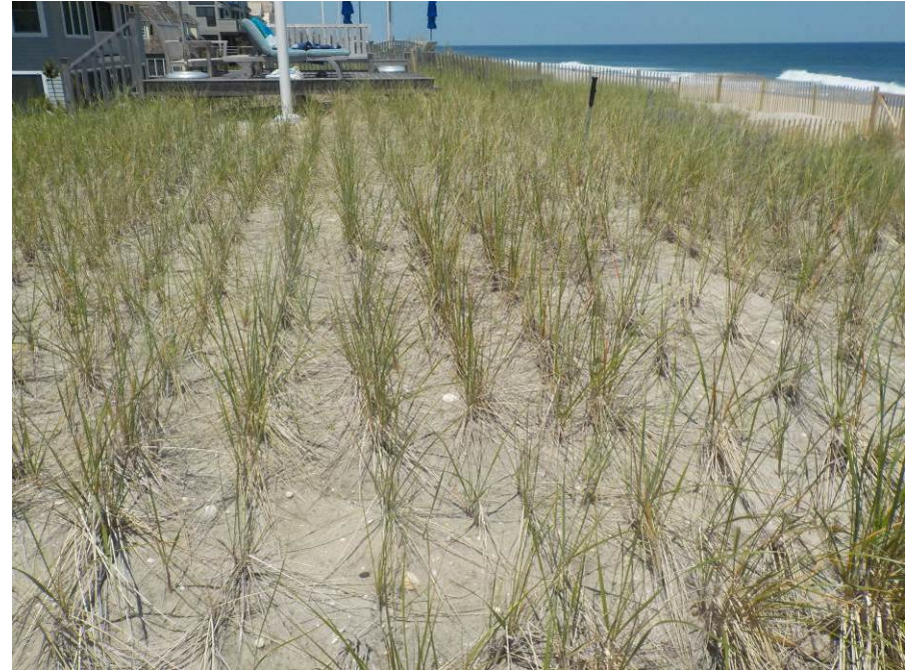
1b. June 6, 2016

Photograph 1b shows the new dune grass at the instrument location with the beach to the seaward.

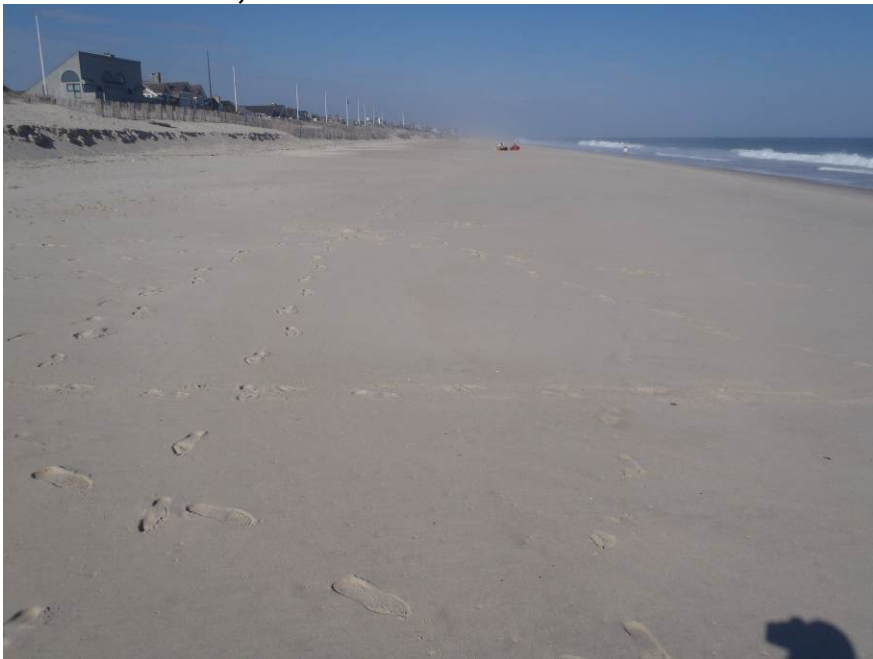
1c. October 17, 2016

Photograph 1c shows the beach after the passing of Hurricane Hermine and late September storm. By the October survey there was a 3-foot scarp in the seaward dune toe without rock revetment exposure.

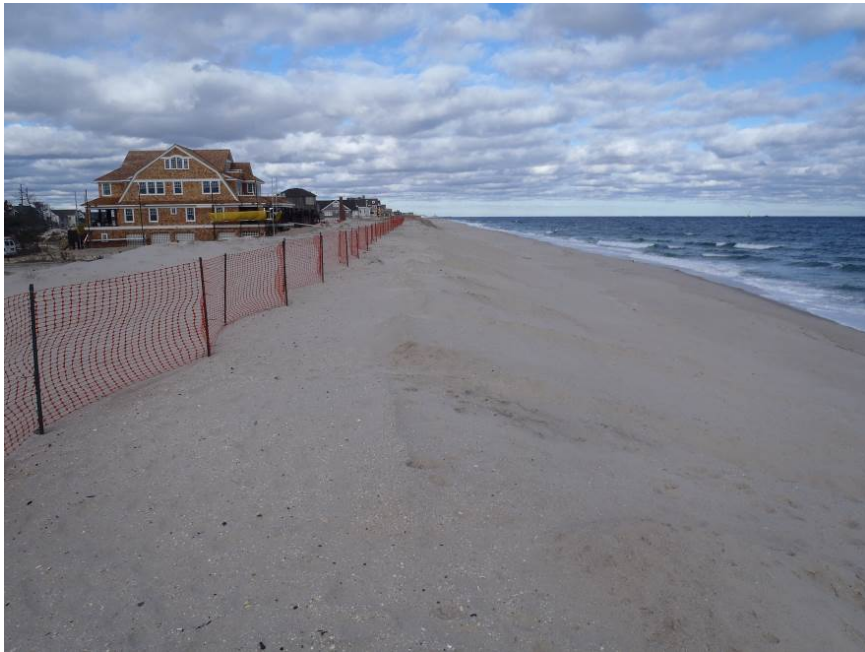
2a. December 16, 2015

Photograph 2a. shows the manmade dune that covers the steel wall. The dune crest remained at nearly the same 18.5 ft. (NAVD88) elevation during 2015.

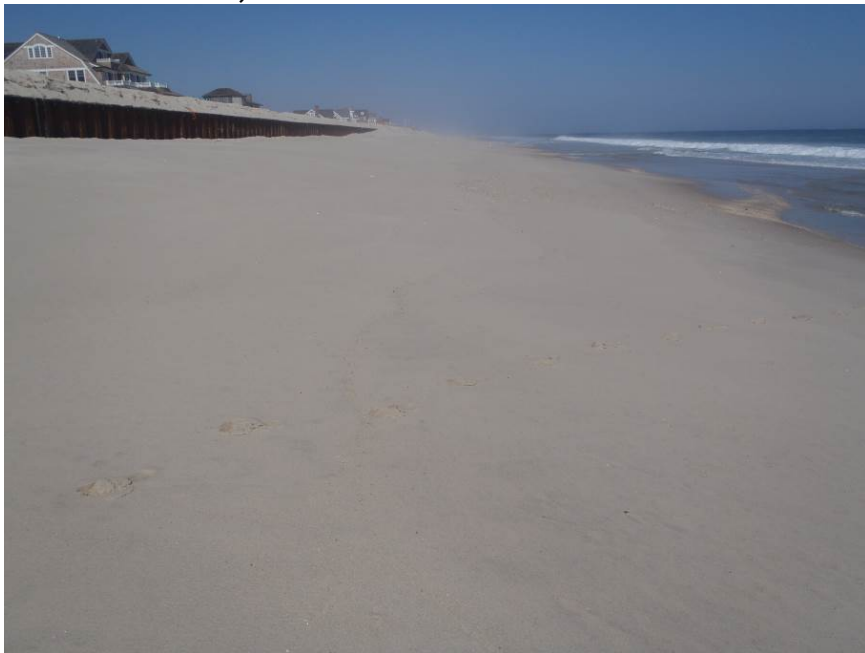
2c. October 17, 2016

Photograph 2c. shows a steep, narrow beach resulting from Hurricane Hermine and a late September storm event that exposed 5.5 feet along 400 feet of the steel sheet wall.

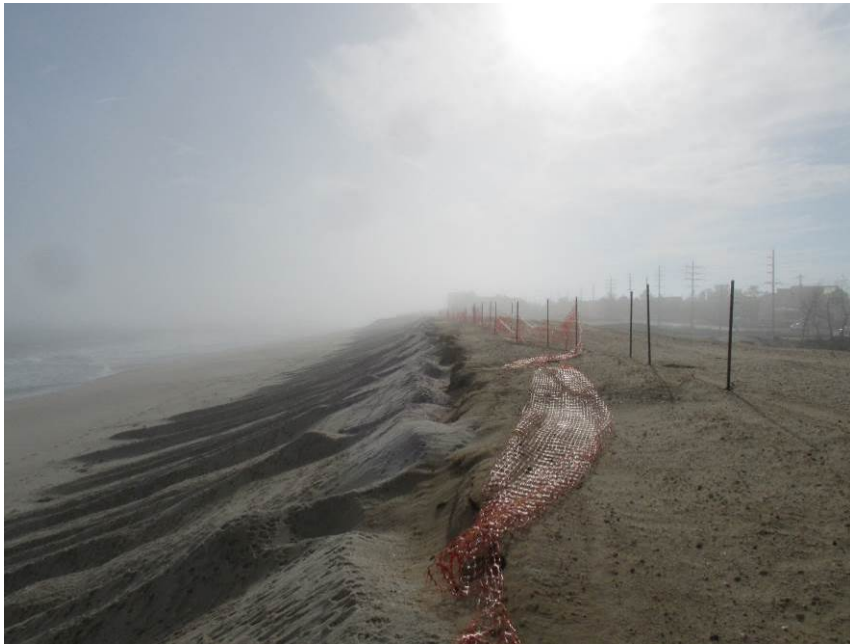
3a. December 16, 2015

Photograph 3a shows the steep, narrow beach. The bulldozer work is evident as the material was being transferred from the berm to the seaward dune slope.

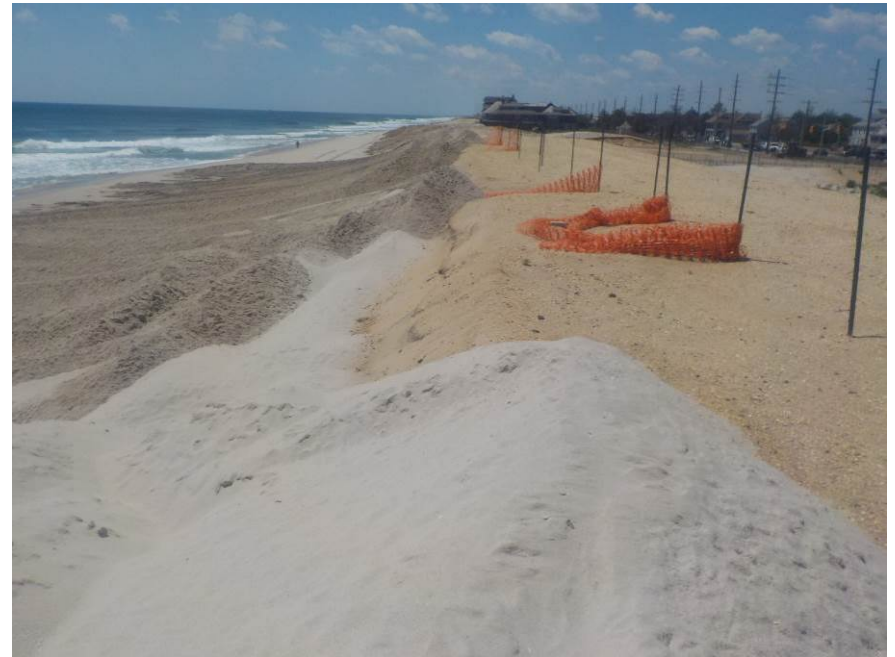
3b. June 6, 2016

Photograph 3b shows both new quarry material and renewed bulldozing of berm sand to match the wall elevation for the summer season.

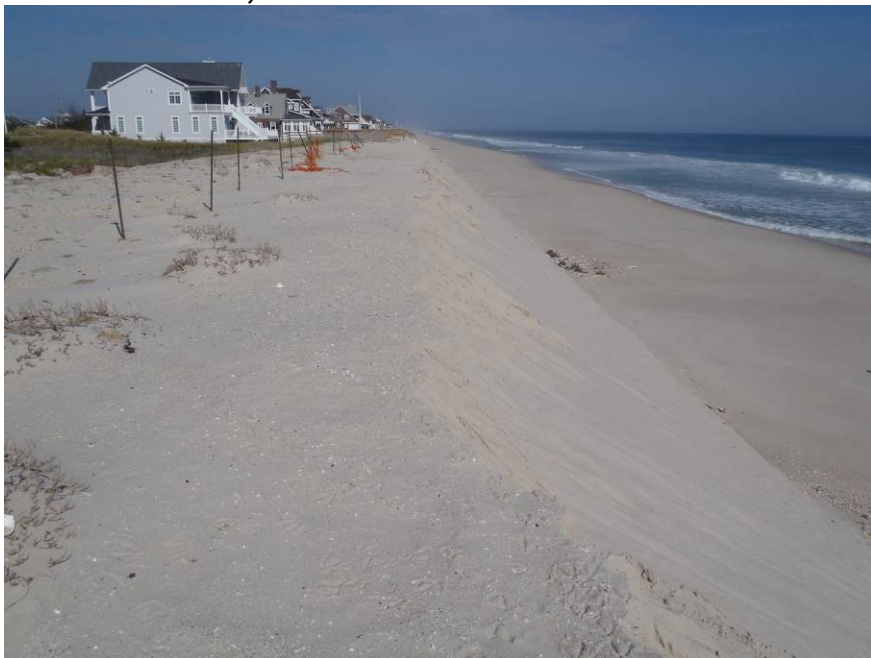
3c. October 16, 2016

Photograph 3c. The October beach profile shows the impact of the late September NE storm that lasted several days with a mild wind set, but a long duration. This set the stage for the scarp seen in the dune toe. No wall exposed at this time.

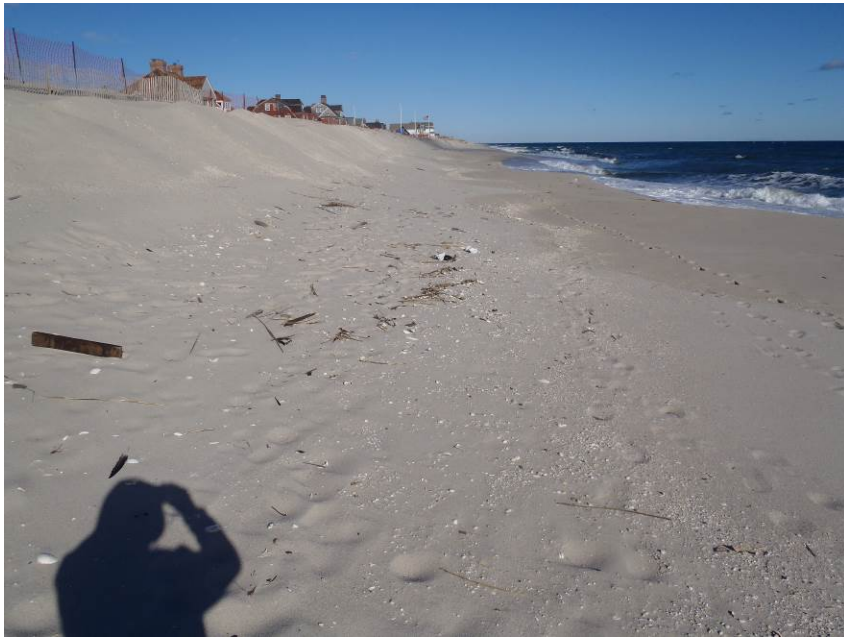
4a. December 16, 2015

Photograph 4a shows a narrow beach and bulldozed sand on the dune slope. This was completed following a minor NE storm in October that lasted for 3 days.

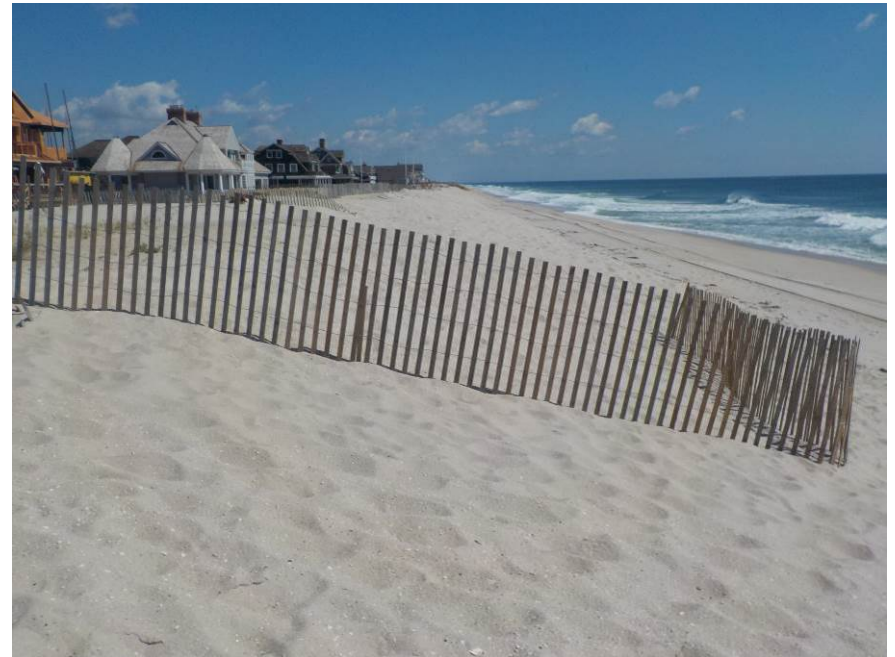
4b. June 6, 2016

Photograph 4b The view along the dune crest in June 2016 shows the results of beach recovery since NE storm Jonas cut the sand away from the steel wall.

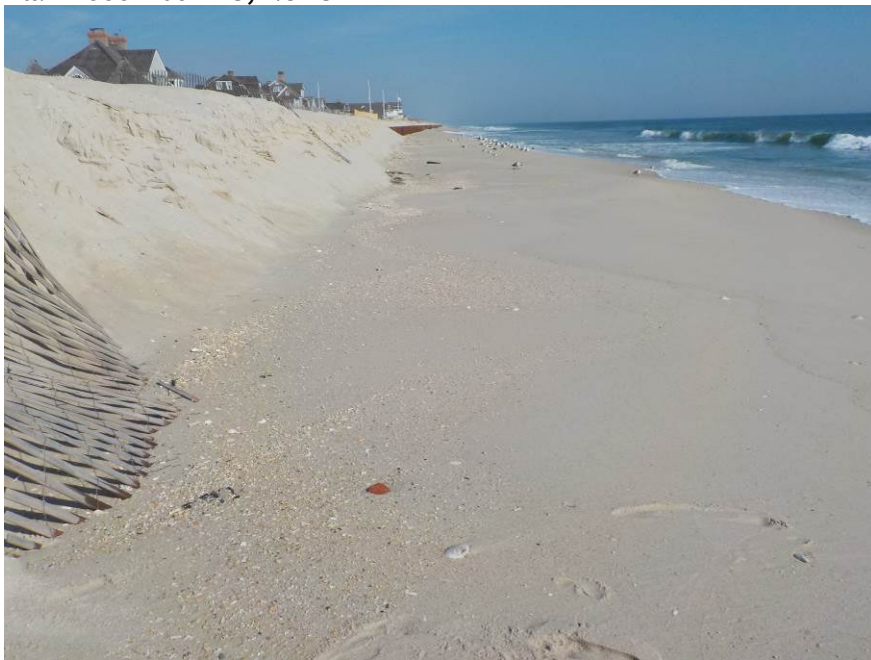
4c. October 16, 2016

Photograph 4c This view shows the impact of September storm erosion with exposed steel wall showing in the distance to the north. Beach recovery did occur since this event.

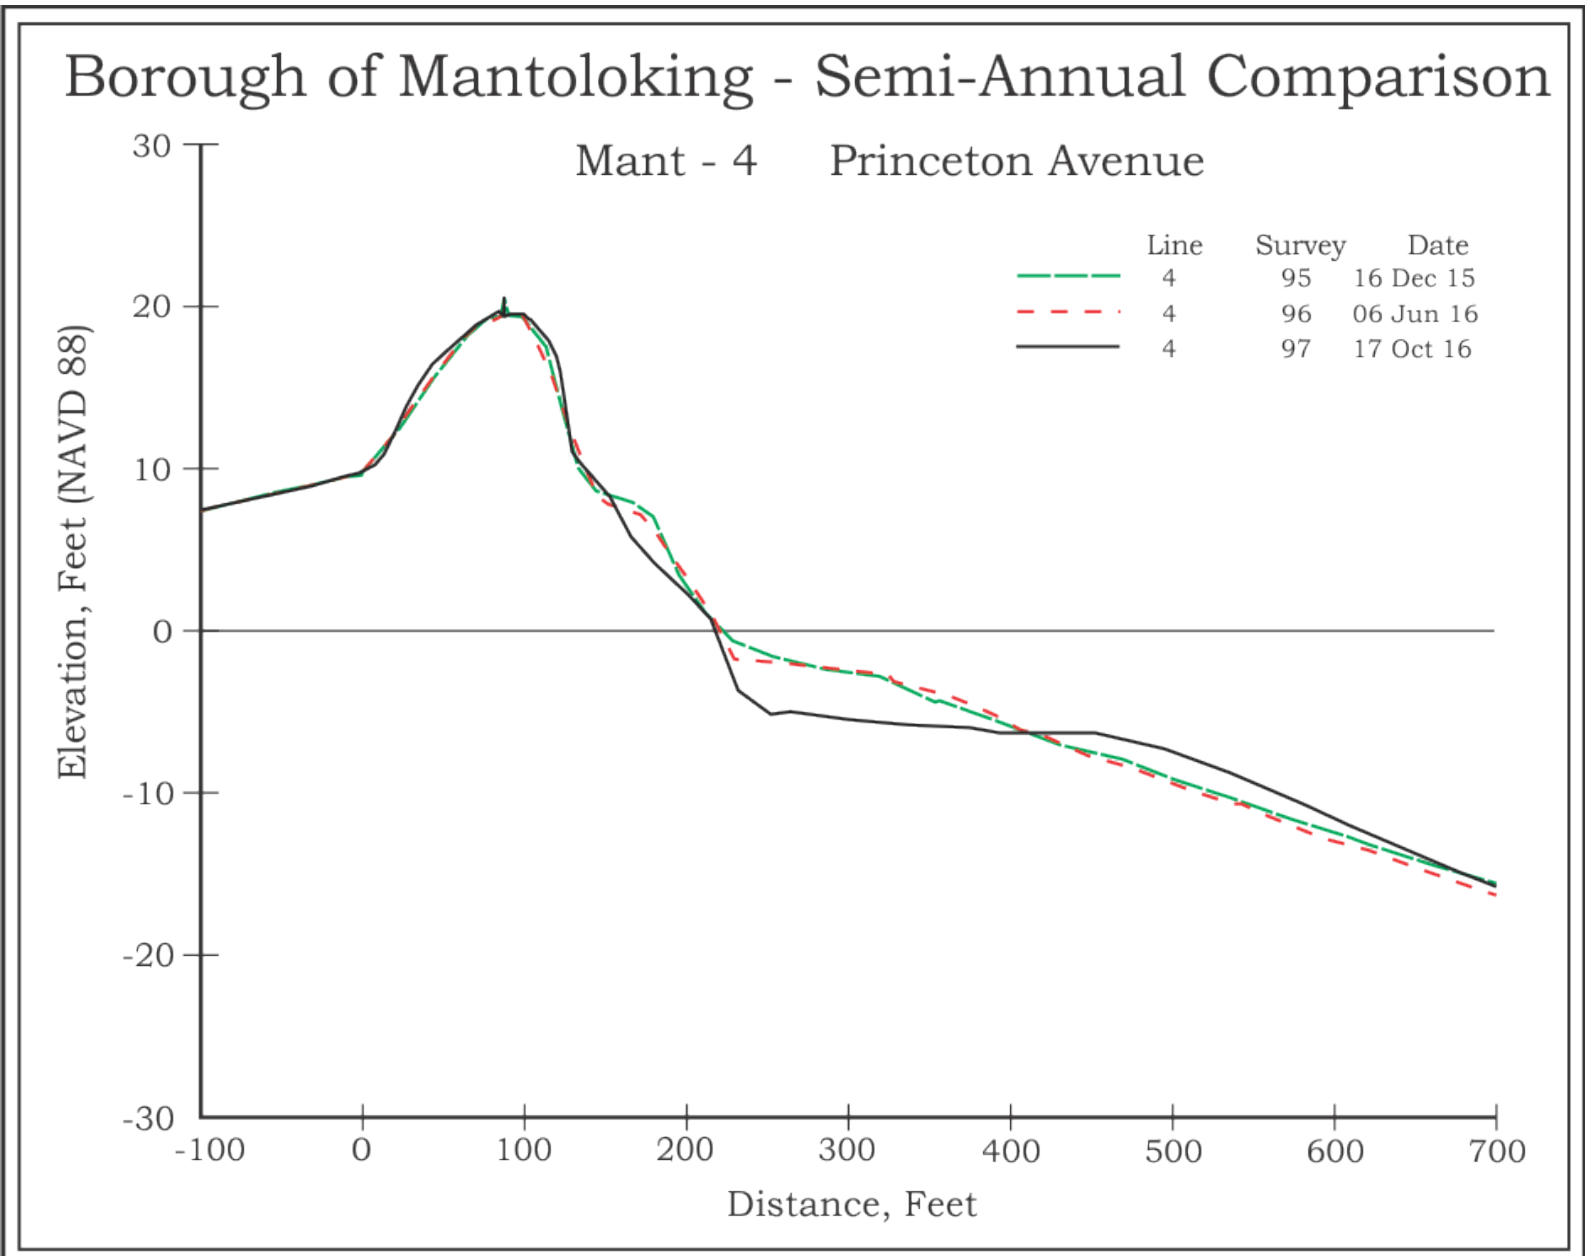
Figure 4d: The dune remained constant during the survey period, but the beach changed configuration prior to the October 2016 survey because northeast winds of modest velocity dominated the time between September 28 to 30, 2016. The net result was a flatter beach with sand moved offshore creating a minor deficit.

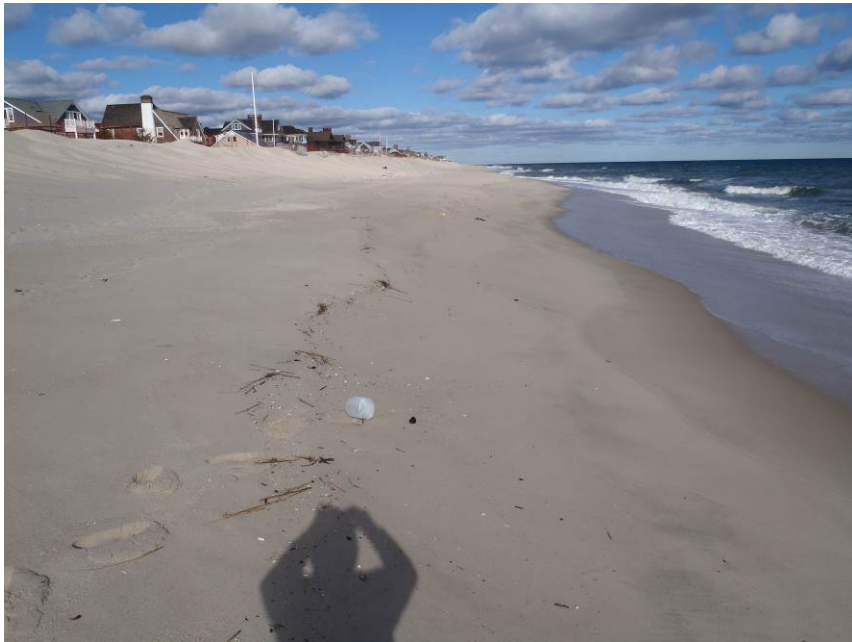
5a. March 25, 2015

Mant-51 Photographs 5a to 5c. All views are to the north from 1543 Ocean Ave.

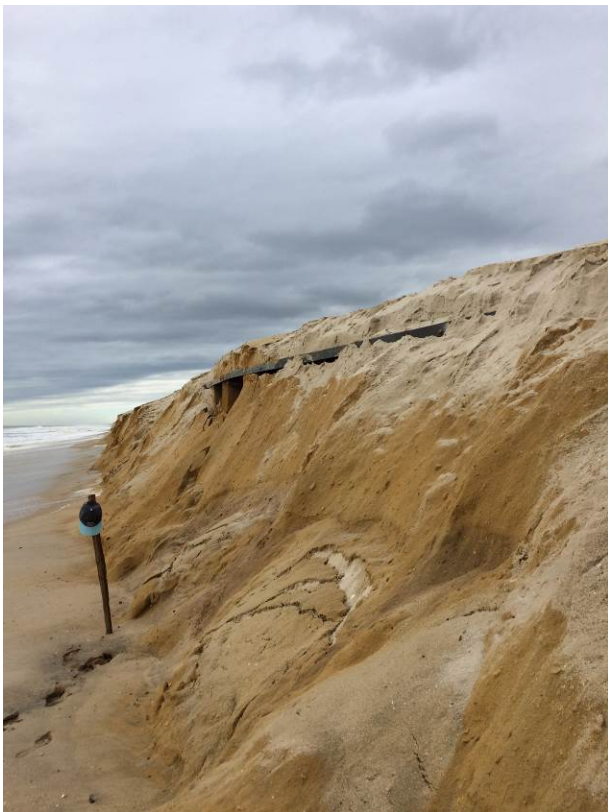
Site #6 located at Herbert Street shows the impacts of Hurricane Hermine to the left and the results on Nov 30, 2016 following a 3-day duration storm in late September.

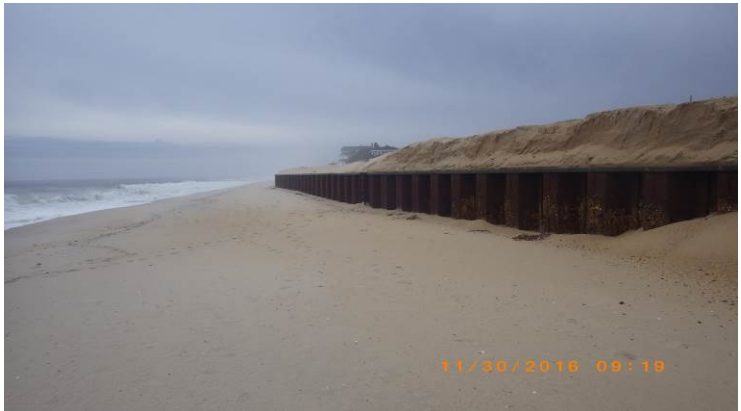
The next set of photographs are of site #2, located at 1041 Ocean Avenue where Hurricane Hermine did not produce wall exposure in spite of substantial berm erosion and cutting into the seaward dune toe slope seaward of the steel wall. However, by November 30th there was an 800-foot extent of wall exposed centered on the site where the measurements and profile were taken.

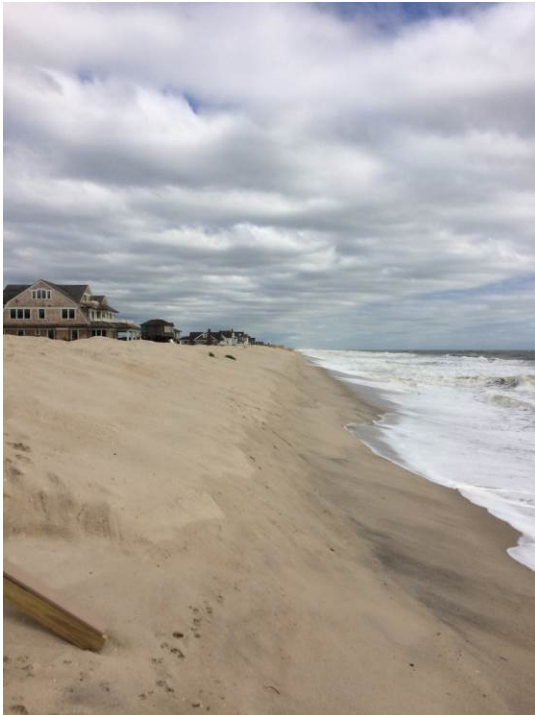
Site #2 is located at 1041 Ocean Avenue and did not erode to the point of wall exposure during Hurricane Hermine in early September (left), but saw 5 feet of surface exposed following the 3-day northeast period in September. Photo below was taken November 30, 2016.

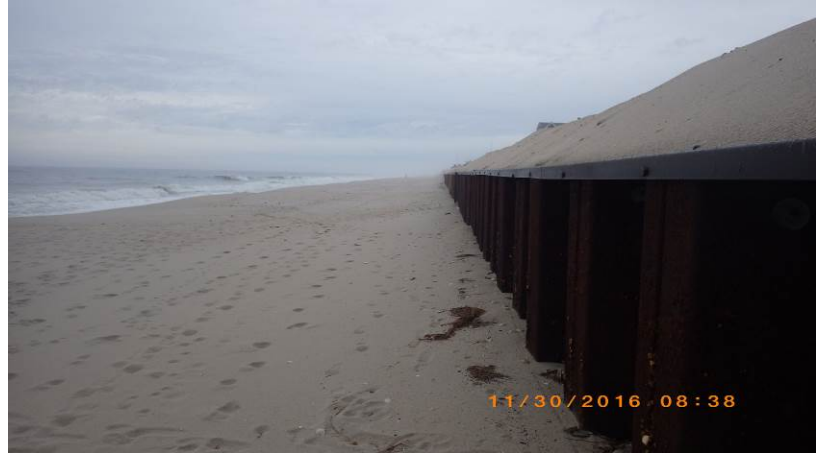
At Downer Avenue the effect of Hermine was to create a scarp in the seaward dune toe, but not to expose the steel wall. By the October 13th survey, the wall was exposed following the 3-day northeast event in late September.

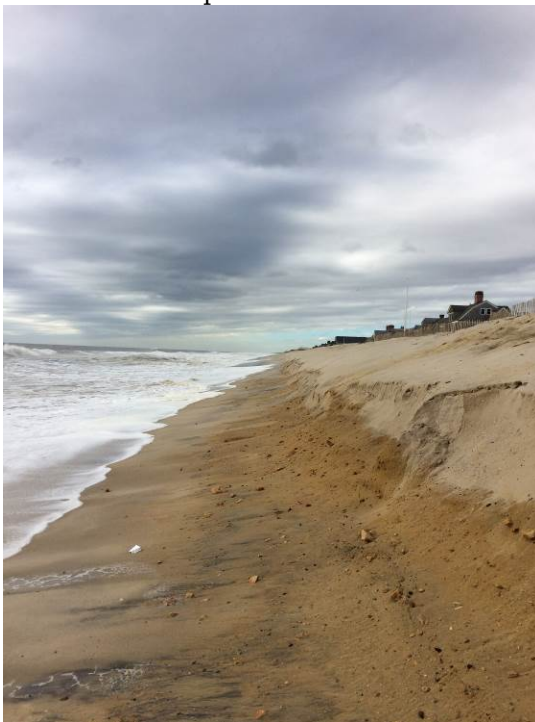
The left photograph was taken as Hurricane Hermine was ending and shows the dune toe scarp. By October 13th the wall was exposed.

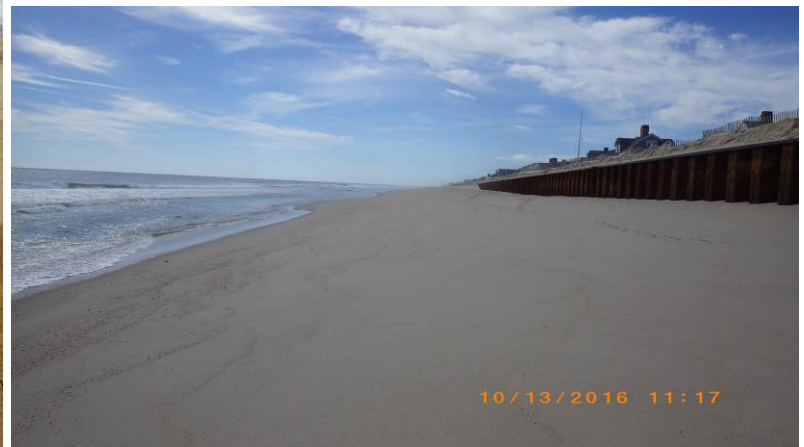
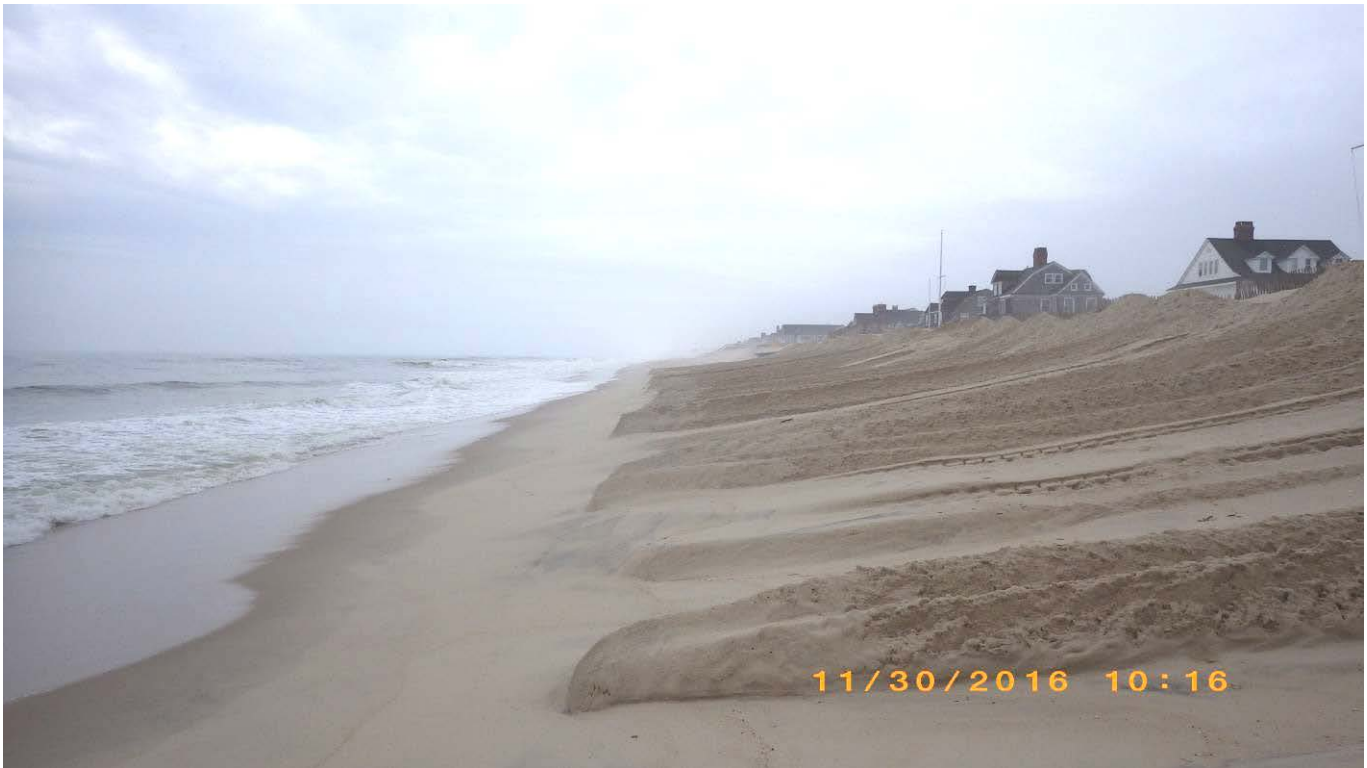
By the November 30th survey, the bulldozers had moved berm sand back to the wall creating a uniform slope once again to the beach. Work was progressing to the north toward Herbert Street as well.

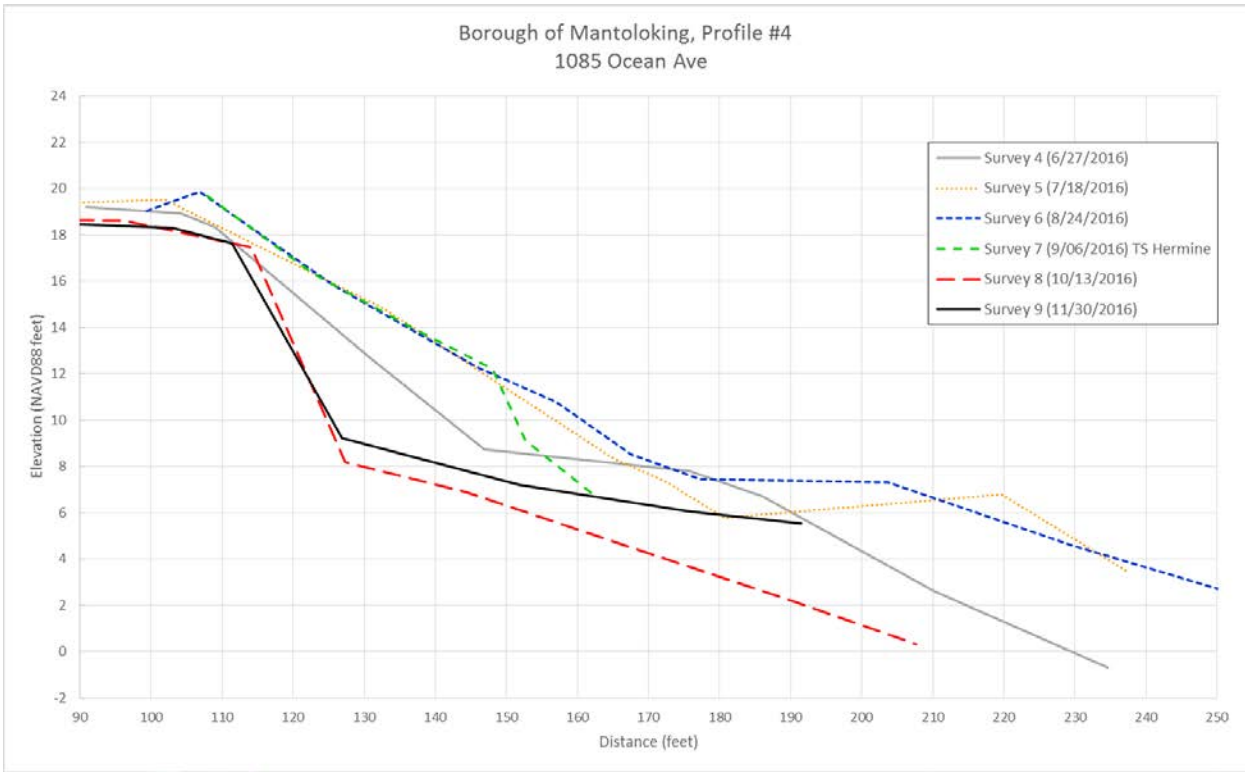
At 1085 Ocean Avenue, the slope retreated substantially during the 3-day September northeast storm, but no wall was exposed. Its location lies buried under the dune crest and has not been seen during this study.

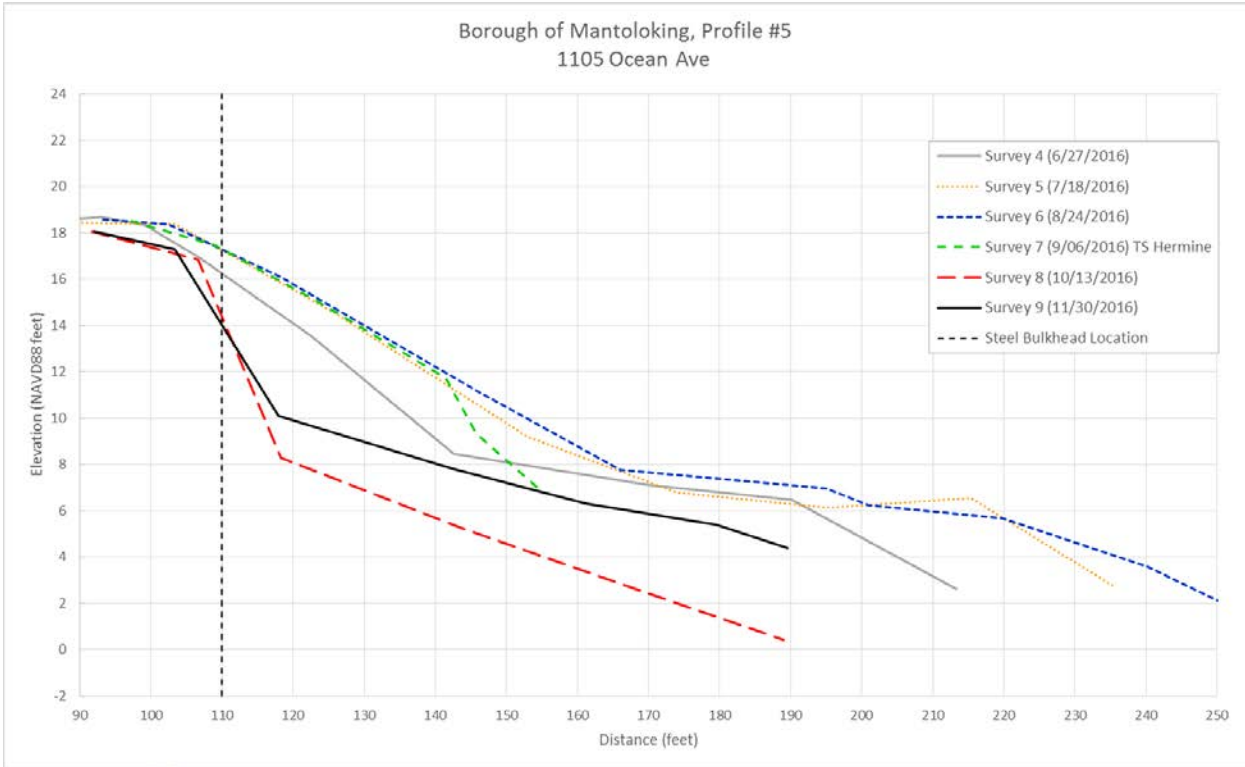
The 1105 Ocean Avenue site also did not see wall exposure, in spite of substantial dune toe slope retreat in the September event. The wall remains buried under the dune crest.

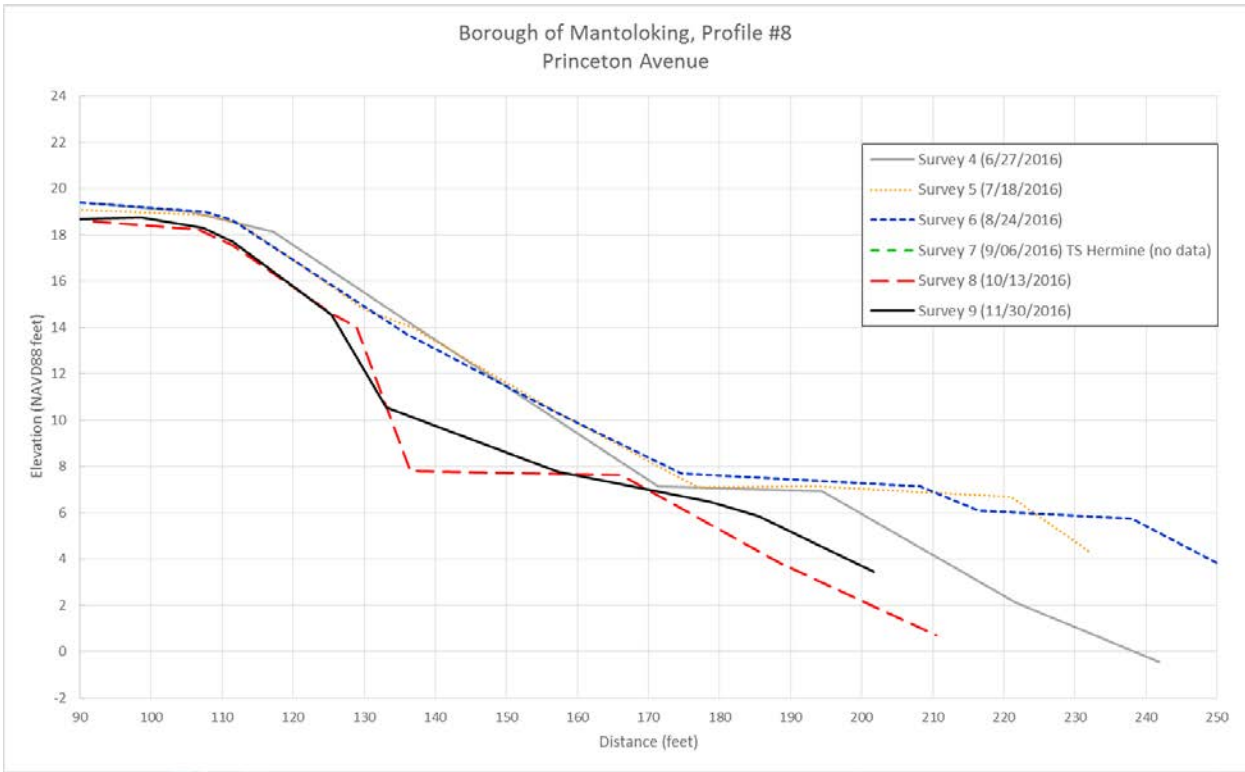
No wall exposure occurred at Princeton Avenue although the September event did produce significant dune toe slope retreat.

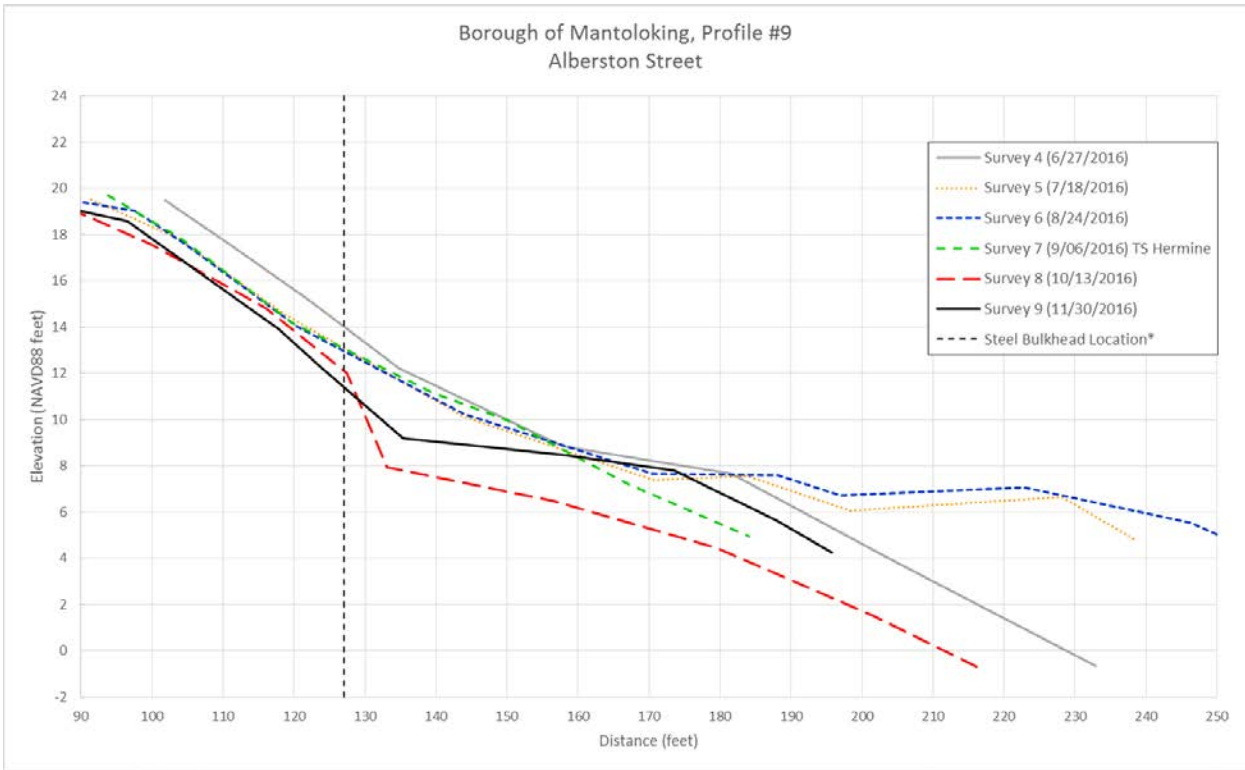
The Albertson Street site saw slope erosion in September but little impact from Hurricane Hermine. The wall was almost exposed in September, but remains buried with an excellent growth in the beach berm seaward by November 30th.

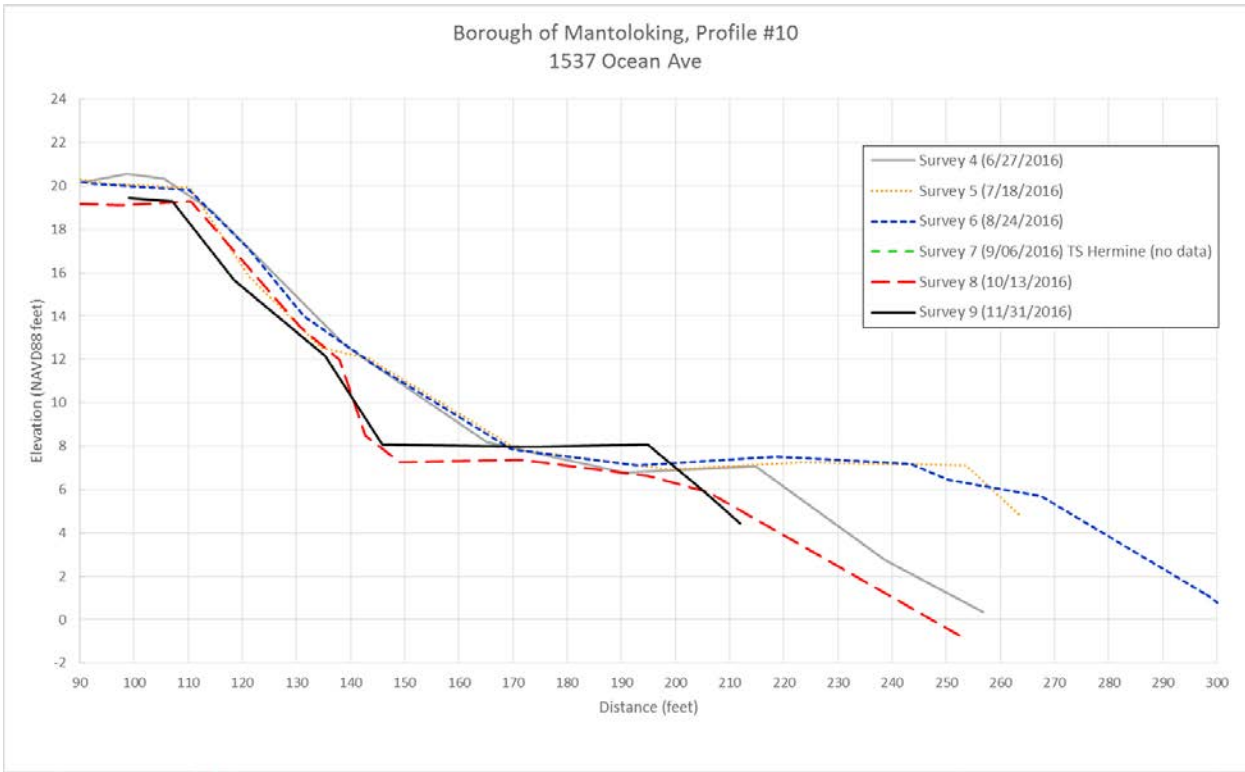
The southernmost survey site at 1537 Ocean Avenue saw minimal erosion during the fall up to November 30, 2016. Some toe steepening occurred due to the September 3-day storm, but no wall exposure has been observed since Jonas.

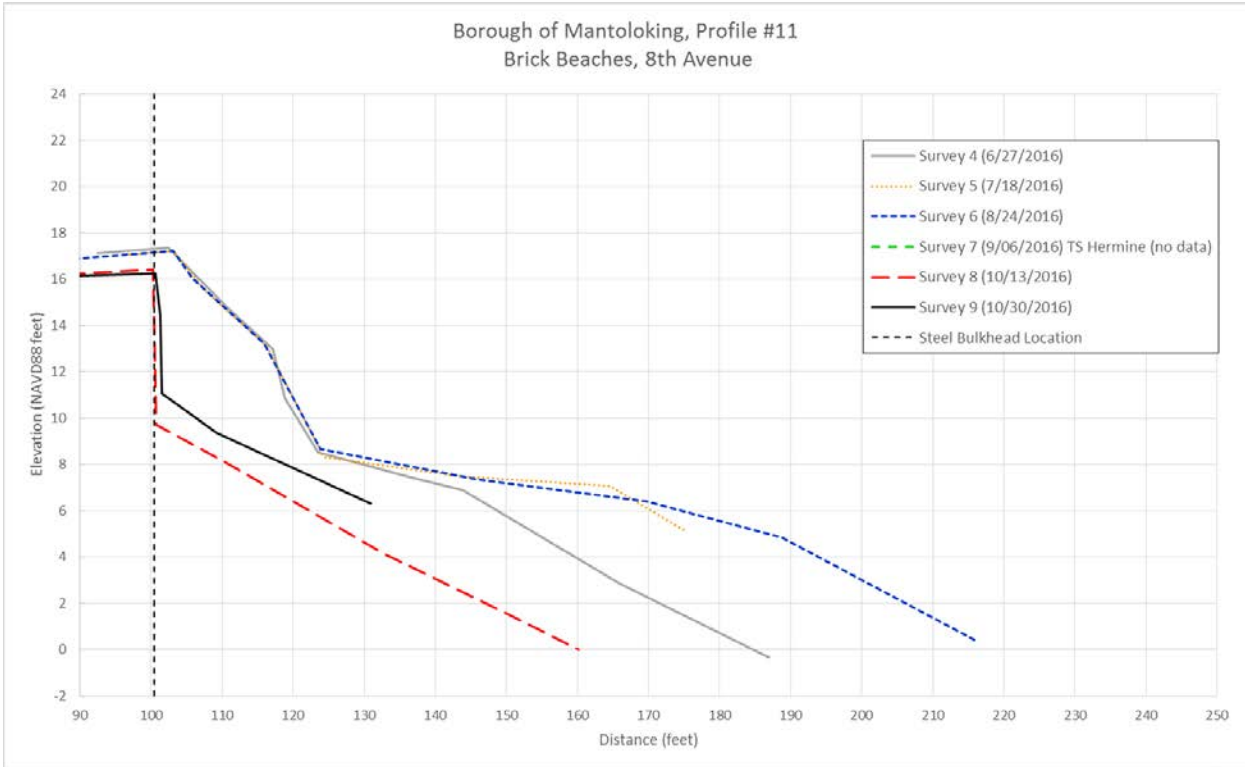
A control site was established in Brick Township at 8th Avenue where the wall remains exposed at 4 feet since the 3-day NE storm in September, which left hundreds of feet exposed to the north of this site. About a foot of sand has been deposited at the wall's base since mid-October.
