**2017 ANNUAL REPORT ON  
THE CONDITION OF THE MUNICIPAL BEACHES FOR  
THE BOROUGH OF STONE HARBOR, CAPE MAY COUNTY, NEW JERSEY**

**PREPARED FOR: THE BOROUGH OF STONE HARBOR  
9508 SECOND AVENUE  
STONE HARBOR, NJ 08247**

**PREPARED BY: THE STOCKTON UNIVERSITY COASTAL RESEARCH CENTER  
30 WILSON AVENUE  
PORT REPUBLIC, NEW JERSEY 08241**

**February 15, 2018**

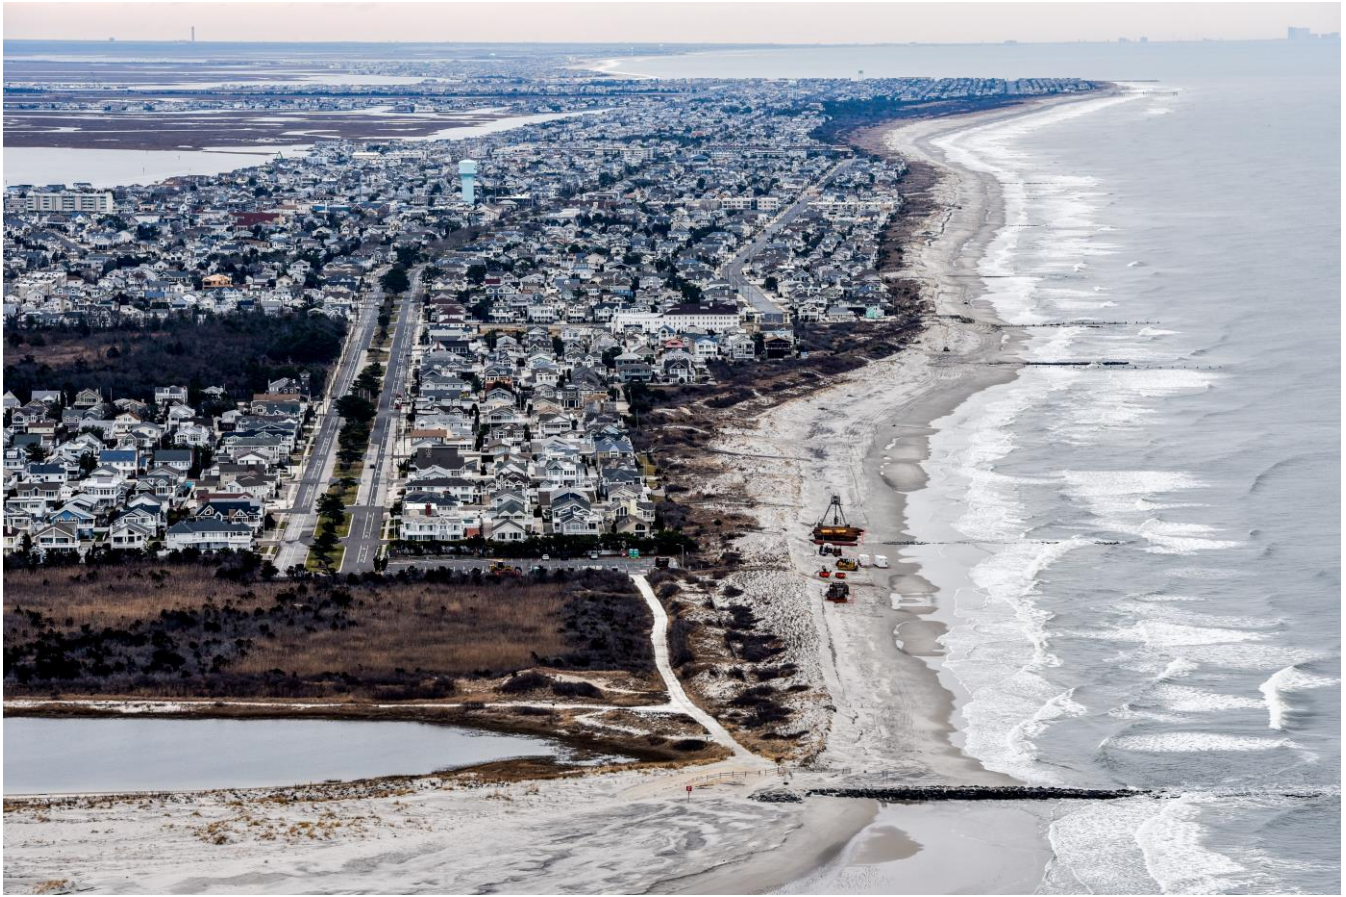
*Aerial photograph taken February 1, 2017 showing staging of equipment used for the 2<sup>nd</sup> Periodic Nourishment Cycle in the Borough's southern section (courtesy Ted Kingston).*

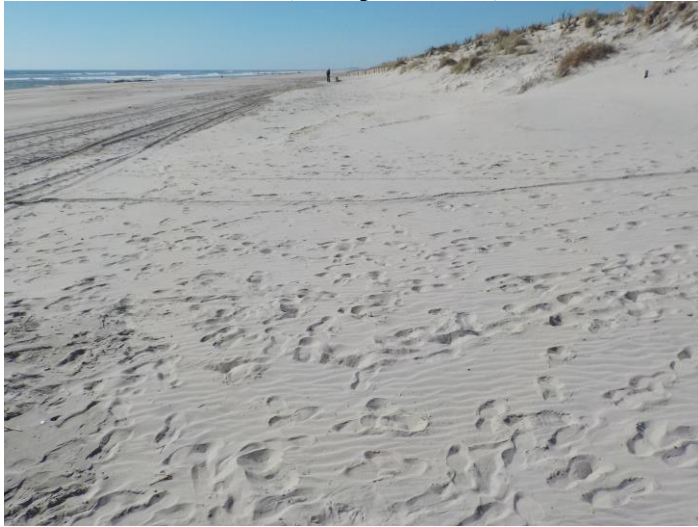
**Photoplate 1a – Photo taken October 14, 2016 shows a low, flat berm and sparsely vegetated dune.**

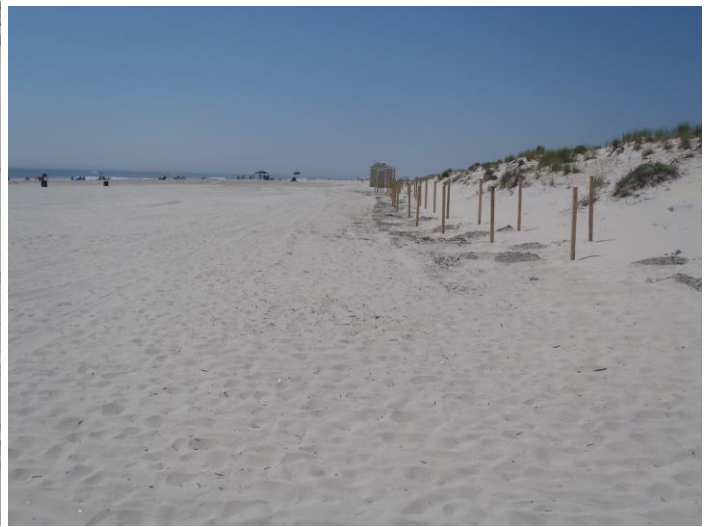
**Photoplate 1b - Photo taken June 12, 2017 days after completion of the beach fill at the Borough's north end.**

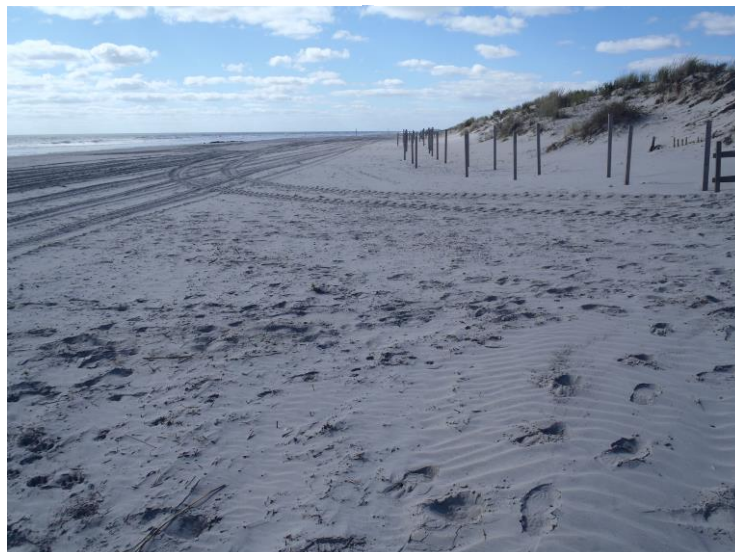
**Photoplate 1c – Photo taken October 3, 2017. The profile gained volume between fall 2016 and fall 2017 due to the beach fill that added 10.53 yds<sup>3</sup>/ft. above the 0.0 ft. datum.**

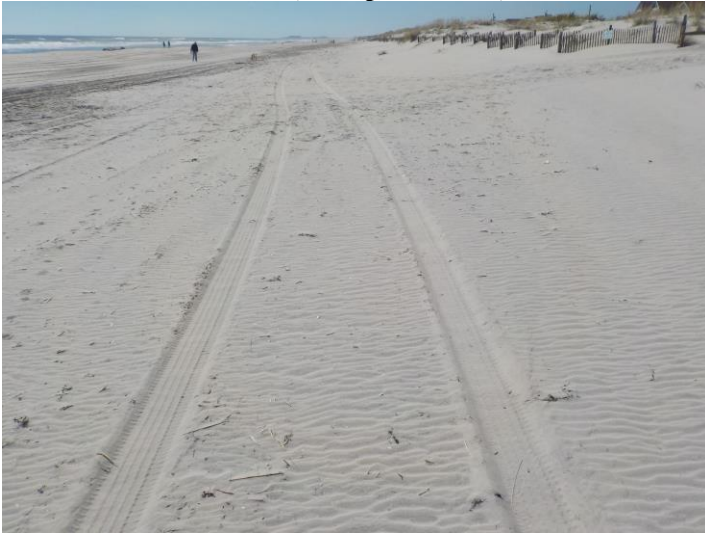
**Photoplate 2a** – Photo taken October 13, 2016 shows a narrow beach and gently-sloped backshore to the dune.

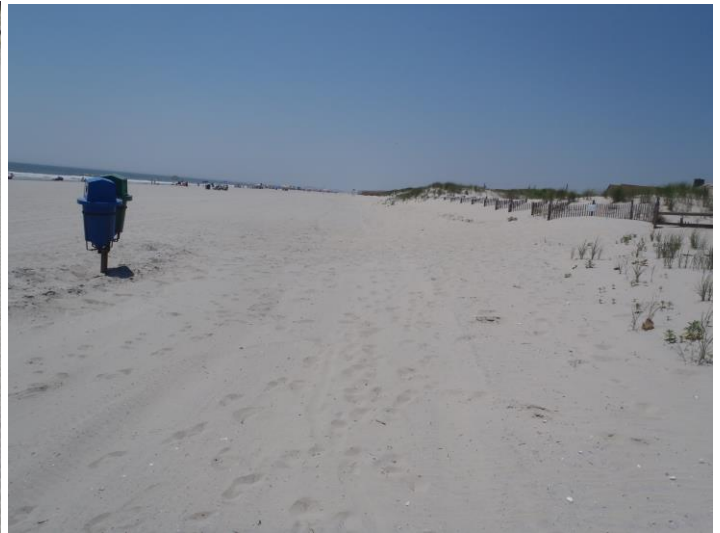
**Photoplate 2b** - Photo taken June 12, 2017 shortly after completion of the north end beach fill which raised the berm elevation from its October 2016 position.

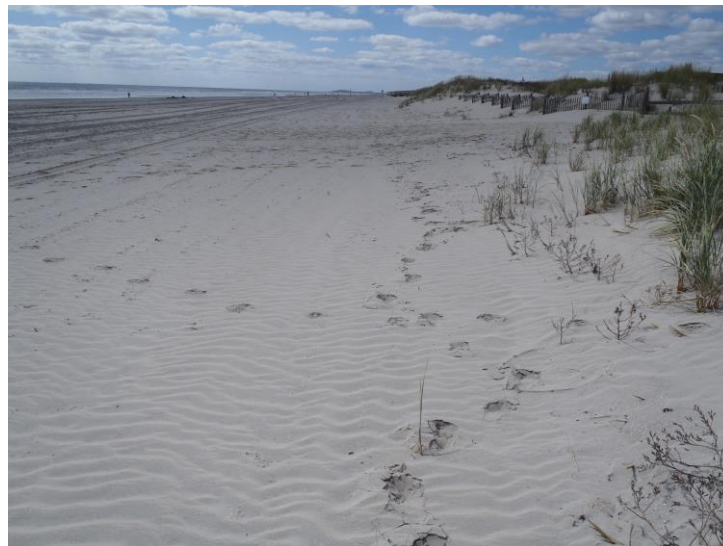
**Photoplate 2c** - Photo taken October 3, 2017 shows a relatively wide beach but less so than the June conditions.

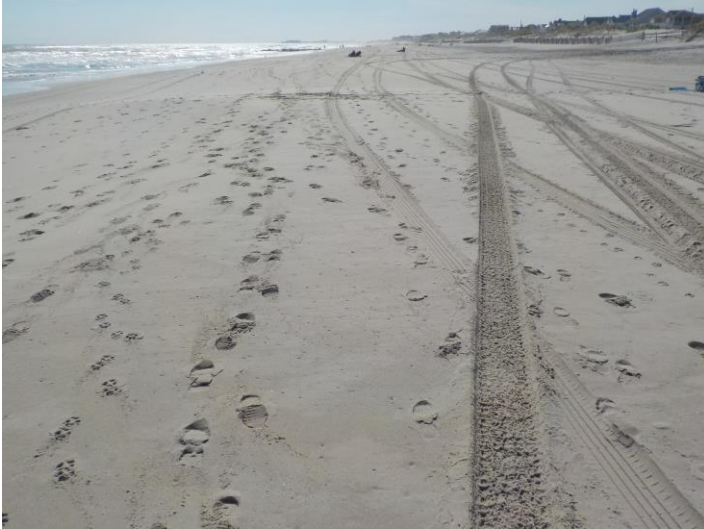
**Photoplate 3a - Photo taken October 13, 2016 shows a low berm which was the same width as it was in the fall of 2015.**

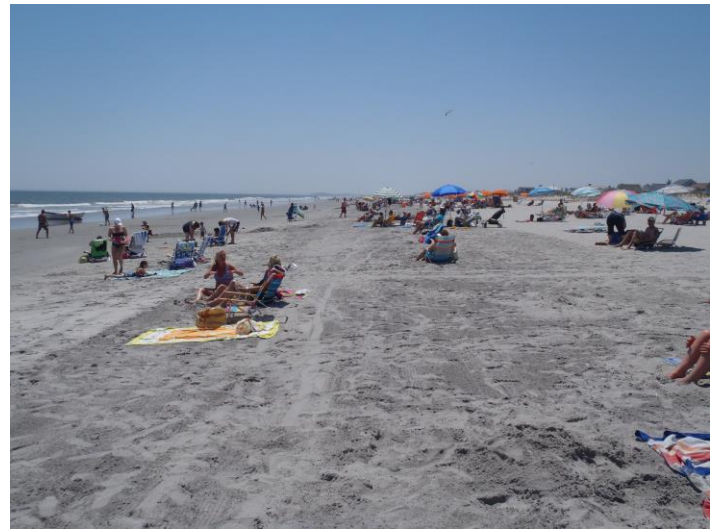
**Photoplate 3b – The June 12, 2017 photo shows a higher berm and wider beach from the previous survey.**

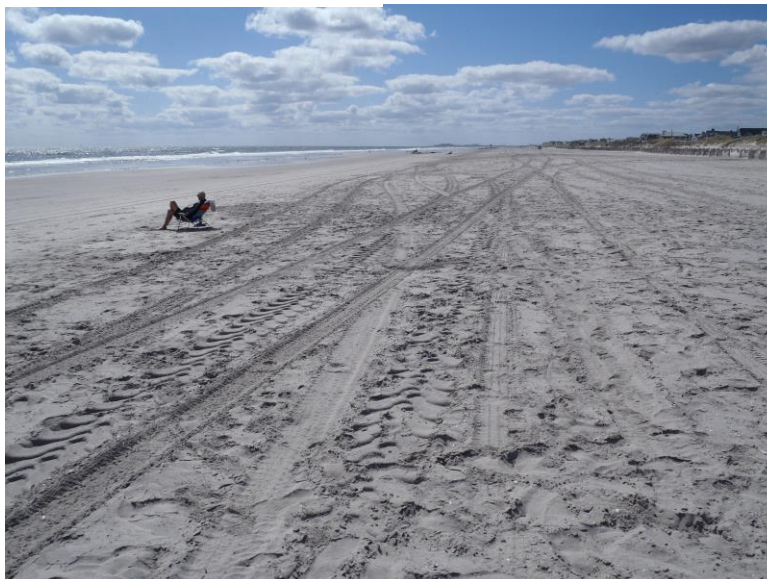
**Photoplate 3c – The photo taken October 3, 2017 shows a wide beach however, the shoreline moved 52 feet landward from its June 2017 position.**

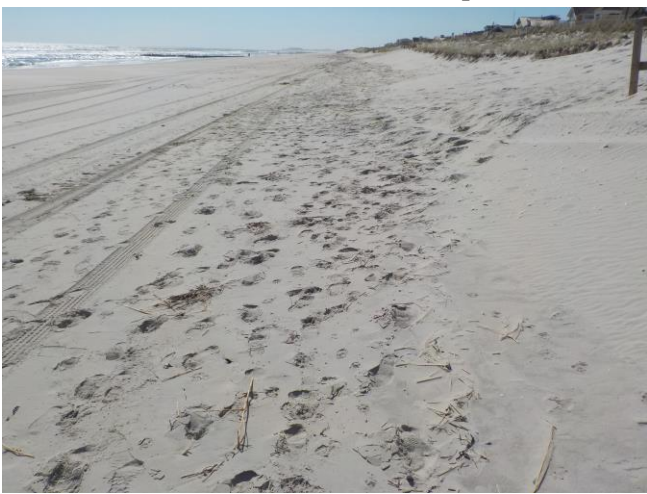
**Photoplate 4a - Photo taken October 13, 2016 shows the low elevation berm and steep backshore to dune toe.**

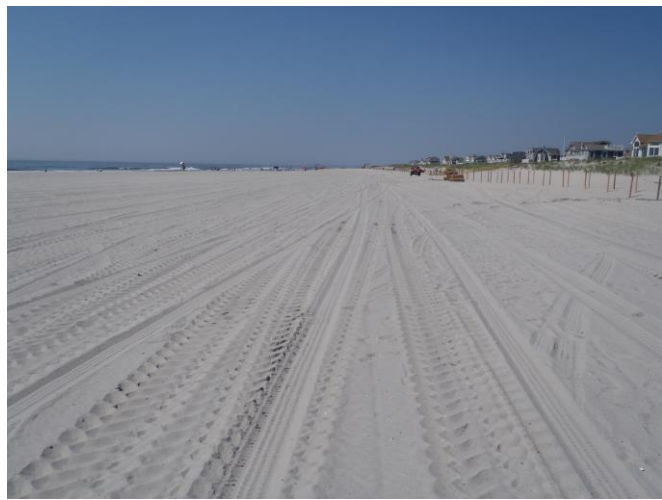
**Photoplate 4b - Photo taken June 12, 2017 shows the southern limits of the north end beach fill. The beach width gained 200 ft. from its October 2016 position.**

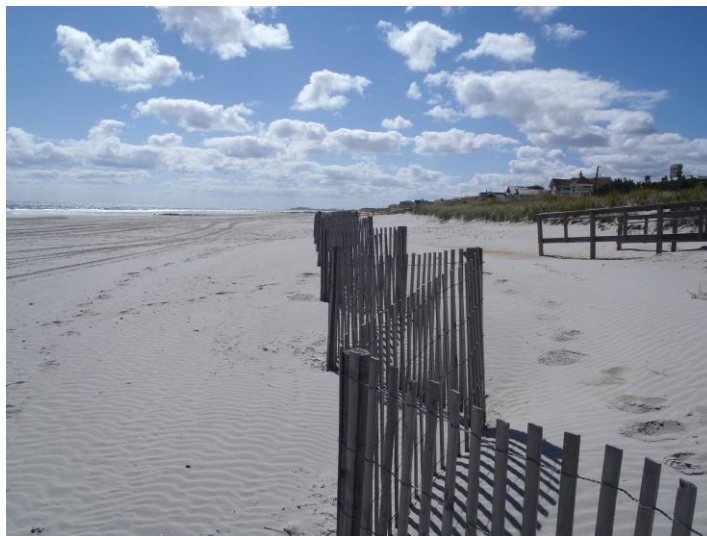
**Photoplate 4c – Photo taken October 3, 2017 showing sand fencing placed seaward of the dune toe. The shoreline moved landward 64 ft. from its June position.**

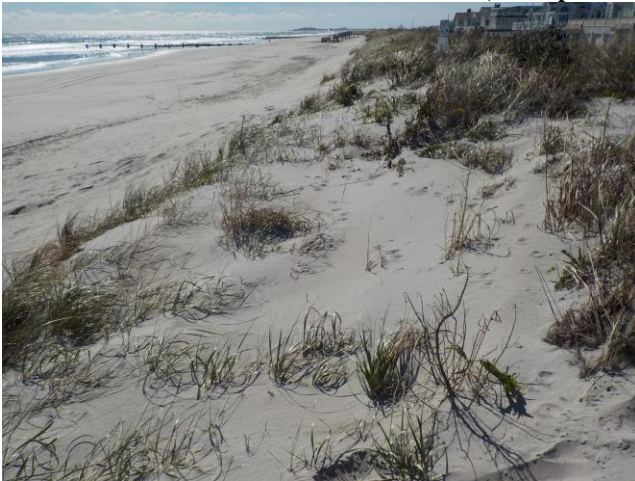
**Photoplate 5a – The October 13, 2016 photo shows the sparsely vegetated dune and nearly 150-ft wide low-elevation berm. Erosion of the dune occurred during northeast storm Jonas in January 2016.**

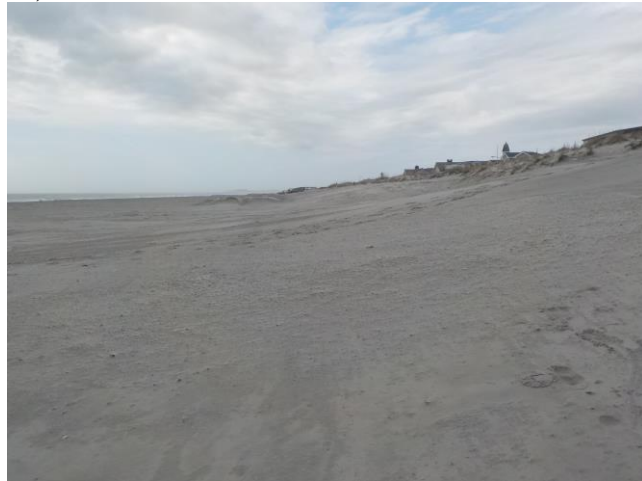
**Photoplate 5b – The photo taken March 27, 2017 shows the wide berm from sand placed in the February-March beach fill.**

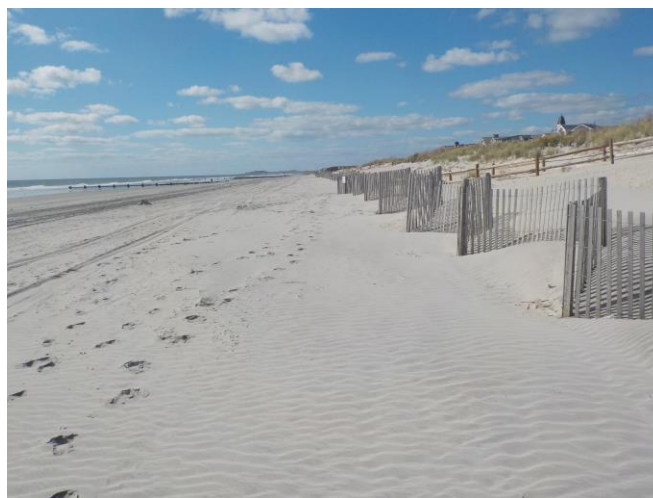
**Photoplate 5c – Photo taken October 3, 2017 shows sand fencing to protect the seaward dune toe. The wide berm had reduced in size and elevation from its March position.**

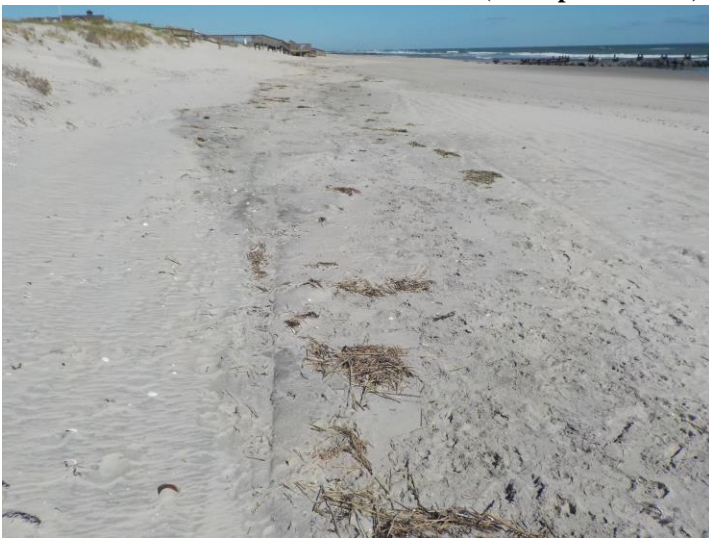
**Photoplate 6a – The October 13, 2016 photo shows evidence wave run-up to near the dune toe.**

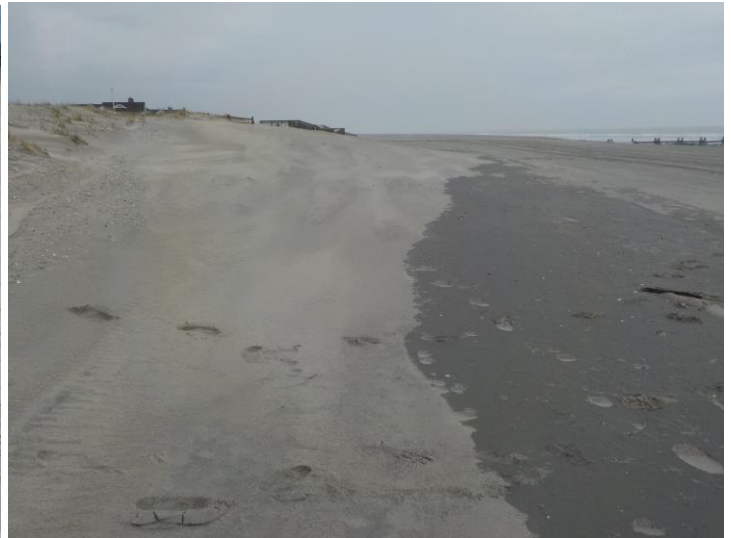
**Photoplate 6b - Photo taken March 27, 2017 shows the conditions after the placement of sand a few weeks prior.**

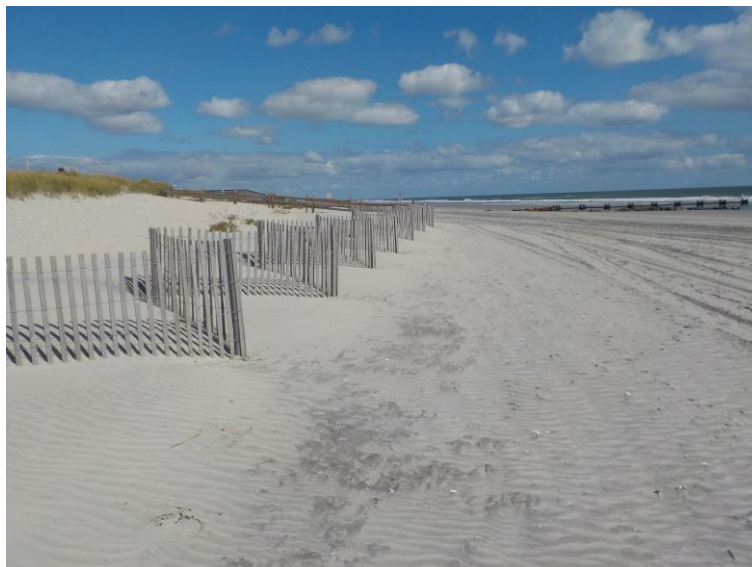
**Photoplate 6c – Photo taken October 3, 2017 shows sand fencing at the seaward dune toe. The shoreline moved 29 ft. seaward from its March position.**

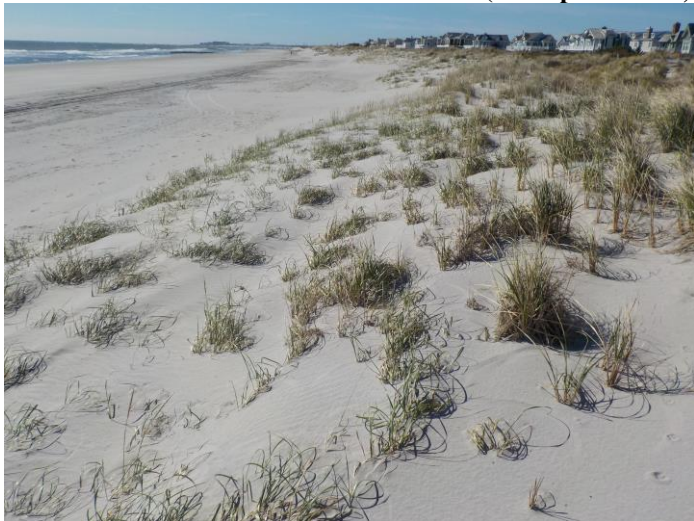
**Photoplate 7a - Photo taken October 14, 2016 shows sand accumulation around vegetation and a sand bar near the water's edge.**

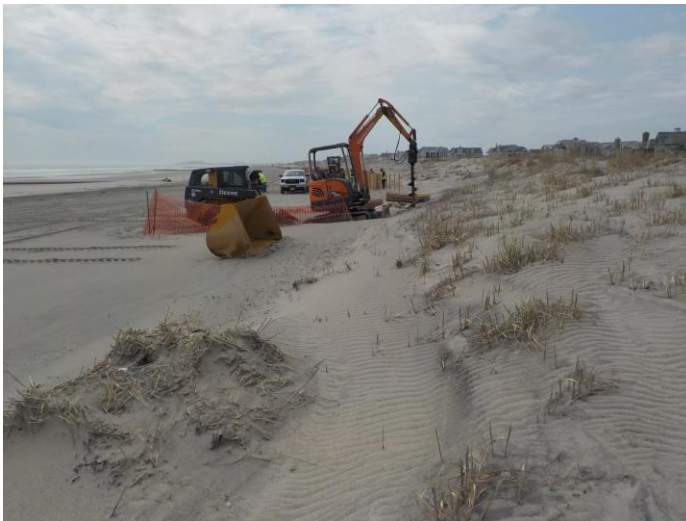
**Photoplate 7b – Photo taken March 27, 2017 showing the installation of fencing at the toe of the dune.**

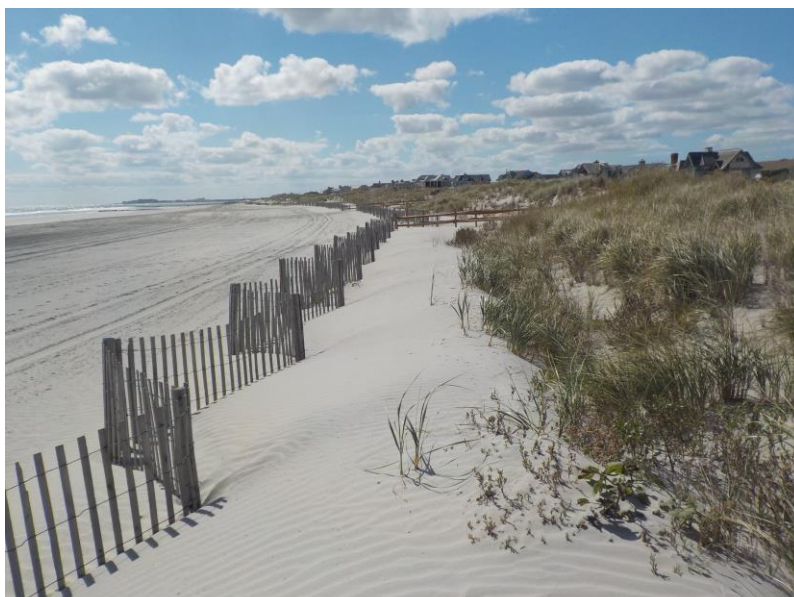
**Photoplate 7c – Photo taken October 3, 2017 shows sand trapped by the sand fencing. This management practice allows the dunes to progress seaward.**

- The zigzag pattern of the installed fence captured wind-blown sand and as a result, the dune toe moved seaward. Fence installation should follow recommendations summarized in past CRC reports and from

the New Jersey Department of Environmental Protection Division of Coastal Engineering and Division of Land Use Regulation.

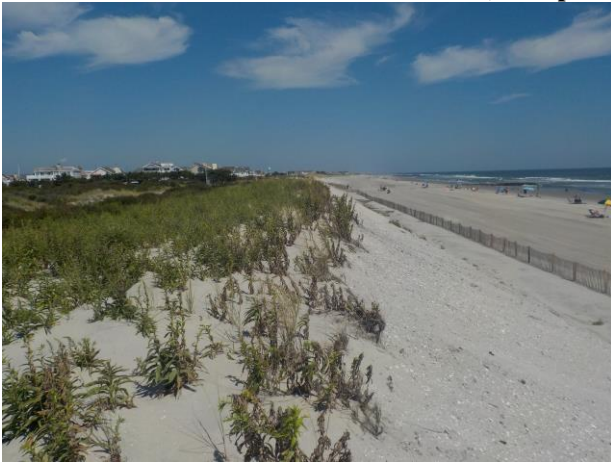
**Photoplate 8a - Photo taken September 14, 2016 showing sand fence at the seaward dune toe. The profile shows a summer accumulation of sand on the berm.**

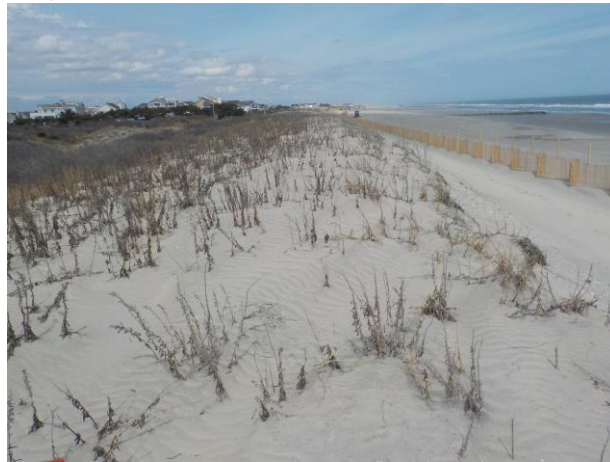
**Photoplate 8b – Photo taken March 27, 2017 after the placement of sand from the 2<sup>nd</sup> Periodic Nourishment project.**

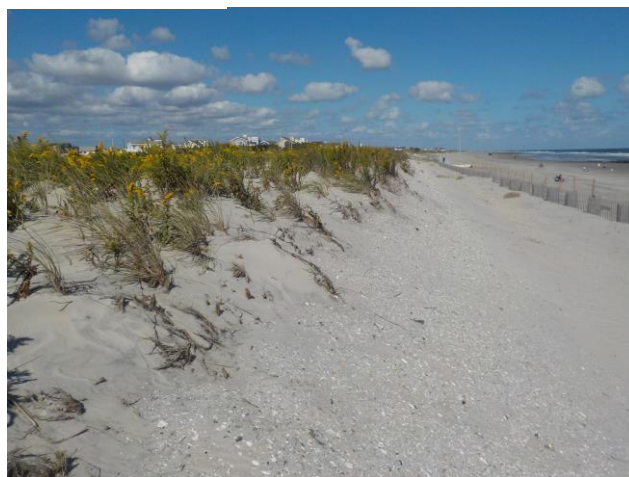
**Photoplate 8c – The photo taken October 3, 2017 shows dune conditions similar to previous survey dates. Most of the changes occurred below the 0.0 ft. datum.**

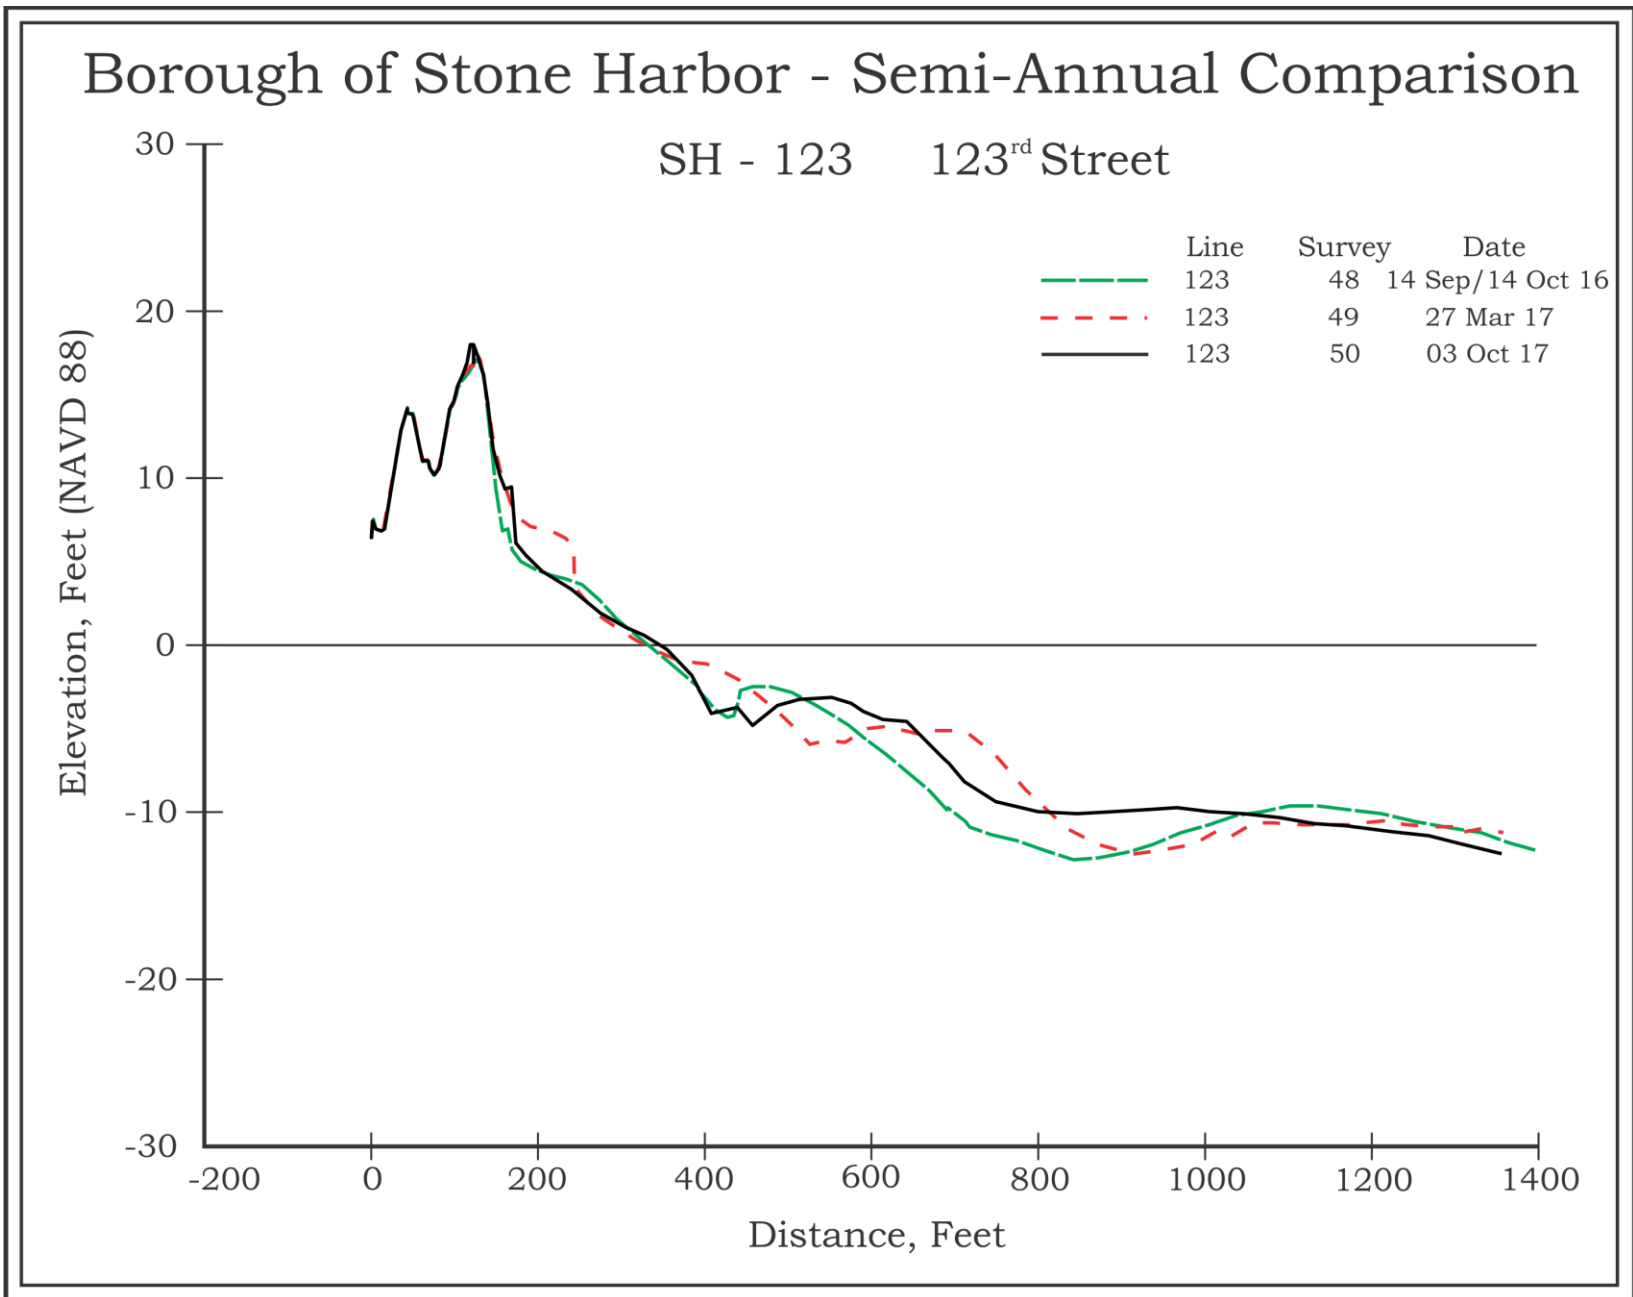
This site was included in the February-March 2<sup>nd</sup> Periodic Nourishment project area. The additional sand was the source for the positive annual volume change (28.5 yds<sup>3</sup>/ft.) and the shoreline moved seaward 13 ft.

**Figure 8.** The cross sections at 123<sup>rd</sup> Street show erosion of the berm sand that was placed in the February-March beach fill. The total volume change between surveys #49 and #50 was not incredibly significant (-1.1 yds<sup>3</sup>/ft.). The above-datum losses nearly balanced the below-datum gain. The shoreline moved 16.5 ft. seaward.
