## An Analysis of Thirty Years' Study of Sand Redistribution and Shoreline Changes in New Jersey's Four Coastal Counties Raritan Bay, the Atlantic Ocean Coast, and Delaware Bay Fall 1986 Through Fall 2016

### ***VOLUME 2 of 4 OCEAN COUNTY***

Prepared for:  
New Jersey Department of Environmental Protection  
Division of Coastal Engineering  
1510 Hooper Avenue, Toms River, New Jersey 08753

Prepared by:  
Stockton University Coastal Research Center  
30 Wilson Avenue, Port Republic, NJ 08241

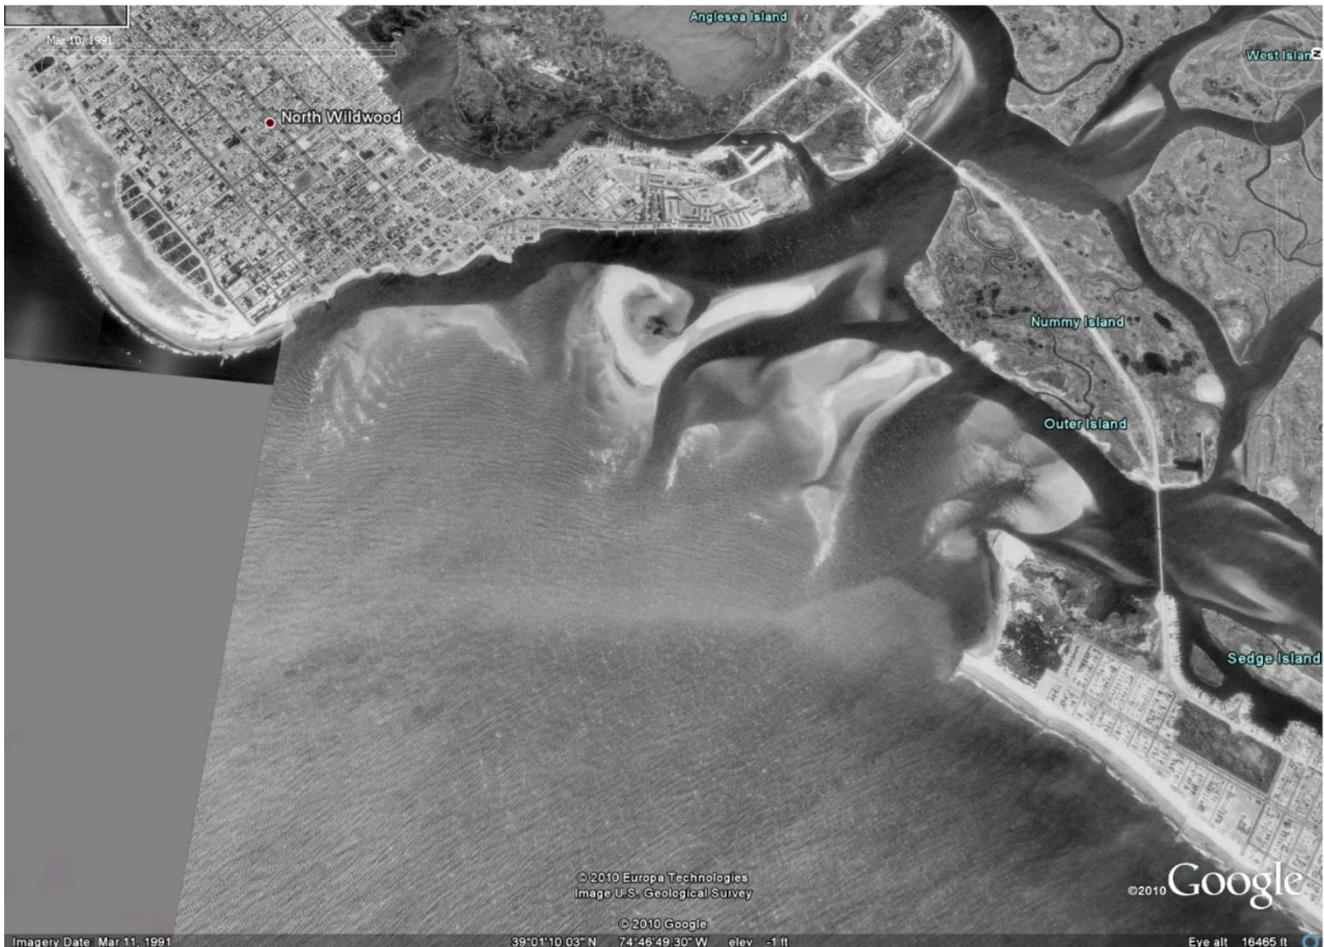
*Hereford Inlet, Cape May County, March 10, 1991, seven years prior to the initial NJ State and municipally funded beach restoration. Bird habitat consisted of four large intertidal shoals situated between the 123rd Street groin in Stone Harbor and the rock revetment protecting North Wildwood. 25 years and 4.8 million cubic yards of beach restoration later, nesting habitat had expanded into a 7,500 foot long spit extending to a point south of the third shoal in the photo.*

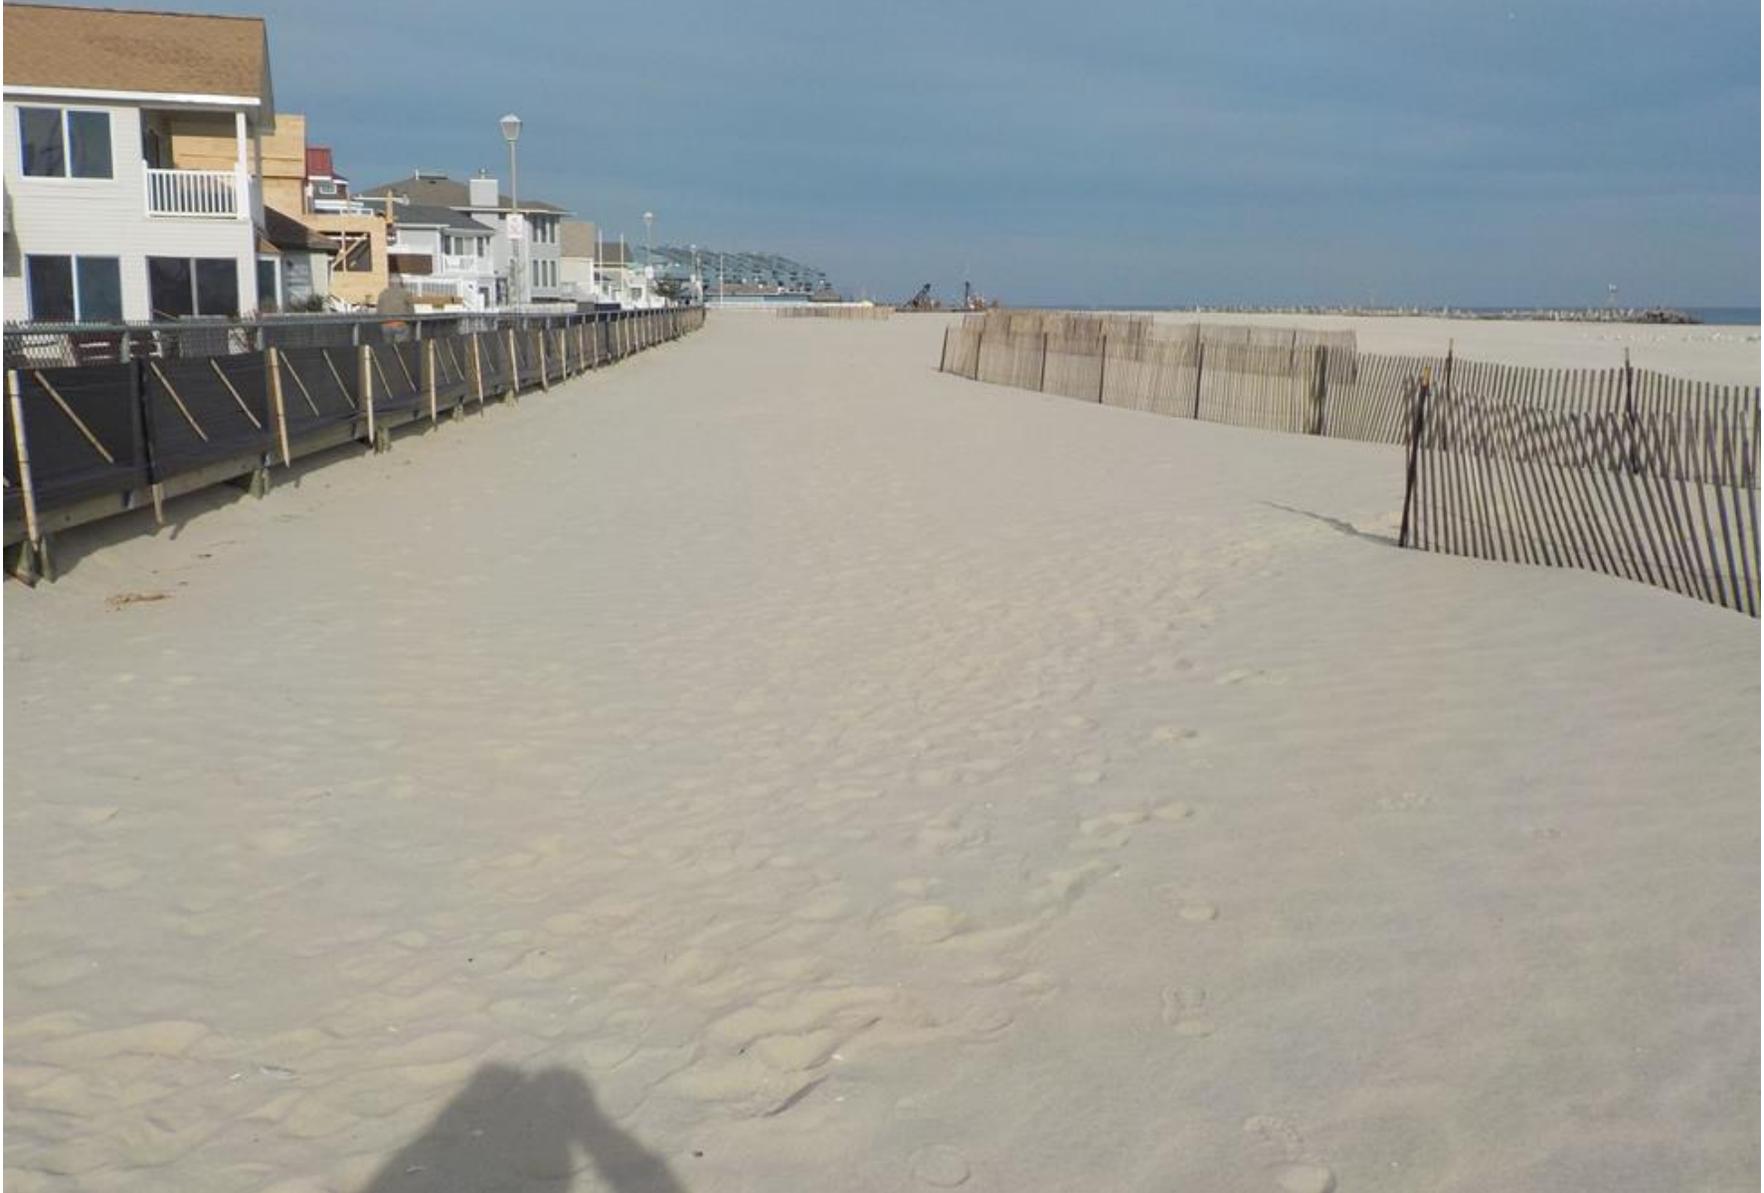
**NJBPN 156 - Water Street, Point Pleasant Beach (December 21, 2016)**

**Figure 219. View to the north from the backshore at Water Street in Point Pleasant Beach. The en eschelon rows of sand fence could be the locus of a dune along this section of beach. Any dune over 4 ft high would have prevented the overwash that was experienced during Hurricane Sandy.**

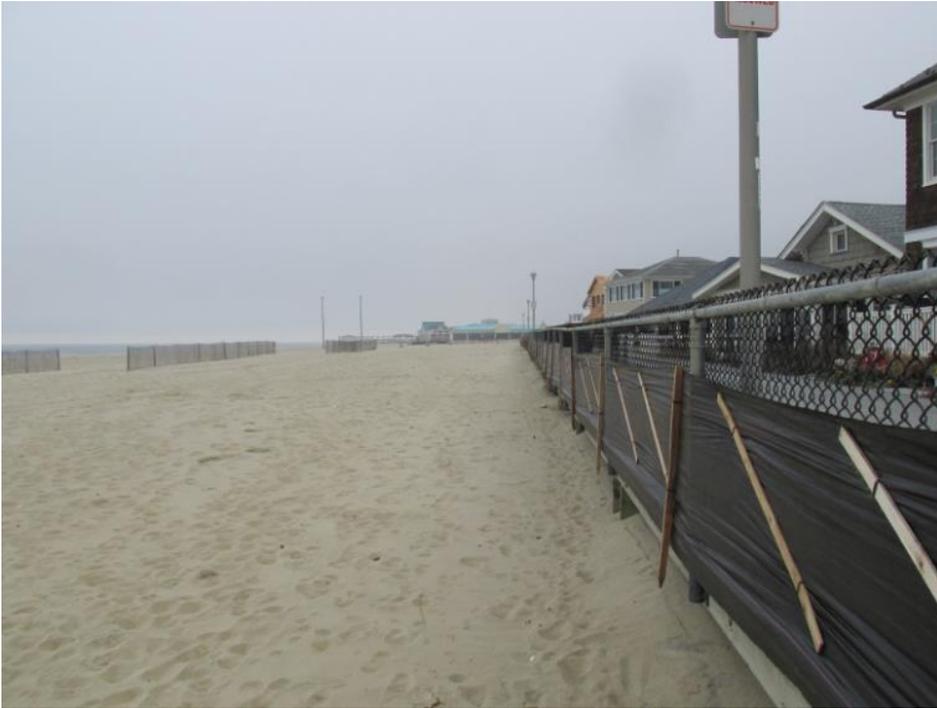
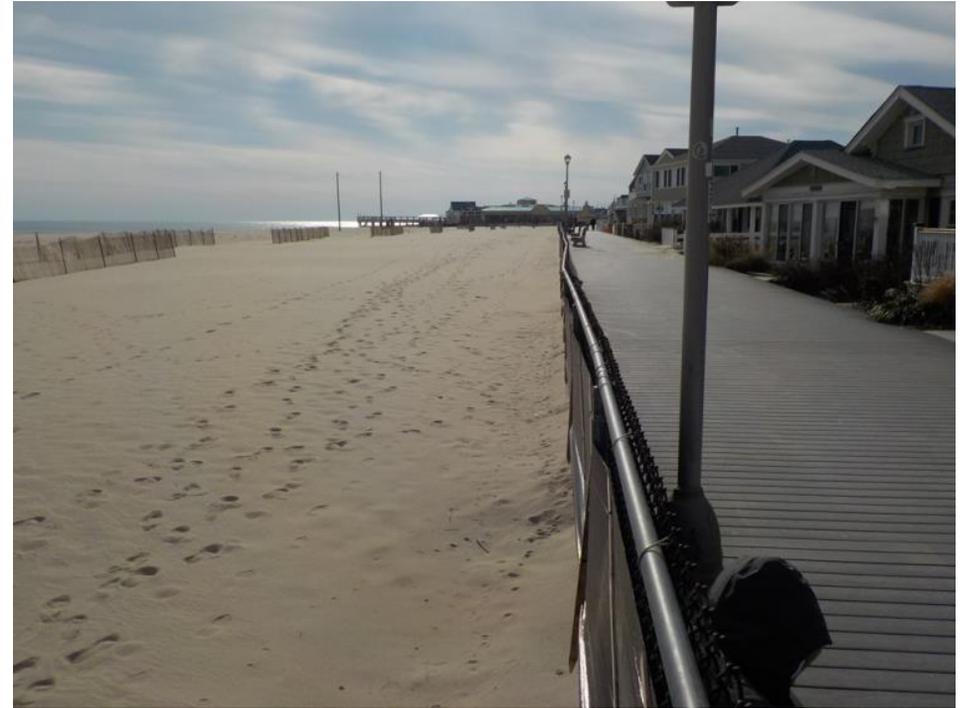
**NJBPN 156 – Water Street, Point Pleasant Beach**

**Figure 220a & 221b. The Water Street site is located toward the south end of the Point Pleasant Beach boardwalk. The photo on the left (taken December 14, 2015) shows the backshore as a result of local efforts in maintaining the dry beach. The photo on the right (taken December 21, 2016) shows a similar backshore to 2015. This beach is included in the proposed federal shore protection project (Manasquan Inlet to Barnegat Inlet).**

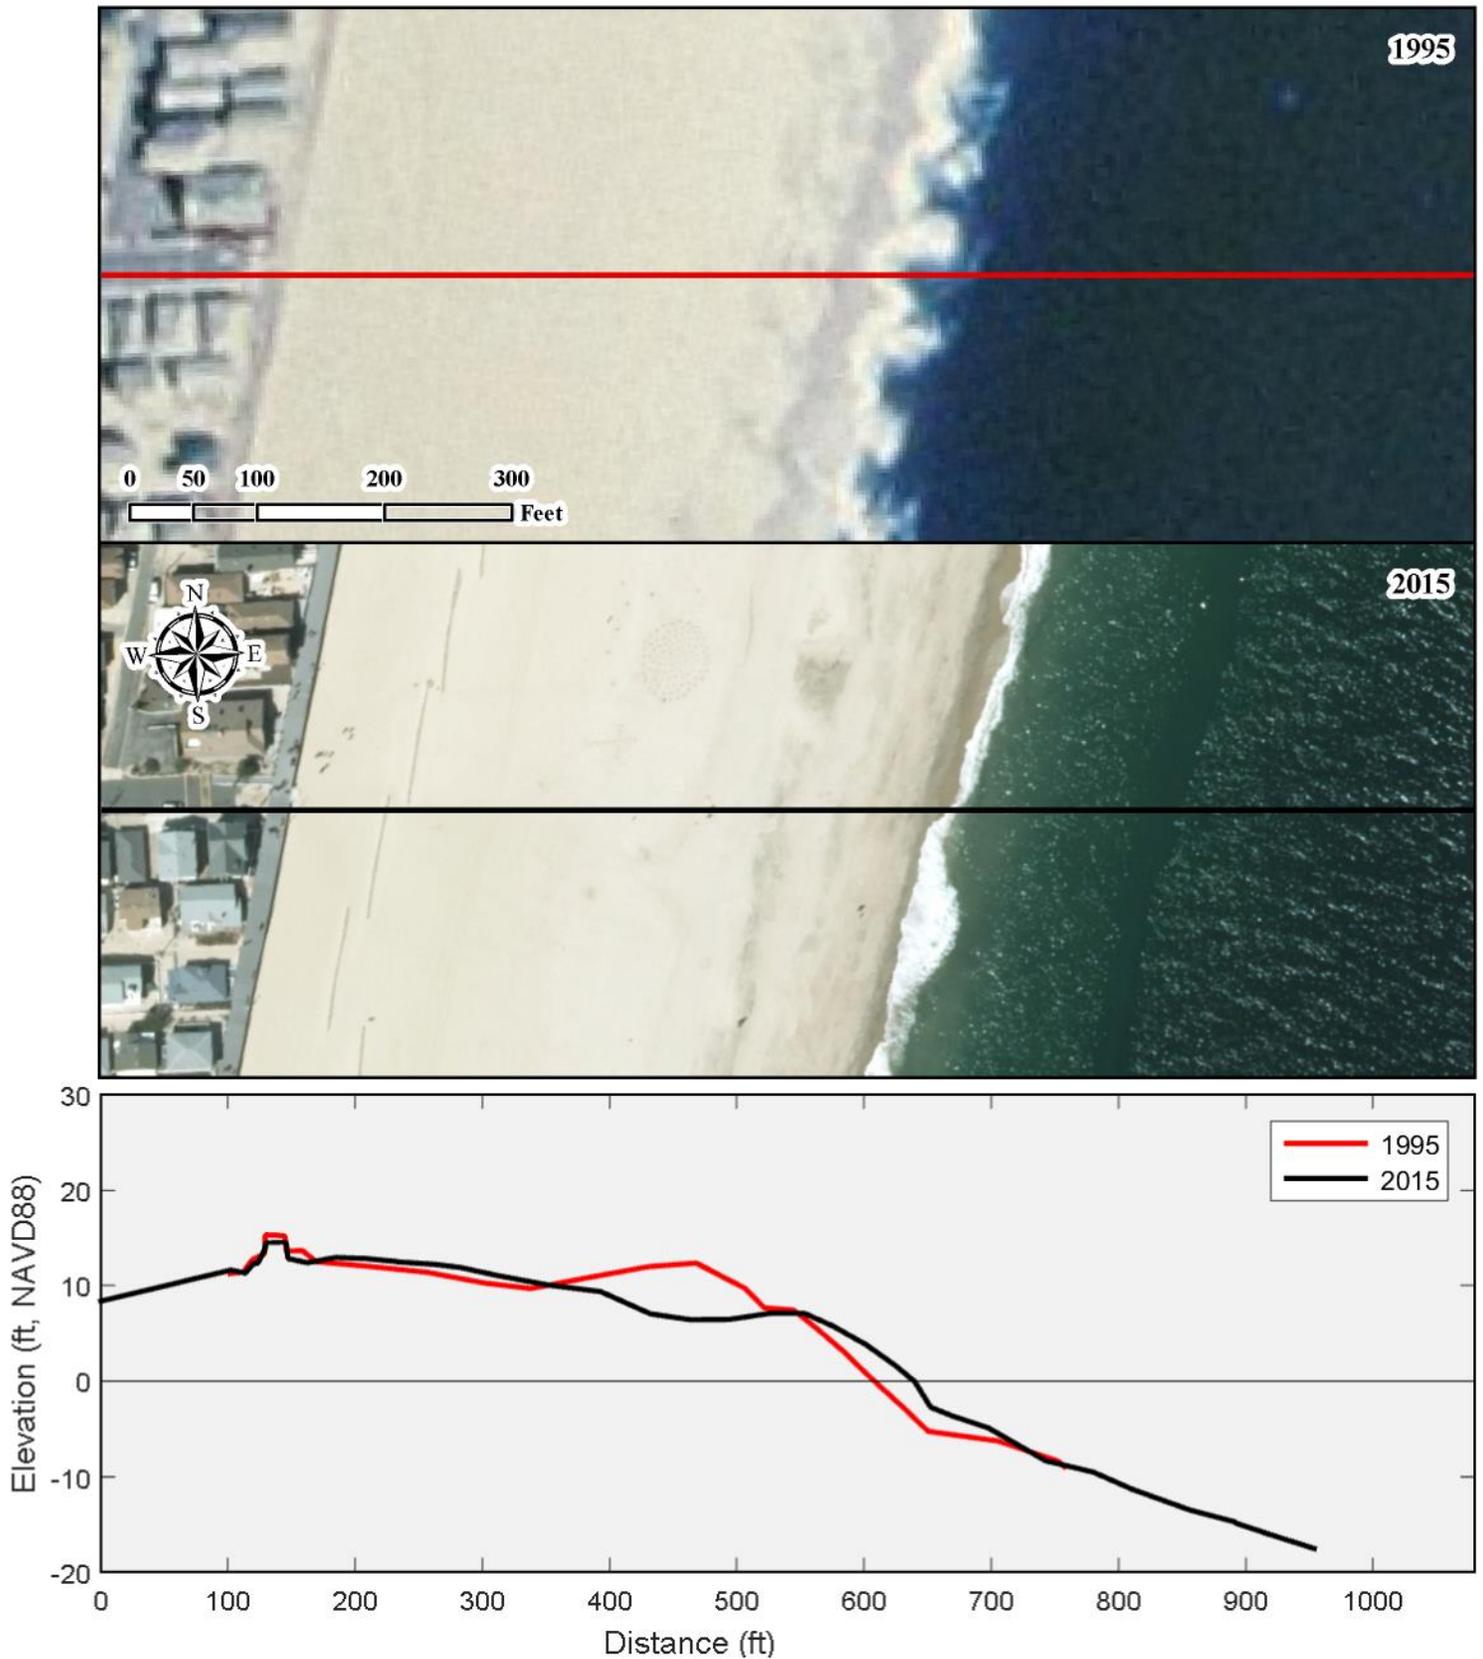
Figure 225. No sand was placed at this location during the study period, though the shoreline moved 31 feet seaward. This is due to the location of the profile with respect to the Manasquan Inlet jetties

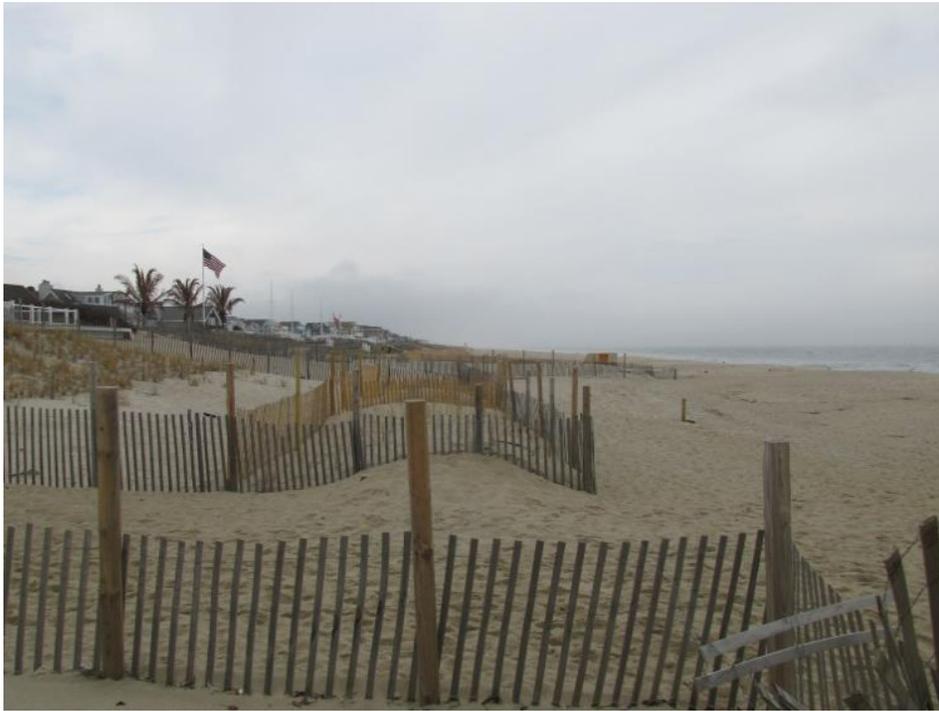
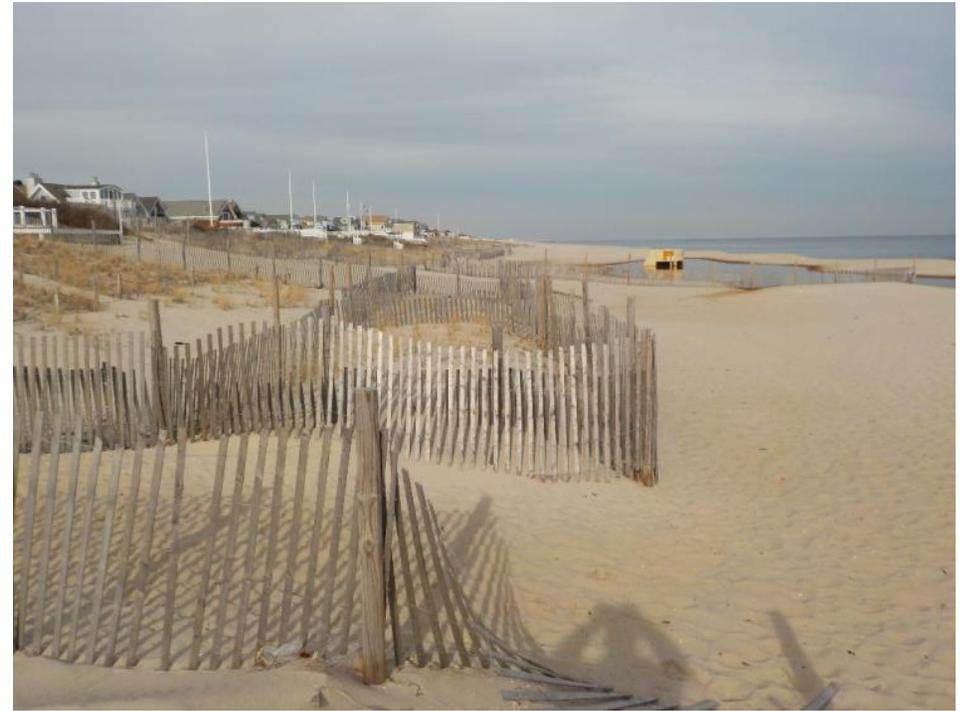
**NJBPN 155 – Maryland Avenue, Point Pleasant Beach**

**Figure 227a & 227b. The Maryland Avenue profile is located over a mile south of Manasquan Inlet. The photos (left taken December 14, 2015 and right taken December 21, 2016) show a maintained beach. Installation of sand fencing seaward of existing fence is a local effort to capture wind-blown sand. The stormwater discharge station from Sea Avenue is evident on the right photograph, but not so visible on the left.**

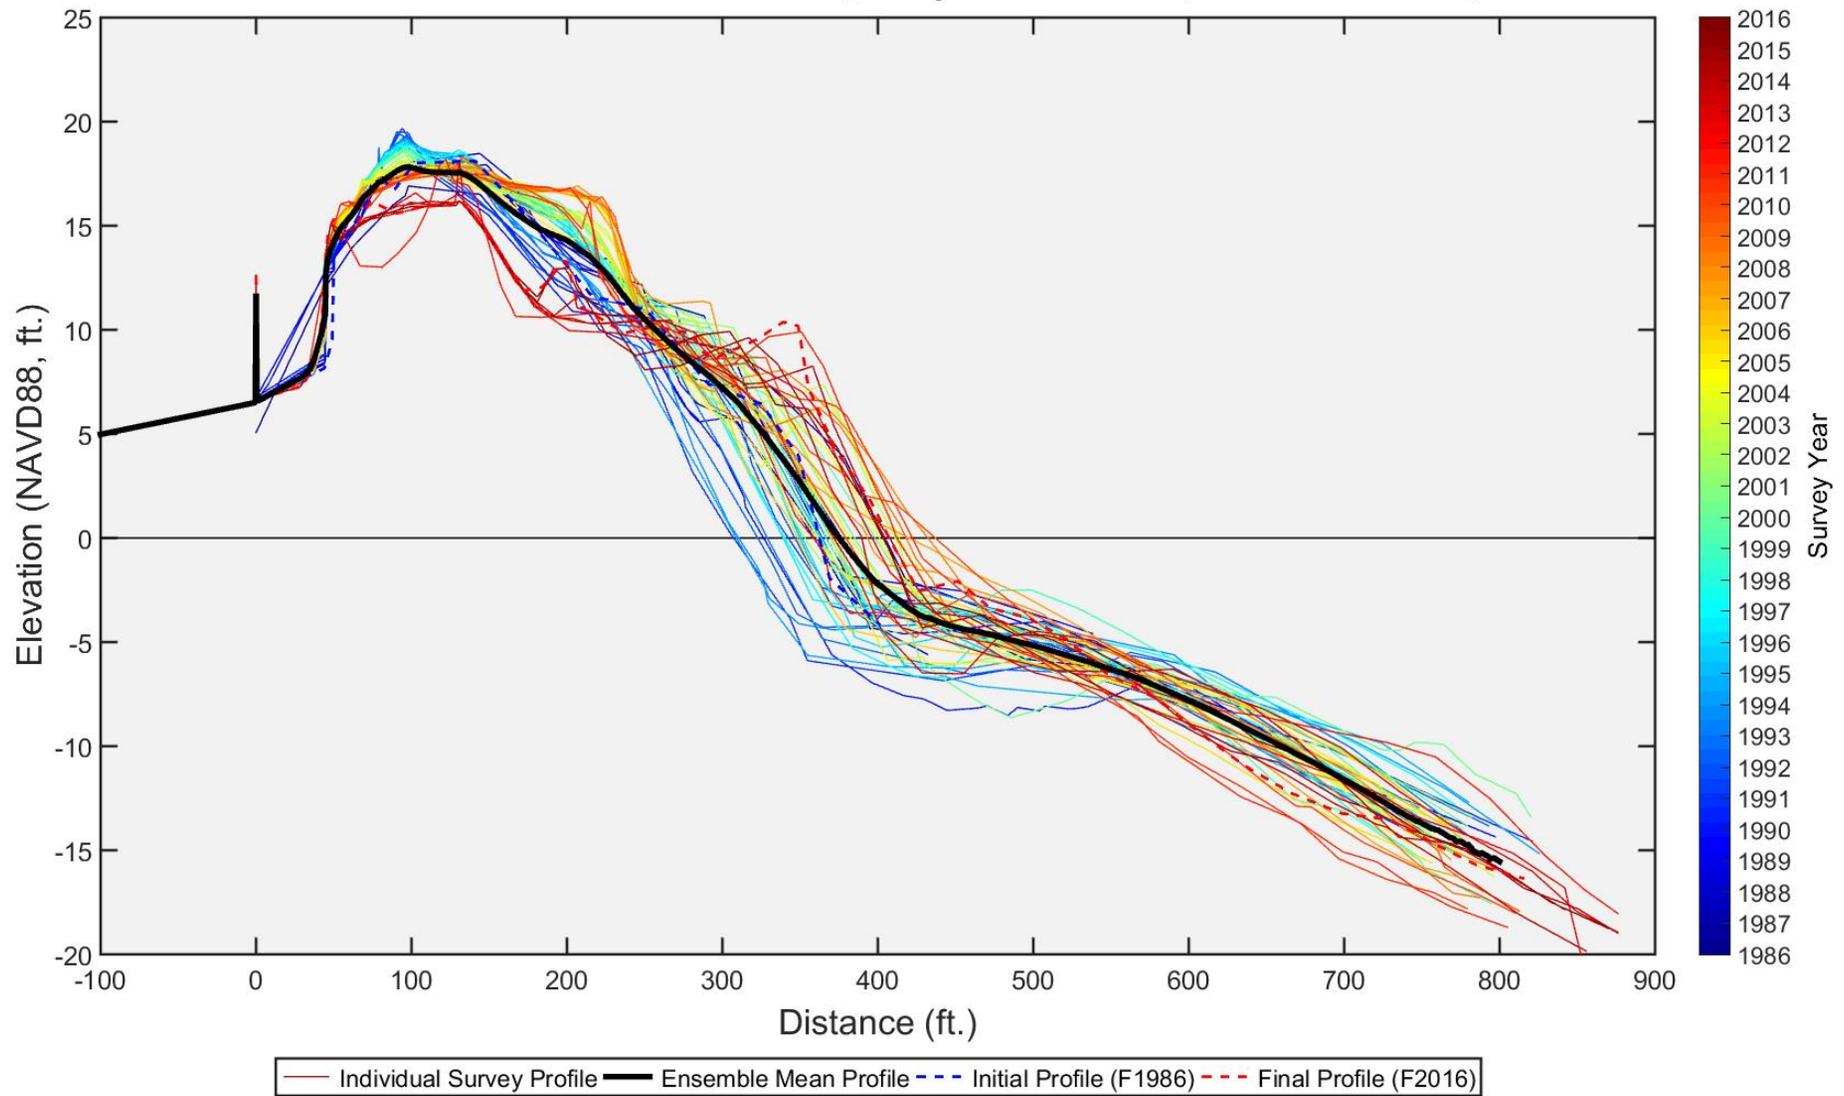
### 30-Year Ensemble Mean Profile at Site 155, Maryland Avenue, Point Pleasant, Ocean Co.

**Figure 230.** The Maryland Avenue profile has a decent dune that is lower in elevation from its 1986 position. The site is adjacent to a low elevation pedestrian accessway from Maryland Avenue that was exploited by Hurricane Sandy and generated a sizable breach in the dunes. Since then, the dune has recovered, though not to pre-Sandy conditions. The beach has grown slightly wider since the Hurricane.

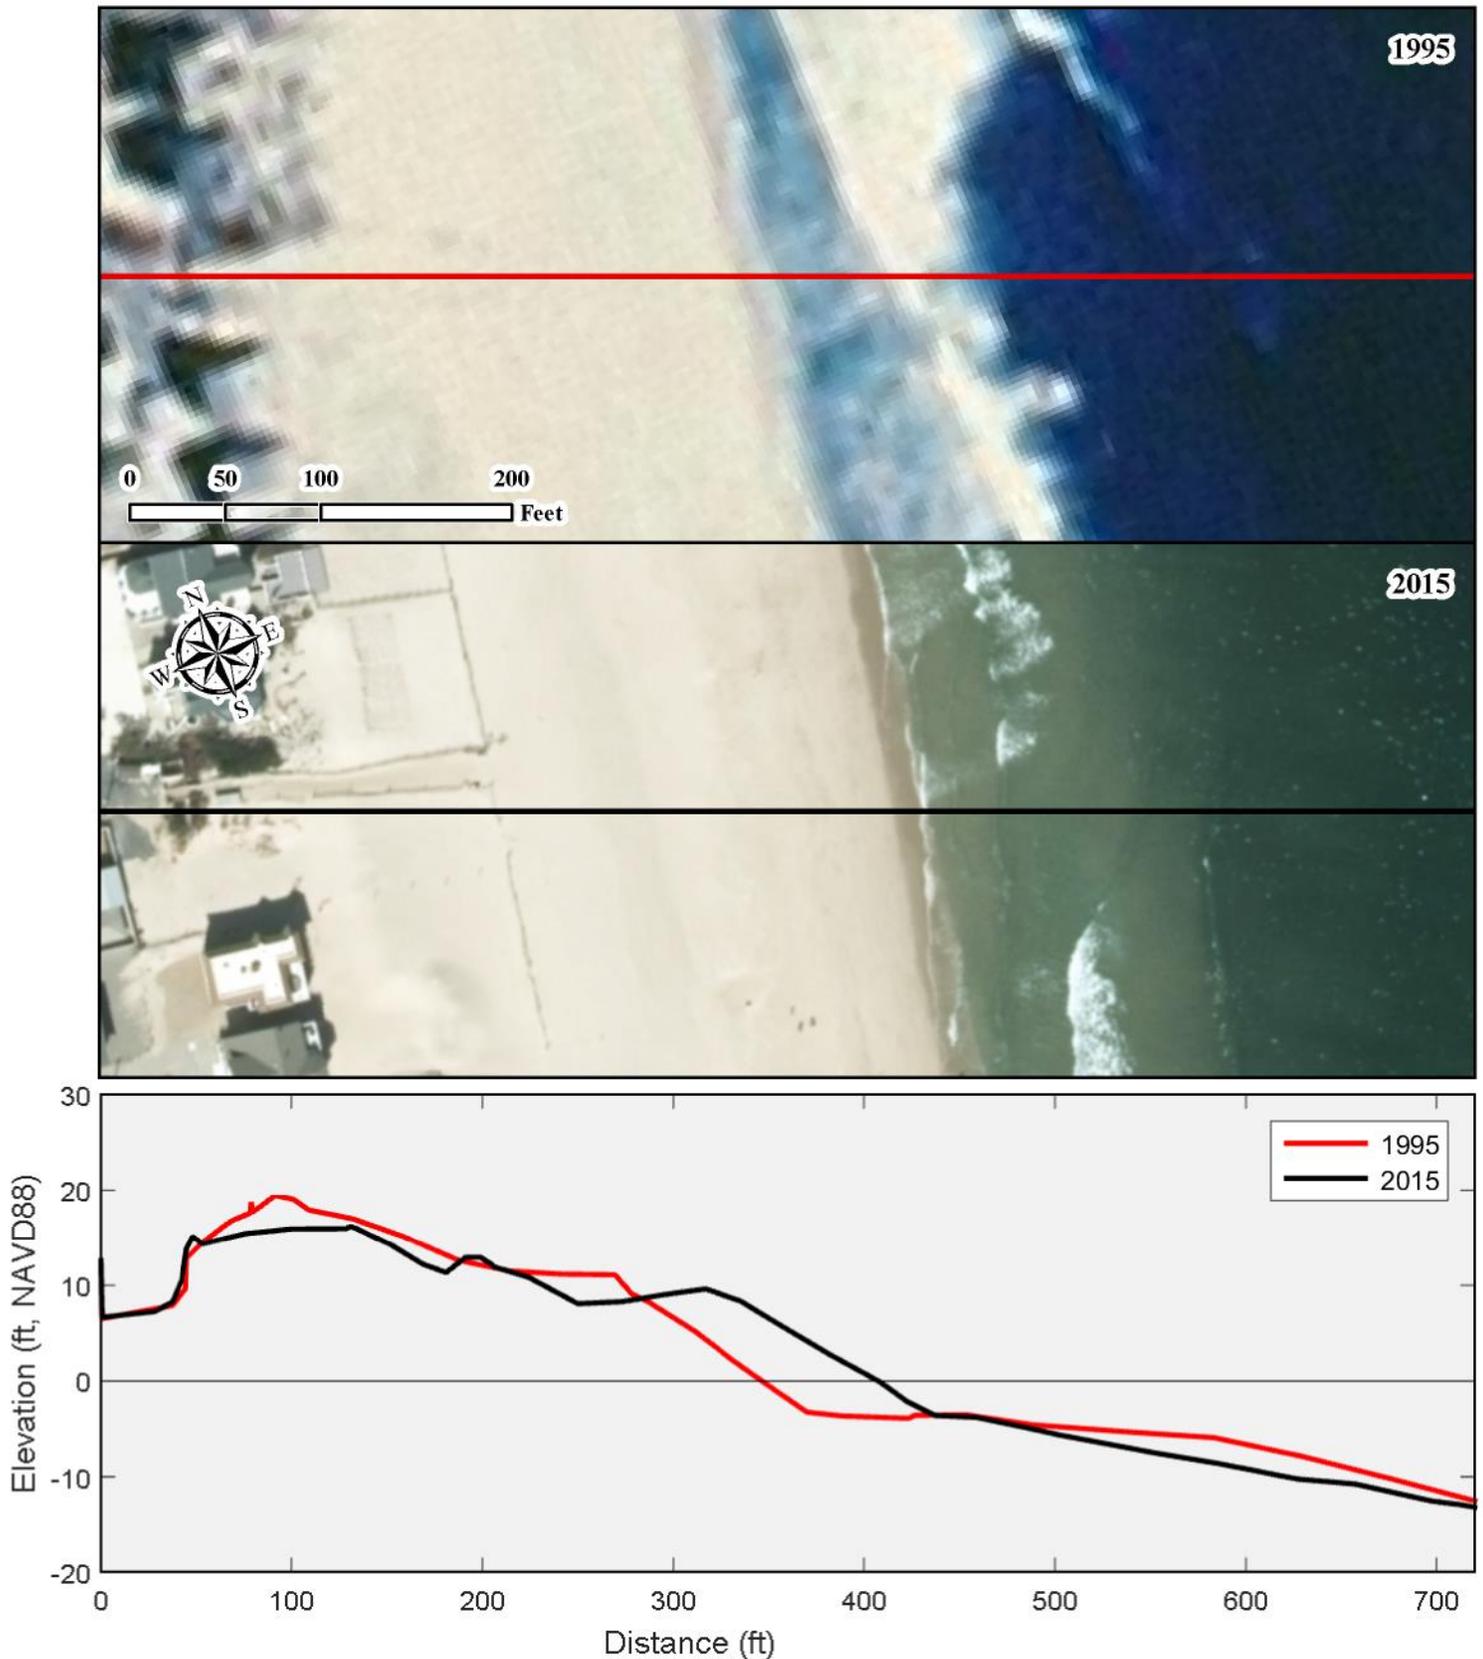
Figure 231. The dune and berm were lowered after the passage of Hurricane Sandy. Even though the beach topography was flattened, the shoreline moved seaward by 61 feet from its 1995 position.

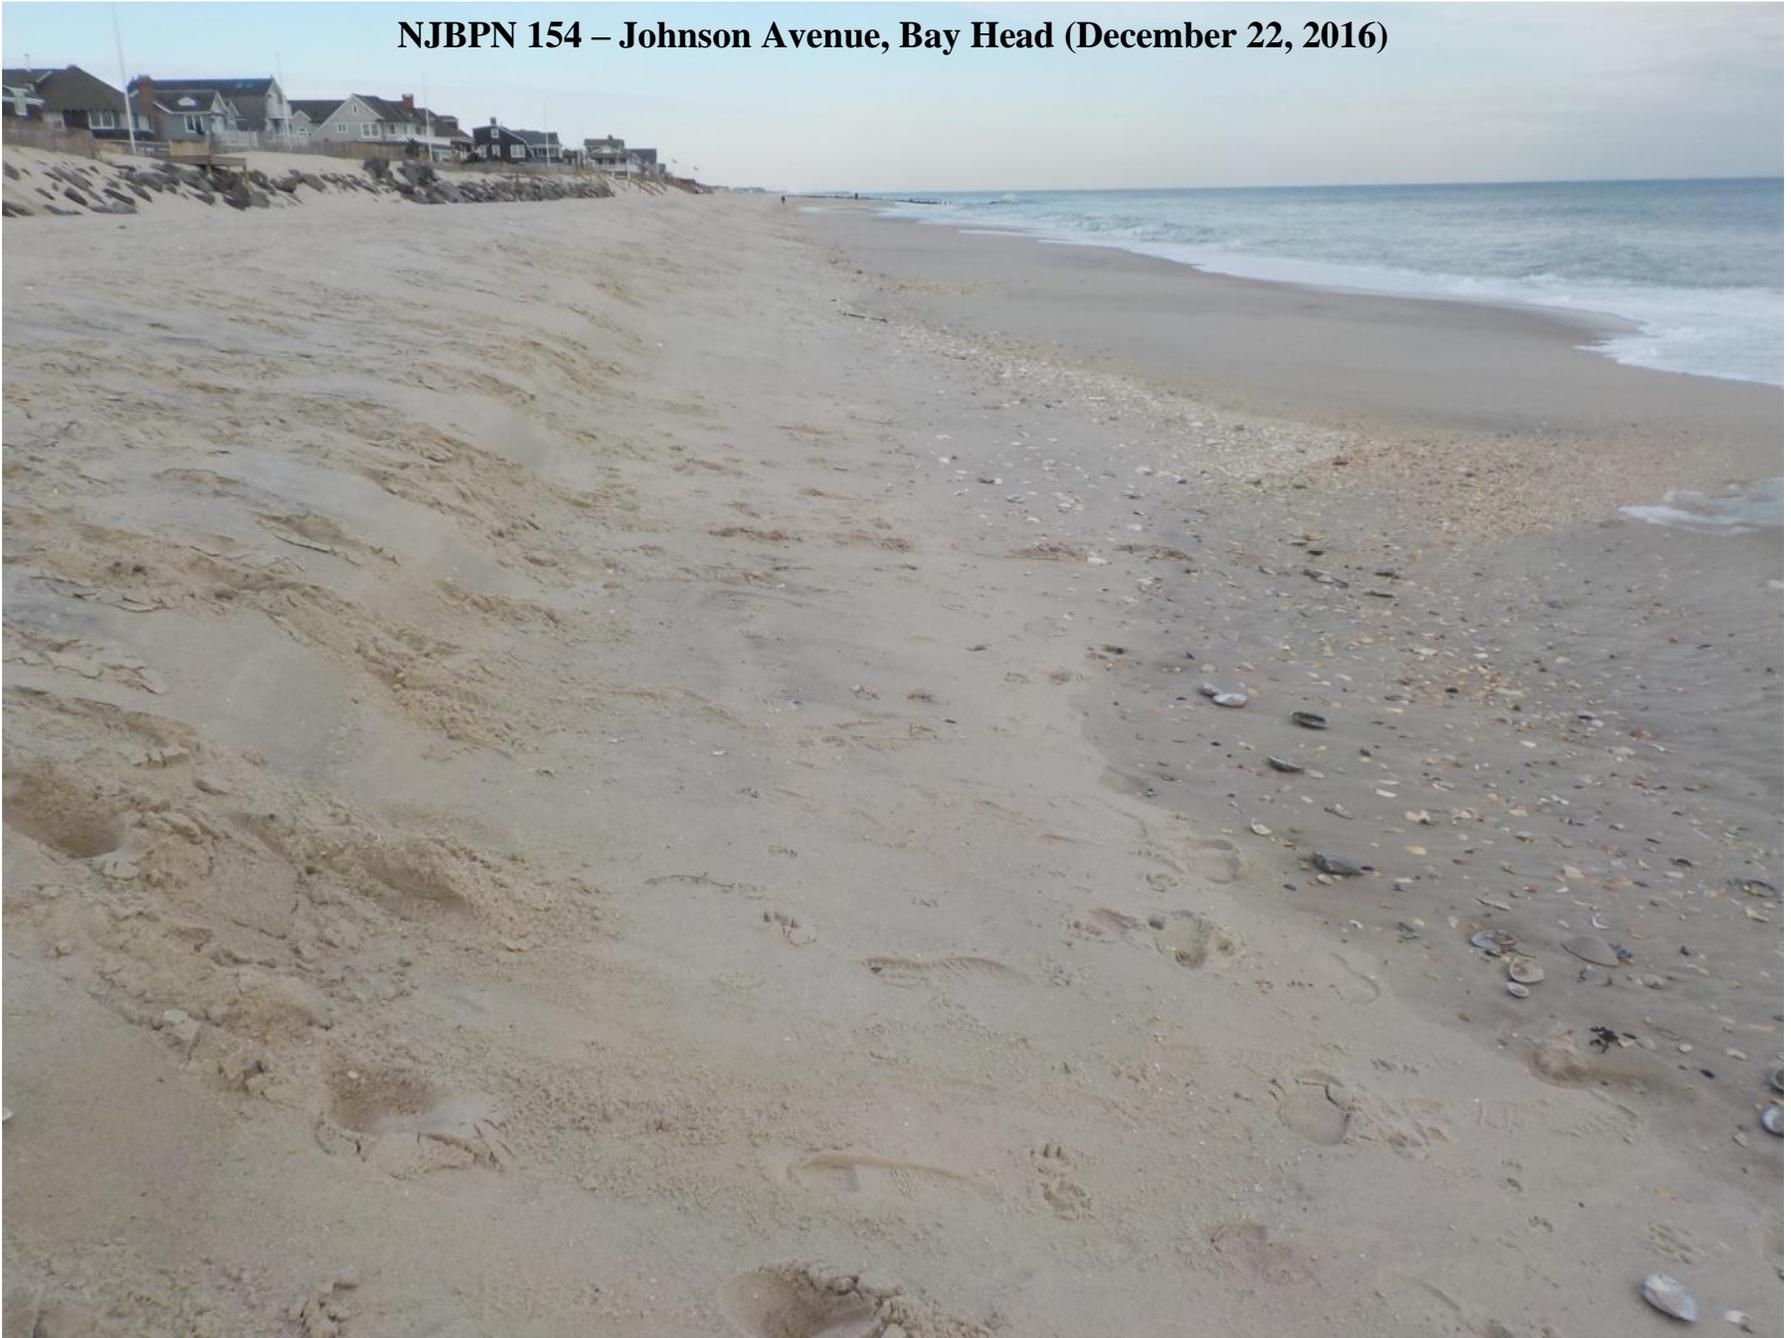
**NJBPN 154 – Johnson Avenue, Bay Head (December 22, 2016)**

**Figure 232. View to the north from the berm break at Johnson Avenue in Bay Head. The rock revetment was exposed following the January 23, 2016 northeaster (Jonas). Here, the berm was eroded into a steep slope with waves reaching its base.**

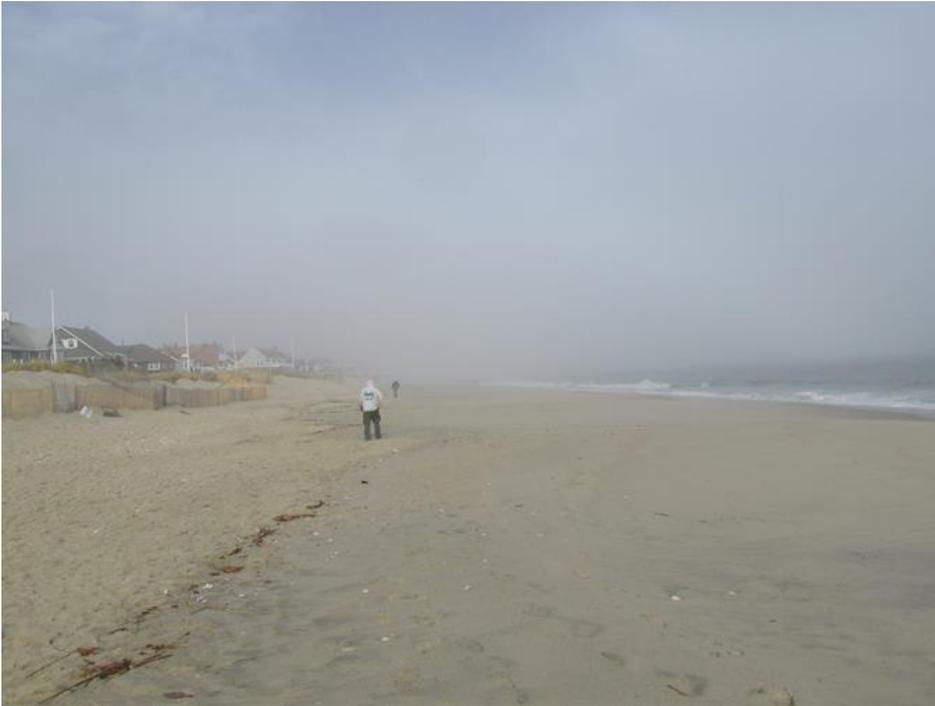
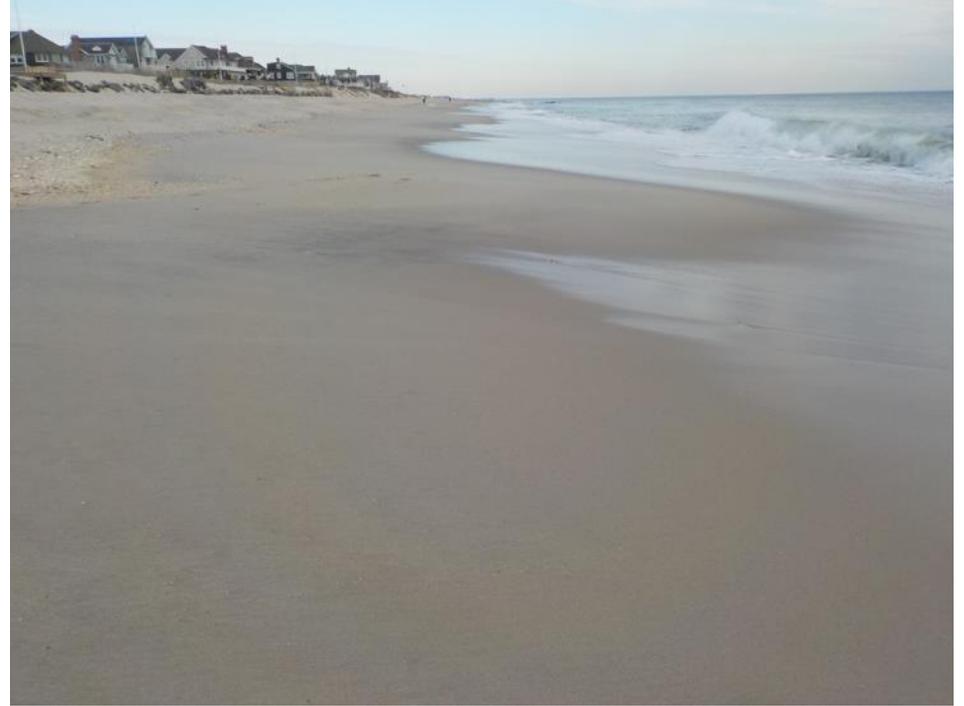
**Figure 233a & 233b. Both photos (left taken December 14, 2015 and right taken December 22, 2016) show the condition of the berm at the Bay Head location. The revetment rocks were covered just prior to Jonas on the left, but were exposed on the right 11 months later.**

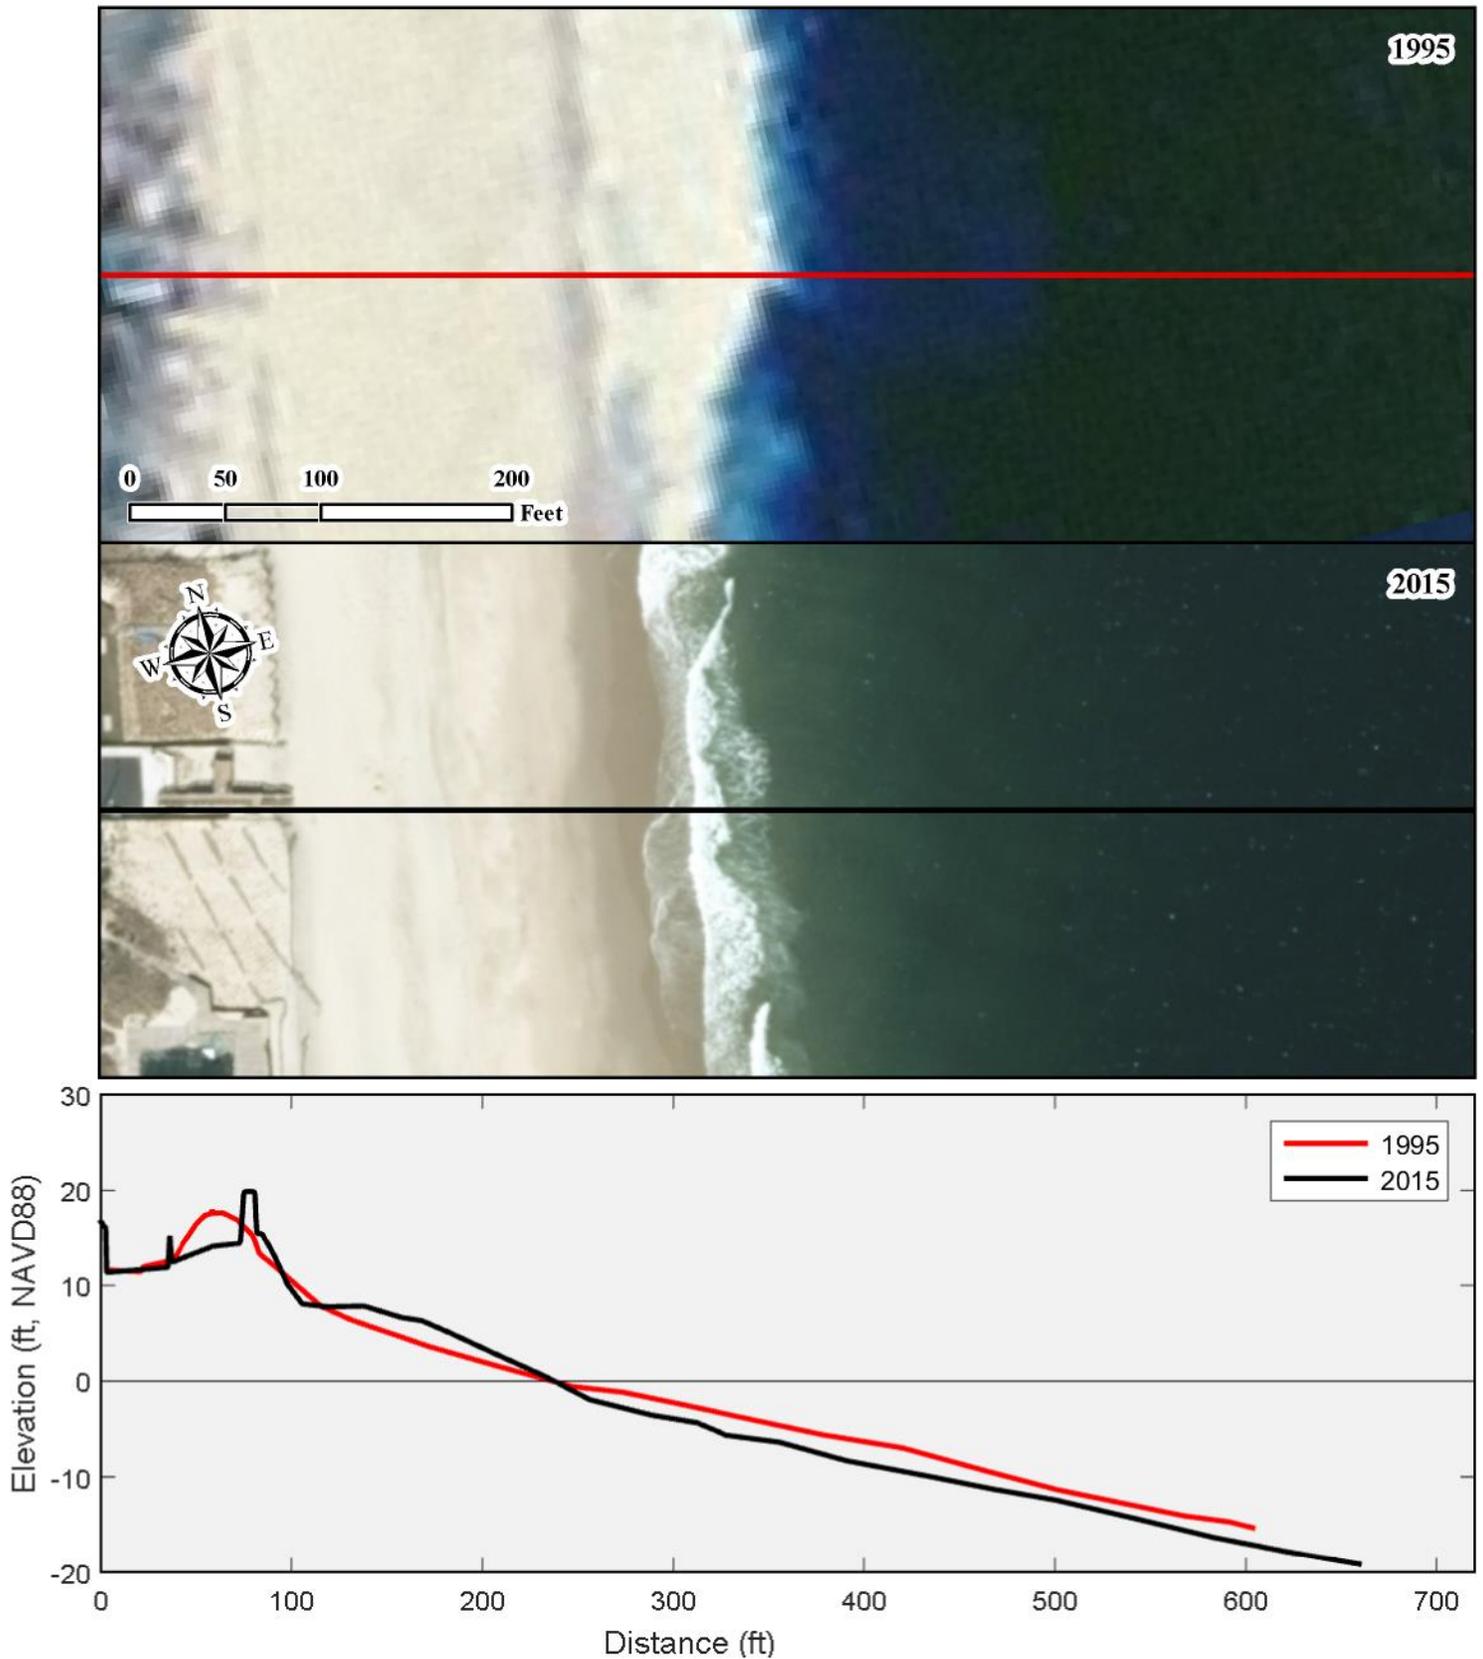
Figure 237. There was a change in the shape of the dune, but little change in shoreline position between 1995 and 2015 (seaward movement +1 ft).

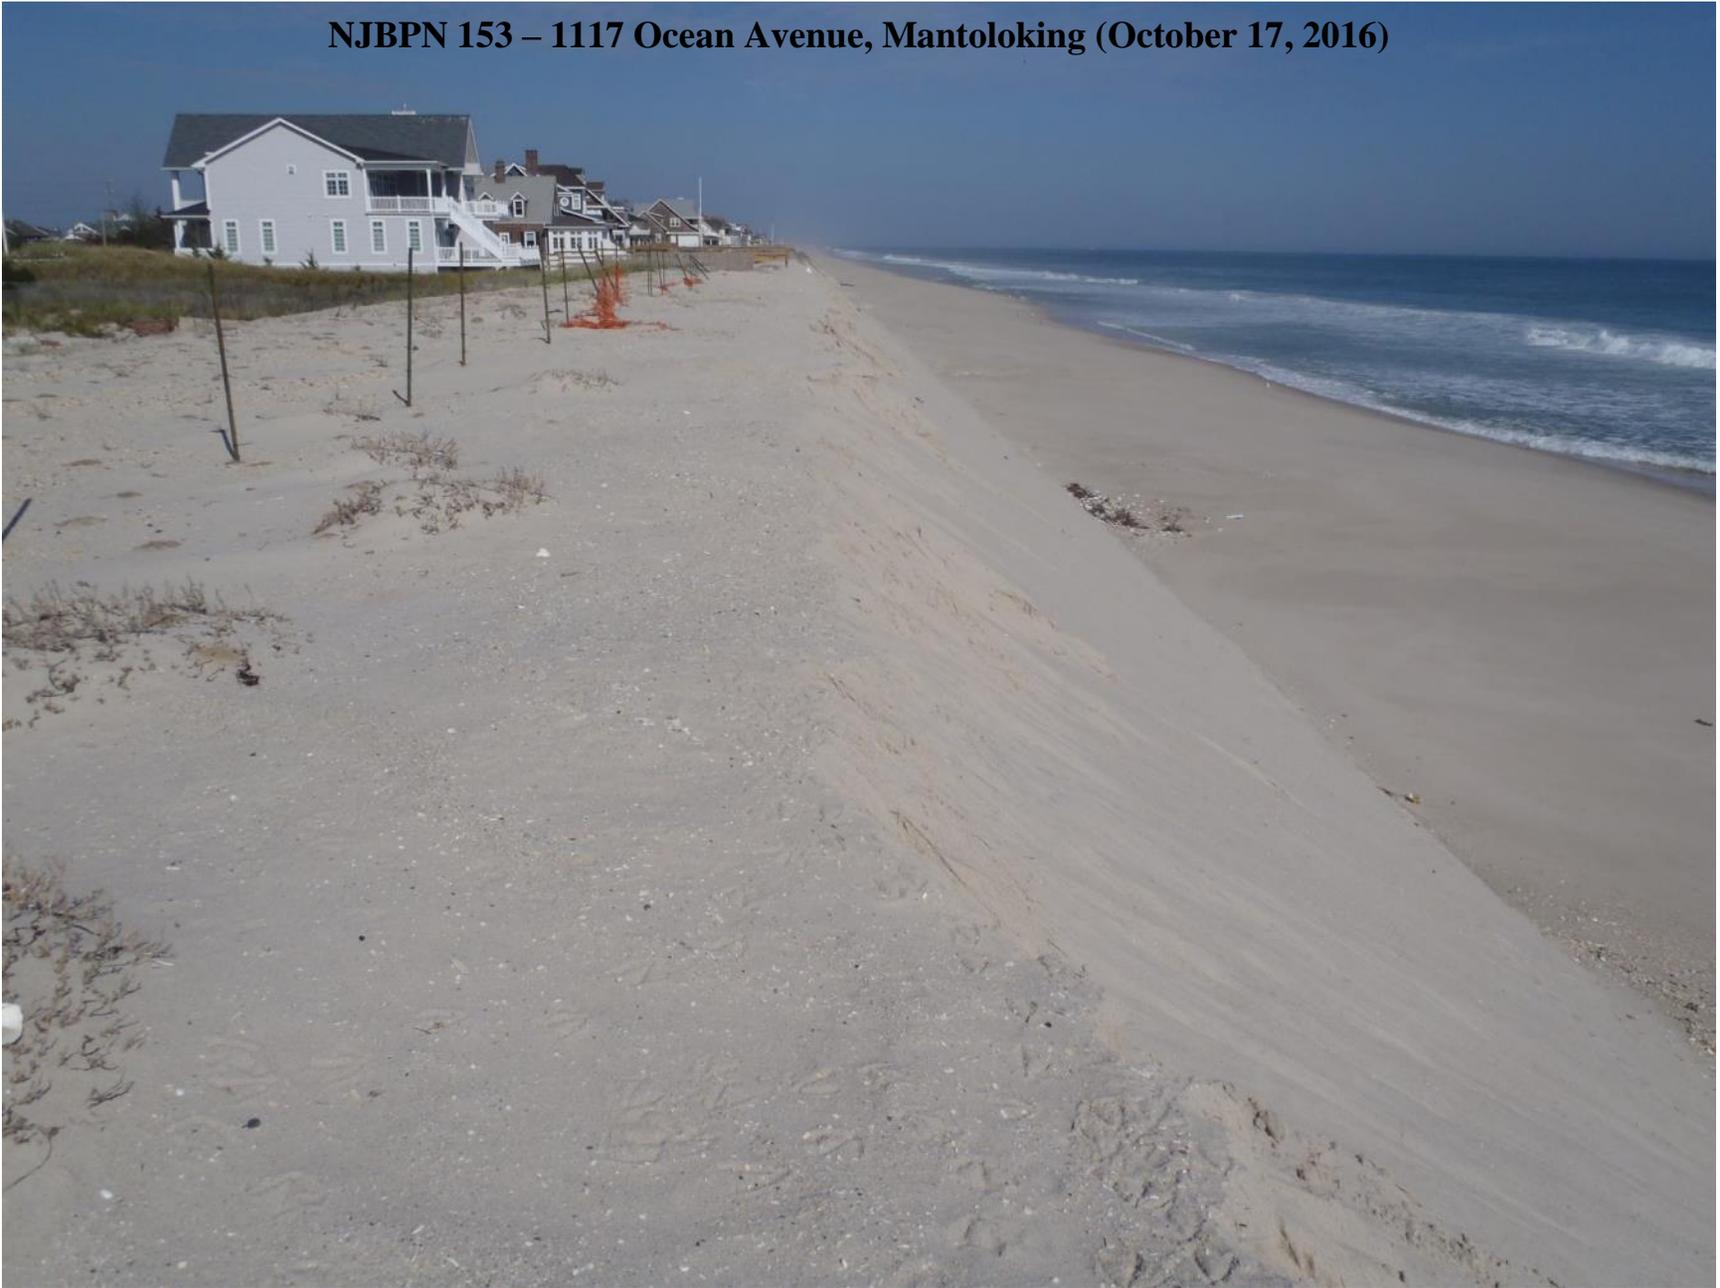
**NJBPN 153 – 1117 Ocean Avenue, Mantoloking (October 17, 2016)**

**Figure 238. View to the north from the top of the sheet-pile wall at 1117 Ocean Avenue in Mantoloking. The Borough conducted an extensive operation in bulldozing sand from the berm back to the steel wall following the northeast storm (Jonas) in late January 2016. This view shows the steep slope to the beach existing as of December 2016.**

The steel wall extends south past this site. It was exposed after the January 2016 northeast storm, Jonas, but not at the amount measured in Mantoloking. The wall was covered with sand again in spring 2016. The site has shown slight recovery but has not reached pre-Sandy conditions.
