## An Analysis of Thirty Years' Study of Sand Redistribution and Shoreline Changes in New Jersey's Four Coastal Counties Raritan Bay, the Atlantic Ocean Coast, and Delaware Bay Fall 1986 Through Fall 2016

### ***VOLUME 2 of 4 OCEAN COUNTY***

Prepared for:  
New Jersey Department of Environmental Protection  
Division of Coastal Engineering  
1510 Hooper Avenue, Toms River, New Jersey 08753

Prepared by:  
Stockton University Coastal Research Center  
30 Wilson Avenue, Port Republic, NJ 08241

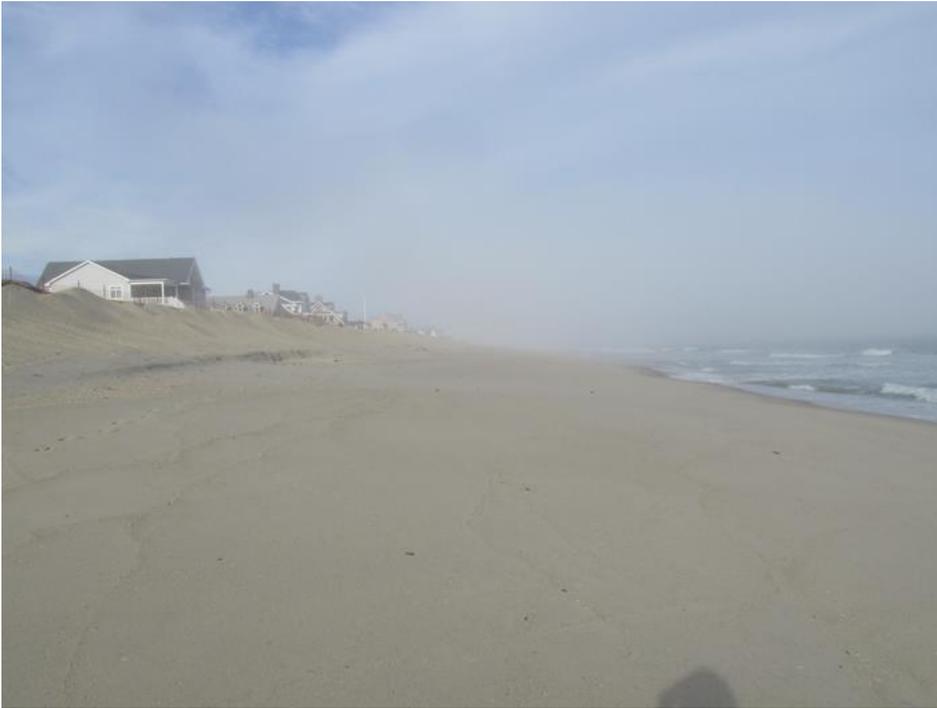
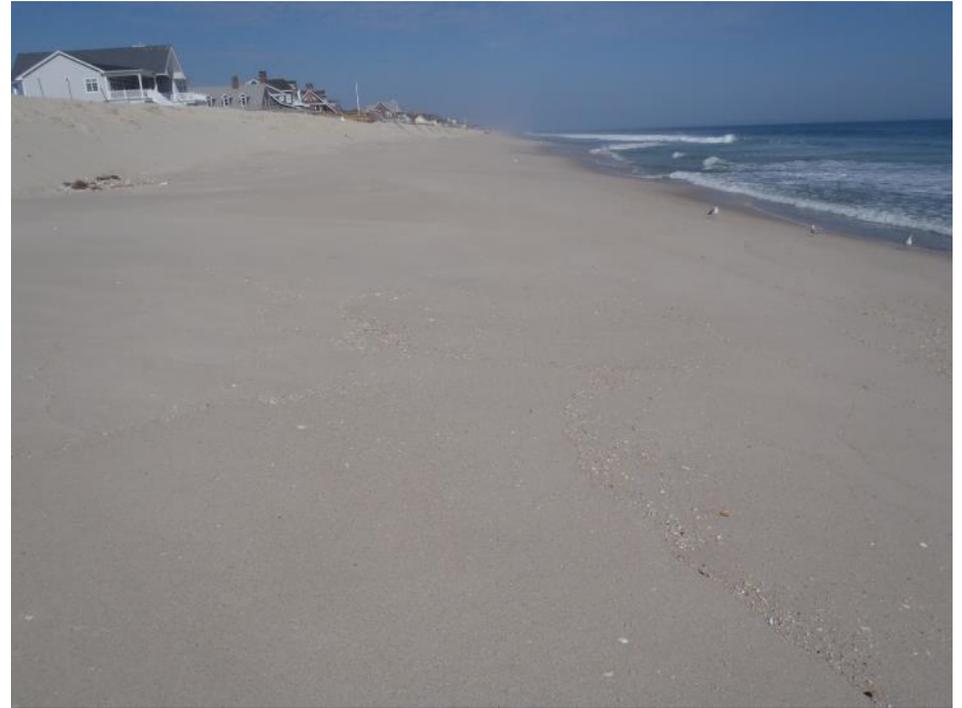
**NJBPN 153 – 1117 Ocean Avenue, Mantoloking**

**Figure 239a & 239b. The photos (left taken December 14, 2015 and right taken October 17, 2016) show the narrow dry beach that is less than 100 ft in width and sand scraped from the berm to cover the steel bulkhead which was exposed following the January 23, 2016 northeast storm. It took the borough from January to June 2016 to re-cover the exposed steel wall following that winter storm (Jonas).**

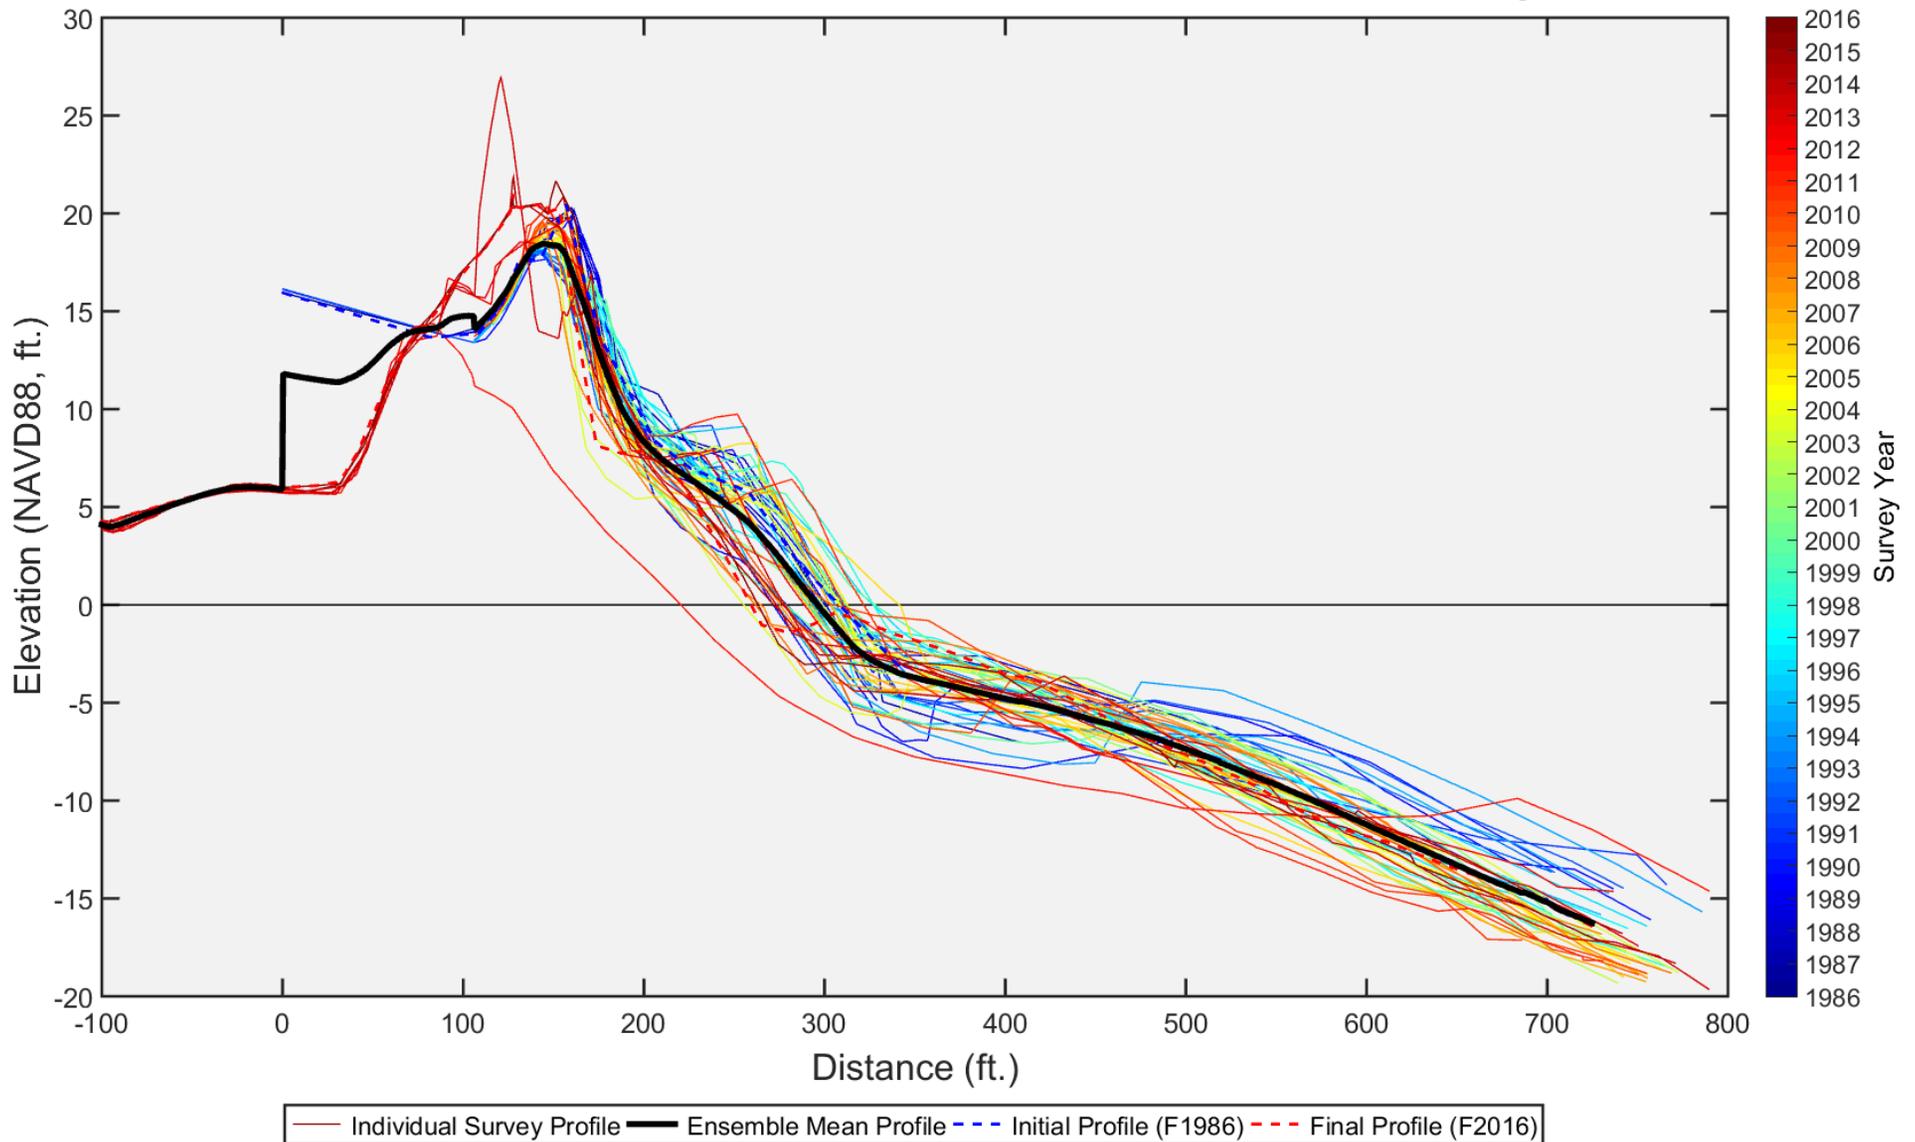
Figure 242. The earliest profiles started from a dune that was altered for a new residence. The envelope of change is relatively small at this site, as the individual profiles do not vary far from the mean and the mean profile shows that the site is typically composed of a berm and offshore bar. The damage from Hurricane Sandy resulted in a complex of reconstructed dunes from sand recovered from nearby streets, lots, and from Barnegat Bay. The only profile to vary farther from the mean is the Spring 2013 survey (orange line below all others) and this was a result of Hurricane Sandy breaching the dune, which is displayed nicely in this cross-section view.

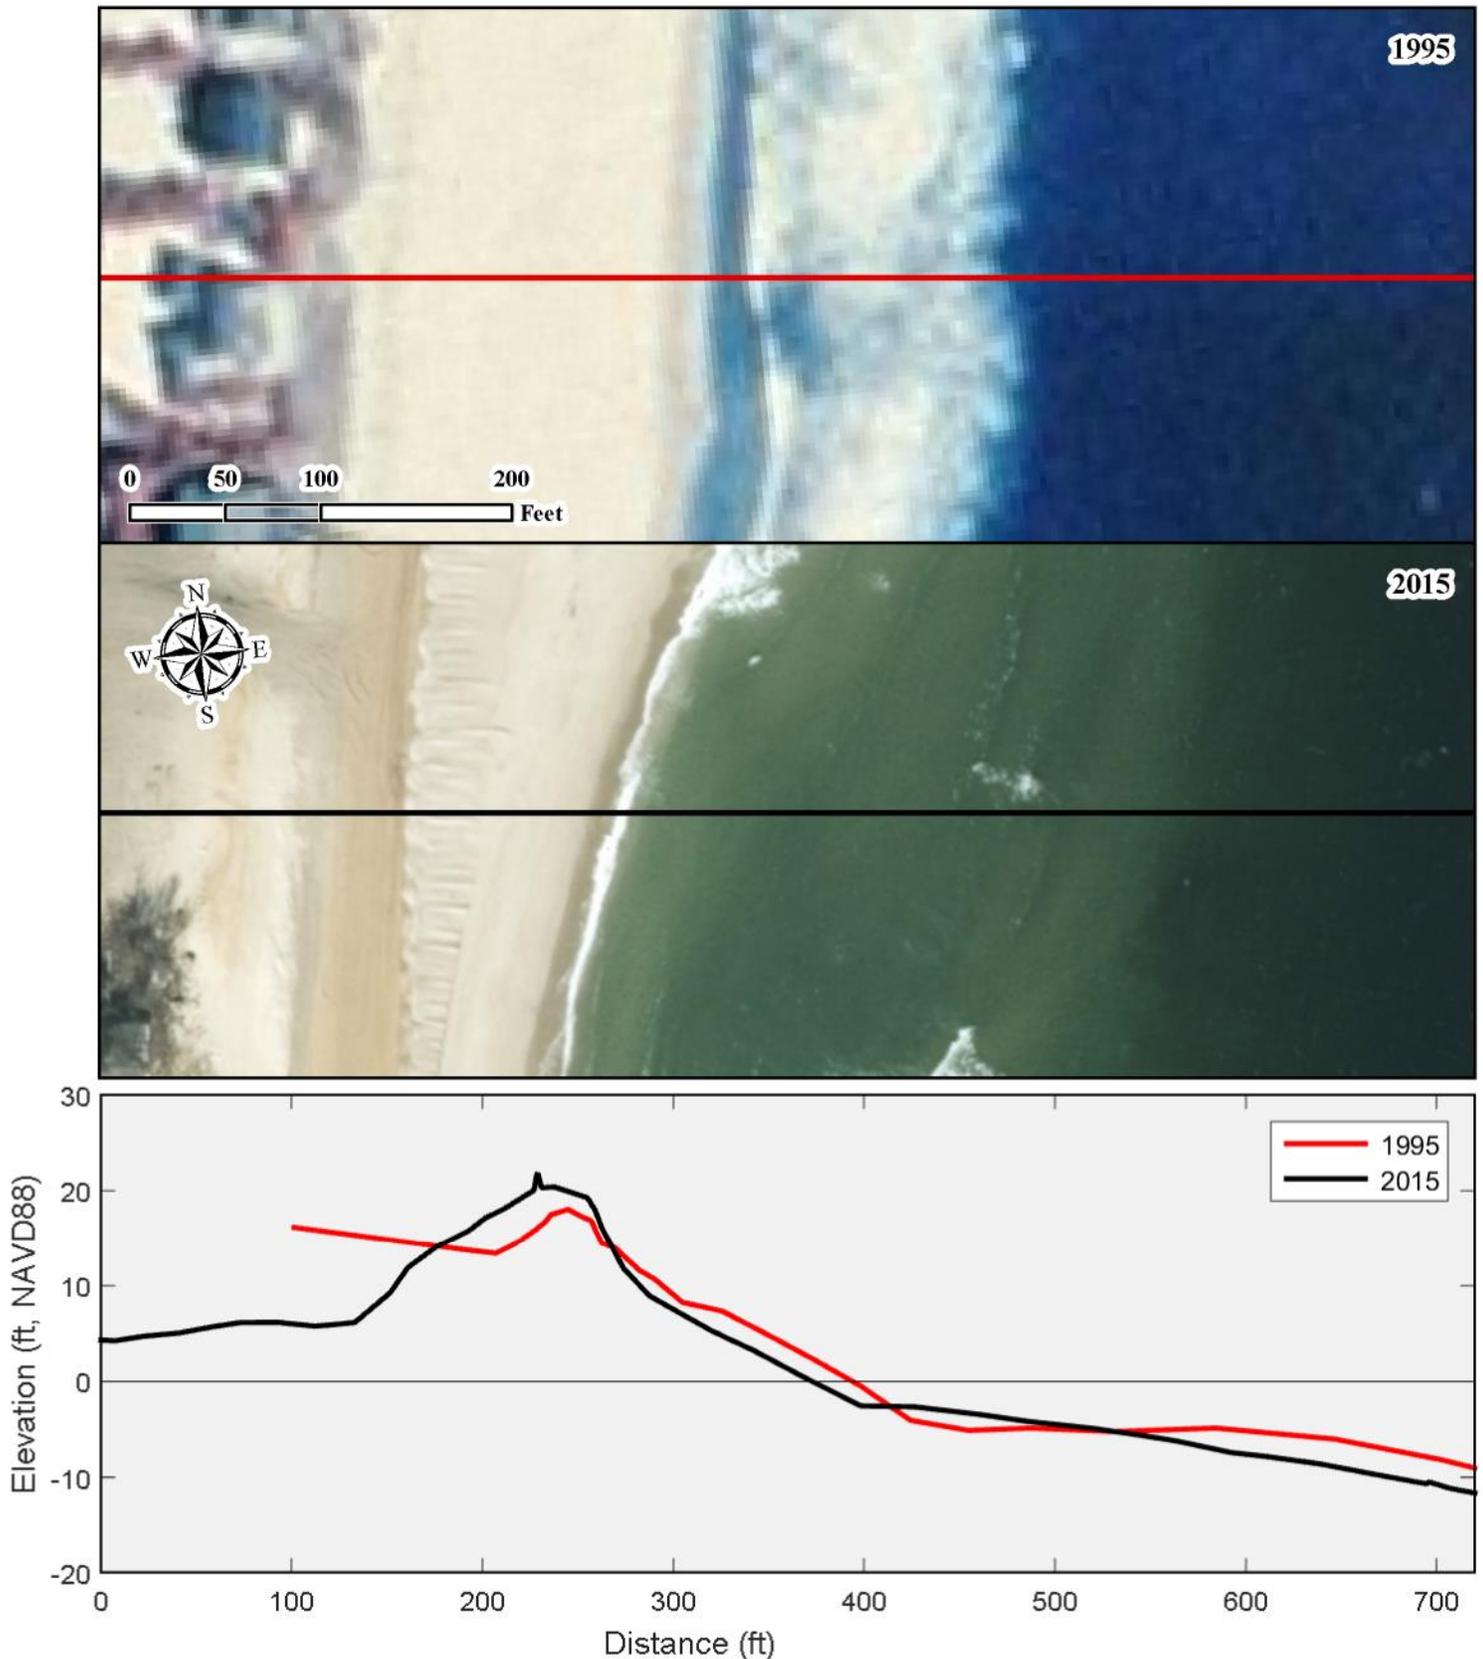
Figure 243. The sand on top of the 2015 vertical wall rises well above the dune that was measured in 1995. Shoreline position moved landward about 21 feet between 1995 and 2015.

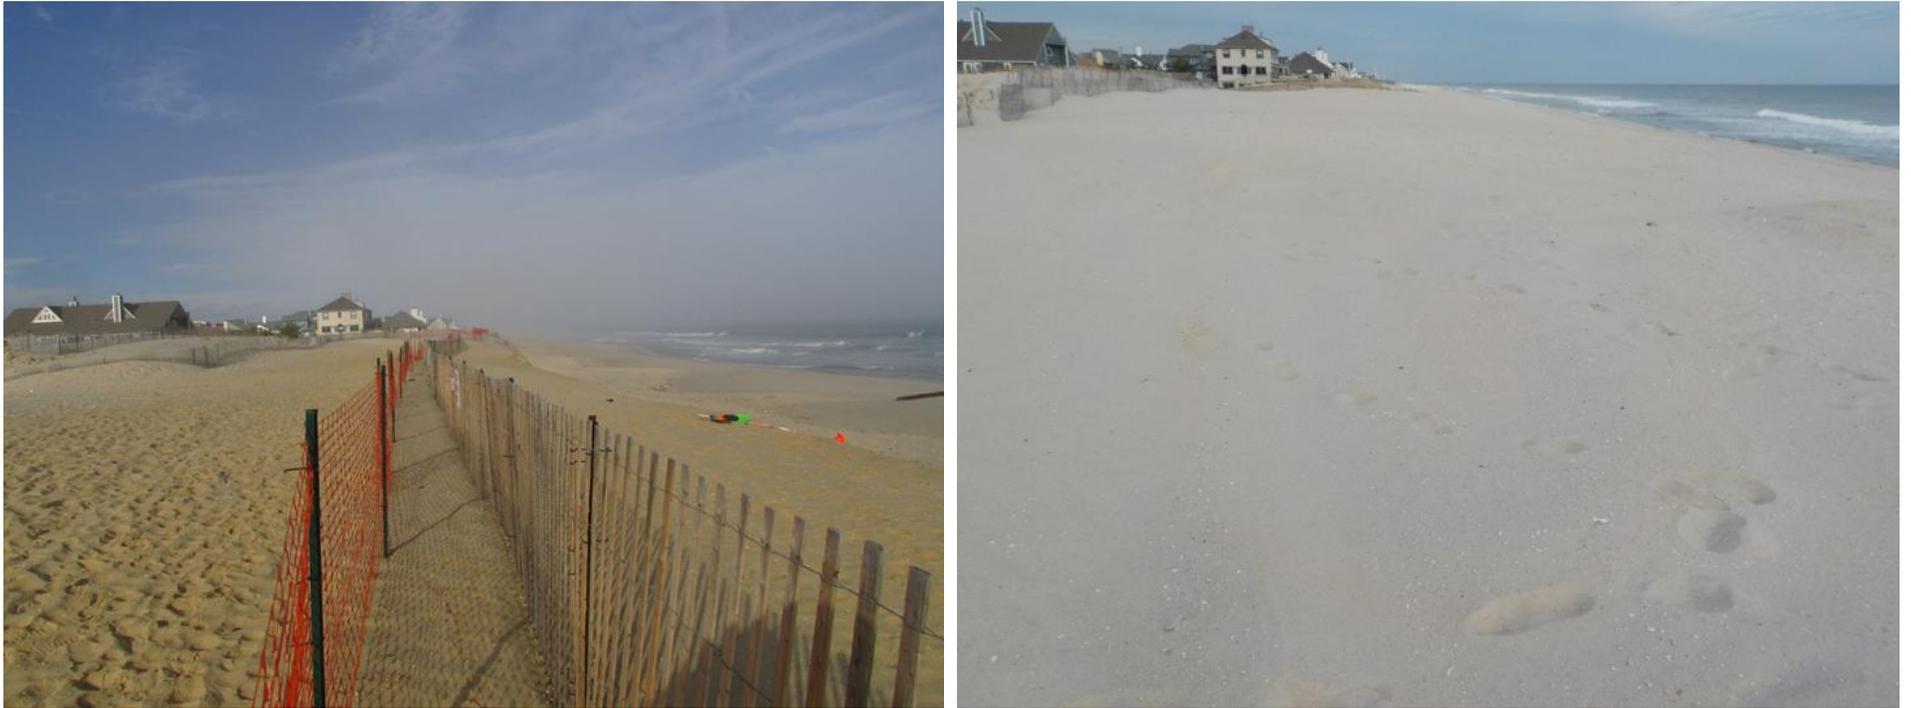
**NJBPN 152 – Public Beach #3, Brick Township**

**Figure 245a & 245b. The view on the left was taken (December 14, 2015) with the new sand fence line erected along the sand ridge covering the steel bulkhead. Covered during the spring of 2016 following a northeast storm, the site returned to recreational uses by June 2016. The right photo was taken December 22, 2016 with a reasonable amount of beach width.**

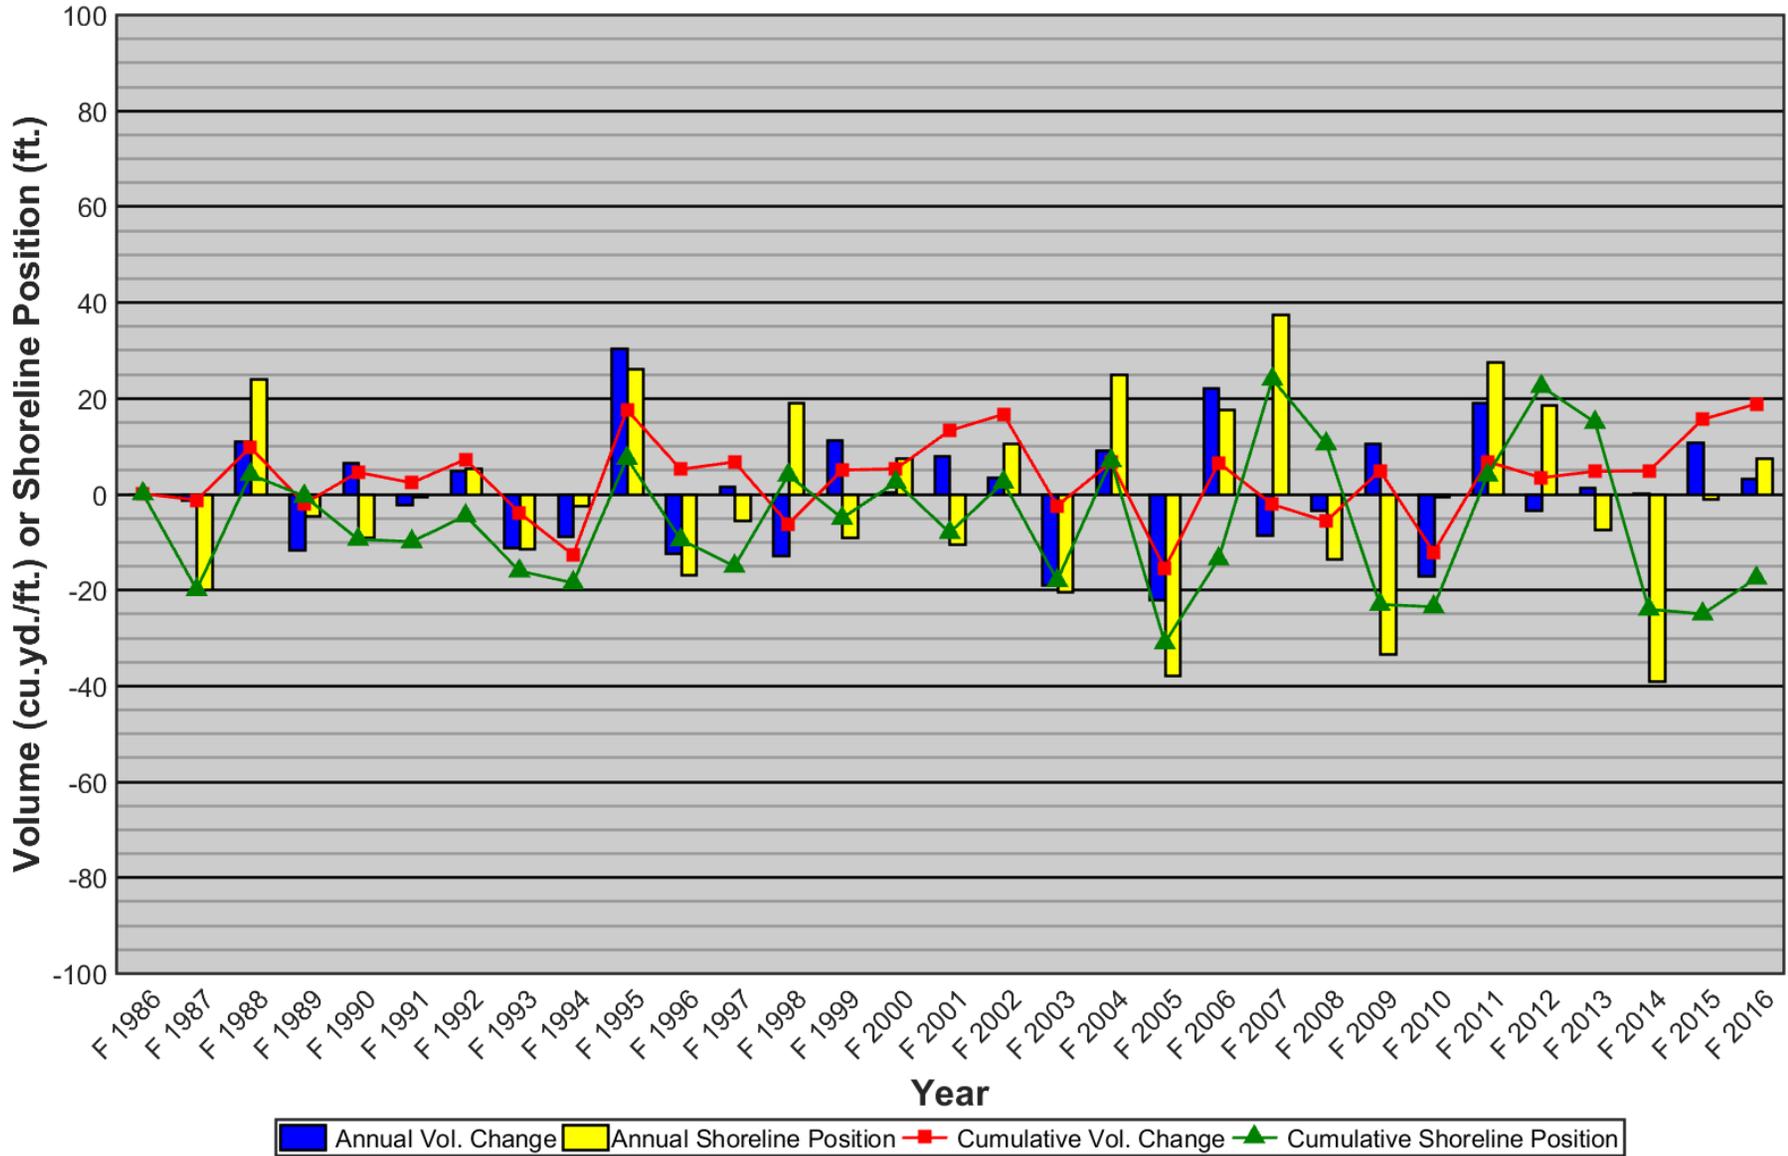
Figure 247. The Public Beach #3 location has had swings in sand volume and shoreline position that hovered around zero net change. Slight advances are noted in 2015 and 2016. Shoreline retreat that most recently began in 2014 is now 18 feet landward of the 1986 position.

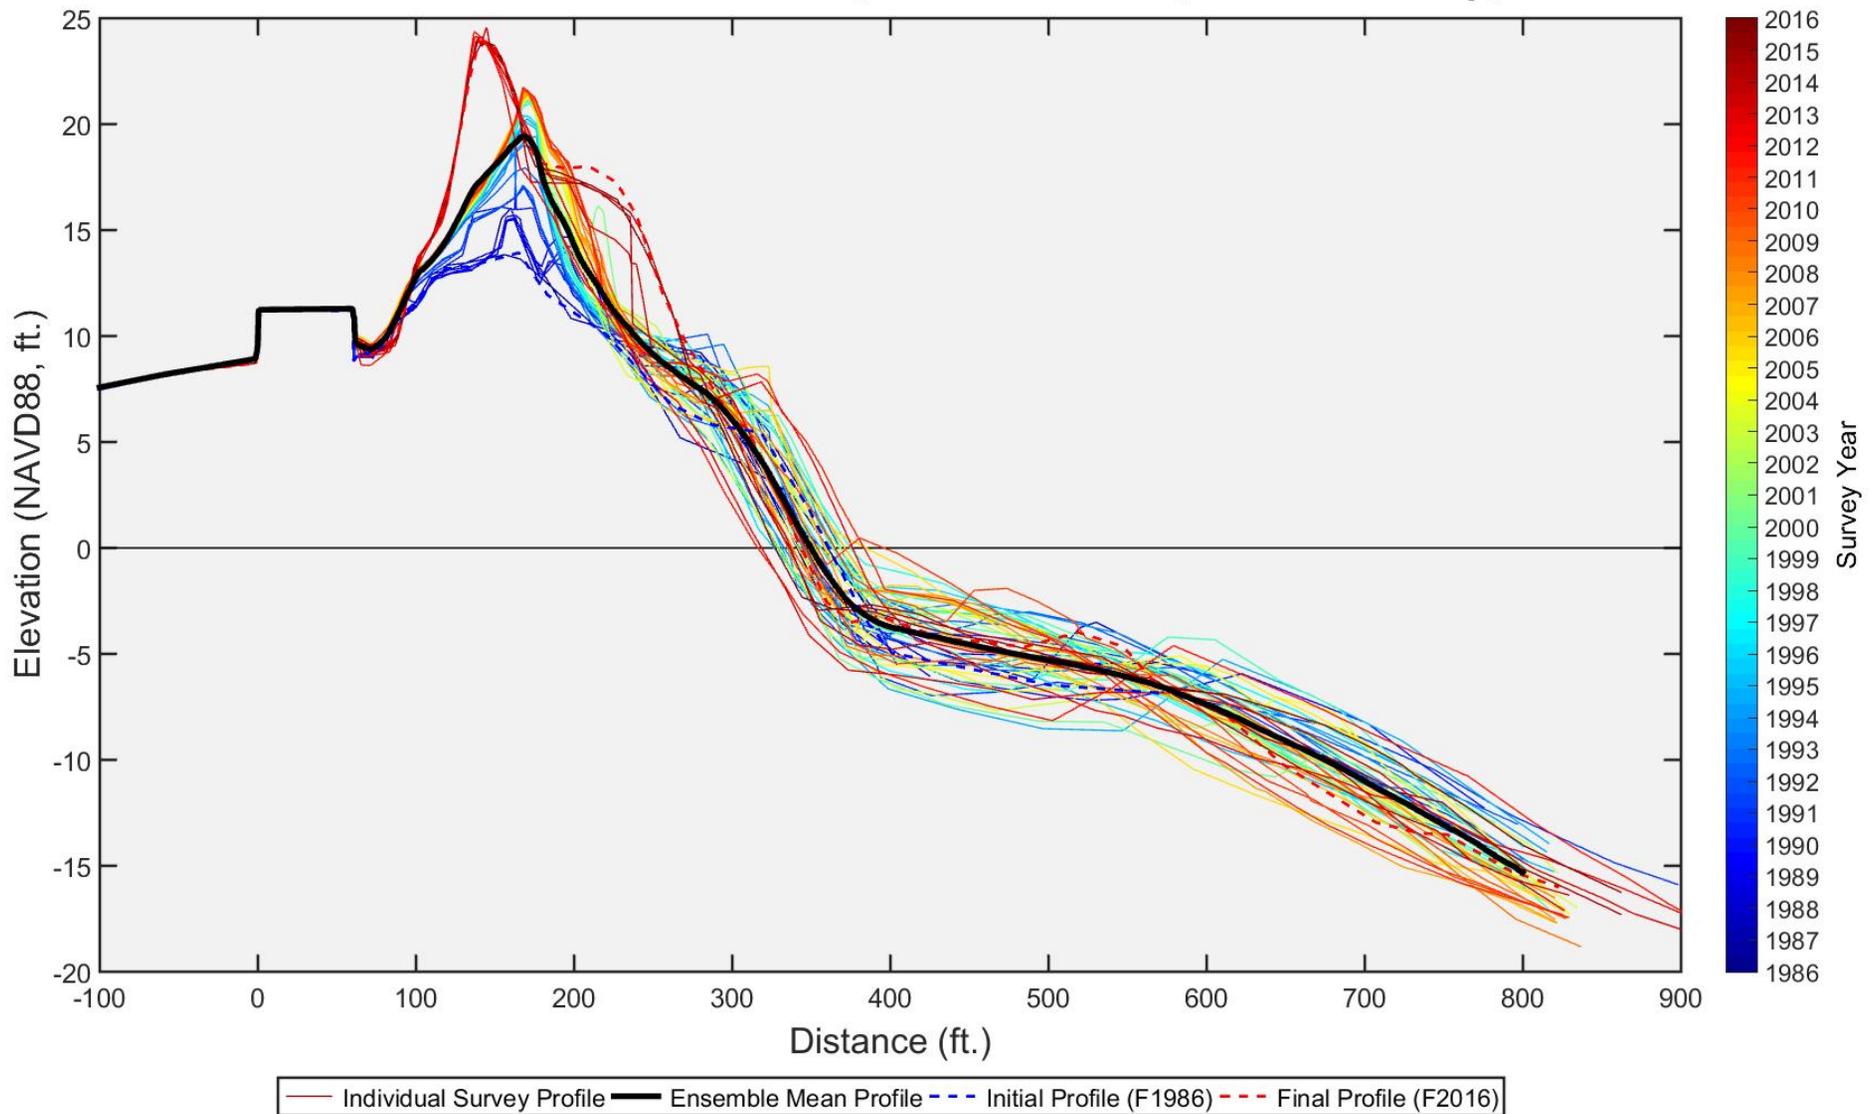
Figure 248. The post-Sandy dune was restored to a higher elevation than the 1986 dune and contains a steel sheet pile bulkhead in its core. The envelope of change on the beach and offshore remained relatively small in vertical distribution but highly variable over time since there is no obvious increasing or decreasing trend (as evident by the colors bouncing back and forth about the mean over time).

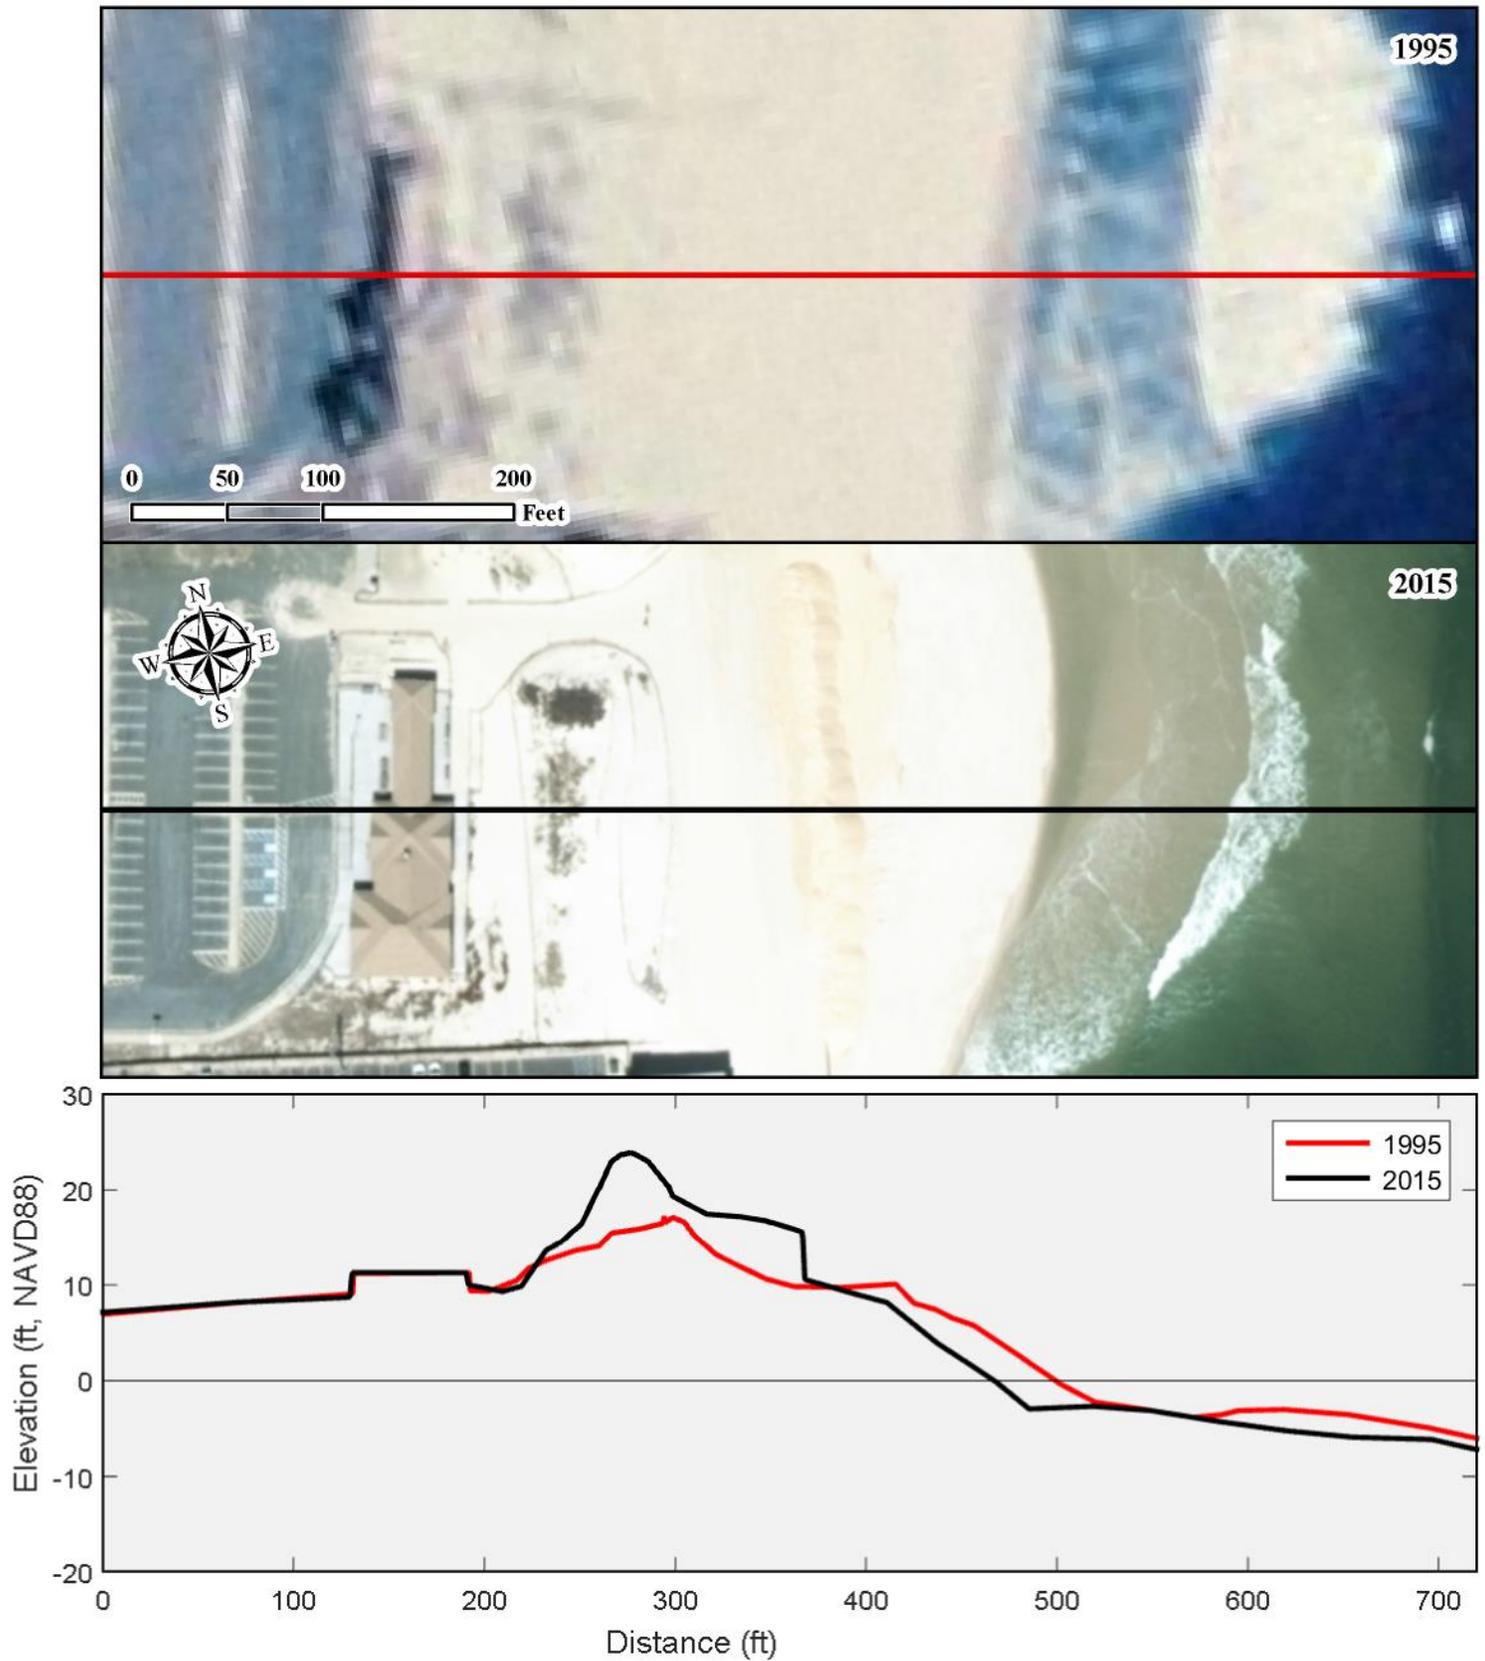
Figure 249. The 2015 cross section shows the dune and sand piles that were created after Hurricane Sandy. The shoreline moved landward about 32 ft between 1995 and 2015.

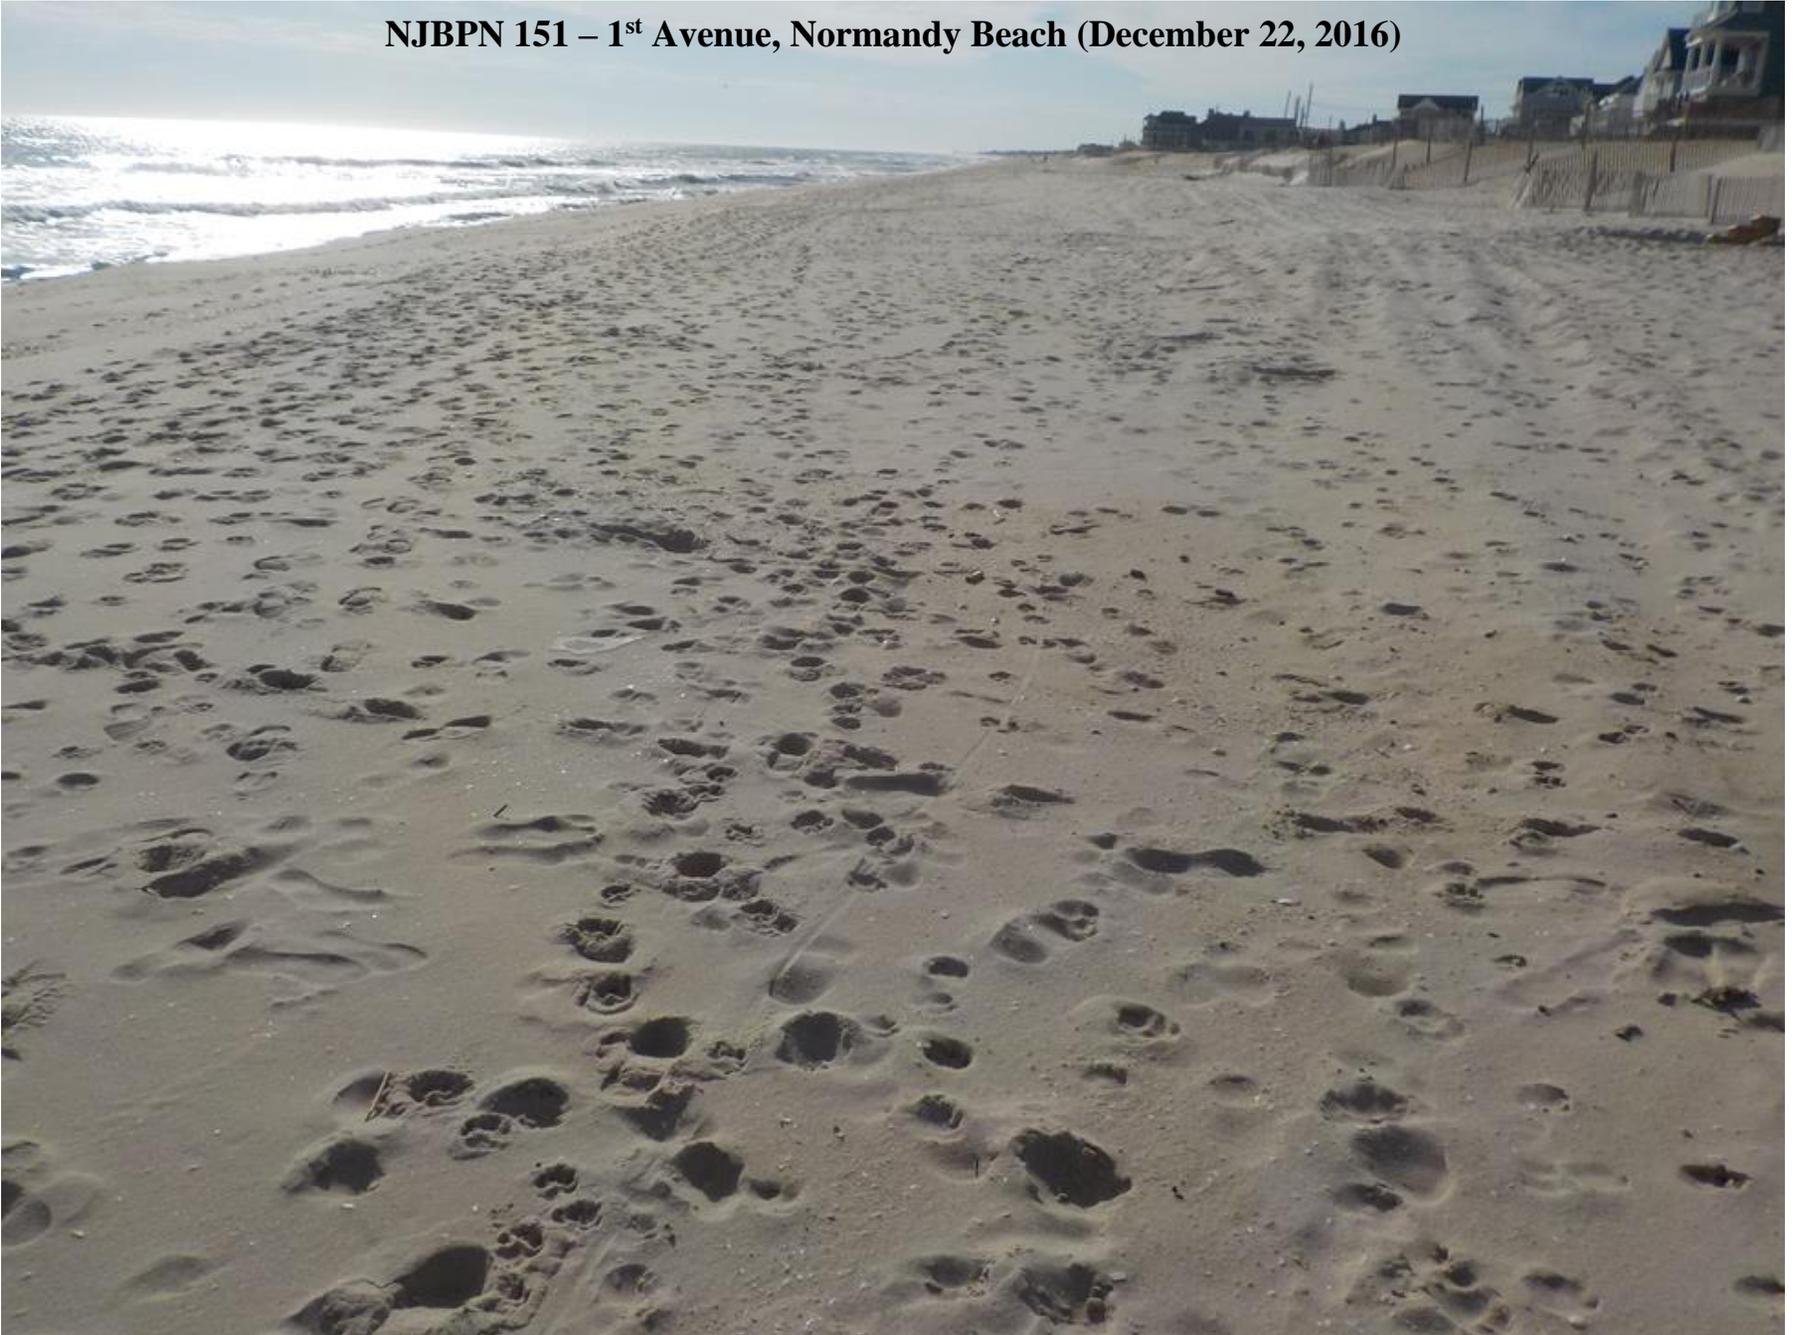
**NJBPN 151 – 1<sup>st</sup> Avenue, Normandy Beach (December 22, 2016)**

**Figure 250. View to the south from the berm at 1<sup>st</sup> Avenue in Normandy Beach. A prominent offshore bar was present at the time of the photograph (Dec 2016).**

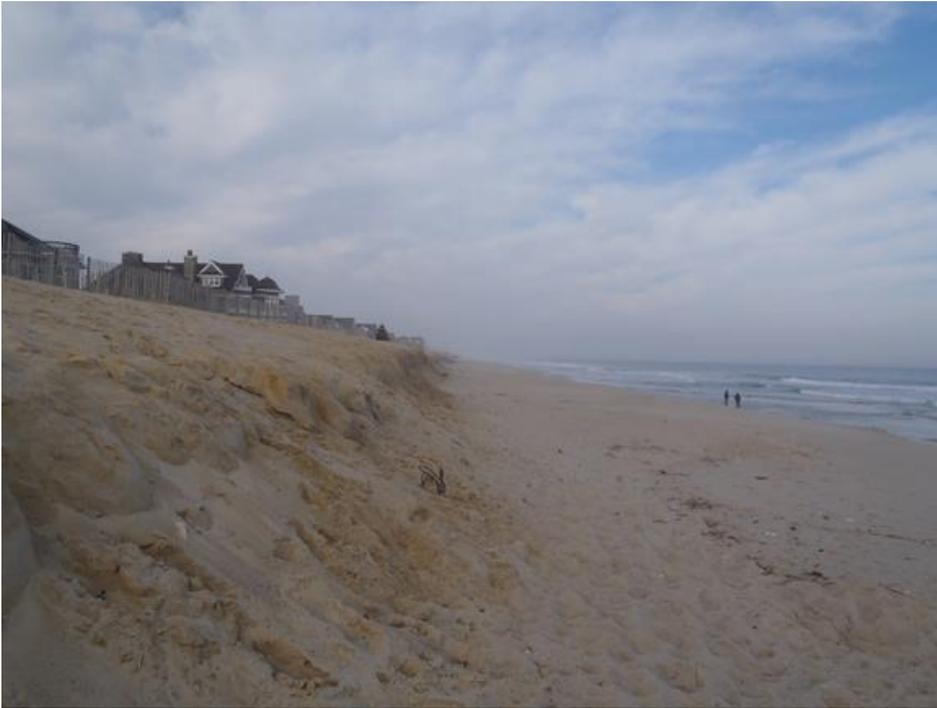
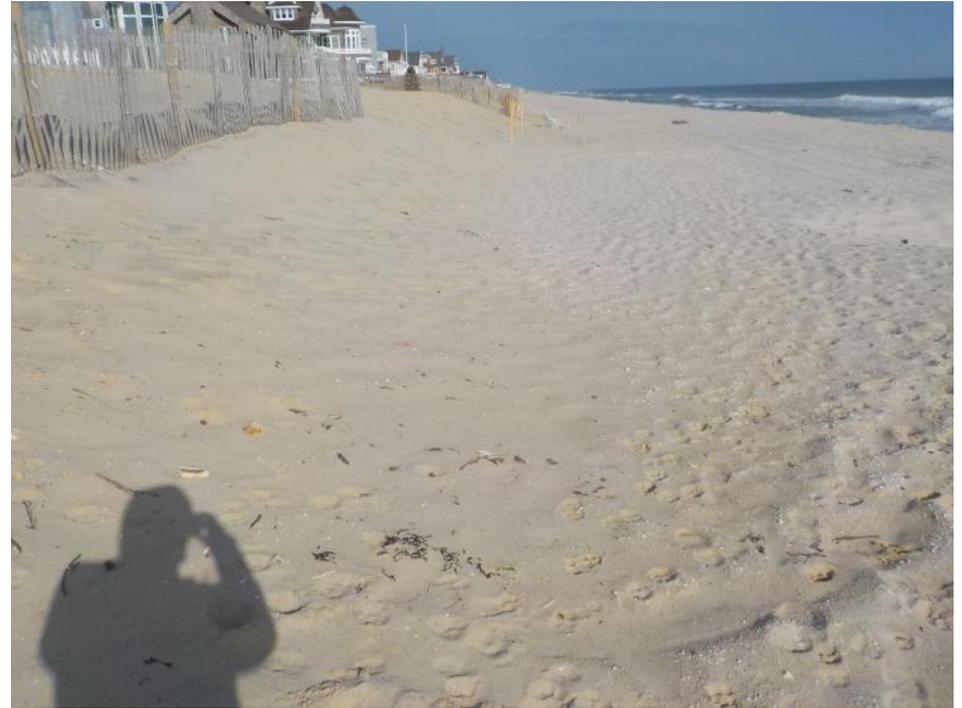
**NJBPN 151 – 1<sup>st</sup> Avenue, Normandy Beach**

**Figure 251a & 251b. The view on the left (December 11, 2015), shows the scarped dune, protected by a narrow 50-foot berm. On the right, (taken December 22, 2016) shows a wider beach following a summer of sand accumulation.**

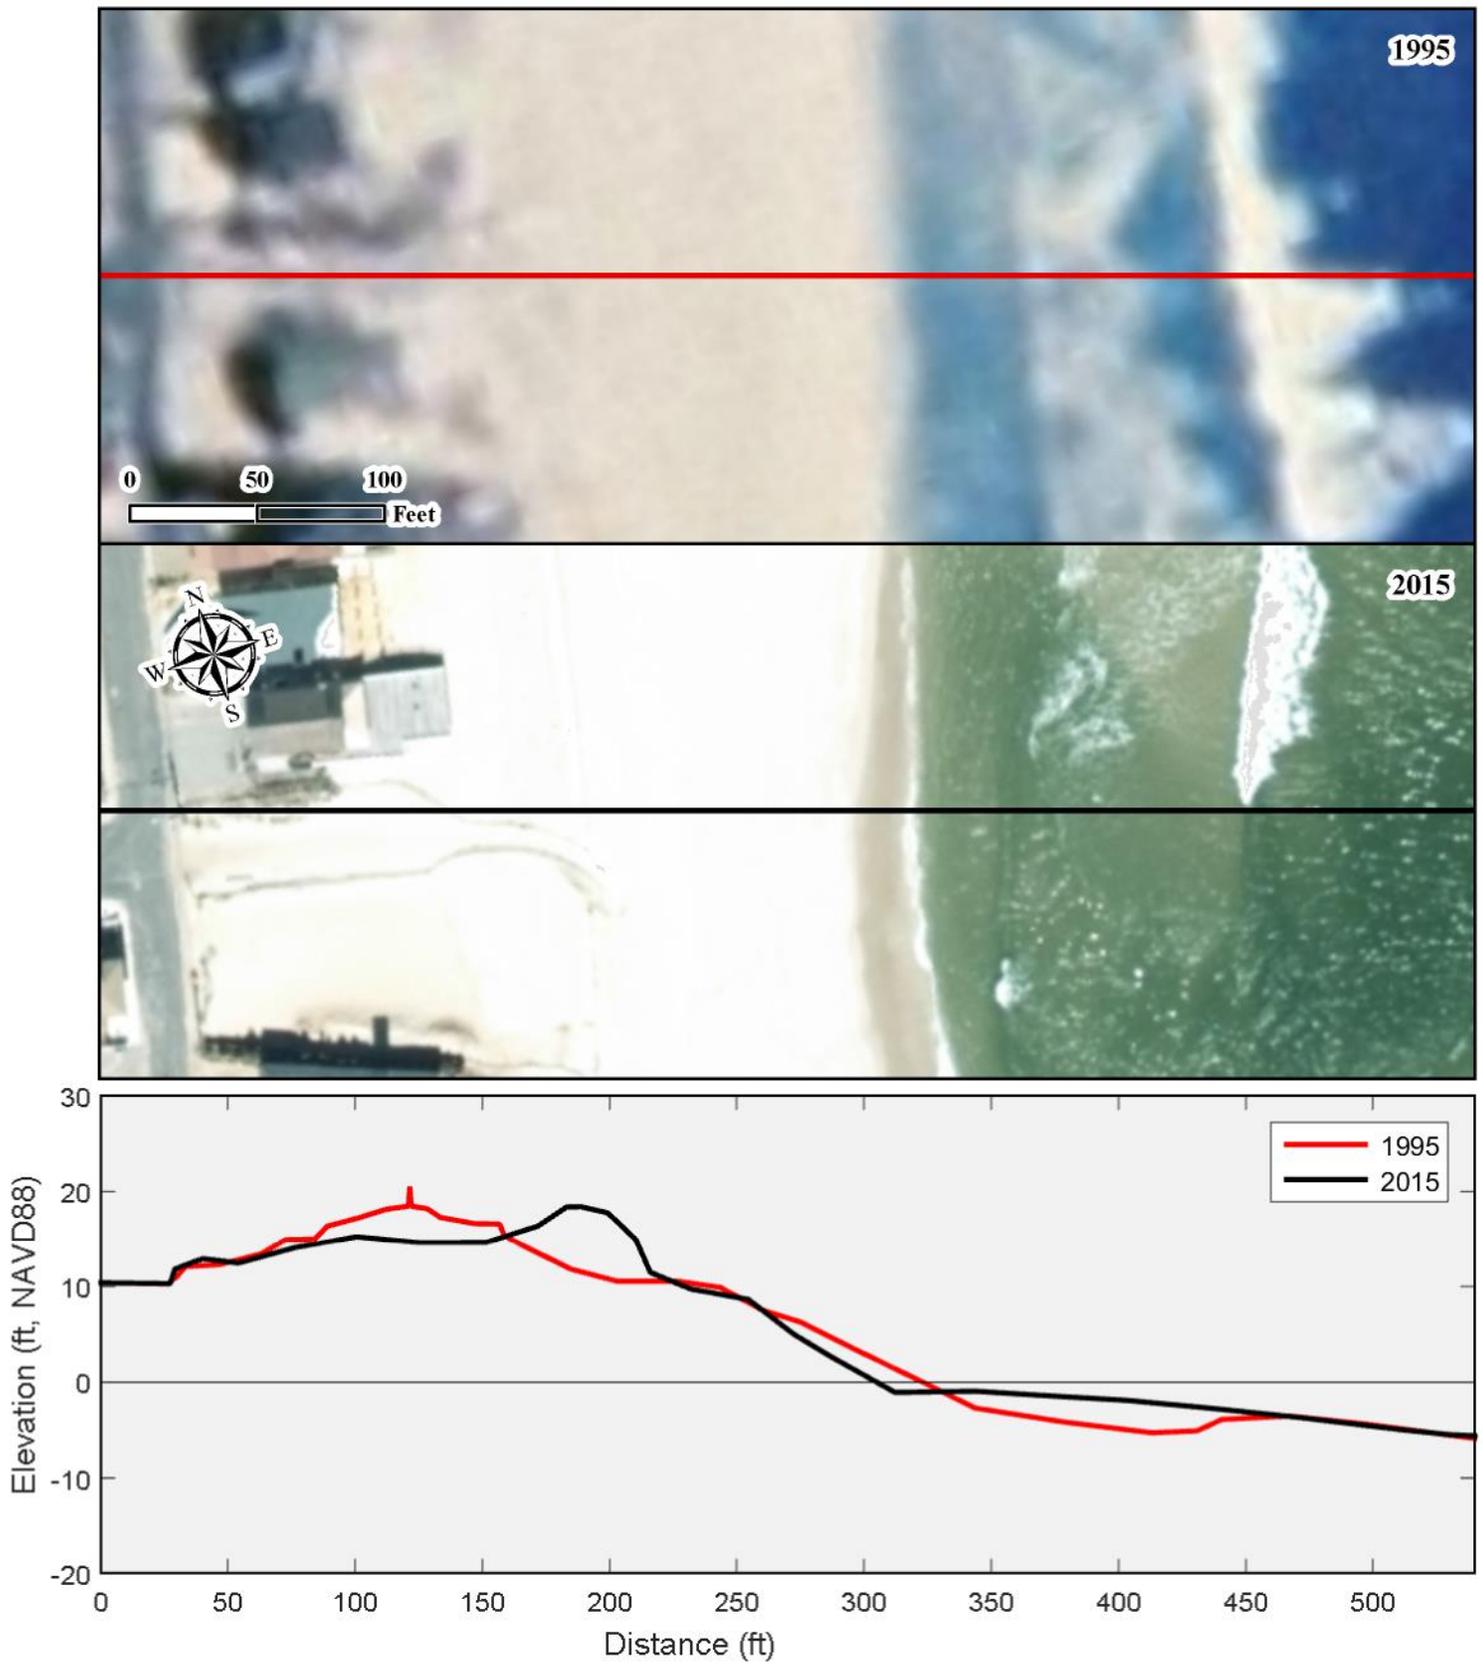
Figure 255. The dune that was measured in 1995 was removed during Hurricane Sandy. The 2015 profile shows a shift in the post-storm dune to a more seaward location. The shoreline retreated by about 18 ft over the 20 year period from 1995 to 2015.
