## An Analysis of Thirty Years' Study of Sand Redistribution and Shoreline Changes in New Jersey's Four Coastal Counties Raritan Bay, the Atlantic Ocean Coast, and Delaware Bay Fall 1986 Through Fall 2016

### ***VOLUME 2 of 4 OCEAN COUNTY***

Prepared for:  
New Jersey Department of Environmental Protection  
Division of Coastal Engineering  
1510 Hooper Avenue, Toms River, New Jersey 08753

Prepared by:  
Stockton University Coastal Research Center  
30 Wilson Avenue, Port Republic, NJ 08241

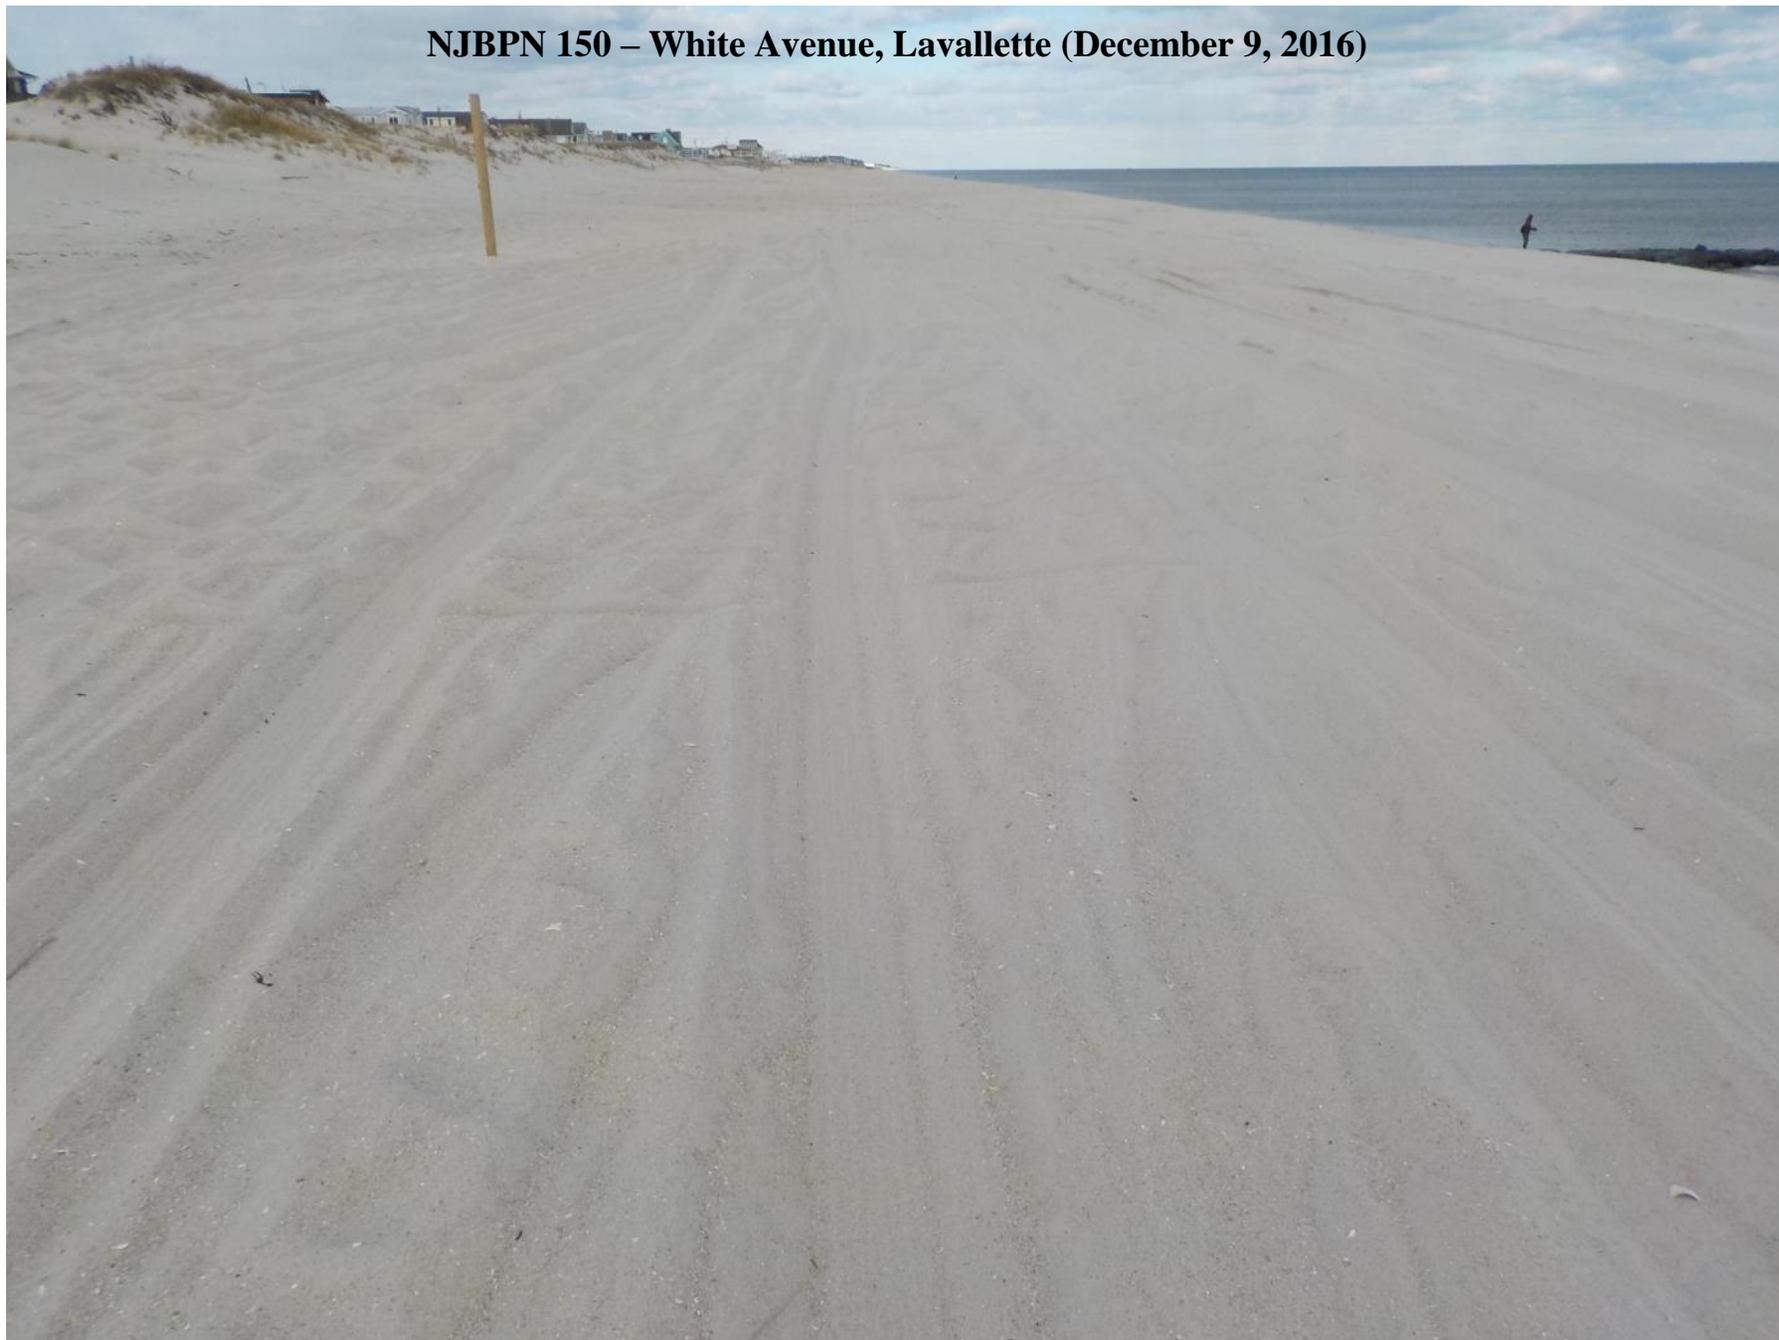
**NJBPN 150 – White Avenue, Lavallette (December 9, 2016)**

**Figure 256. View to the north from the berm at White Avenue in Lavallette. The late fall beach appeared in good condition.**

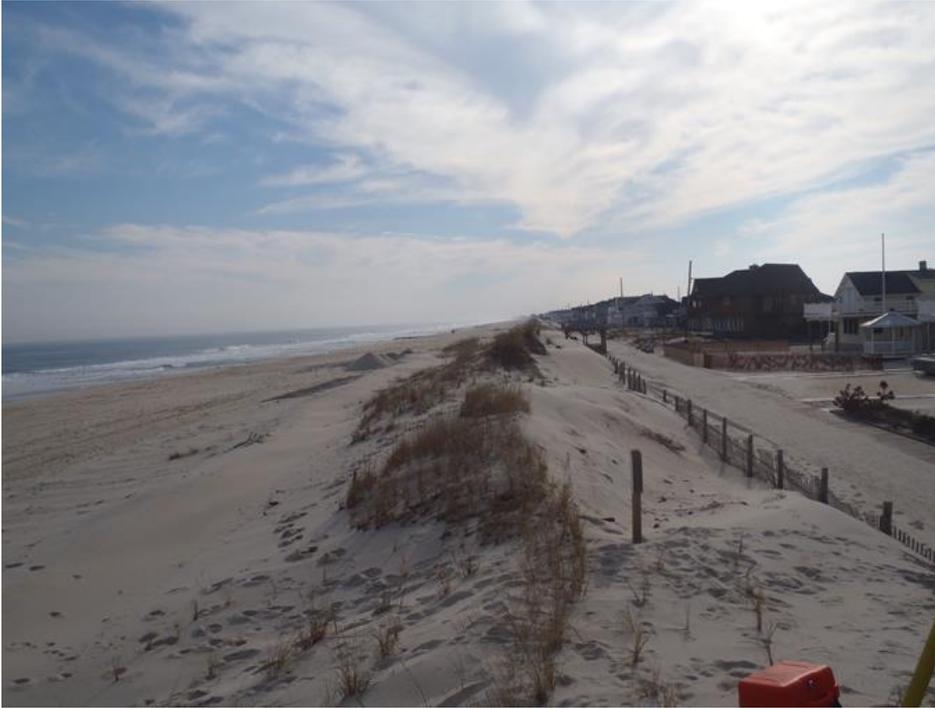
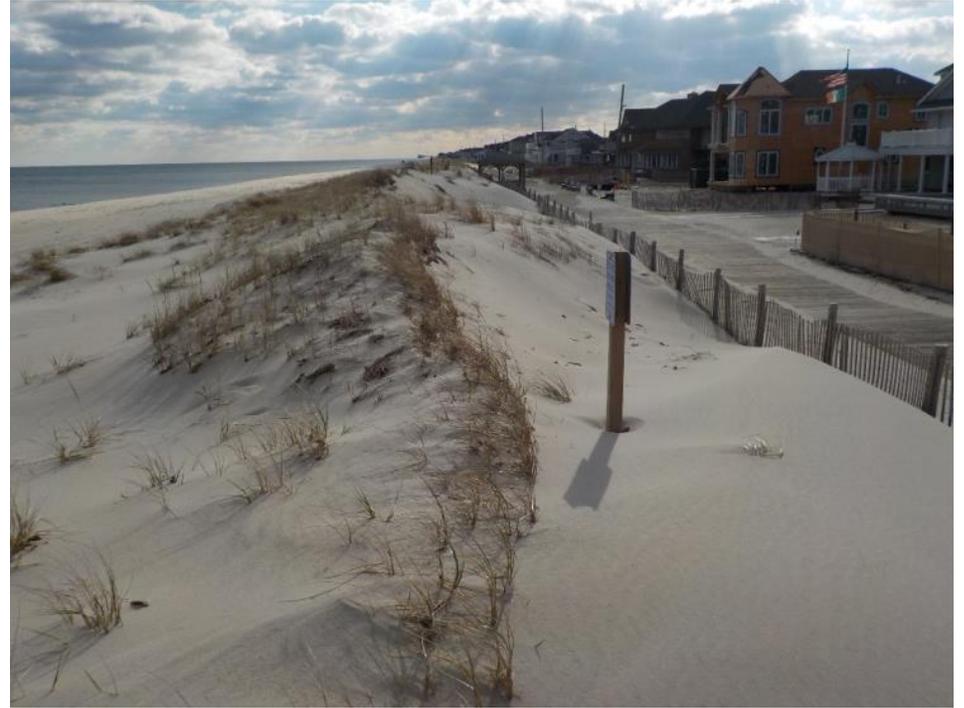
**Figure 257a & 257b.** The photos show the condition of the dunes at the Lavallette site (left photo taken December 11, 2015 and right photo taken December 9, 2016). Hurricane Sandy eroded the dunes at this site and these modest dunes were created from sand that was recovered after the storm. Some sand accumulated at the seaward base of the dune after the June 2015 survey.

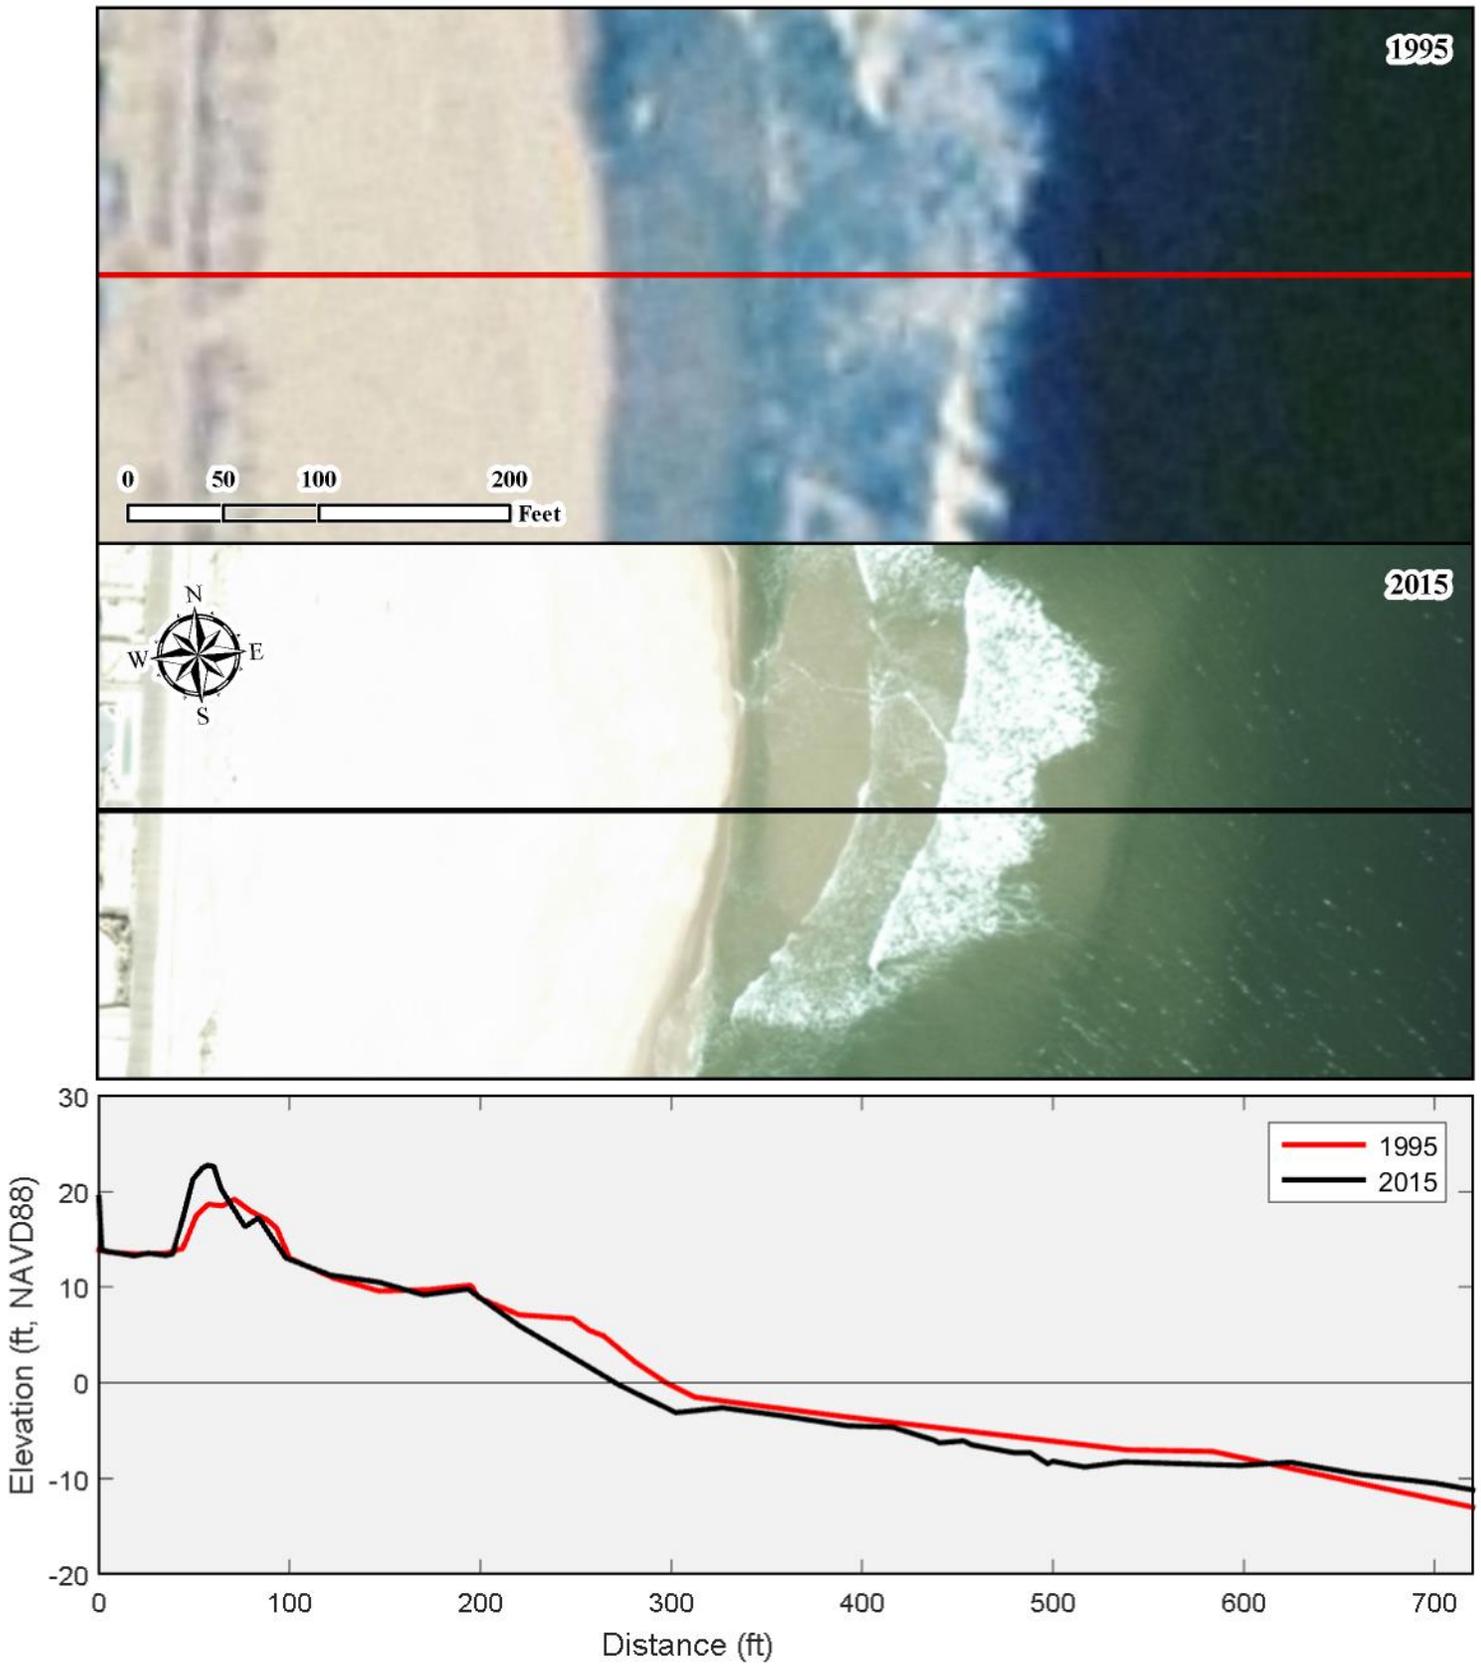
Figure 261. The dune gained in elevation but the shoreline retreated landward by about 35 feet from 1995 to 2015.

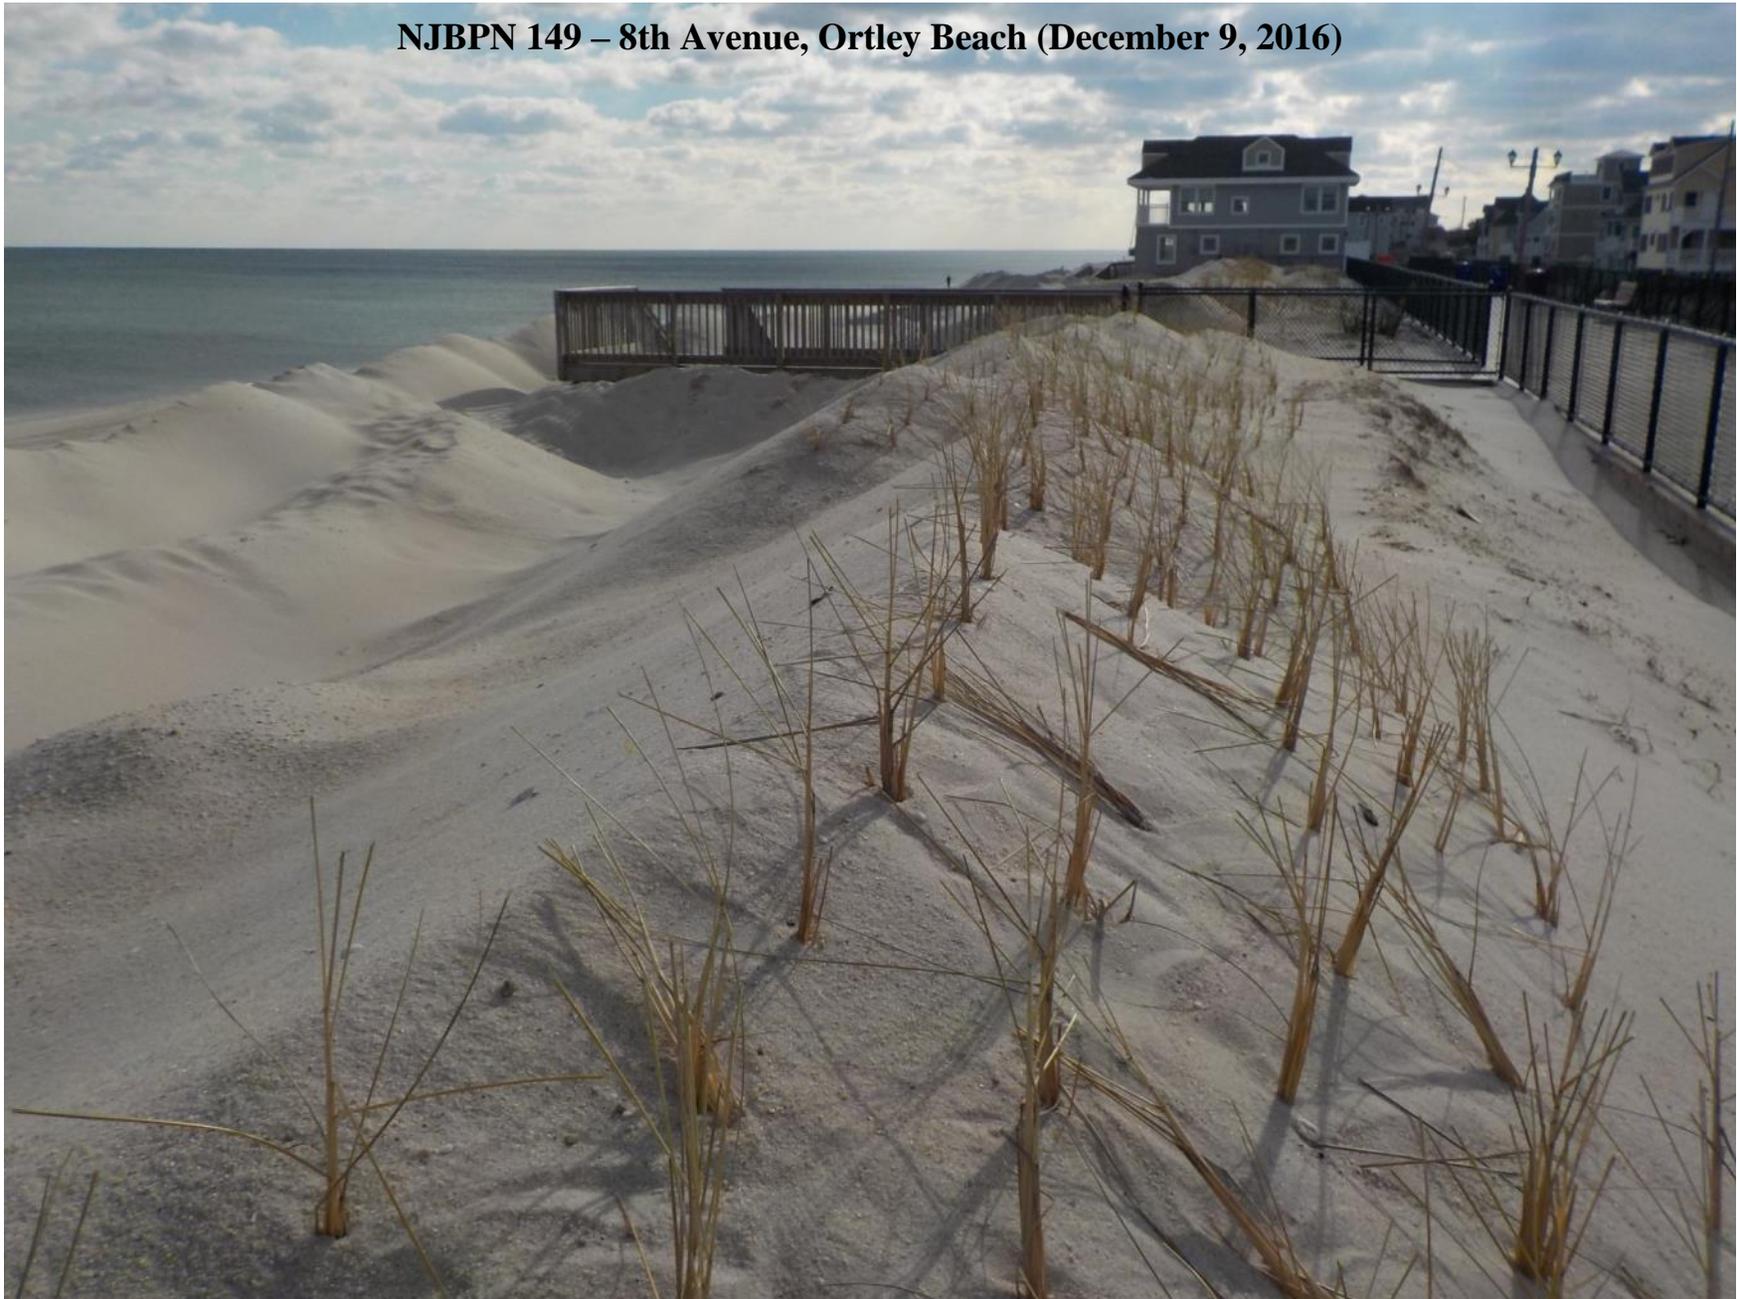
**Figure 262. View to the south from the dune crest at 8th Avenue in Ortley Beach. The January 2016 northeast storm (Jonas) eroded the seaward portion of the dune. While the dune was not breached entirely, the proximity of failure was clear enough to municipal officials that they chose to add sand to the seaward dune slope for protection for the upcoming winter.**

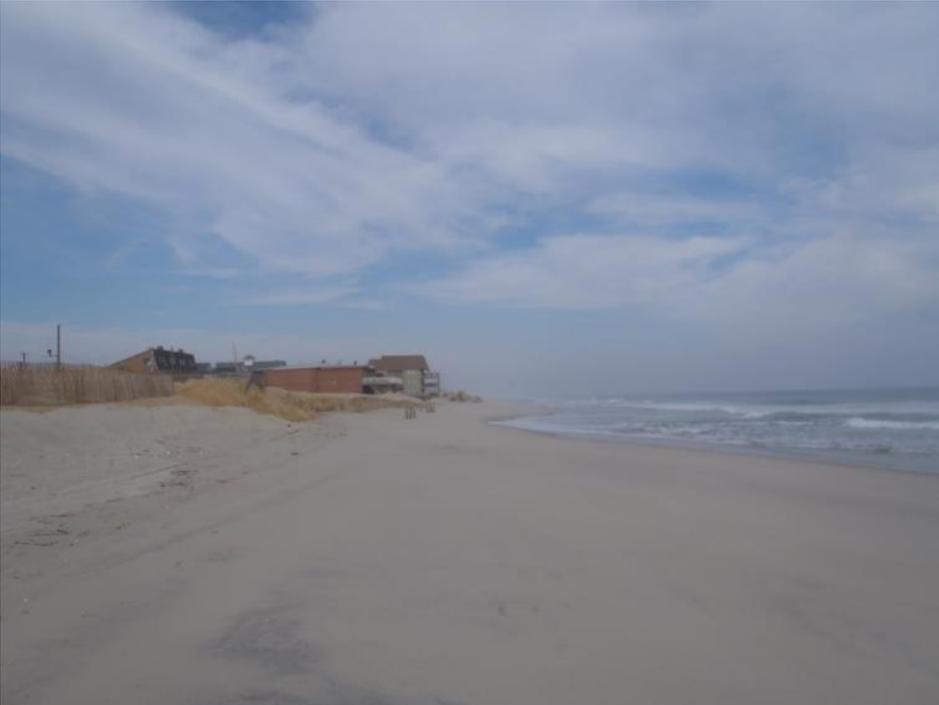
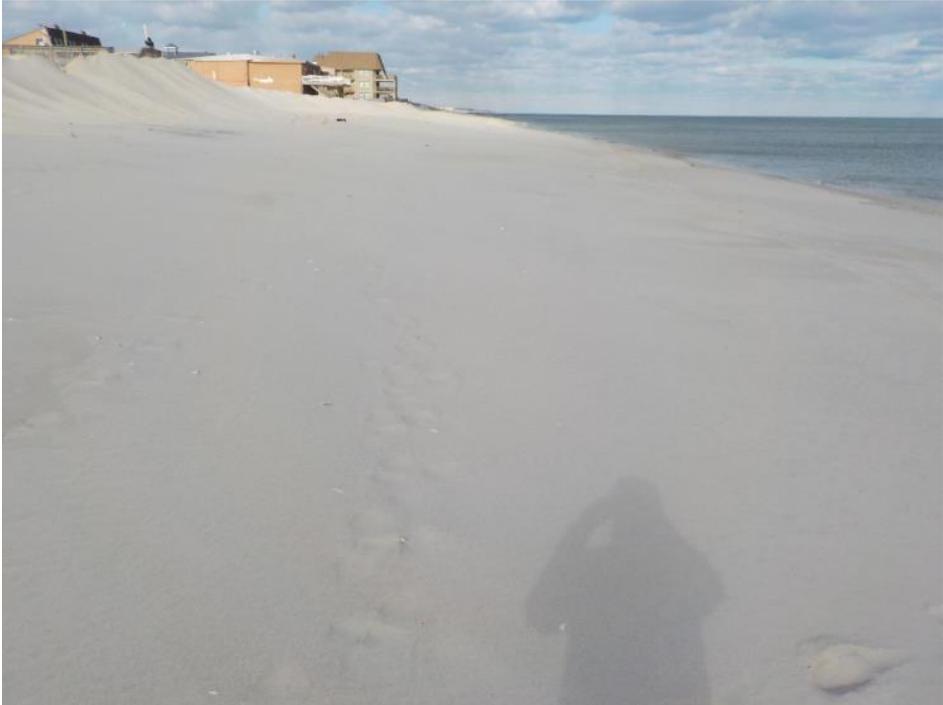
**Figure 263a & 263b. The photos show the condition and width of the berm at 8<sup>th</sup> Avenue in Ortley Beach (left photo taken December 11, 2015 and right photo taken December 9, 2016). Sand was added to reinforce the dune that was damaged during the January 2016 northeast storm.**

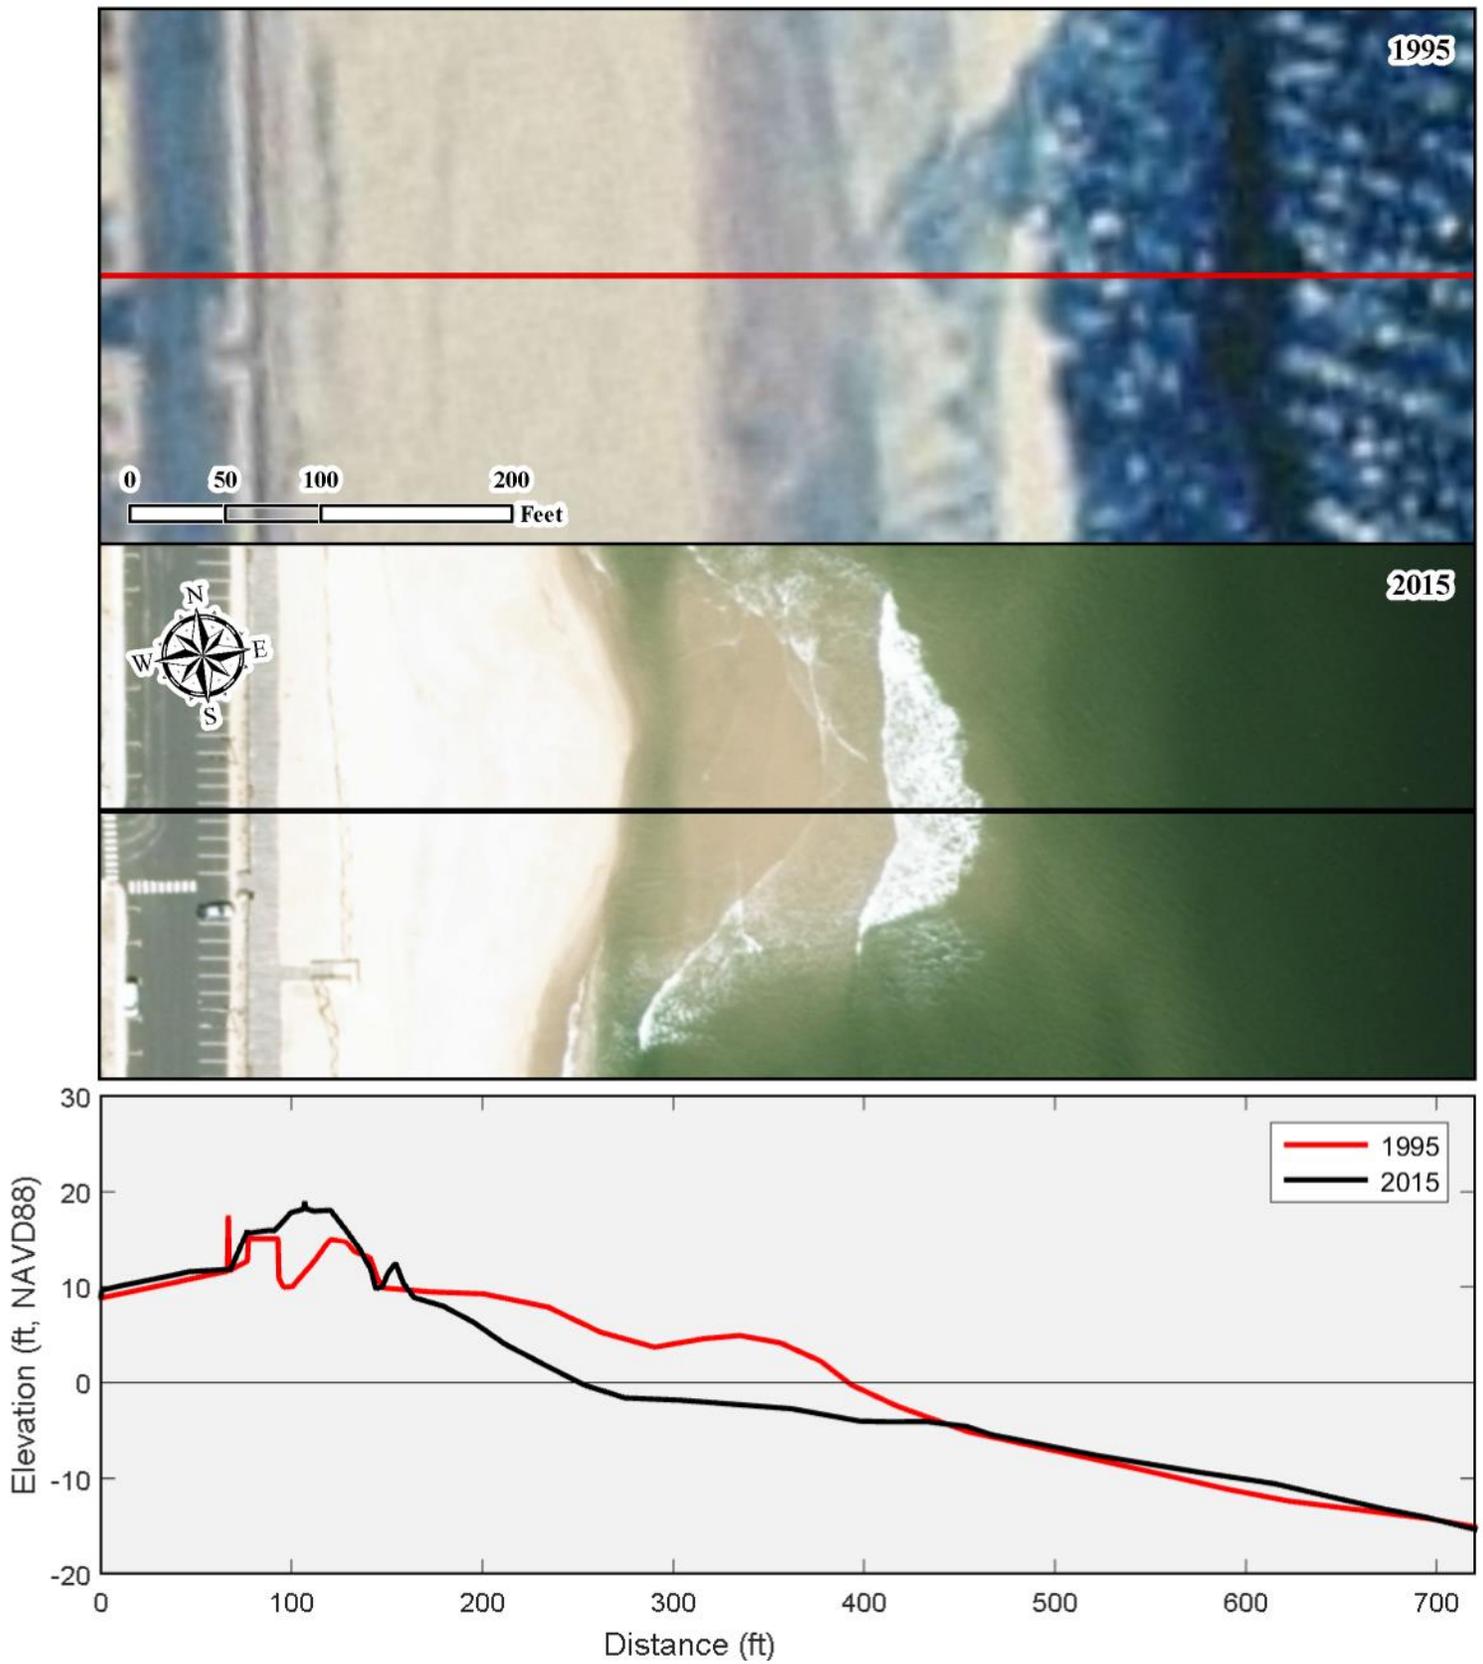
Figure 267. The 2015 profile shows the restored dune at an elevation nearly 20 ft. The berm is much lower in elevation from its 1995 position and the shoreline has retreated by about 140 ft between 1995 and 2015.

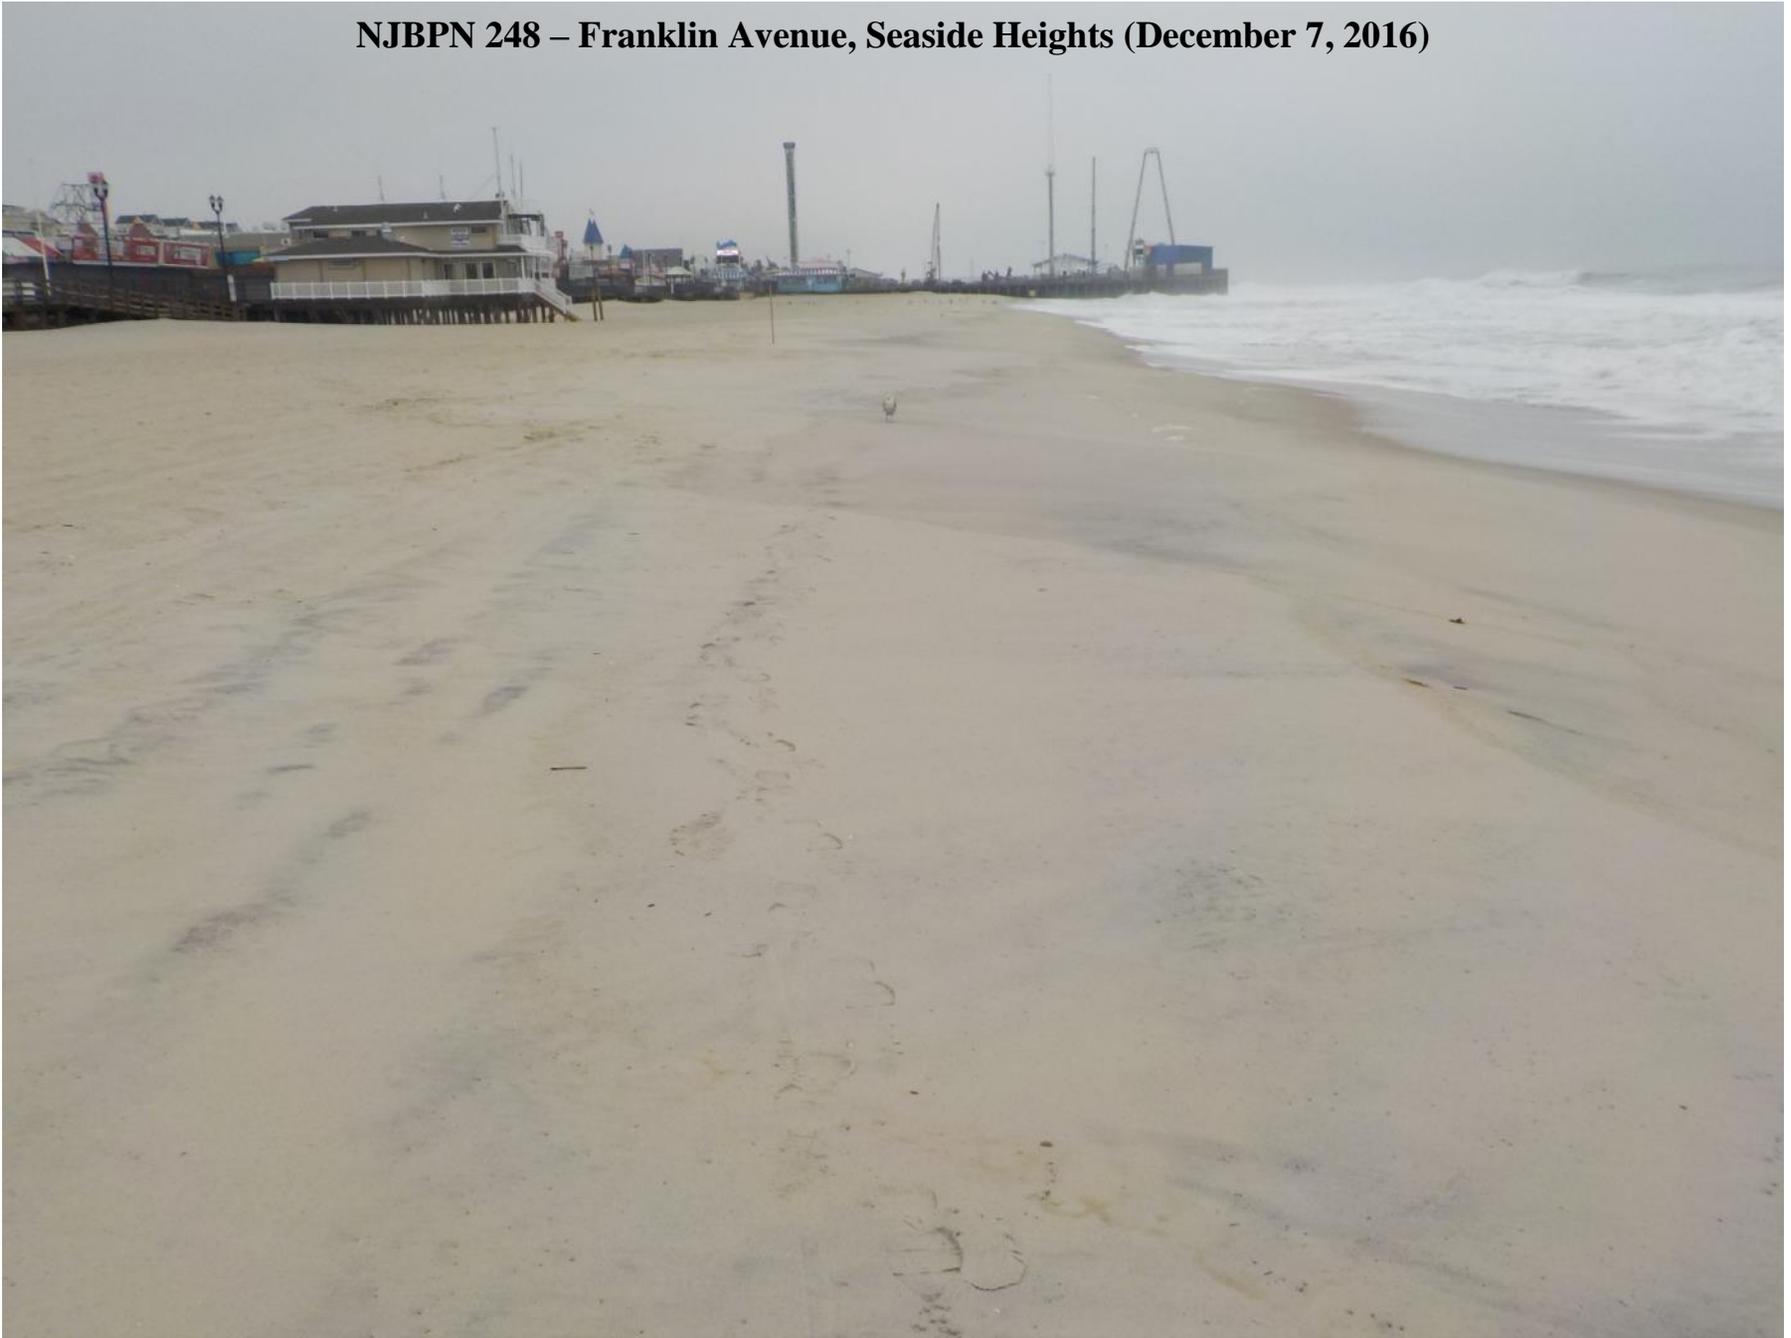
**NJBPN 248 – Franklin Avenue, Seaside Heights (December 7, 2016)**

**Figure 268. View to the north from the beach at Franklin Avenue in Seaside Heights looking at the amusement pier complex.**

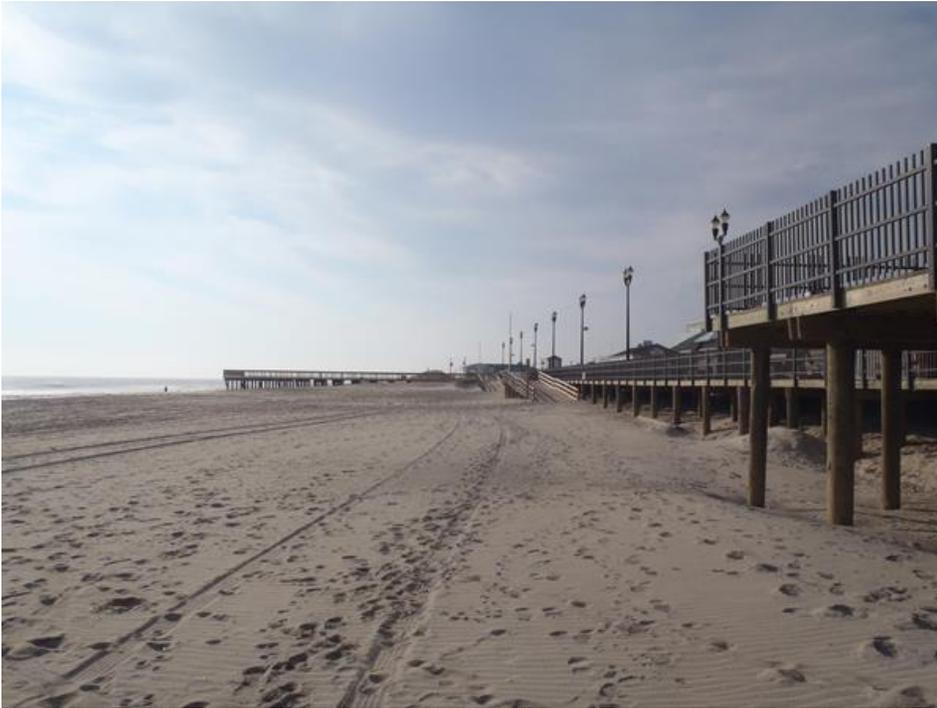
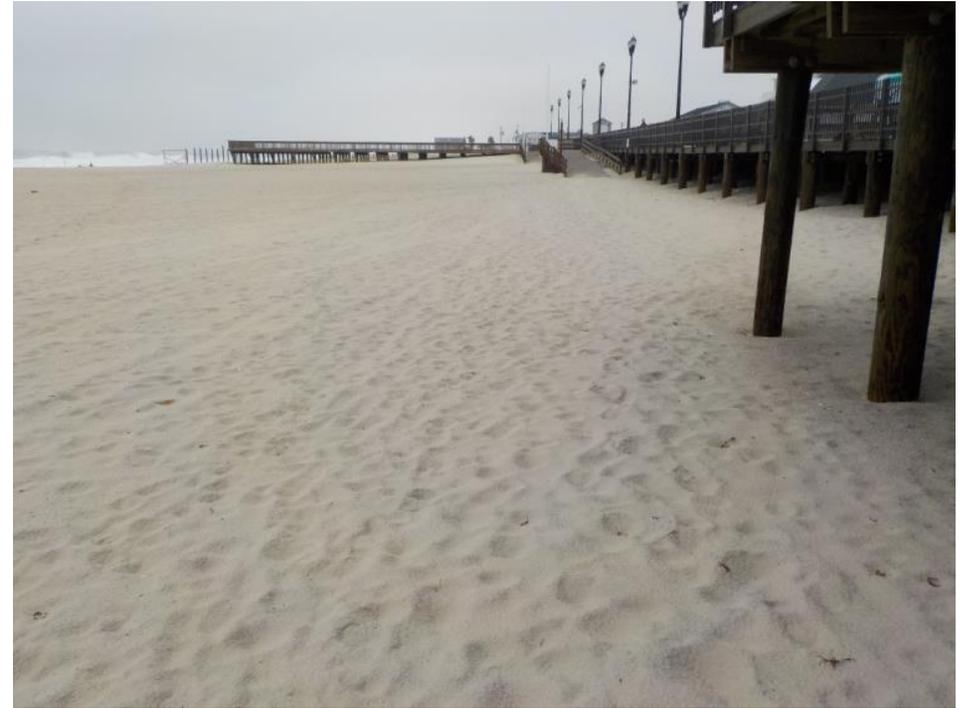
**NJBPN 248 – Franklin Avenue, Seaside Heights**

**Figure 269a & 269b. The two annual photos at the Franklin Avenue site show a nearly identical backshore elevation (left taken December 12, 2015 and right photo taken December 7, 2016). However, the 2015 photo does not clearly depict the deep runnel feature on the berm that is apparent in the profile cross section below.**

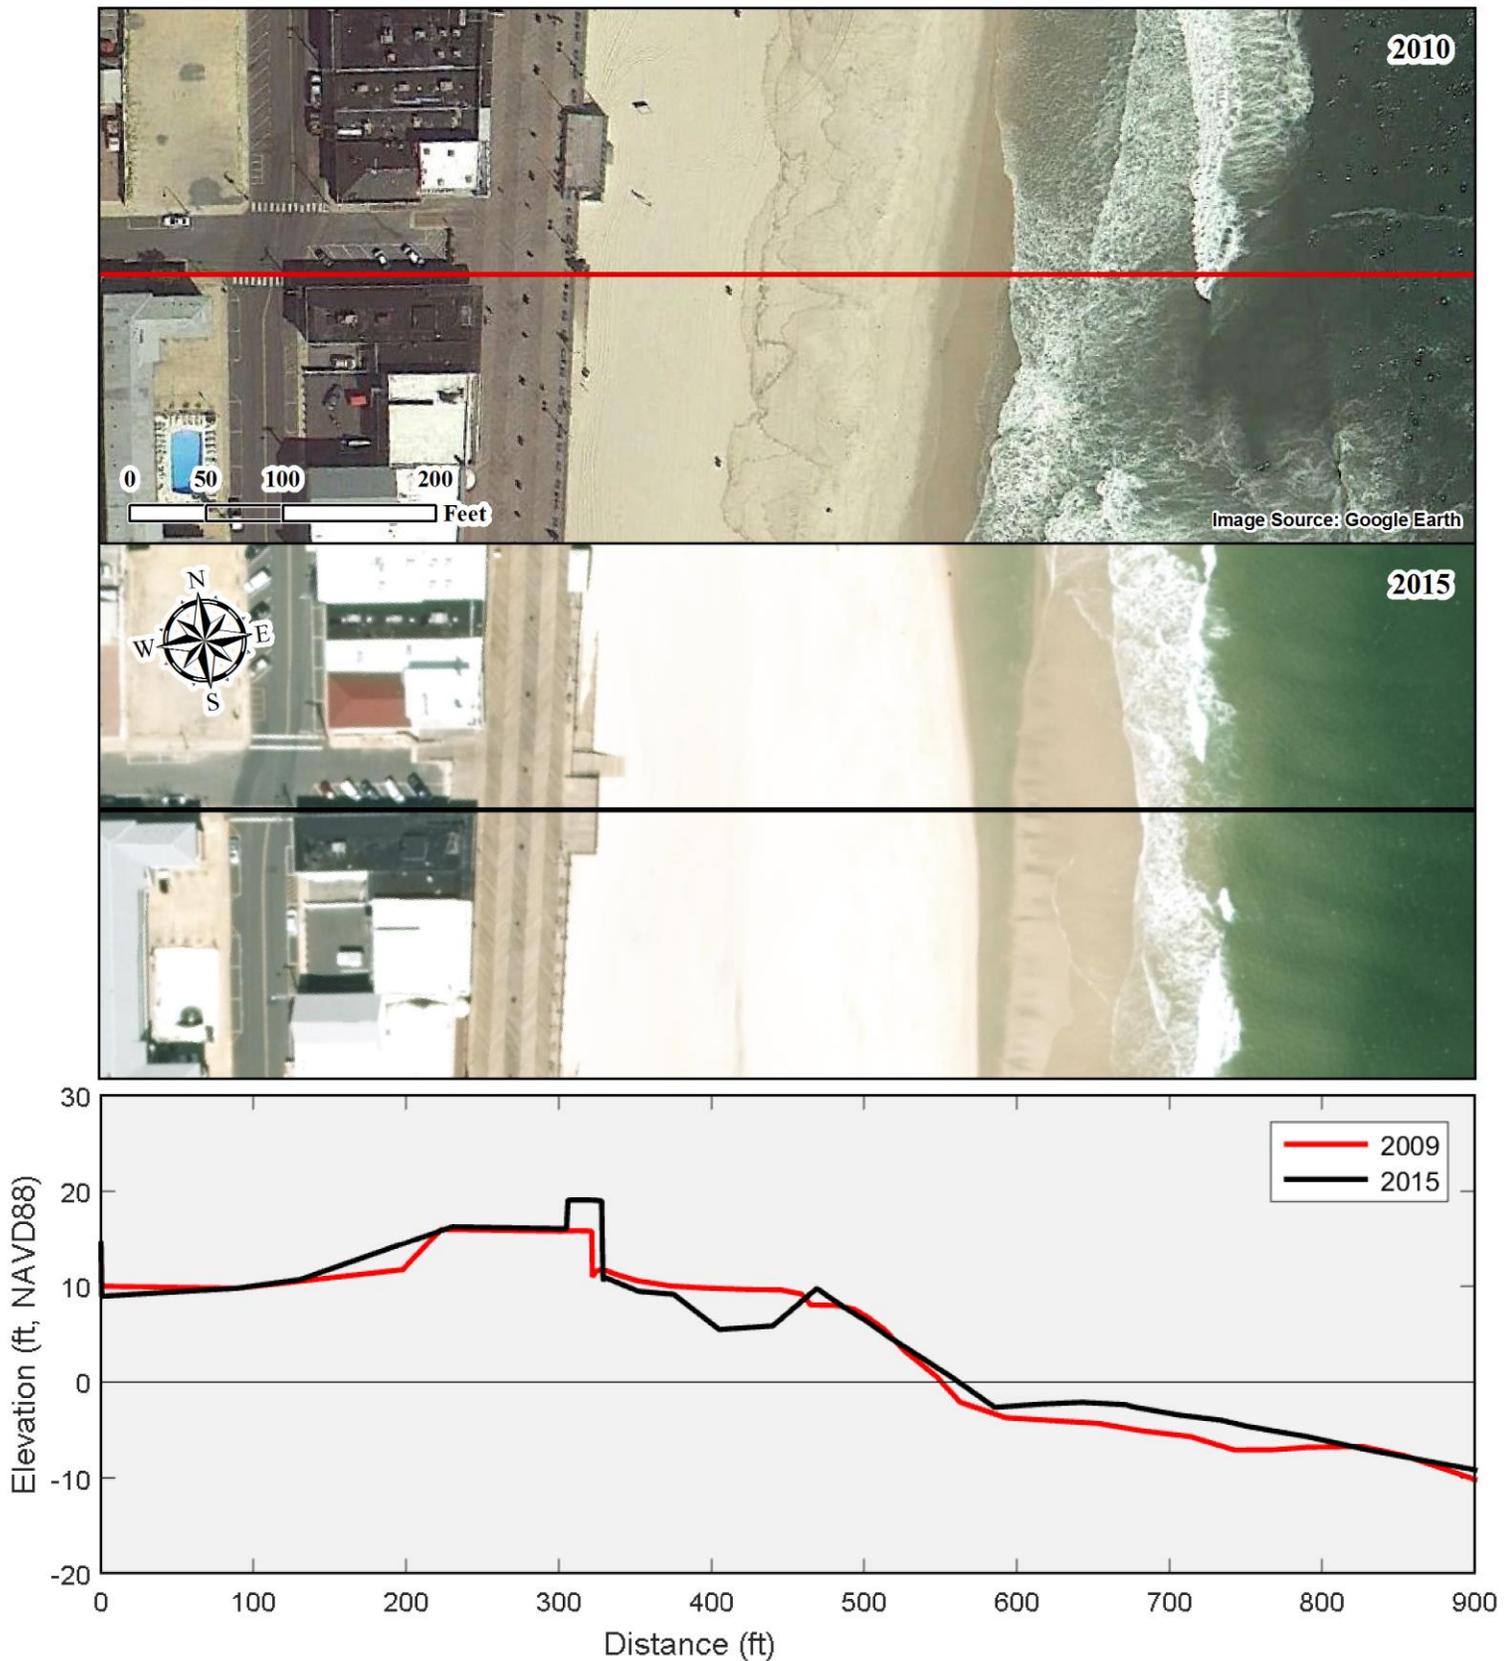
Figure 273. A revised boardwalk structure was added to this site after Hurricane Sandy. The berm lowered from its 2009 position. The shoreline moved 15 ft seaward between 2009 and 2015.

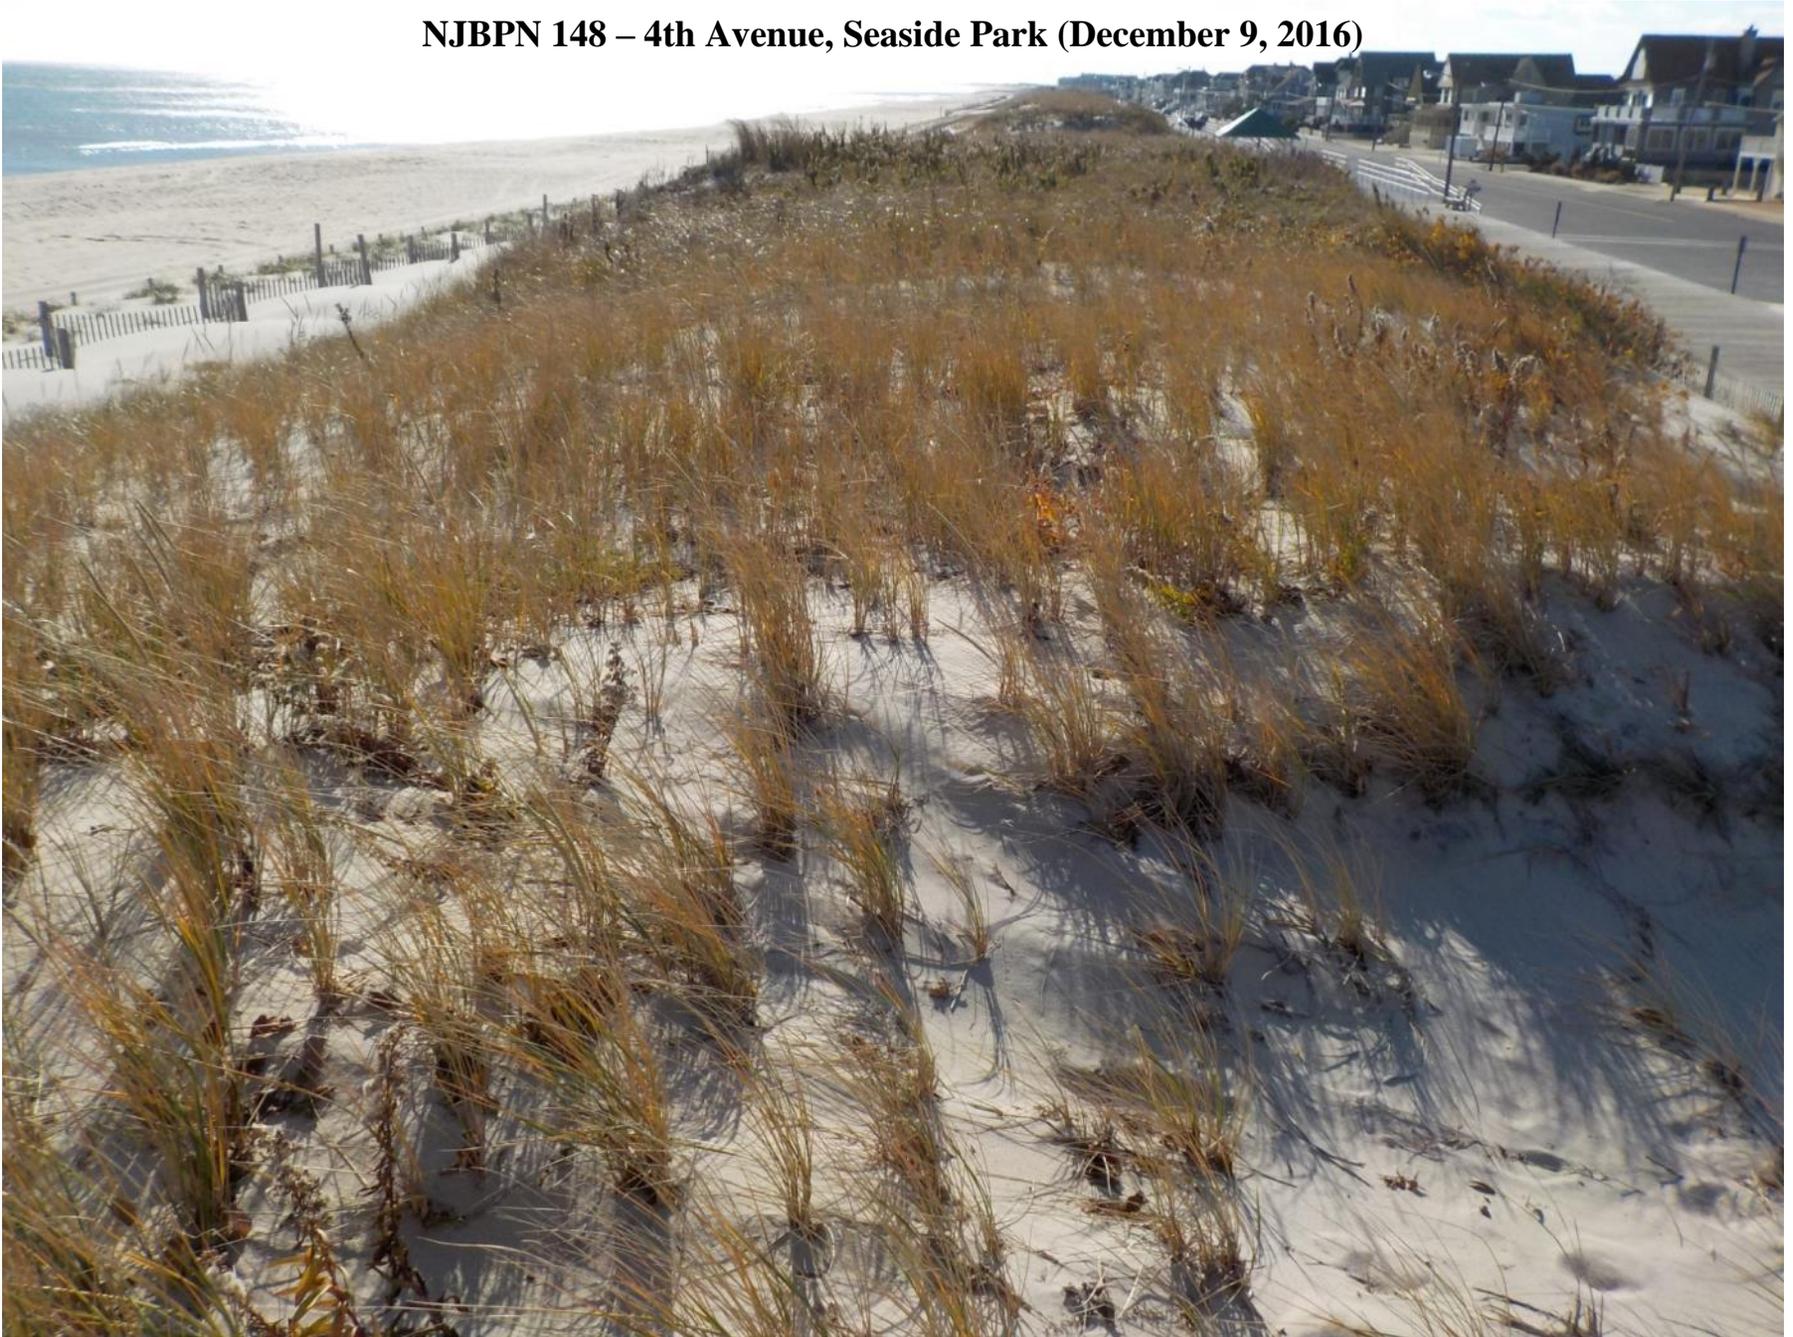
**NJBPN 148 – 4th Avenue, Seaside Park (December 9, 2016)**

**Figure 274. View to the south from the dune crest at 4<sup>th</sup> Avenue in Seaside Park that show parking, dune condition, and new fencing partially buried by wind deposited sand.**
