## An Analysis of Thirty Years' Study of Sand Redistribution and Shoreline Changes in New Jersey's Four Coastal Counties Raritan Bay, the Atlantic Ocean Coast, and Delaware Bay Fall 1986 Through Fall 2016

### ***VOLUME 2 of 4 OCEAN COUNTY***

Prepared for:  
New Jersey Department of Environmental Protection  
Division of Coastal Engineering  
1510 Hooper Avenue, Toms River, New Jersey 08753

Prepared by:  
Stockton University Coastal Research Center  
30 Wilson Avenue, Port Republic, NJ 08241

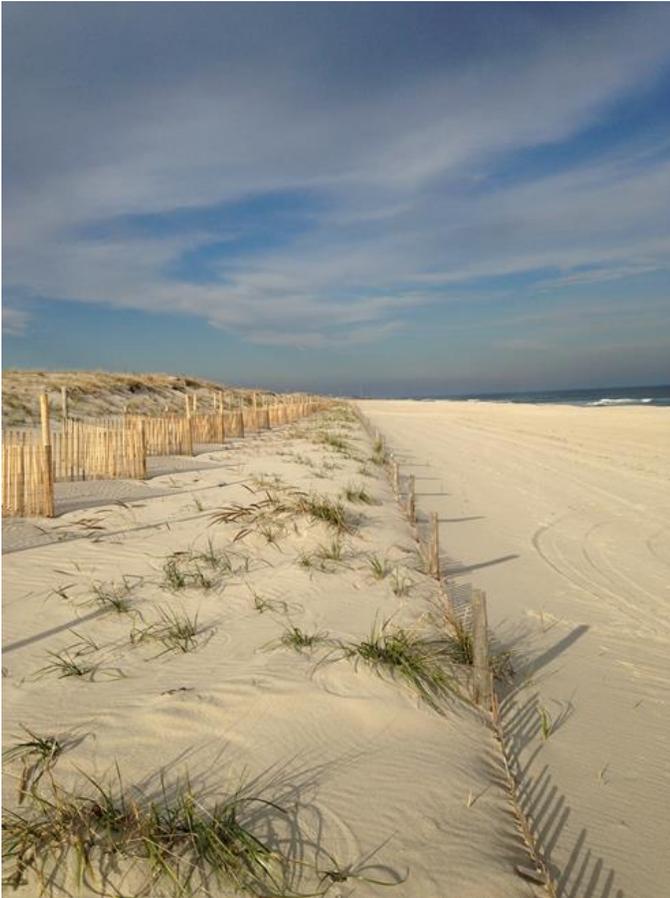
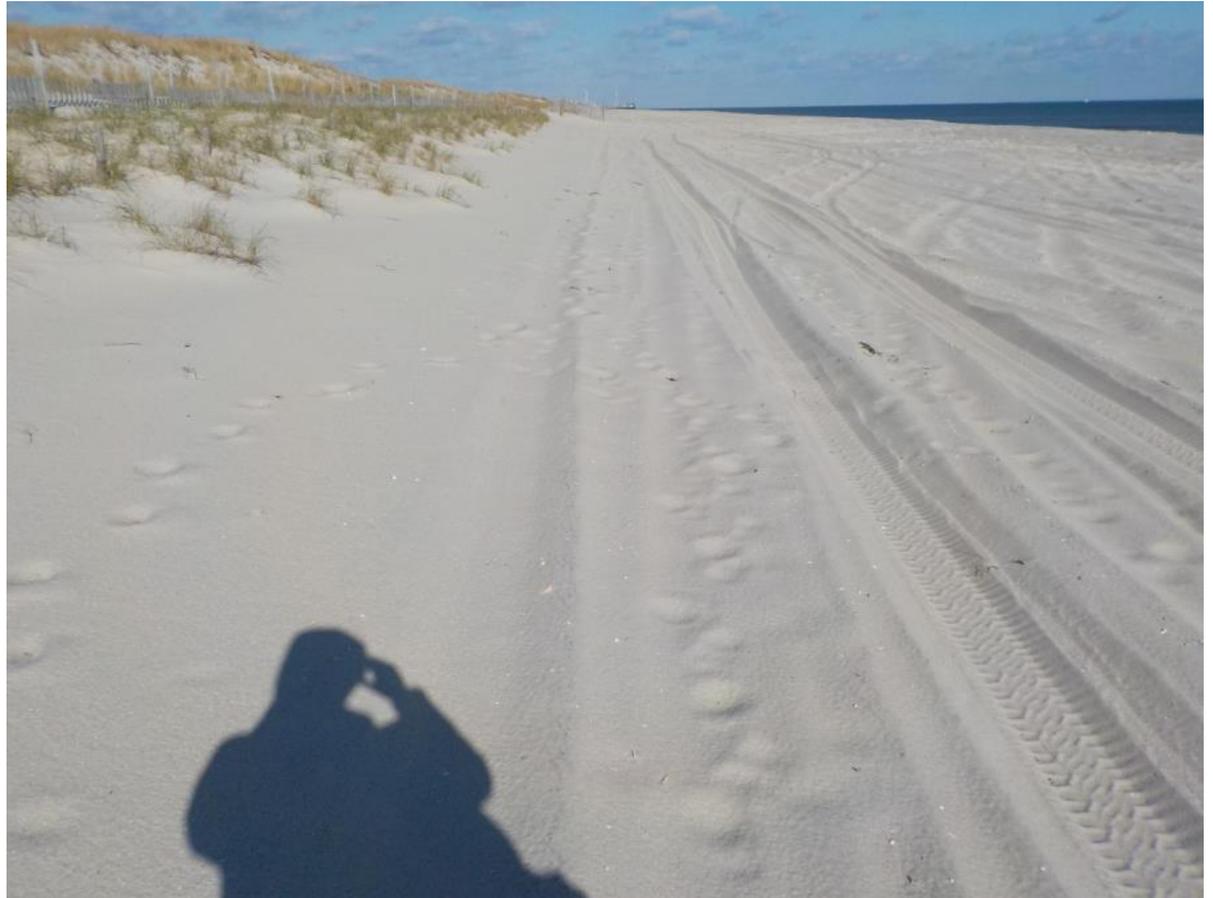
**Figure 275a & 275b. The photo on the left (taken December 7, 2015) shows the dune has gained sand landward of the old fence line. The right photo (December 9, 2016) shows the toe of the foredune developed at the original fencing. A more recently installed row of fence is set landward of the original fence line.**

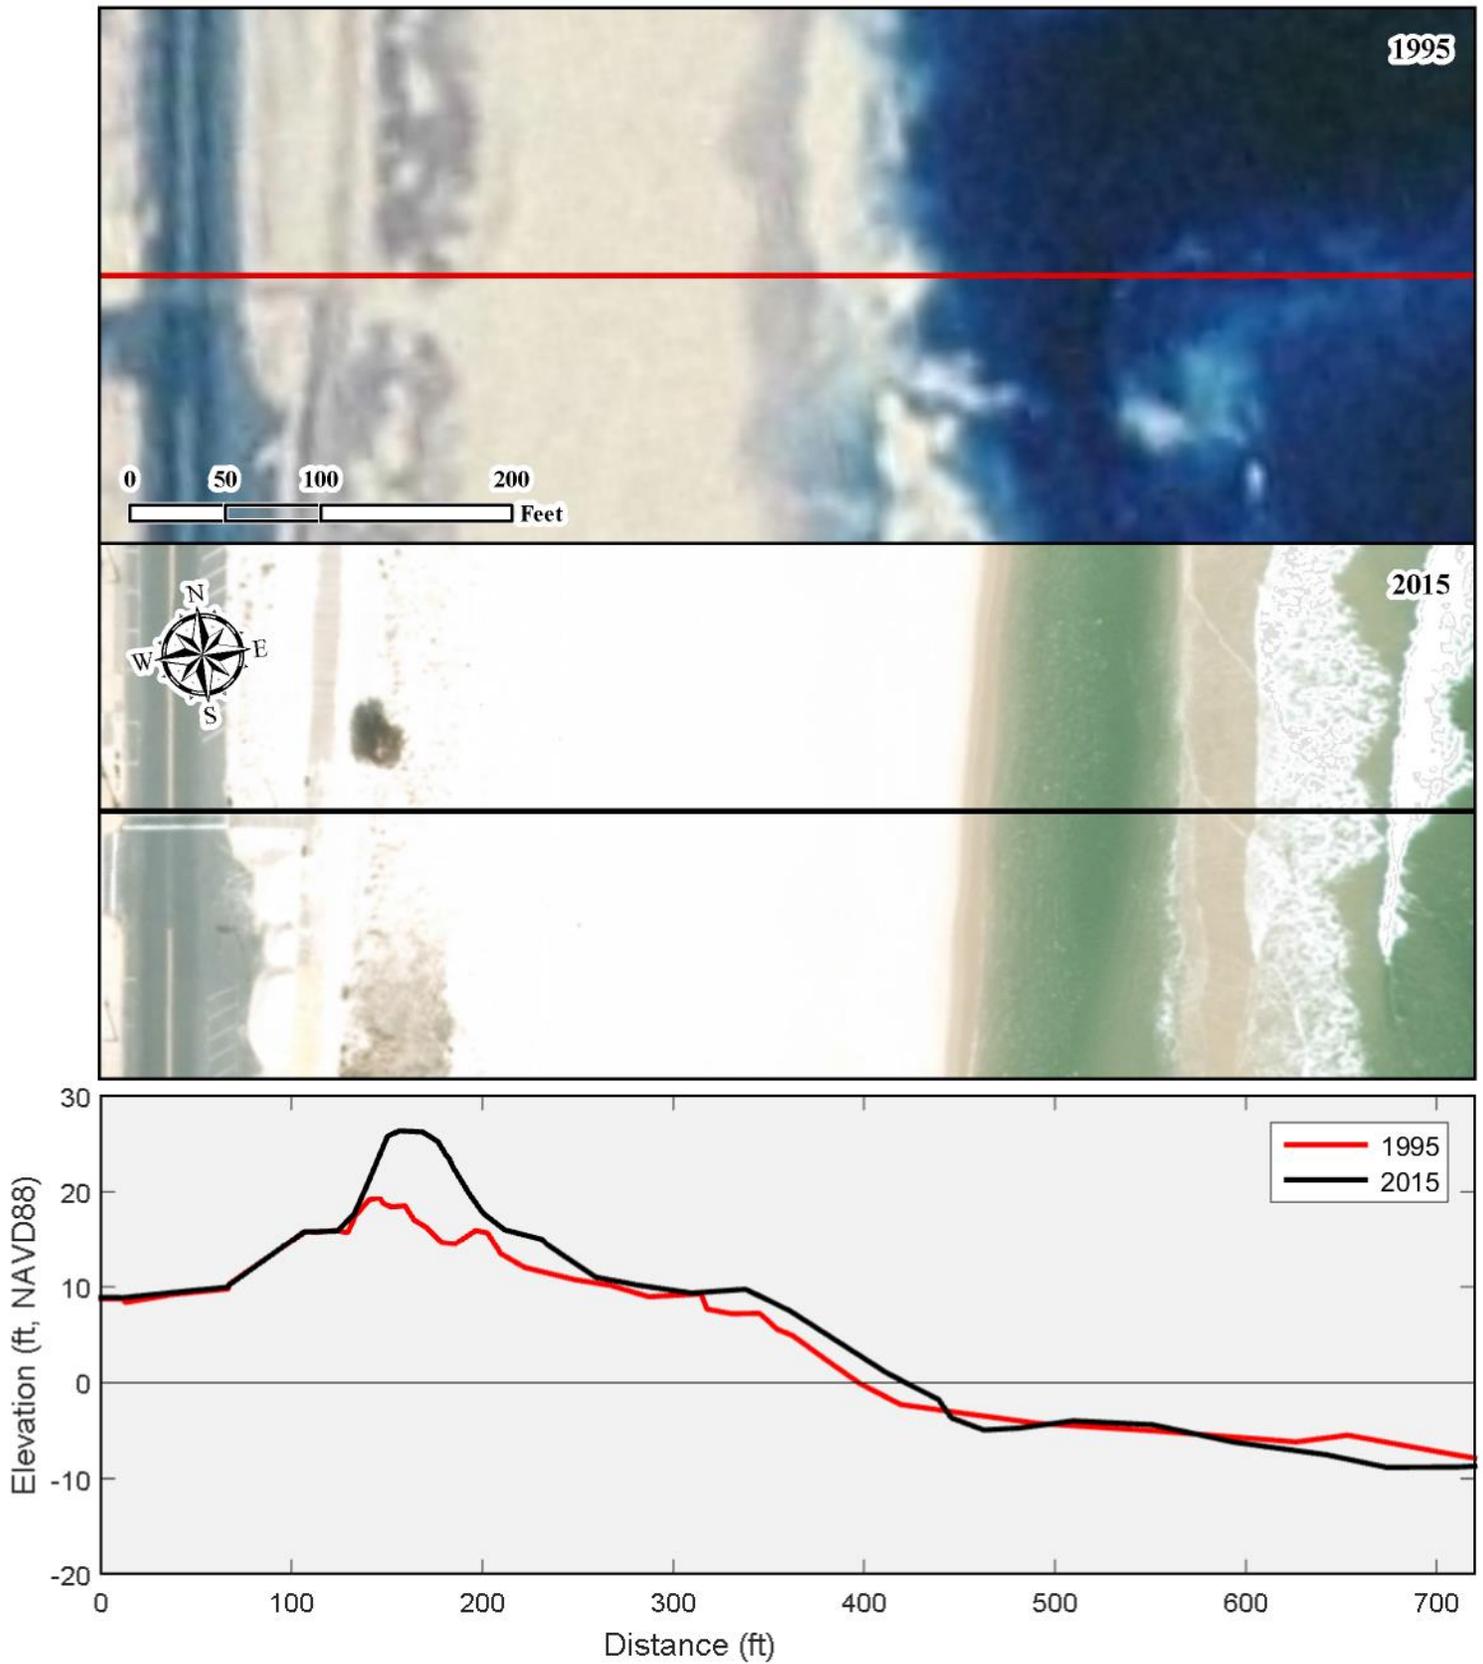
Figure 279. The dune and berm grew through natural accretion between 1995 and 2015. The shoreline advanced 25 ft seaward.

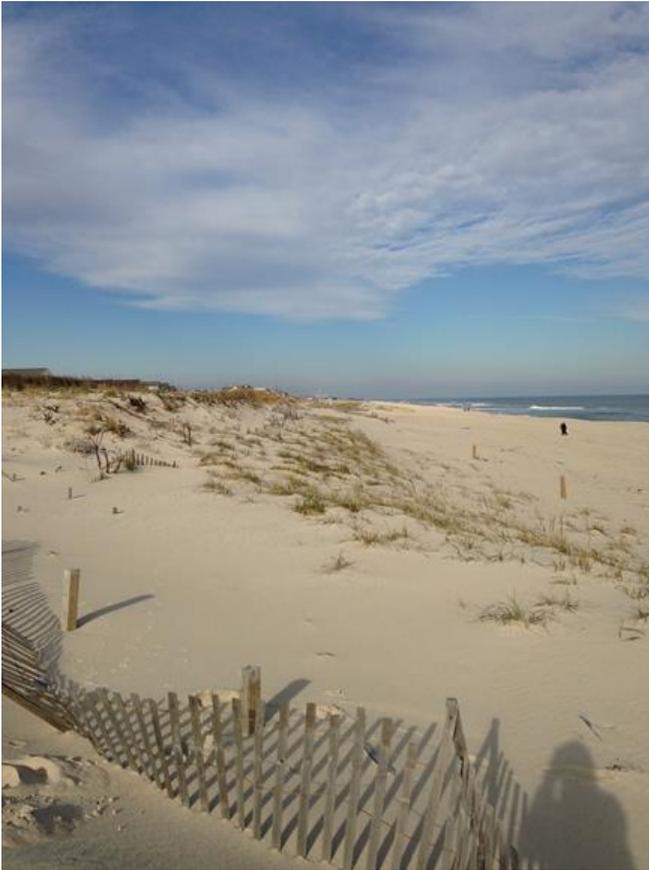
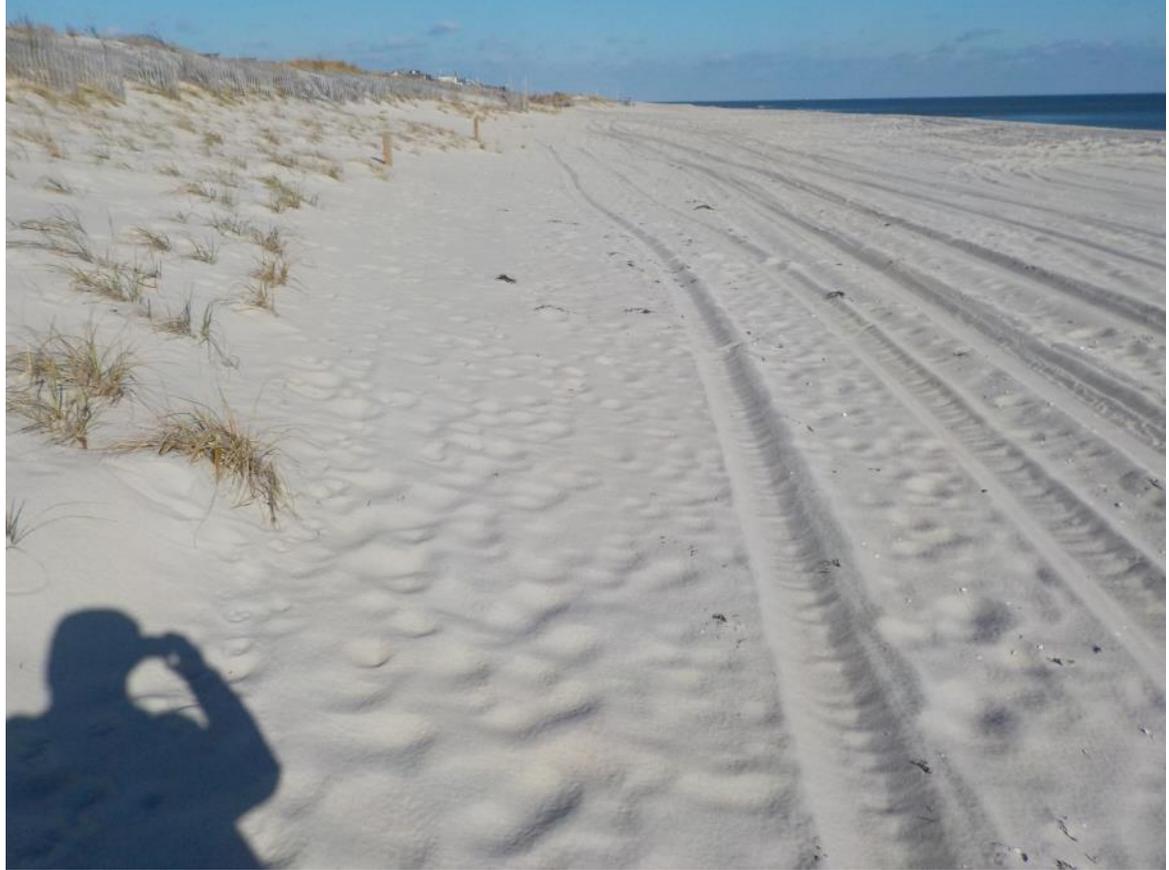
**Figure 281a & 281b. The photos show the condition of the backshore and seaward dune toe at 6<sup>th</sup> Lane (left taken December 7, 2015 and right taken December 9, 2016). This section of the profile showed little change over the past year and appeared to have fared well through the January 2016 northeast storm.**

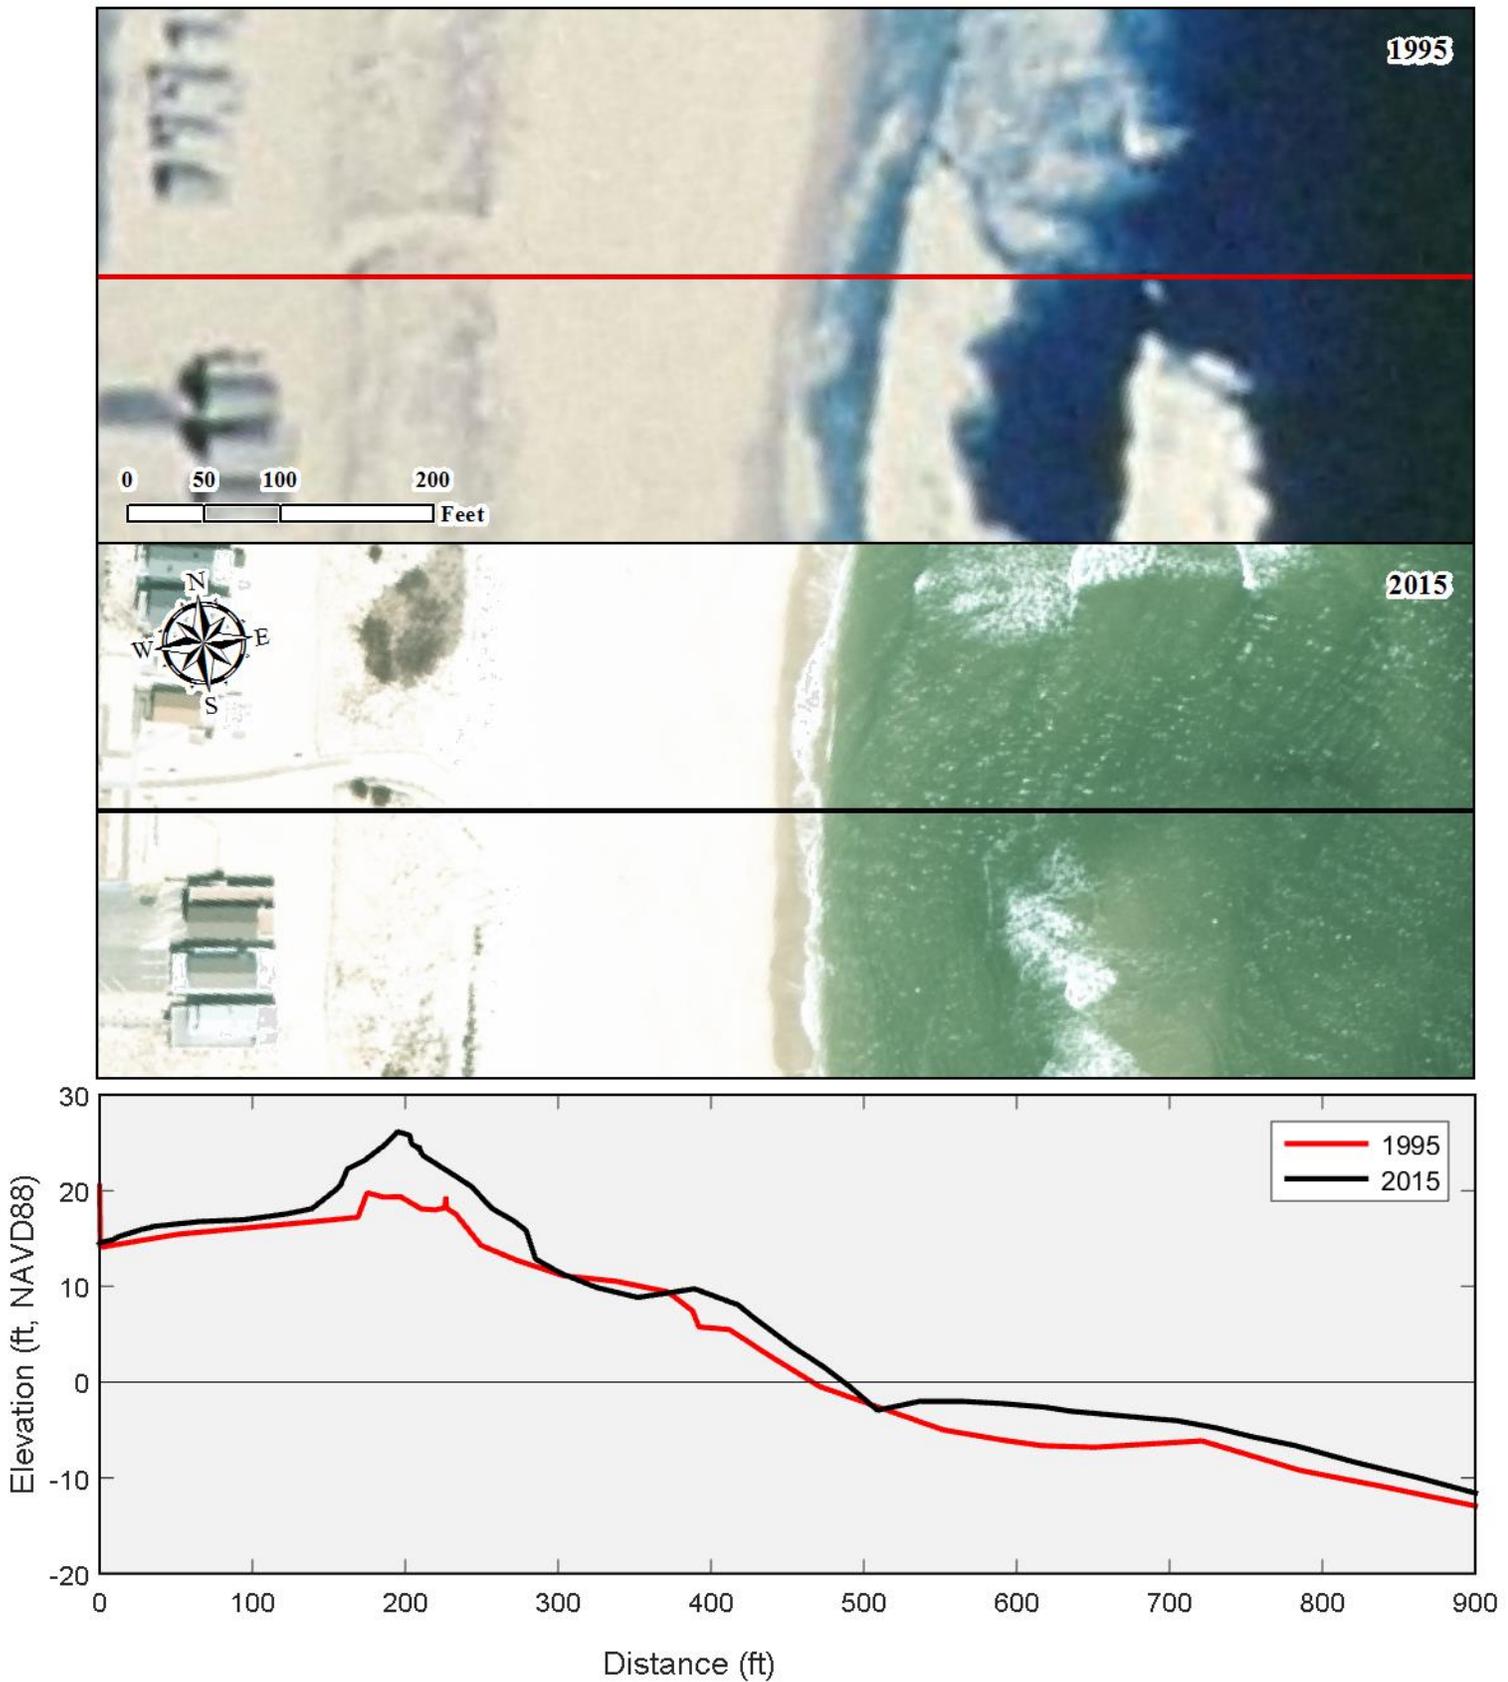
Figure 285. Comparison of site 147 after it was moved in 2005 out of the beach access way and onto the adjacent dune. The berm and nearshore sections fall along the original transect and the shoreline moved about 20 ft seaward.

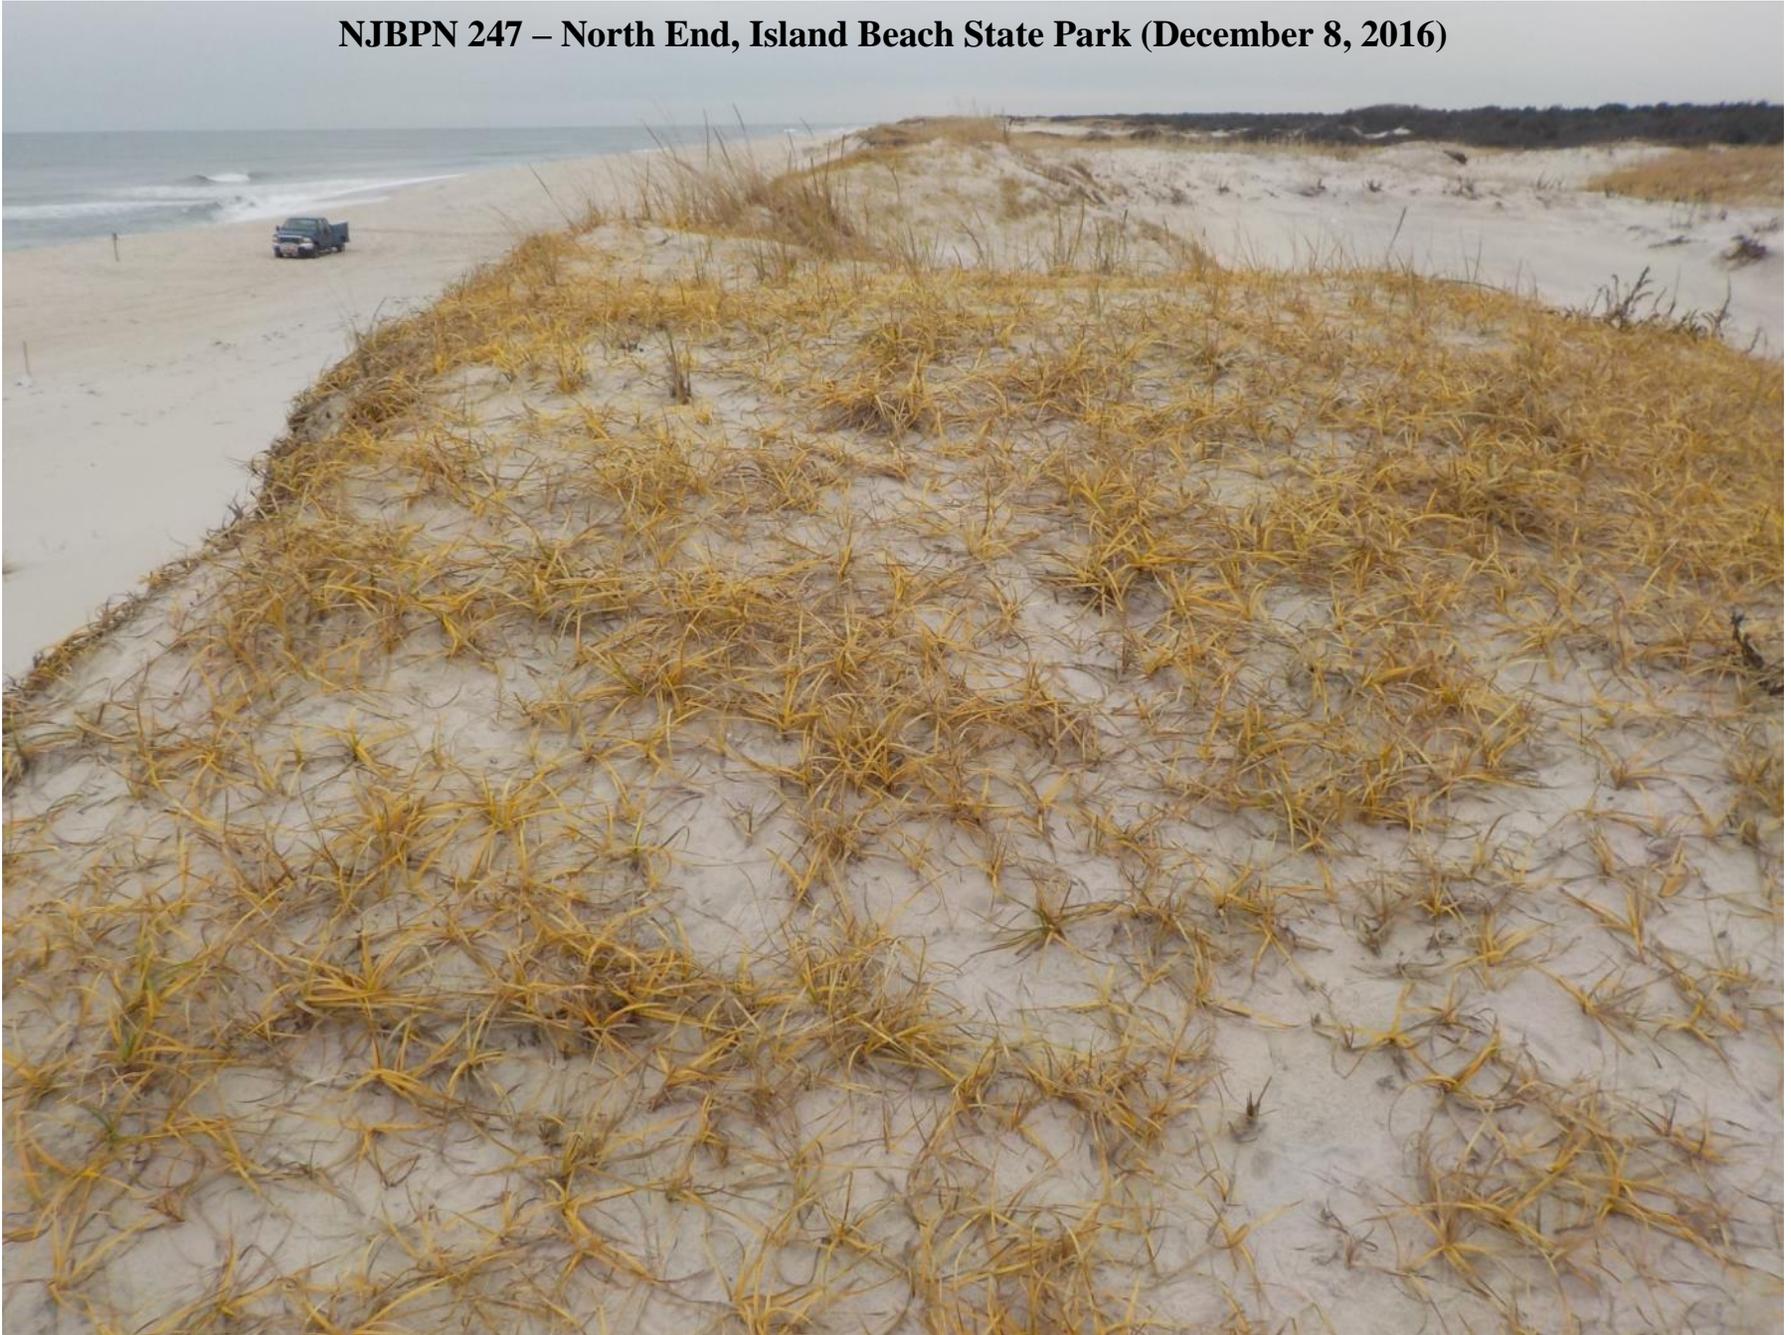
**NJBPN 247 – North End, Island Beach State Park (December 8, 2016)**

**Figure 286. View to the south from the dune crest at the North End location in Island Beach State Park.**

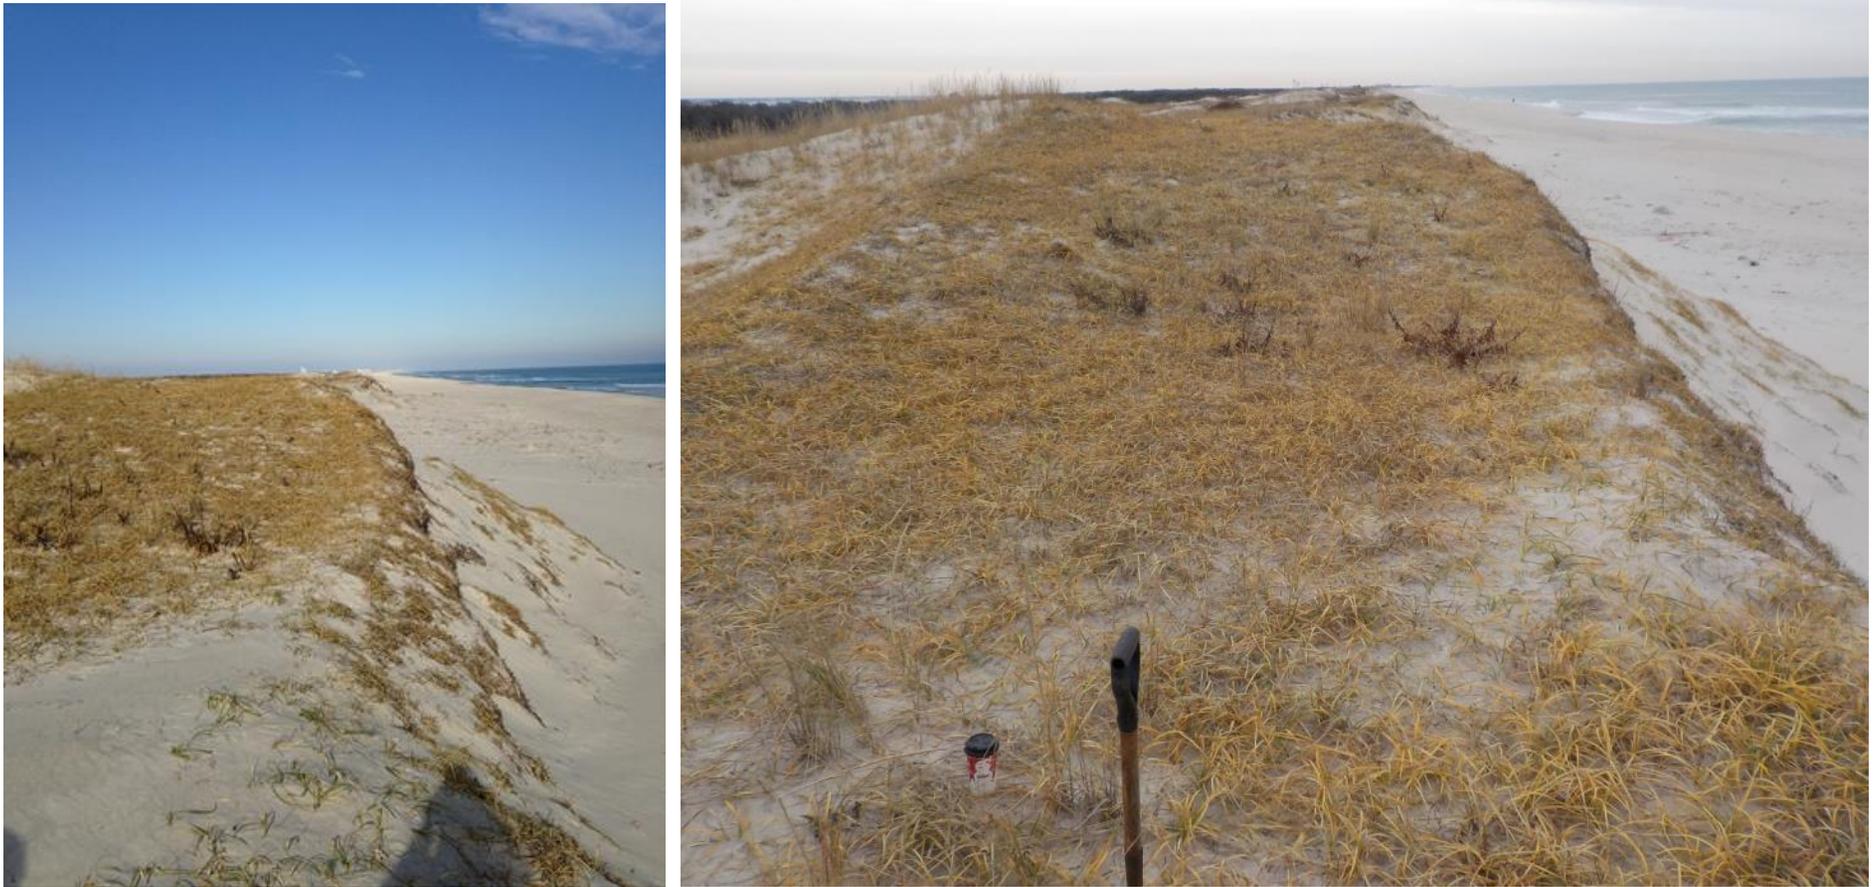
**Figure 287a & 287b. The left photo (taken December 7, 2015) shows the scarp in the dune system that was generated during Hurricane Sandy and still not recovered three years later. The December 8, 2016 photo (right) shows nearly exact conditions four years later. Sporadic sections along the dune scarp have begun to vegetate and trap sand.**

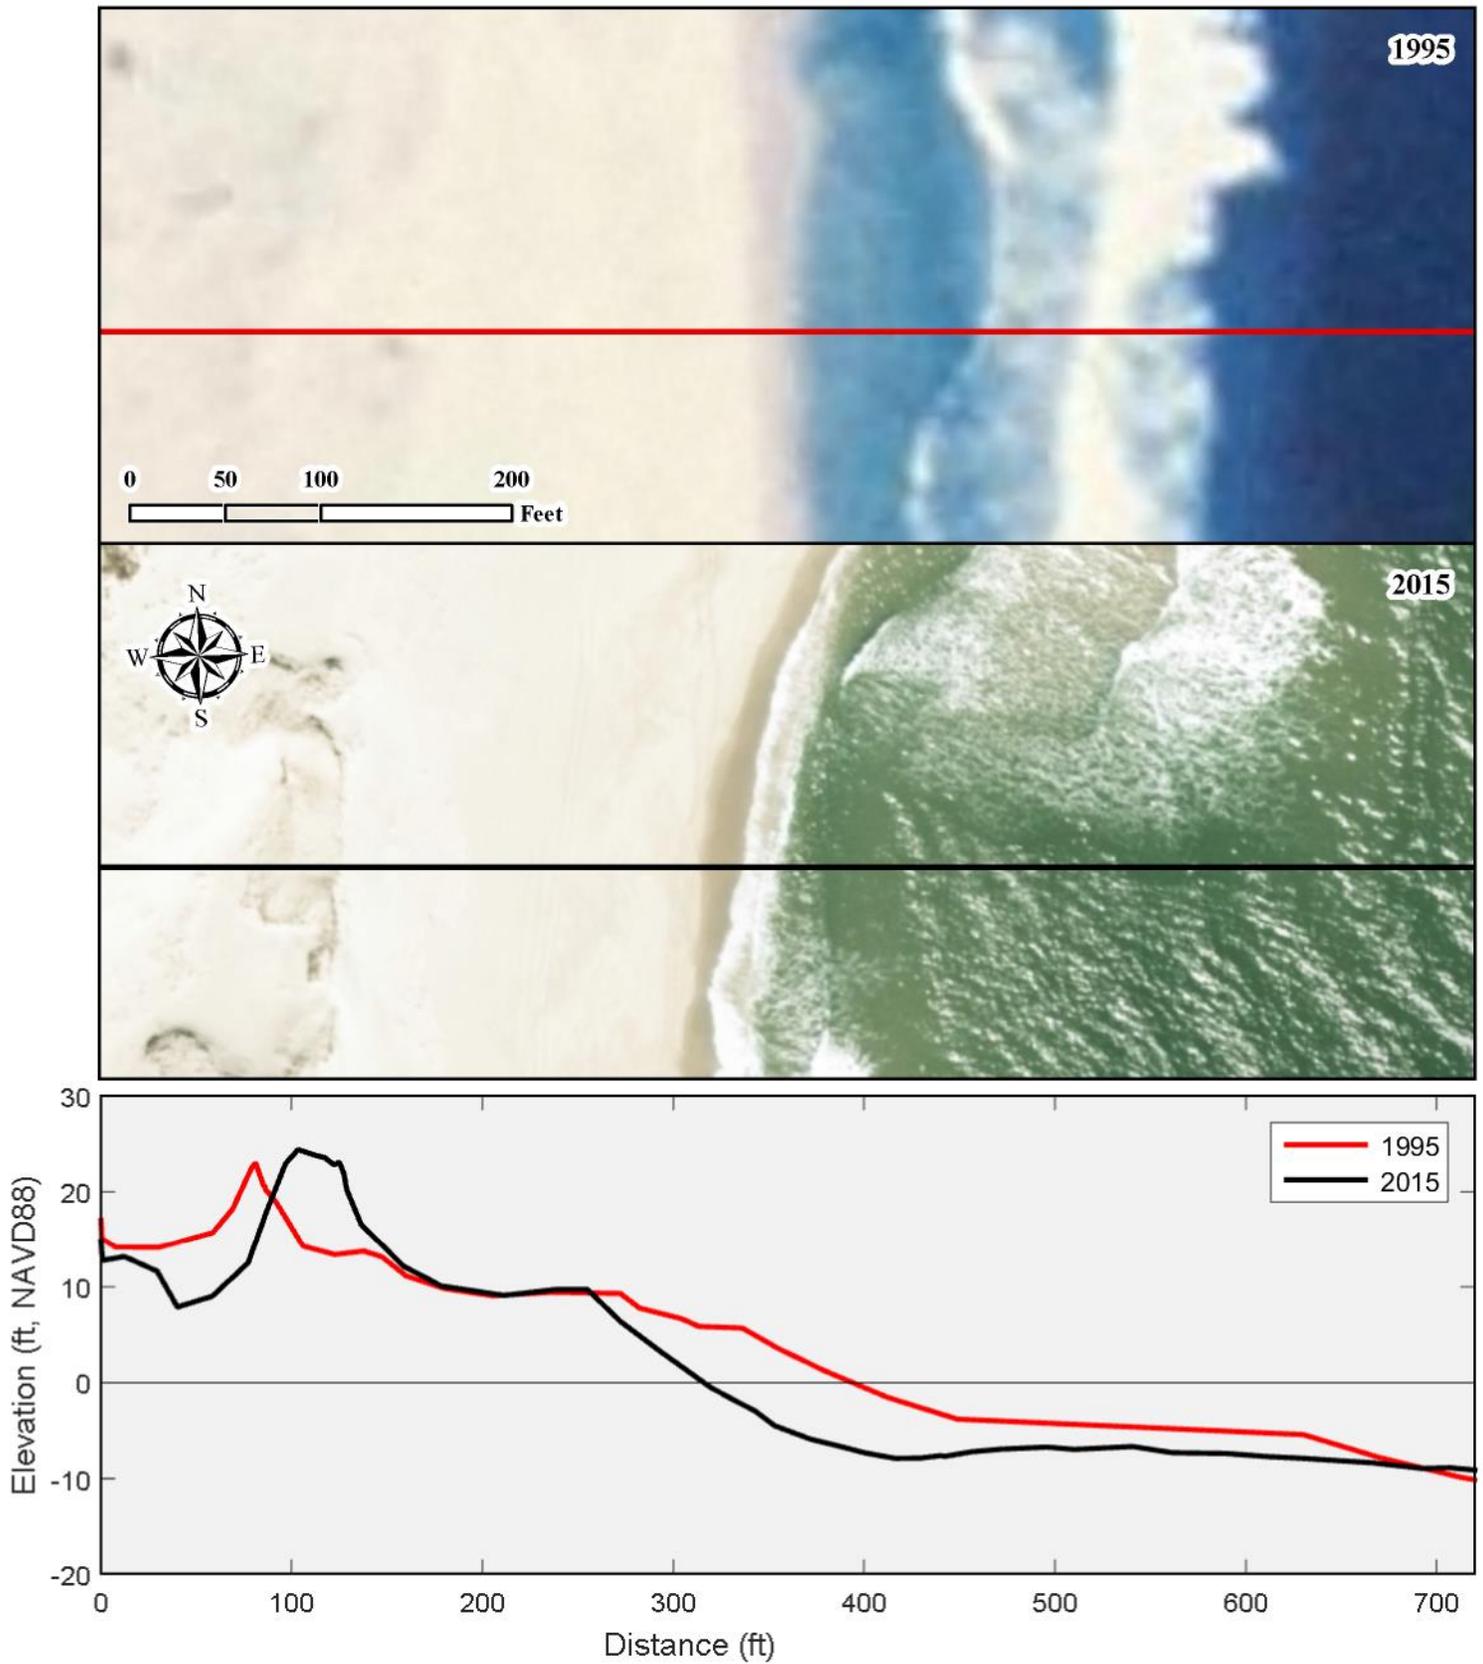
Figure 291. The dune moved seaward from its 1995 position while the berm remained in the same elevation. The shoreline retreated landward by almost 80 ft from 1995 to 2015.

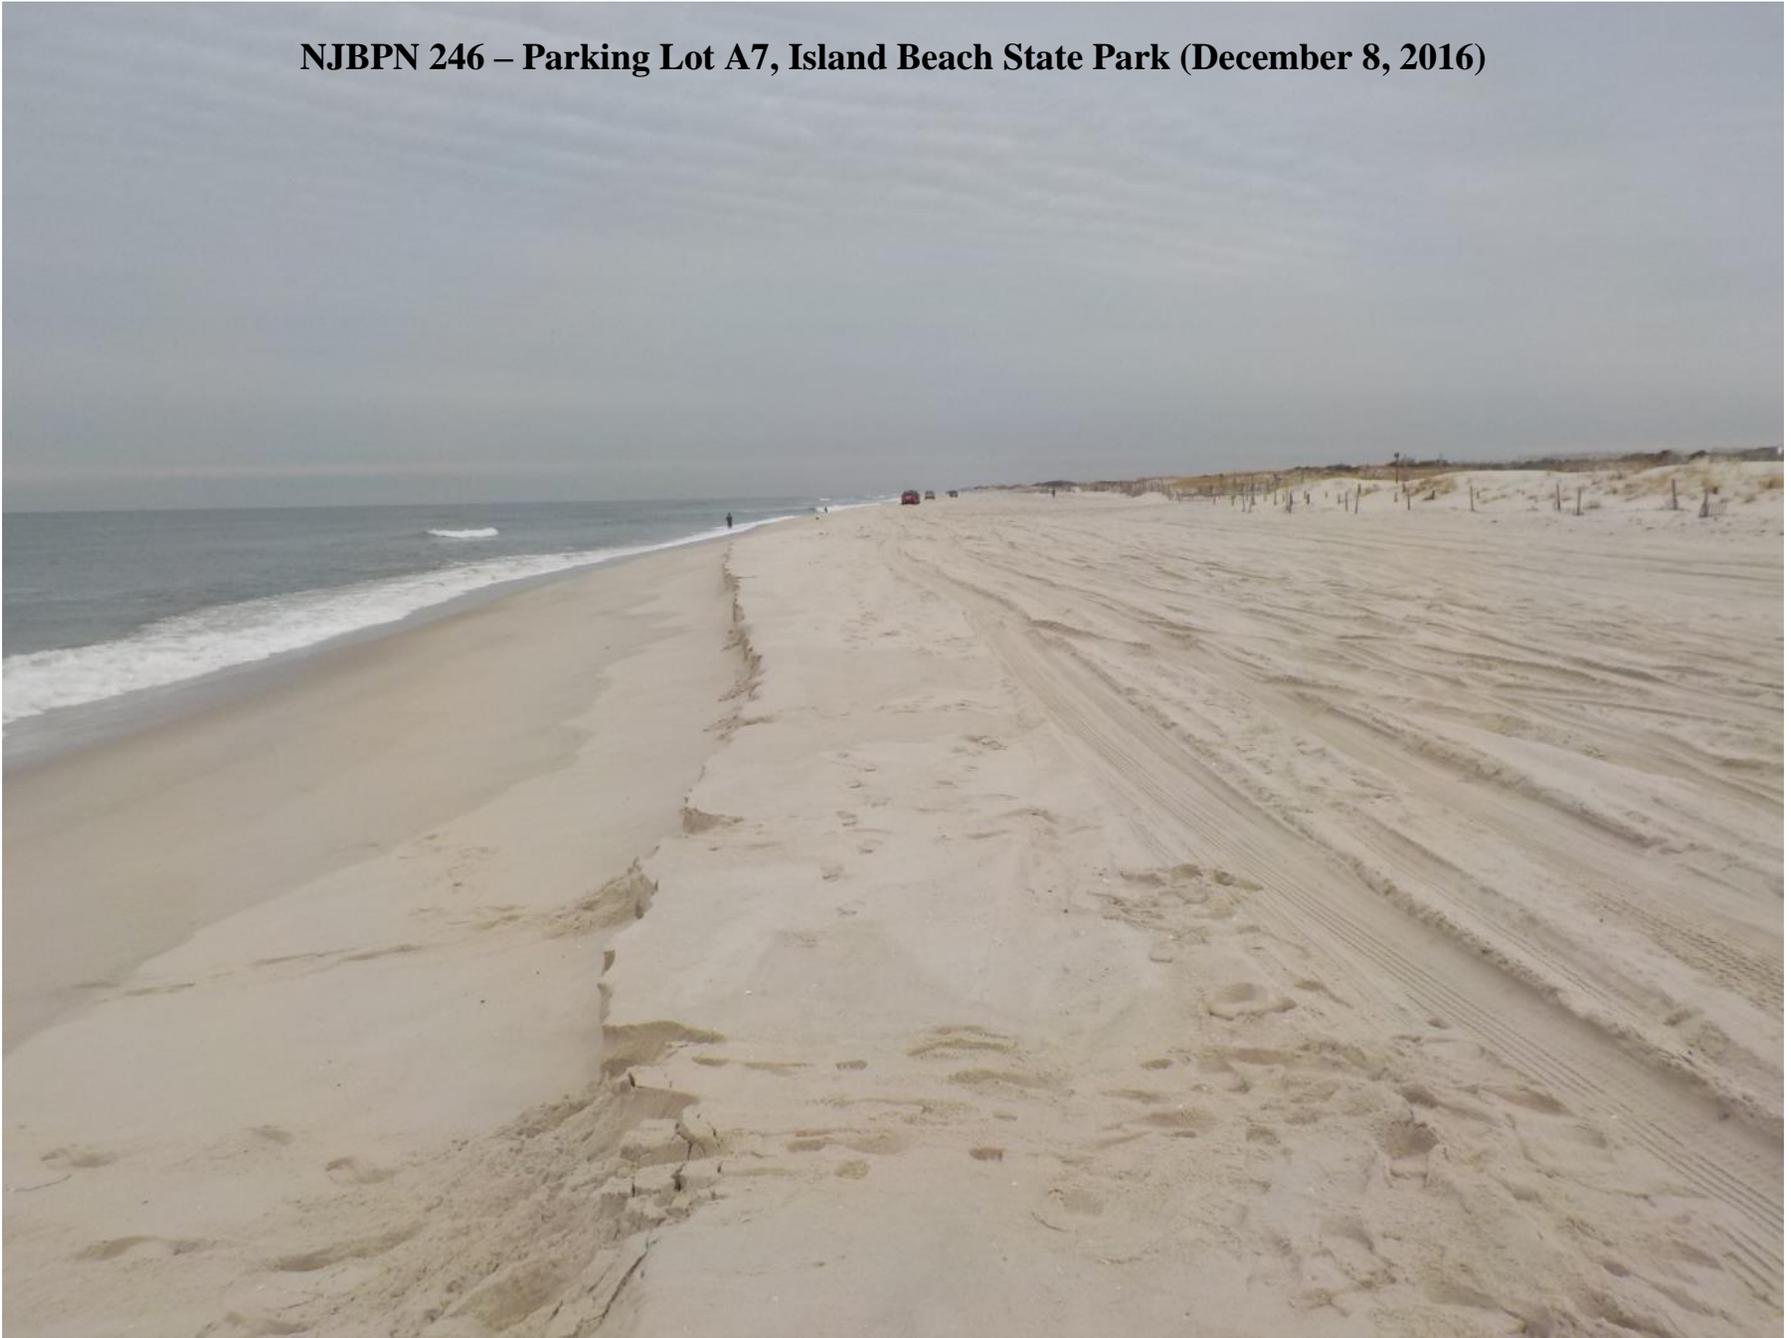
**NJBPN 246 – Parking Lot A7, Island Beach State Park (December 8, 2016)**

**Figure 292. View to the south from the berm at the Parking Lot A7 location in Island Beach State Park. The profile line is located 400 ft north of the vehicle access point.**

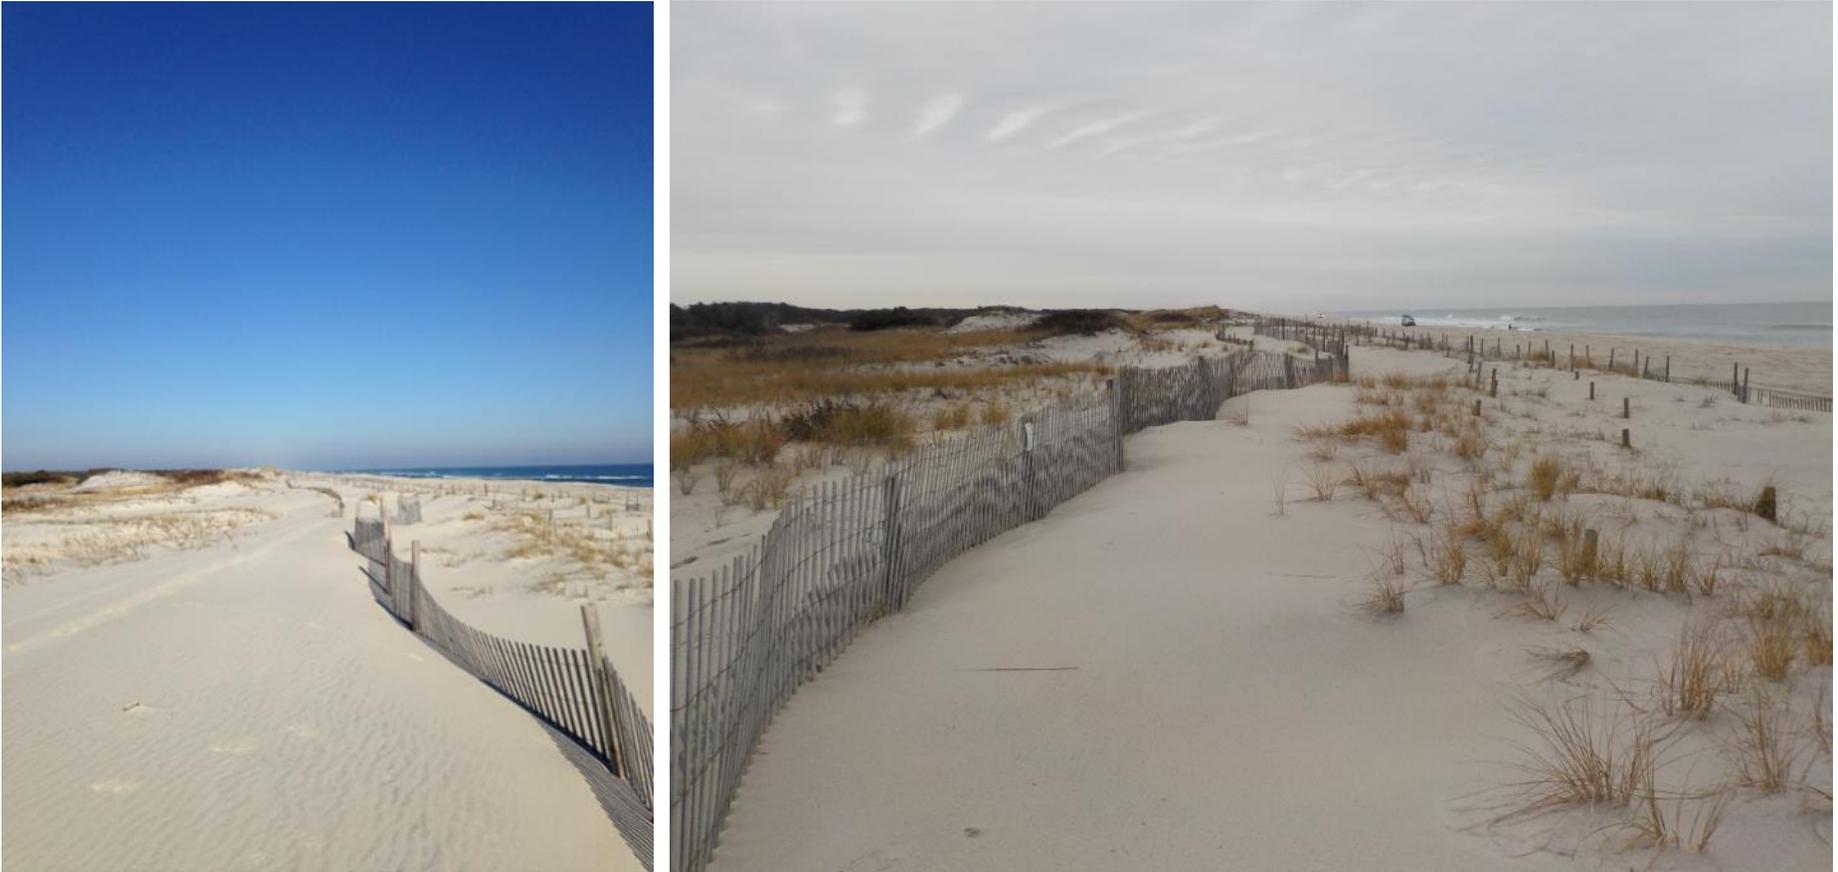
**NJBPN 246 – Parking Lot A7, Island Beach State Park**

**Figure 293a & 293b. The photos along the fence line show the sparsely vegetated dunes at the Parking Lot A7 location (left taken December 7, 2015 and right taken December 8, 2016). Dune elevations along this profile are low compared to other measured locations within the park, though the dune field is nearly 200 ft in width.**

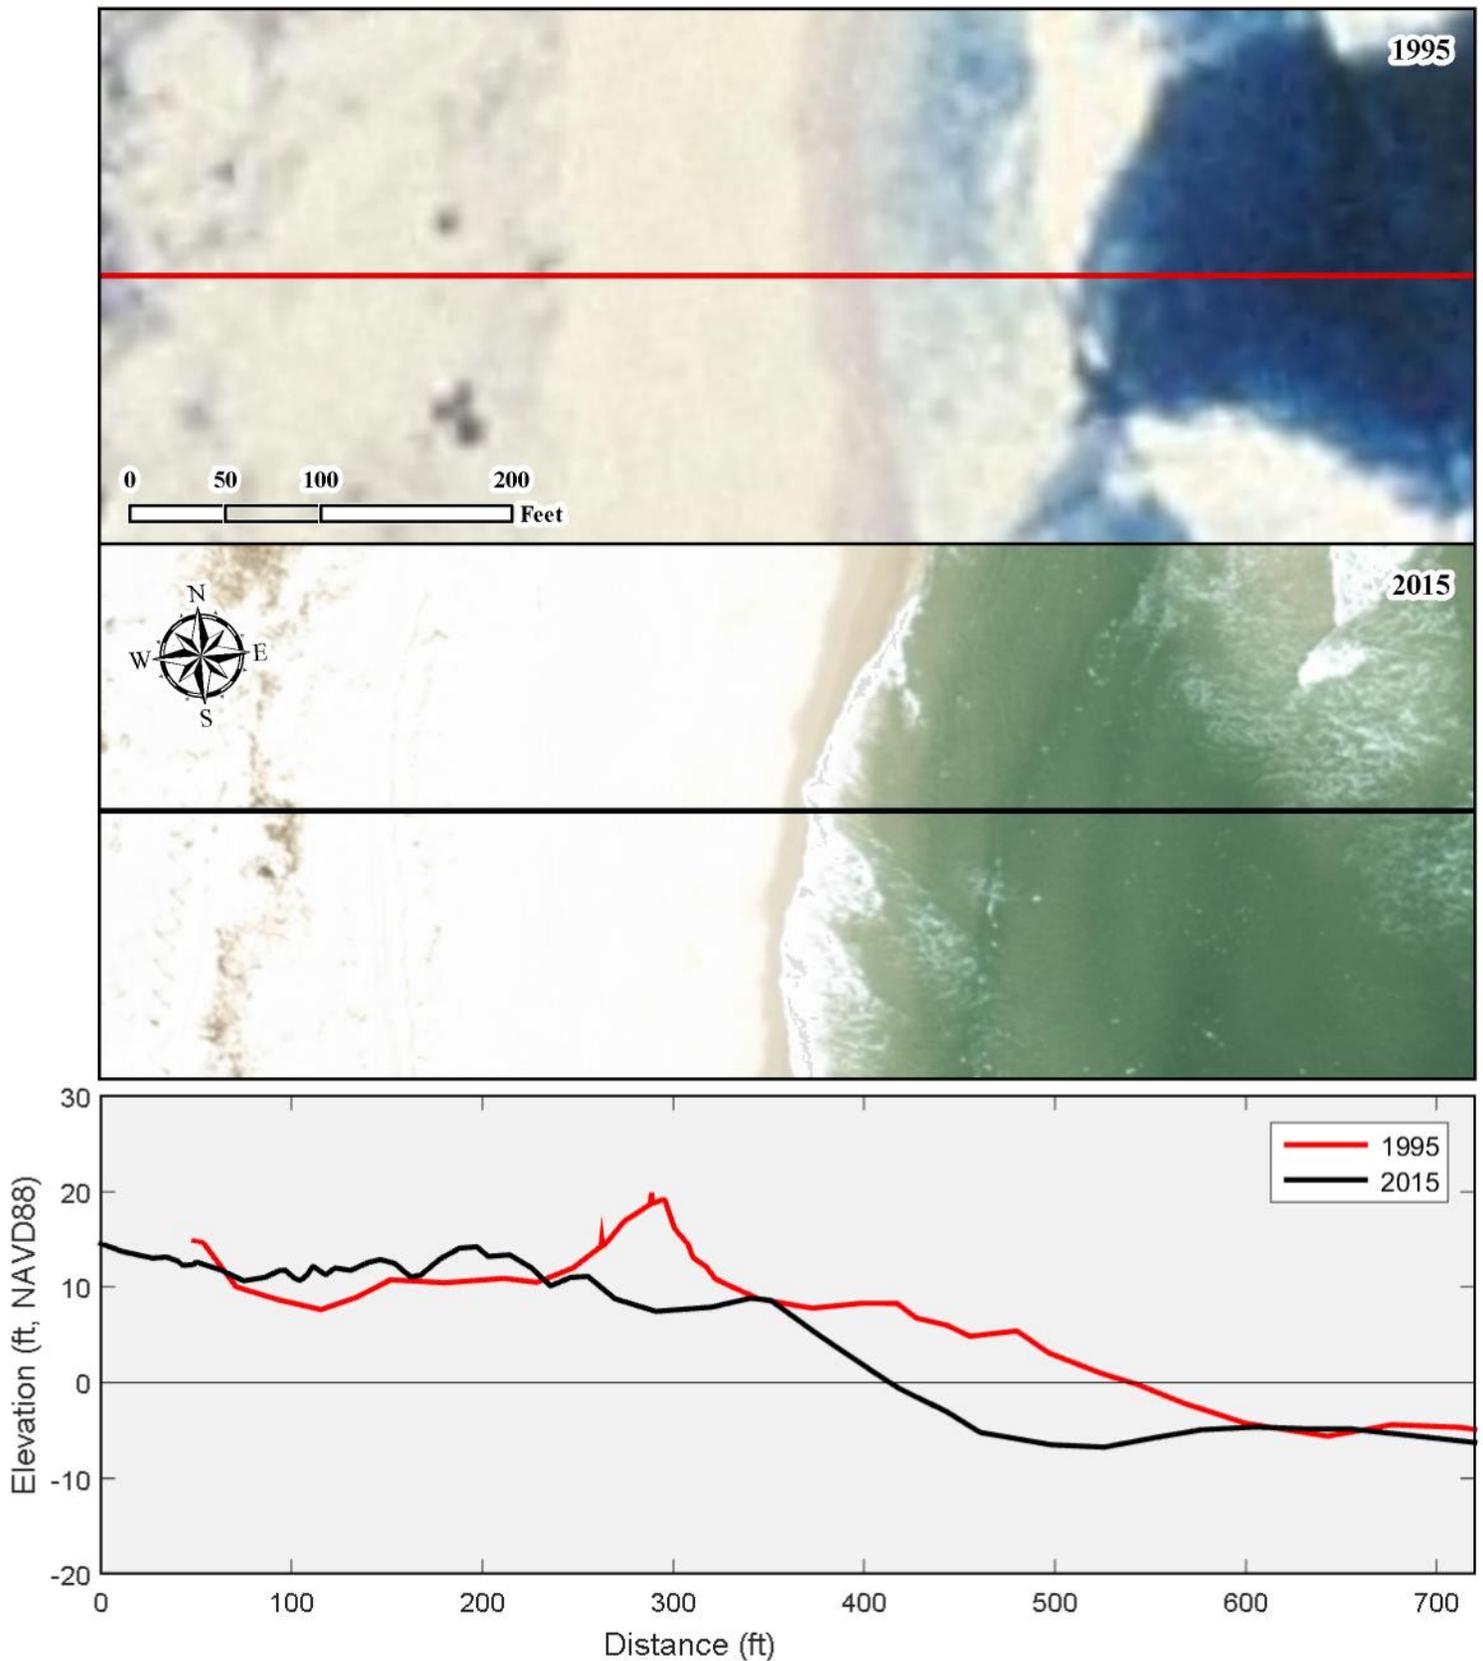
Figure 297. The comparison between 1995 and 2015 shows a significant change between dune elevation and position, due in part to northeast storms (2009, 2015, 2016), Hurricanes Irene and Sandy, and the profile's position near a "blow out" in the dune. The shoreline moved landward by almost 130 ft over this time period.
