## An Analysis of Thirty Years' Study of Sand Redistribution and Shoreline Changes in New Jersey's Four Coastal Counties Raritan Bay, the Atlantic Ocean Coast, and Delaware Bay Fall 1986 Through Fall 2016

### ***VOLUME 2 of 4 OCEAN COUNTY***

Prepared for:  
New Jersey Department of Environmental Protection  
Division of Coastal Engineering  
1510 Hooper Avenue, Toms River, New Jersey 08753

Prepared by:  
Stockton University Coastal Research Center  
30 Wilson Avenue, Port Republic, NJ 08241

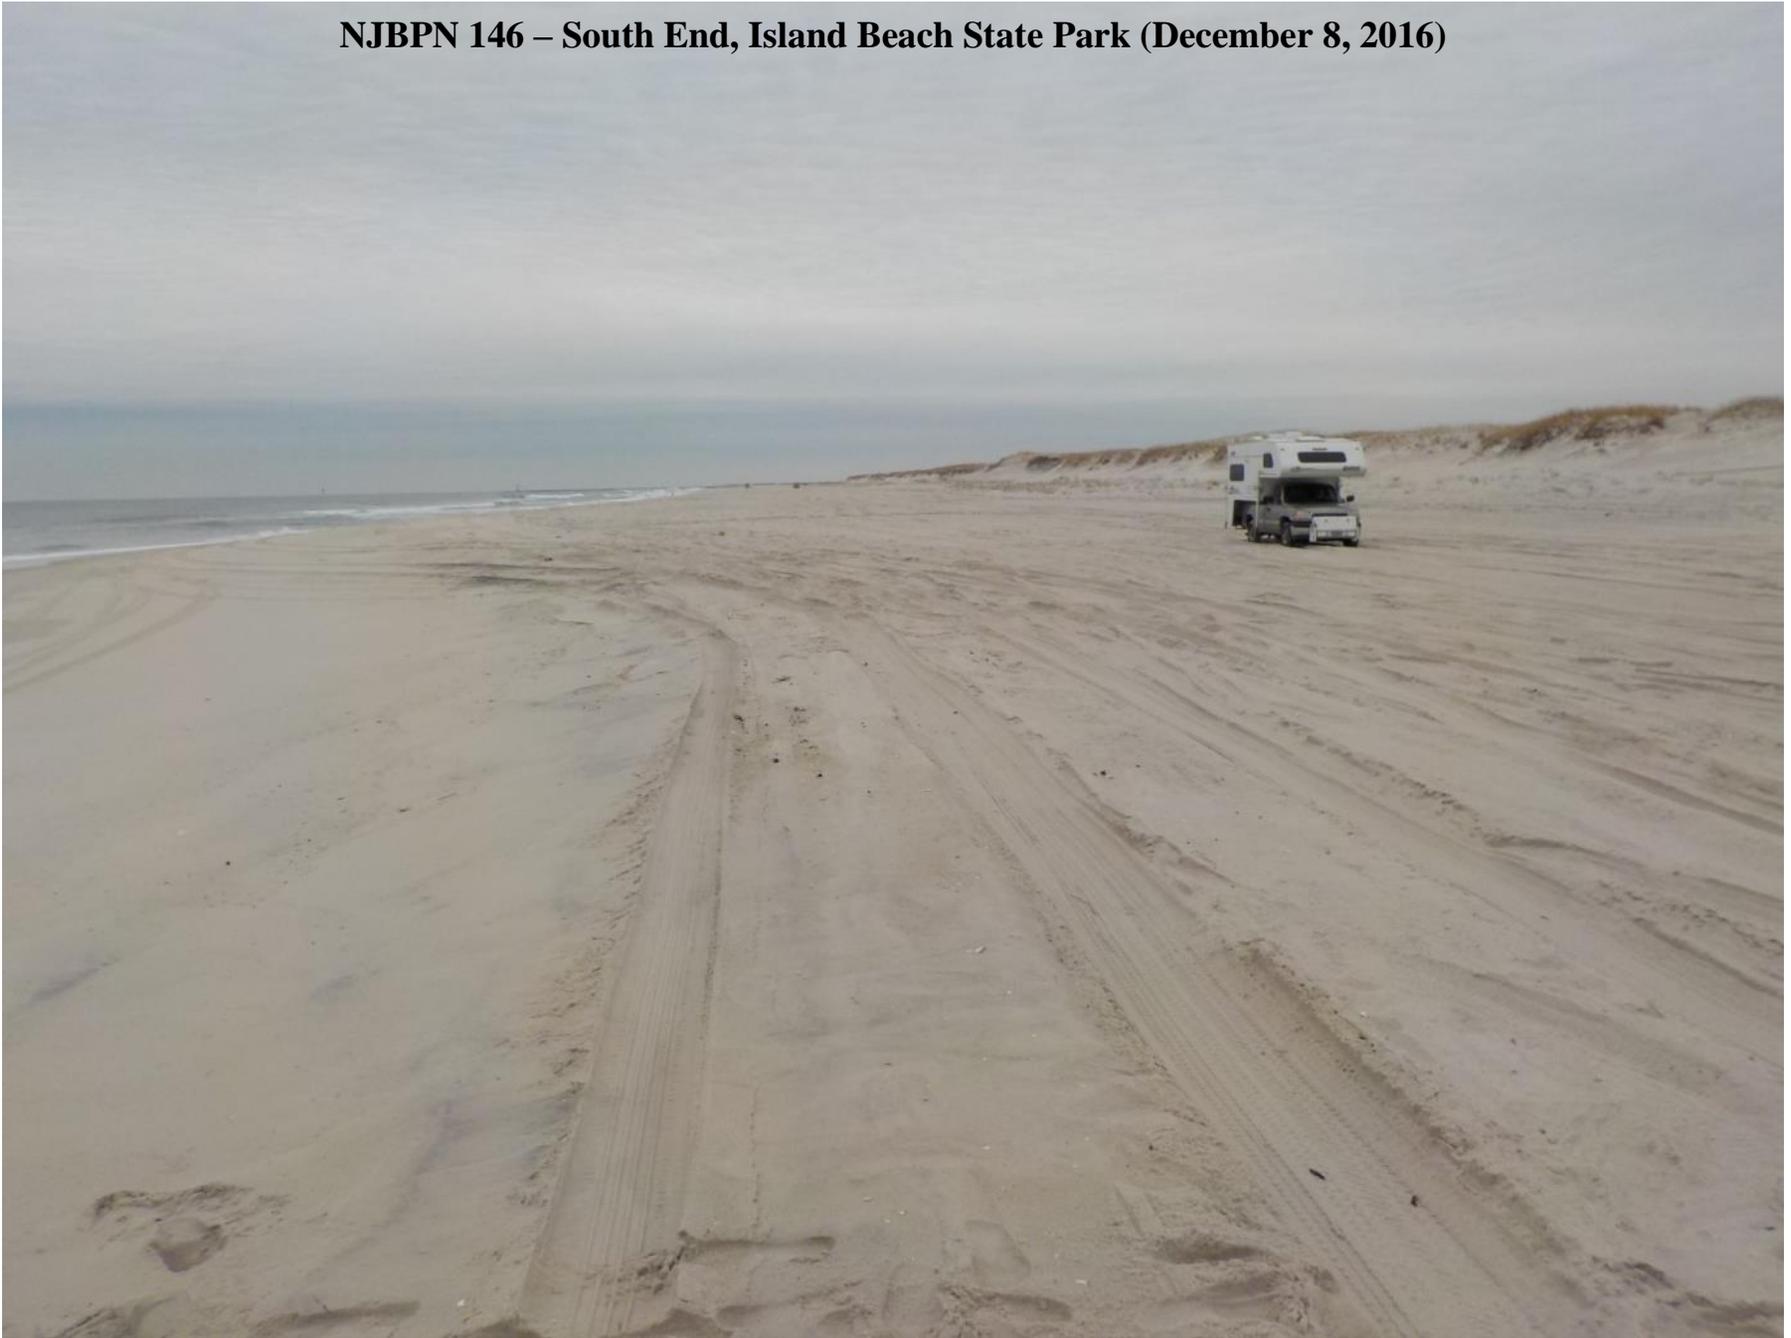
**NJBPN 146 – South End, Island Beach State Park (December 8, 2016)**

**Figure 298. View to the south from the berm at the South End location in Island Beach State Park. This profile location is located about 6,500 ft north of the Barnegat Inlet north jetty.**

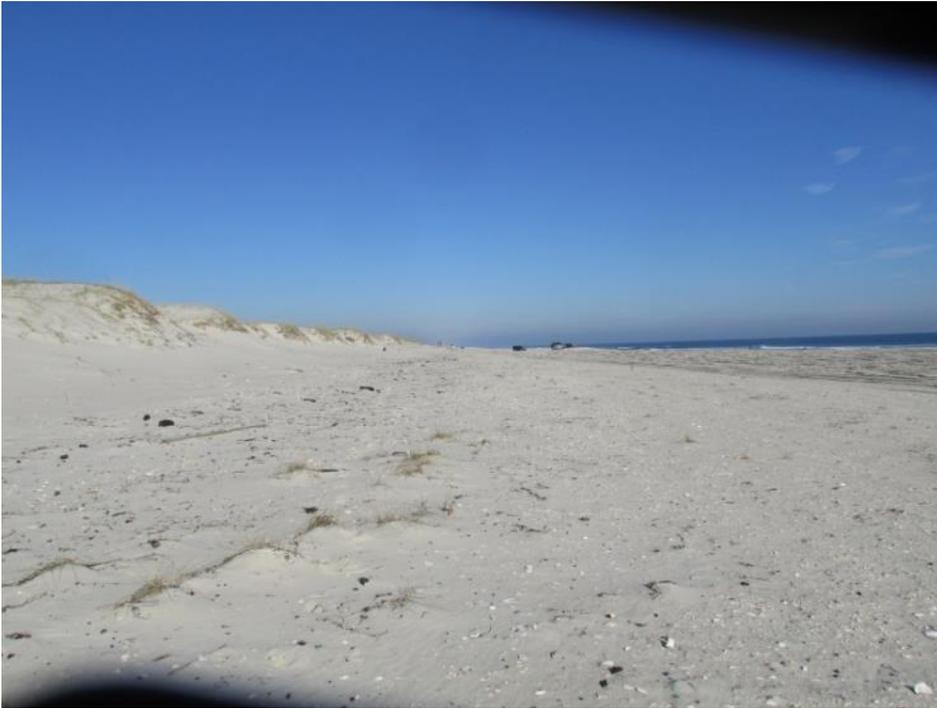
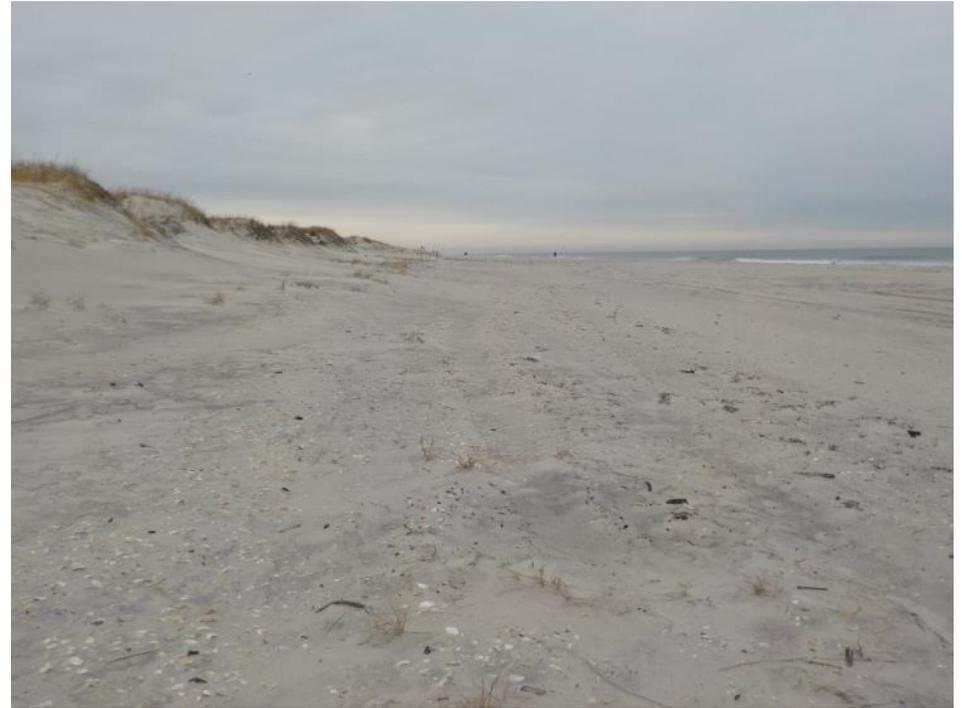
**NJBPN 146 – South End, Island Beach State Park**

**Figure 299a & 299b. The views of the seaward dune slope and backshore at the South End Island Beach State Park site shows little change in vegetation cover or sand accumulation (left photo taken December 7, 2015 and right photo taken December 8, 2016). The dunes here were scarped during Hurricane Sandy but less affected than the dune areas at the other two park locations.**

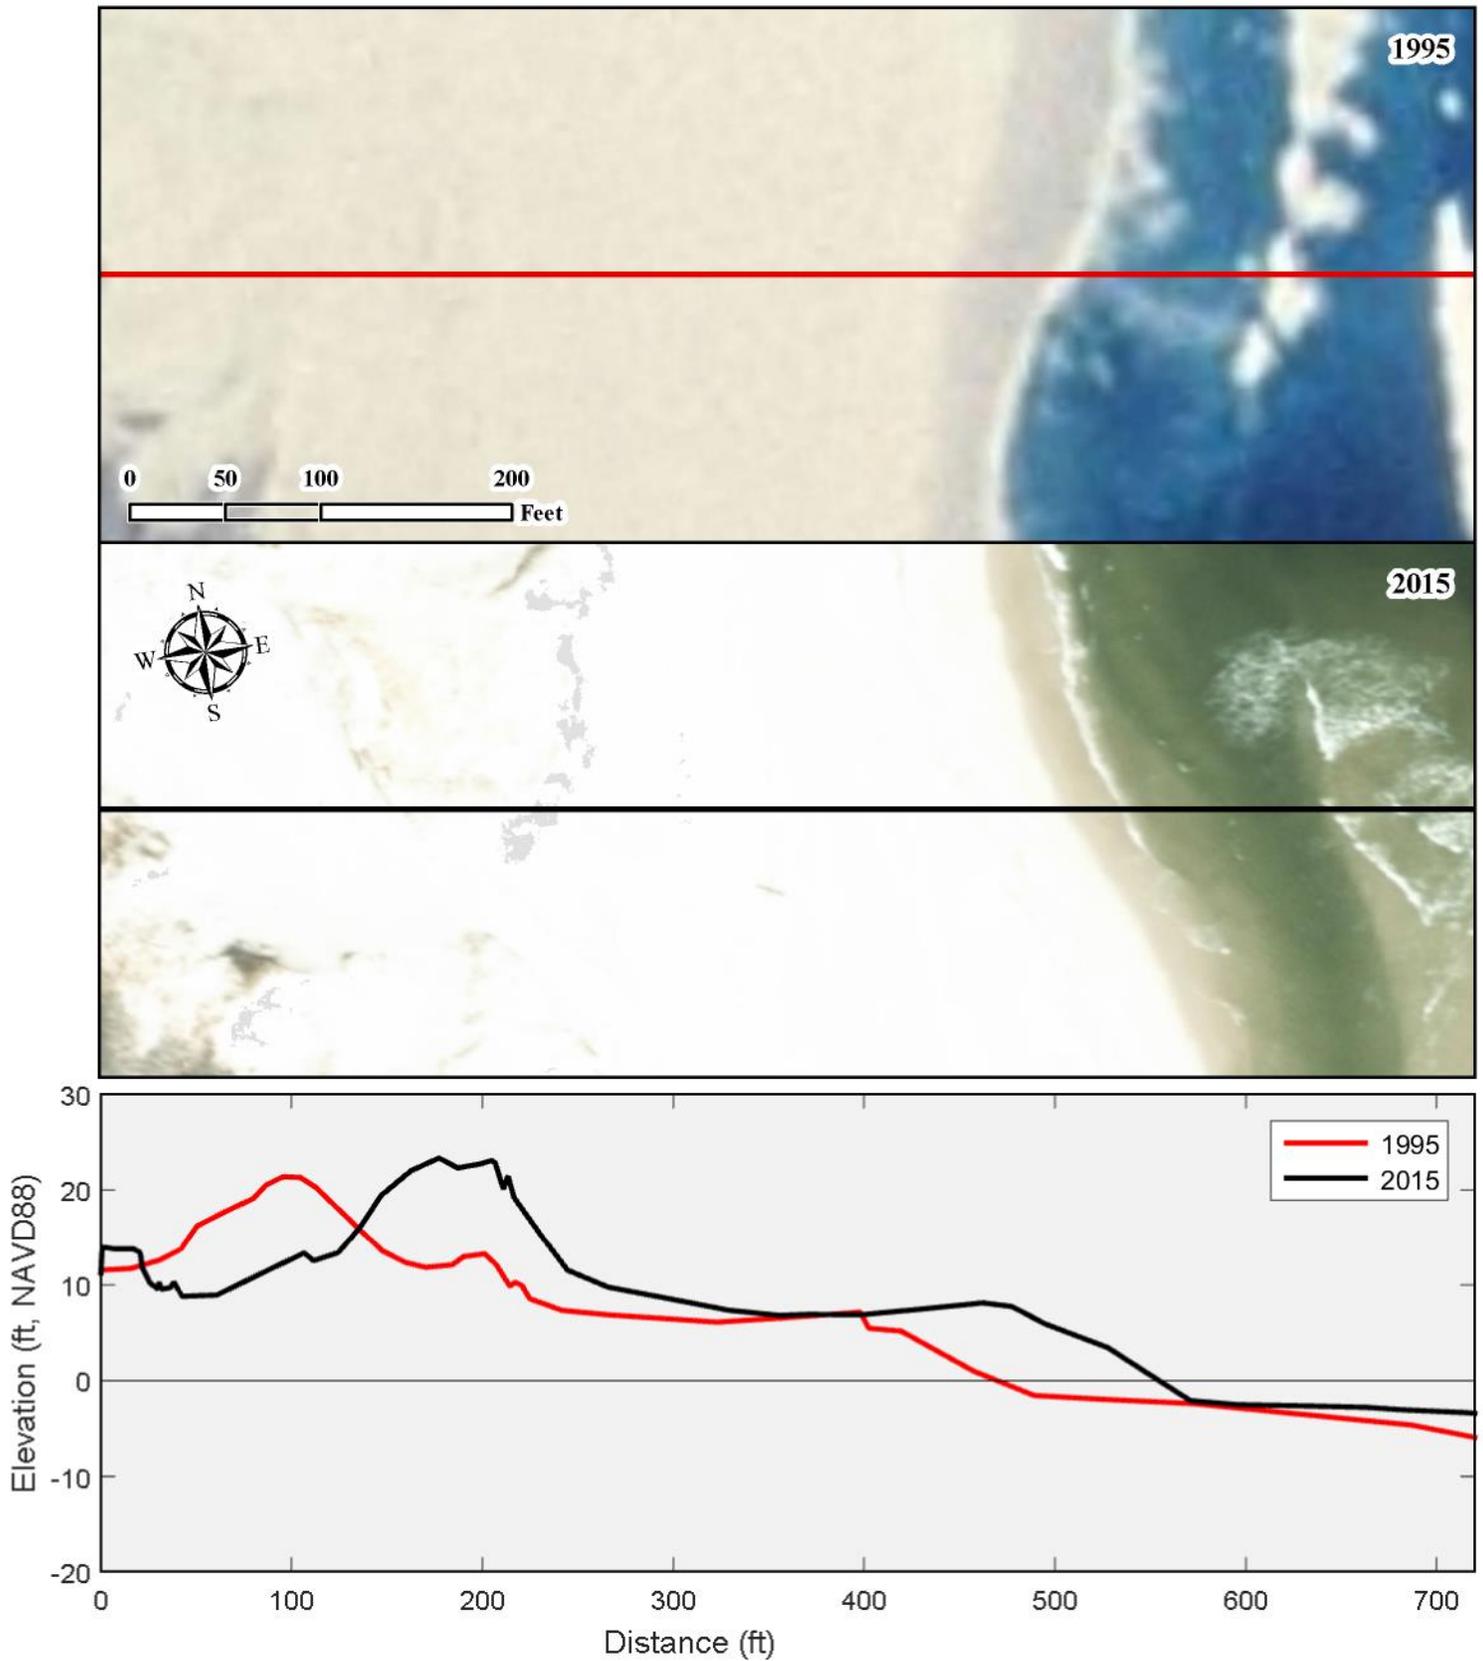
Figure 303. The 1995 and 2015 cross sections show the seaward movement of the dune and berm. The shoreline moved 85 ft seaward during the period from 1995 to 2015.

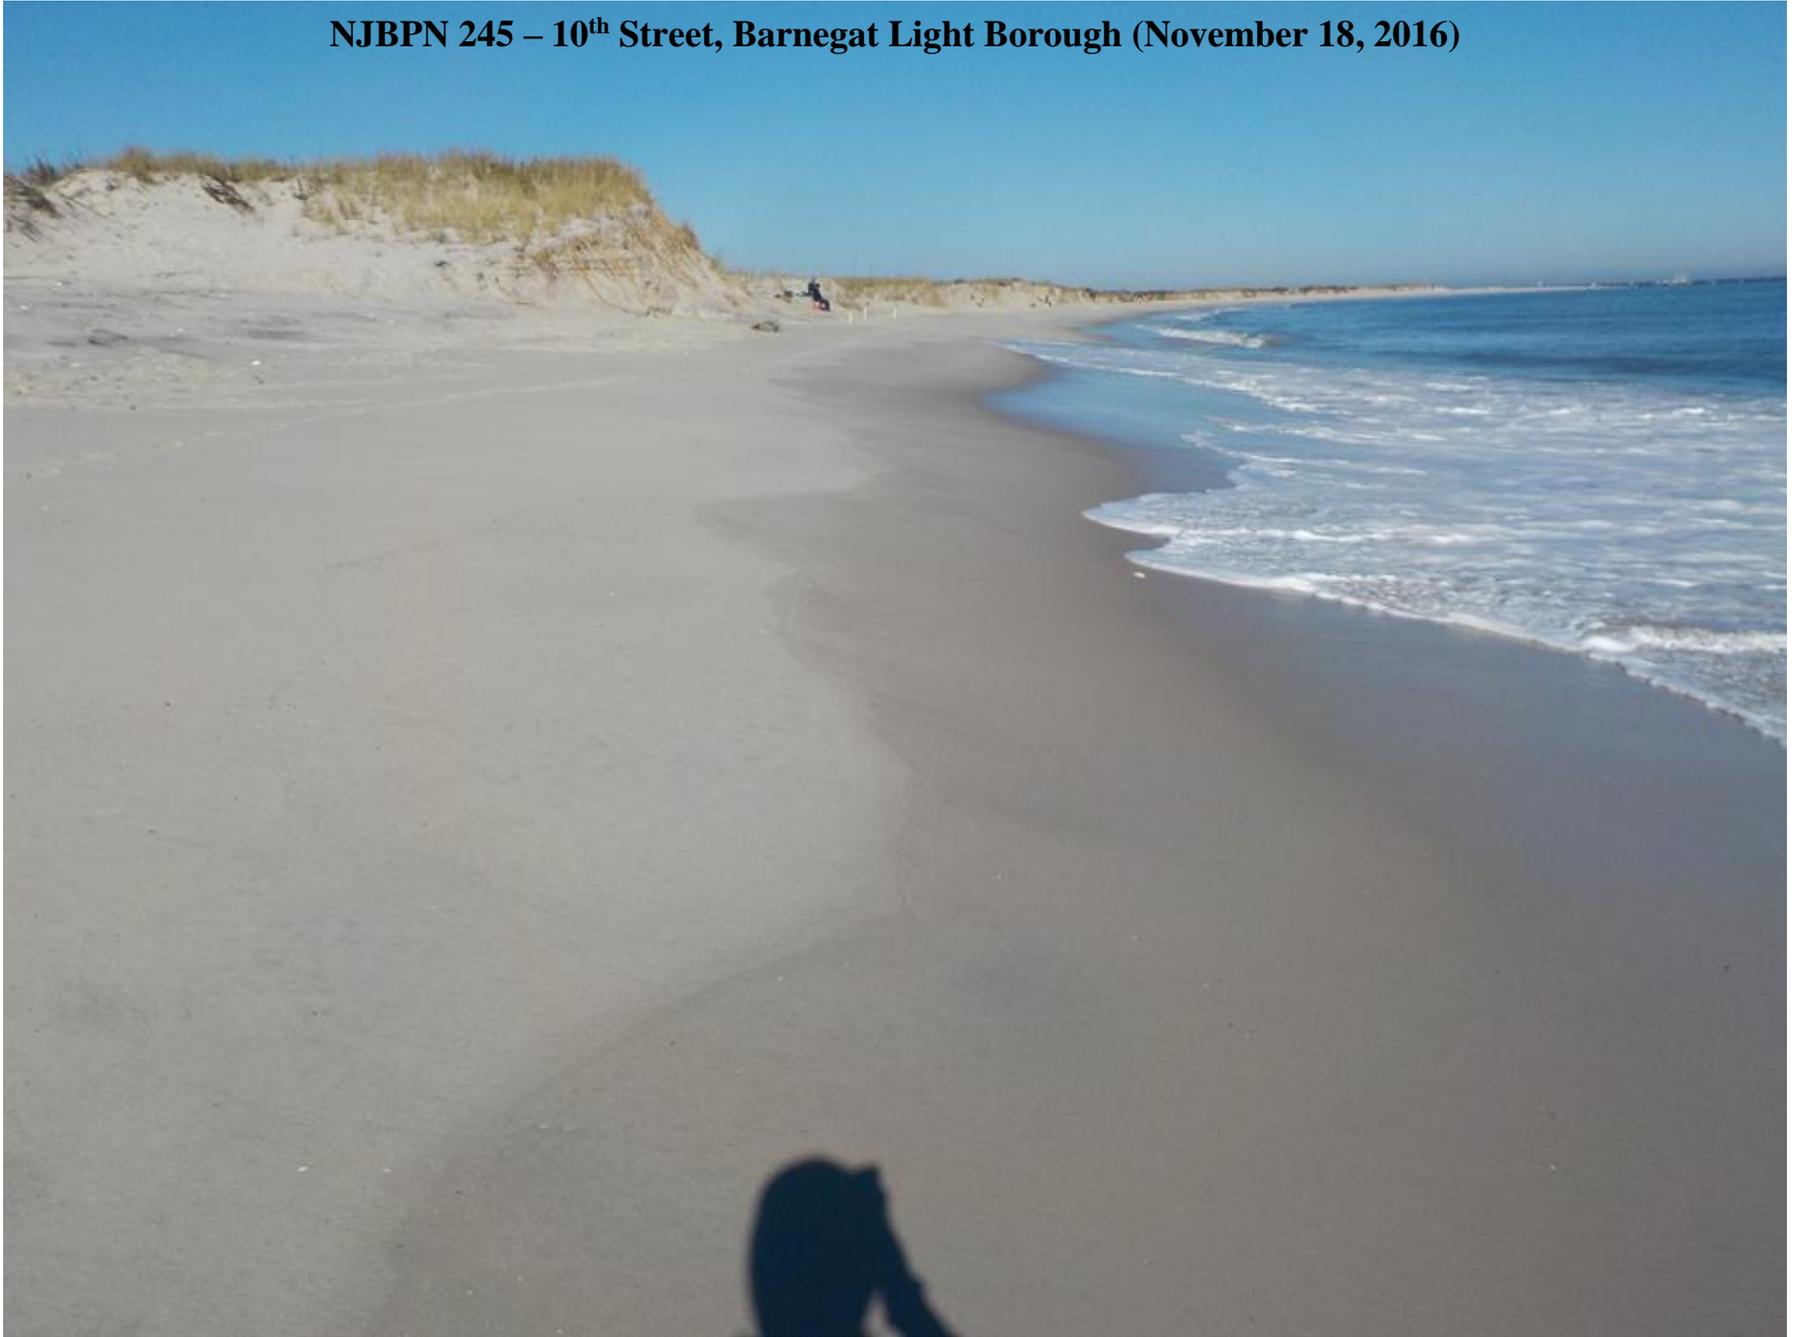
**Figure 304. View to the north of the scarped foredune from the swash at 10<sup>th</sup> Street in Barnegat Light Borough. The dune field at this site is nearly 1000 ft wide and developed naturally through windblown processes. All thanks to the trapping of sand by the new Barnegat Inlet south jetty that was reconfigured in 1991.**

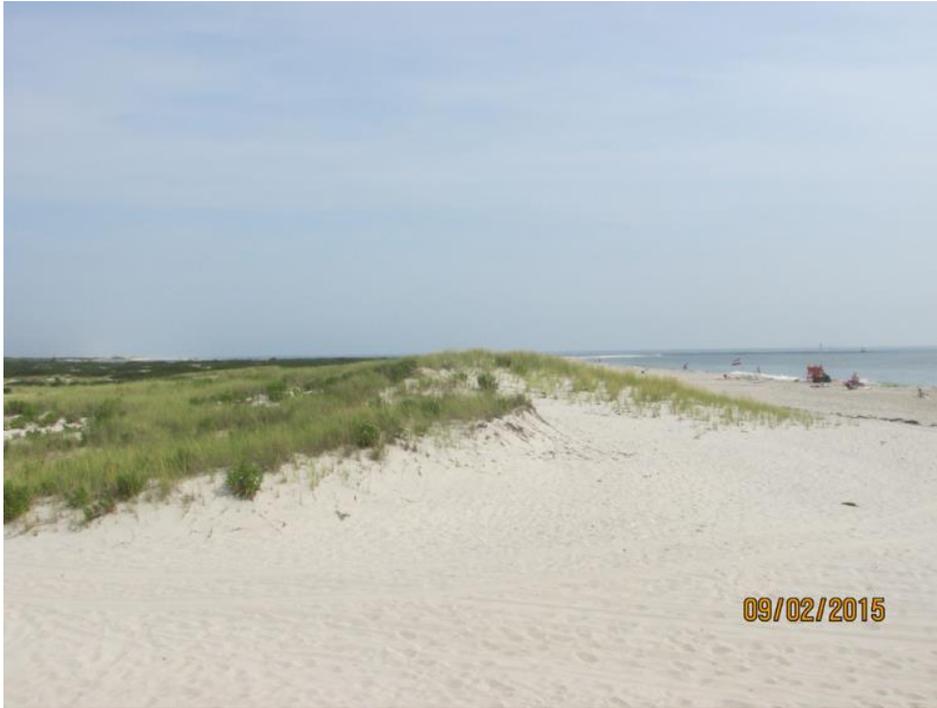
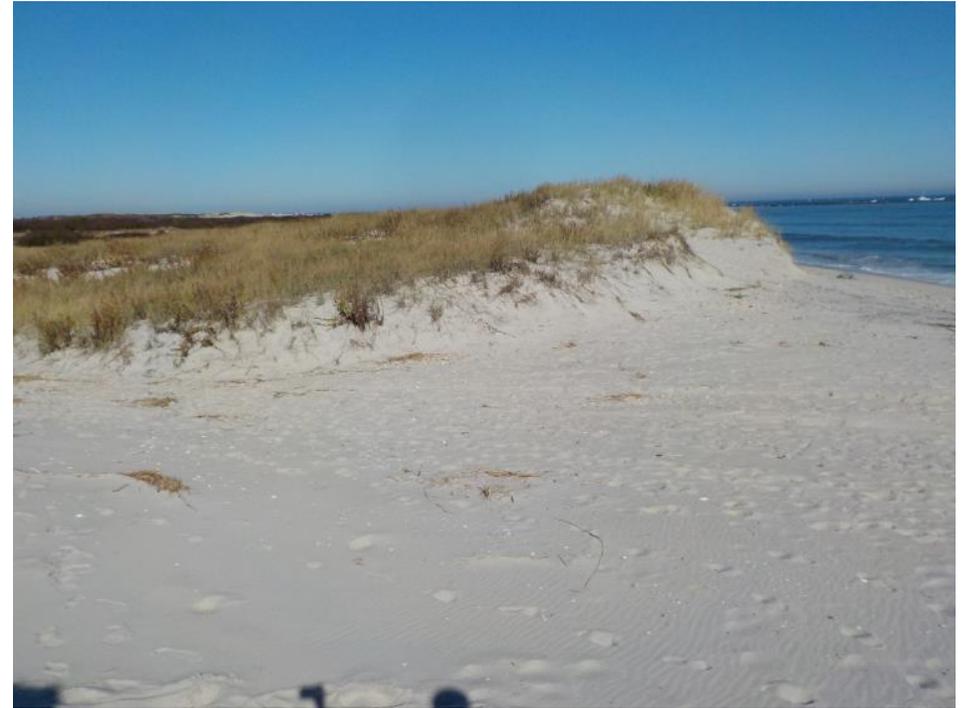
**NJBPN 245 – 10<sup>th</sup> Street, Barnegat Light**

**Figure 305a & 305b.** This site is located approximately 1500 ft south of the Barnegat Inlet south jetty and was established to monitor the changes at the inlet. The foredune shown in both photos (left taken September 2, 2015 and right November 18, 2016) shows evidence of recent scarping, but has little effect on the stability of the entire dune field at this location.

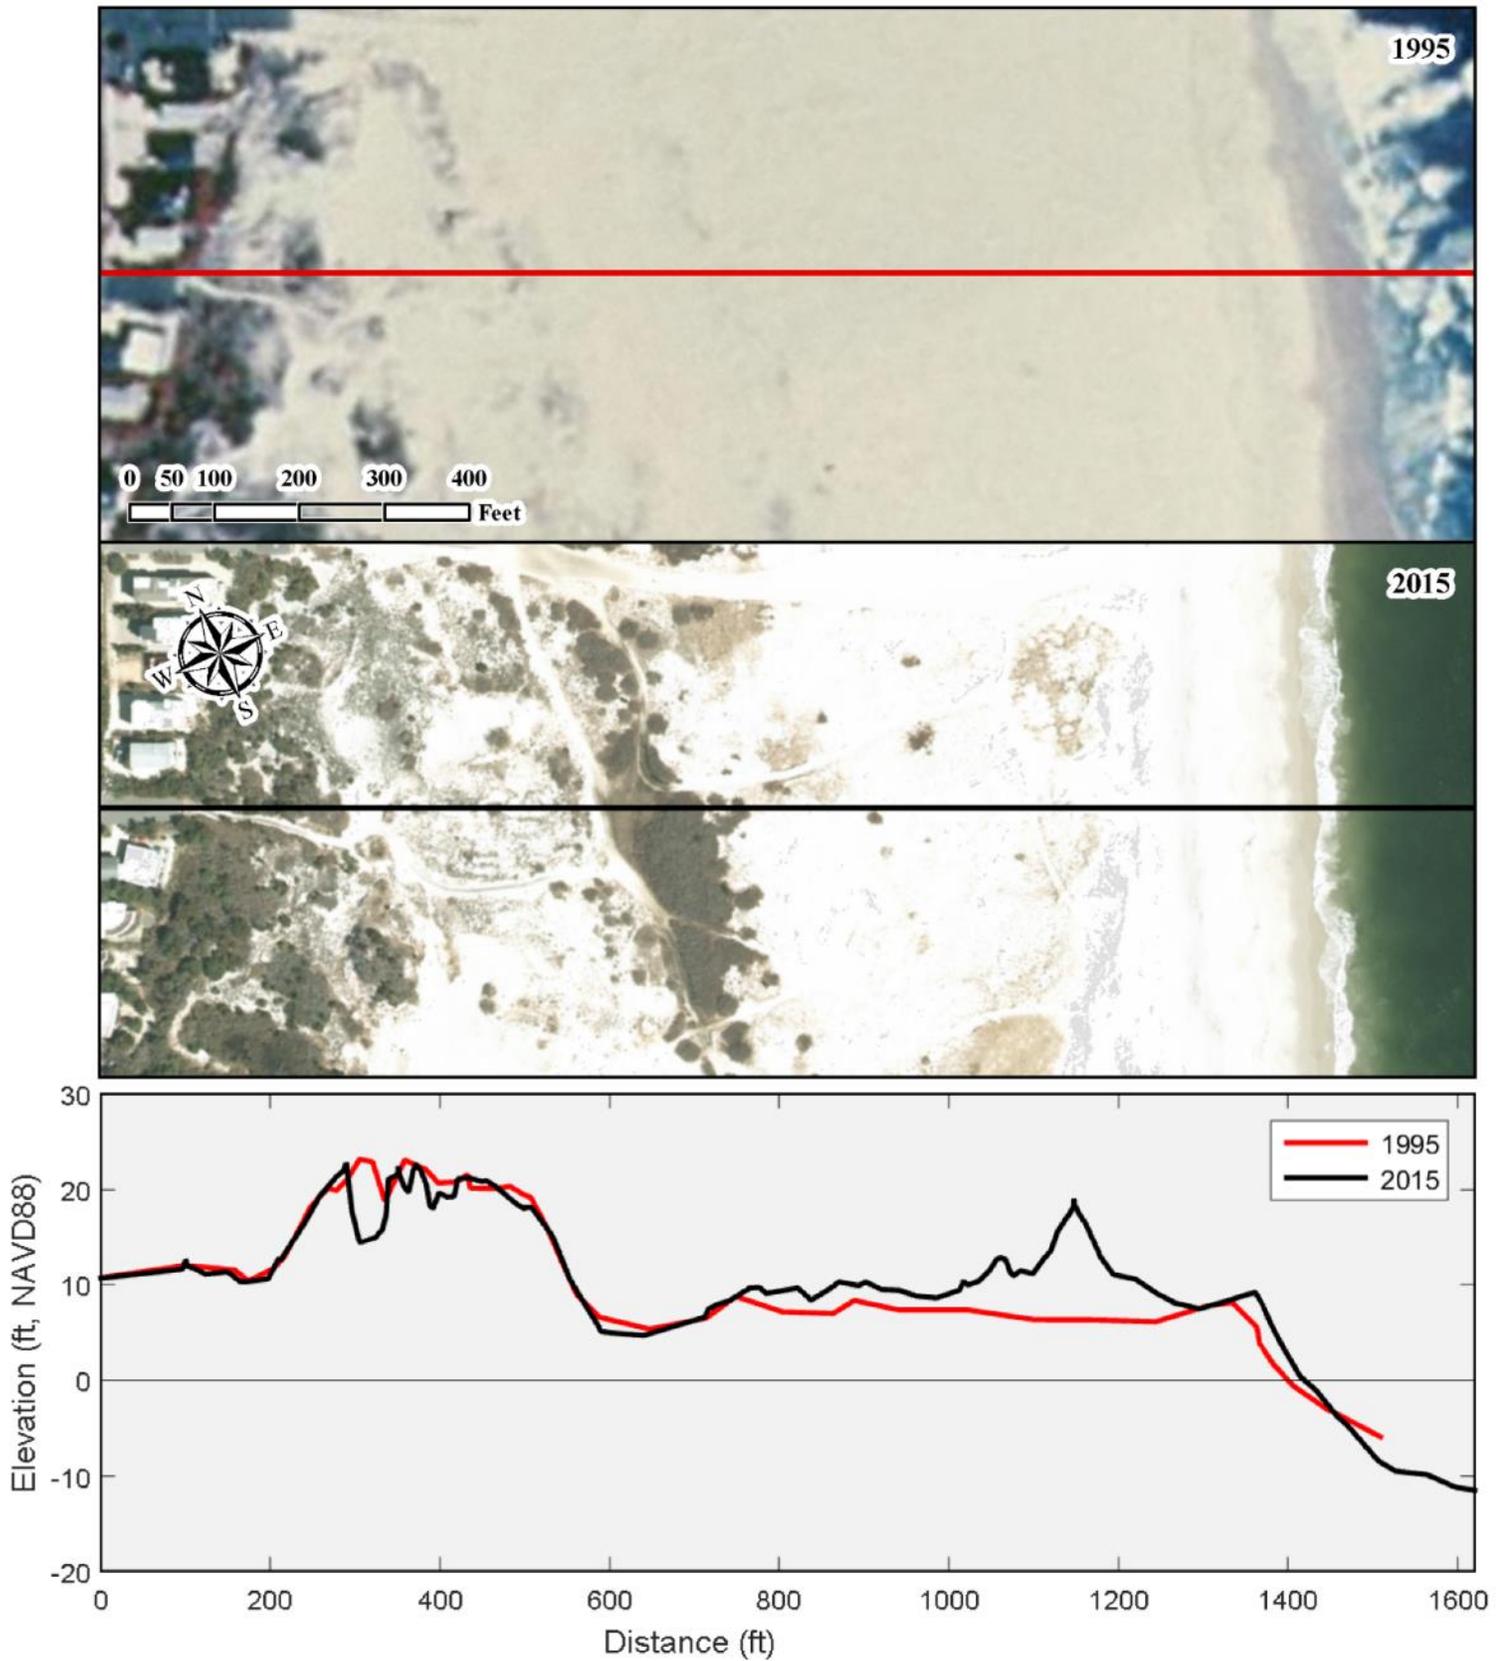
Figure 309. The 1995 and 2015 cross section comparison shows the growth of the foredune following the reconfiguration of the Barnegat Inlet jetties. The shoreline moved 19 ft seaward during this time and dune growth at the seaward margin was substantial.

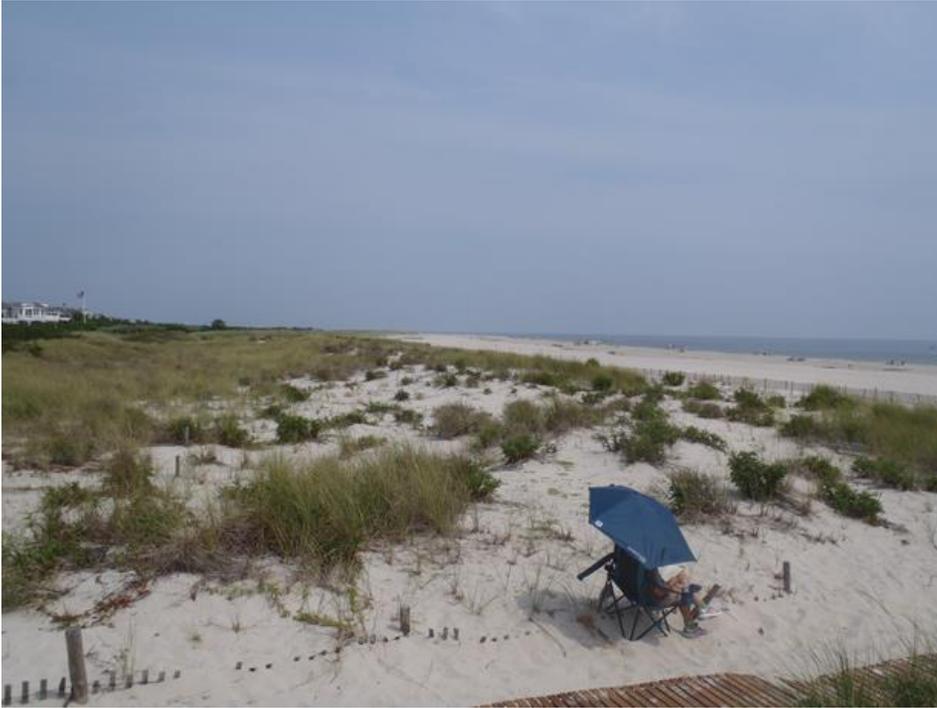
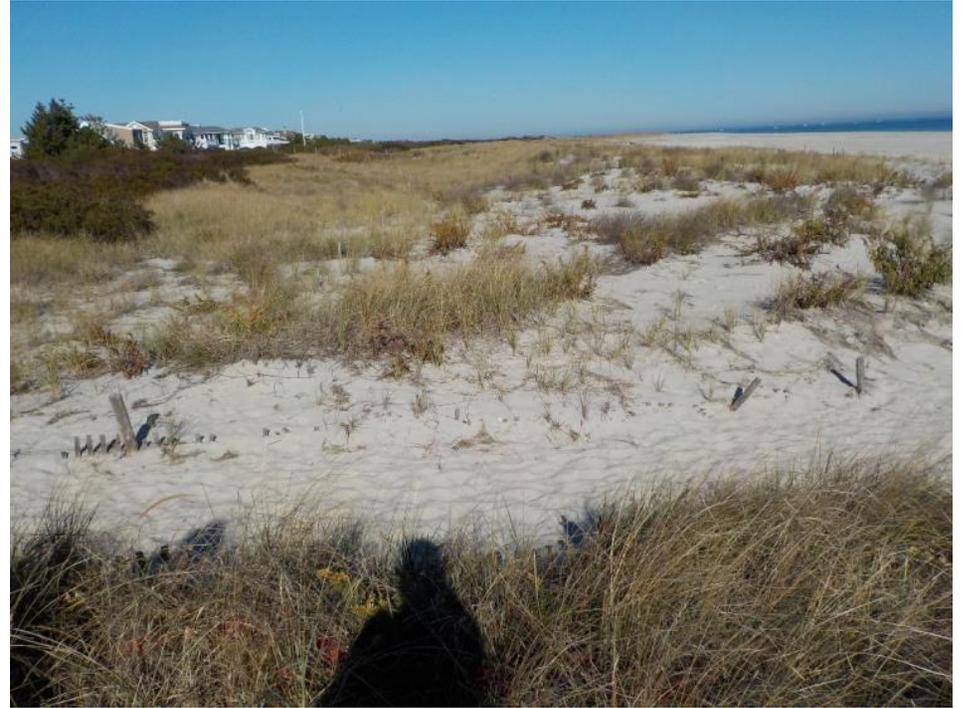
**NJBPN 145 – 26<sup>th</sup> Street, Barnegat Light**

**Figure 311a & 311b. Though never included in the federal shore protection project boundaries, the dune field at the 26<sup>th</sup> Street location is nearly 200 feet wide, sparsely vegetated and stable (left photo taken September 2, 2015 and right photo taken November 18, 2016). The growth is related to the new Barnegat Inlet south jetty's sand capture capacity**

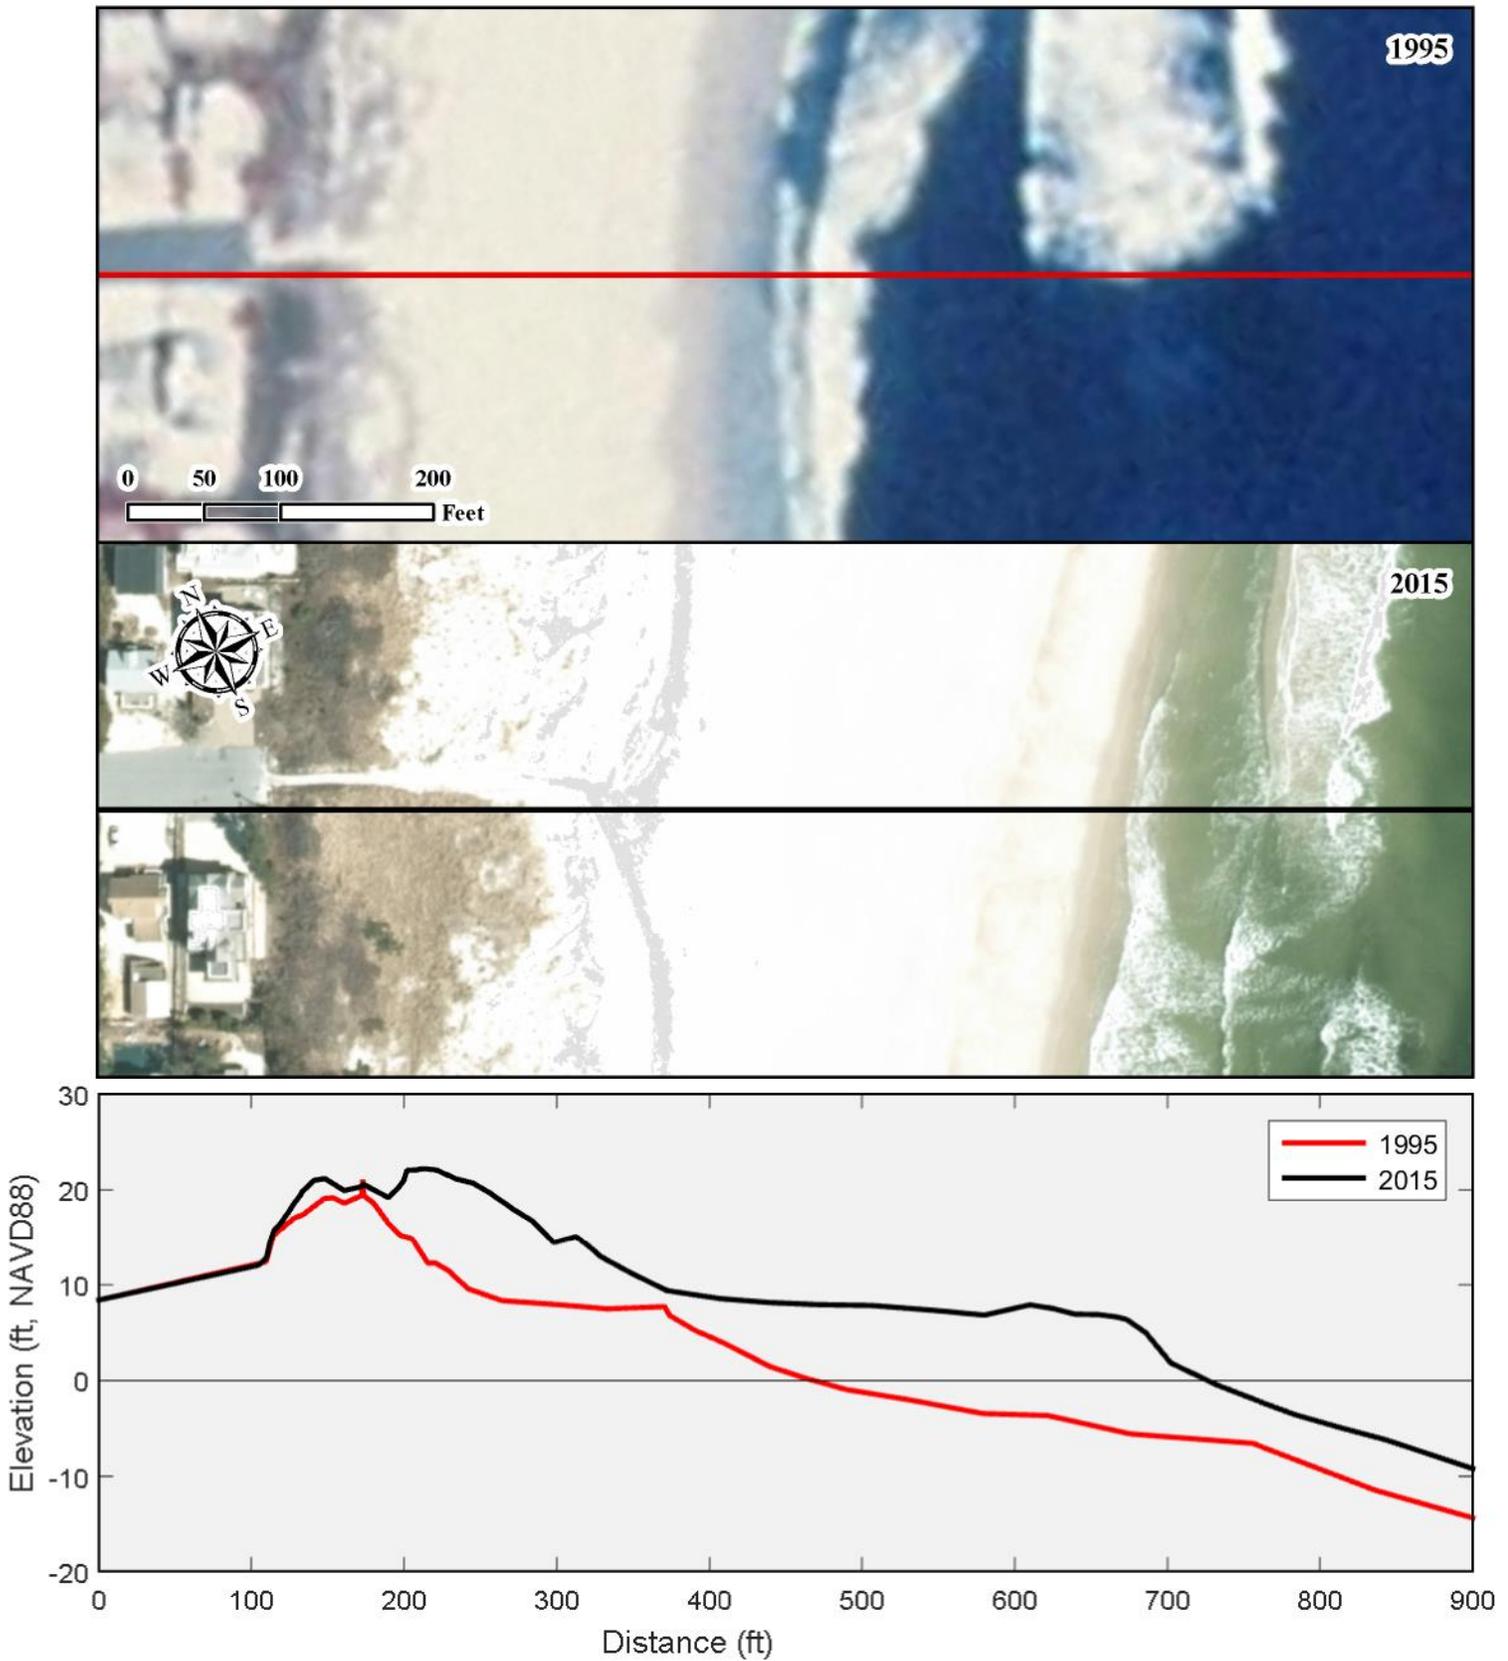
Figure 315. Though this site is not included in the federal shore protection project, it has shown long-term growth of the dune and berm throughout time. Between 1995 and 2015, the shoreline advanced seaward by 258 ft, which is a greater amount than USACE project beaches to the south.

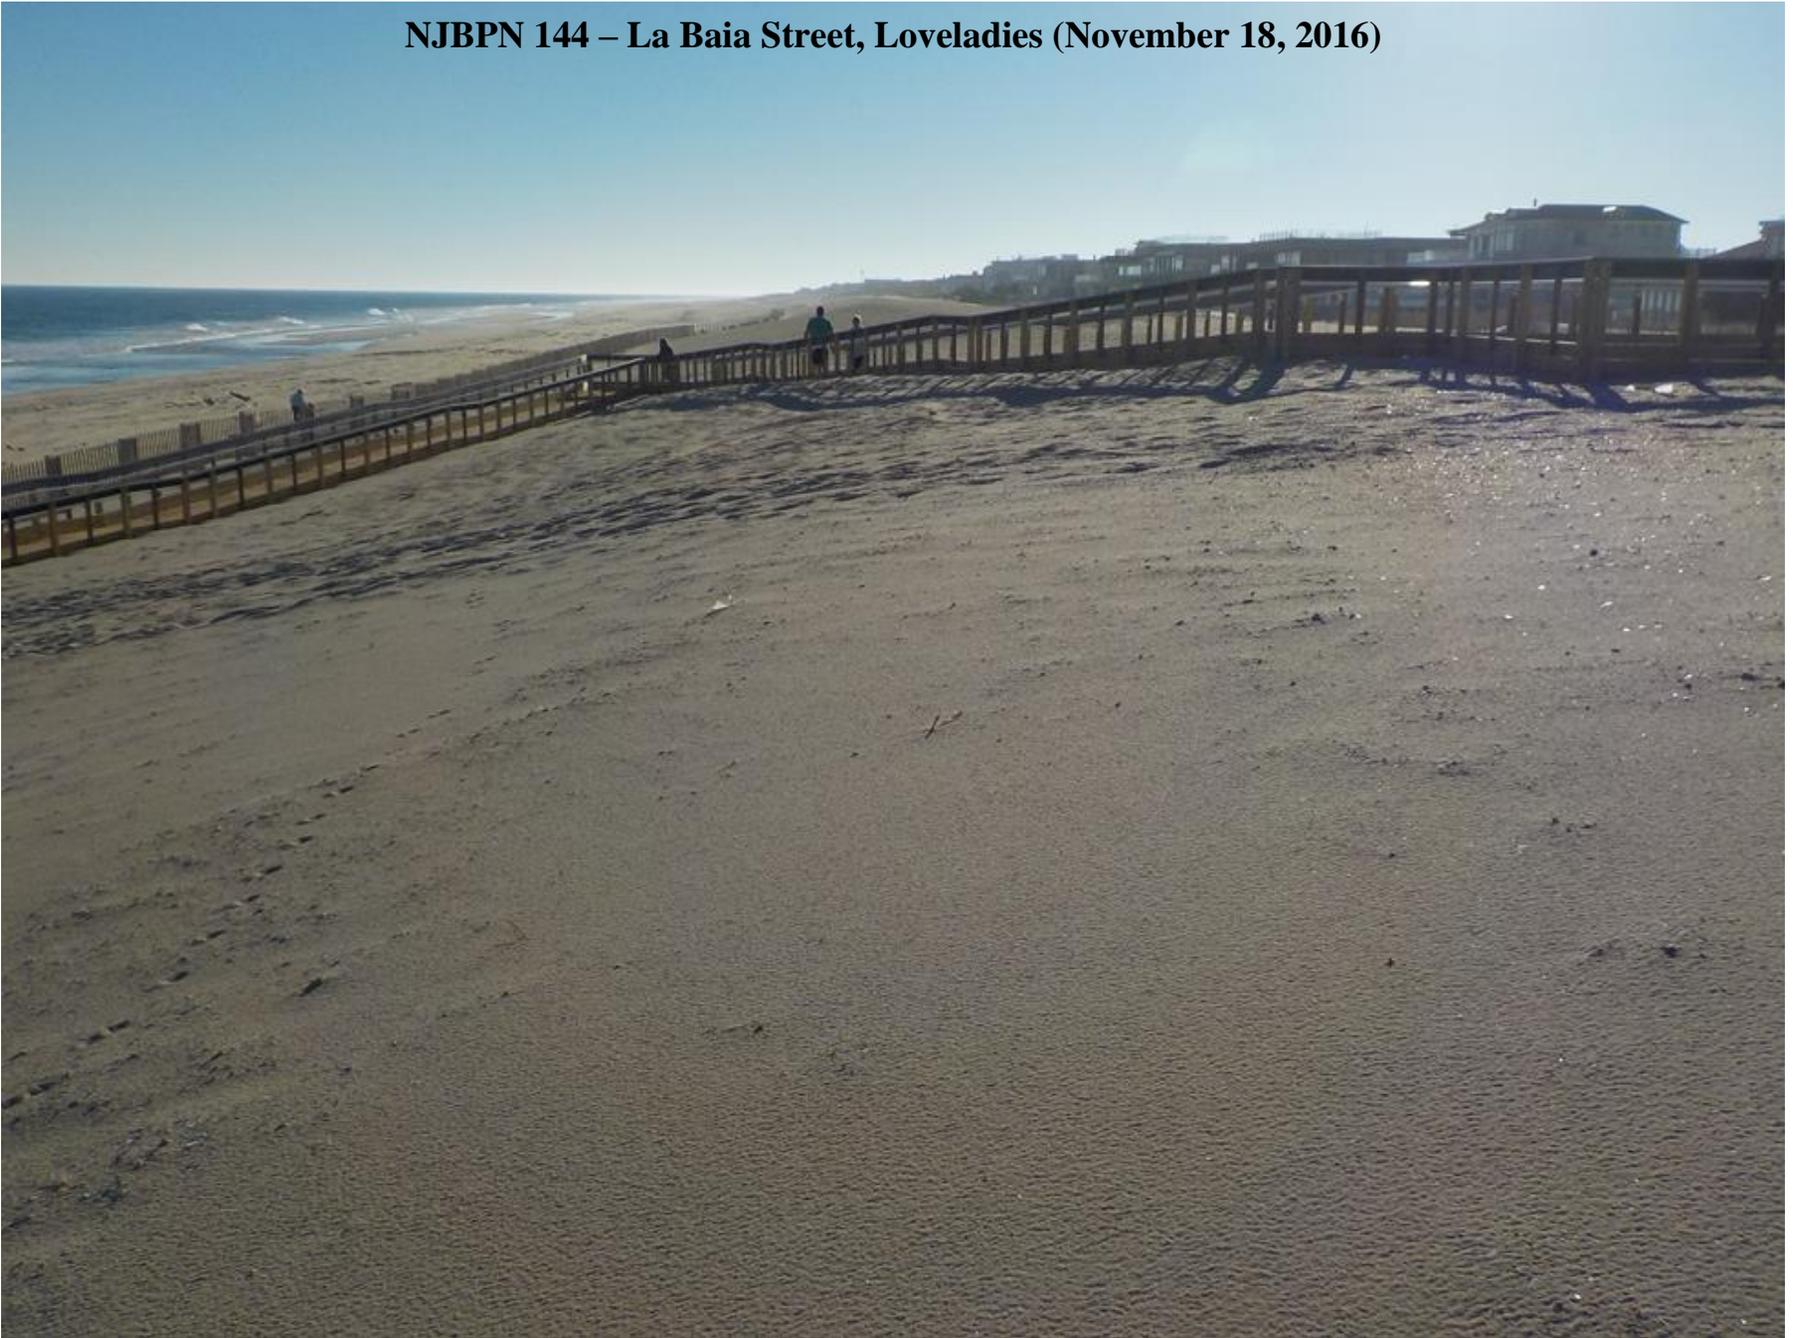
**NJBPN 144 – La Baia Street, Loveladies (November 18, 2016)**

**Figure 316. View to the south from the recently completed engineered dune at La Baia Street in Loveladies.**

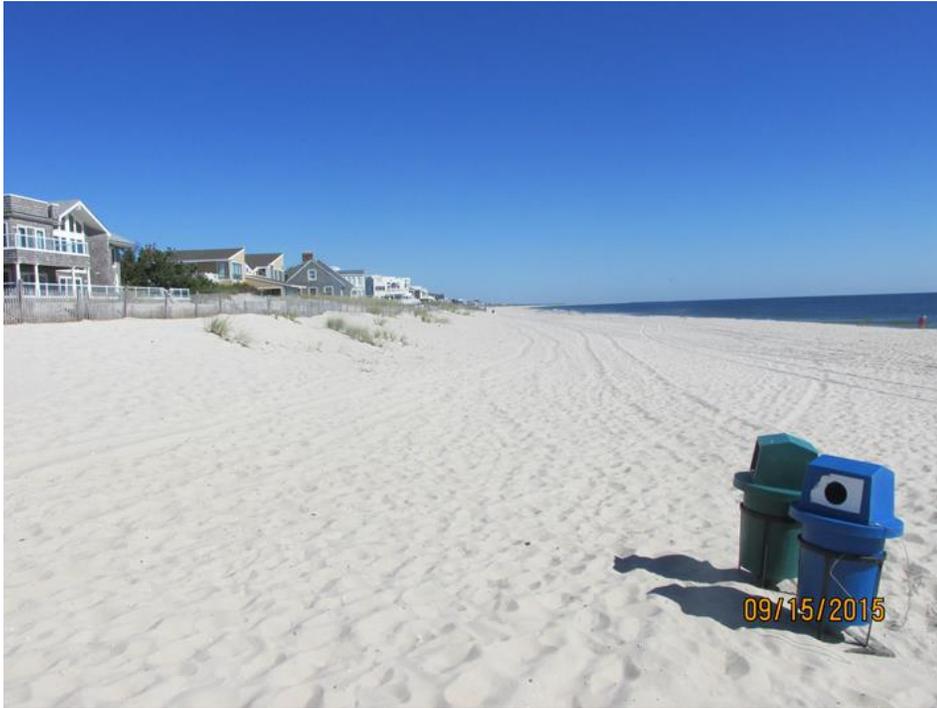
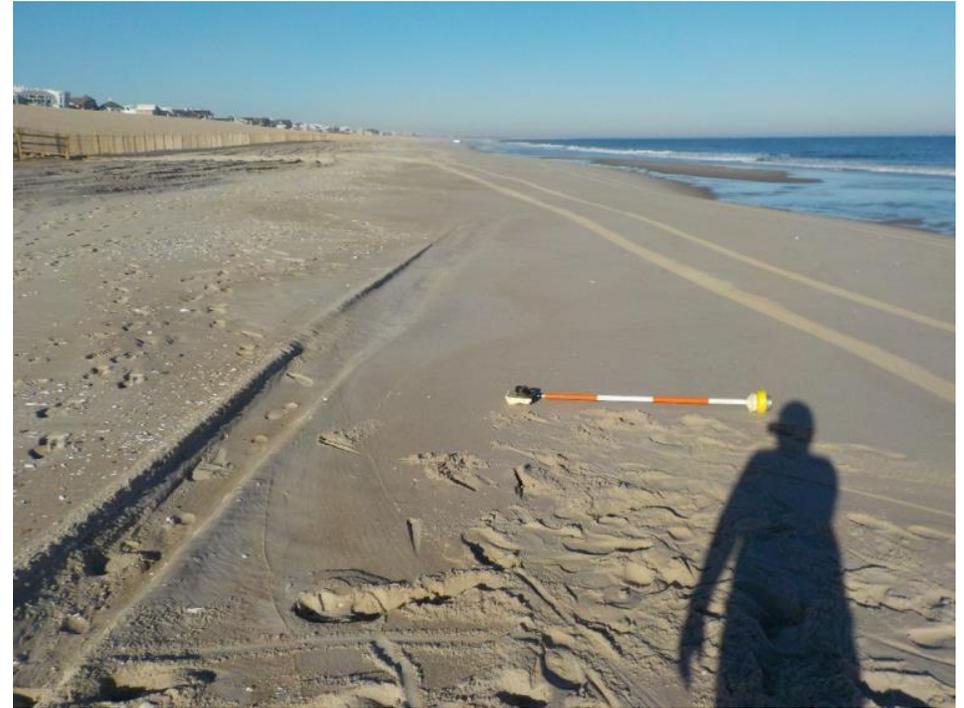
**NJBPN 144 – La Baia Street, Loveladies**

**Figure 317a & 317b. The La Baia Street site is located in Loveladies, an unincorporated community in the Township of Long Beach. This site was included in the federal shore protection project in 2016, which constructed an engineered dune that added significant elevation to the pre-project dune (left taken right taken September 15, 2015 versus the view to the right taken November 18, 2016).**

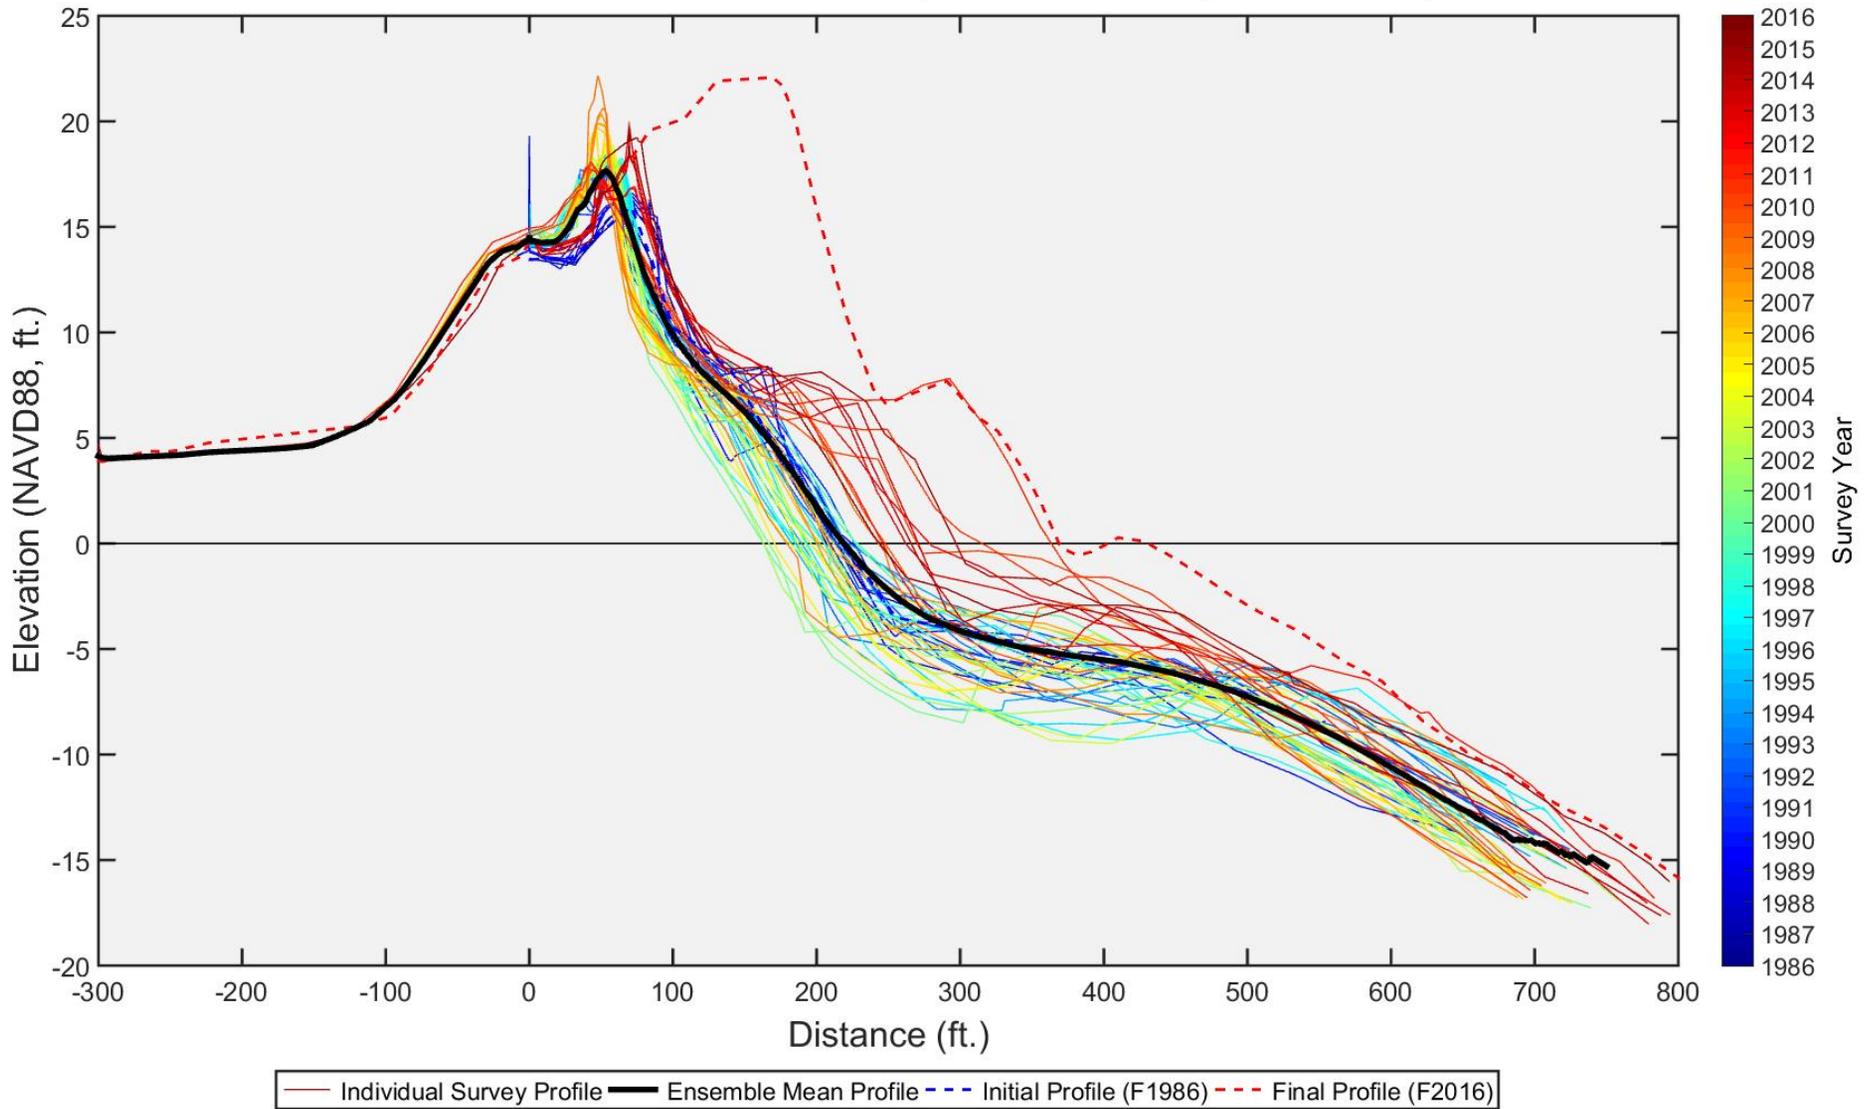
Figure 320. The plots of the individual profiles show near stable conditions from the 1980s to early 1990s and a generally erosional pattern up to about 2010. The fall 2016 profile (red dashed line) shows the significance of the size of the engineered dune that was constructed in the summer of 2016 when compared to the early profiles.
