## An Analysis of Thirty Years' Study of Sand Redistribution and Shoreline Changes in New Jersey's Four Coastal Counties Raritan Bay, the Atlantic Ocean Coast, and Delaware Bay Fall 1986 Through Fall 2016

### ***VOLUME 2 of 4 OCEAN COUNTY***

Prepared for:  
New Jersey Department of Environmental Protection  
Division of Coastal Engineering  
1510 Hooper Avenue, Toms River, New Jersey 08753

Prepared by:  
Stockton University Coastal Research Center  
30 Wilson Avenue, Port Republic, NJ 08241

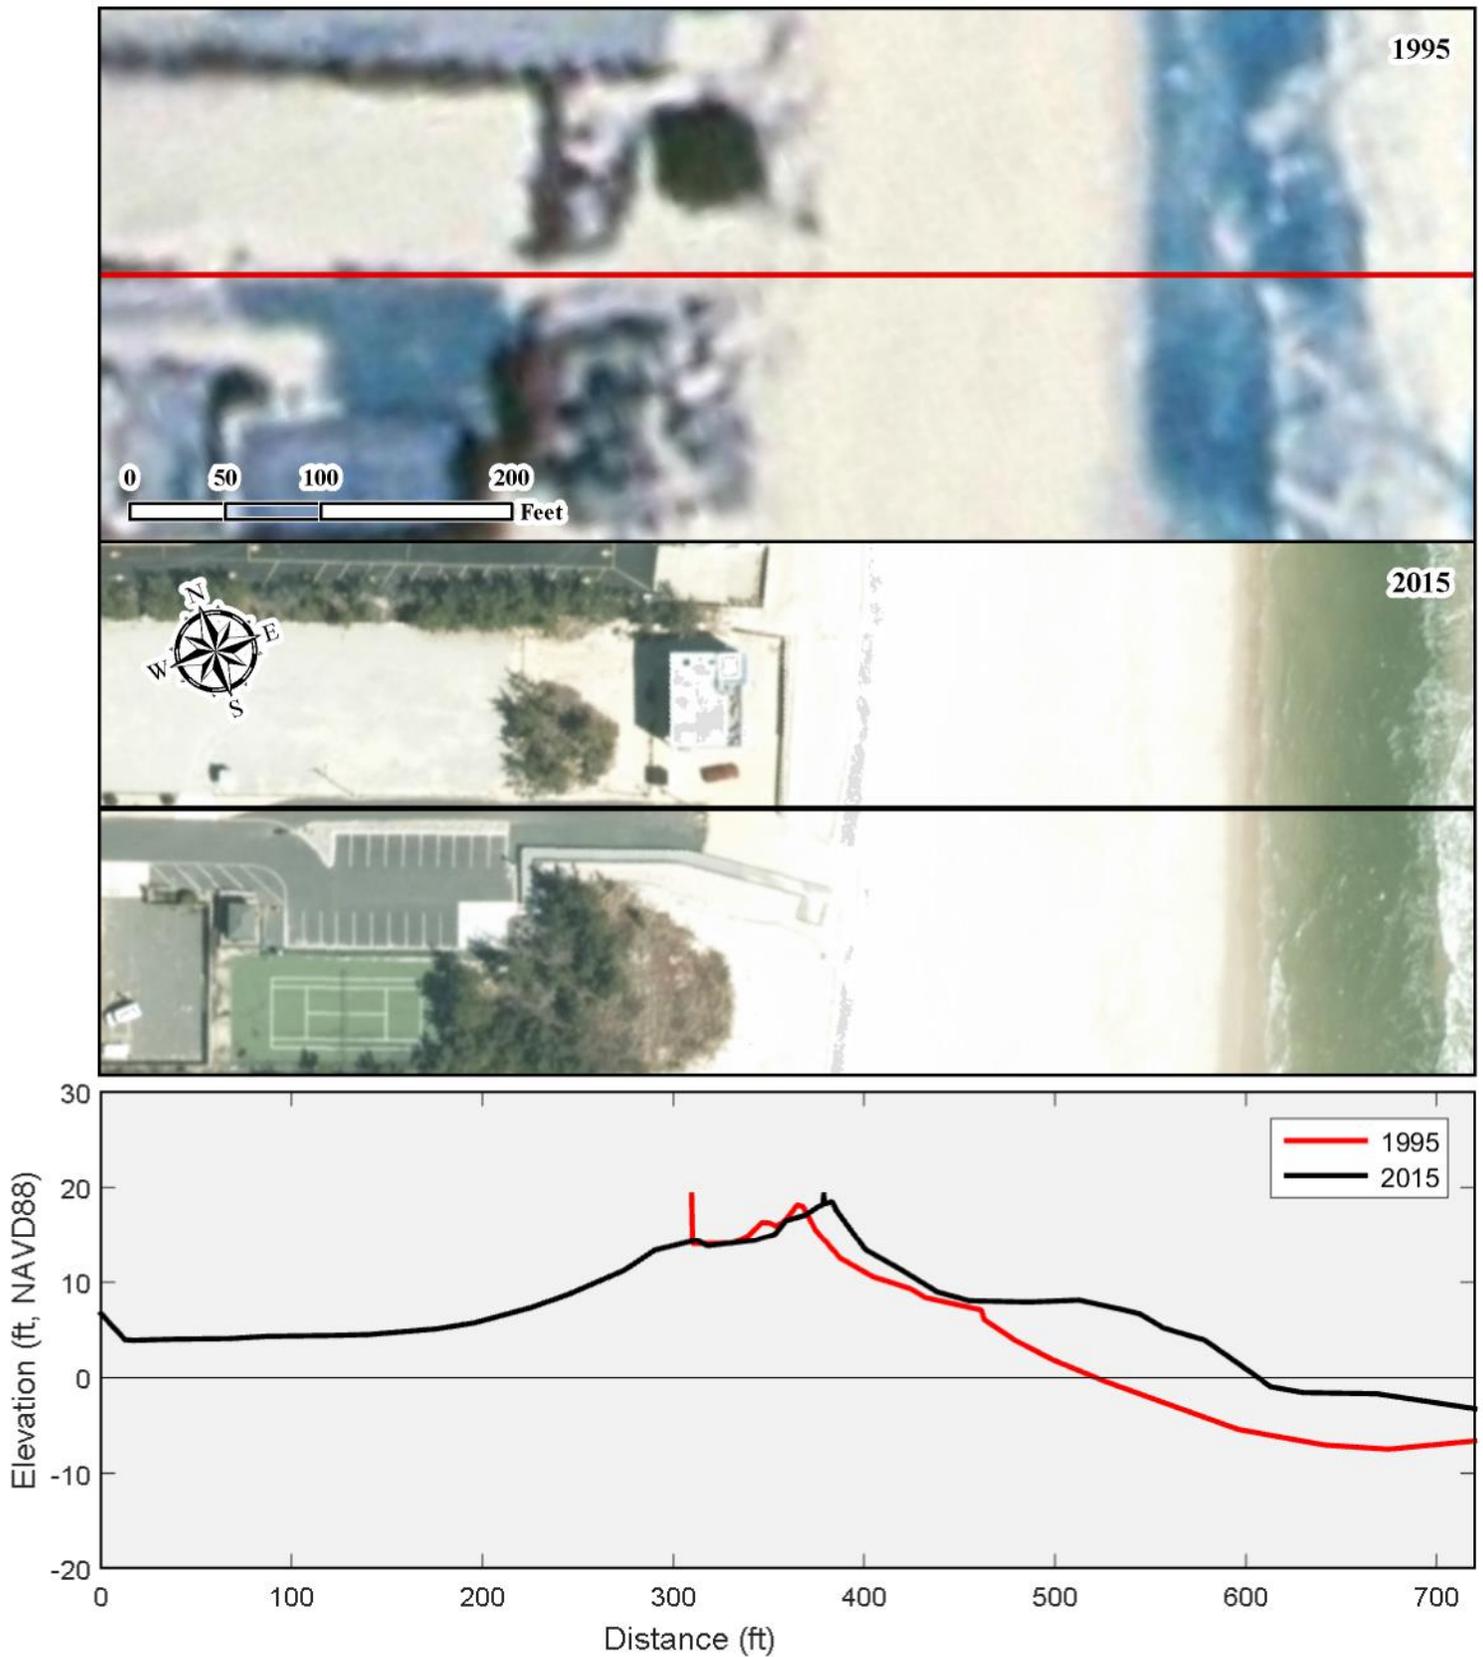
Figure 321. The 1995 and 2015 comparison shows the conditions before the federal beach fill was completed. The shoreline advanced seaward by 85 ft during this period without benefit of direct sand fill placement until 2016.

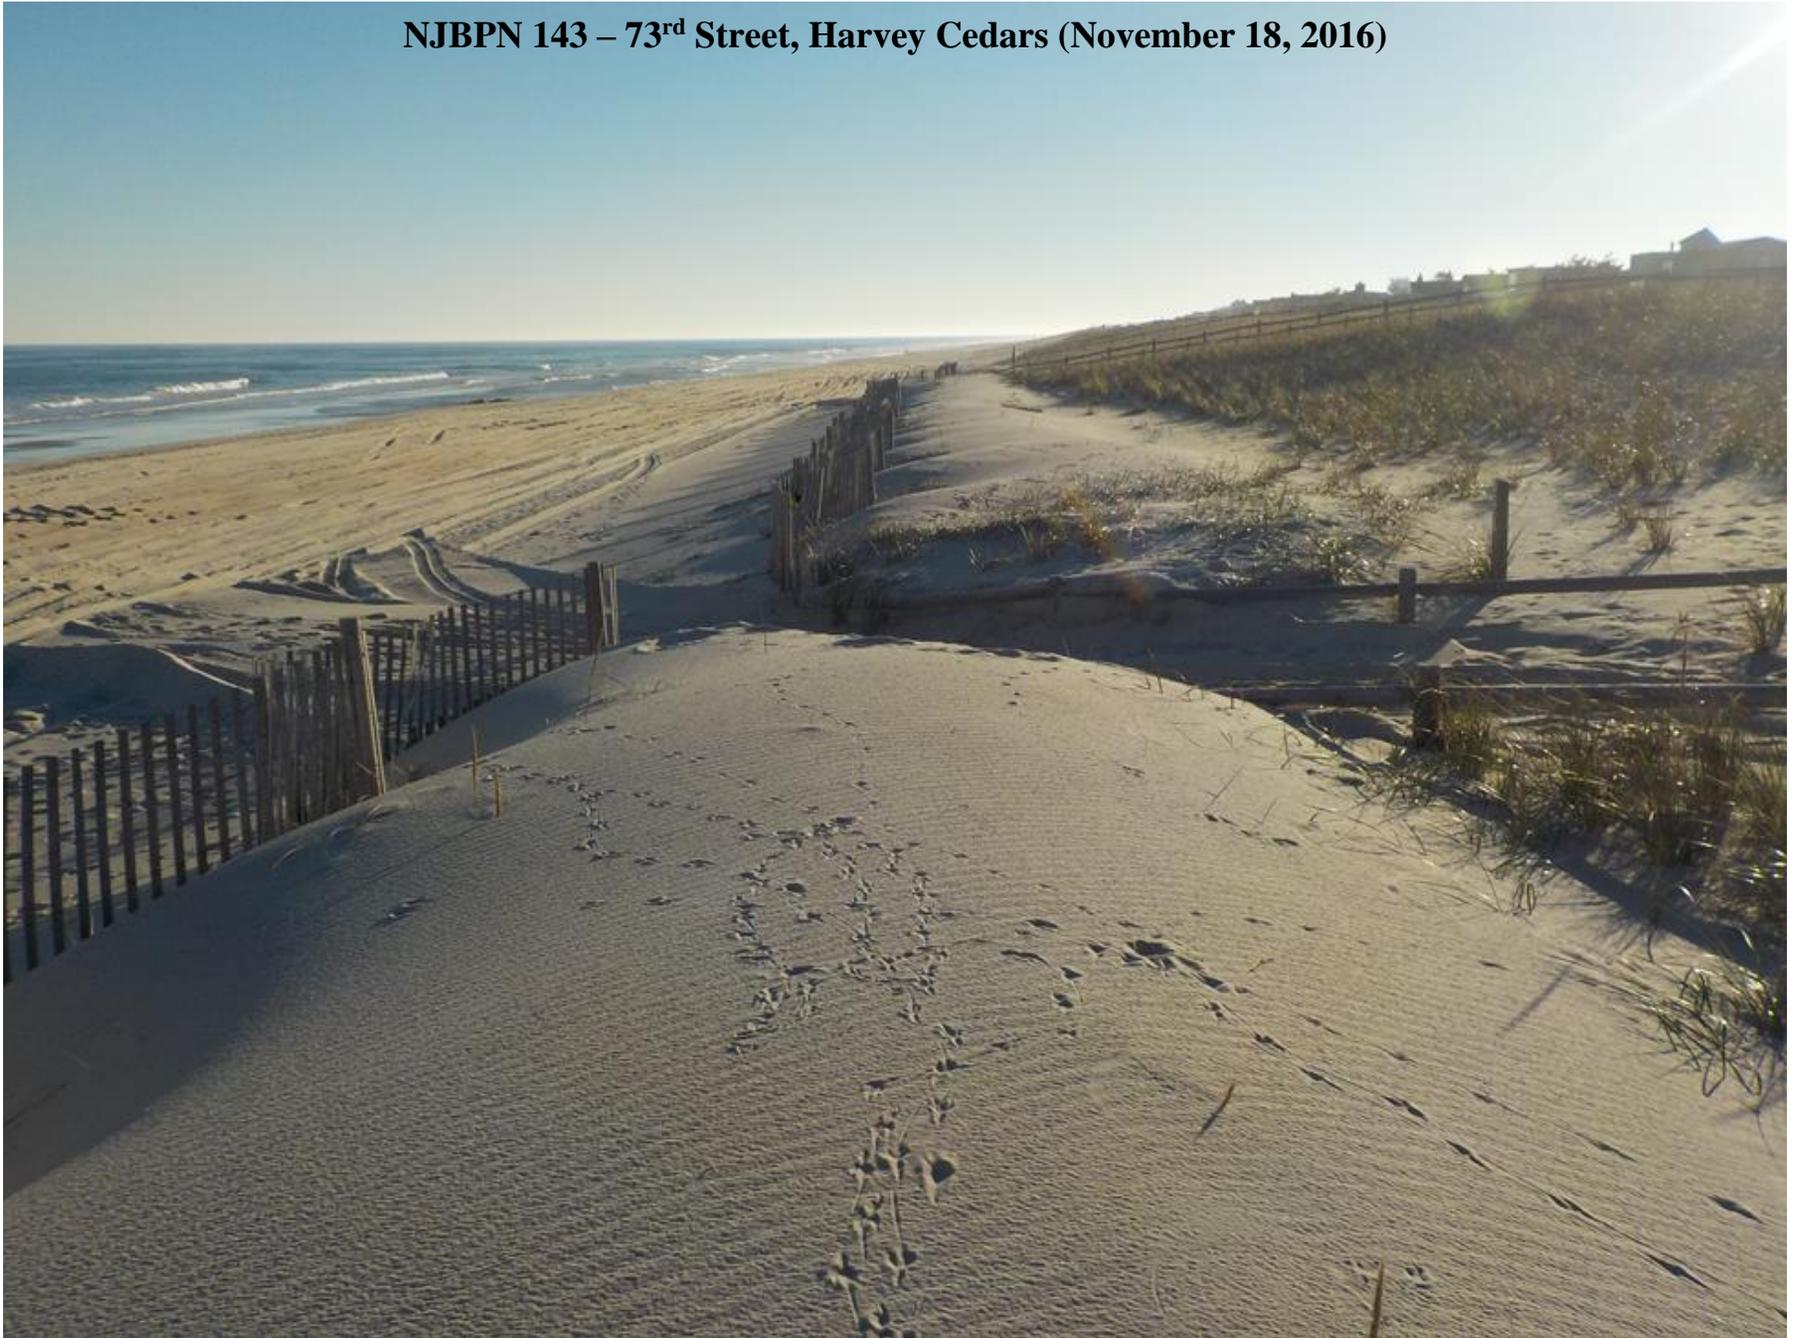
**NJBPN 143 – 73<sup>rd</sup> Street, Harvey Cedars (November 18, 2016)**

**Figure 322. View to the south from the dune at 73<sup>rd</sup> Street in Harvey Cedars. The accumulation of sand trapped by fencing adds to the dune's volume.**

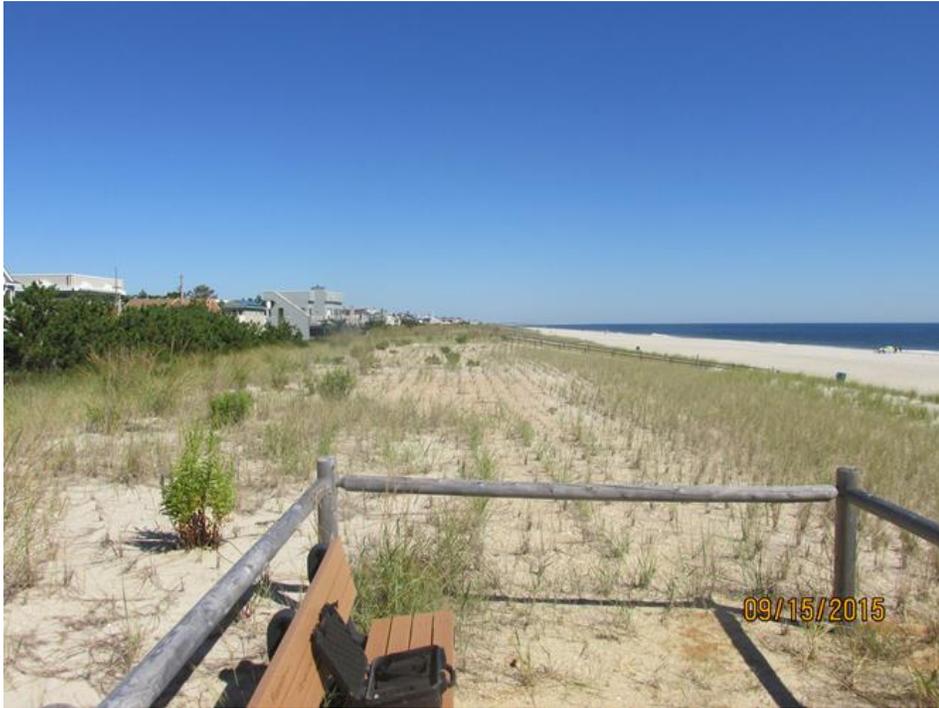
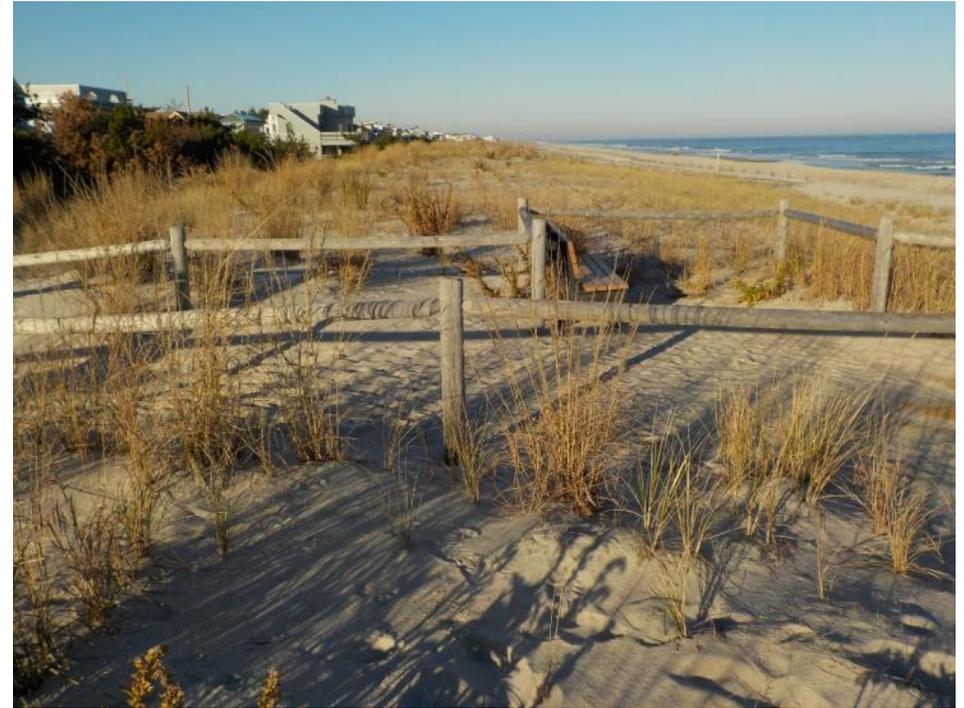
**Figure 323a & 323b. The photos show the condition of the vegetation on the engineered dune that was created in the 2009 federal shore protection project. Though scarped by Hurricane Sandy's waves, the dune (and wide beach) provided the necessary protection to landward properties during the storm. The 2013 emergency fill restored the dune and berm to the original design template. Left photo was taken September 15, 2015 and right photo taken November 18, 2016.**

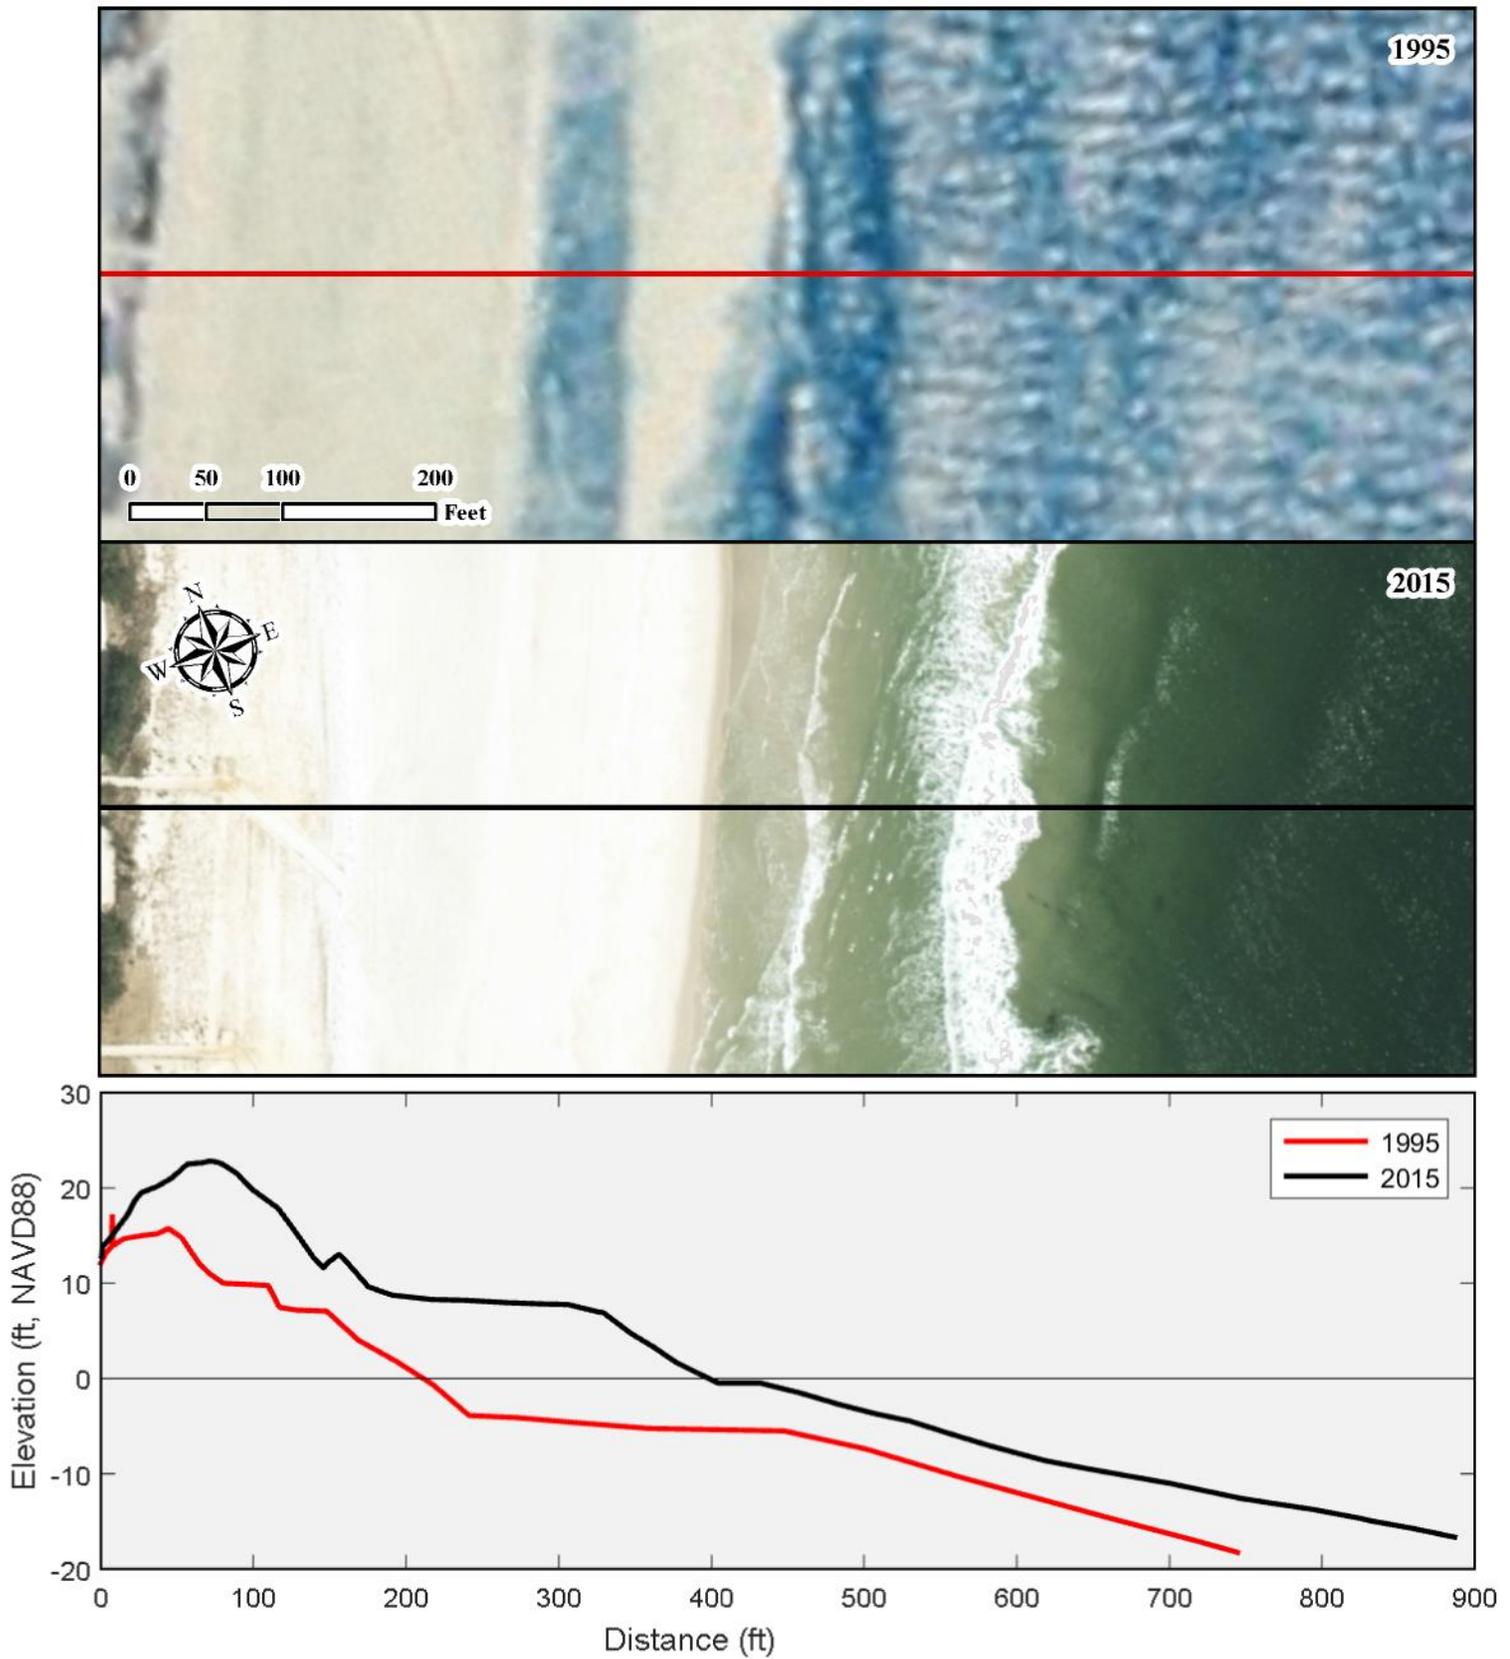
Figure 327. The cross section comparison shows the effects of the federal shore protection project that includes an engineered dune and a 9 ft berm elevation. The shoreline moved 187 ft seaward during this time.

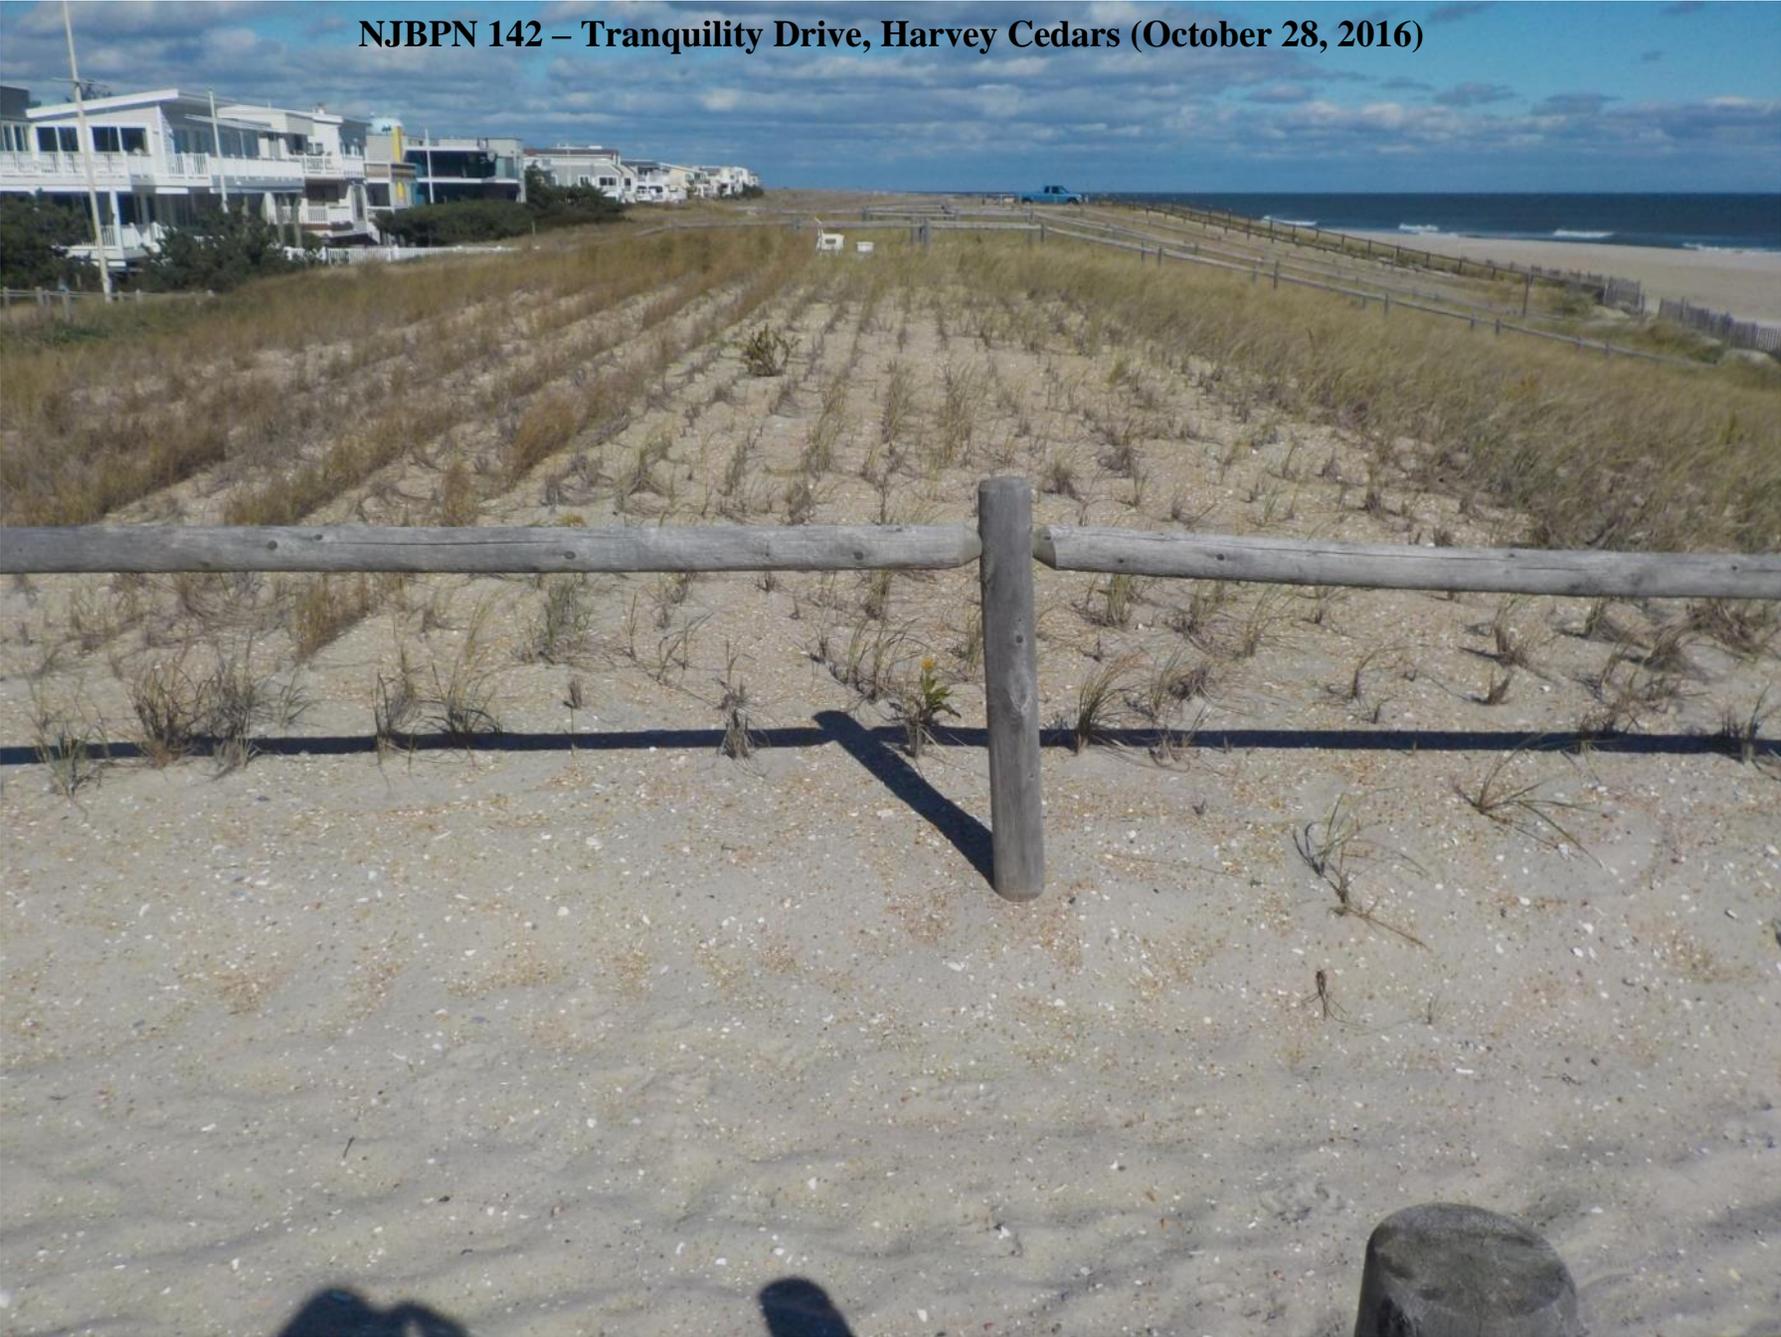
**NJBPN 142 – Tranquility Drive, Harvey Cedars (October 28, 2016)**

**Figure 328. View to the north from the crest of the engineered dune at Tranquility Drive in Harvey Cedars.**

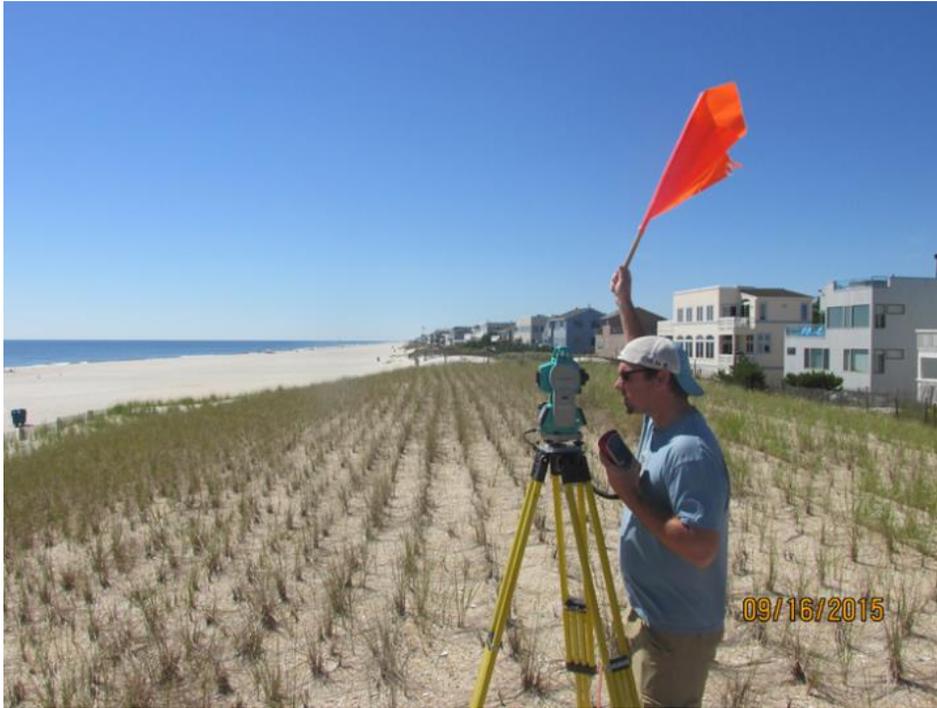
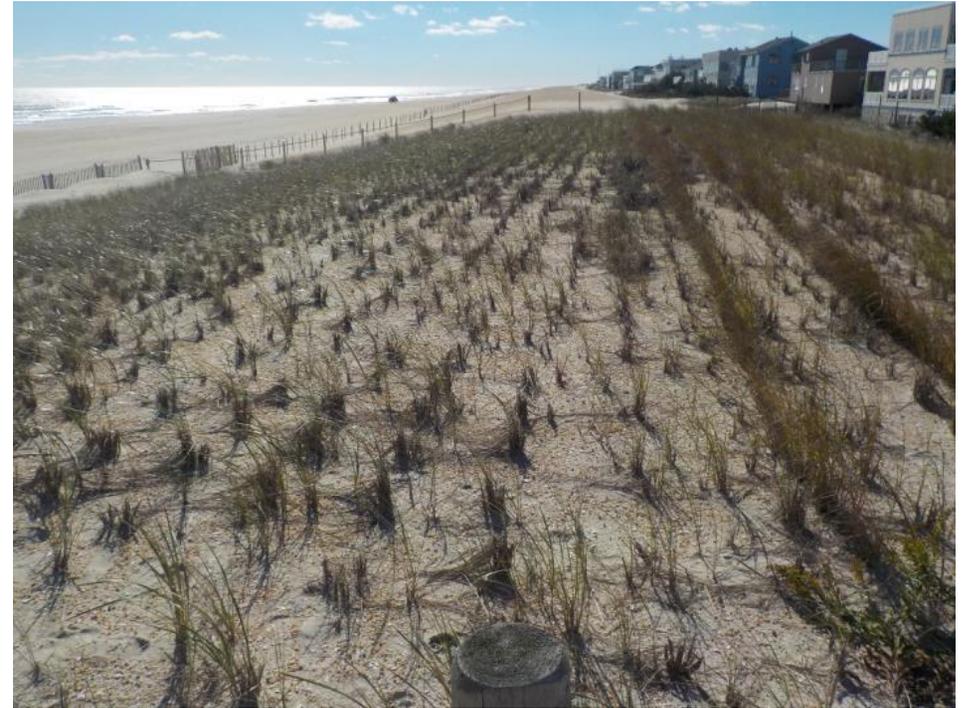
**Figure 329a & 329b. Conditions of the engineered dune have remained unchanged since the completion of the post-Sandy emergency beach fill. Sand accumulated at the seaward toe during fall 2016 (left taken September 16, 2015 and right taken October 28, 2016).**

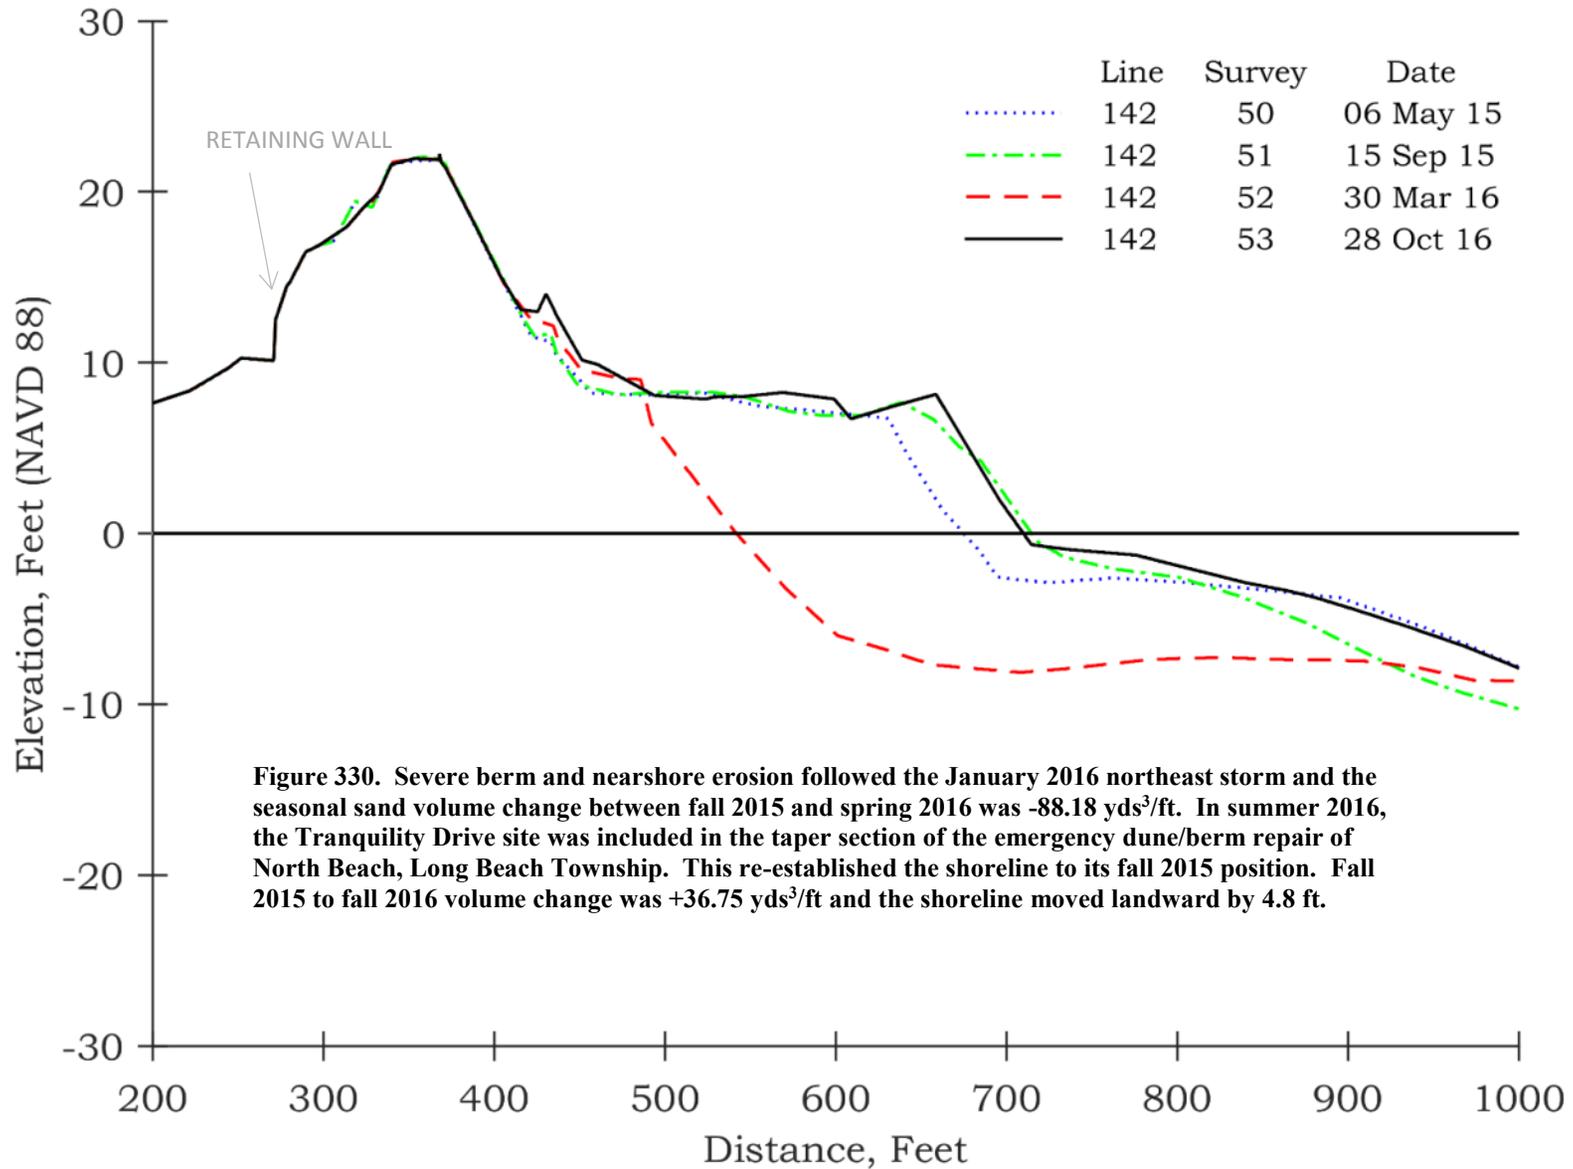
**Figure 330. Severe berm and nearshore erosion followed the January 2016 northeast storm and the seasonal sand volume change between fall 2015 and spring 2016 was  $-88.18 \text{ yds}^3/\text{ft}$ . In summer 2016, the Tranquility Drive site was included in the taper section of the emergency dune/berm repair of North Beach, Long Beach Township. This re-established the shoreline to its fall 2015 position. Fall 2015 to fall 2016 volume change was  $+36.75 \text{ yds}^3/\text{ft}$  and the shoreline moved landward by 4.8 ft.**

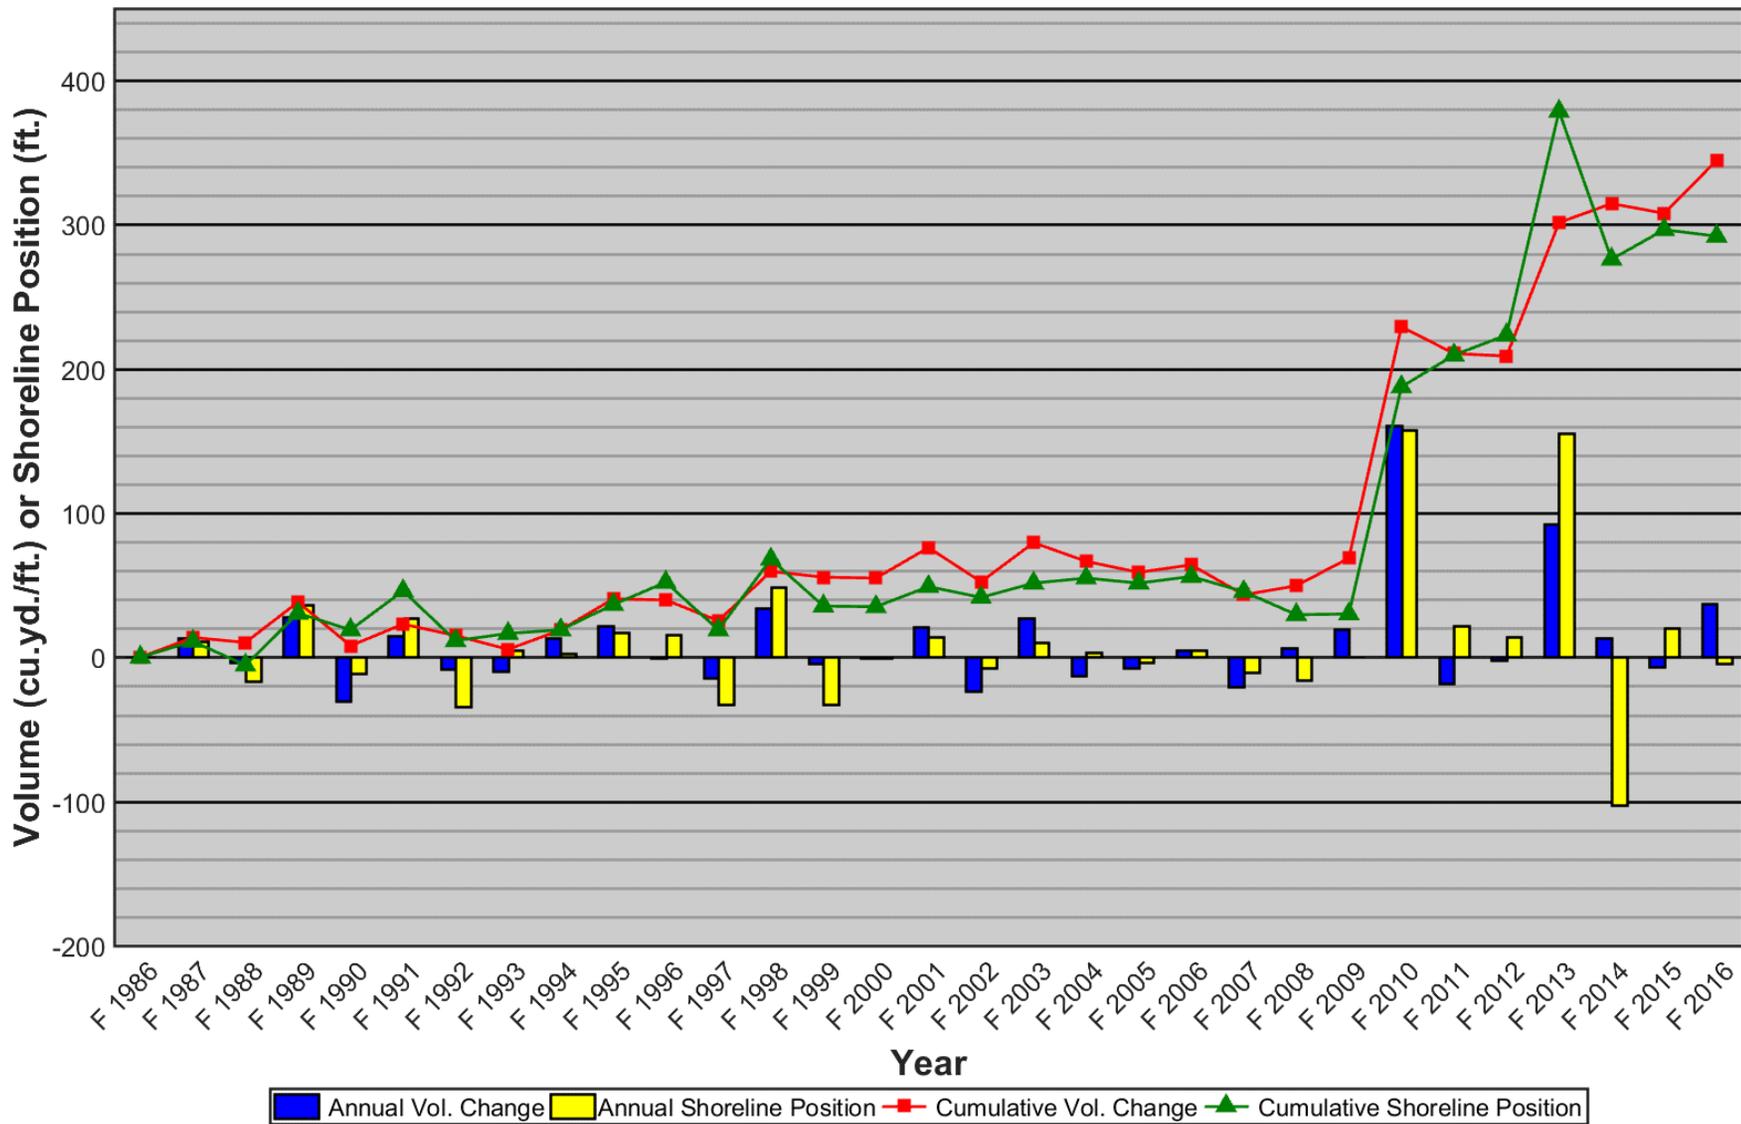
Figure 331. Over the past 30 years, sand volumes at Tranquility Drive were relatively stable. Note the dramatic increase in volume and shoreline position in 2010 and again in 2013 from the federal shore protection and emergency post-Sandy restoration projects. The southern Harvey Cedars site appears to be more stable and accretional, as compared to the 73<sup>rd</sup> Street site. Both sand volume and shoreline change show large, positive increases of 342 yds<sup>3</sup>/ft and 292 ft, respectively.

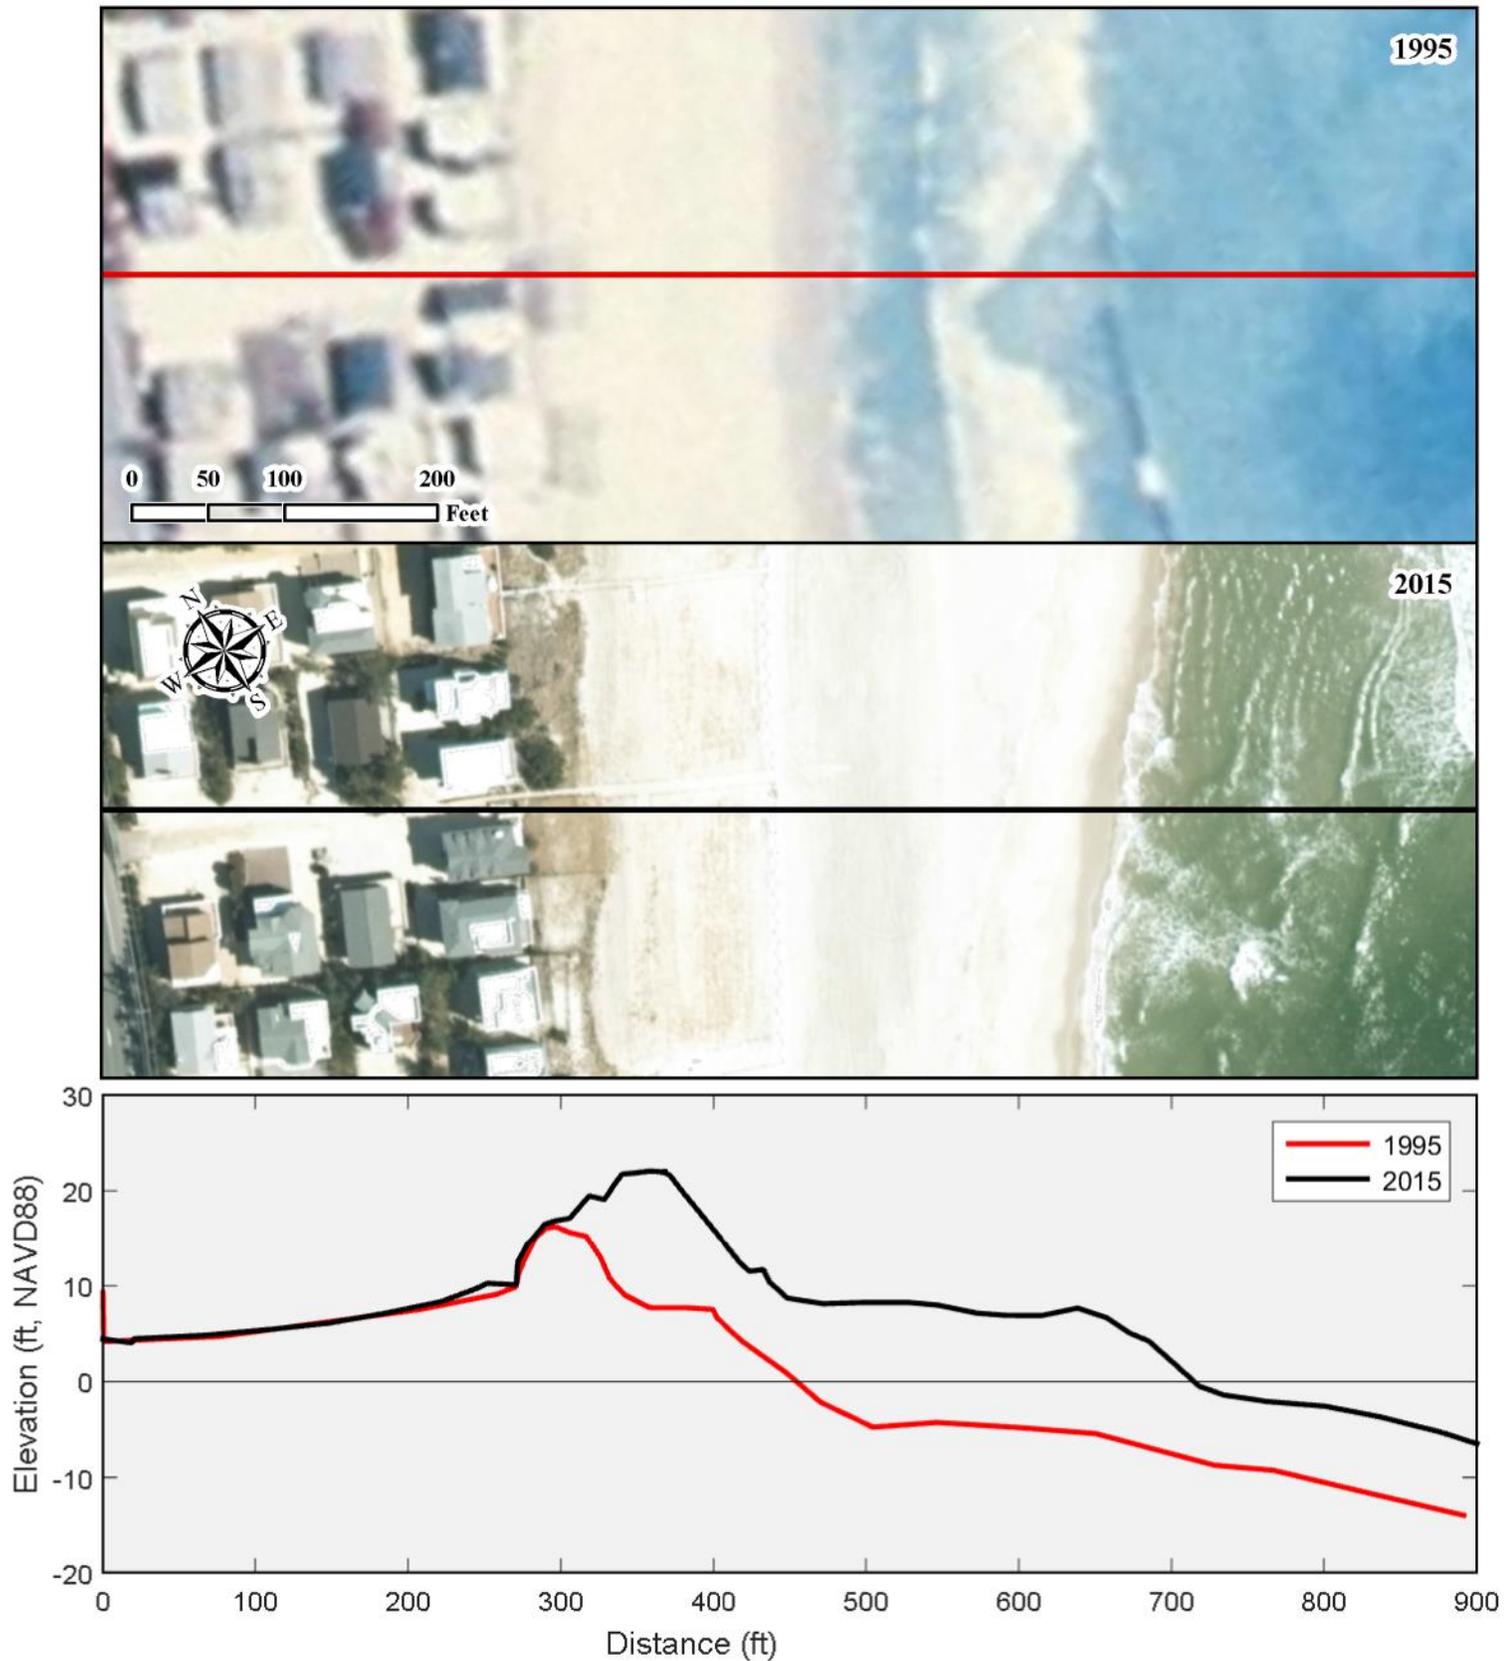
Figure 333. The federal project incorporated the 1995 dune into the engineered dune design. The shoreline moved 260 ft seaward from its 1995 position.

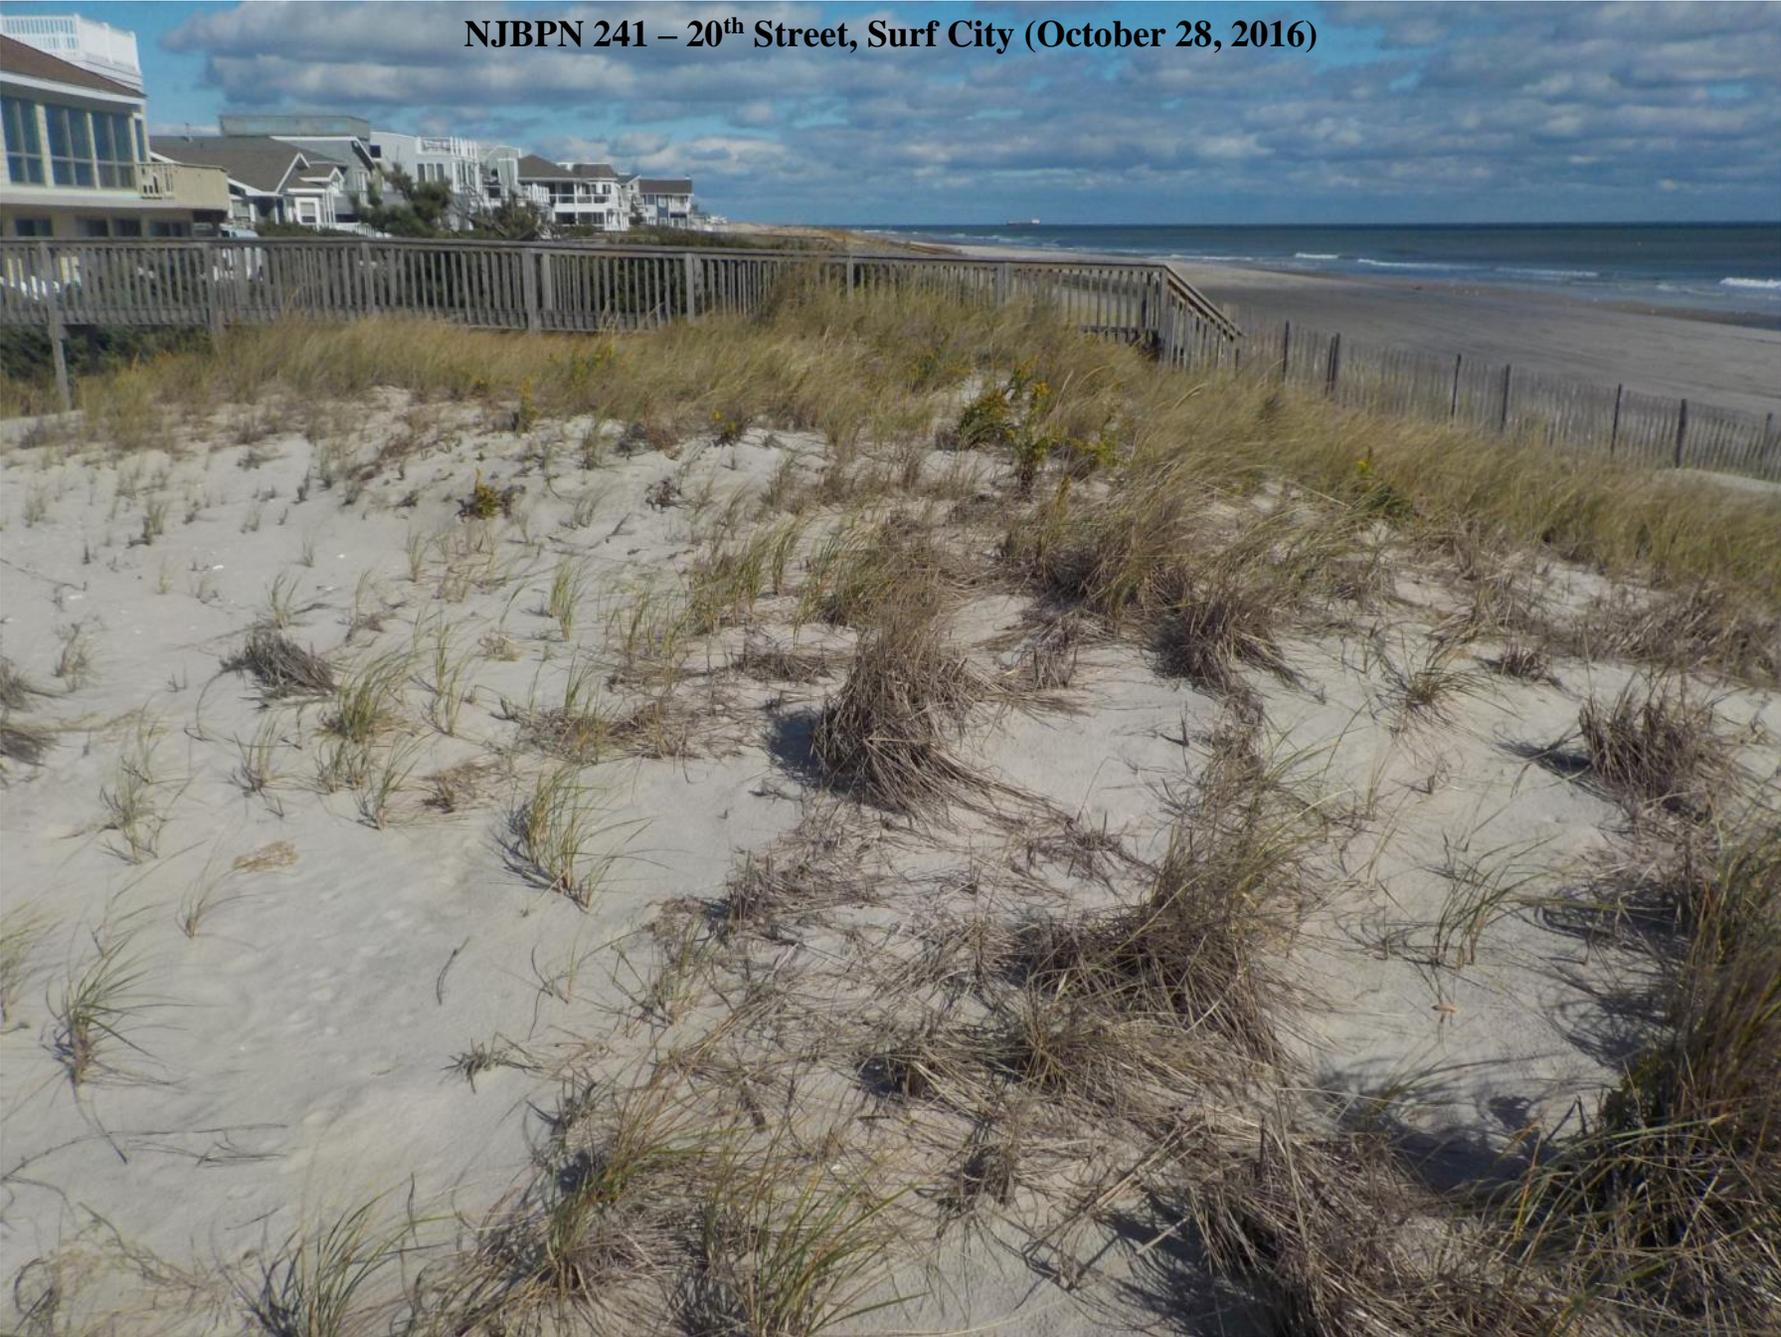
**NJBPN 241 – 20<sup>th</sup> Street, Surf City (October 28, 2016)**

**Figure 334. View to the north from the crest of the engineered dune at 20<sup>th</sup> Street in Surf City.**
