## An Analysis of Thirty Years' Study of Sand Redistribution and Shoreline Changes in New Jersey's Four Coastal Counties Raritan Bay, the Atlantic Ocean Coast, and Delaware Bay Fall 1986 Through Fall 2016

### ***VOLUME 2 of 4 OCEAN COUNTY***

Prepared for:  
New Jersey Department of Environmental Protection  
Division of Coastal Engineering  
1510 Hooper Avenue, Toms River, New Jersey 08753

Prepared by:  
Stockton University Coastal Research Center  
30 Wilson Avenue, Port Republic, NJ 08241

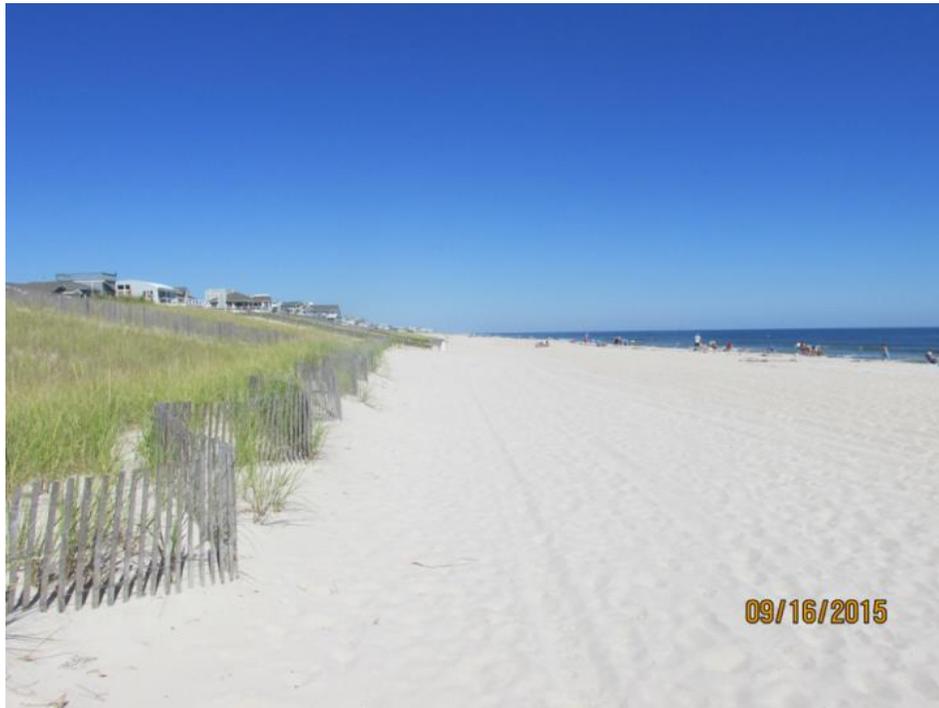
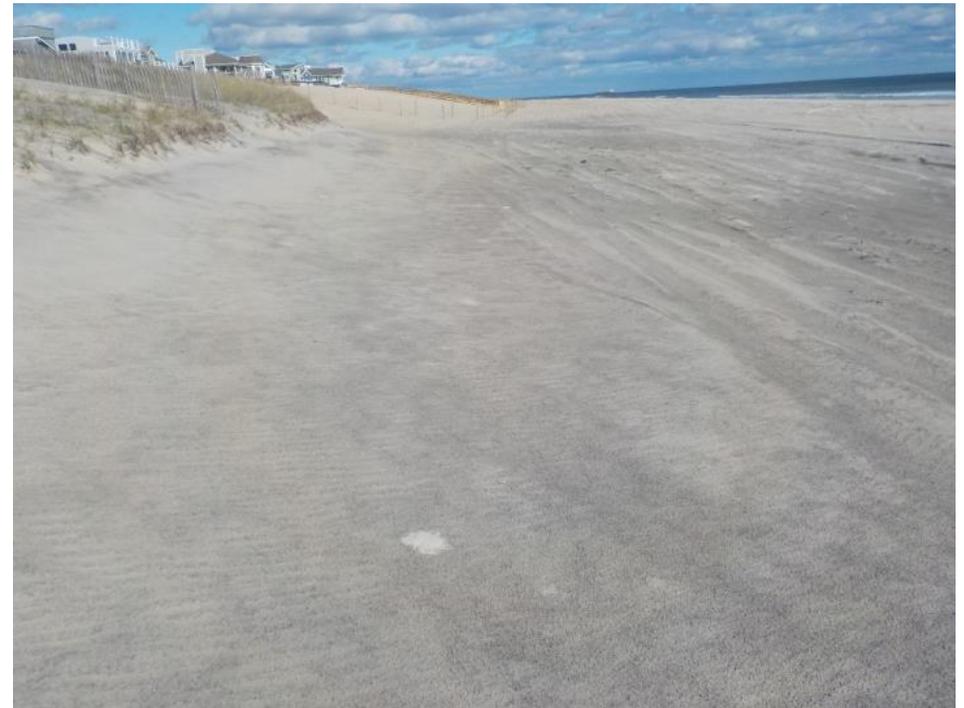
Figure 335a & 335b. The photos show the conditions of the backshore/seaward dune toe at 20<sup>th</sup> Street. Berm widths were comparable and are typical for late summer/early fall accretional beach conditions. The left photo was taken on September 15, 2015 and right photo taken October 28, 2016.

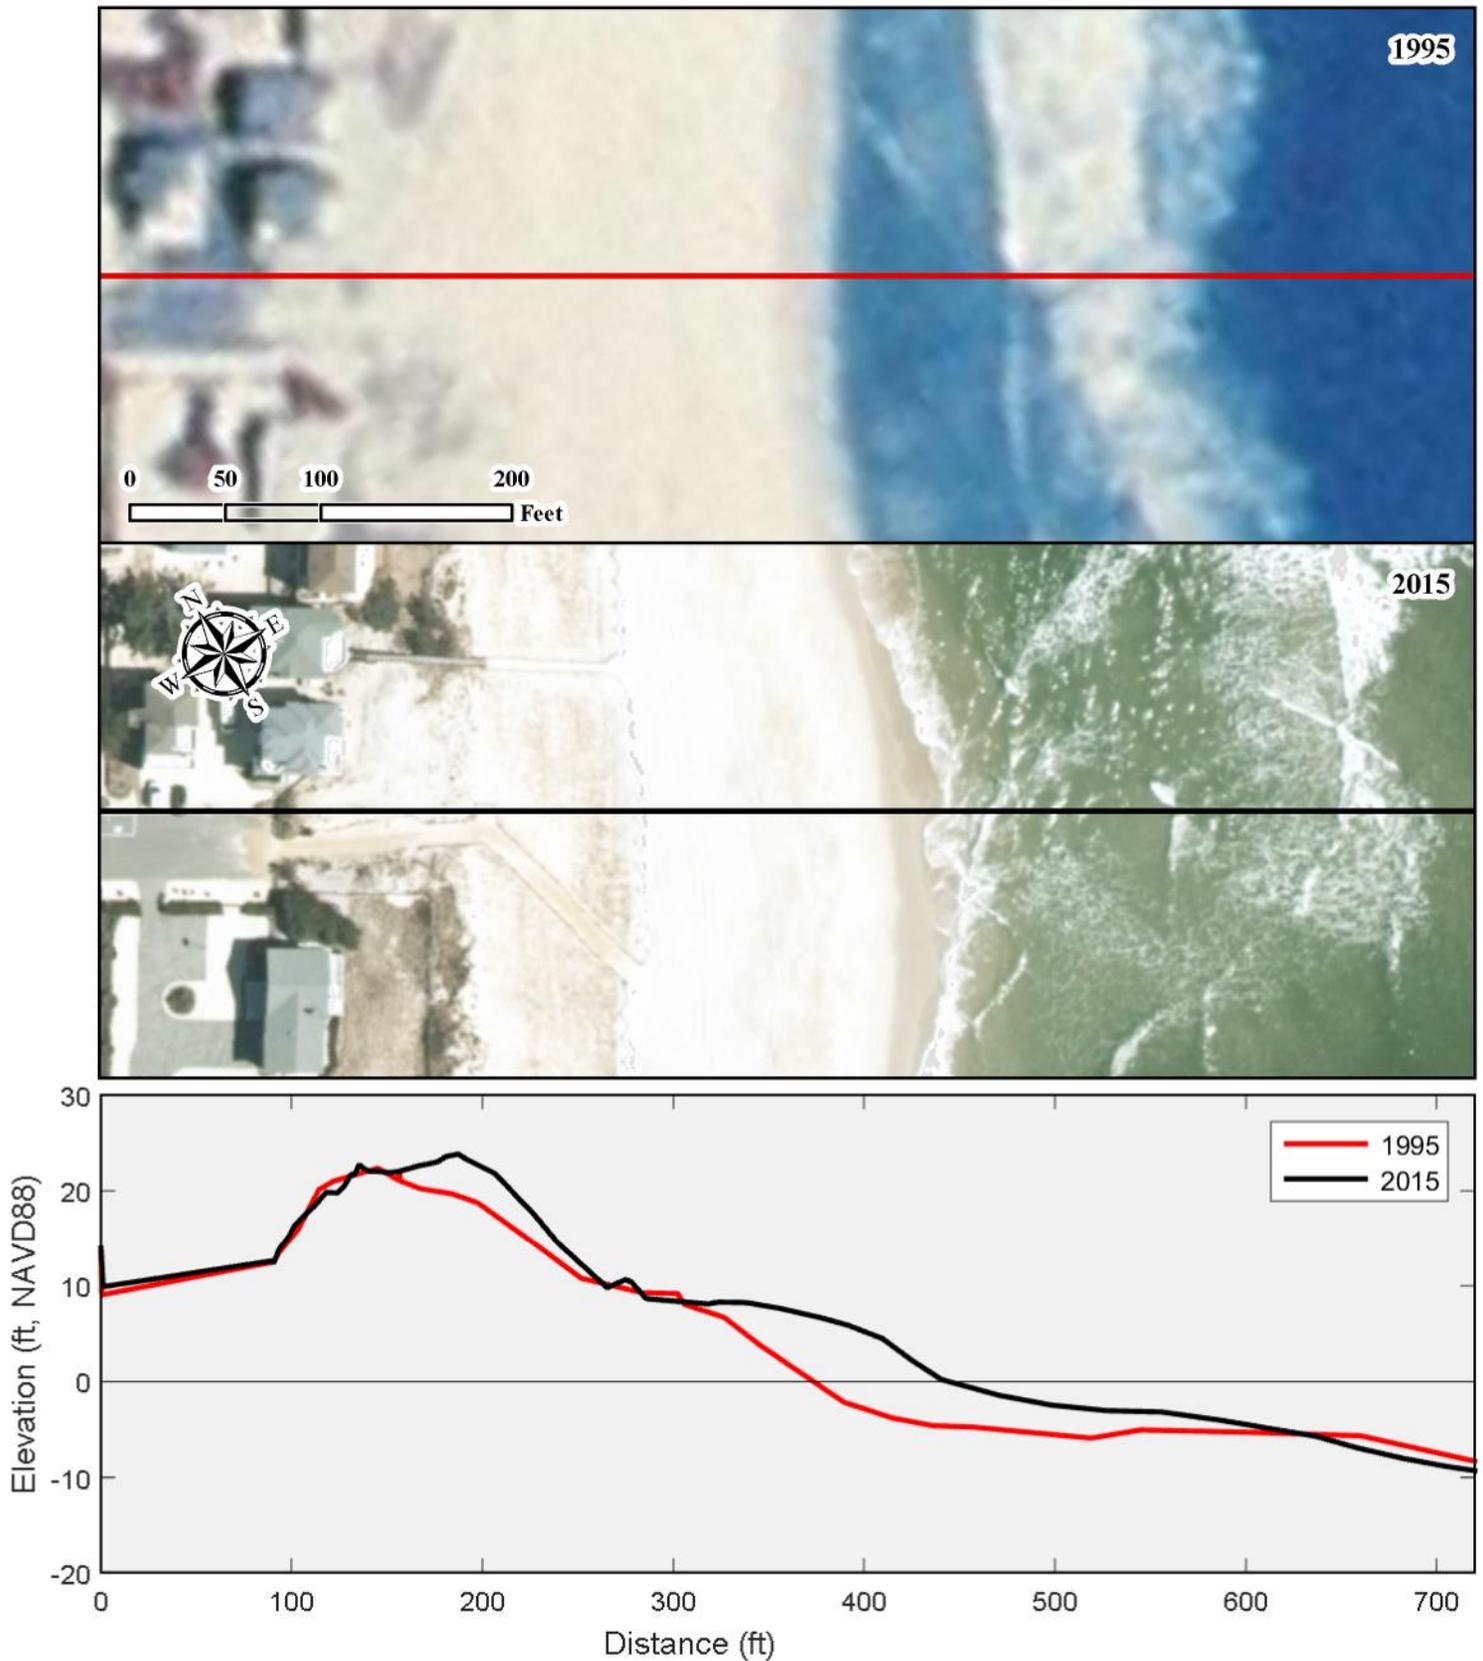
**Figure 339.** The federal shore protection project incorporated the 1995 dune into the engineered dune design. This site was restored in 2013 and the shoreline moved seaward by 71 ft between 1995 and 2015.

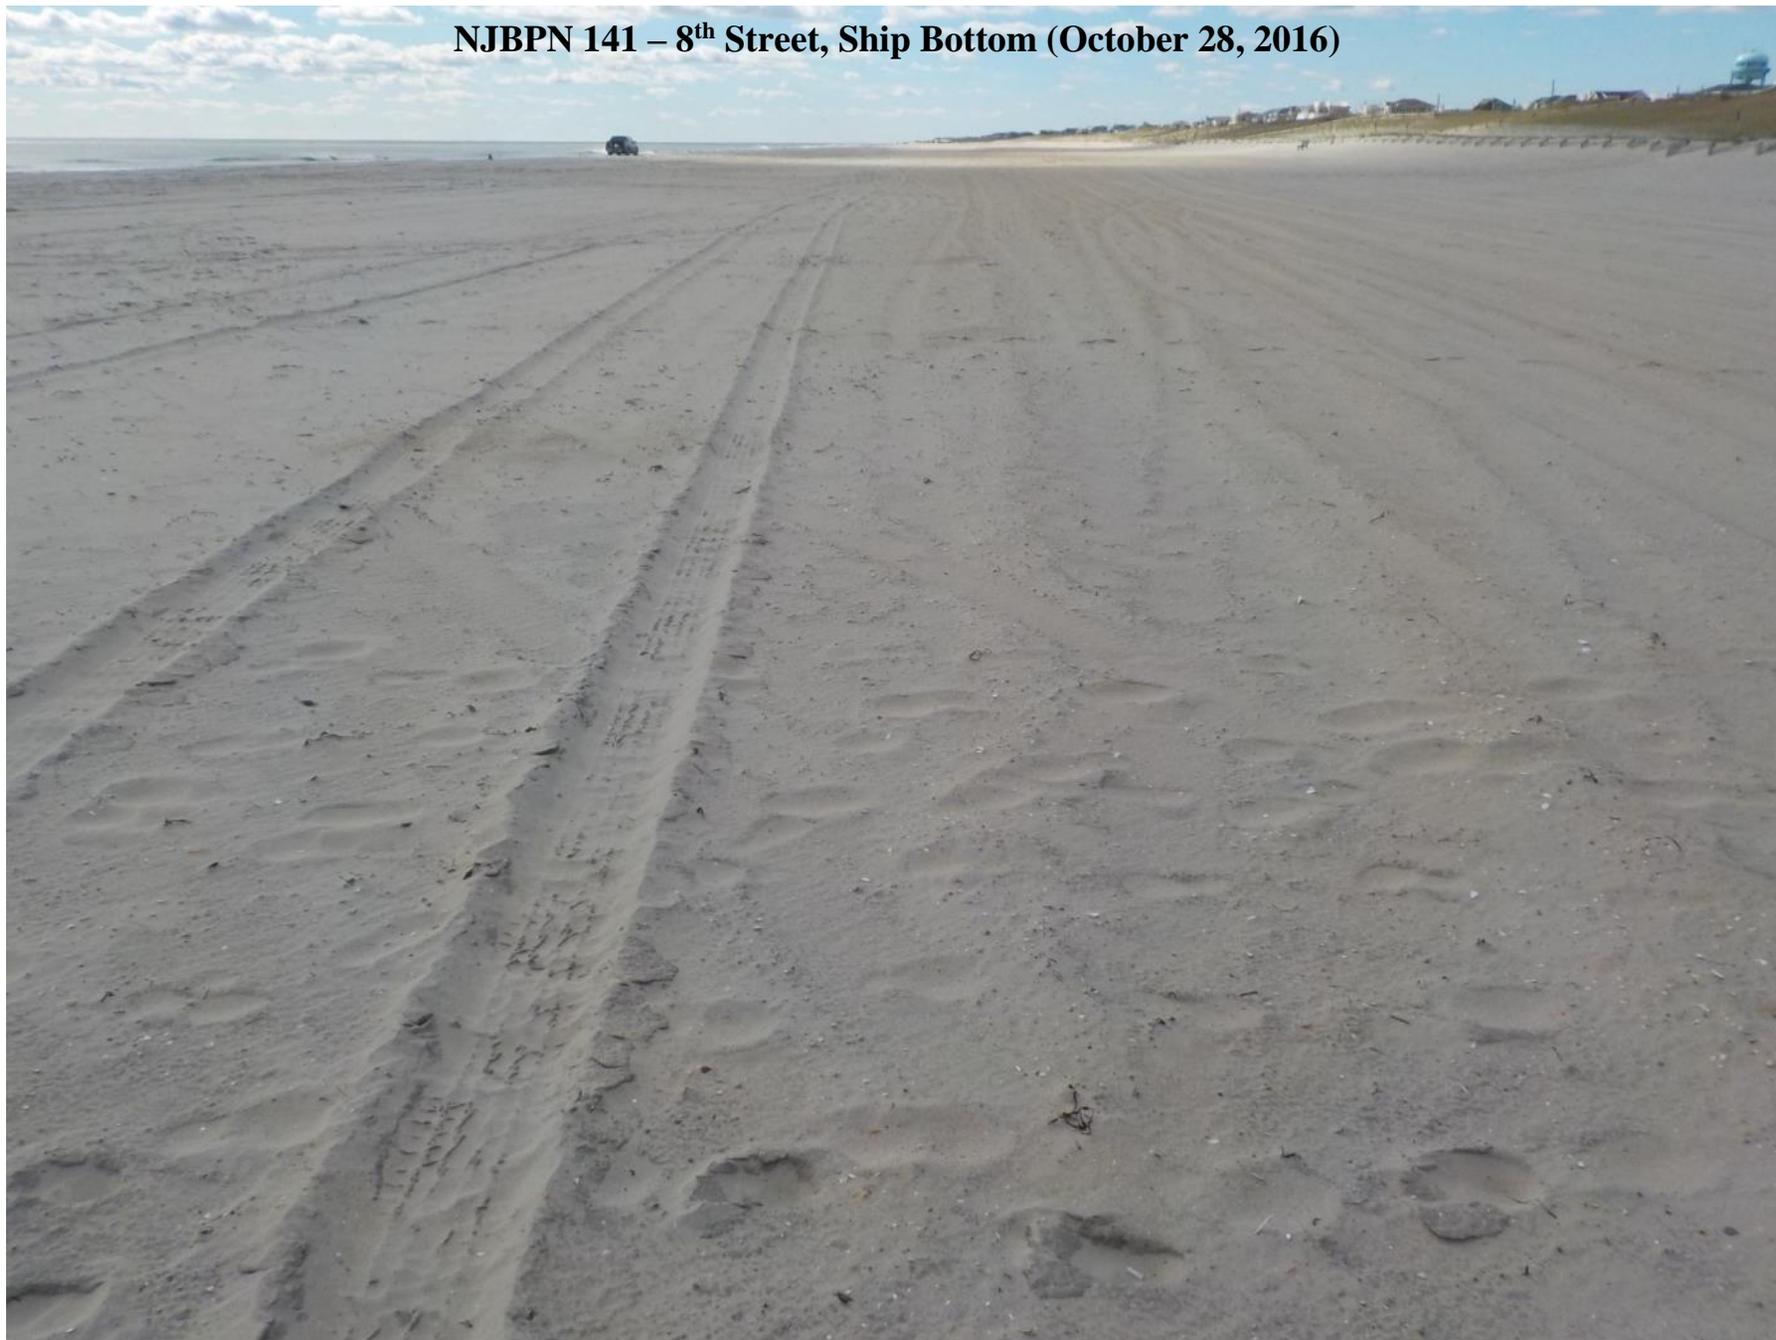
**NJBPN 141 – 8<sup>th</sup> Street, Ship Bottom (October 28, 2016)**

**Figure 340. View to the south from the berm at 8<sup>th</sup> Street in Ship Bottom.**

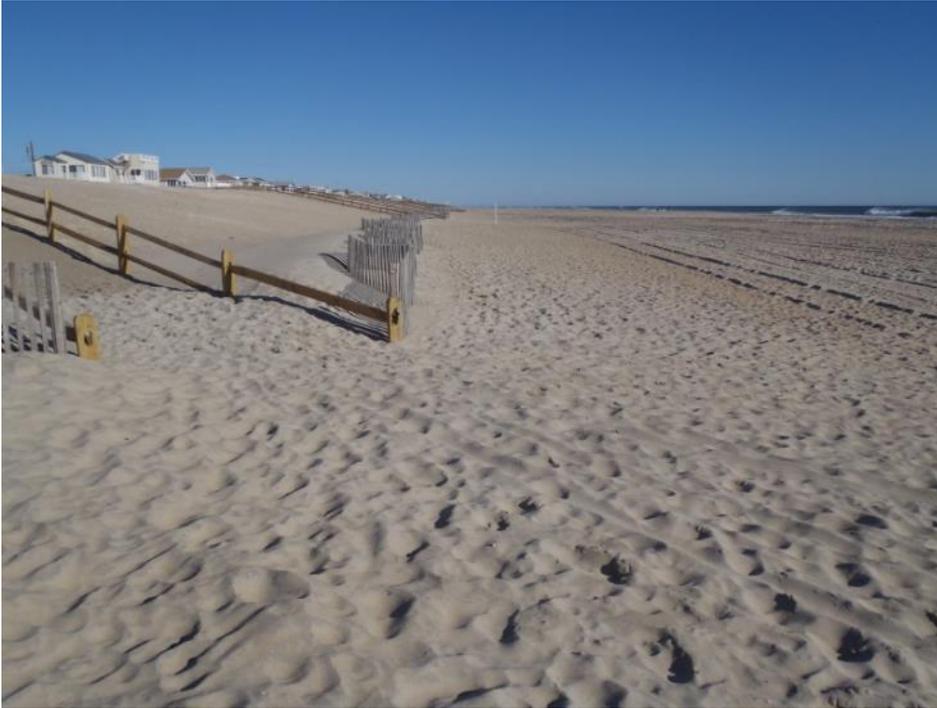
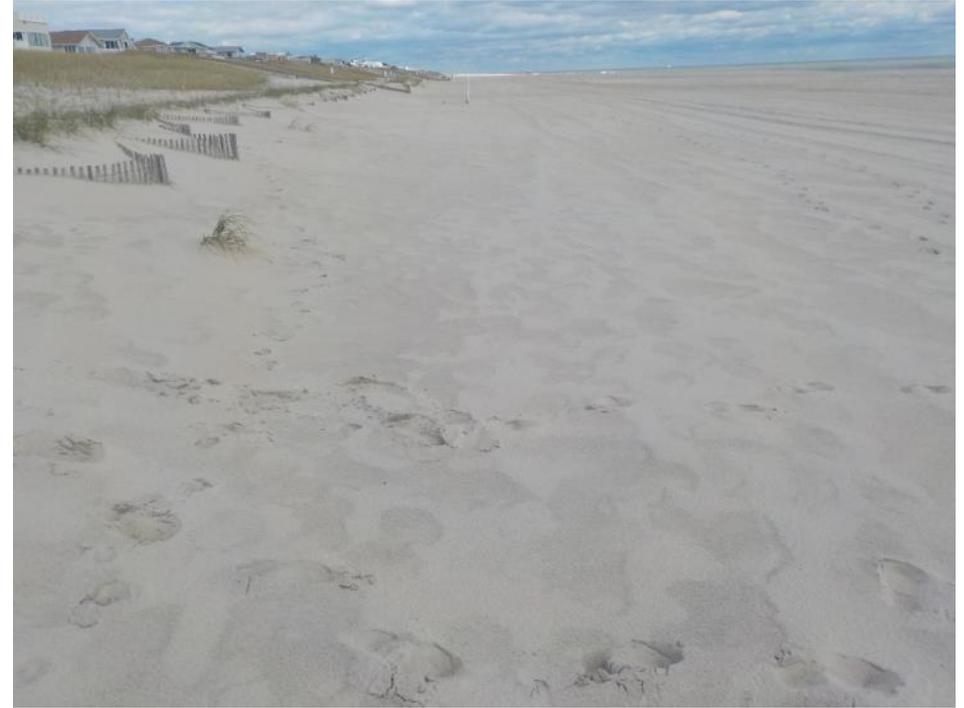
**Figure 341a & 341b.** The photos of the 8<sup>th</sup> Street location (left taken December 15, 2015 and right taken October 28, 2016) show the conditions of the dune toe and backshore. This site was included in the federal beach fill which was completed in spring 2015. The right photo shows sand that accumulated from early fall high winds, burying the dune vegetation and sand fencing.

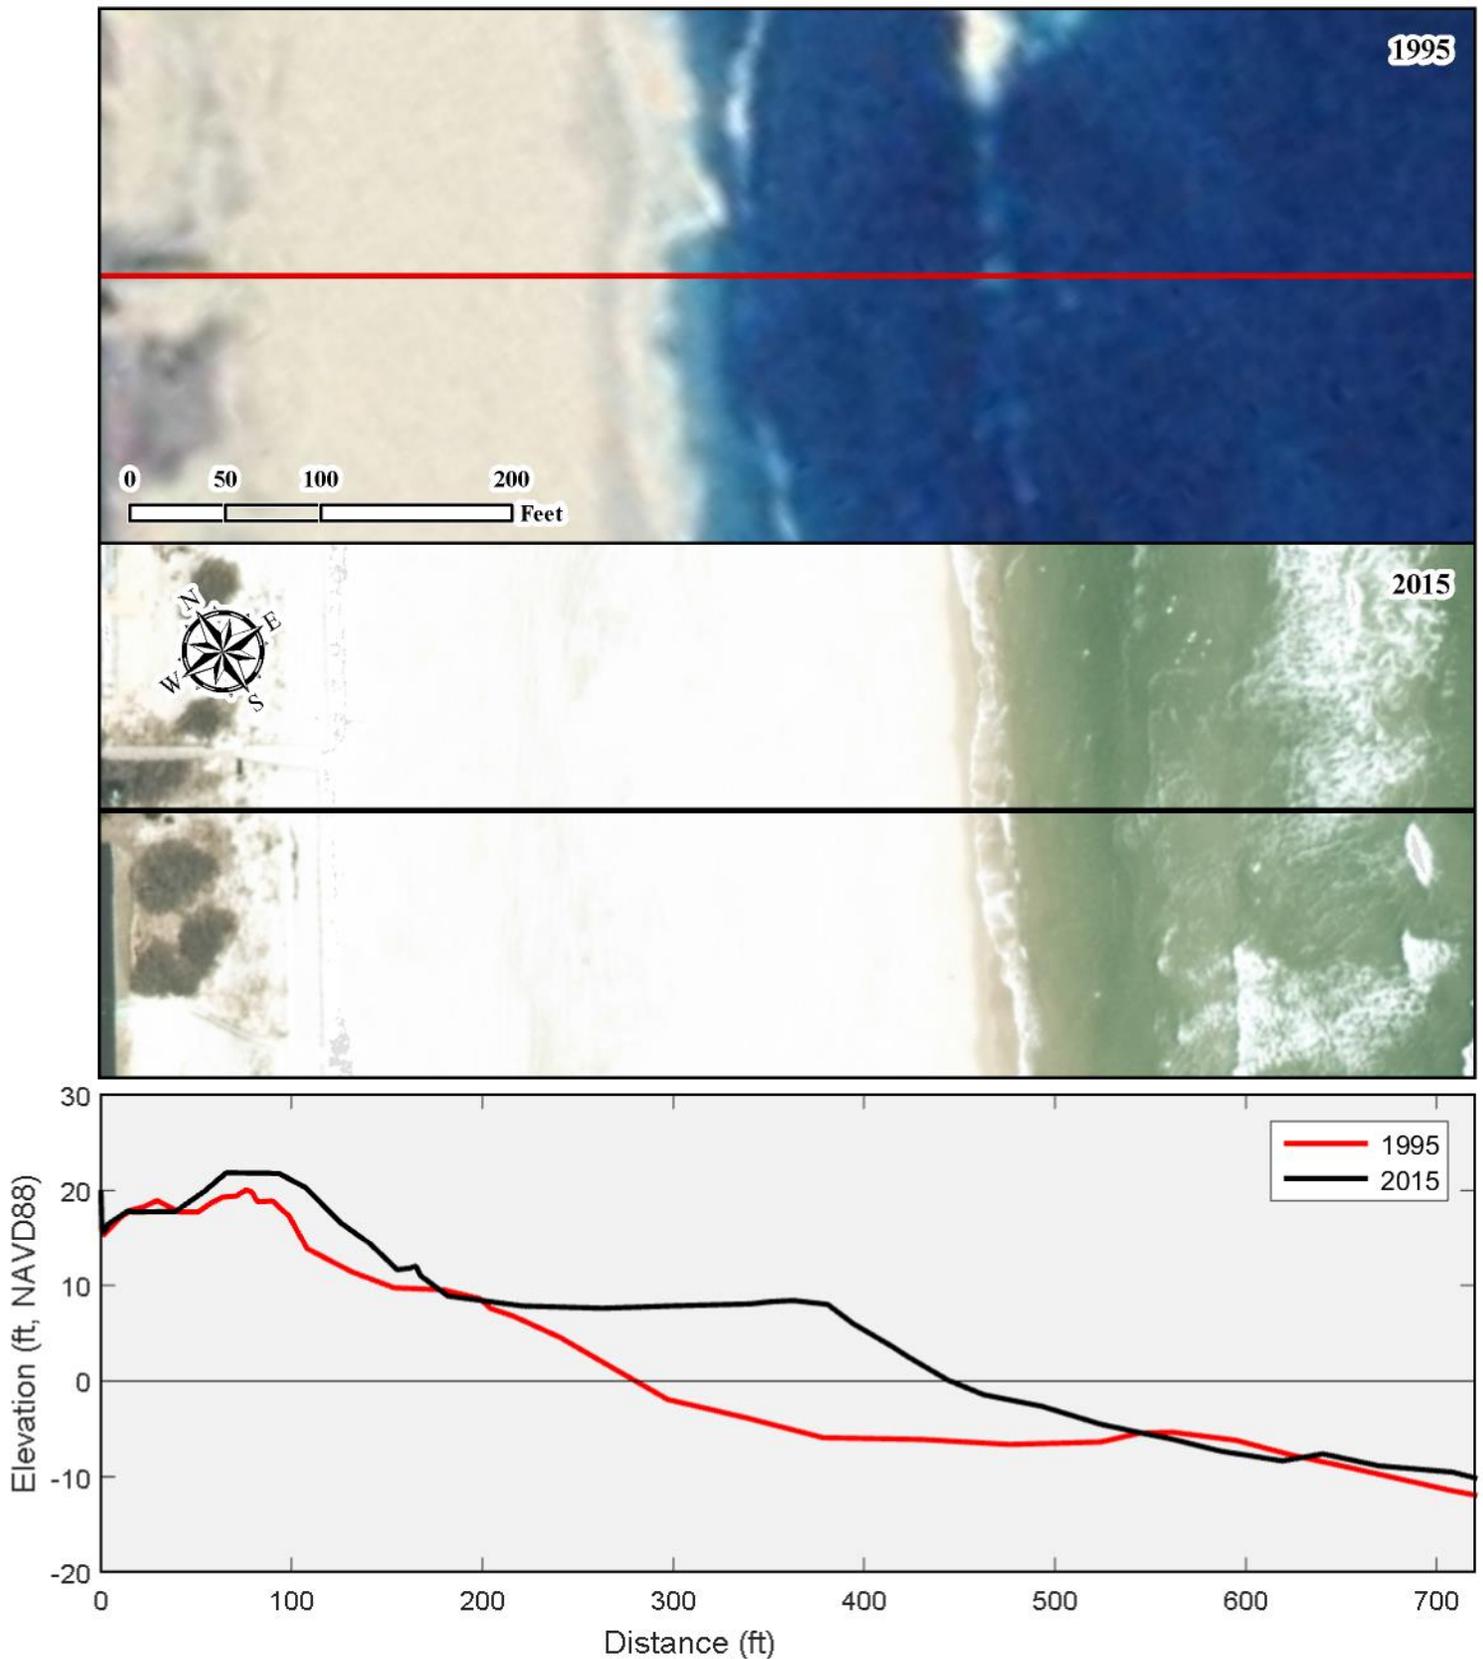
Figure 345. The 2015 profile shows a newly restored engineered dune and elevated berm. Between the 1995 and 2015 surveys, the shoreline moved seaward by 165 ft.

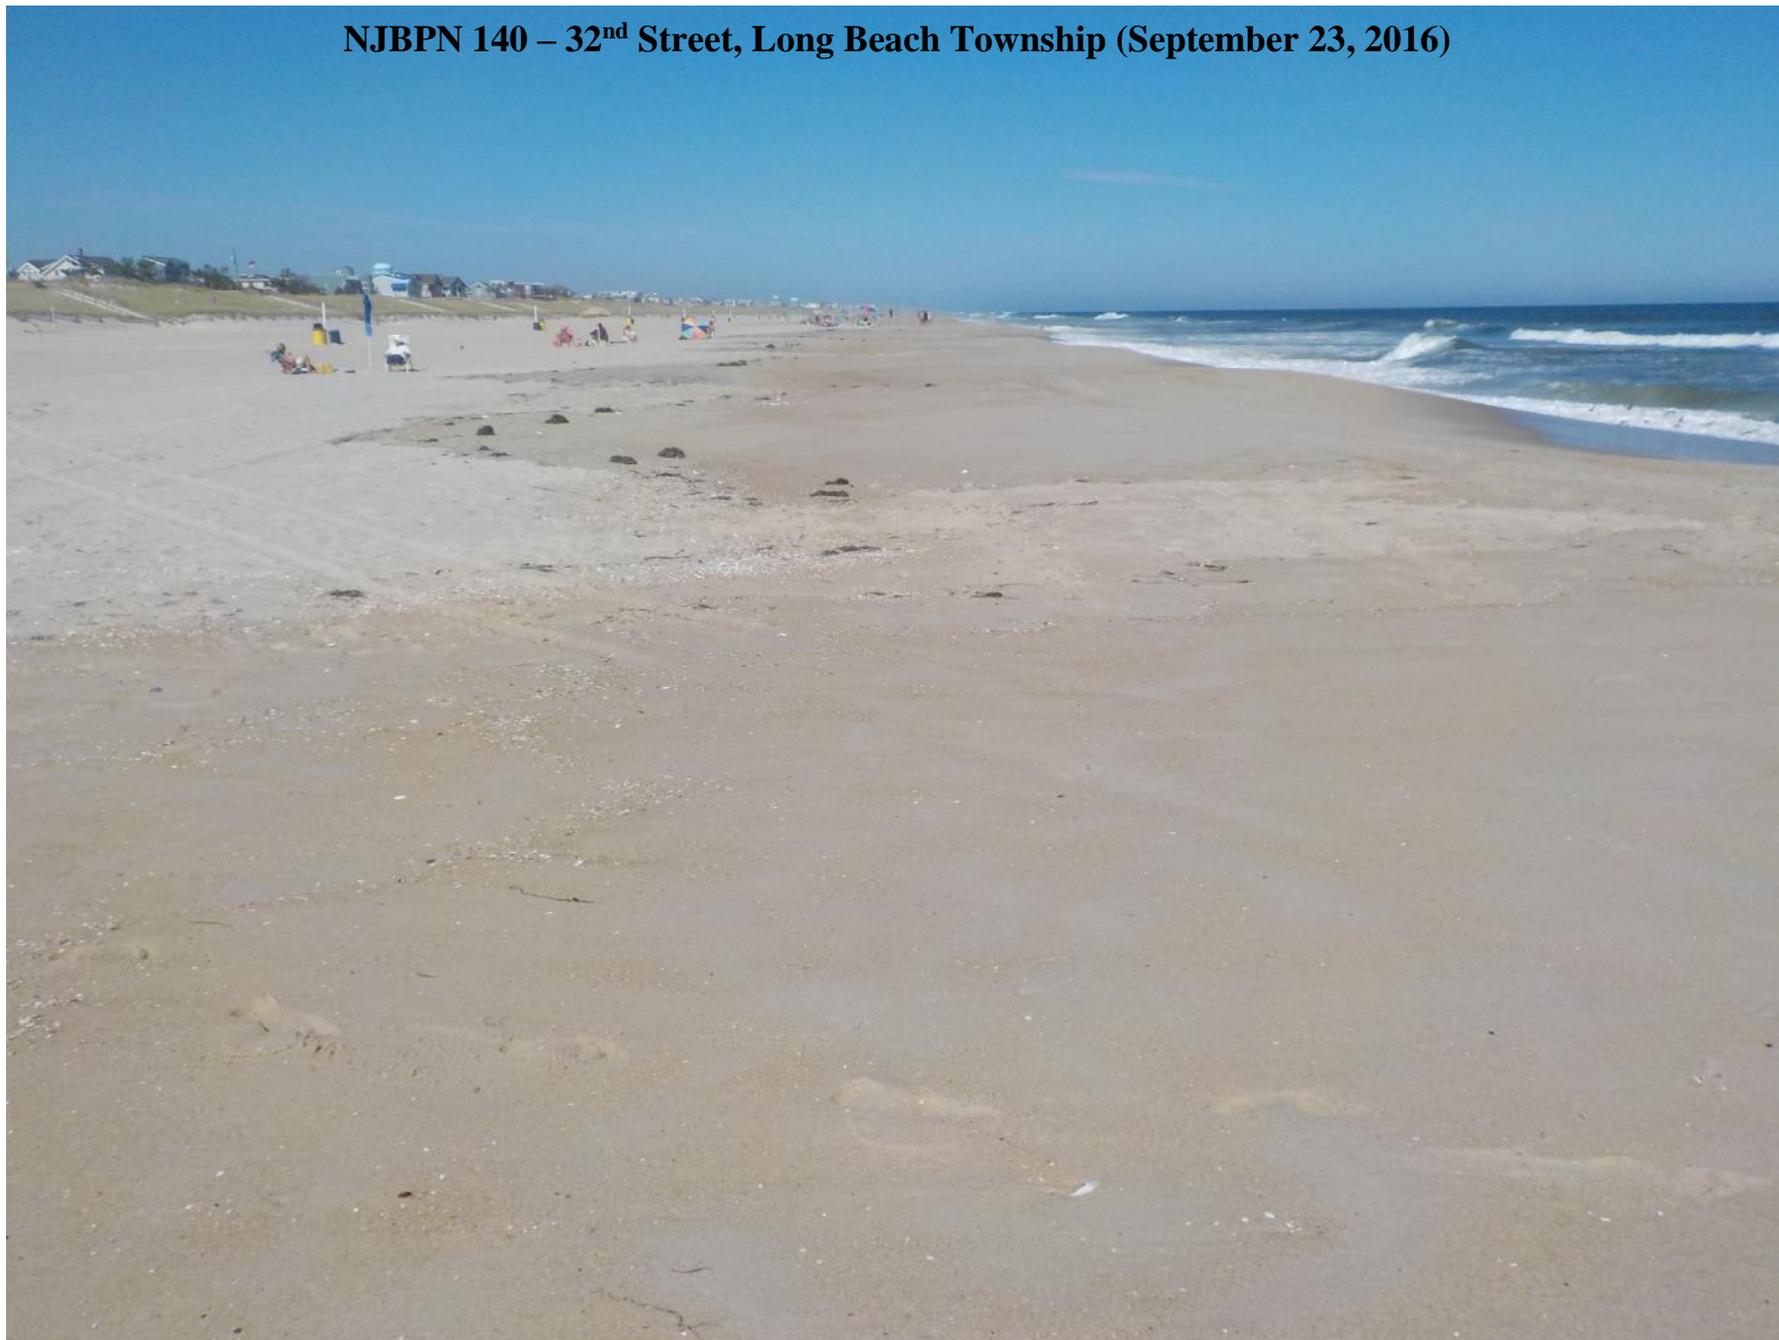
**NJBPN 140 – 32<sup>nd</sup> Street, Long Beach Township (September 23, 2016)**

**Figure 346. View to the north from the berm at 32<sup>nd</sup> Street in Long Beach Township.**

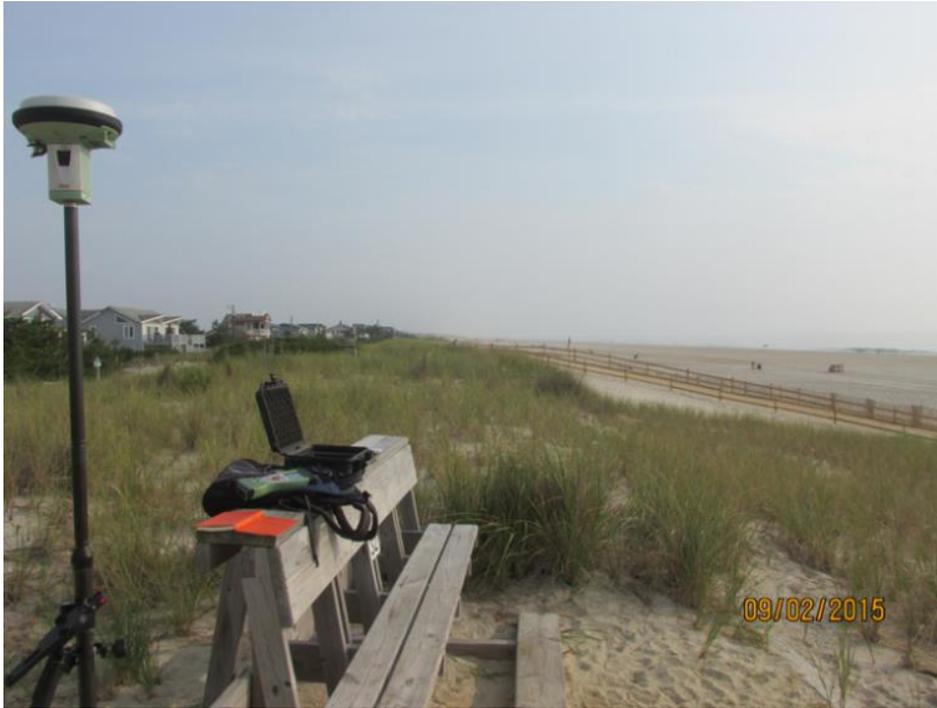
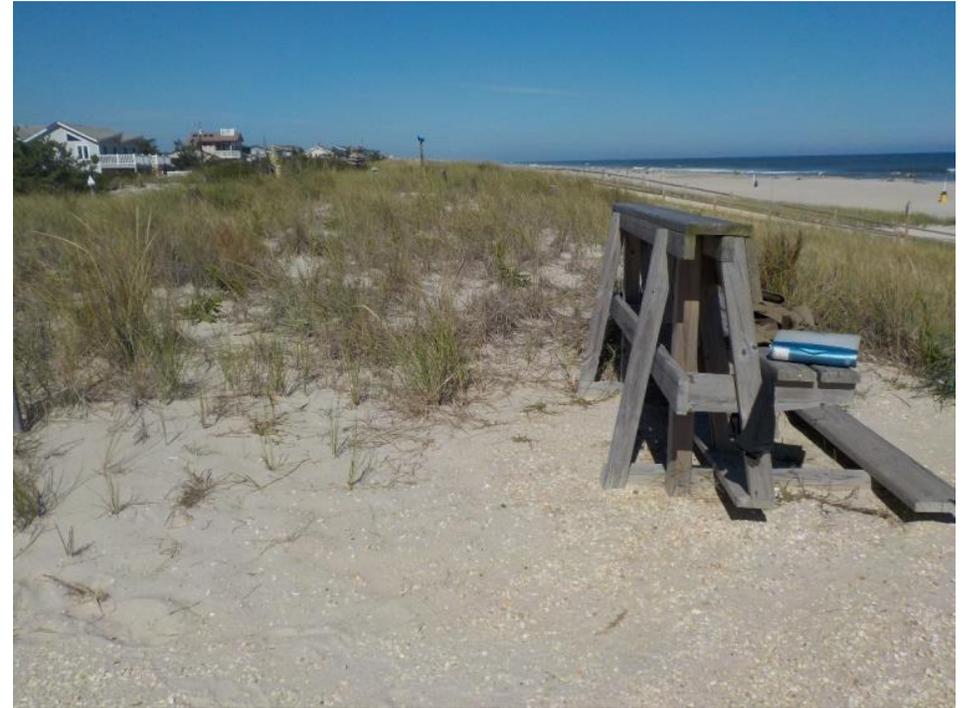
**NJBPN 140 – 32<sup>nd</sup> Street, Long Beach Township**

**Figure 347a & 347b. The photos at 32<sup>nd</sup> Street show a stable engineered dune that has remained in place since it was constructed in spring 2012 (left taken September 2, 2015 and right taken September 23, 2016). The 2015 emergency beach fill restored the berm to the template design.**

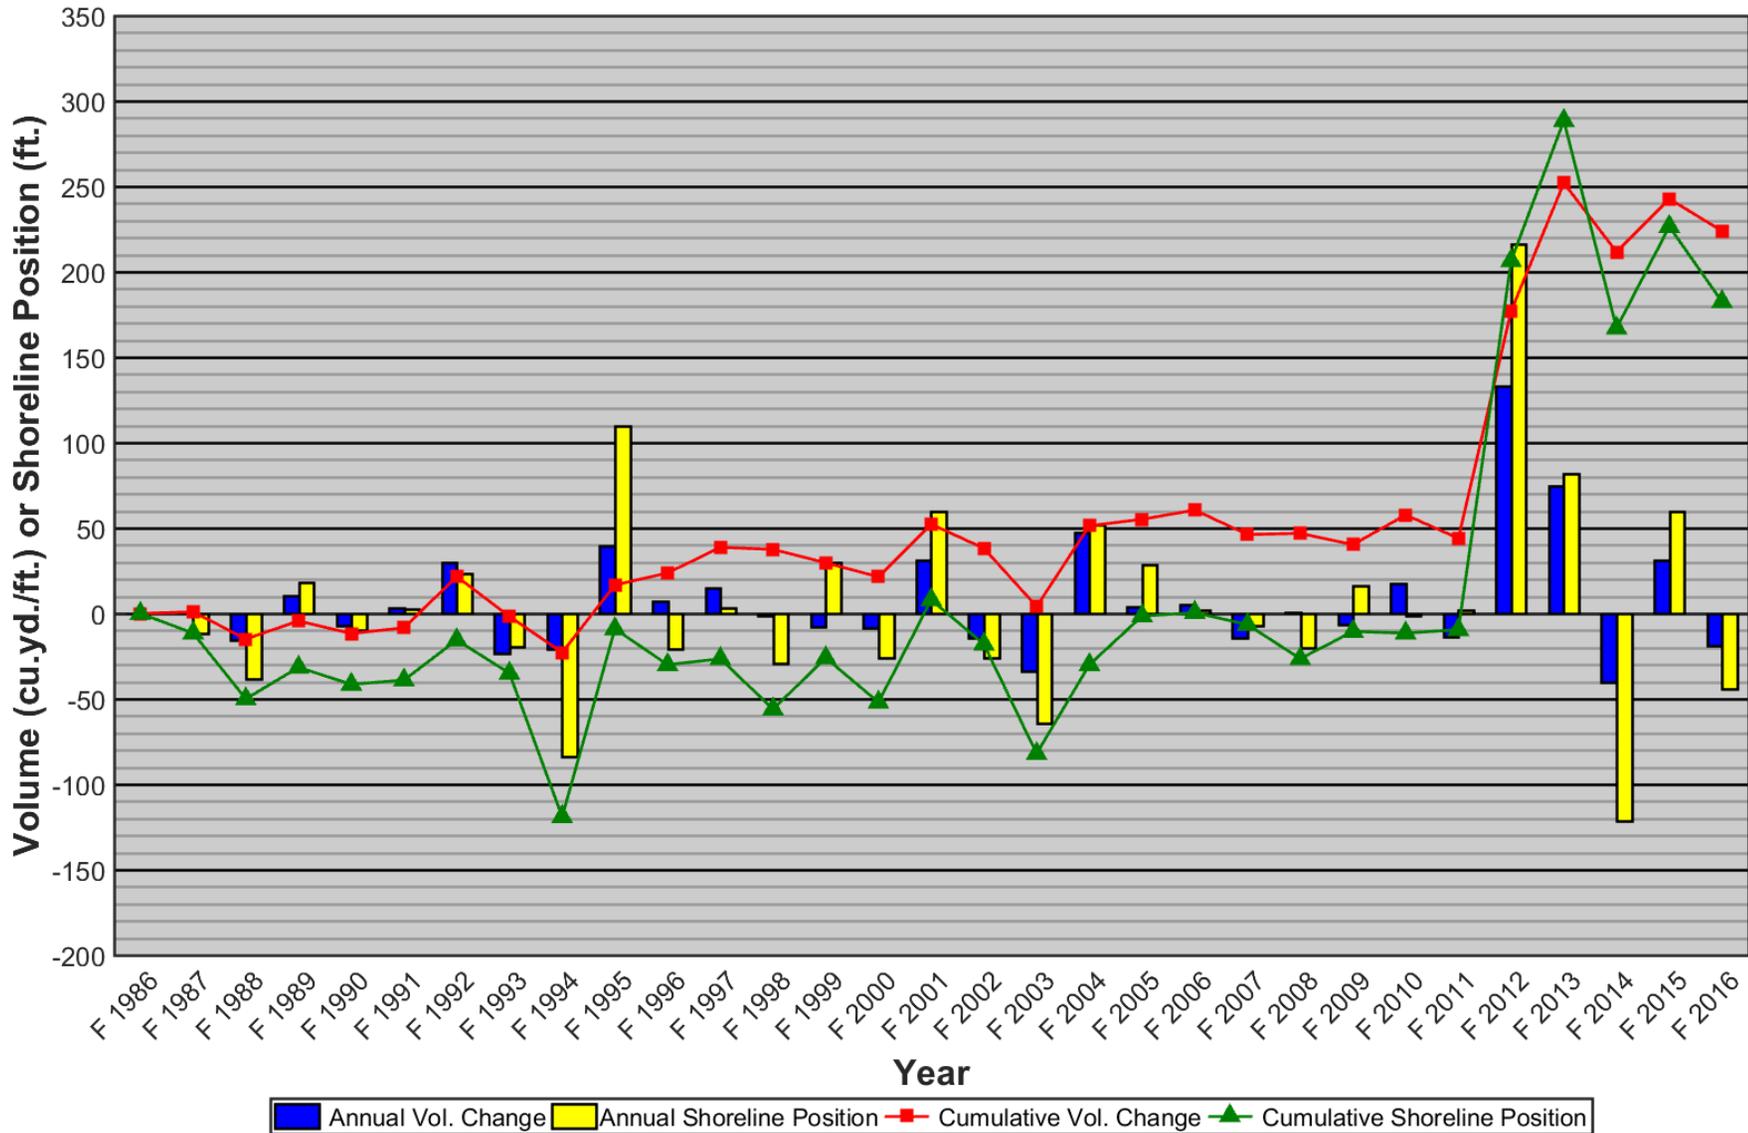
Figure 349. The 32<sup>nd</sup> Street location shows some moderate swings in erosion and accretion prior to nourishment in 2012. This site was included in the post-Sandy federal restoration in summer 2013 and the losses found in 2014 are probably due to profile adjustment. Note that the fall 2012 survey was completed one month prior to Hurricane Sandy and only a few months following the 2012 beach fill. This site has benefited from the federal project because the shoreline has advanced 184 ft seaward while the sand volume increased by 225 yds<sup>3</sup>/ft since 2012.

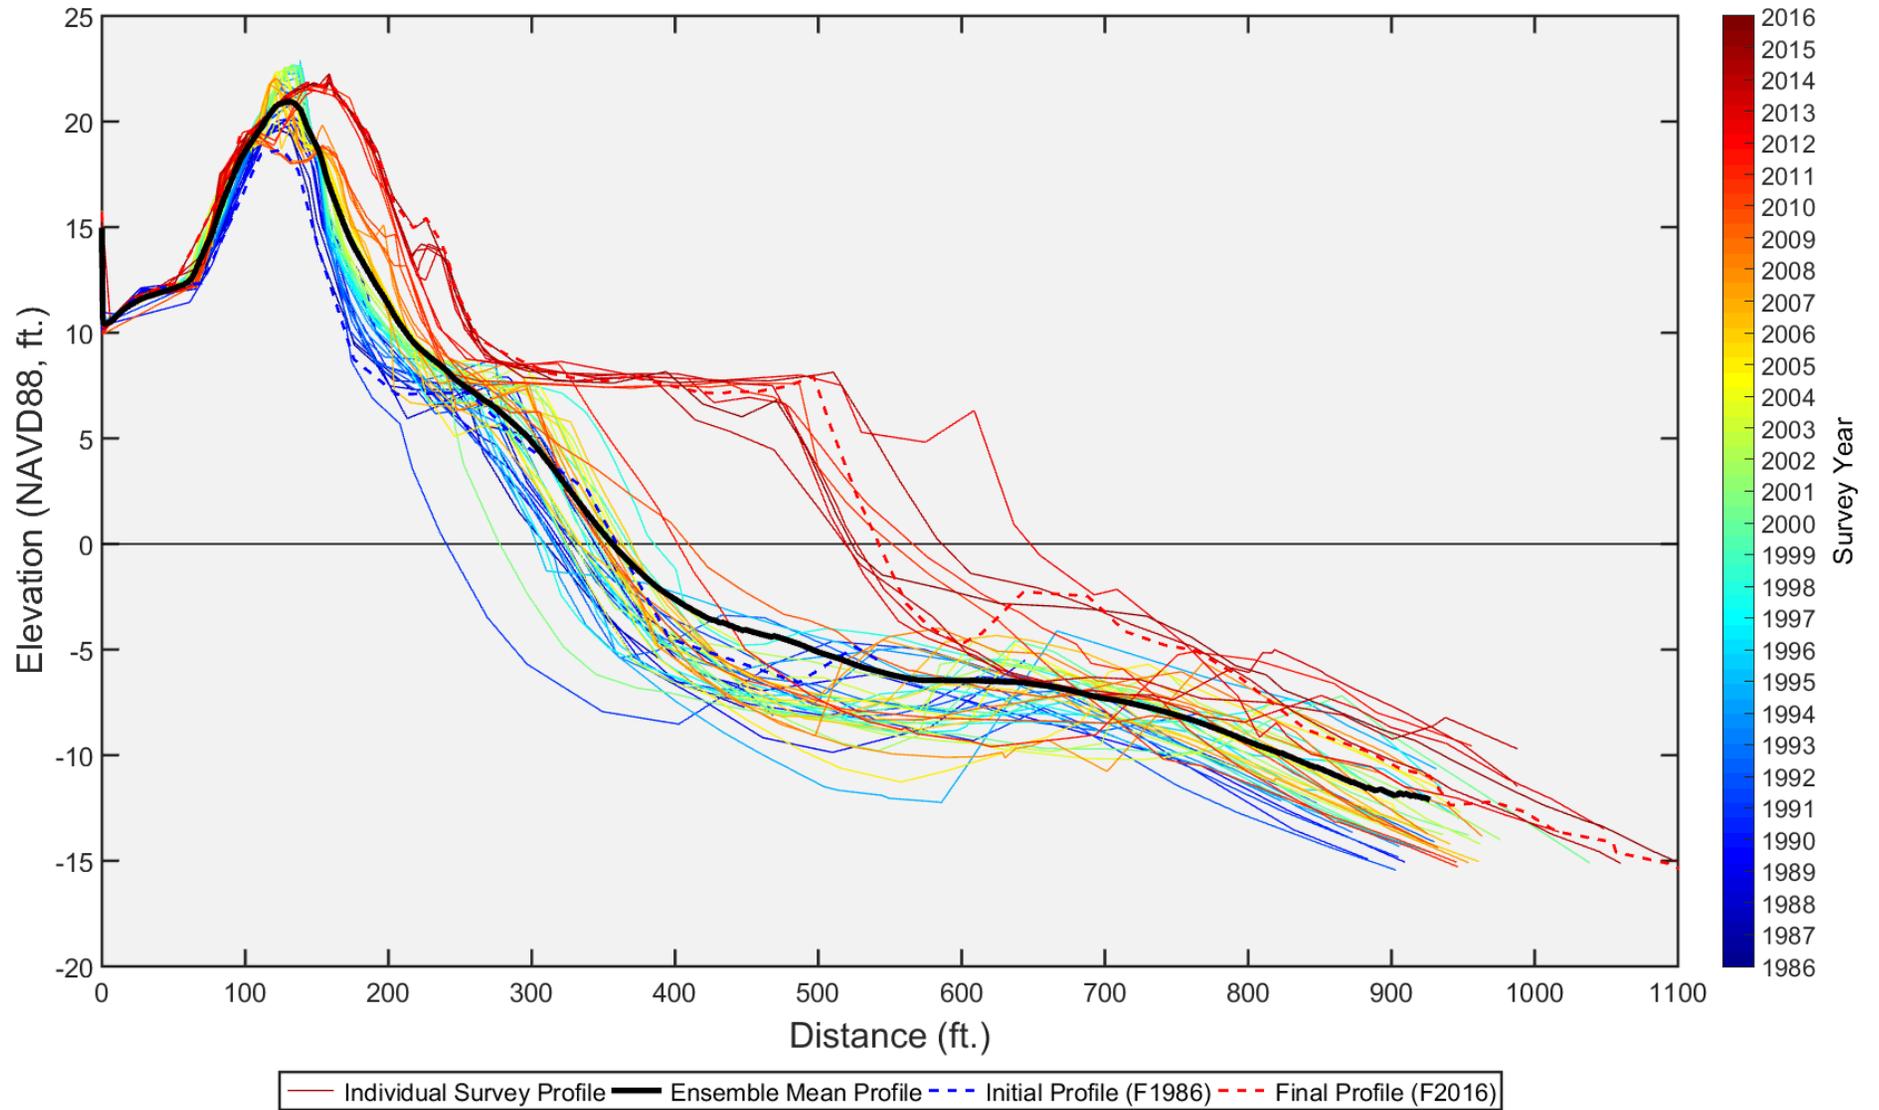
Figure 350. The profile time series at 32<sup>nd</sup> Street shows variability of the berm location and elevation until the construction of the federal shore protection in 2012. The original dune has remained in relatively the same position and was increased to the design template standard (approximately 22 ft NAVD88).

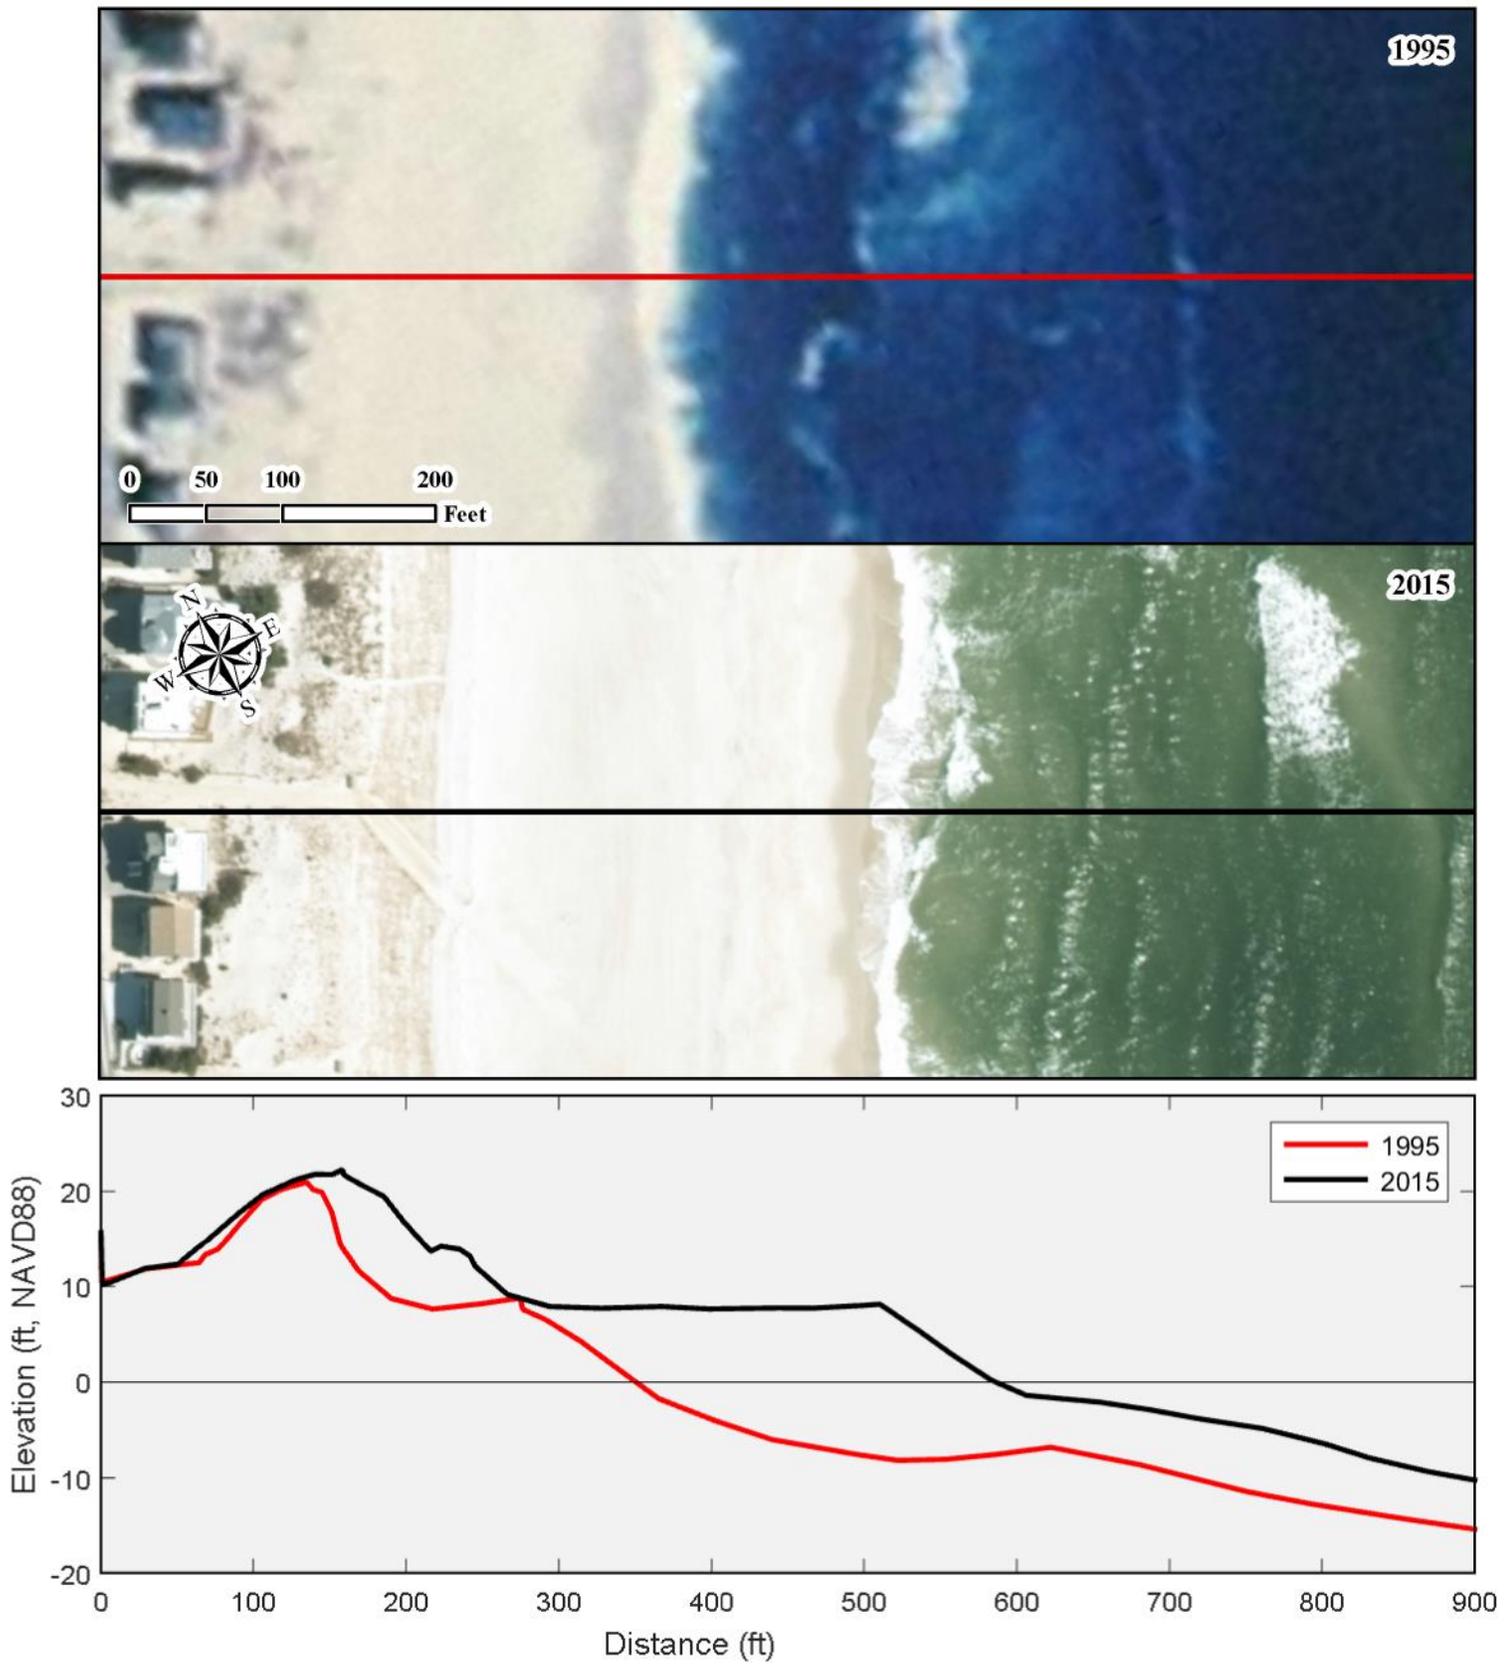
Figure 351. The profile comparison shows the inclusion of the 1995 dune into the engineered dune design. Between 1995 and 2015, the shoreline moved seaward by 236 ft.
