## An Analysis of Thirty Years' Study of Sand Redistribution and Shoreline Changes in New Jersey's Four Coastal Counties Raritan Bay, the Atlantic Ocean Coast, and Delaware Bay Fall 1986 Through Fall 2016

### ***VOLUME 2 of 4 OCEAN COUNTY***

Prepared for:  
New Jersey Department of Environmental Protection  
Division of Coastal Engineering  
1510 Hooper Avenue, Toms River, New Jersey 08753

Prepared by:  
Stockton University Coastal Research Center  
30 Wilson Avenue, Port Republic, NJ 08241

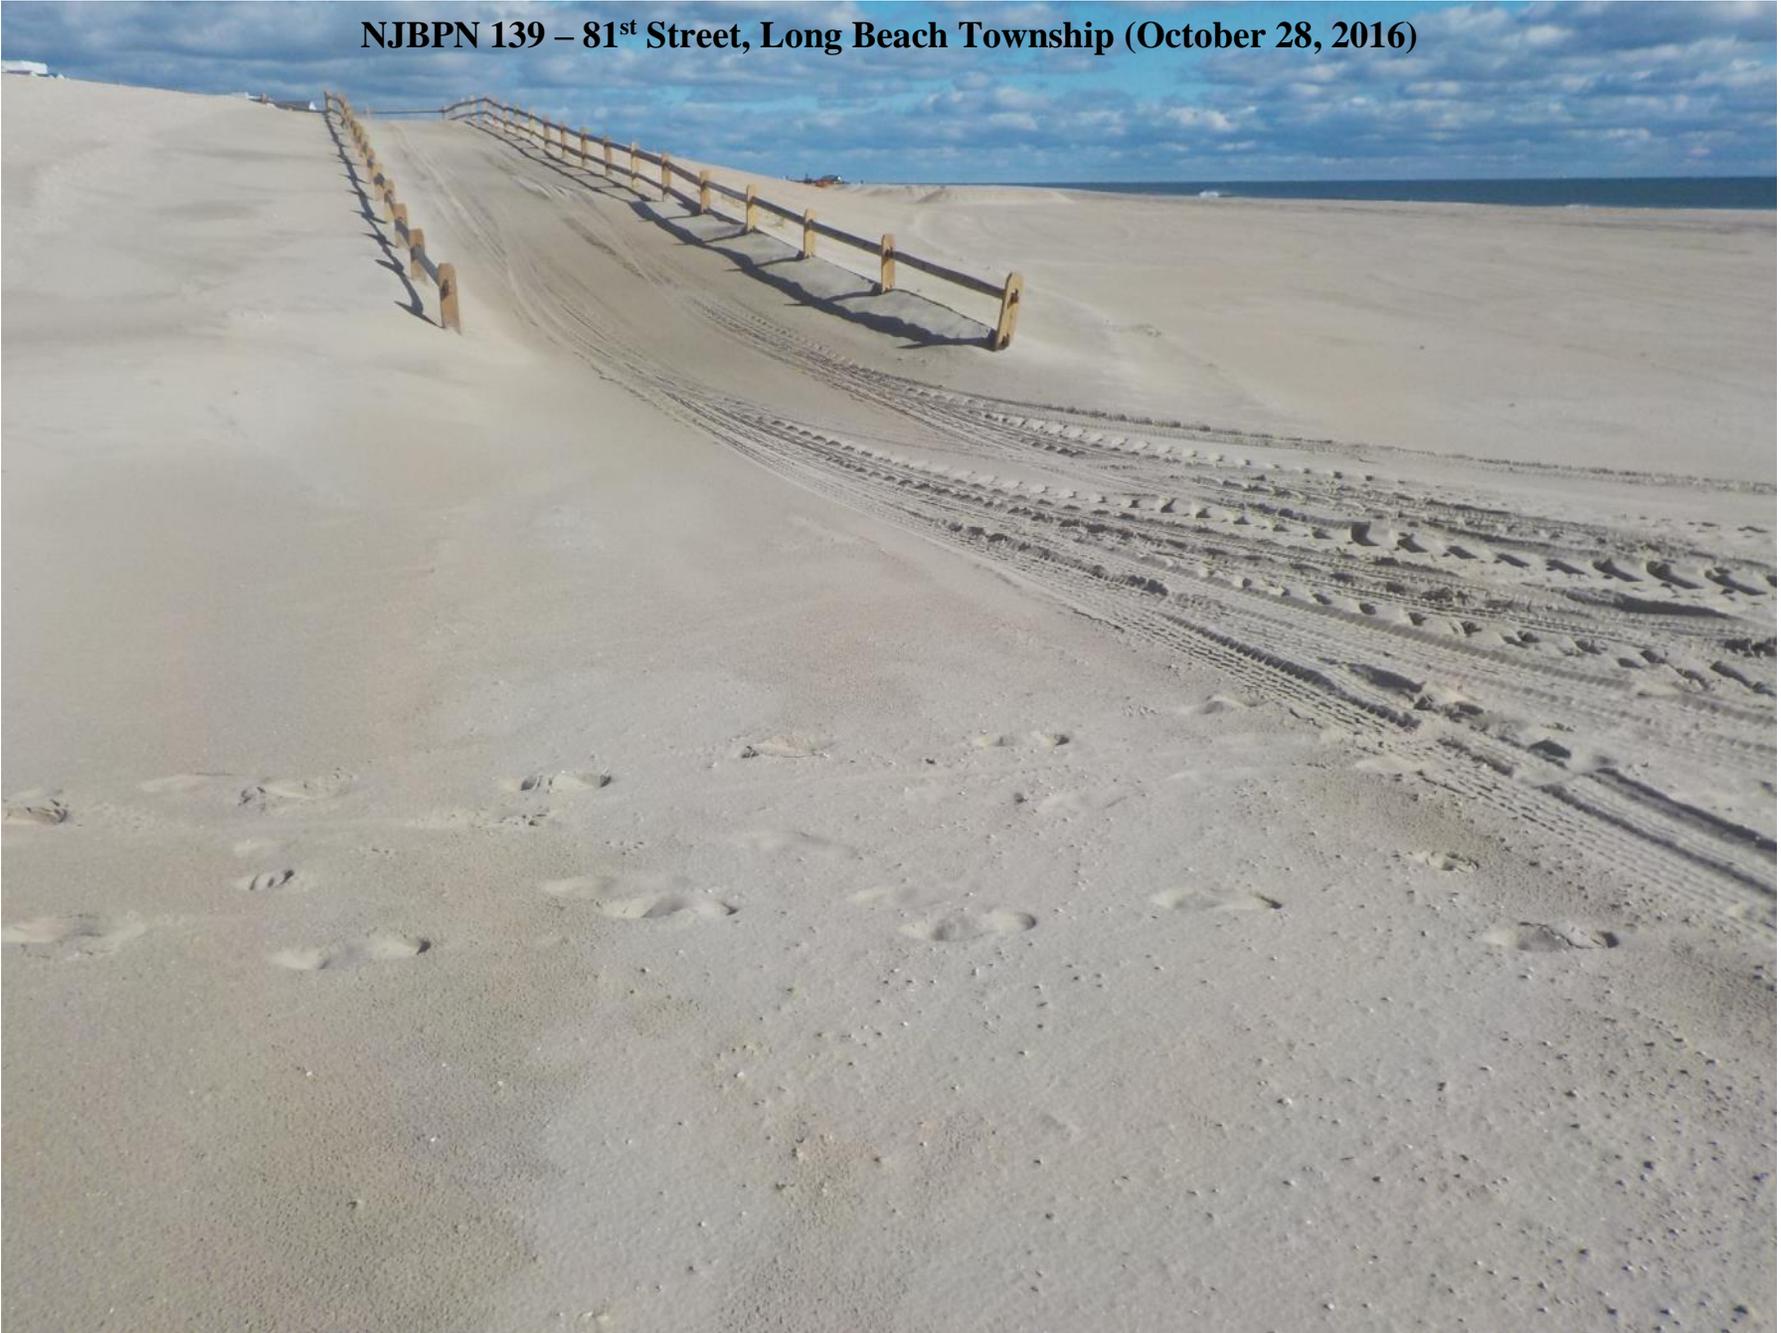
**NJBPN 139 – 81<sup>st</sup> Street, Long Beach Township (October 28, 2016)**

**Figure 352. View to the north from the dune toe and vehicular access at 81<sup>st</sup> Street in Long Beach Township.**

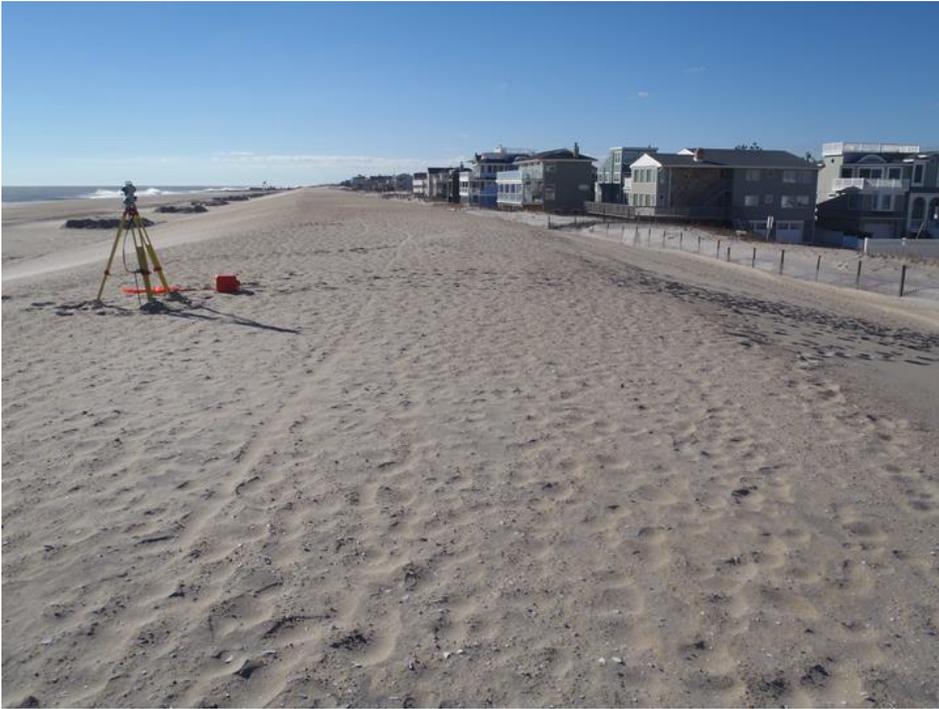
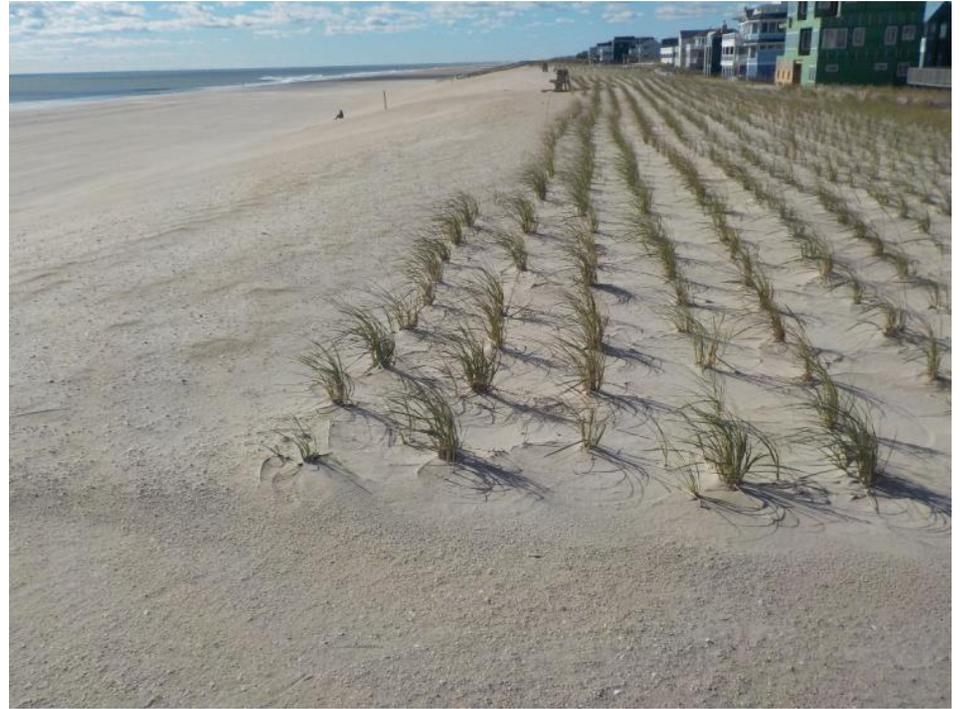
**NJBPN 139 – 81<sup>st</sup> Street, Long Beach Township**

**Figure 353a & 353b. The view from the dune crest at the 81<sup>st</sup> Street location shows the newly constructed dune in 2015 (left photo taken December 15, 2015) and the dune with partially planted vegetation (right photo taken October 28, 2016). Sand fencing and more planting was set to be completed shortly after the picture was taken.**

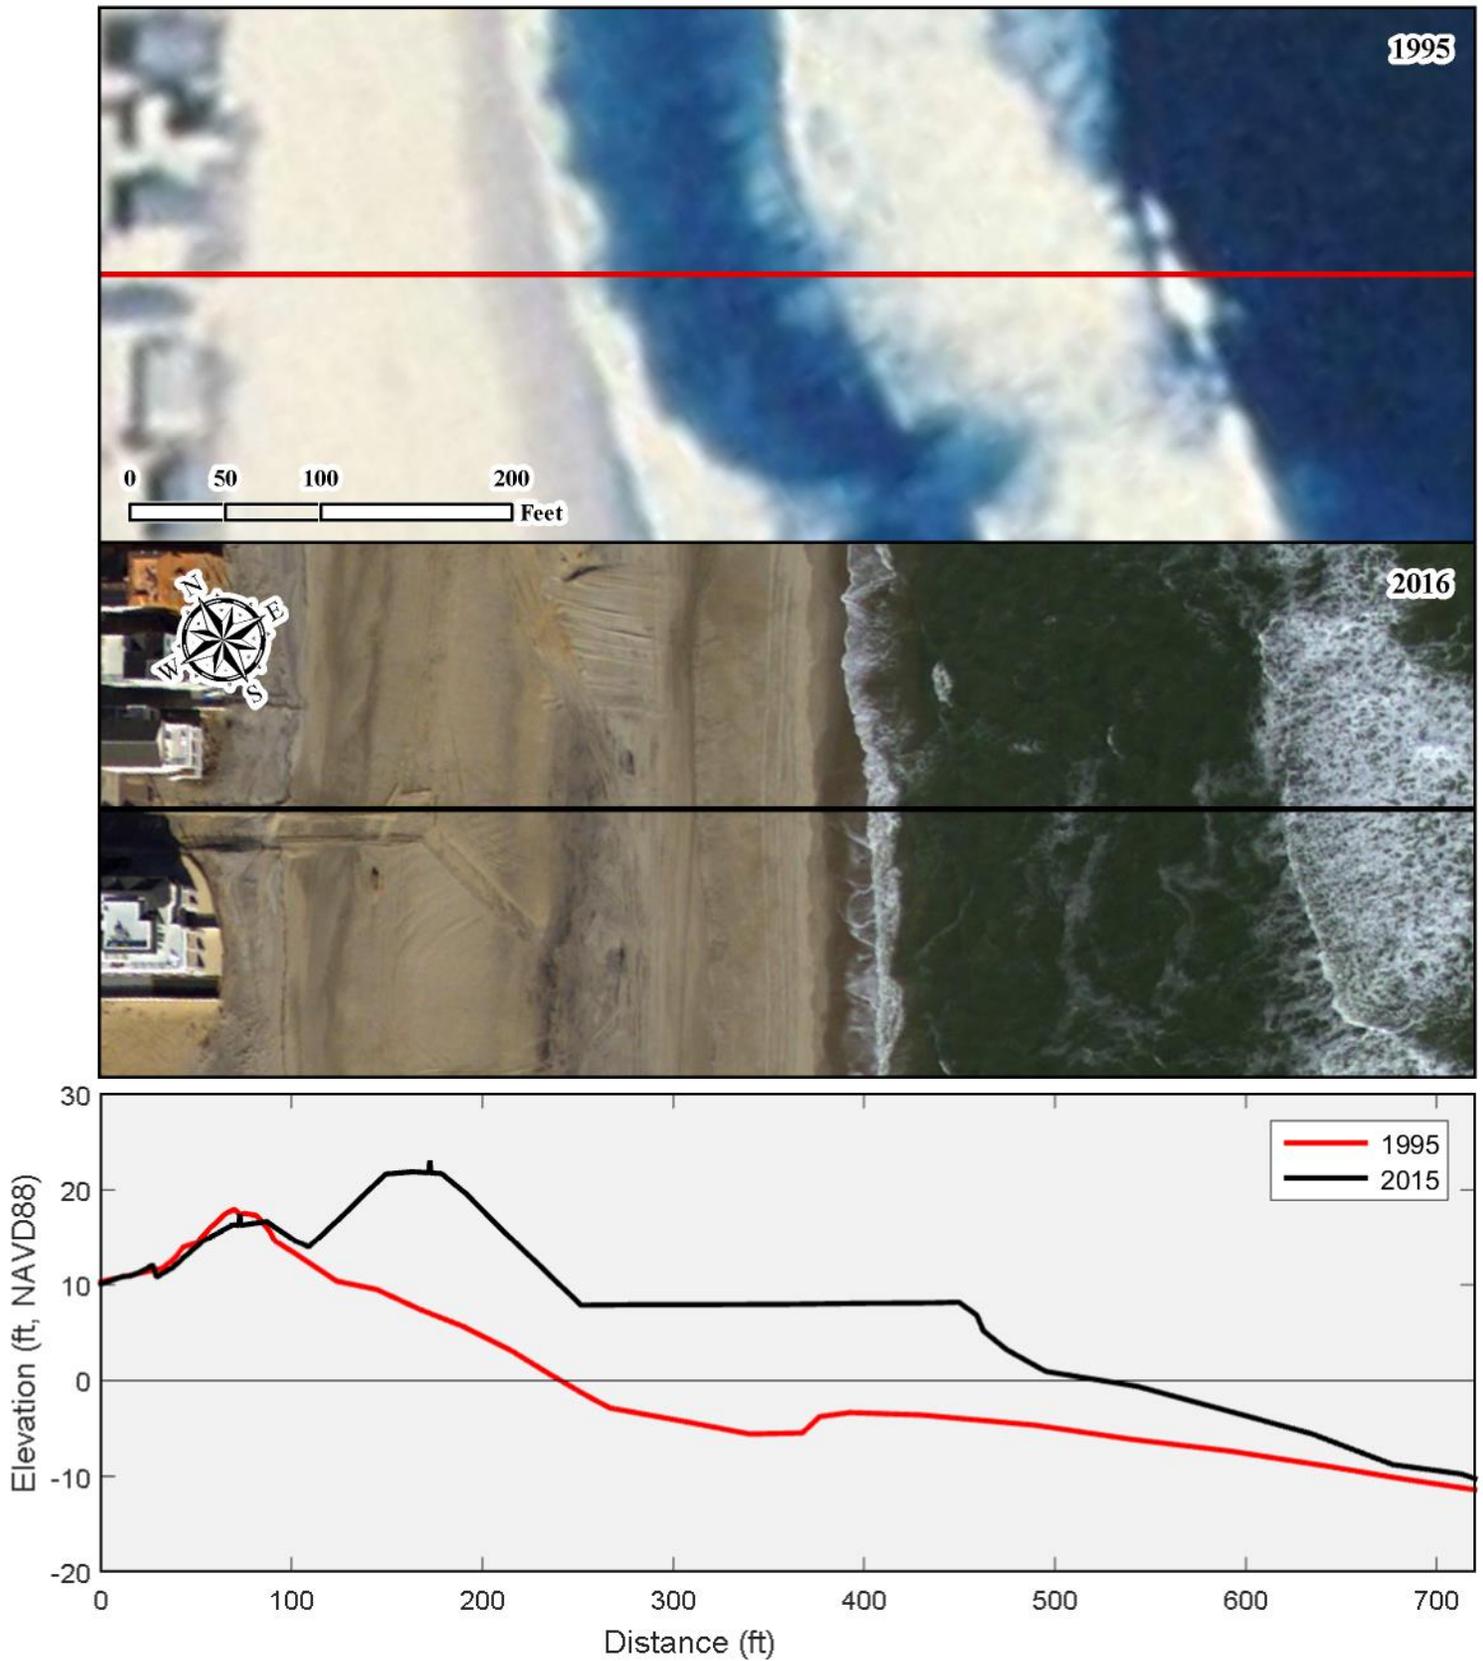
Figure 357. The 2015 federal shore protection project raised the dune elevation and moved it seaward by 283 ft from its 1995 position due to the beach fill.

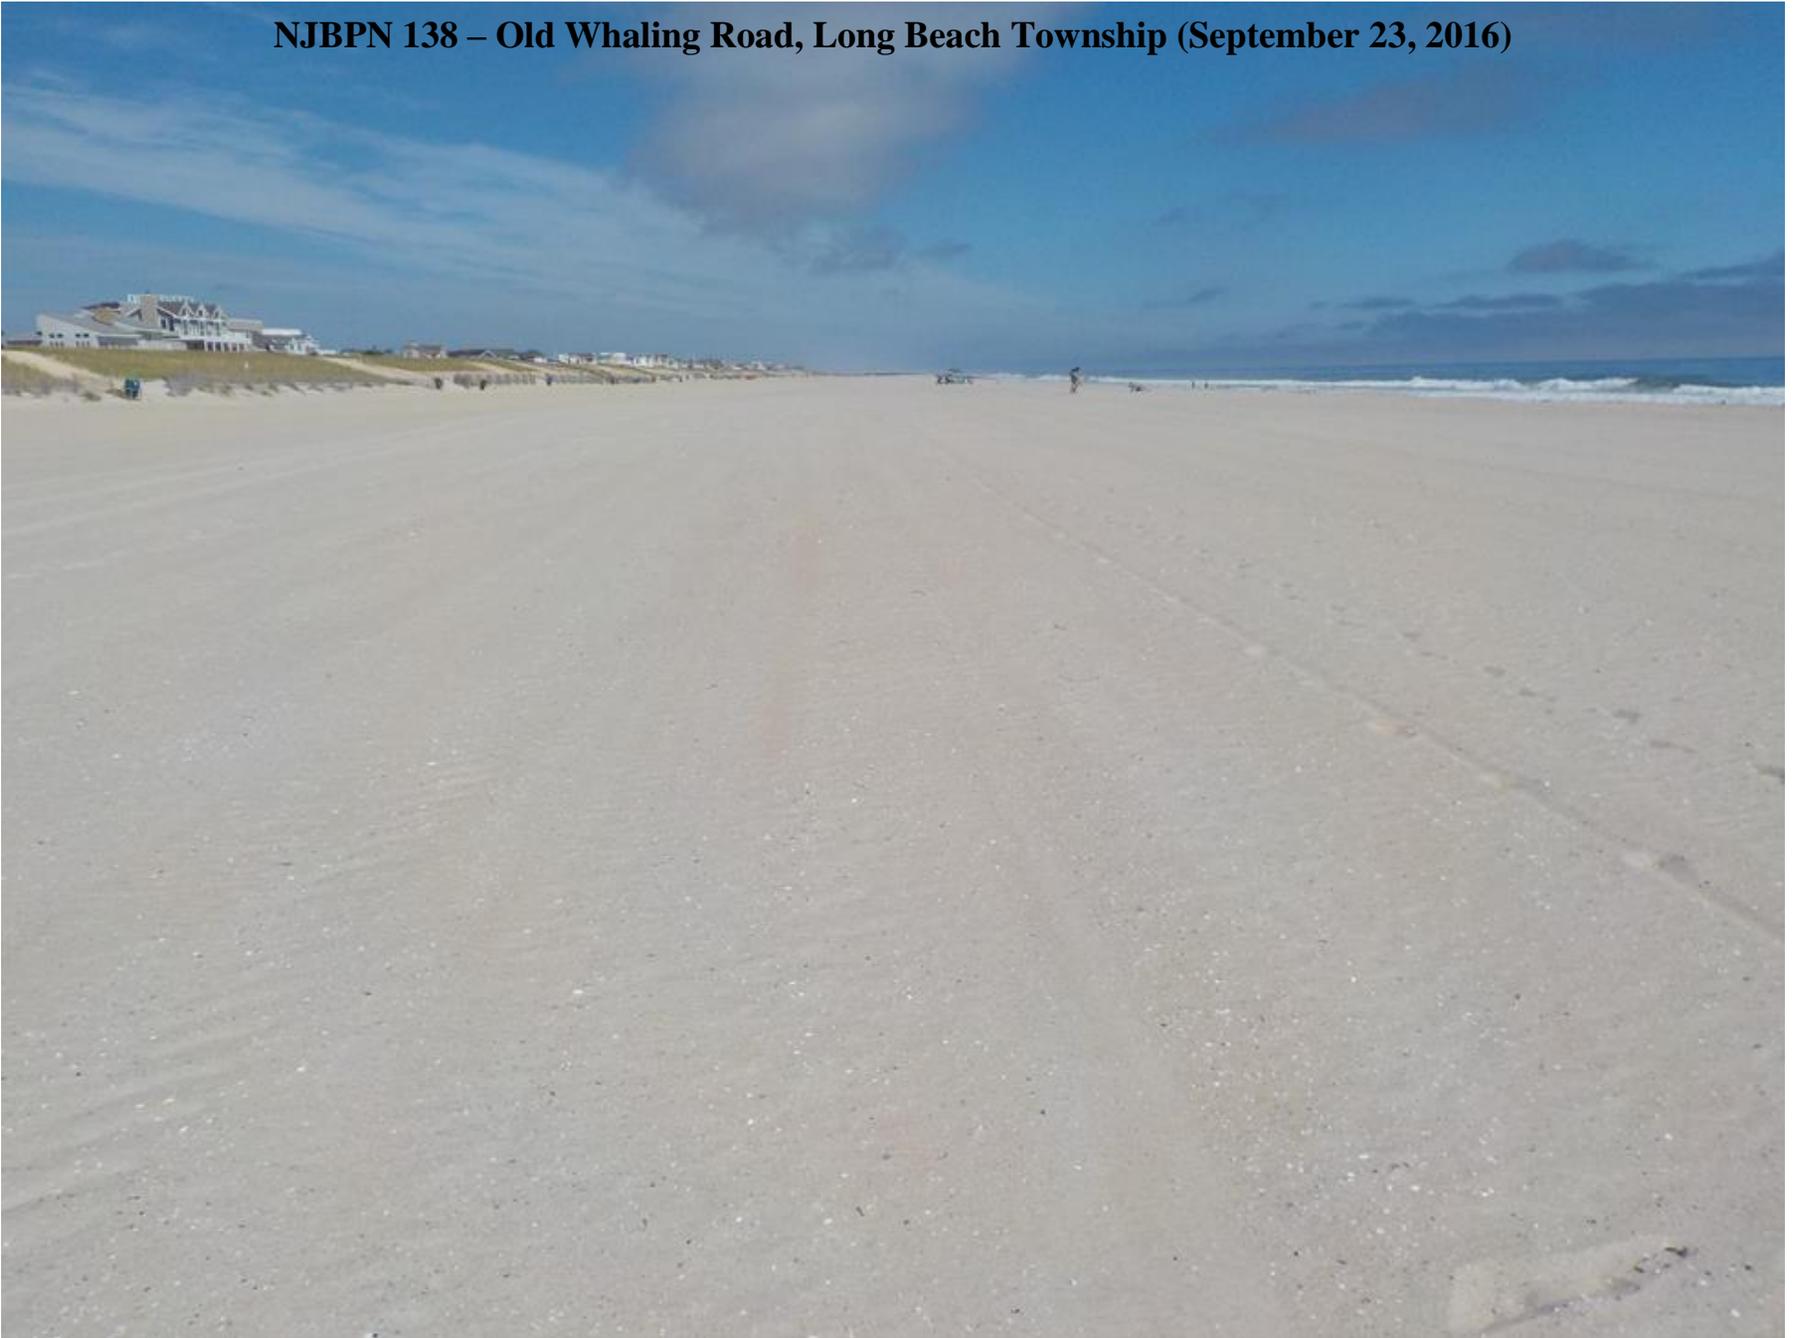
**NJBPN 138 – Old Whaling Road, Long Beach Township (September 23, 2016)**

**Figure 358. View to the north from the berm at Old Whaling Road (124<sup>th</sup> Street) in Long Beach Township.**

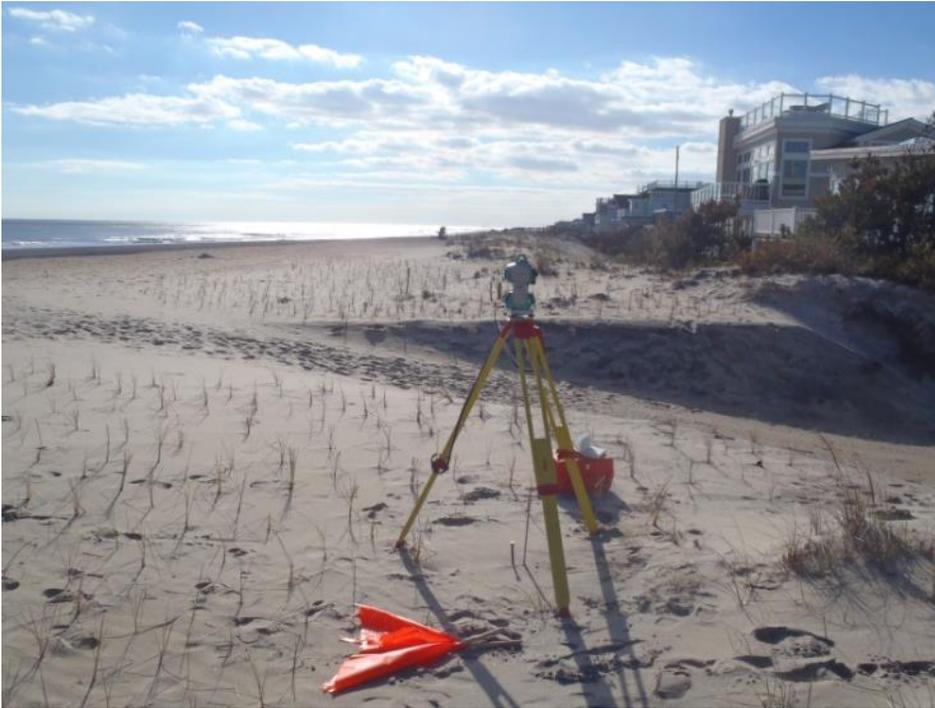
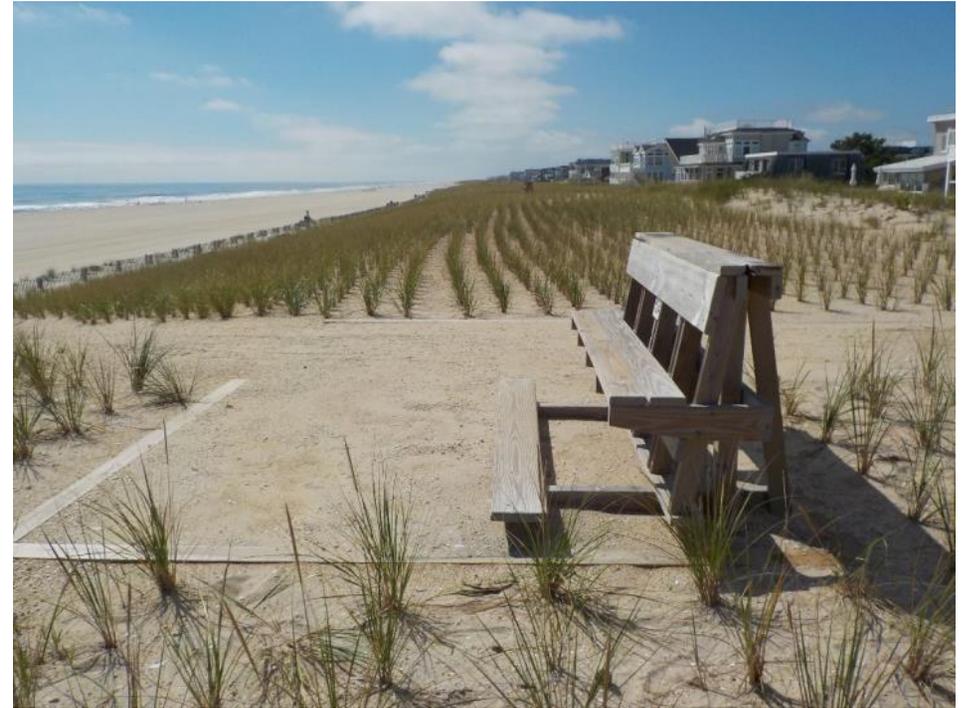
**NJBPN 138 – Old Whaling Road (124<sup>th</sup> Street), Long Beach Township**

**Figure 359a & 359b.** The photos from the top of the dune at 124<sup>th</sup> Street show the changes in the dune vegetation from December 15, 2015 (left) to September 23, 2016 (right). The federal project incorporated the original dune into the engineered design.

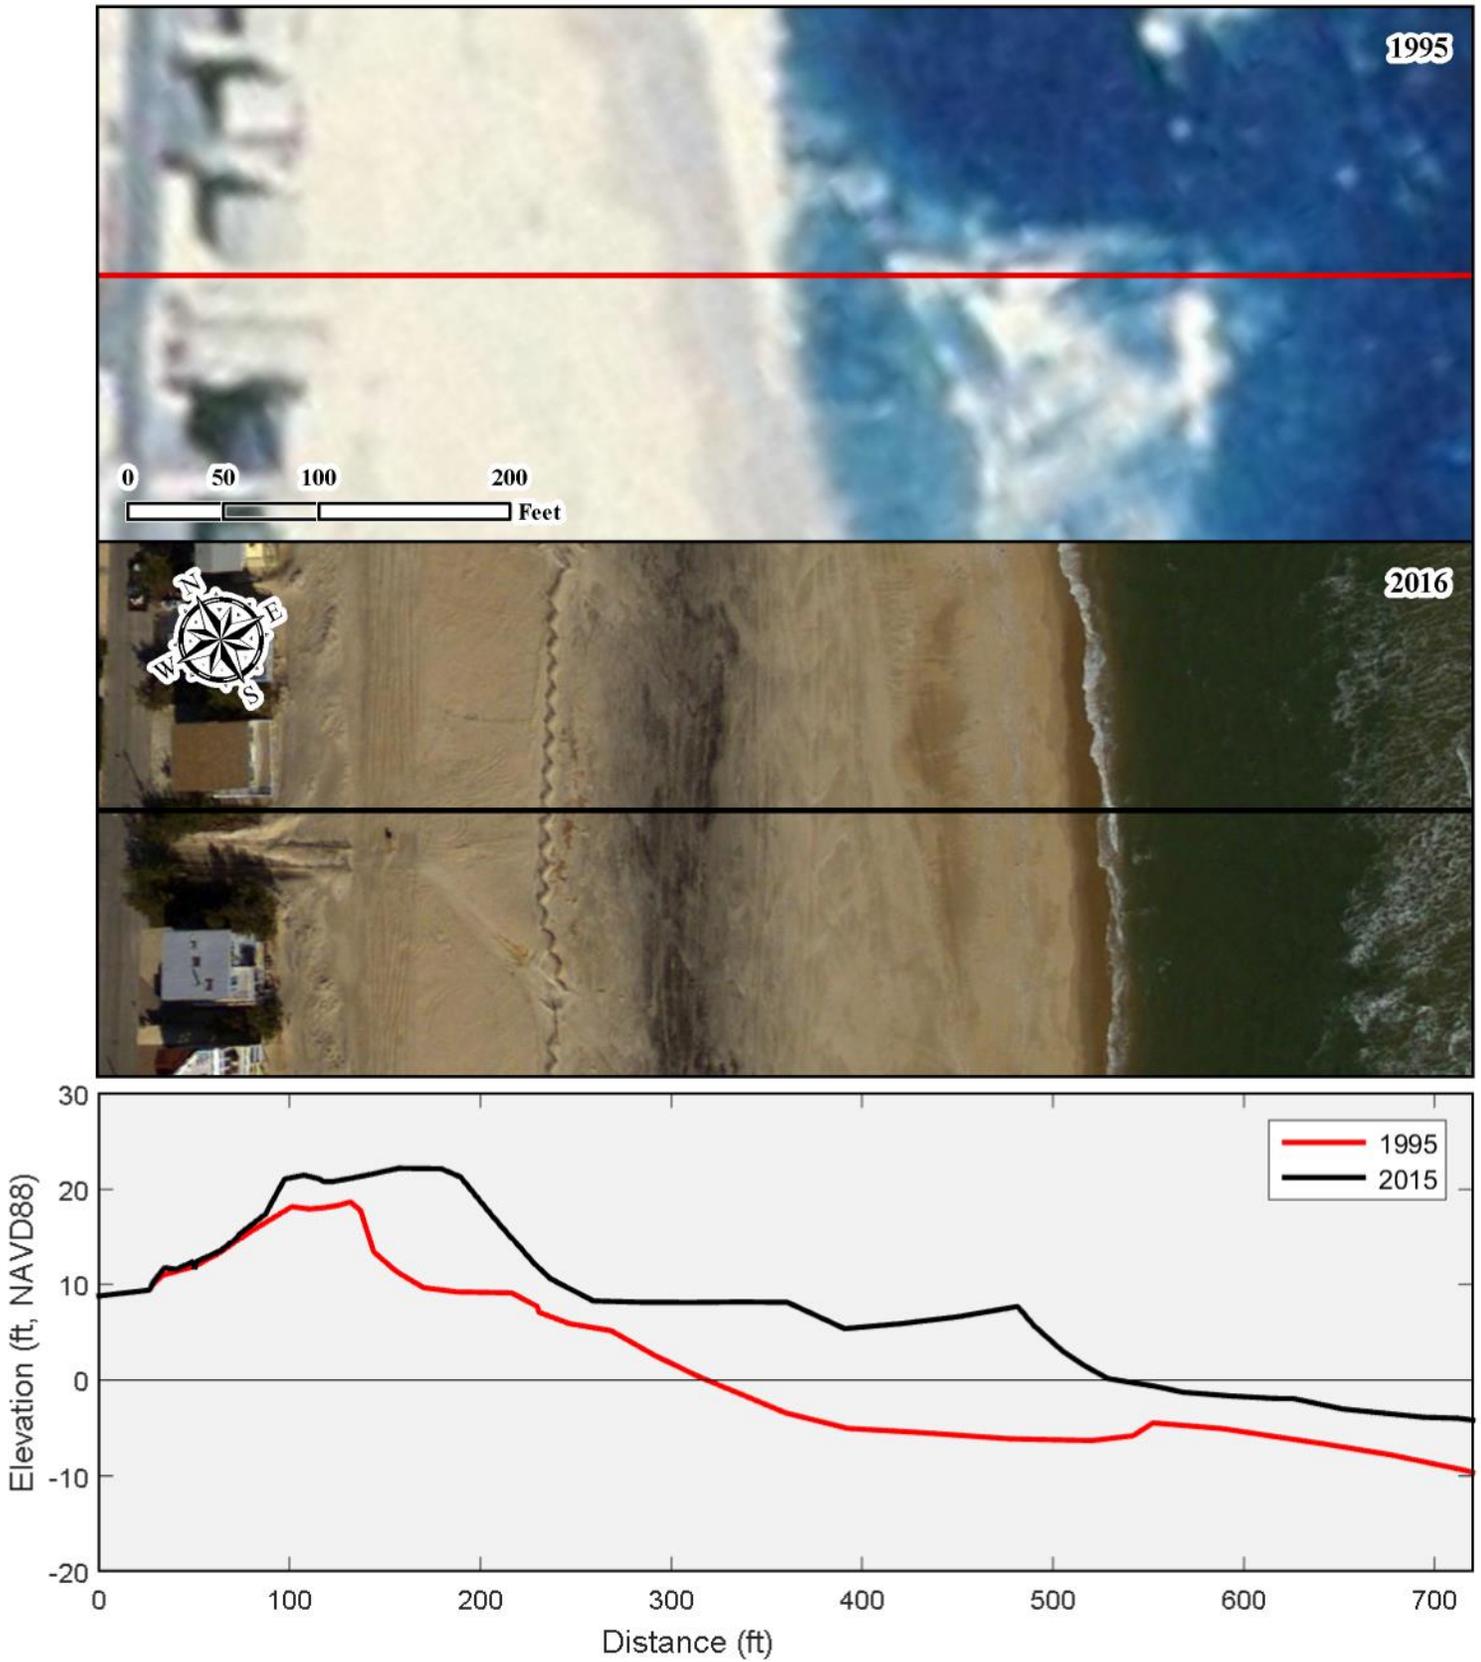
Figure 363. The 2015 profile shows the newly completed engineered dune and berm. The 1995 to 2015 comparison shows a seaward movement of the shoreline by 215 ft.

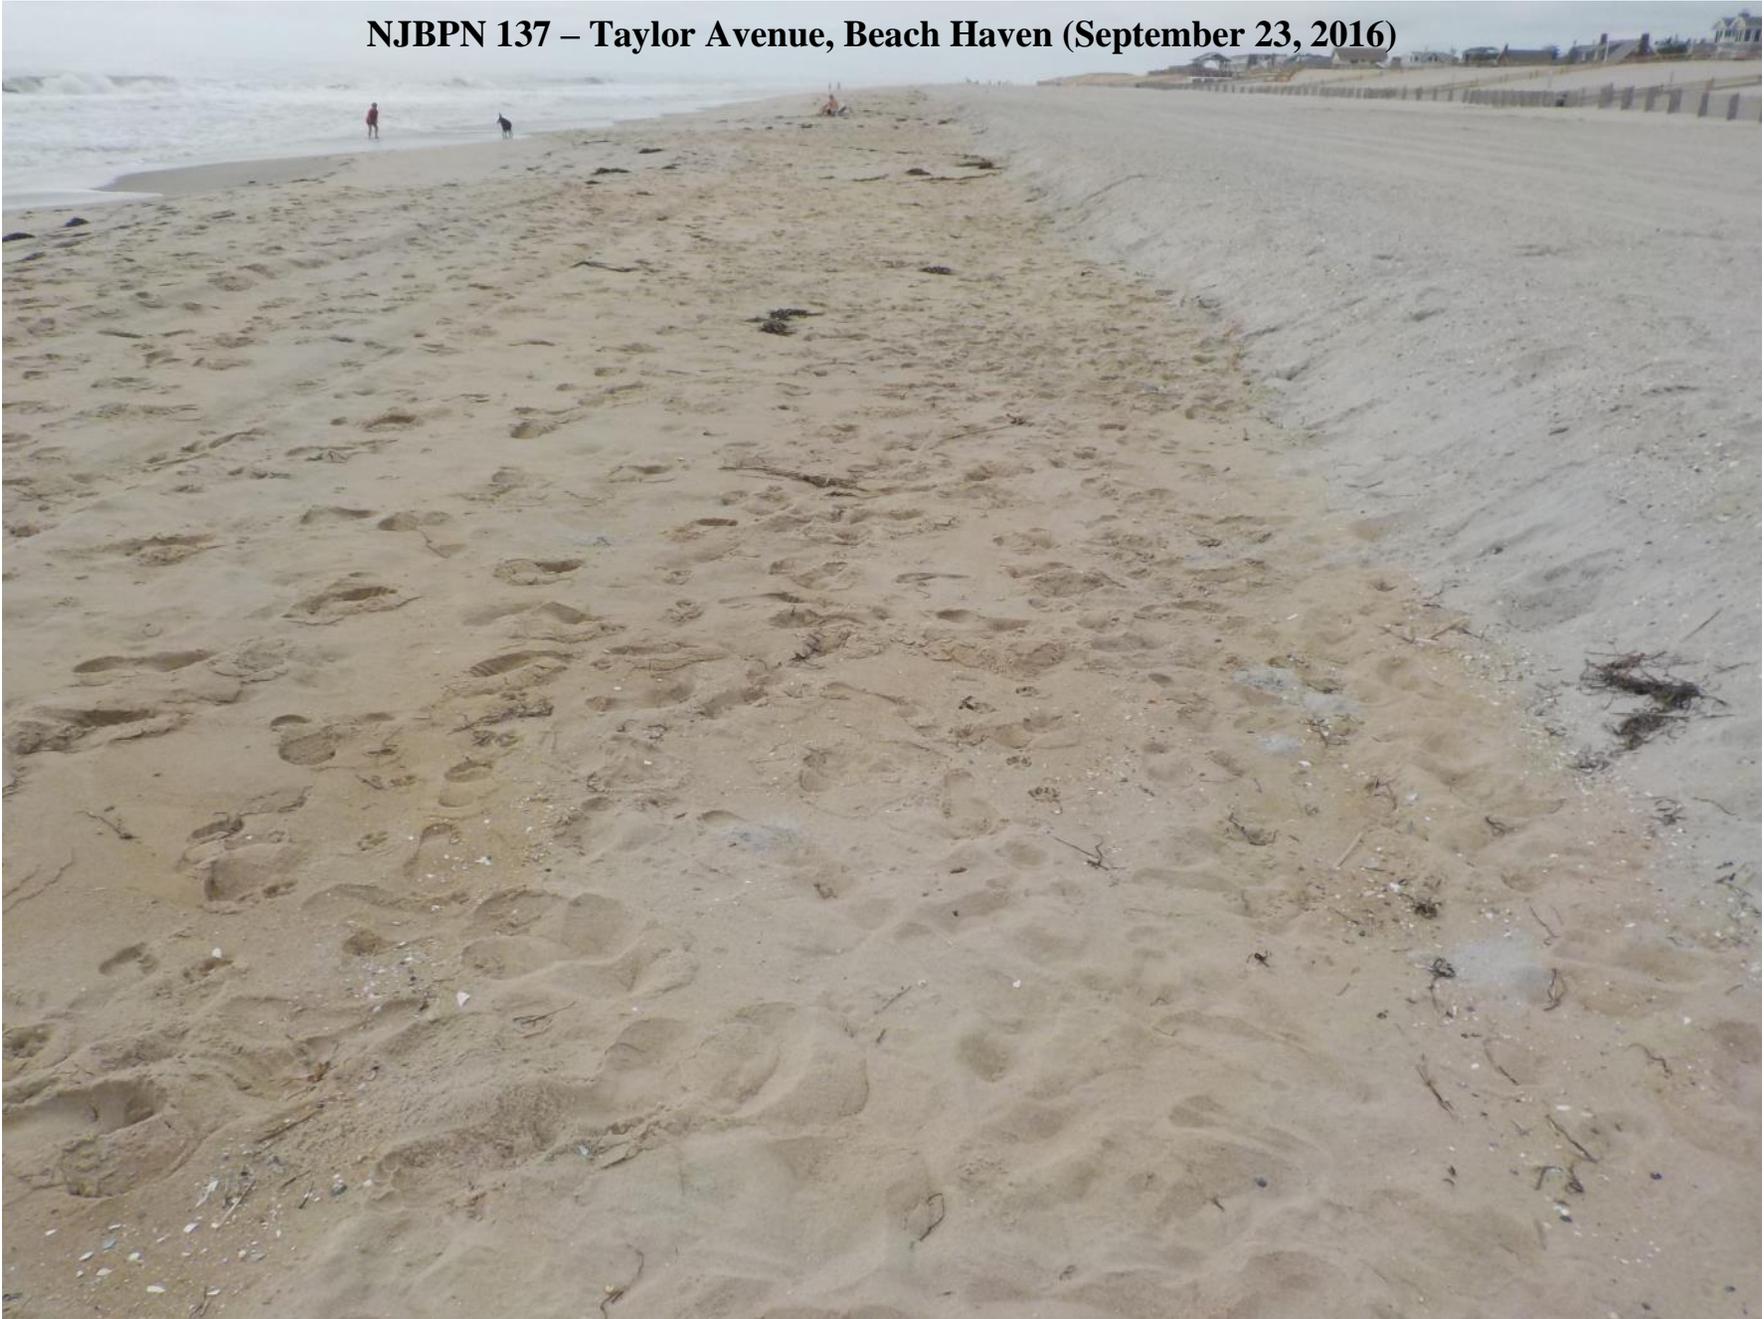
**NJBPN 137 – Taylor Avenue, Beach Haven (September 23, 2016)**

**Figure 364. View to the south from the foreshore at Taylor Avenue in Beach Haven.**

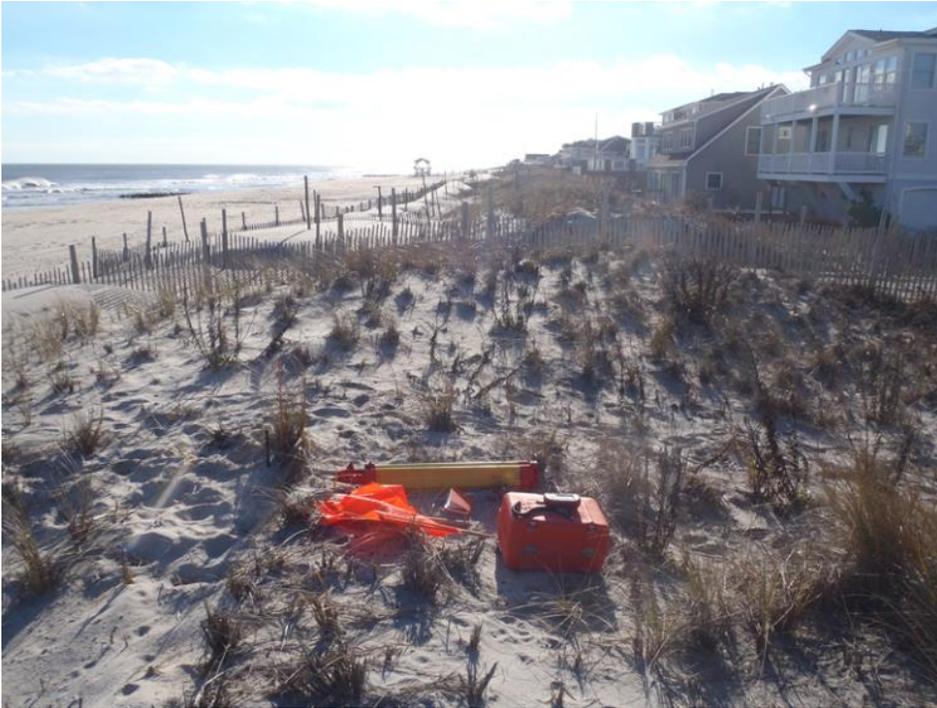
**NJBPN 137 – Taylor Avenue, Beach Haven**

**Figure 365a & 365b. The photos from the Taylor Avenue location were taken from the dune crest (left taken December 15, 2015 and right taken September 23, 2016). The engineered dune was completed at this location in spring 2016 but not yet planted by the time of the fall survey.**

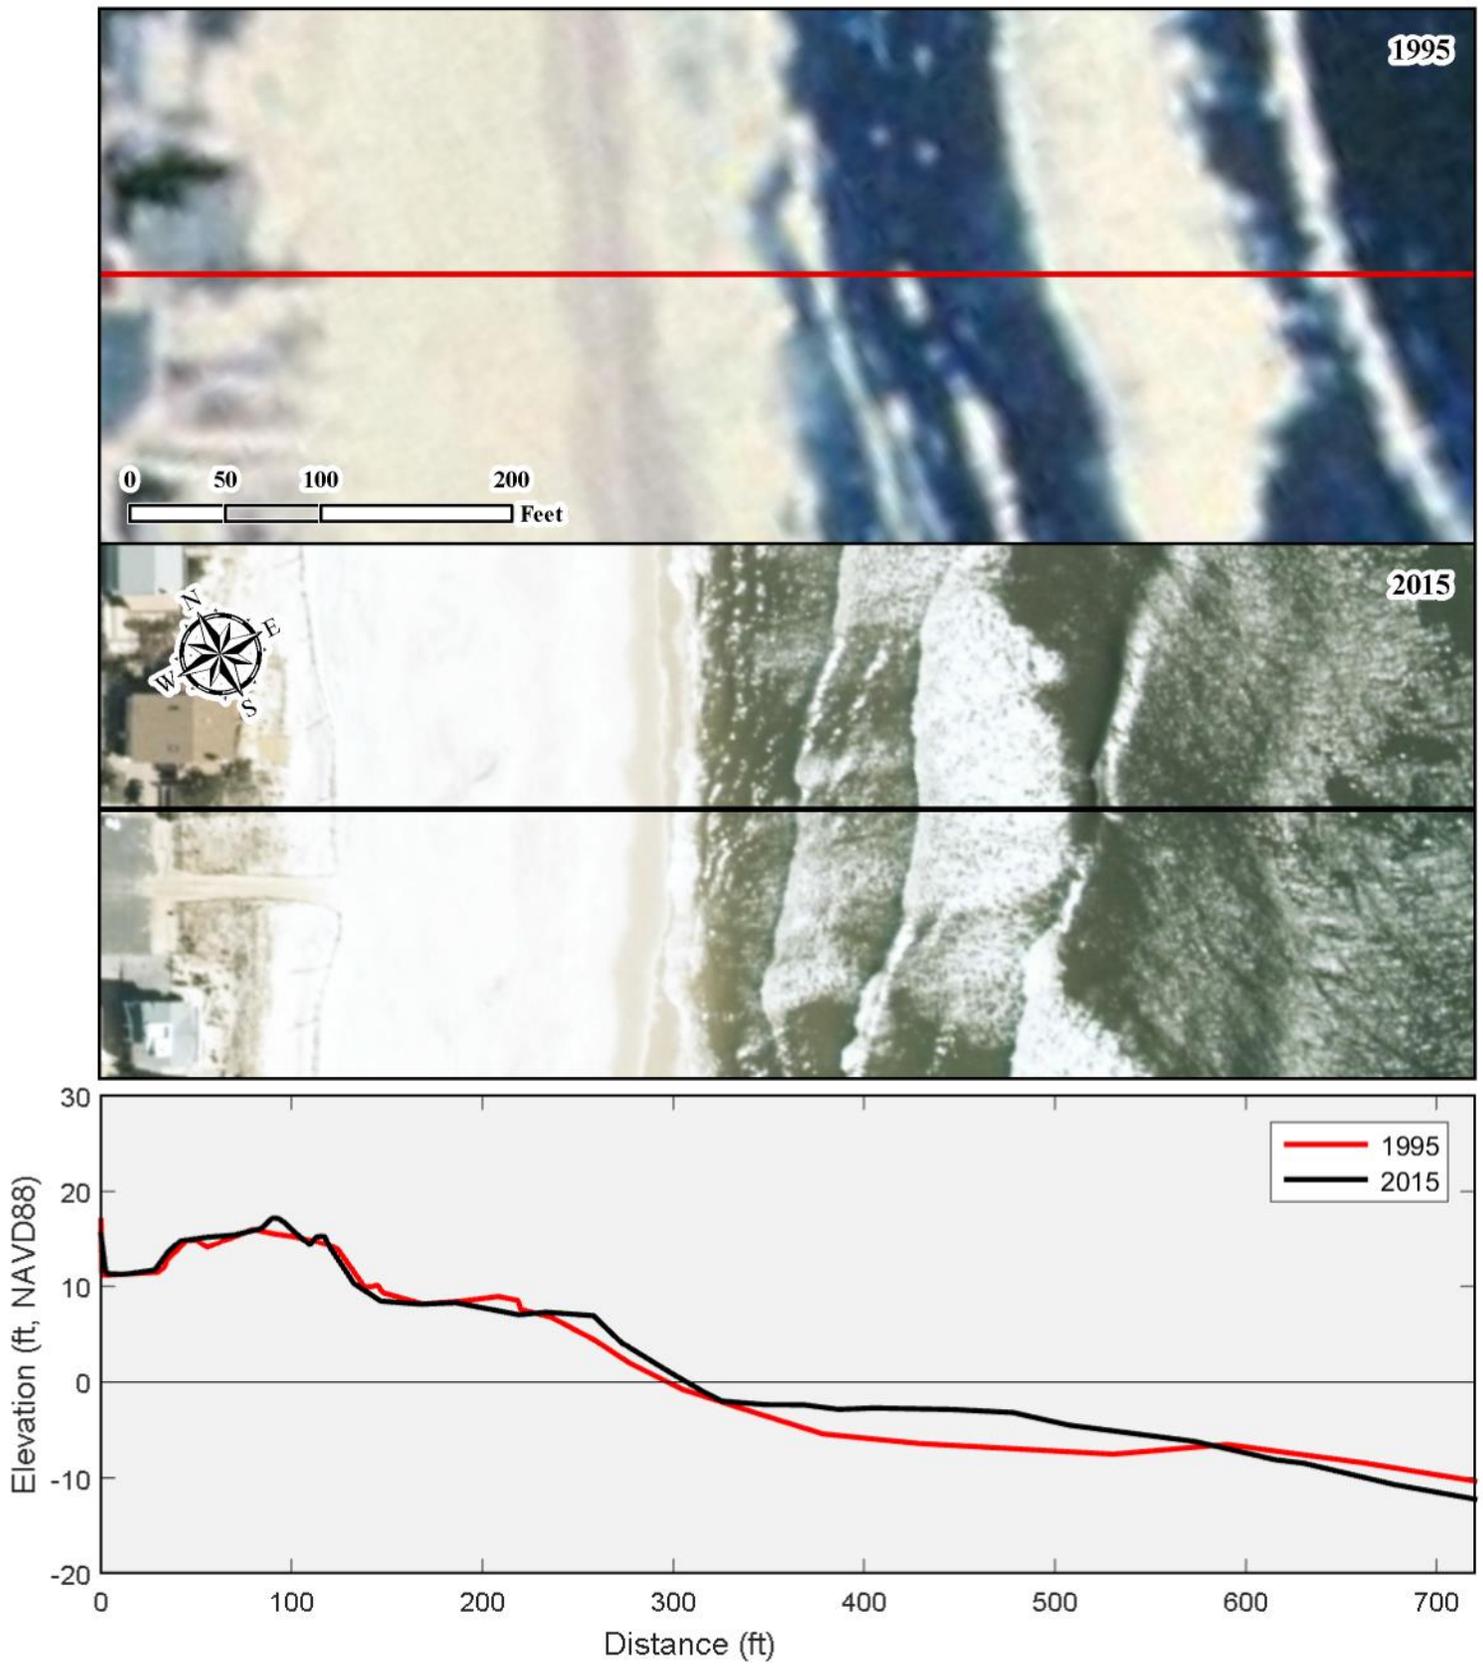
Figure 369. The 2015 profile was measured prior to the federal shore protection project. Between 1995 and 2015, the shoreline moved seaward by 10 ft.

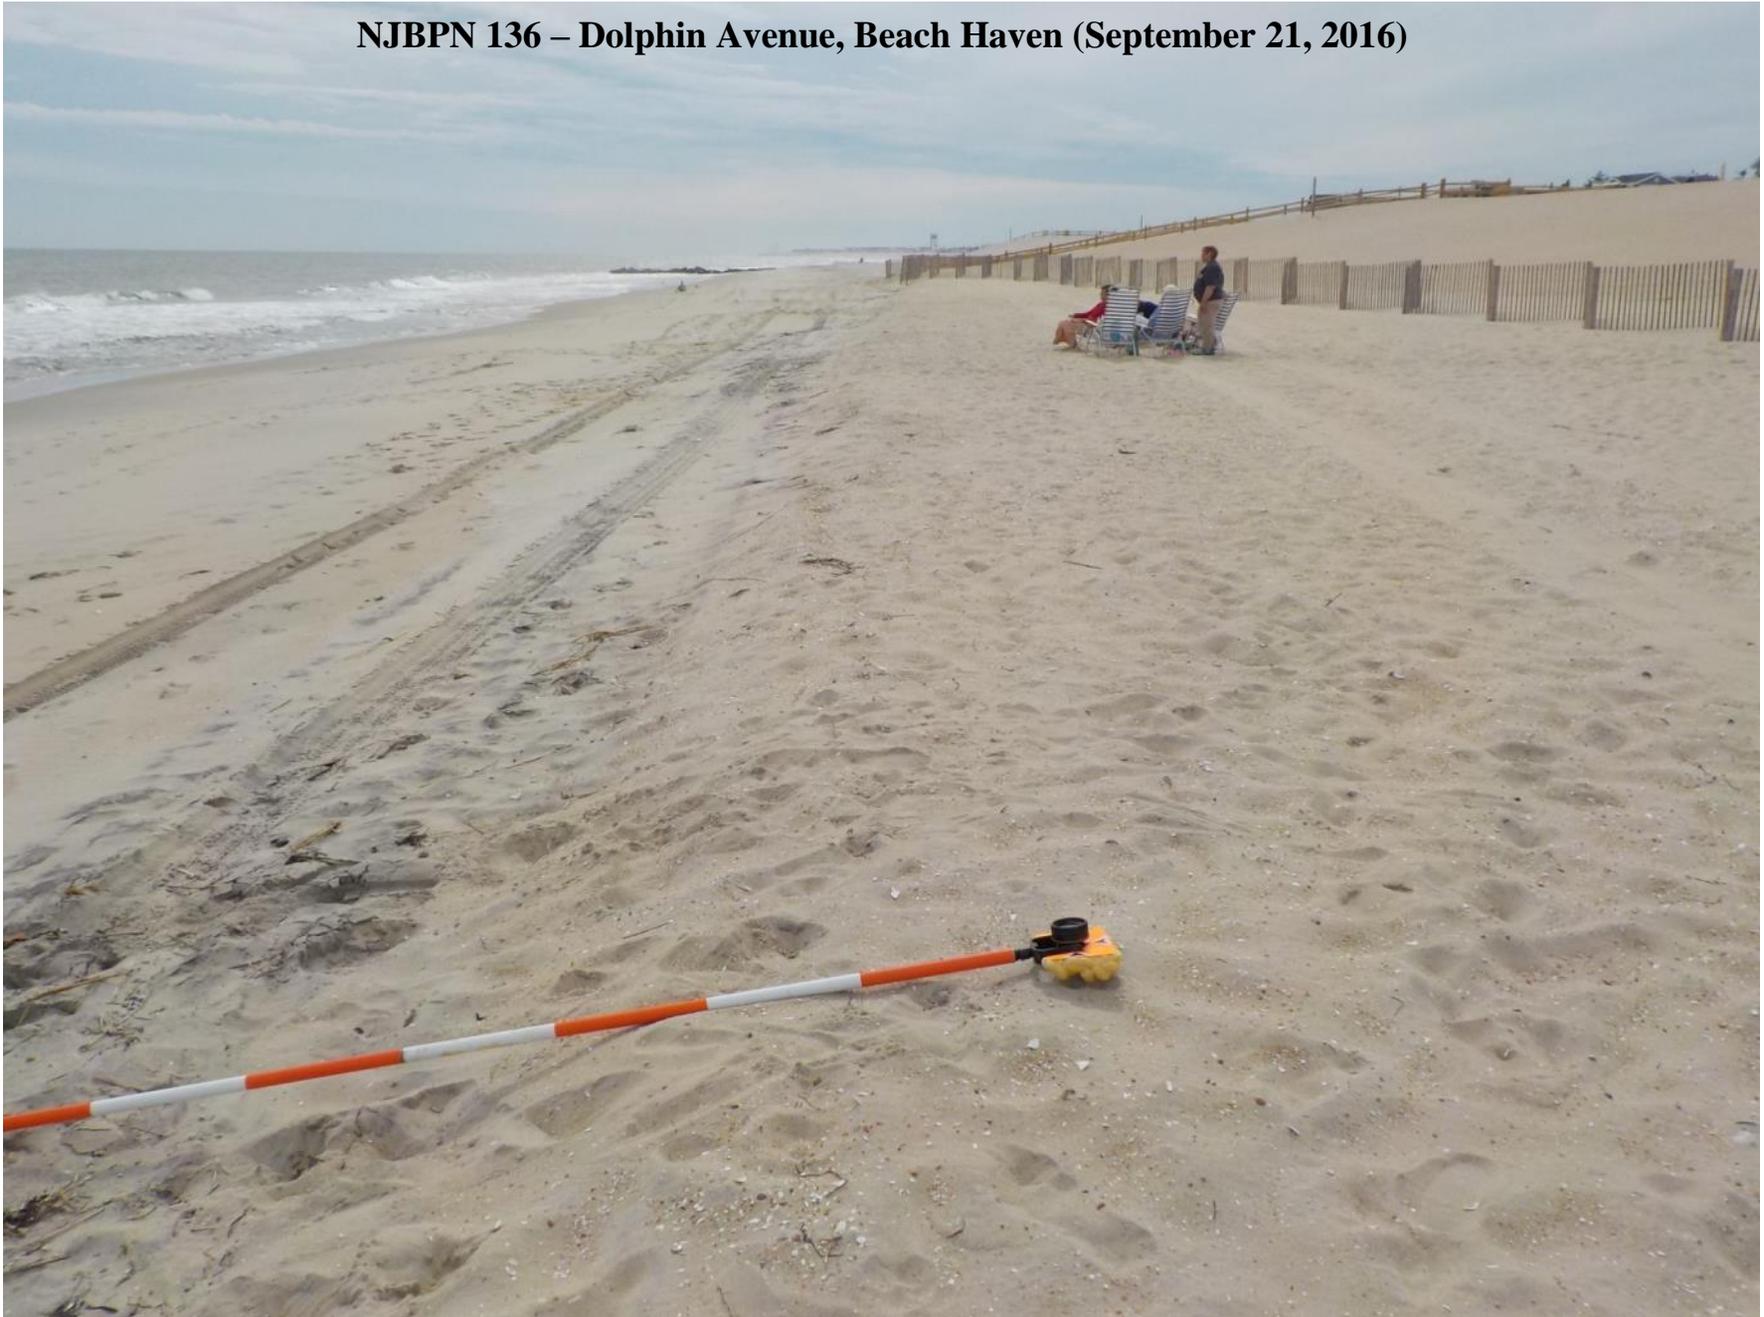
**NJBPN 136 – Dolphin Avenue, Beach Haven (September 21, 2016)**

**Figure 370. View to the south from the berm at Dolphin Avenue in Beach Haven.**

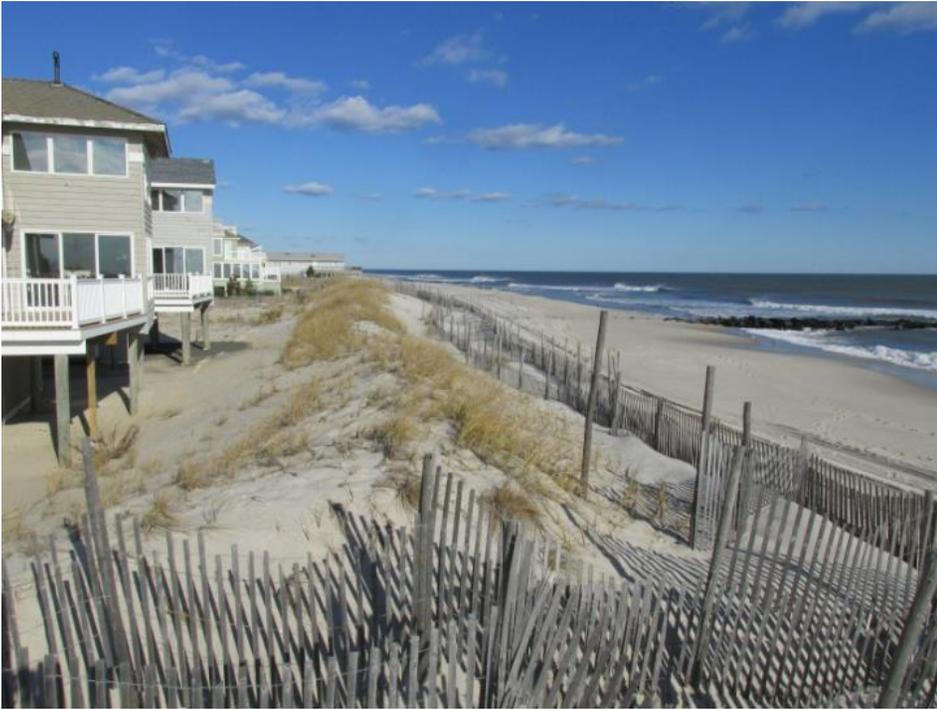
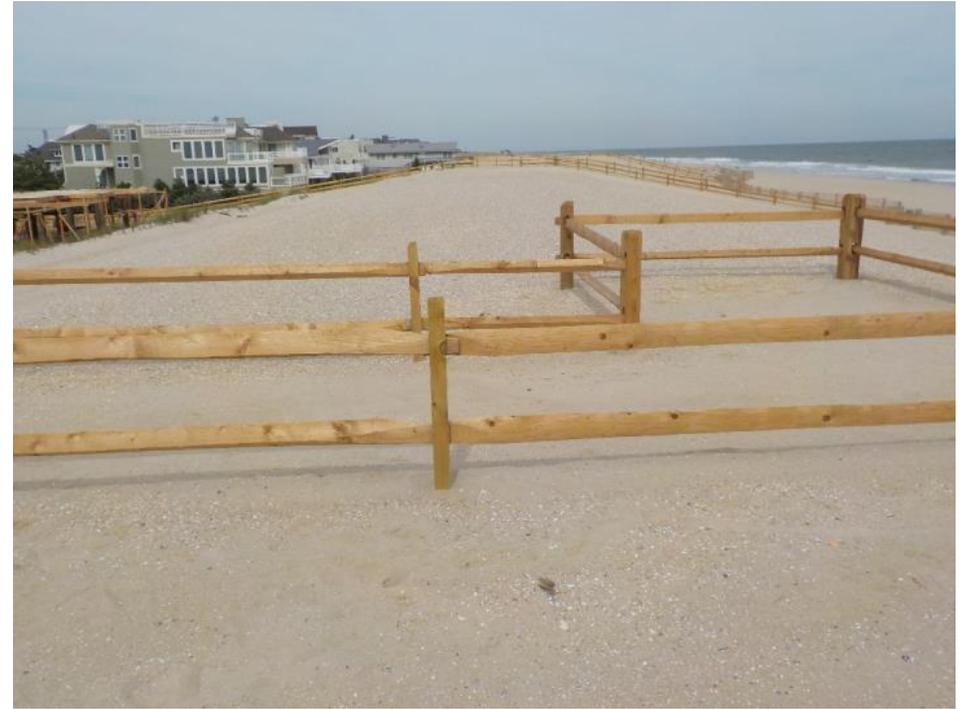
**NJBPN 136 – Dolphin Avenue, Beach Haven**

**Figure 371a & 371b. The photos above (left taken December 15, 2015 and right photo taken September 21, 2016) show the drastic change in the dune at Dolphin Avenue. The narrow dune shown in the 2015 photo was created from recovered sand that was over-washed during Hurricane Sandy. The engineered dune and berm was completed during the summer of 2016.**
