## An Analysis of Thirty Years' Study of Sand Redistribution and Shoreline Changes in New Jersey's Four Coastal Counties Raritan Bay, the Atlantic Ocean Coast, and Delaware Bay Fall 1986 Through Fall 2016

### ***VOLUME 2 of 4 OCEAN COUNTY***

Prepared for:  
New Jersey Department of Environmental Protection  
Division of Coastal Engineering  
1510 Hooper Avenue, Toms River, New Jersey 08753

Prepared by:  
Stockton University Coastal Research Center  
30 Wilson Avenue, Port Republic, NJ 08241

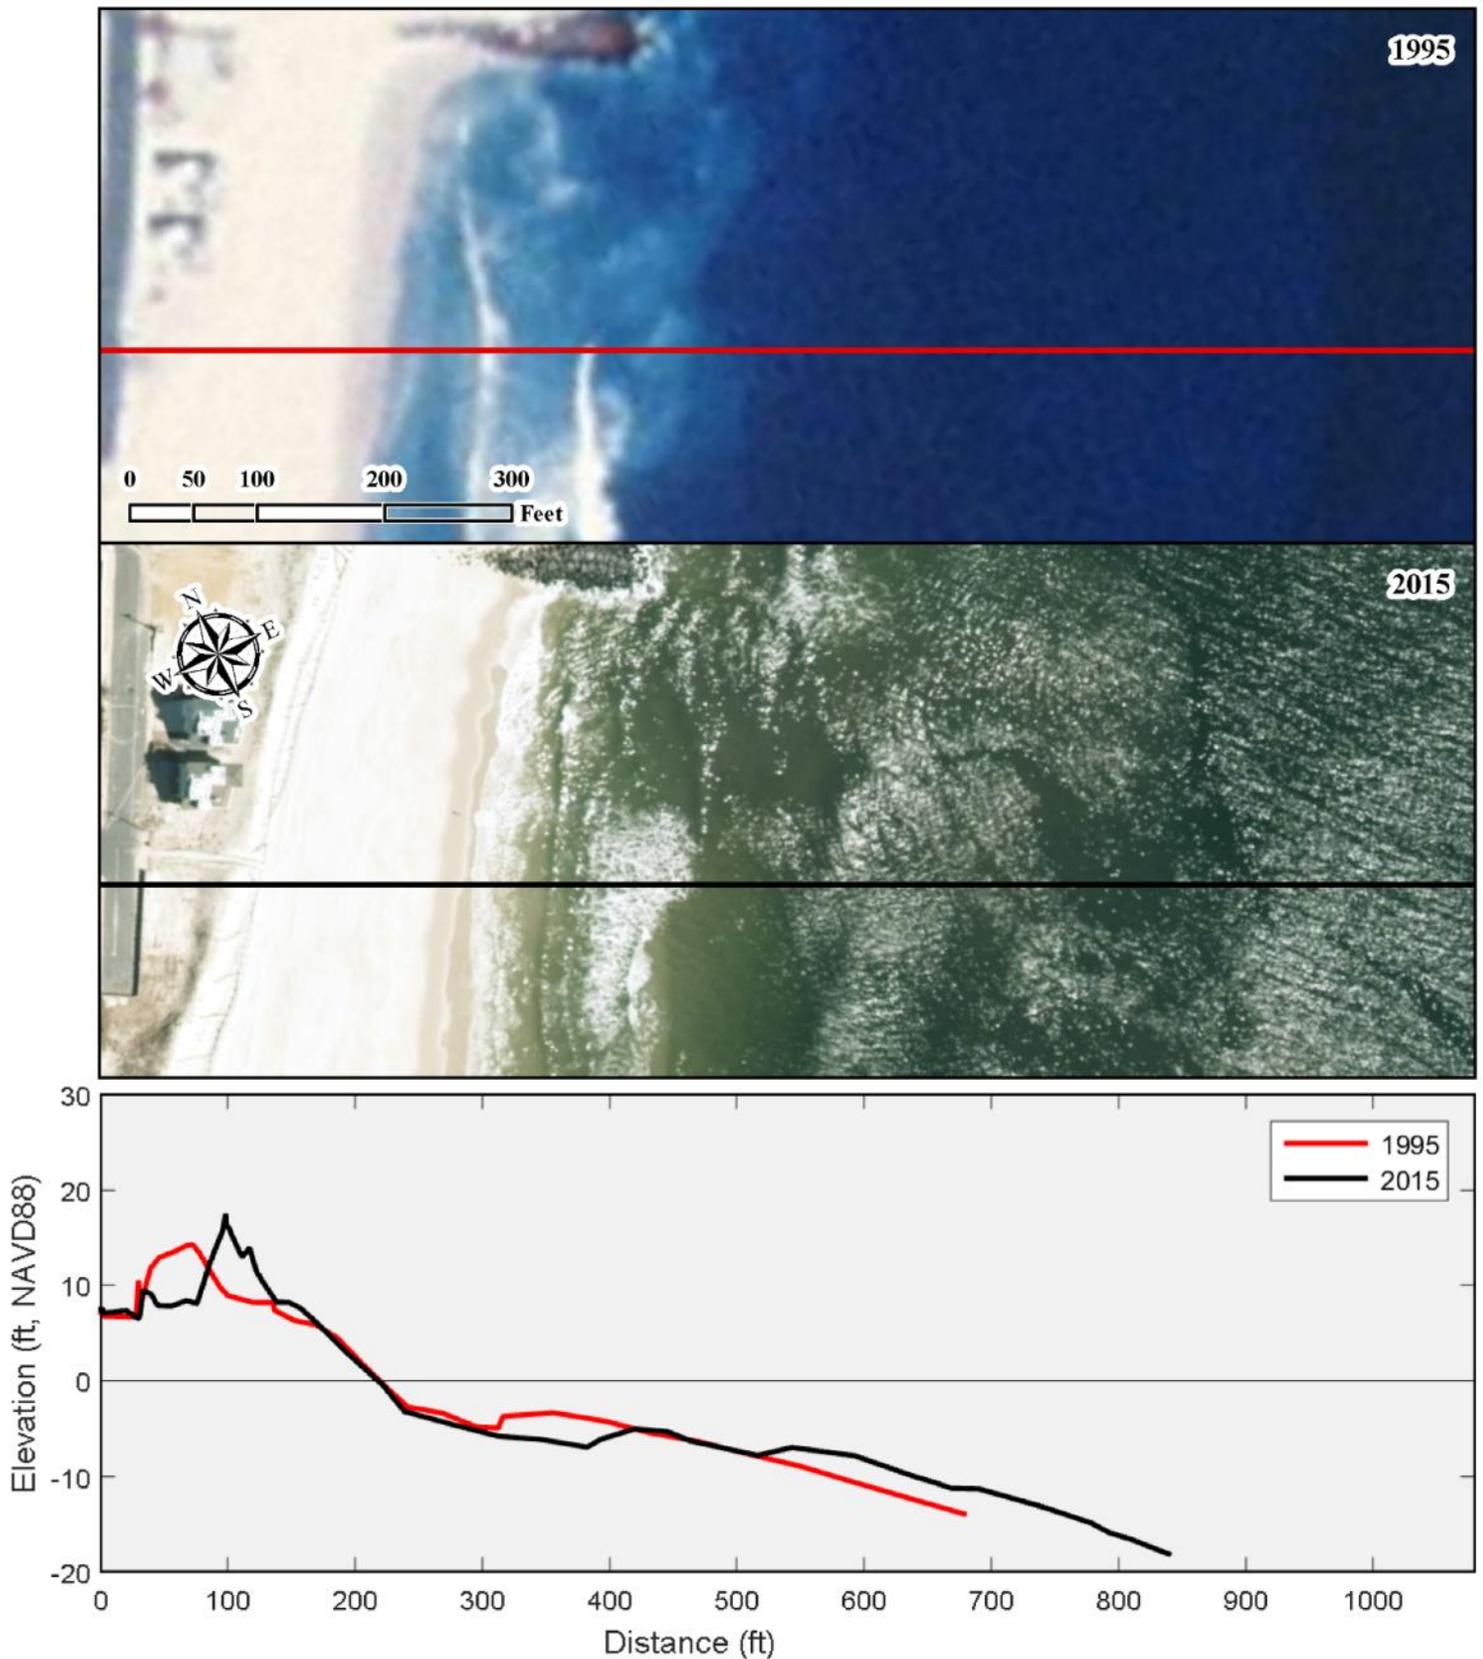
Figure 375. The 2015 survey was completed prior to the construction of the federal shore protection project. The 1995 to 2015 comparison shows a post-Sandy dune that is seaward of the 1995 position. The beach face and shoreline are nearly in the same location for both profiles, with a shoreline retreat of just 1.0 ft.

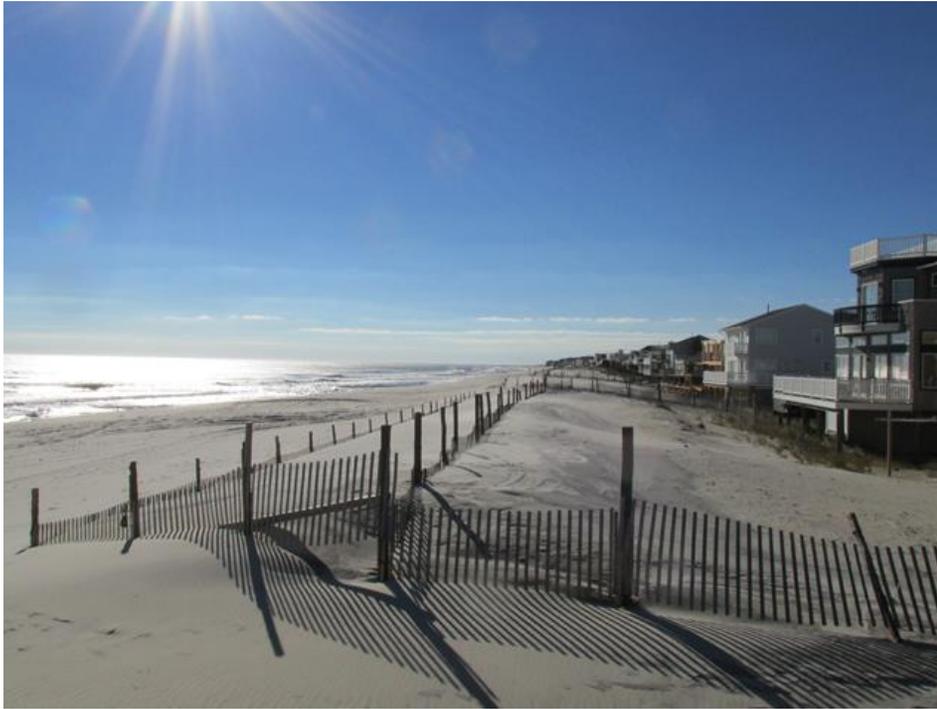
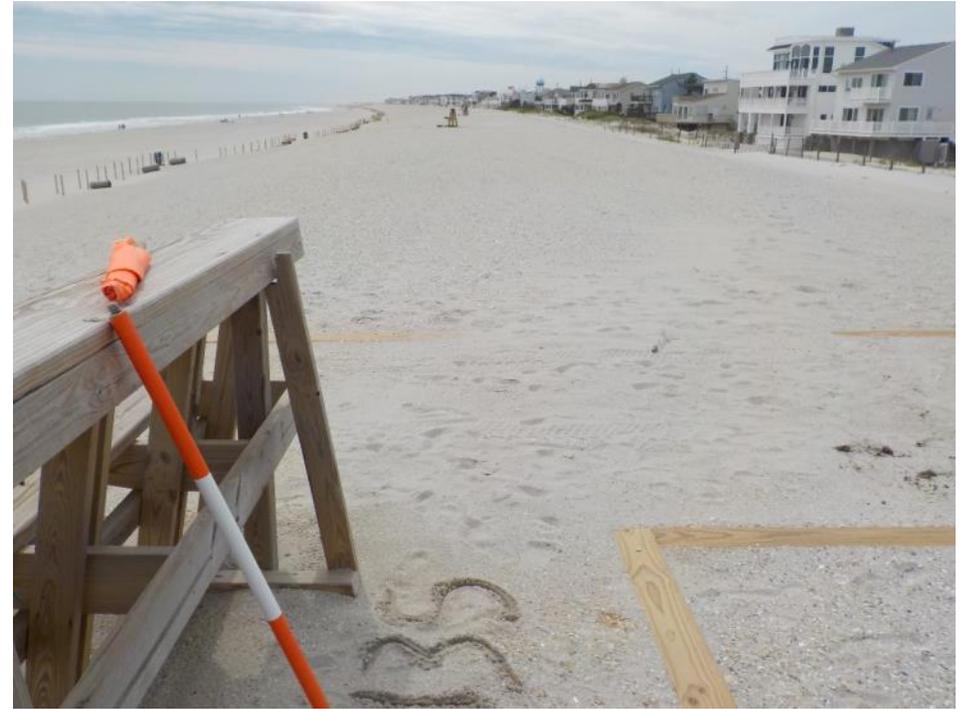
**Figure 377a & 377b. The photos show the view to the south from the dune crest at Webster Avenue. The left photo (taken December 15, 2015) shows the dune that was constructed in 2013 from sand that had been recovered following Hurricane Sandy. The right photo (taken September 21, 2016) shows the condition of the engineered dune prior to fencing and planting of vegetation. The engineered dune was constructed seaward of the 2013-2015 feature.**

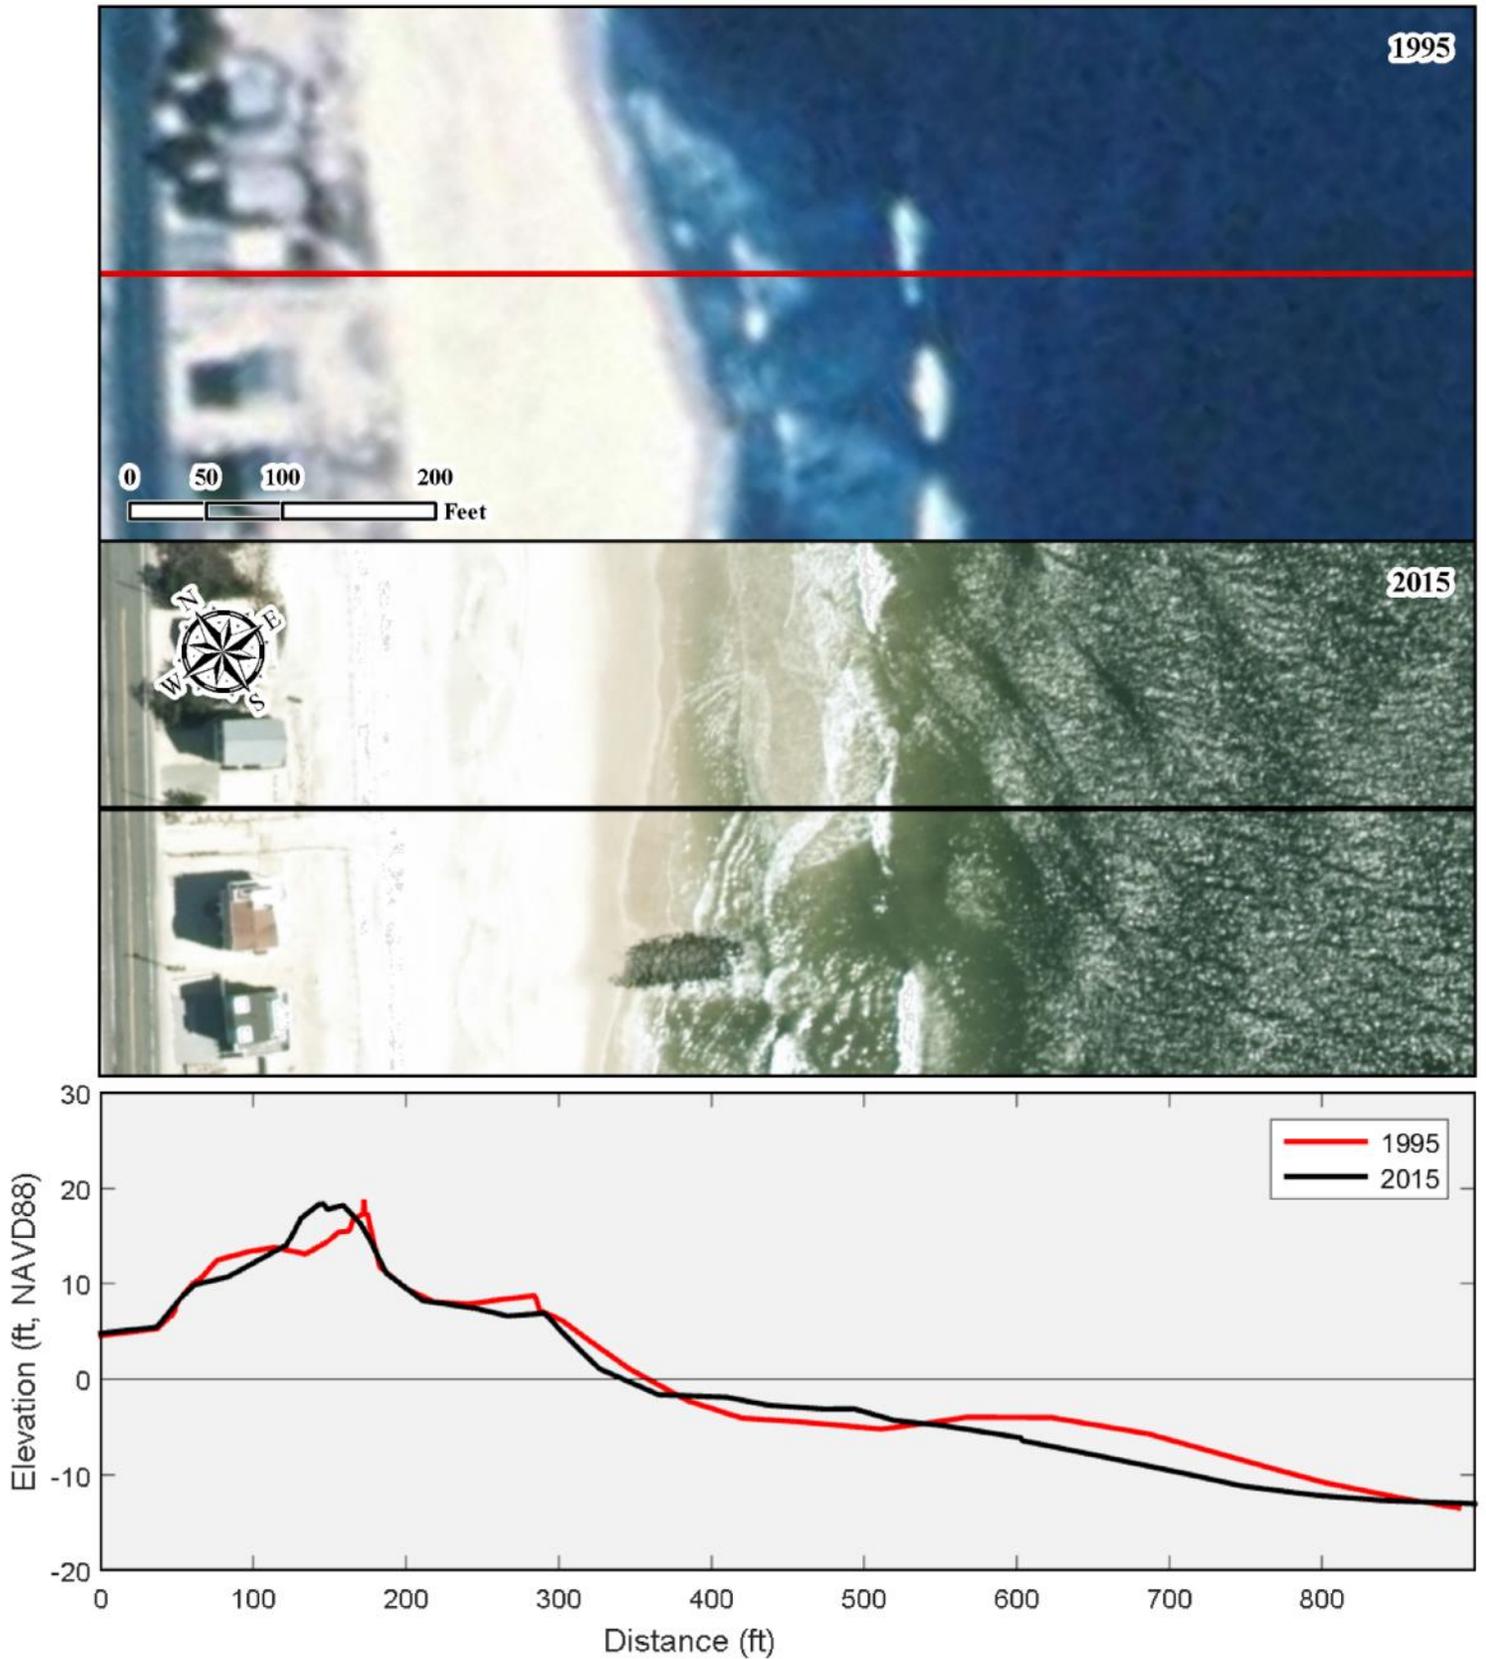
Figure 381. The 2015 post-Sandy dune was reconstructed landward of its 1995 position. The shoreline moved landward by 16 ft between 1995 and 2015.

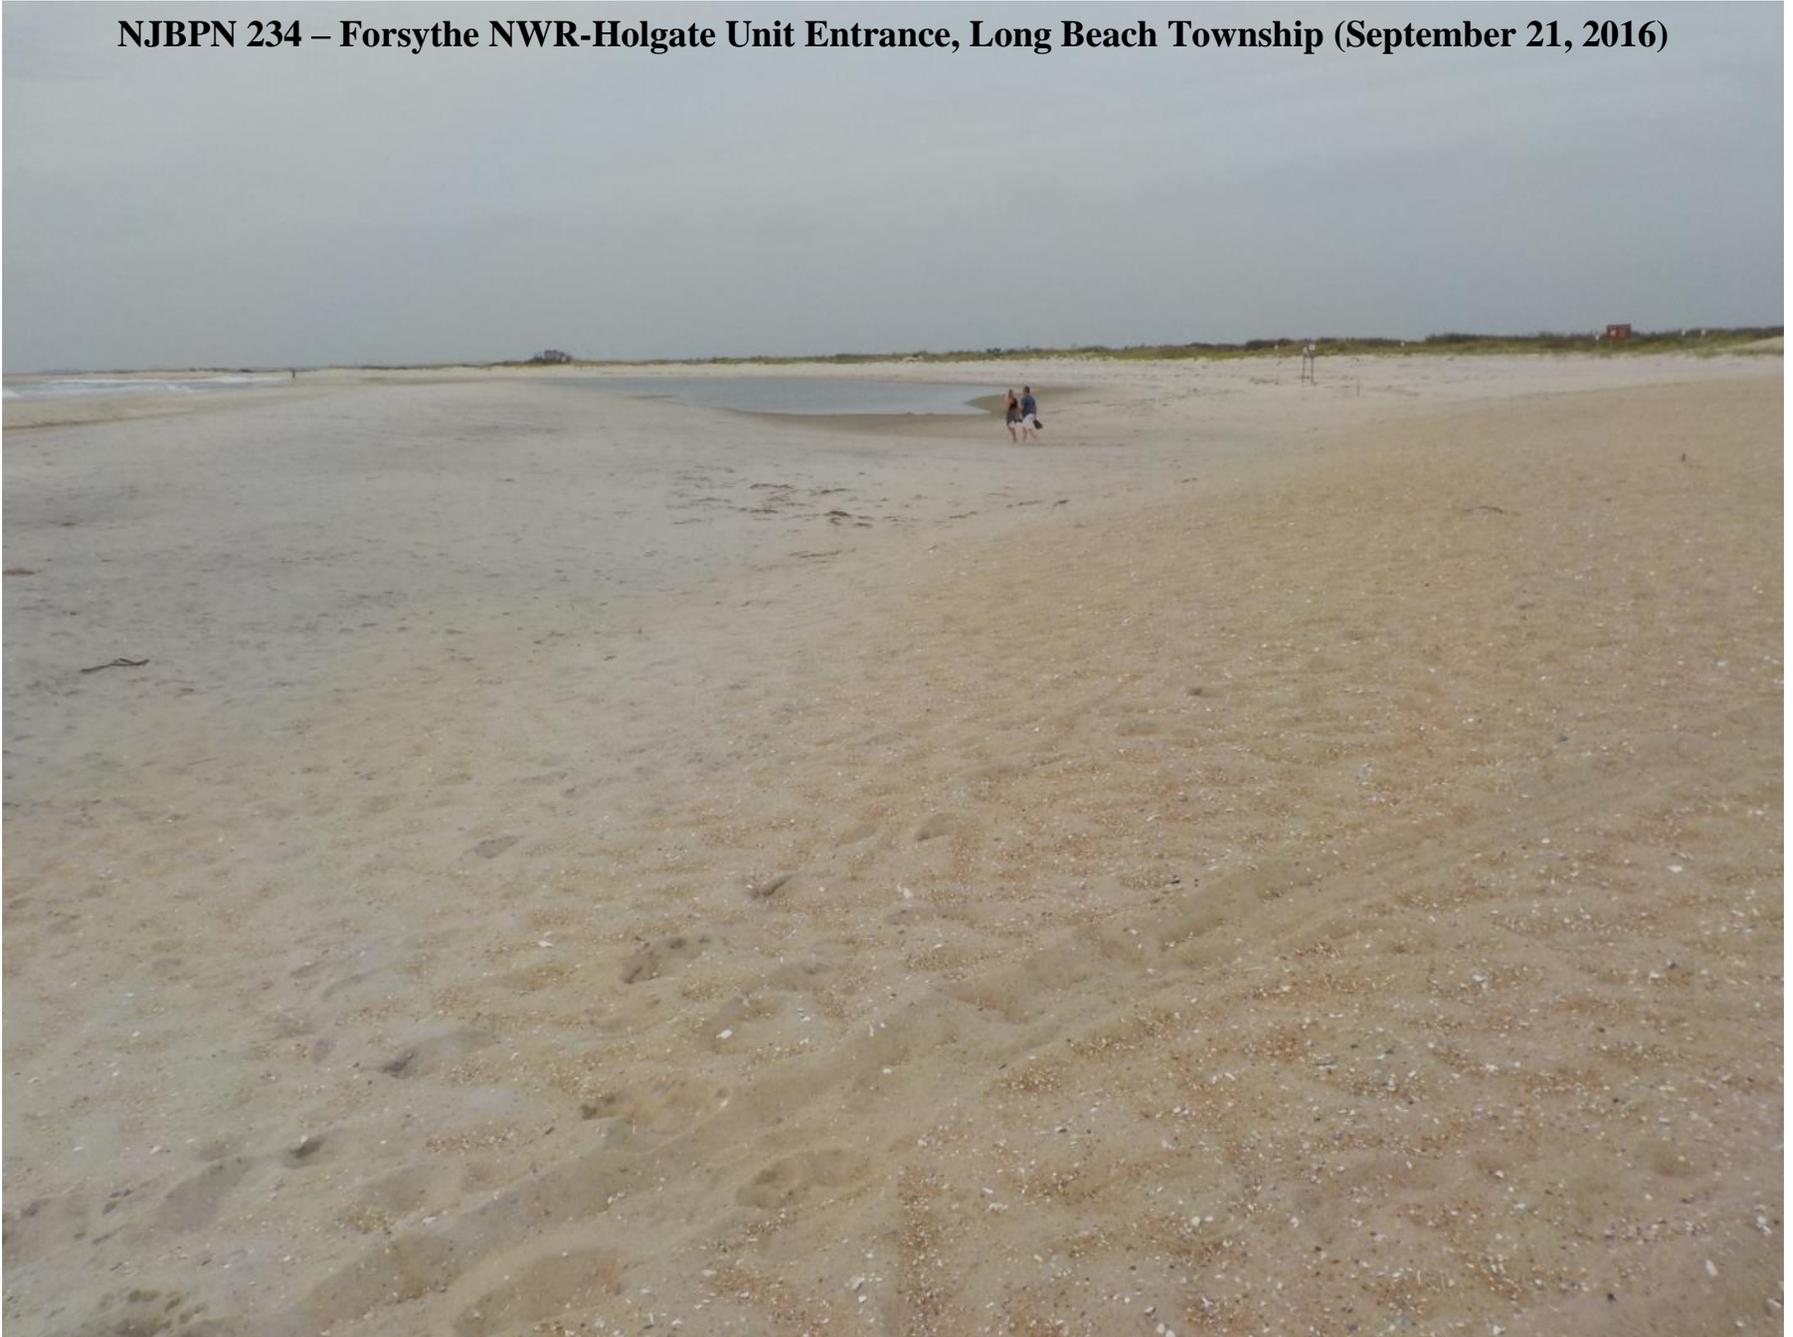
**NJBPN 234 – Forsythe NWR-Holgate Unit Entrance, Long Beach Township (September 21, 2016)**

**Figure 382. View to the southwest from the berm at the border between the Forsythe National Wildlife Refuge-Holgate Unit and Long Beach Township.**

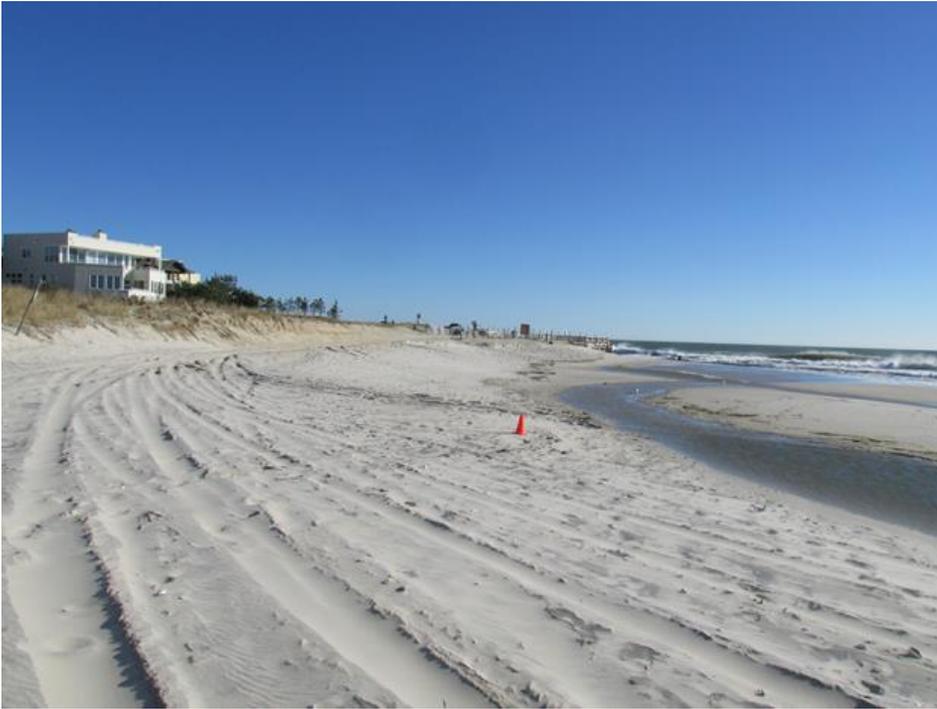
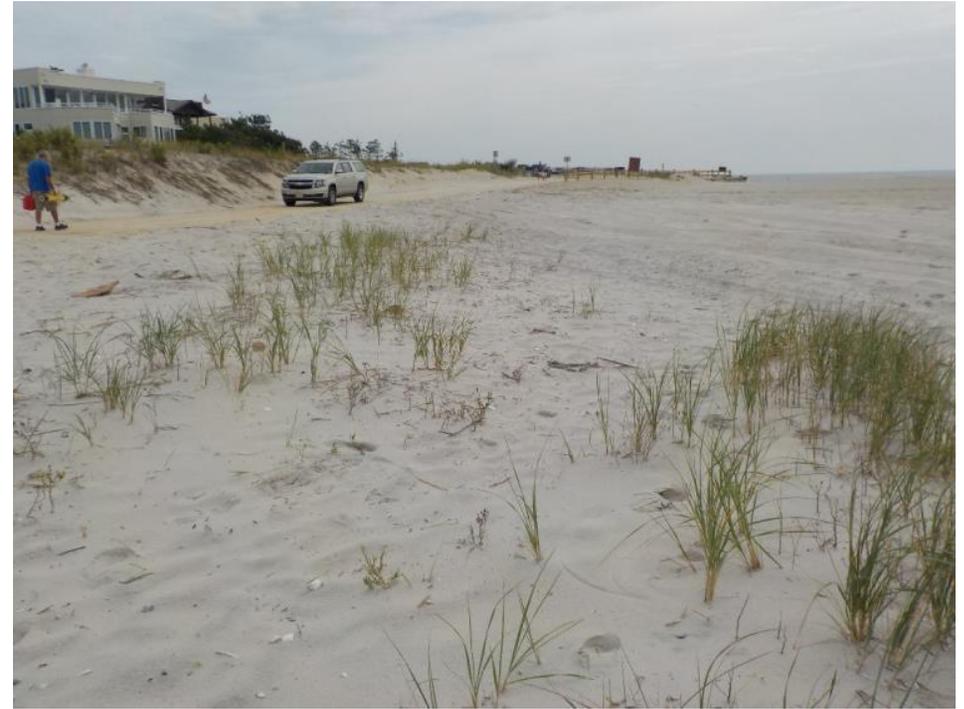
**Figure 383a & 383b. The comparison views from a similar vantage point at the Forsythe-Holgate site shows the extreme change in beach conditions within the year (left photo taken December 15, 2015 and right photo taken September 21, 2016). The profile is located in the “taper” section of the federal beach fill.**

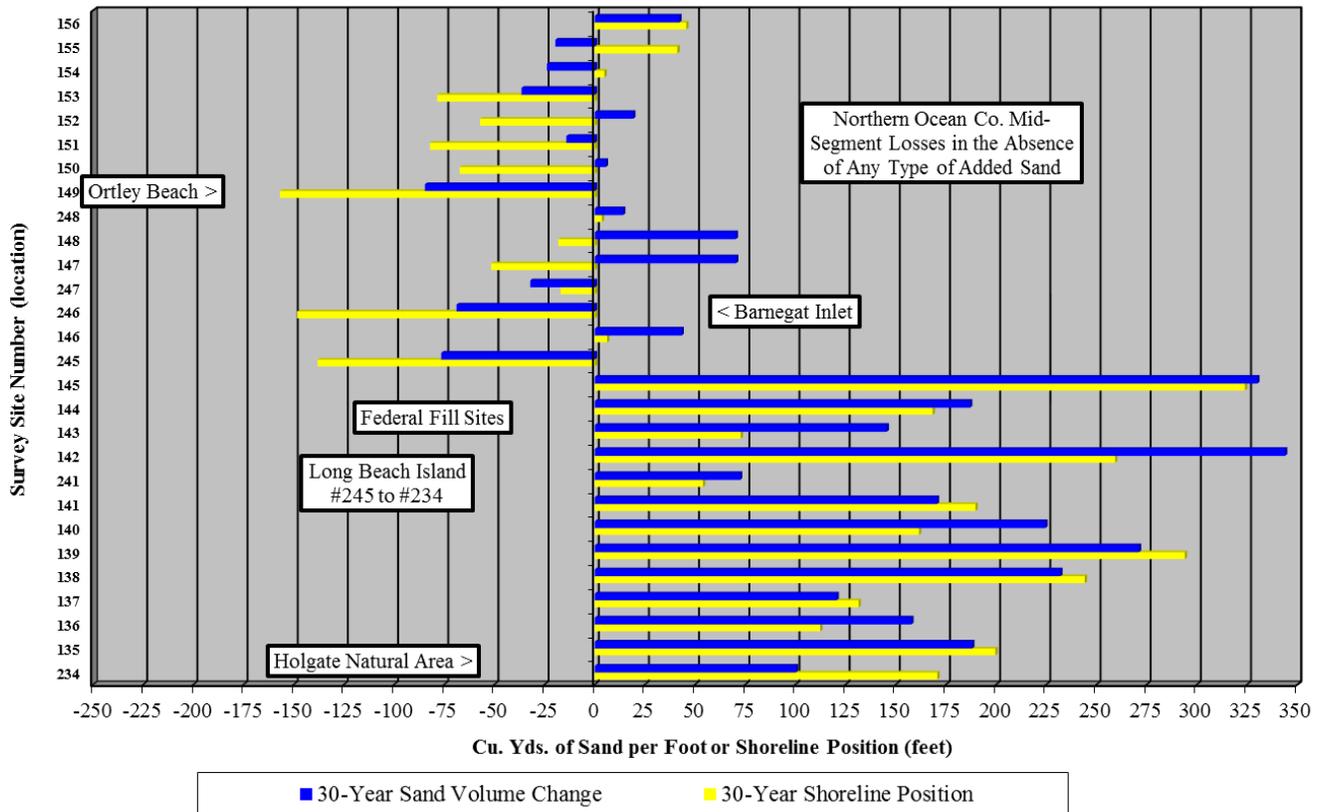
Figure 388 shows the cumulative volume and shoreline position changes at each of the Ocean County profile locations from the earliest dataset to fall 2016. This chart shows the impact of federal involvement in shore protection. Sites 156 to 146 are located in northern Ocean County (north of Barnegat Inlet). Sites 245 to 234 are located on Long Beach Island. Several of the profile locations are included in the federal/state/local *Barnegat Inlet to Little Egg Inlet* flood and coastal storm damage reduction project which was initiated in 2006 in Surf City (NJBPN 241). The graphic clearly depicts the influence of beach nourishment with sand volume gains in some areas of the island exceeding 325 yds<sup>3</sup>/ft along the profile. The beach fill design was tested during Hurricane Sandy. NJBPN profiles with wide berms and high dunes protected landward properties from the storm surge (Coastal Research Center, 2013; Barone, McKenna, and Farrell, 2014). The initial commencement of the Long Beach Island Coastal Storm Damage Reduction Project began in Surf City in 2006, Harvey Cedars 2010, and Brant Beach between 31<sup>st</sup> & 57<sup>th</sup> Streets in 2012 (Surf City and Harvey Cedars were repaired in 2012 after Hurricane Irene). All three locations were restored to the design template by August 2013 following Hurricane Sandy. Ship Bottom, Beach Haven, and the remainder of Long Beach Township were restored by November 2016 (funded by PL 113-2 – 2013 Disaster Relief Appropriations Act).
