Mapping the Mullica River Shipwrecks of the Revolutionary War

Stephen D. Nagiewicz, Peter F. Straub, Steven P. Evert, Vincent Capone,
Student Researchers: Shannon Chiarel, Jaymes Swain, Travis Nagiewicz, Elizabeth Klein, Christina Price,
Ashlyn Rowe and Jason Sass

Abstract

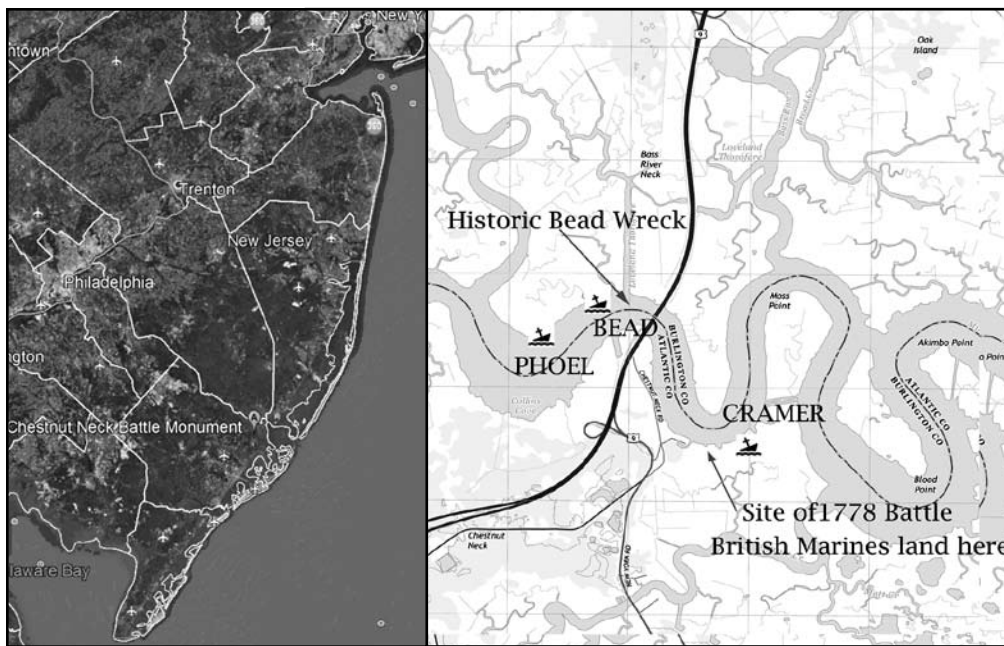
Figure 3. Google Earth image of Chestnut Neck in relation to the coast of New Jersey (left) and (right) local chart showing the relative positions of the three-known revolutionary war era shipwrecks from the Battle of Chestnut Neck on October 6th, 1778. Credit: Stockton University.

This engagement is referred to locally as the Battle of Chestnut Neck and the Massacre of Little Egg Harbor and the site commemorated as the Chestnut Neck Battle Monument (Figure 2). Several of the vessels linked to the engagement are in shallow water close to the former village site and have been sighted at low water. One of these vessels is on the NJ State and National Historic Register and has undergone significant deterioration since its inclusion. Stockton University has documented this deterioration over the past three years and provided the data to the State of New Jersey's Office of Historic Preservation to document how wrecks are affected by riverine currents and tidal forces. One vessel in this report, the Phoel archaeological site wreck (hereafter the Phoel wreck) has not been previously documented and may be the most intact in the historic district (Figure 3). The other two known wrecks are the Cramer and the Bead.

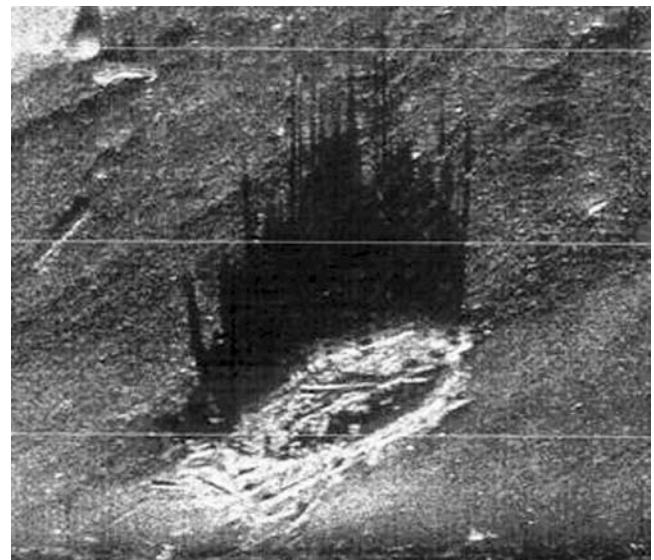
Figure 4. Sonar image of a target in Mullica River known now to be the Phoel wreck. The image was originally captured in 2008 using thermal paper with a Klein 595 side scan sonar system. Credit: Stockton University and William Phoel.

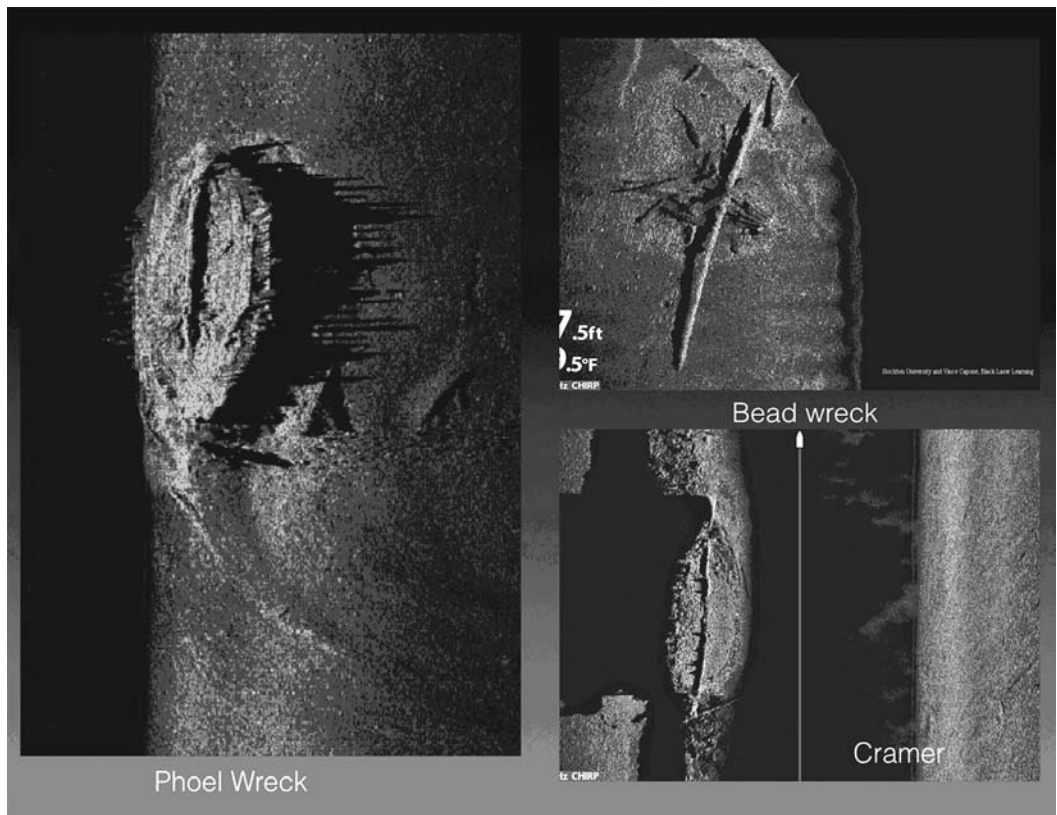
Figure 5. All three Mullica shipwrecks found and mapped to date. Credit: Stockton University

The Bead wreck now rests in 11.8 m of water and is quickly migrating its way over the marsh ledge into the deeper water of a man-made borrow pit used for the construction of the Garden State Parkway Bridges a few decades ago. Figure 5 (upper right corner) shows how the wreck is being undercut by tidal and river currents. In the image, the dark shadow along the straight line, is the shipwreck’s keelson, or what is left of it. That shadow has a slight bend to it, indicating that it is raised off the marsh shelf, allowing currents to

pass underneath, further destroying what is left of the structure. The image also shows that a small section of the keelson overhangs the drop-off, which is supportive of the movement of the wreck due to environmental causes. It should be noted that the Bead wreck was placed on the State and National Registers of Historic Shipwrecks in 1988, (ID# 744) and the National Register (ID #88001899). It is now in danger of total break-up, and its historical significance will be lost.

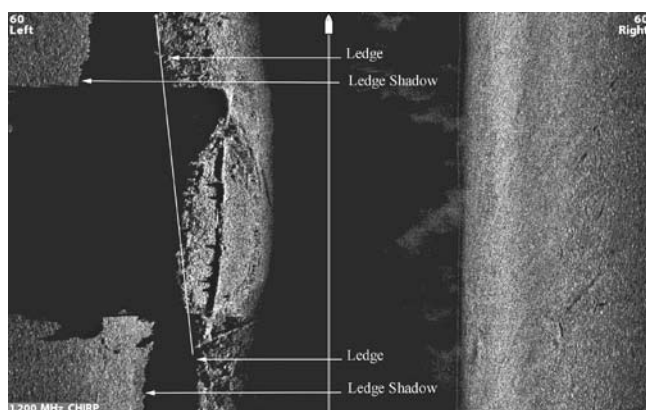
Figure 6

although it is not as intact. There are several areas where the wreck has broken up and debris is scattered about. Further complicating the area, the Cramer lies along a ledge created by river currents over her entire length and is gradually slipping off into deeper waters. In figure 6, the ledge (arrows) can be identified by the black shadow it casts on the left or port side of the wreck. Shadows are created as the beam fans out from the transducer. (the solid white line in the center of the image) As they pass over objects such as the shipwreck, the height or depth of the object creates a return that the sonar interprets as an image. The height of the object can be calculated in post-processing software. In this case the shadow to the left of the wreck varies from 3 to 5 meters deep. Viewing the grayscale sonar image Figure 7, illustrates much of the debris field that the trails the wreckage, while the cross-section of the Cramer Wreck in figure 8 outlines her frames or ribs, (inset zoom) enough so to be able to count them and measure dimensions. Cross-cutting the wreck highlights parts difficult to see in other images. While the wreck has been accurately mapped, it has not been nominated to the State or National Register, in part because it lies within a working marina, although at some point its designation will happen.

Figures 6, 7 and 8 These three different views of the Cramer wreck help identify feature and document its orientation and physical condition. Credit all three images; Stockton University

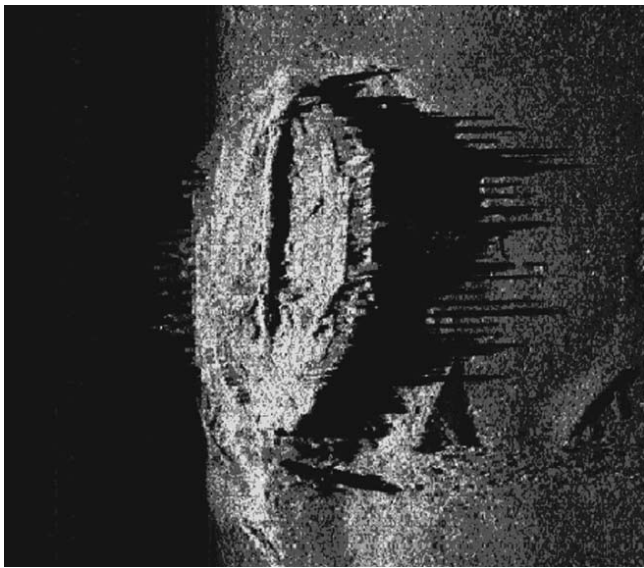
The high resolution in Figure 9 enables scientists and researchers to use sonar data processing software to measure the ceiling planks of the uppermost deck of the wreck and count the individual frames along its port side. Utilizing the software’s capabilities, allows us to collect data remotely that would be difficult if based solely on diver measurements in turbid conditions, and can be used in conjunction with diver measurements to calibrate remote methods. In addition, these images allow a historical interpretation (Davis, 2012; Desmond, 1997), and reconstruction of the actual vessel from the sonar record (Figure 8).

Figure 9. Side scan sonar image of Phoel wreck in the Mullica River. Credit: Stockton University & Vince Capone.

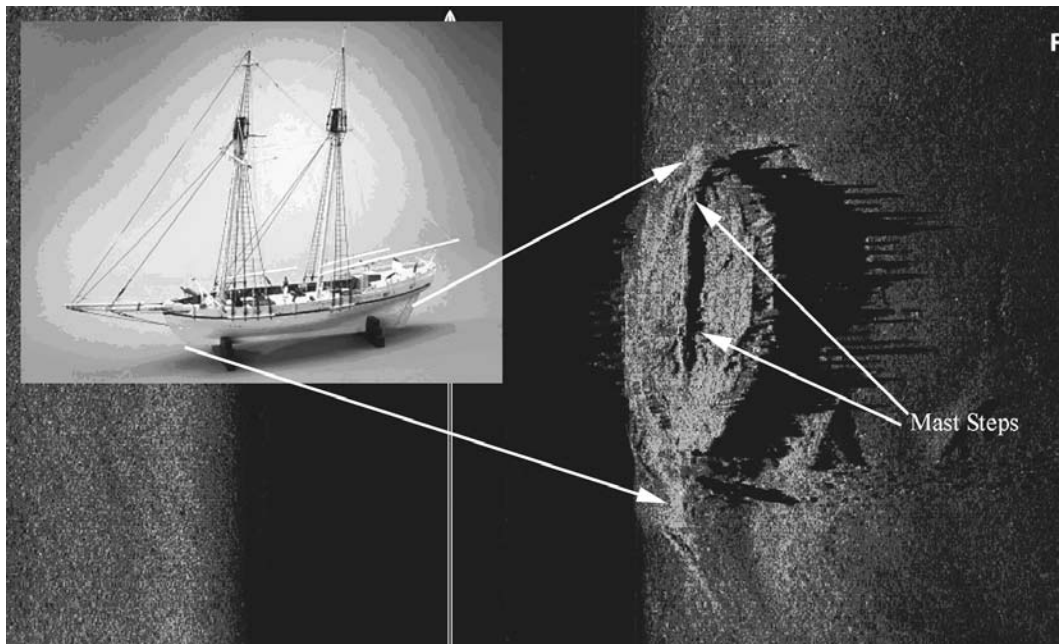
Figure 10. Typical sloop of the 18th century, with arrows pointing to the part of the sloop that is represented by the Phoel wreckage. Credit: Stockton University and the Smithsonian Museum of Natural History for inset.

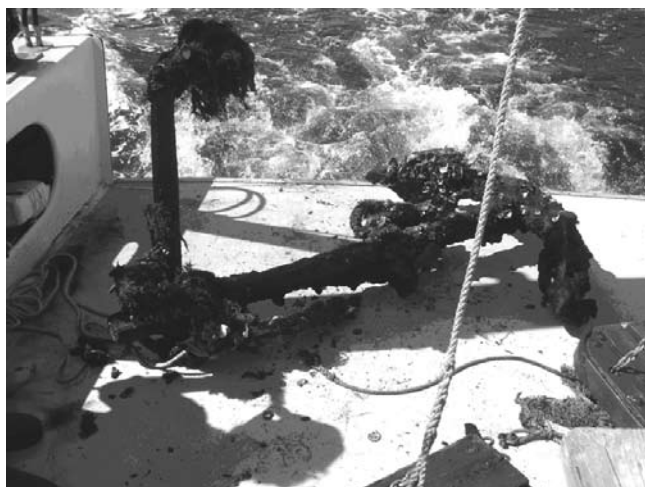
Figure 11. Bead anchor initially dragged from wreck site.

For example, a kedge or stream type anchor was dragged up accidentally from the Bead wreck site several years ago, even though the wreck location is marked on charts. The anchor was accepted by Stockton University, with approval of the State Office of Historic Preservation, for conservation (Figure 11). The Bead wreck lies on a marsh ledge located near very dynamic water flow locations of both the river and marsh drainage canals. In 1975, when first explored and mapped by divers, the wreck was mostly intact (at least the lower meter of the hull) and rested in 3.3 meters of water. Over the years, this ledge has been migrating. Erosional forces have undercut the ledge and the wreck has slipped downward into a deep hole created several decades ago when the area was used as a borrow pit during construction of larger highway bridges and power lines. Images from Figures 6 and 7 now show the wreck in 11.58 m of water, a drop of over 8 meters in 43 years. As the wreck slipped further down the ledge, it has almost completely broken apart, and released the anchor. Only the keelson and a few frames are still recognizable.

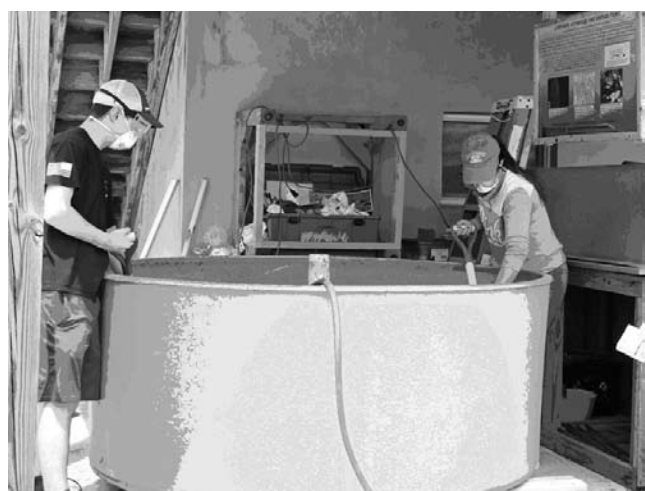
Figure 12. Conservation tank for the Bead anchor at Stockton Marine Field Station. The anchor will undergo chemical bath and electrolysis to slow corrosion and help preserve it for display. Credit: Stockton University

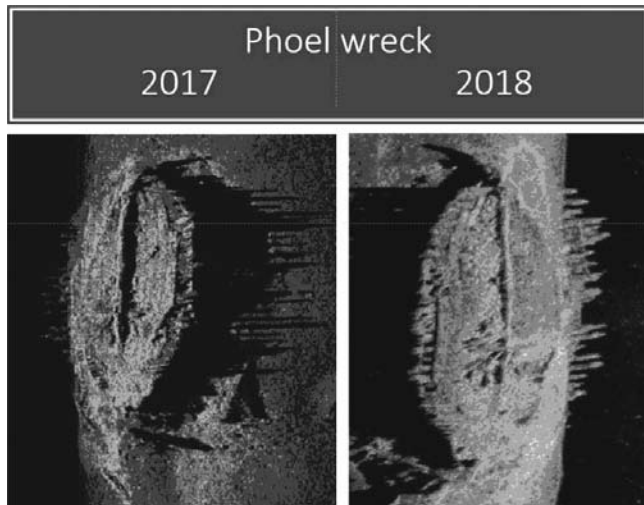
Figure 13. Two-year sonar image comparison of the Phoel wreck. Noticeable damage to the bow section of the shipwreck, likely due to anchoring and natural causes.

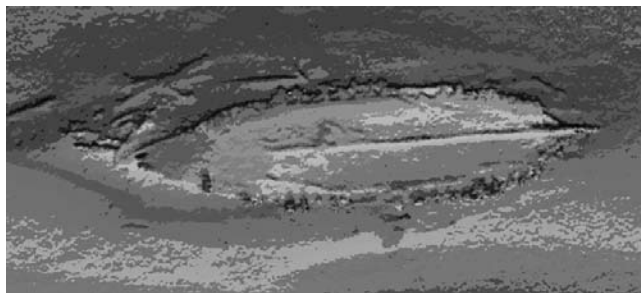
The Phoel, which is a popular fishing site, now shows signs of man-caused damage probably due to anchoring. While its location close to the marsh shoreline helps slow down environmental deterioration, substantial hull damage has been recorded that is human caused. The multibeam image (figure 14) provides evidence of more damage at the bow, and more pieces of the wreck have fallen or been dragged off the wreck. Most wrecks provide habitat for marine life, and these Revolutionary War wrecks are no different. Large fish schools hover around the wreck, something fishermen will see on their fish-finders, even if they don't know a 240-year shipwreck is part of the bottom profile.

Figure 14. Multibeam image of the Phoel wreck collected with a R2Sonic 2024 during a training exercise conducted for Stockton University (Galloway, NJ) by ECHO81 (Hartwell, GA).

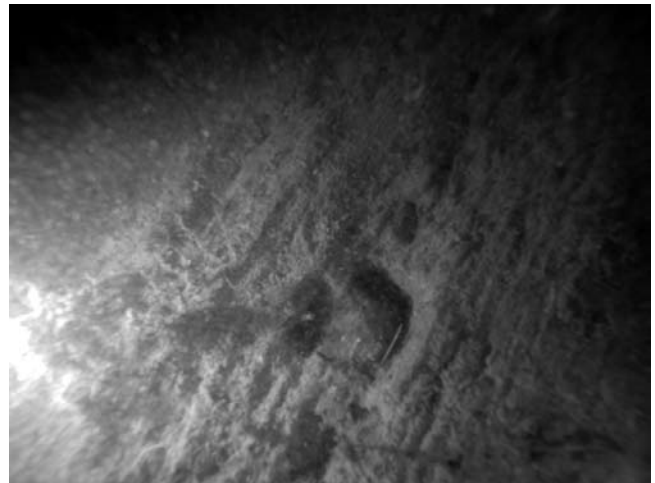
Two mast steps were confirmed. The only evidence is a deep center gouge for the insertion of the tapered end of the mast and some signs of framed support on either side of the mid ship mast. The hull planking near the stern showed ‘tree-nail’ fasteners which are a very positive indication of the age of the shipwreck and determination of its type. Treenails (trunnels) or wood dowel fasteners were often economical cost-cutting features of building large fleets of merchant ships that were not built to last more than 3- 5 years of heavy use. Their use also dwindled into the 19th century where iron, or steel and bronze and brass were normally used. Some iron fasteners were observed, one wrought iron was recovered with evidence of extreme oxidation near the stern where the keelson is fastened to the frames.

Figure 16. Image of tree nail. Courtesy Stockton University.

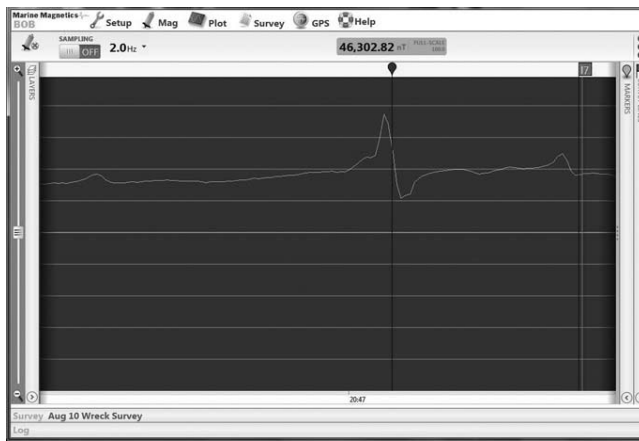
A Marine Magnetics ‘Explorer’ magnetometer was deployed to survey the wreck with the intent to measure for magnetic field or signature or iron content of the wreck. The wreck showed an extremely low value in nanoteslas which seems to indicate little iron content on the wreck. Readings do show a slight magnetic field, but this can be explained by some of the iron fasteners and hand-struck red brick. It also means anything of iron or metal had been removed prior to burning and sinking.

Figure 17. Magnetic field of the Phoel wreck. Courtesy Vince Capone and Stockton University.

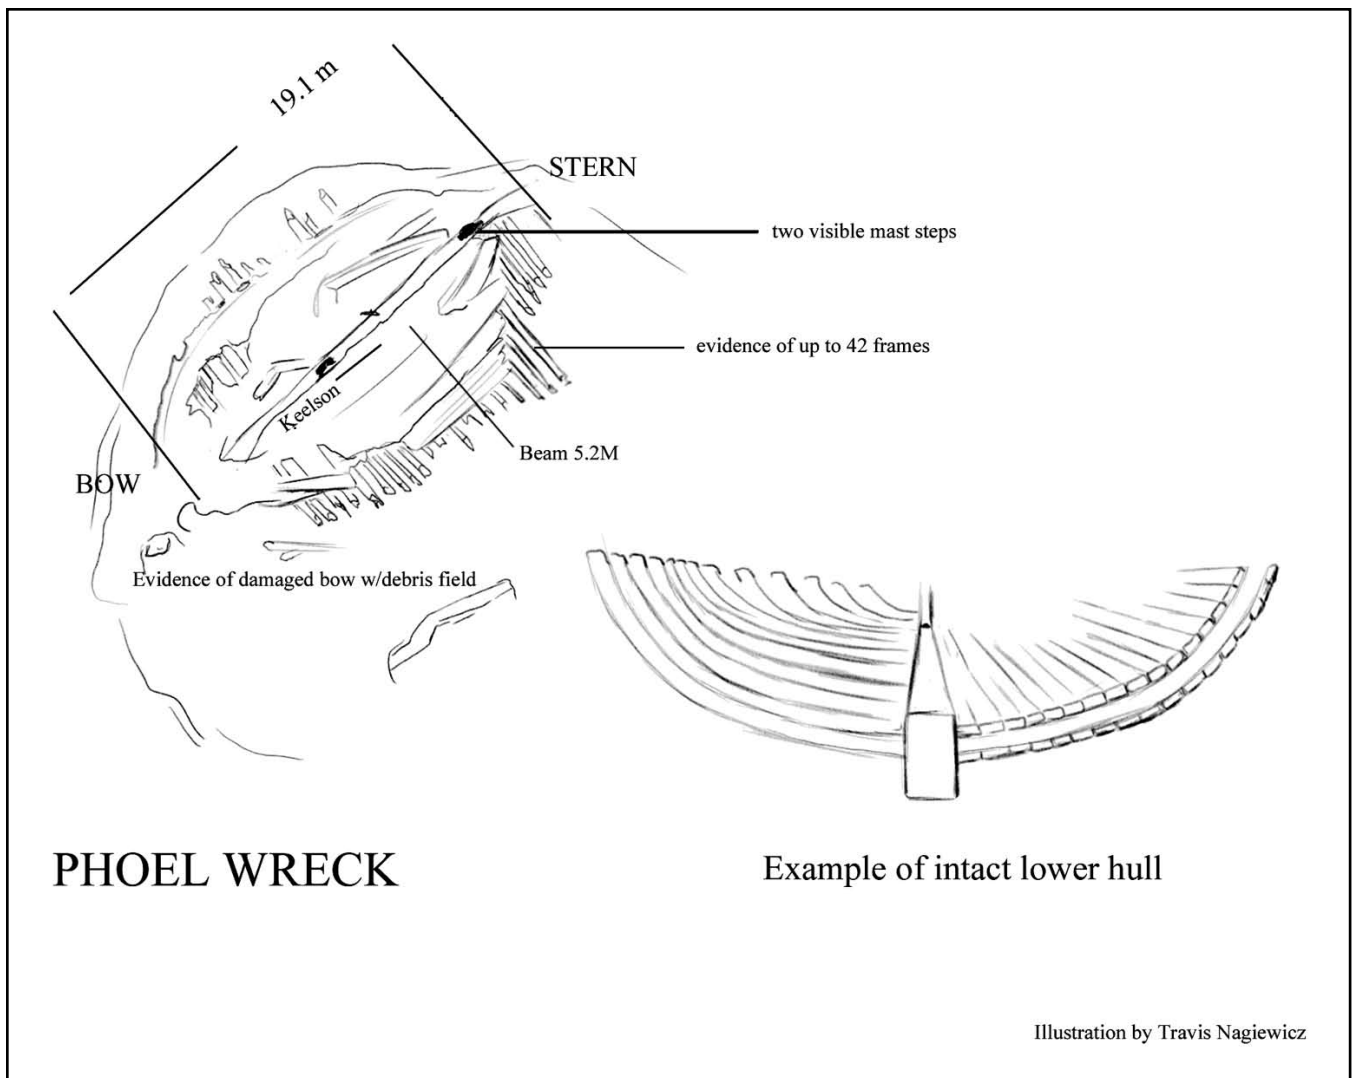
Figure 18. Annotated illustration of the Phoel wreckage, with a comparison to an intact lower hull. Credit: Travis Nagiewicz.
