New Jersey Beach Profile Network 2014 Annual Report on Shoreline Changes in New Jersey's Four Coastal Counties Raritan Bay to Delaware Bay Spring of 2013 Through Fall of 2014

New Jersey Beach Profile Network 2014 Annual Report

Shoreline Changes In New Jersey In the Four Coastal Counties Raritan Bay to Delaware Bay

NJBPN Profile #'s
187 - 256

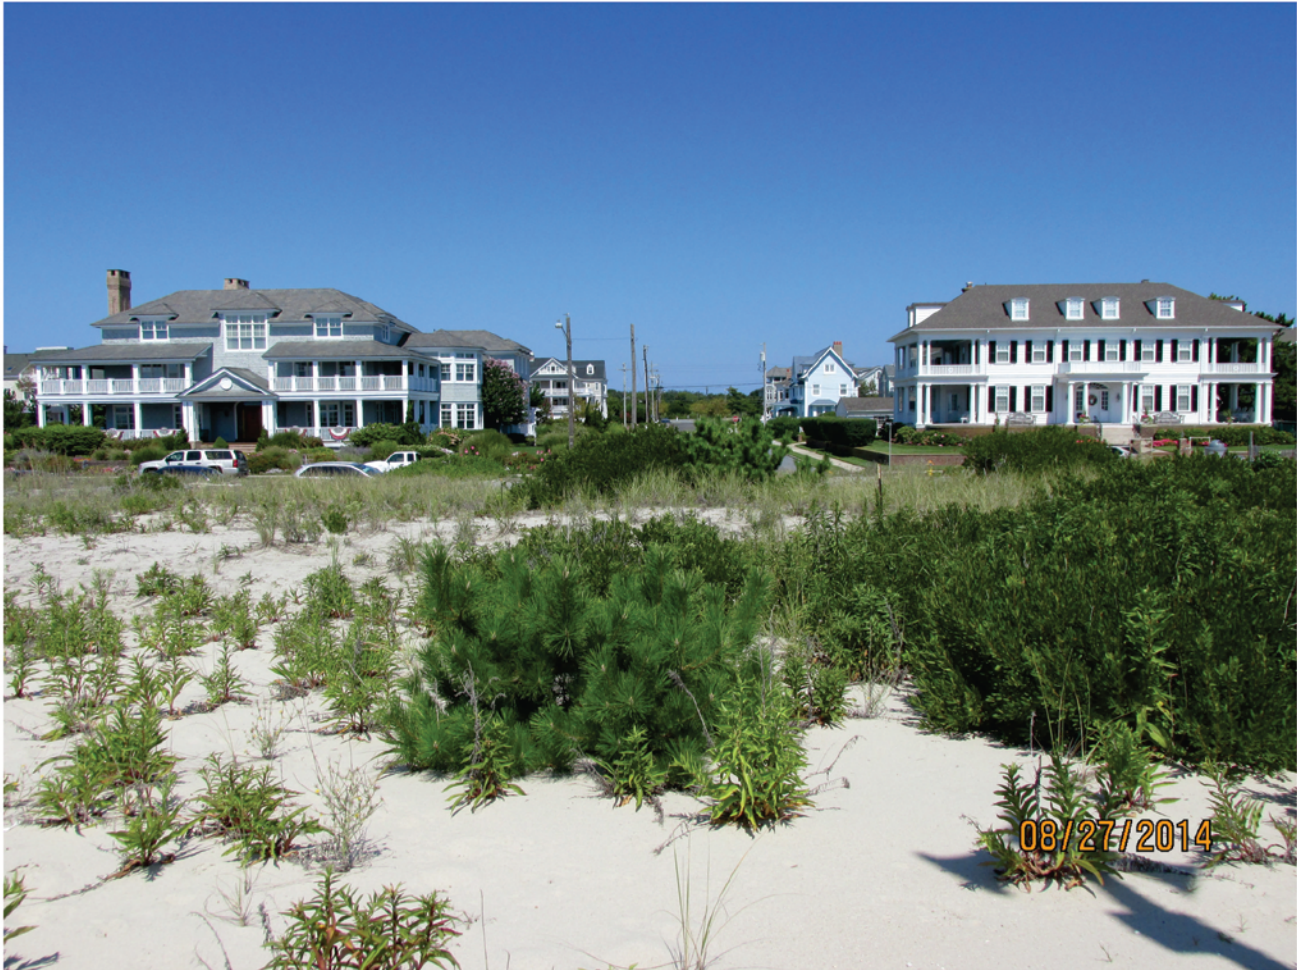
Cape May City, NJ August 27, 2014 looking west toward Ocean Avenue at Baltimore Avenue where 25 years earlier this instrument location near the seaward toe of the dunes would have been over 150 feet out into the ocean in 1989. This illustrates the long term benefit realized with large-scale beach restoration.

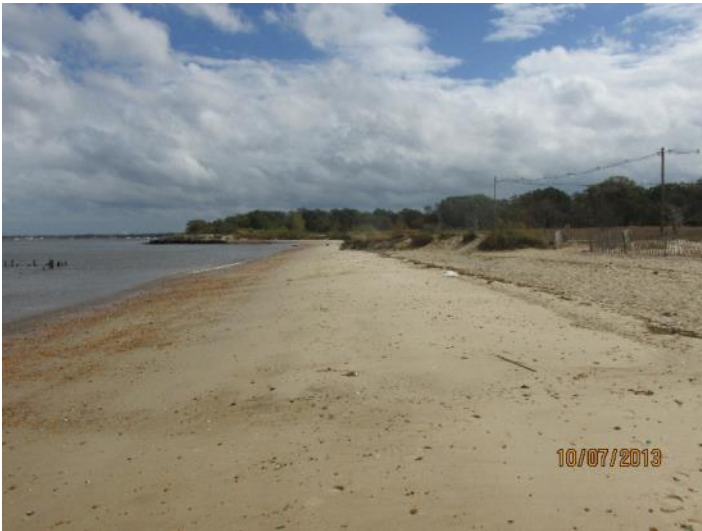
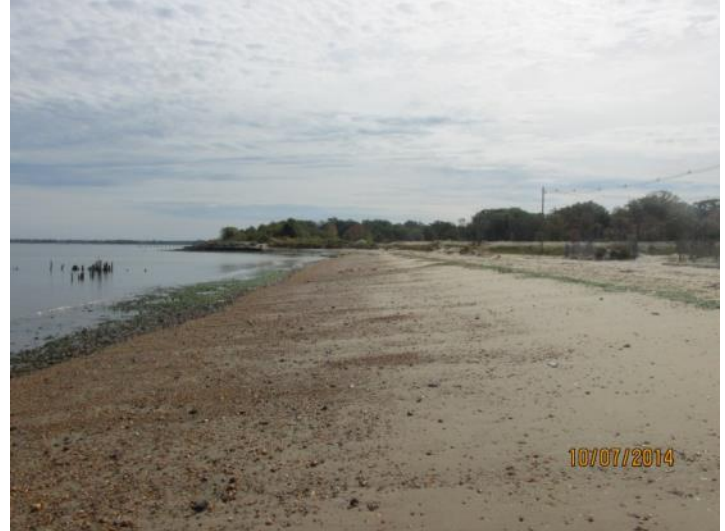
This is the westernmost NJBPN site located on Raritan Bay. The photograph on the left shows the shoreline on October 7, 2013. The photo on the right shows the beach, the transition to the bay floor and a modest dune (taken on October 7, 2014).

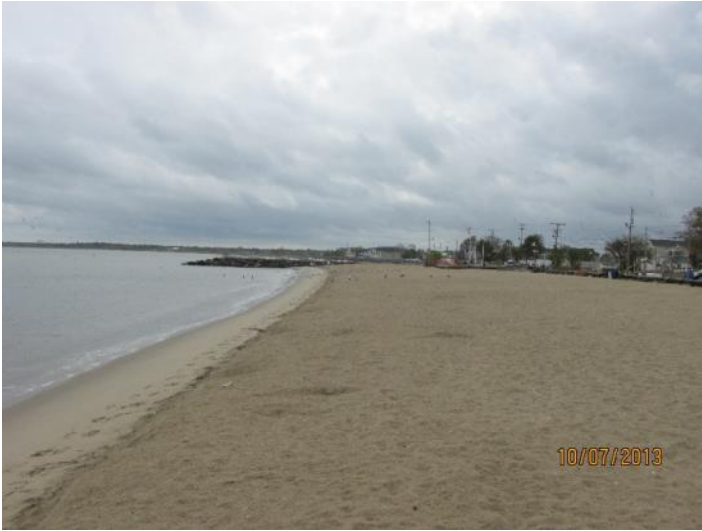
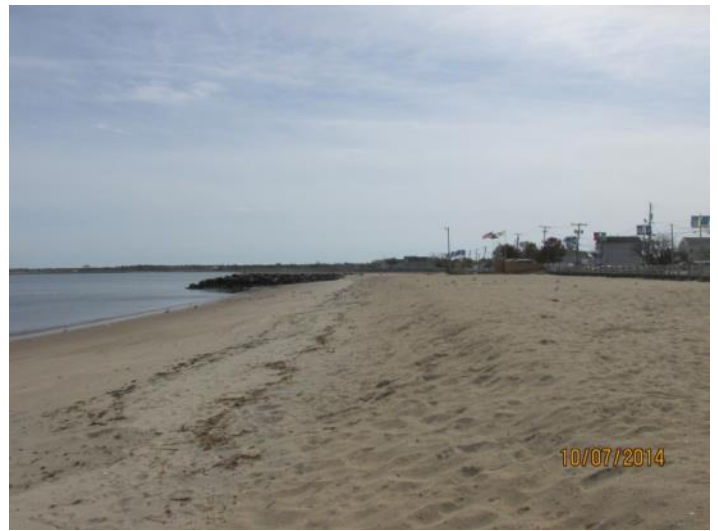
This site was moved to the public bathing beach in 2009. The photograph on the left shows the shoreline on October 7, 2013 following the addition of 14,000 cu. yds. of added sand. The photo on the right shows the adjustment in beach width over a year following the municipality’s efforts in replacing lost sand following Sandy (taken on October 7, 2014).

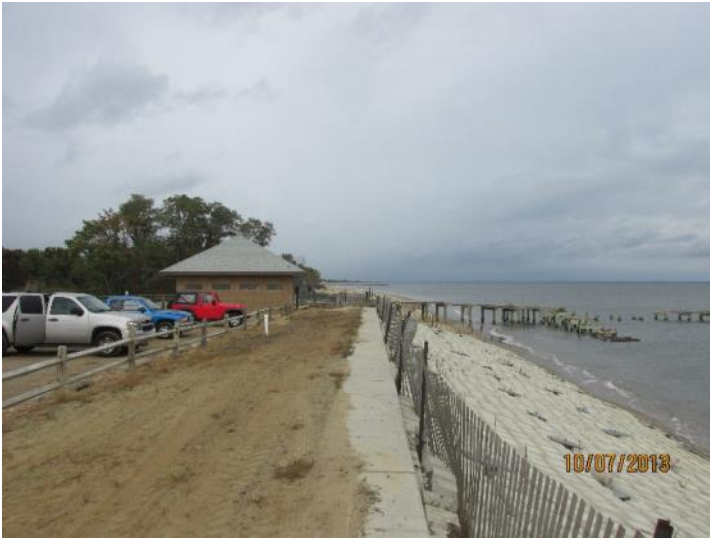
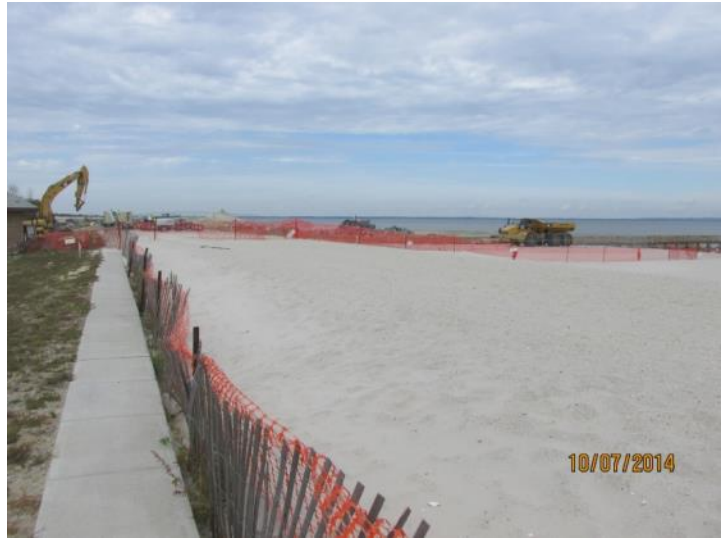
This site was enhanced by adding slope protection to the eroding uplands bluff prior to Sandy. The photograph on the left shows the shoreline on October 7, 2013. The right picture was taken October 7, 2014 as a massive beach restoration was being completed.

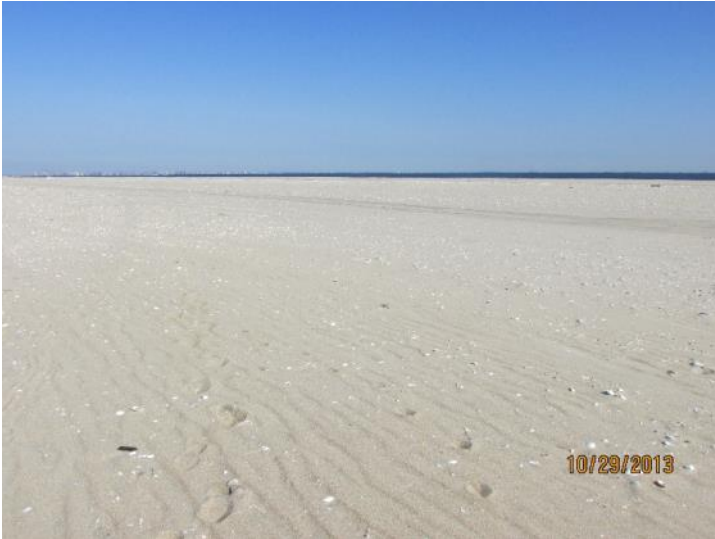
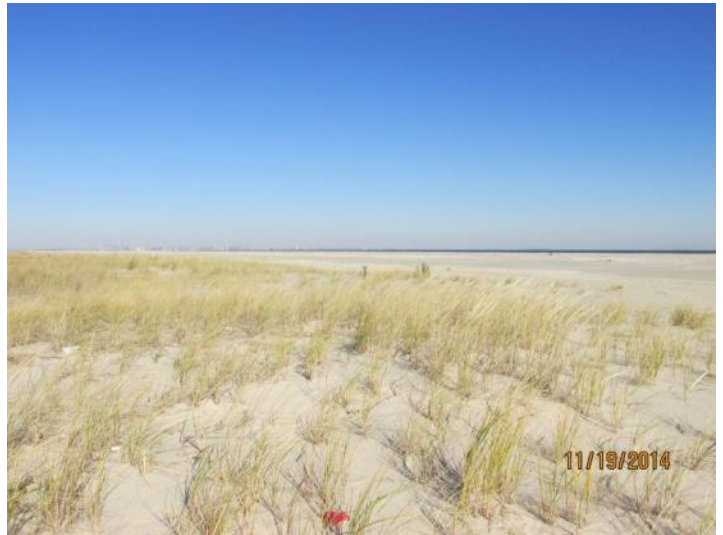
This is the northernmost ocean NJBPN site that has shown advances in the berm position since 1999. The photograph on the left shows the October 29, 2013 beach looking north; on the right is the same view from the toe of the dune Nov. 19, 2014.

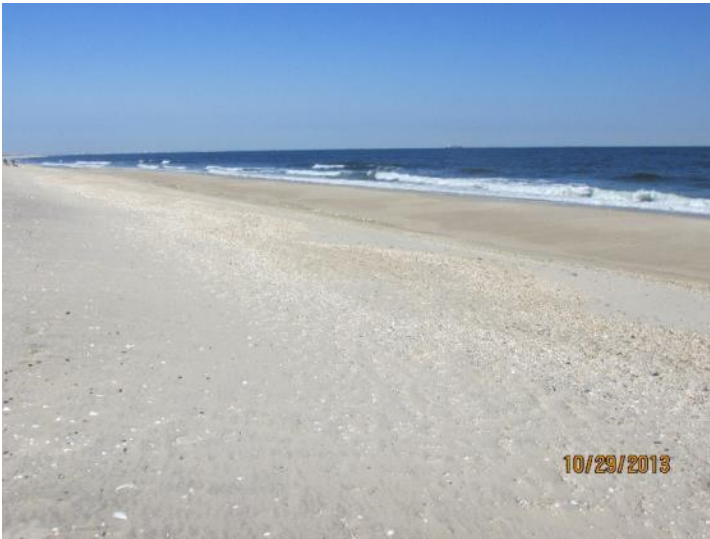
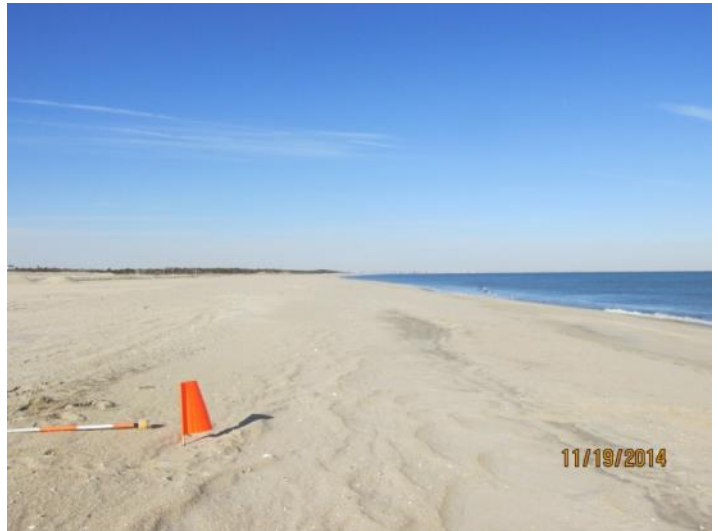
On the left is a beach picture from October 29, 2013 looking north along the shoreline. The same perspective on November 19, 2014 shows a slightly wider beach with an essentially identical configuration.

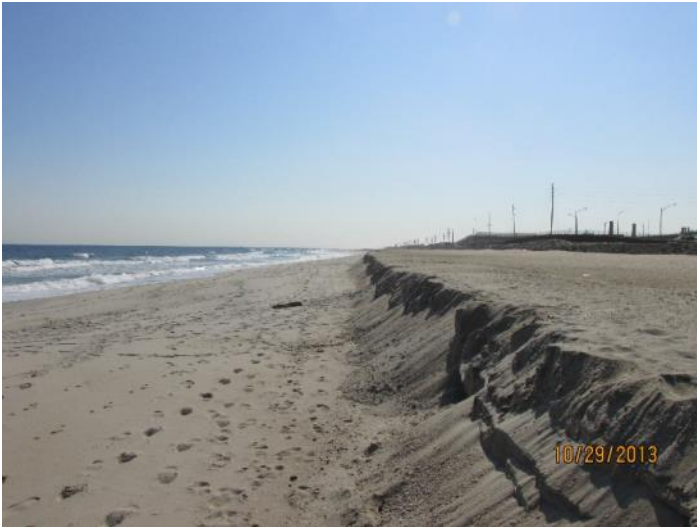
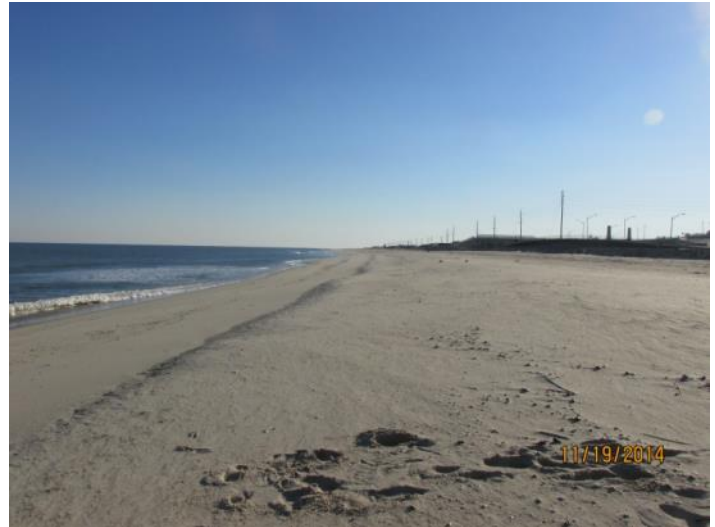
This southern Sandy Hook site is located near the entrance to the park and has gained in volume since the 1995 start of the federal shore protection project. The left view was taken October 29, 2013 after the ACOE had returned and placed sand to design template cross section. Erosion of the berm is evident following a minor NE storm. By November 19, 2014 added sand had extended the profile seaward. Coastal littoral transport moved sand north from sites further south.

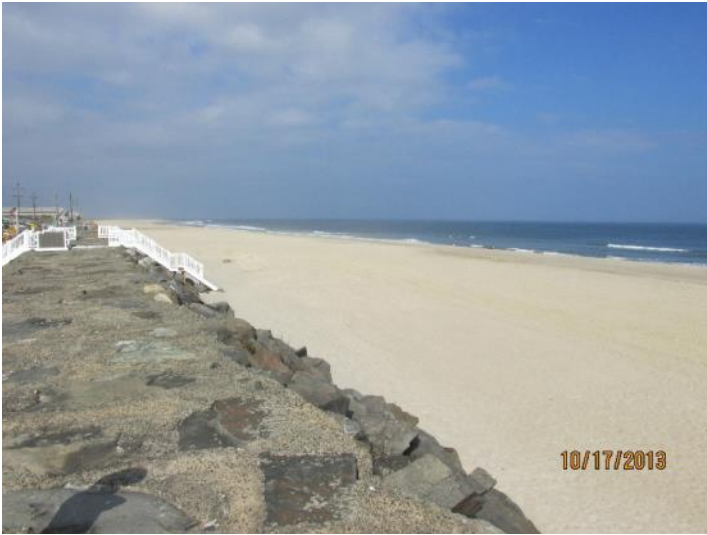
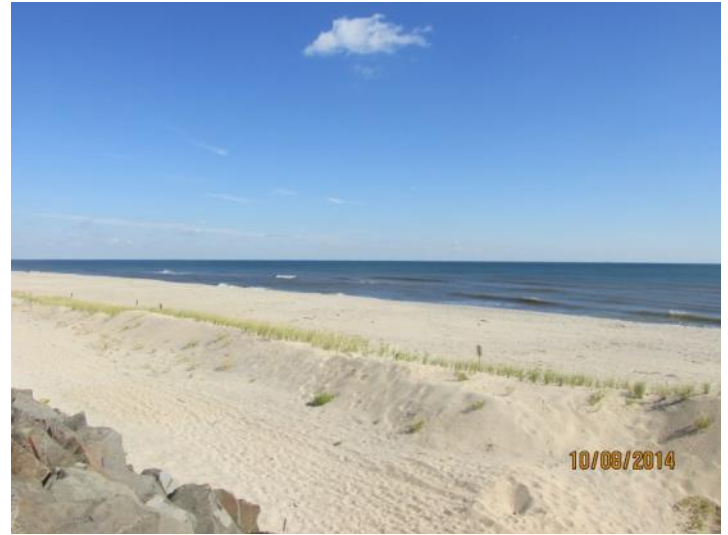
This site is near the northern limit of the initial Federal shore protection. The left side shows the results of the placement of 40.12 yds³/ft. of new sand on the beach by Oct 17, 2013, while the right side (Oct. 8, 2014) shows the added dune.

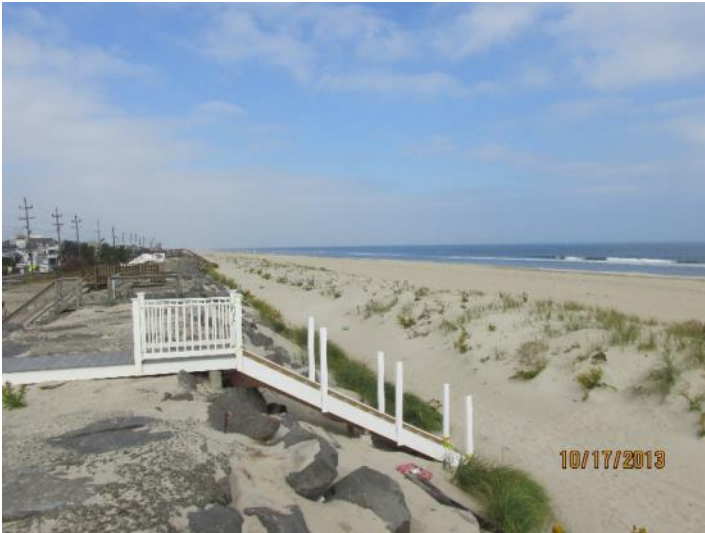
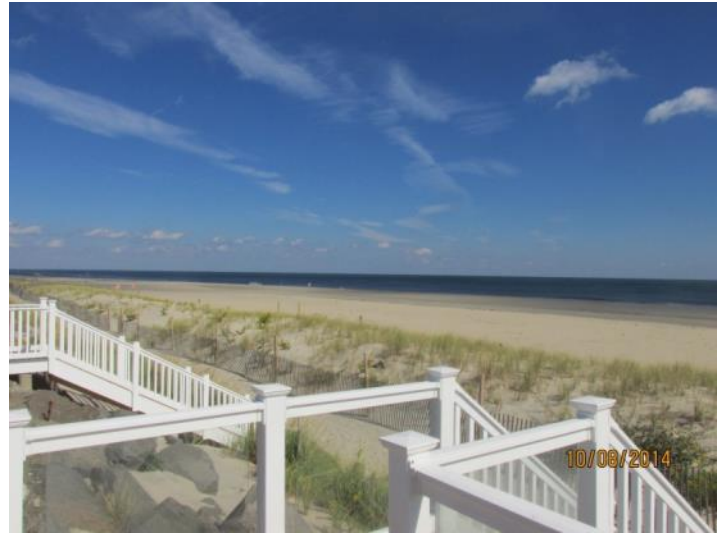
The left view shows ACOE pumped sand back to the original design cross section and the sand the storm pushed up the seaward face of the seawall was extracted and formed into the dune seen on the left view October 17, 2013. A wide, new berm accumulated between February and October 2014 adding 42.25 yds³/ft. to the profile.

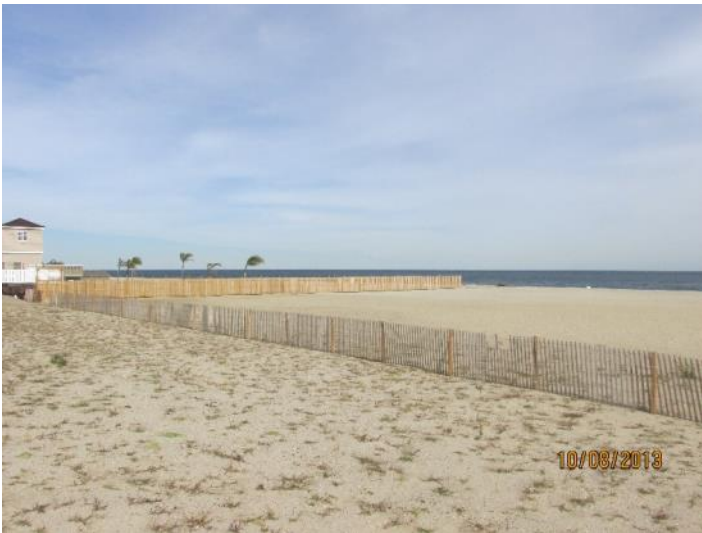
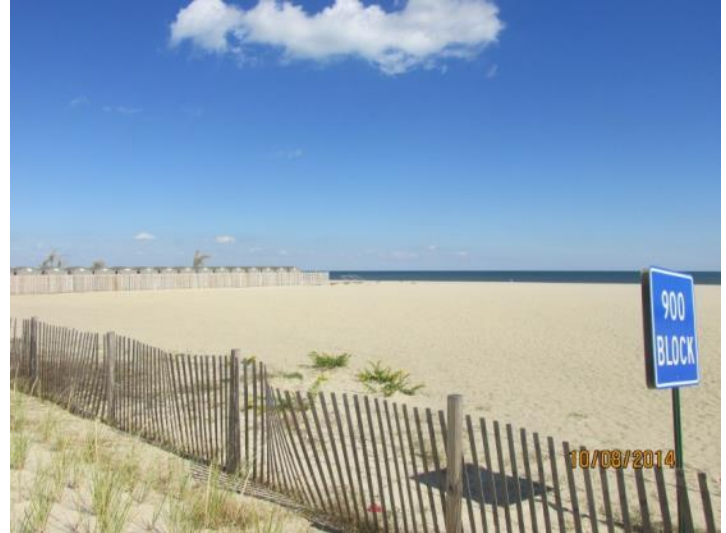
By October 8, 2013 the ACOE had restored the beach width and a dune was added from sand extracted from inland and the material ramped up to the rock seawall. The dune was modified over the winter with more material deposited as a berm.

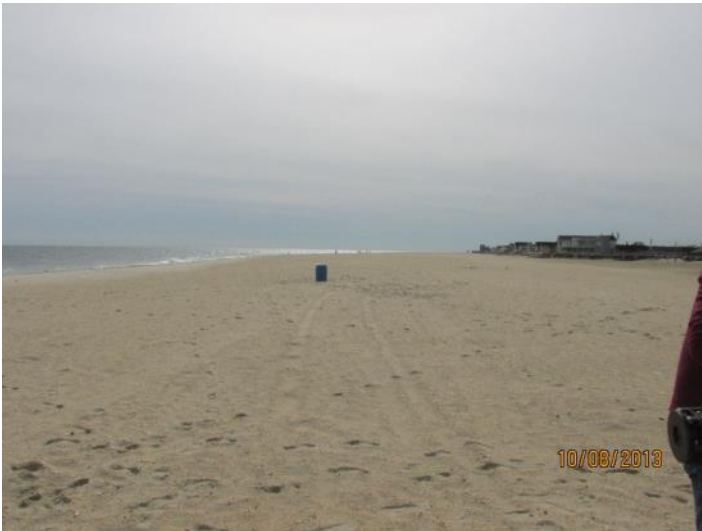
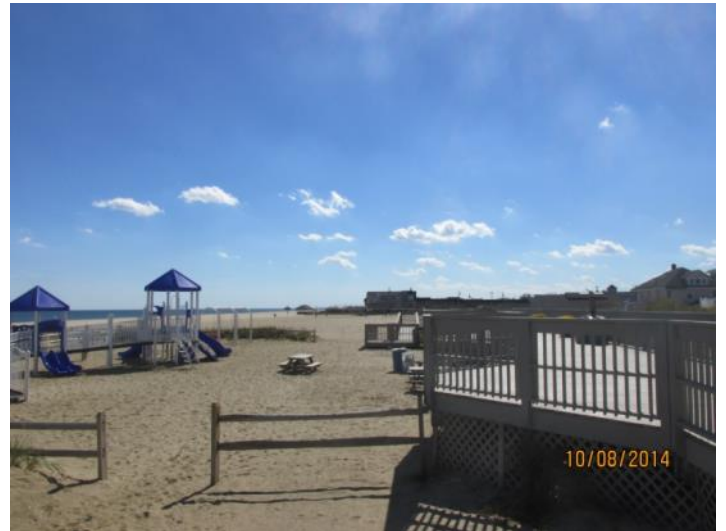
By October 8, 2013 the ACOE had deposited 110.88 yds³/ft. to restore the design cross section. The view one year later (Oct. 8, 2014) shows the new deck and access ramp to the beach.

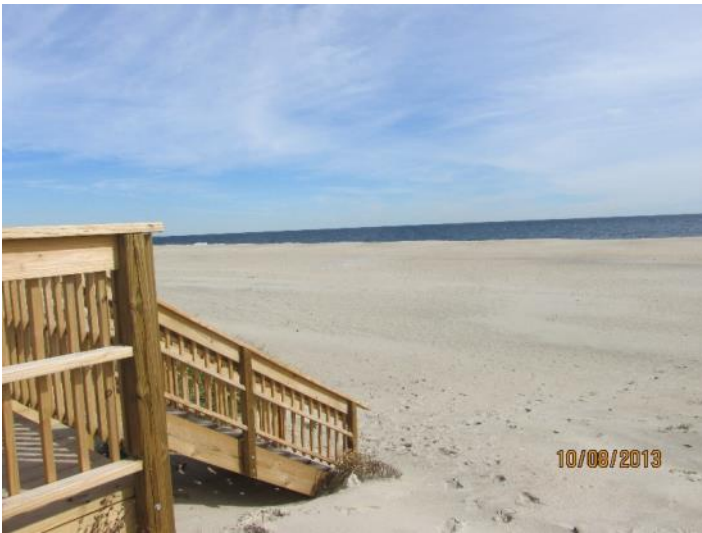
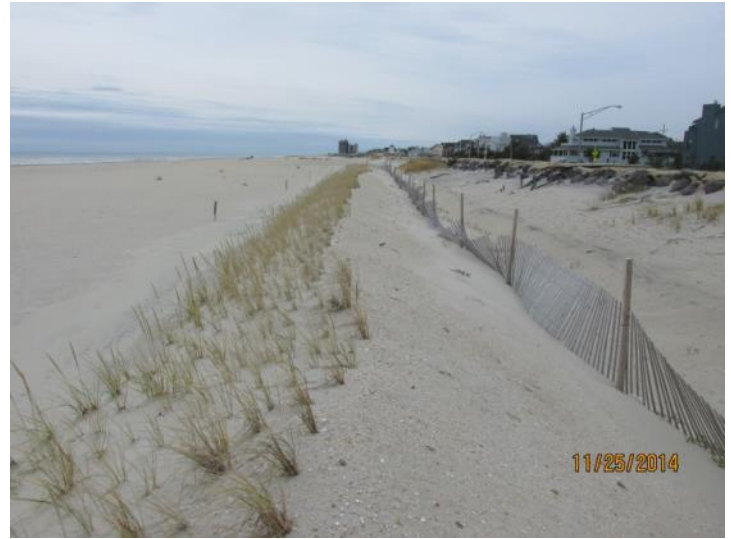
The restoration by the ACOE had just been completed in the left photo taken October 8, 2013 with the addition of 101.64 yds³/ft. to the profile's cross section. A small dune was added by the summer of 2014 as sand was redistributed somewhat at the water's edge over the course of 2014.

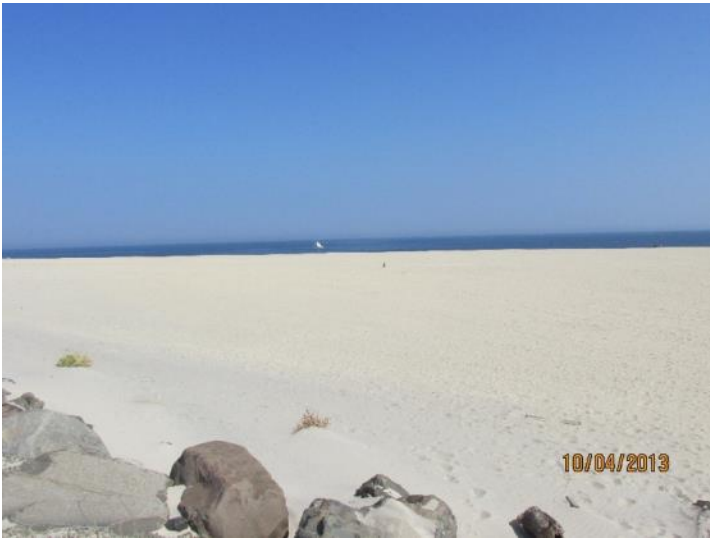
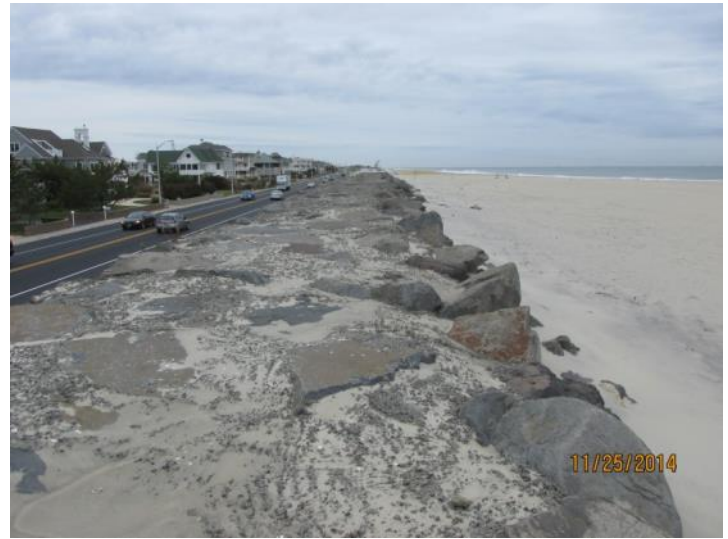
This site has the worst erosion history of any site in Monmouth County. The left photograph Oct. 4, 2013 shows the completed work by the ACOE (182.99 yds³/ft. added to the beach). On the right the existing beach has narrowed with no dune built on site.

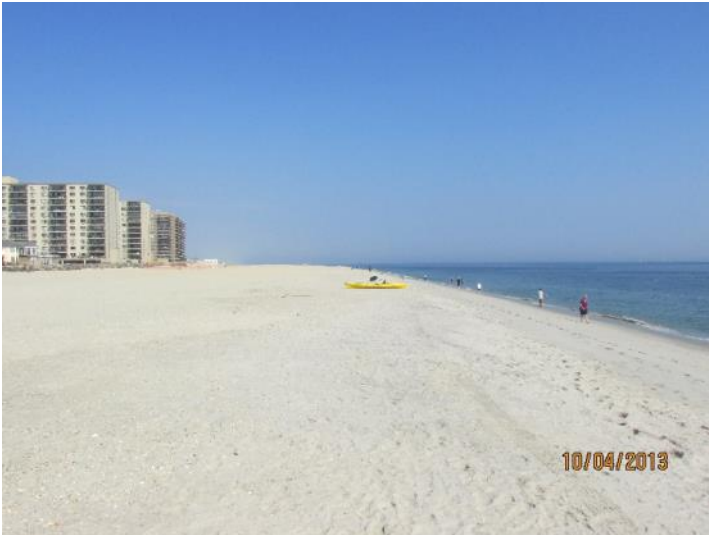
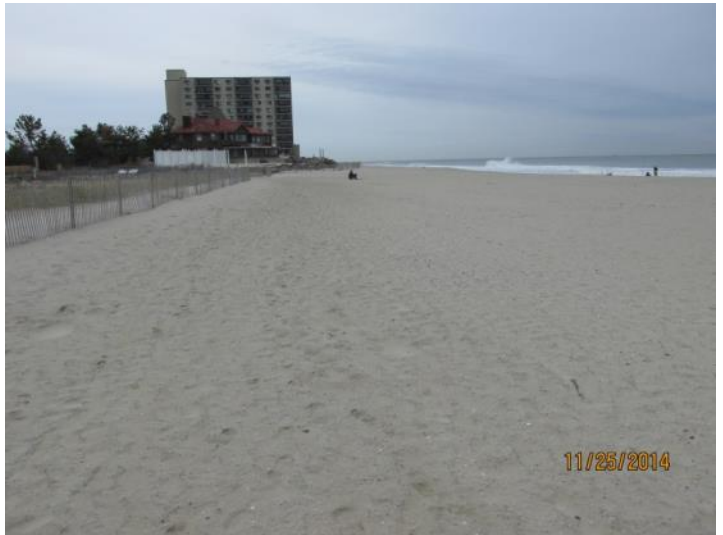
The left photo taken October 4, 2013 shows the results of the ACOE work to restore the project to design specifications (140.98 yds³/ft. of added sand). To the right the beach remains substantial by November 25, 2014.

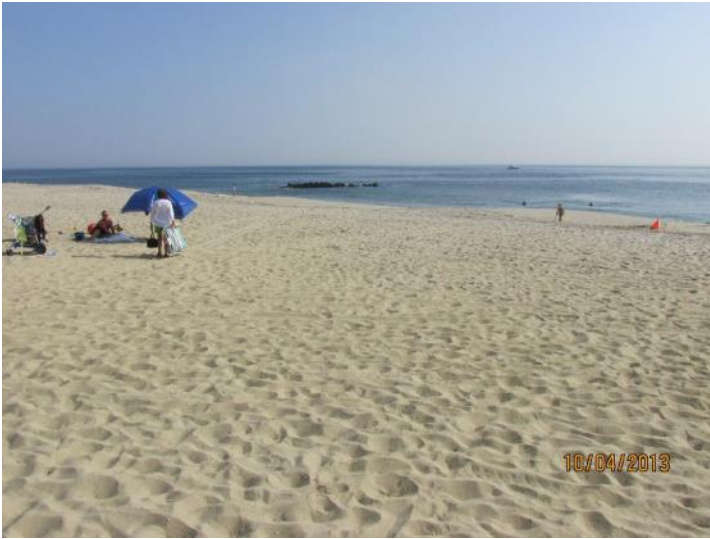
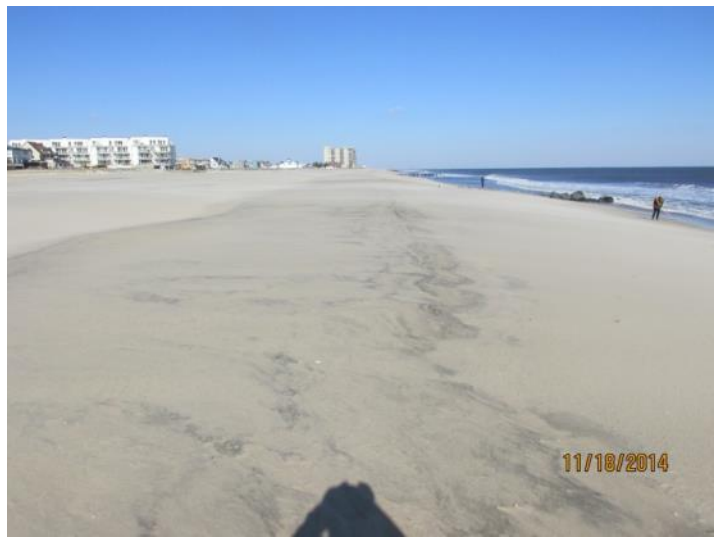
The left photo was taken October 4, 2013 following the recovery of 22.93 yds³/ft. on the beach naturally, prior to the arrival of the ACOE to complete the northern segment of their project. The beach gained 123.04 yds³/ft. over the 18-month interval. The shoreline advanced 185 feet as well.

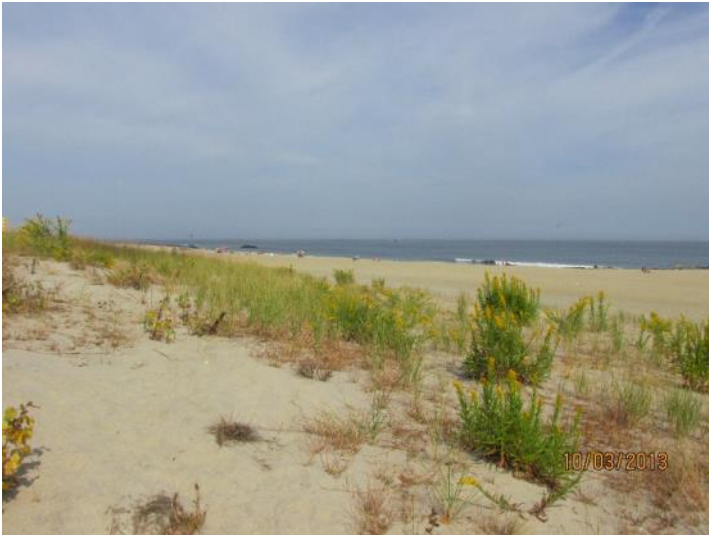
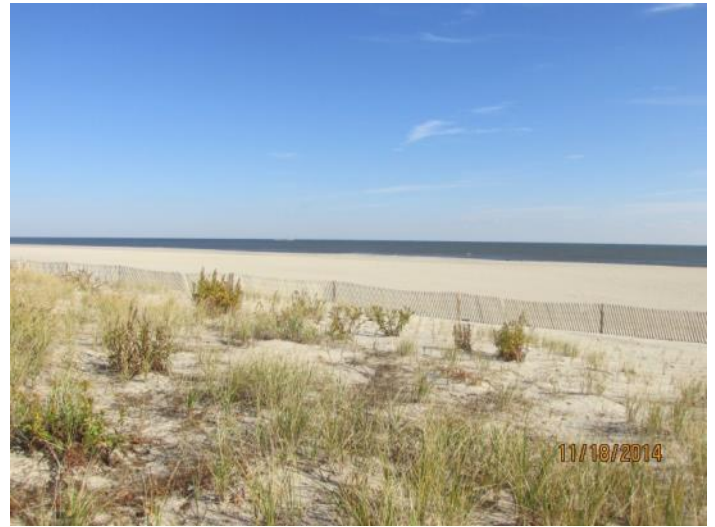
This site is a popular recreational park with a partial ridge of 25-foot elevation dunes. Natural recovery added 20.68 yds³/ft. to the beach prior to the ACOE work (left photo taken October 3, 2013) and by survey #48, the sand volume increased by 115.73 yds³/ft.

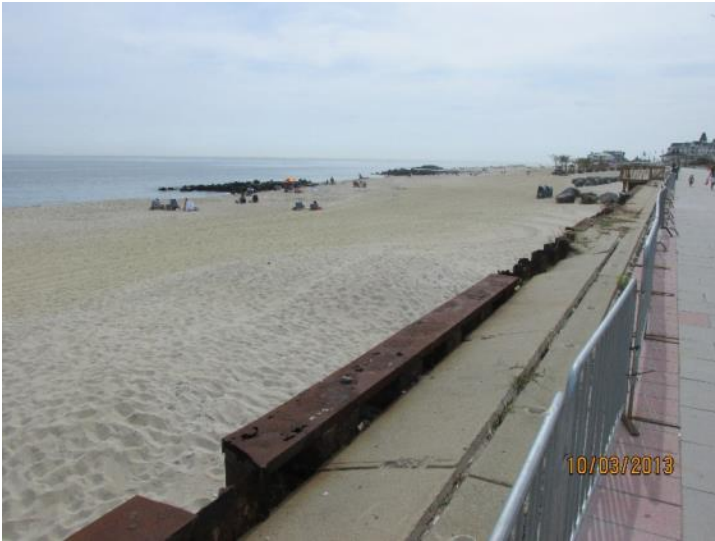
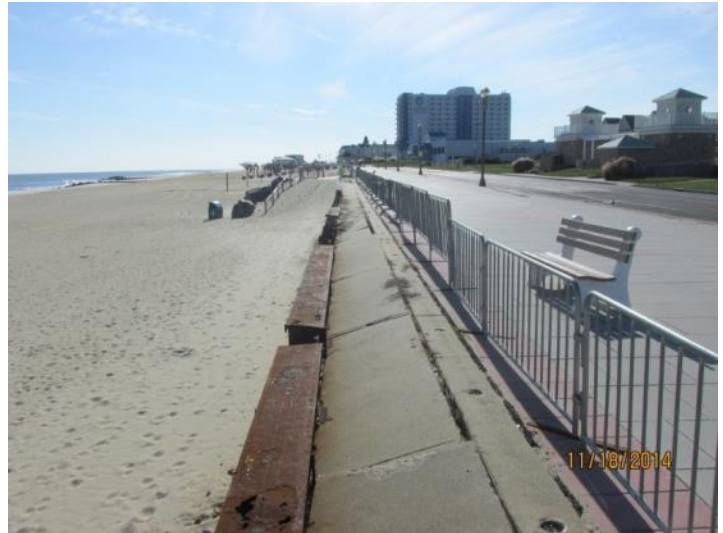
Natural recovery from the offshore deposits added 22.72 yds³/ft. to the beach prior to 2014 ACOE restoration activities. The right photograph taken November 18, 2014 shows a wider beach relative to the rock groins compared to the left photo.

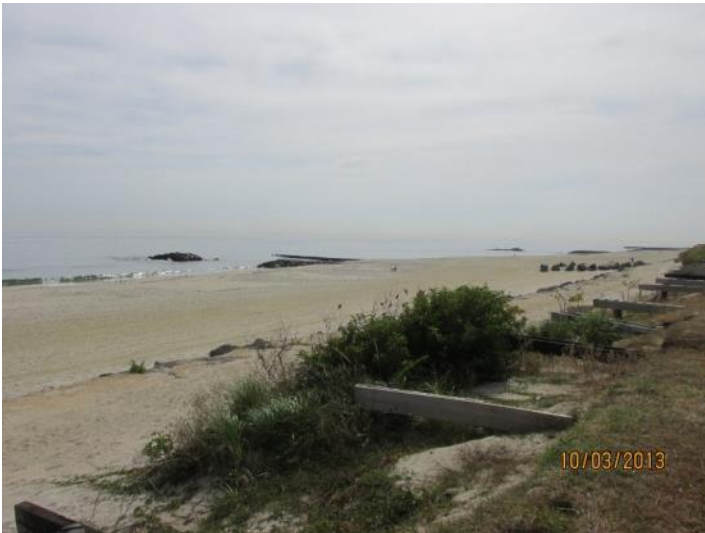
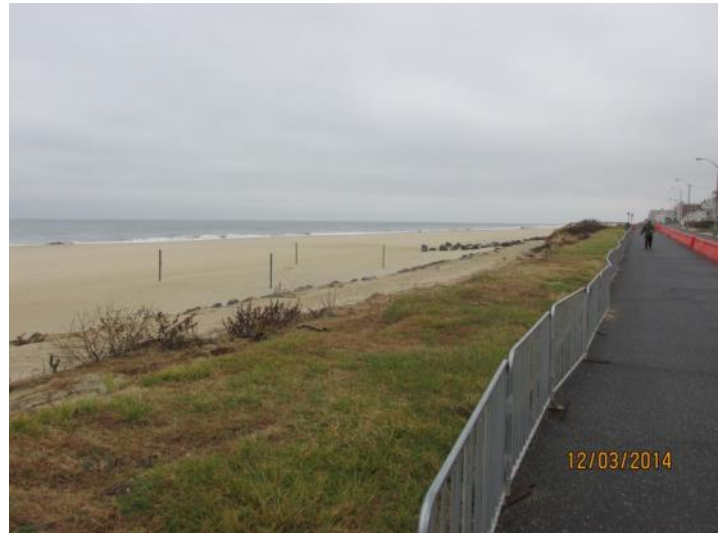
It appears as if the City has moved the pedestrian walking zone onto half the remaining southbound roadway that once existed here as a dual road as Ocean Avenue plus the boardwalk in 1960. The ACOE activity is very evident in the right picture taken December 3, 2014.

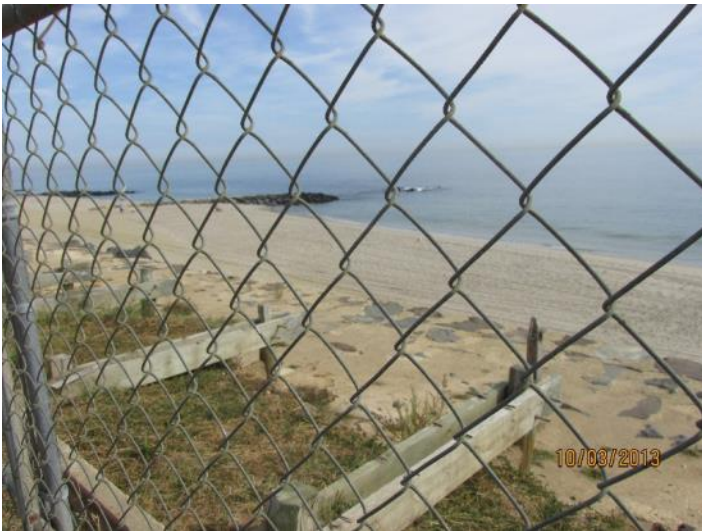
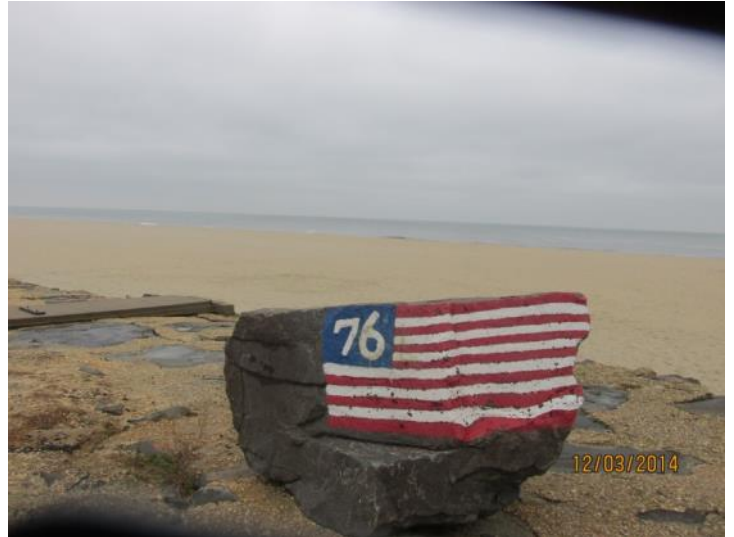
This site is located near the southern limit of the Federal beach nourishment project. The fencing keeping people out has been removed with the walkway moved onto the southbound road once part of Ocean Avenue. The December 3rd view shows artwork on one revetment rock re-deposited on the seawall, looking over the new federal beach.

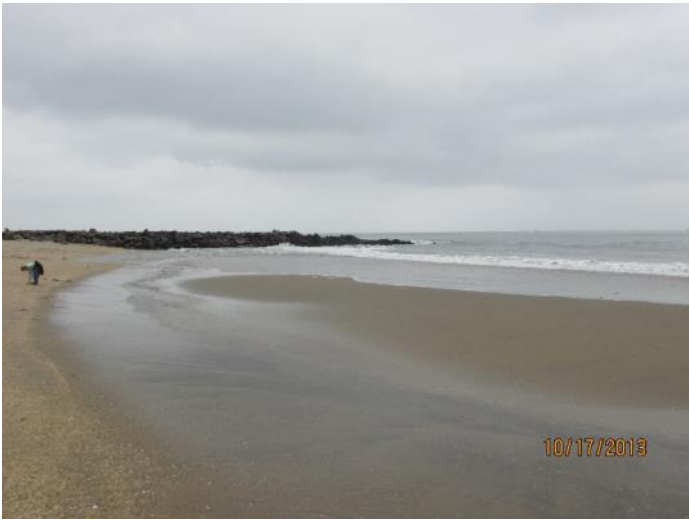
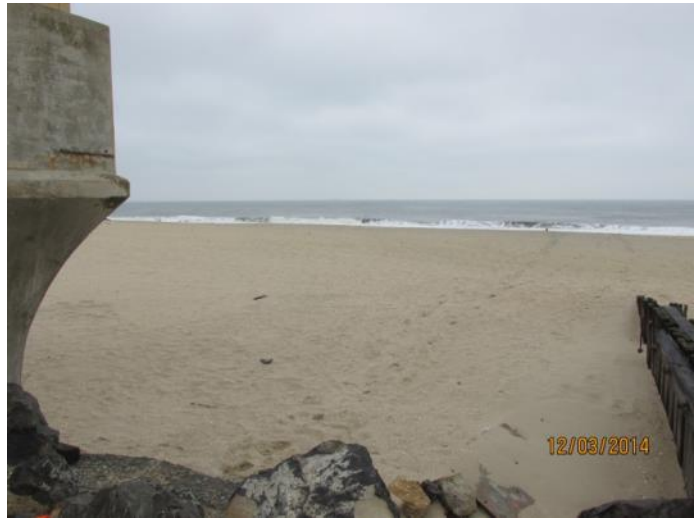
This site, established in 2010, is located on the northeastern edge of Lake Takanassee and within a groin compartment. On the left (Oct. 17, 2013) the swash zone and beach extends to the north. The ACOE restoration effort extended to the south into Elberon during 2014.

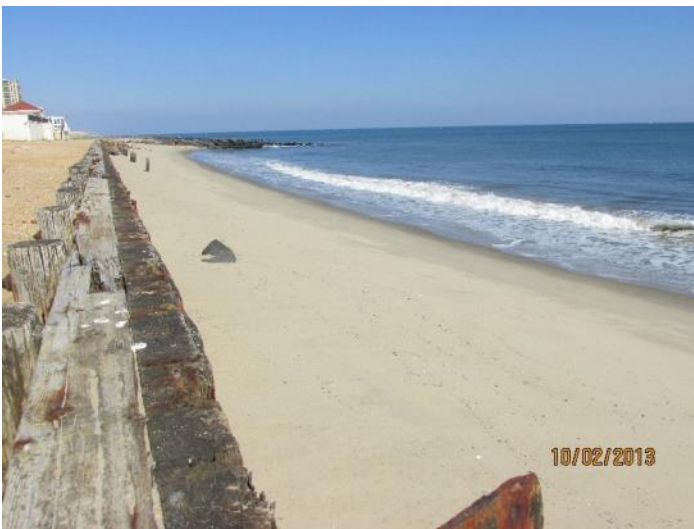
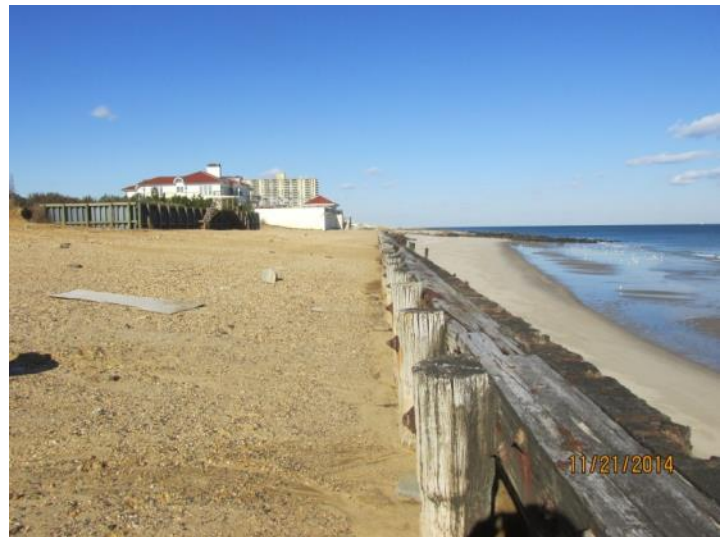
NJBPN 171 – Pullman Avenue, Elberon

This site is located on the highest point along the bluff shoreline and erosion of the bluff generated the first dry beach ever seen October 2, 2013. Over a year later the beach is narrower, but still present.

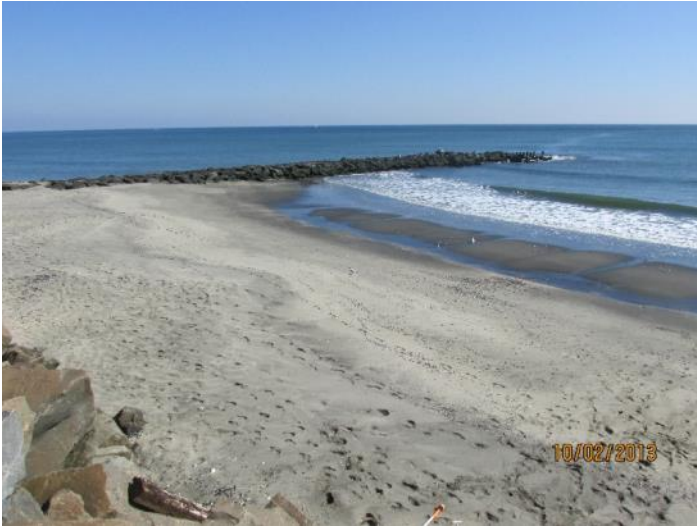
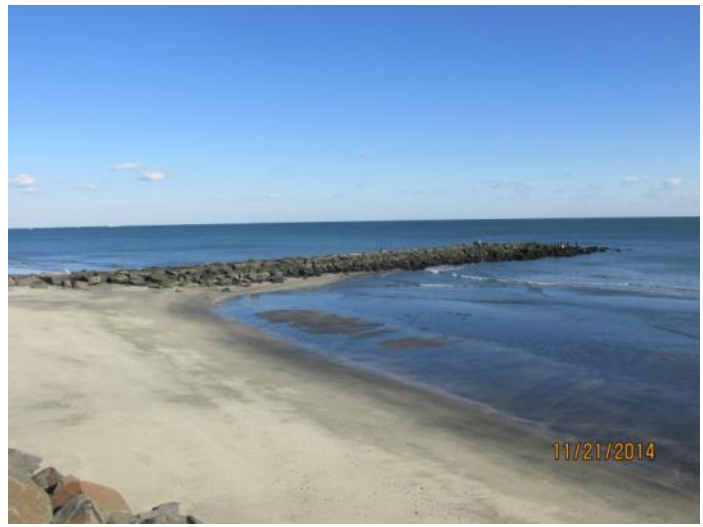
This profile is located between two rock groins that limit sediment movement. This area has never received sand from direct beach nourishment and has never benefited from the addition of sand from the littoral system derived from the Federal beach fills. The photo on the left (taken October 2, 2013) shows the deposit of sand derived from the storm erosion of the bluff. By November 21, 2014 sand moved offshore and adjusted lower at the rocks.

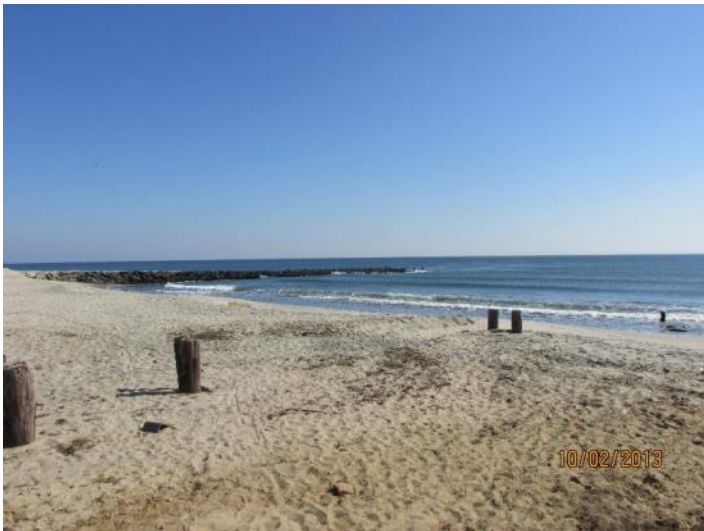
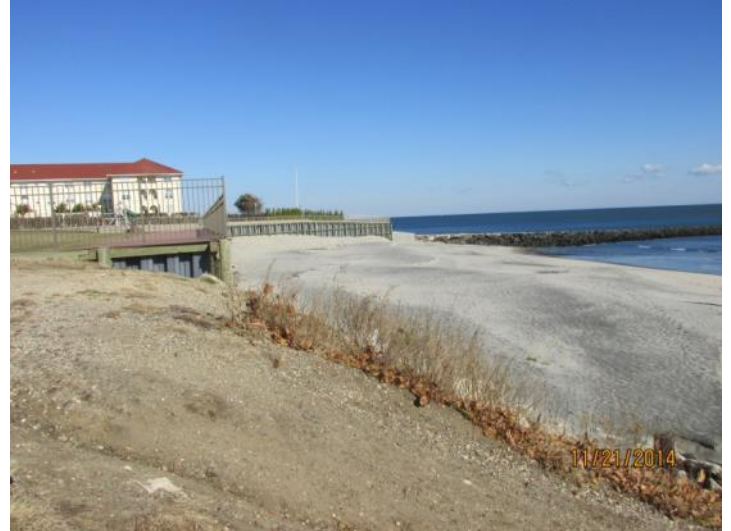
The Darlington site has a small sub-aerial beach contained between two larger groins. The upland bluff was eroded significantly during Sandy and added to the beach sand. By October 2, 2013 (left) natural recovery added 21.60 yds³/ft. back to the beach with some reconstruction of bluff protection structures. A year later the beach gained 4.72 yds³/ft. with a 5-foot shoreline advance.

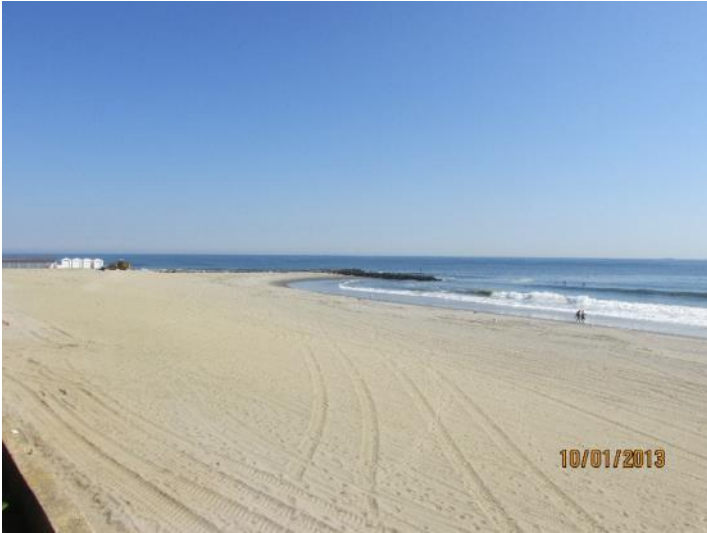
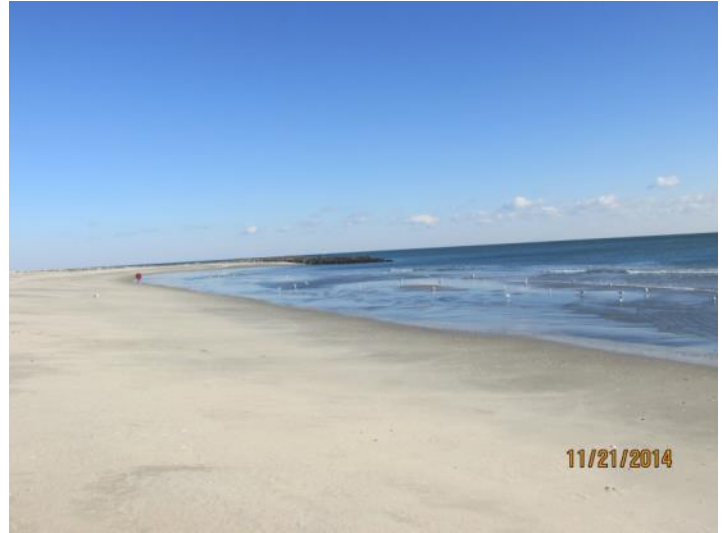
This site in Allenhurst also represents the shoreline conditions for Loch Arbor’s 2-block shoreline. Here an old concrete wall protects the sedimentary bluff. The left photograph shows conditions as of October 1, 2013 when a fairly significant wedge of sand was on the berm. Reduced during the following year, the deposit is still better than it was April 2013.

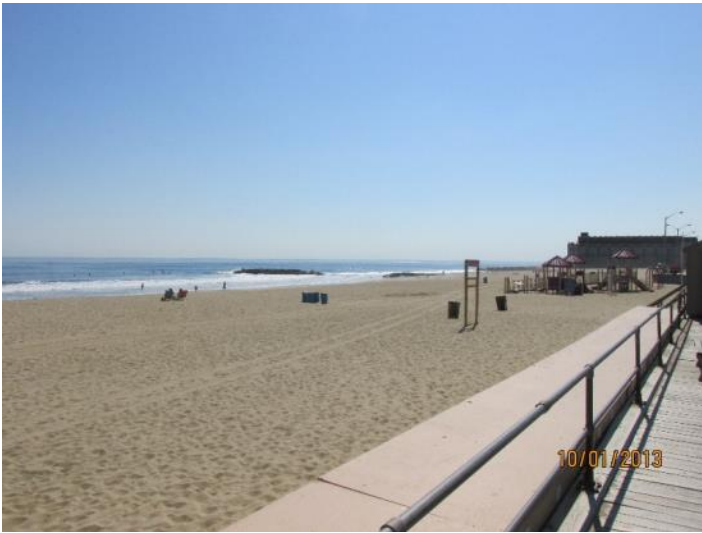
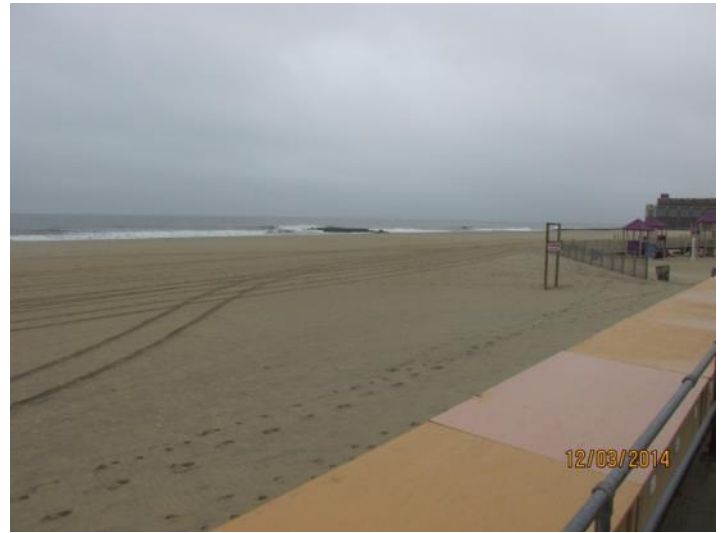
This site is the northernmost site included in the Federal shore protection southern project segment. The left photo (taken on October 1, 2013) showed natural sand recovery. Natural recovery permitted 17.79 yds³/ft. in offshore deposition to return to the beach. The federal project added 92.68 yds³/ft. and produced a 100-foot shoreline advance.

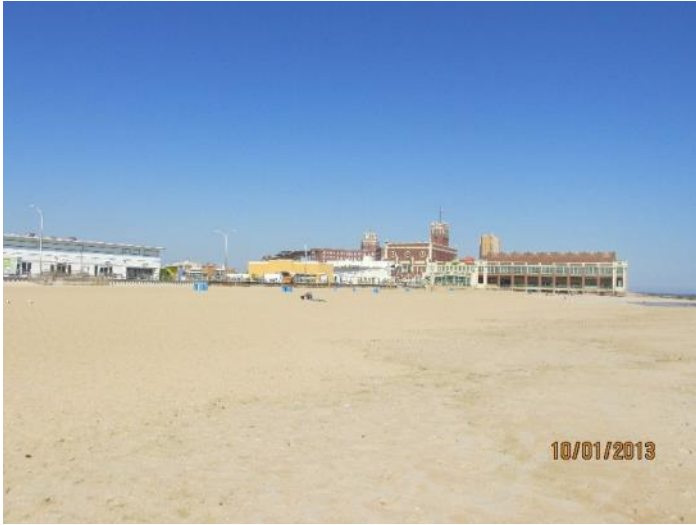
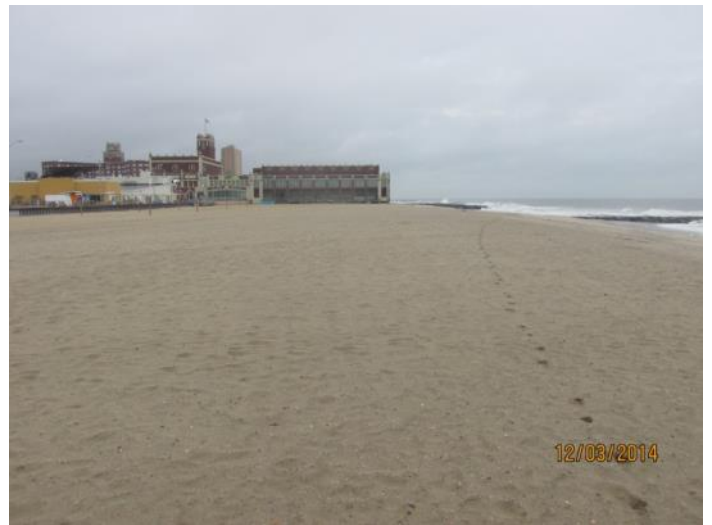
By October 1, 2013 natural recovery had restored 26.98 yds³/ft. to the beach prior to the ACOE completing this southern section's project restoration. The ACOE work added the berm as more sand accumulated offshore.
