New Jersey Beach Profile Network 2014 Annual Report on Shoreline Changes in New Jersey's Four Coastal Counties Raritan Bay to Delaware Bay Spring of 2013 Through Fall of 2014

New Jersey Beach Profile Network 2014 Annual Report

Shoreline Changes In New Jersey In the Four Coastal Counties Raritan Bay to Delaware Bay

NJBPN Profile #'s
187 - 256

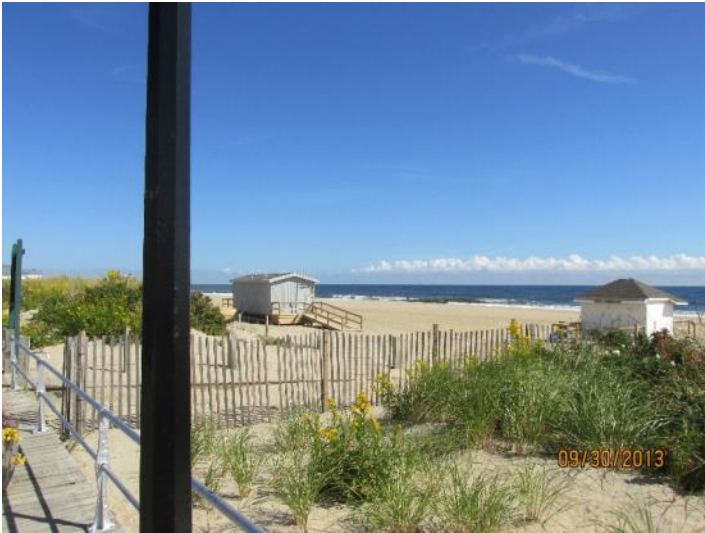
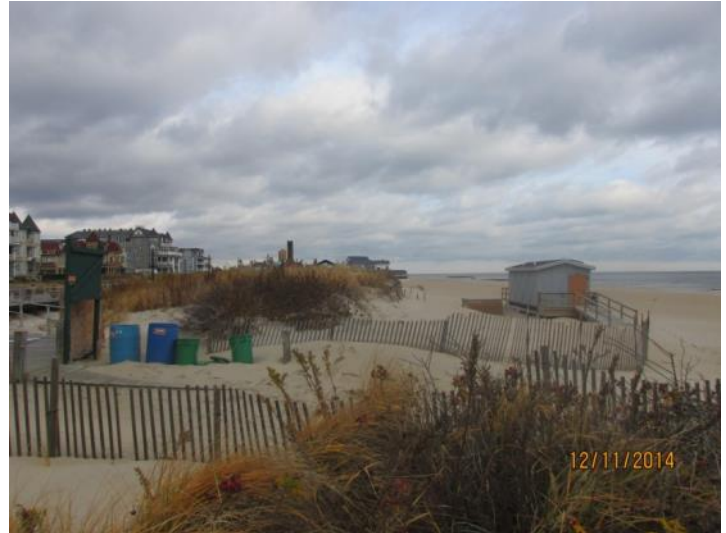
By September 29, 2013 the beach had recovered 22.65 yds³/ft. prior to the ACOE commencing restoration work. The sand volume added over the next year amounted to 35.79 yds³/ft. with a 12-foot shoreline advance (12/11/2014).

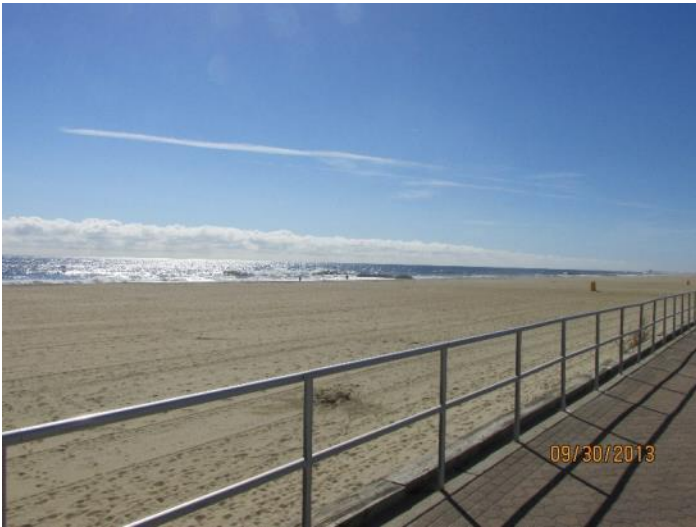
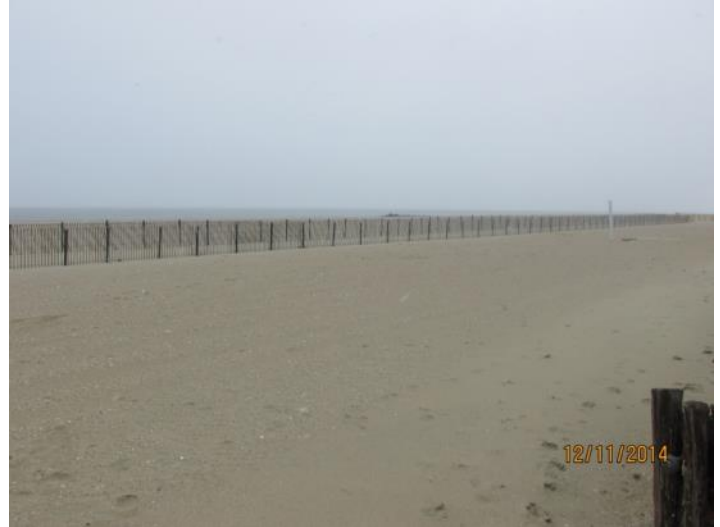
No dune was restored by September 30, 2013, but 9.77 yds³/ft. in offshore sand deposits had returned to the beach prior to the ACOE work on this shoreline. The beach and fencing was restored as of December 11, 2014 adding elevation to the beach if not much width.

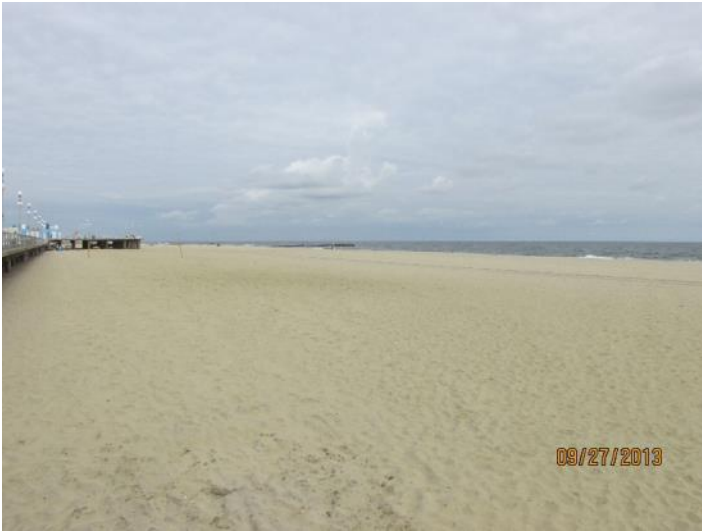
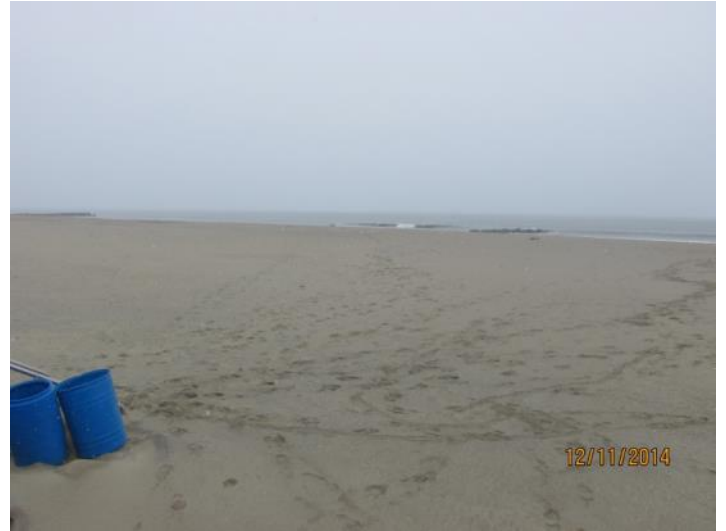
This site is located north of the Shark River inlet and was nourished in the 1999 Federal shore protection project. 10.48 yds³/ft. in natural recovery was added to the beach by Sept 27, 2013 prior to the ACOE restoring the beach to their design specifications. Sand was added across the berm to raise the beach elevation and increase width.

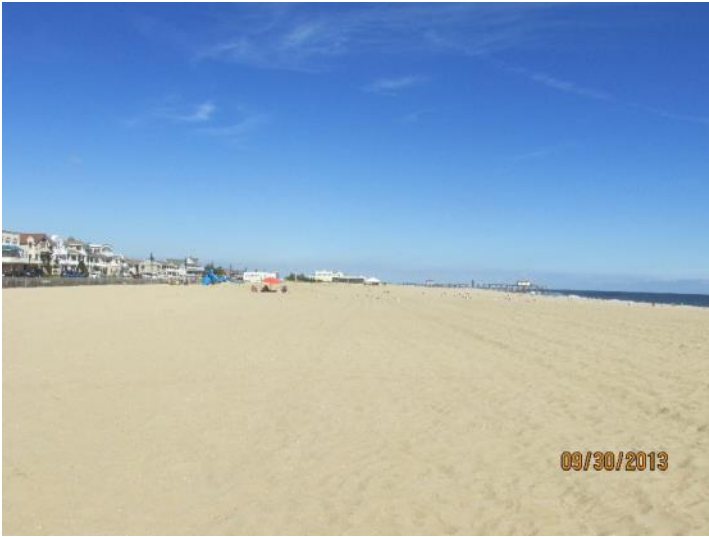
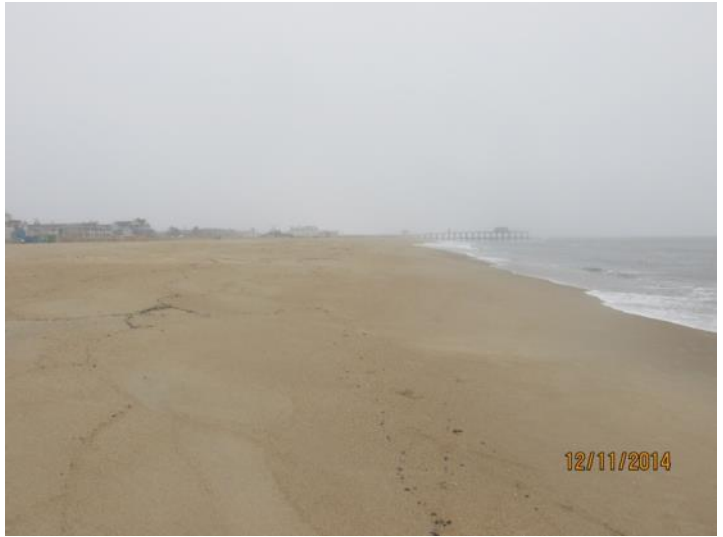
This site did not have a dune prior to Sandy but had a wide, dry beach. Natural recovery brought 31.76 yds³/ft. of sand back to the beach leaving little additional sand placement by the ACOE later into 2014.

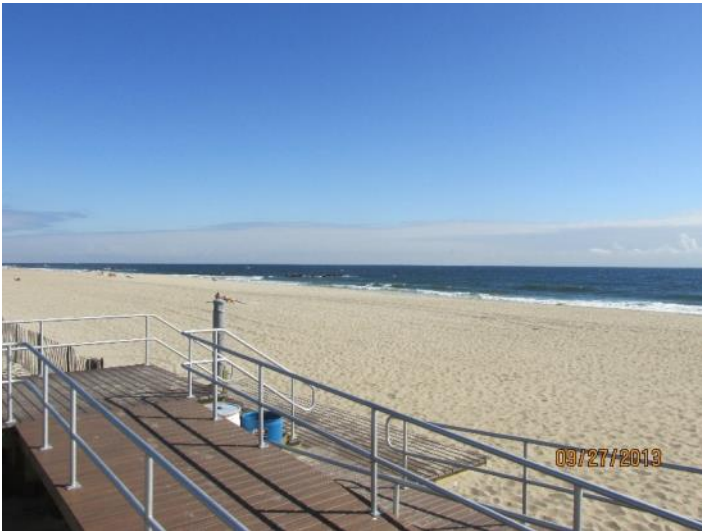
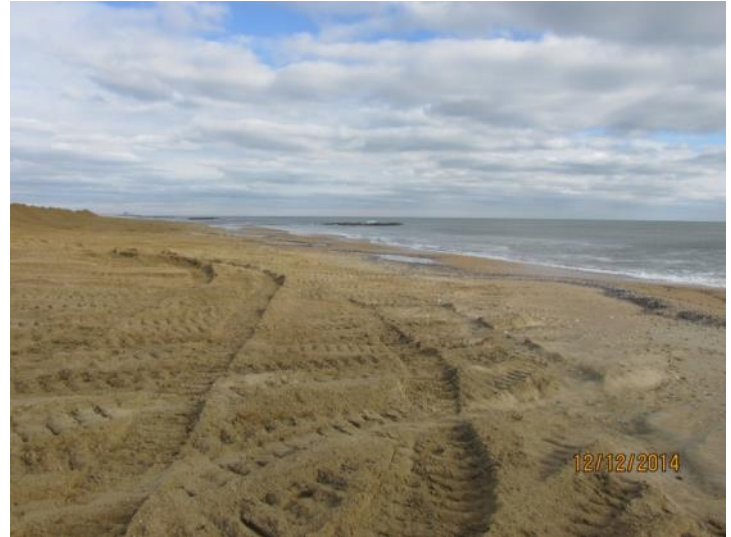
The southern Belmar shoreline saw 11.23 yds³/ft. recovered on the beach naturally by 9/27/2013. ACOE work was in progress on December 12, 2014 to widen the beach and add sand.

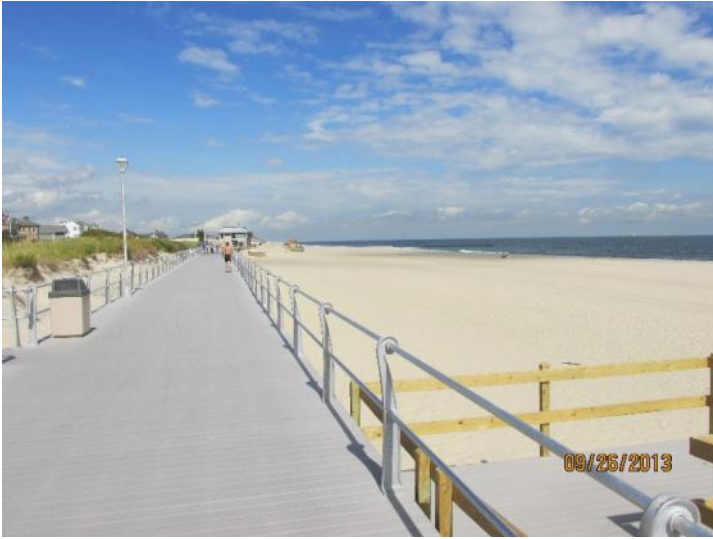
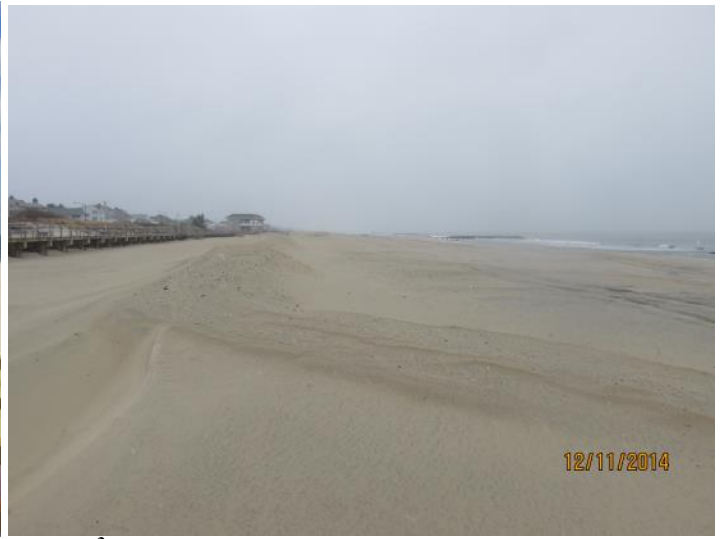
A massive effort restored the boardwalk by Sept 26, 2013 and 31.40 yds³/ft. in eroded beach/dune sand returned to the beach naturally. By December 11, 2014 (right) the ACOE had added 40.47 yds³/ft. in new sand advancing the shoreline by 13 feet.

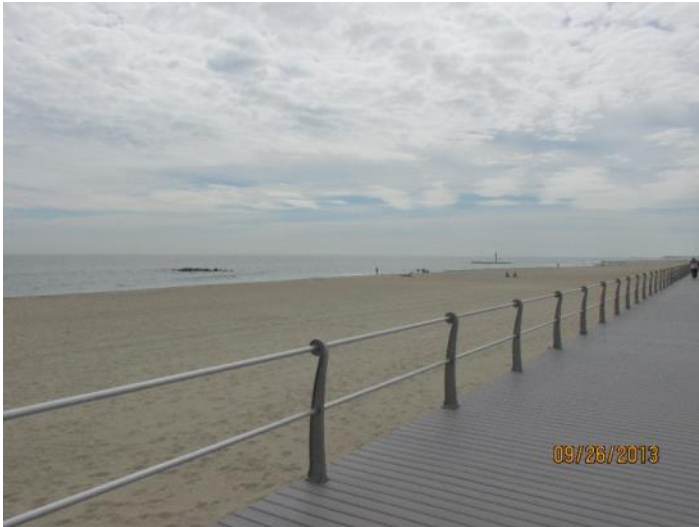
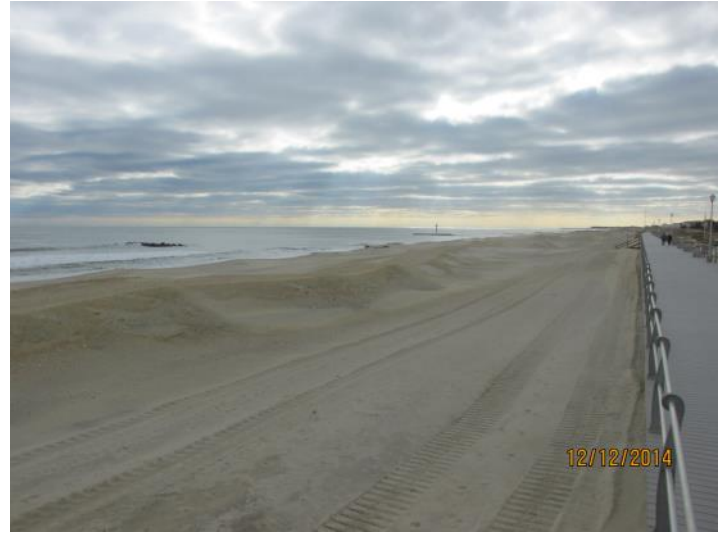
By the end of September 2013 the boardwalk was replaced with a modest recovery in beach sand from offshore sources. The ACOE completed restoration in 2014 adding 32.29 yds³/ft. This site did not have a dramatic post-construction outcome.

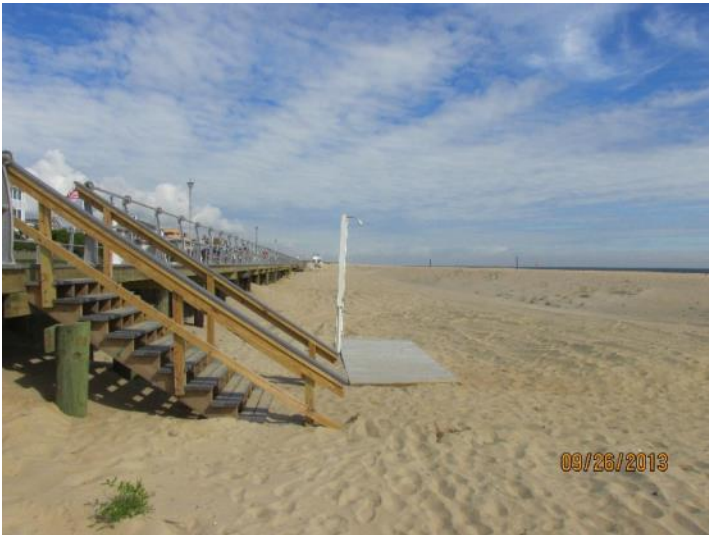
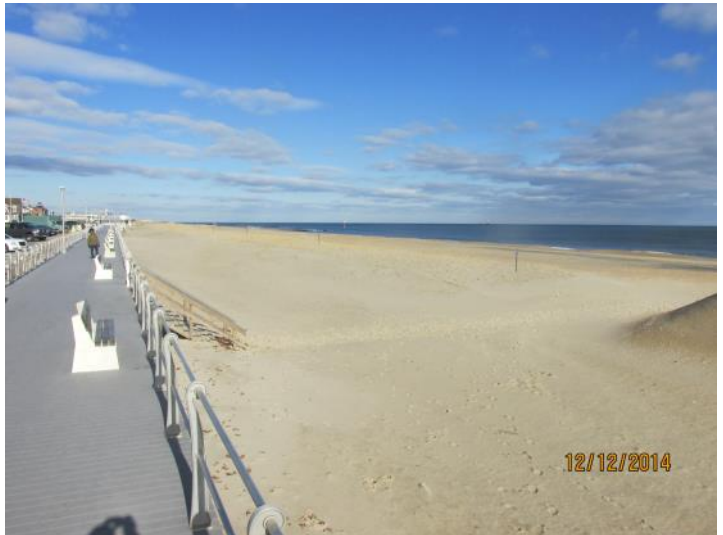
Boardwalk damage was restored and 39.16 yds³/ft. in lost sand returned by Sept 26, 2013 from deposits formed offshore. Modest additions were made by the ACOE during 2014 (23.81 yds³/ft.) and the beach was wider.

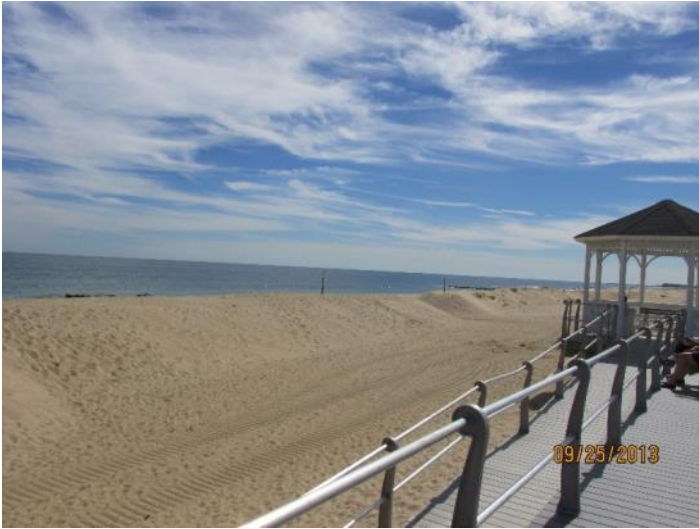
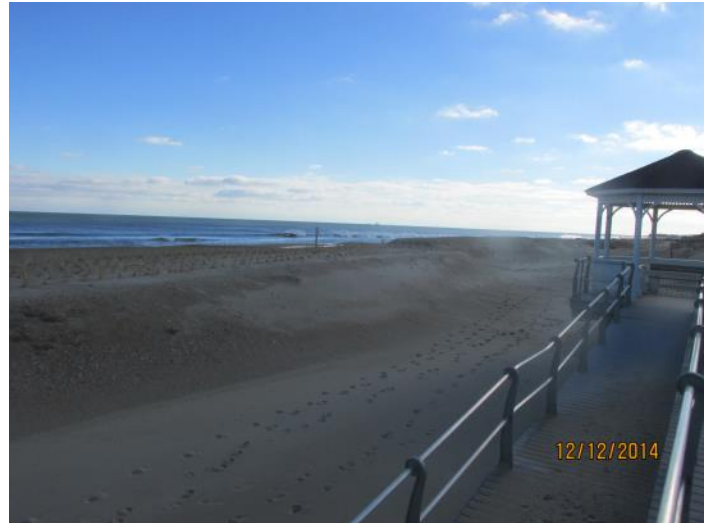
The ridge of recovered sand remains along this segment of the Borough beach and was augmented by 35.07 yds³/ft. in sand returned to the beach from offshore. Sand was added by the ACOE in early 2014 and the recovered sand was molded into a dune ridge at the toe of the primary dune.

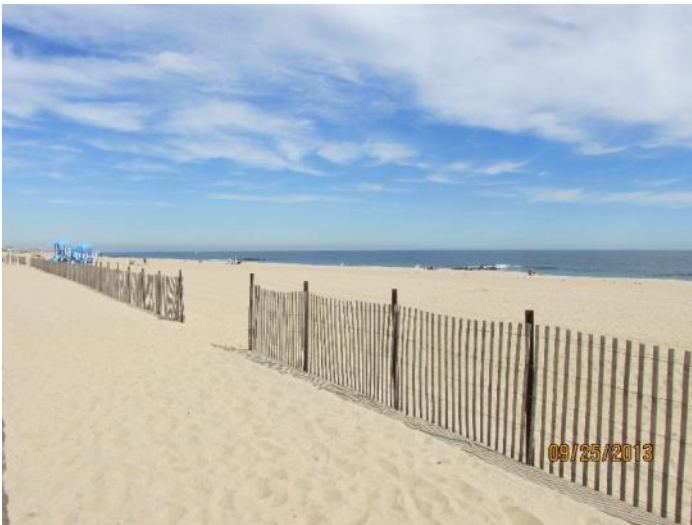
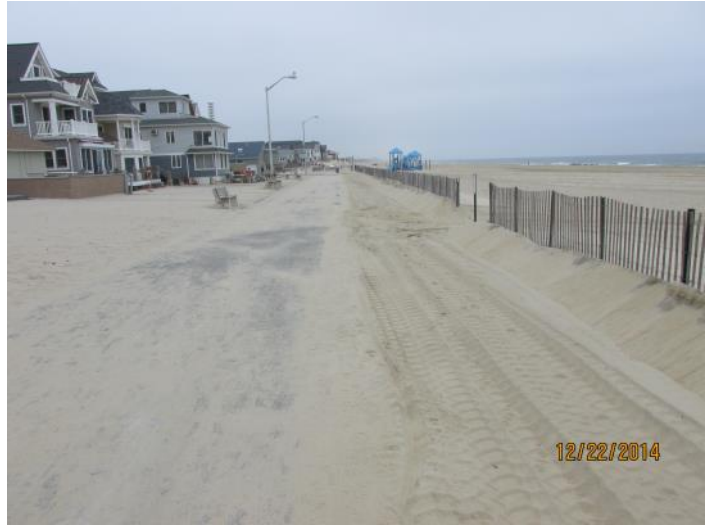
At Riddle Way, material was recovered and spread with little help from offshore migration (1.20 yds³/ft. 9/25/2013). By May 2014 the ACOE had added sand to the beach, but with the shoreline-parallel sand fencing located at the promenade, there has been little dune development since Sandy.

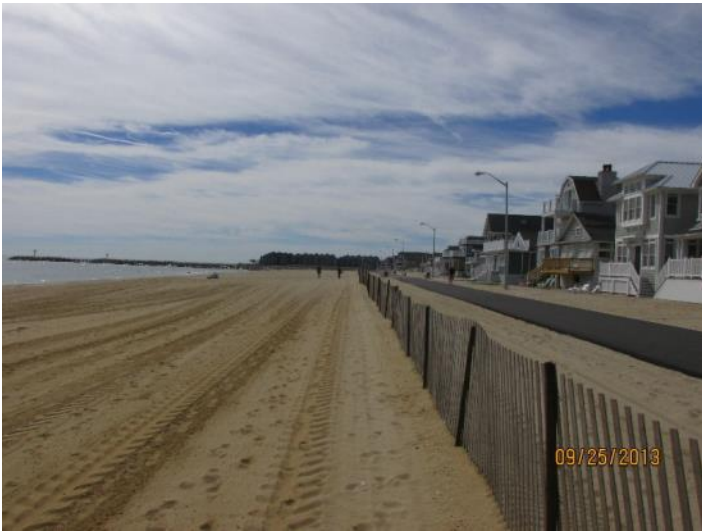
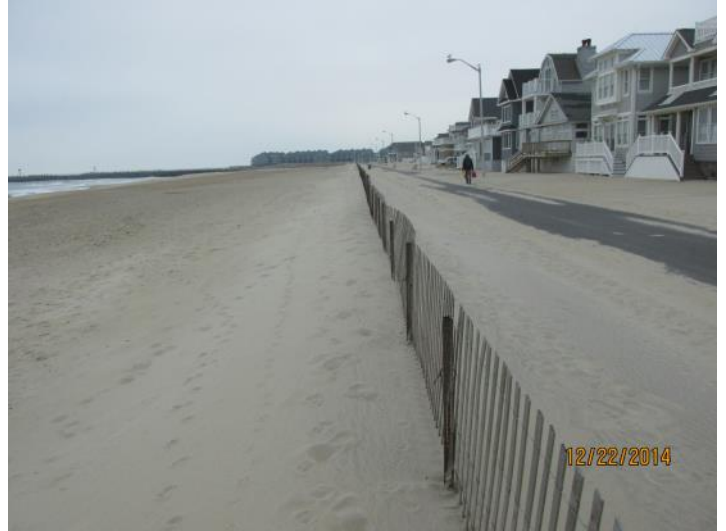
This site is located just north of the Manasquan Inlet. By 9/25/2013 the structural damage was restored, no dune replaced the loss and just 12.80 yds³/ft. was recovered naturally by the beach from offshore. By May of 2014 the beach had 82.26 yds³/ft. in new sand added by the ACOE resulting in a 113-foot shoreline advance.
